1 Pump House Close, London SE16 7HS

Heritage Statement

Reinstatement of pre-existing window to side facade and enlargement of existing window to the rear.

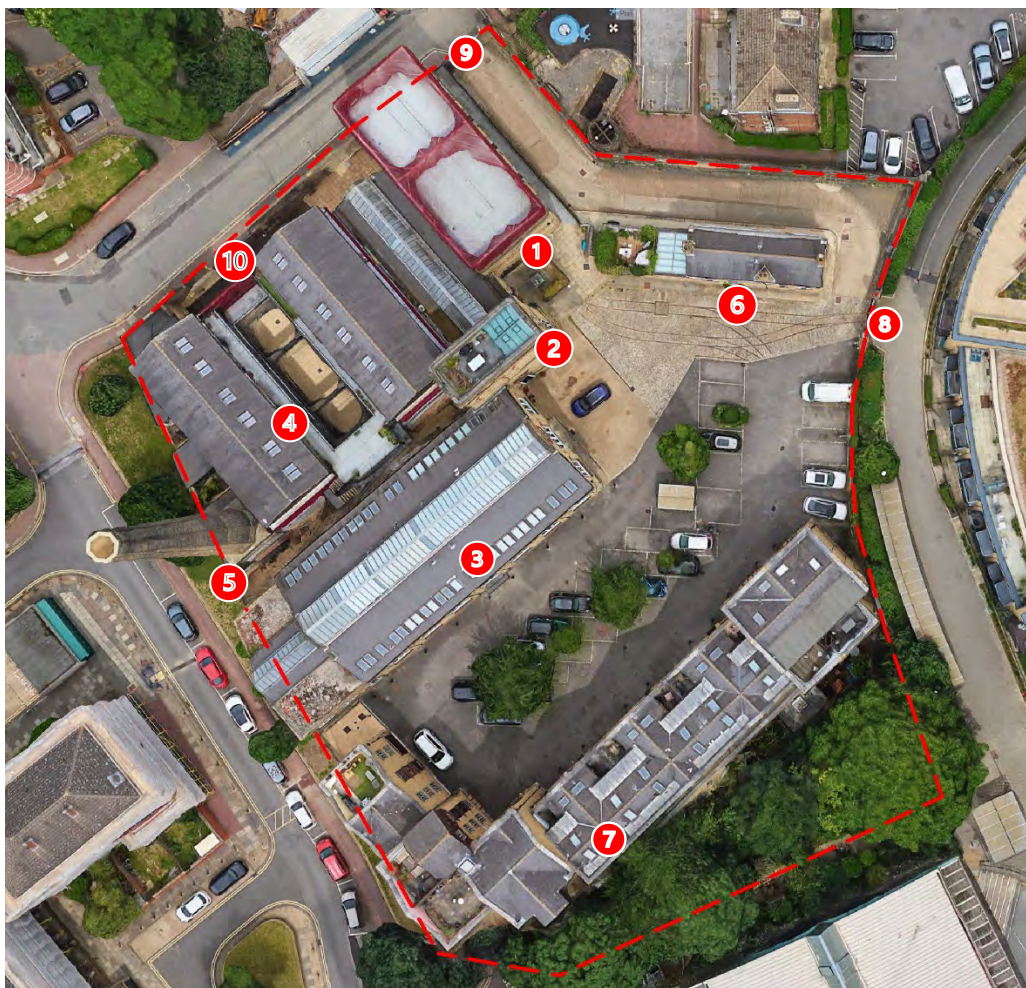
Figure 3: Satellite image of the site: (1)The Gateway Building (ex-Coal Store), (2)The Accumulator Tower, (3) The Engine House, (4) The Boiler House, (5) the Chimney, (6) the Pump House Master's cottage and the Tramway rails, (7) New-built residential buildings with parking yard in front of them, (8) pedestrian access from Albatross way, (9) vehicular access from Renforth Street (10) access to the lower yard to 70 Renforth Street.

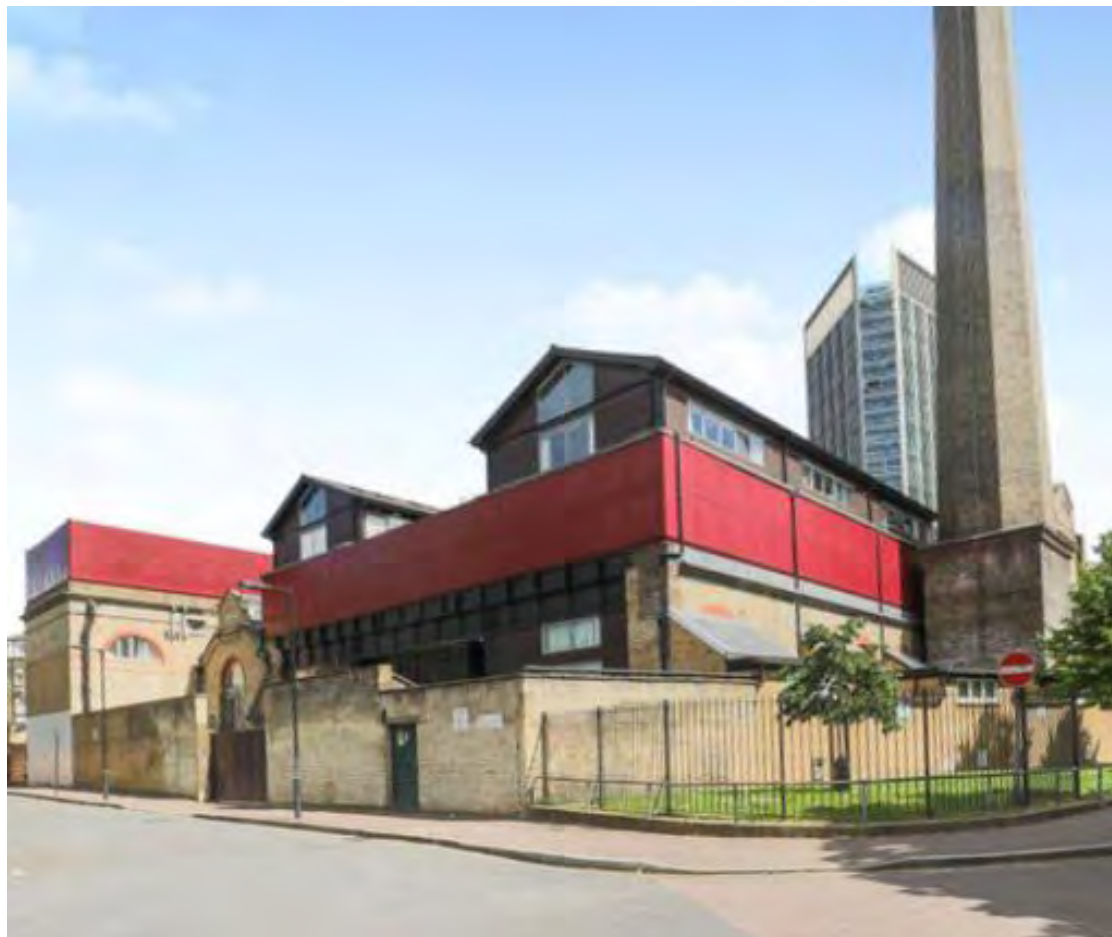
Besides the alterations described in the previous pages, the major alteration to the original buildings consisted in the addition of two pitched-roof blocks placed on the water tank of the boiler house visible from Renforth Street.

Figure 4: The two pitched-roof blocks added with the conversion viewed from Renforth street.

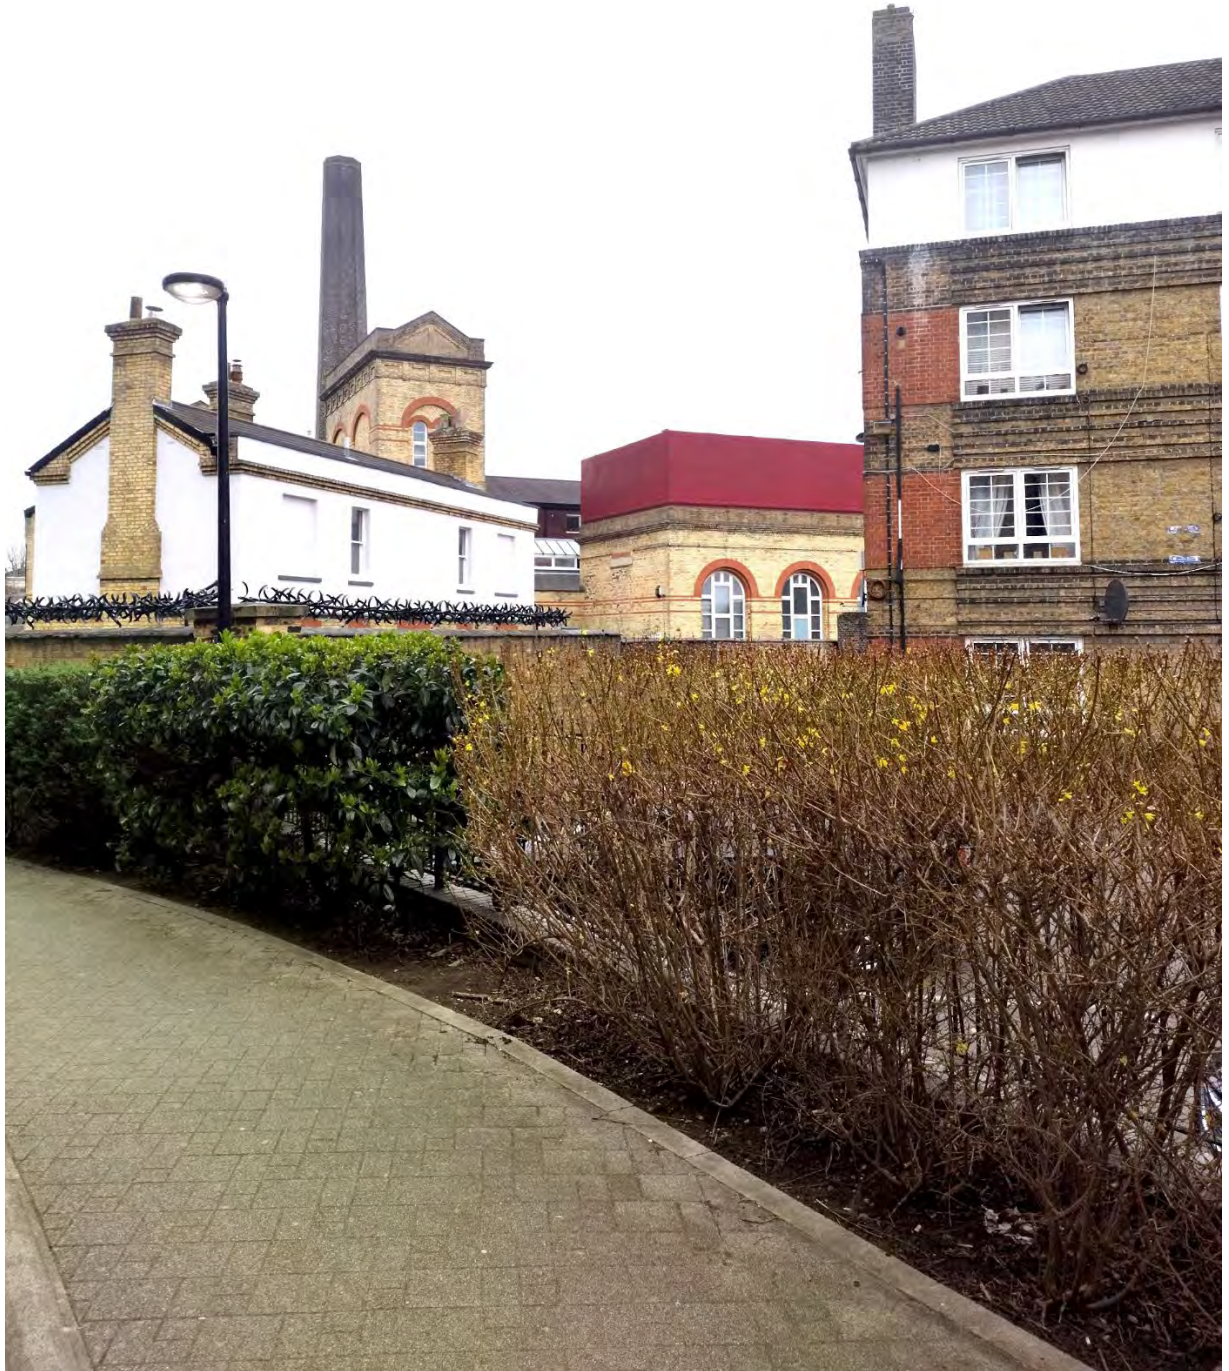
Figure 5: The Pump Station from Albatross Way. IN the red square, the area of the side facade where it is proposed to reinstate the opening.

As shown in the image next page (figure 5), from Albatross Way, besides the chimney and the Accumulator Tower, it is possible to spot the Gateway Building (Coal Store), the Pump House Master's Cottage, and, in the background, the additional blocks over the Boiler House.

To be noted that the side façade of the Gateway Building and the area where is proposed to reinstate the opening, is visible from this pathway.

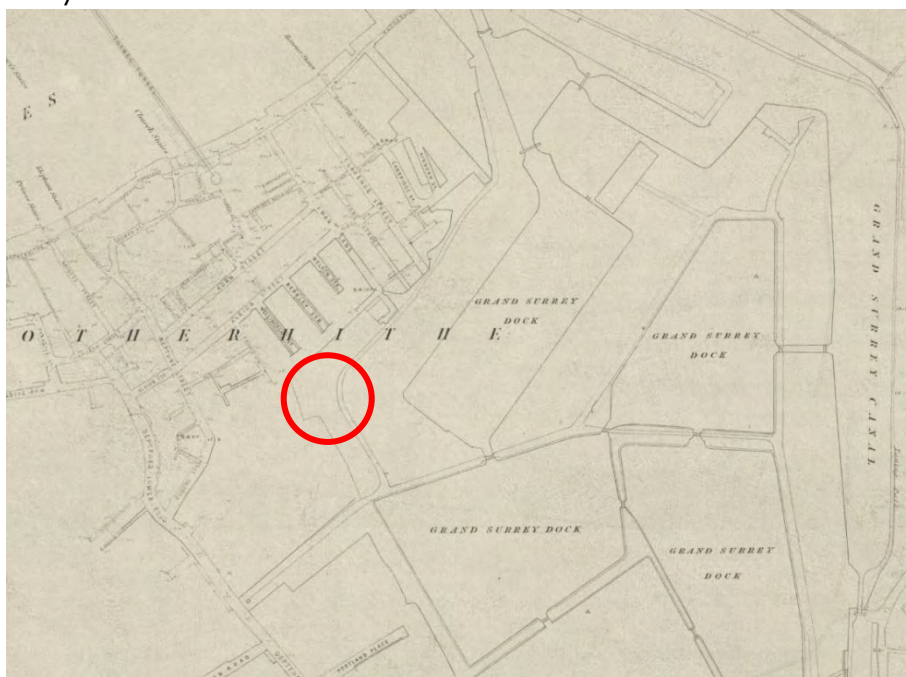
The map below⁵ shows the site before the construction of the pumping station marked by the red circle.

Figure 6 London and its environment Sheet VII.SE -surveyed 1848-51 - published 1851.

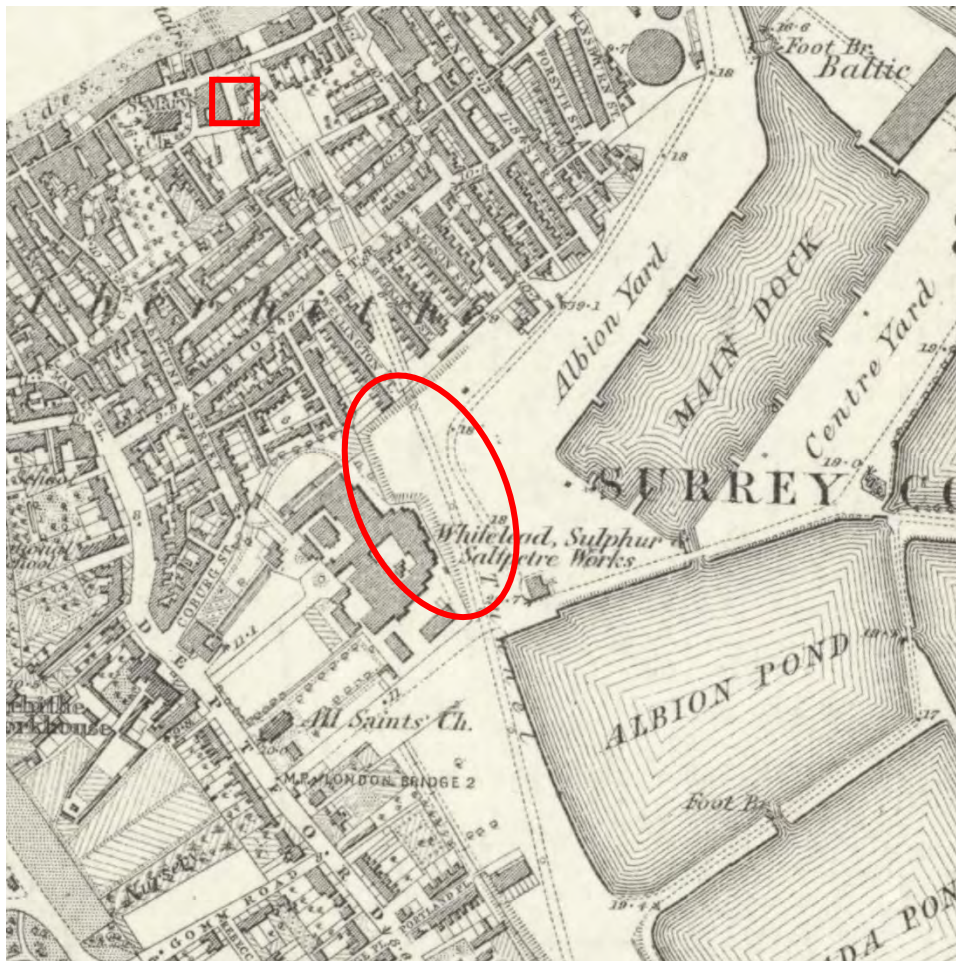
Figure 7 Essex Sheet LXXXI - surveyed 1862-1873 - published 1870-1882. In the red oval the embankment of tipping soil from the building of the docks nearby. It is also visible as dotted line the tunnel under the Thames of the East London Railway (currently use by the overground service). In the red square, the position of the current Brunel Museum, originally designed the shaft to access the tunnel. Meanwhile, from 1851, the names of the docks have changed: the three ponds of the Grand Surrey Dock are now identified as Main Dock, Albion Pond, Canada Pond.

A detail from a map of Essex surveyed between 1862 and 1873 (see Figure 7 below), shows the embankment of tipping soil mentioned in the article from GLIAS.

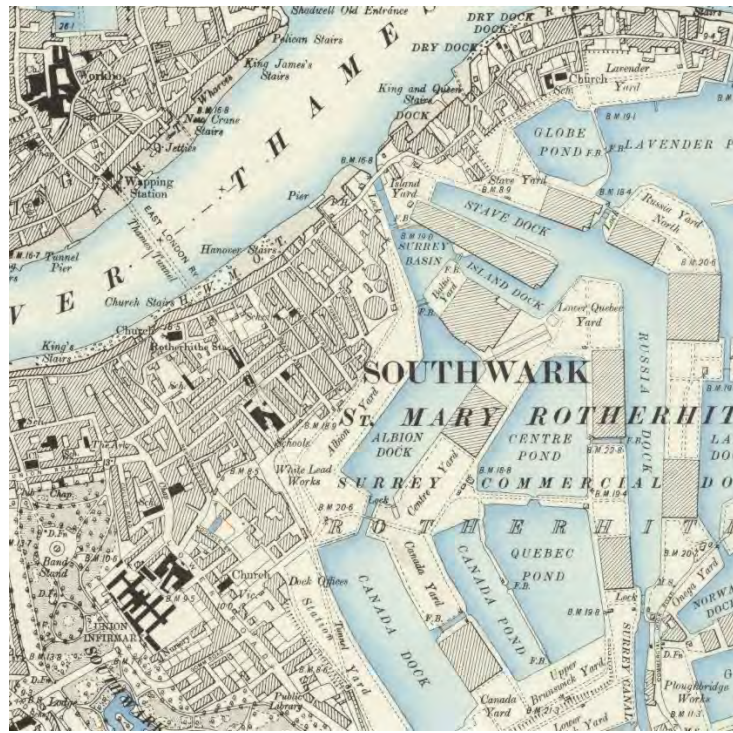
Besides some changes in the docks (Albion Pond and Canada Pond unified in Canada Dock), there are no significant changes in the area towards the end of the century as testified by the map surveyed in 1893-1894 and published in 1894-1896 (see Figure 8 next page).

Figure 8 London Sheet VII.SE - revised 1893-1894 - published 1894-1896

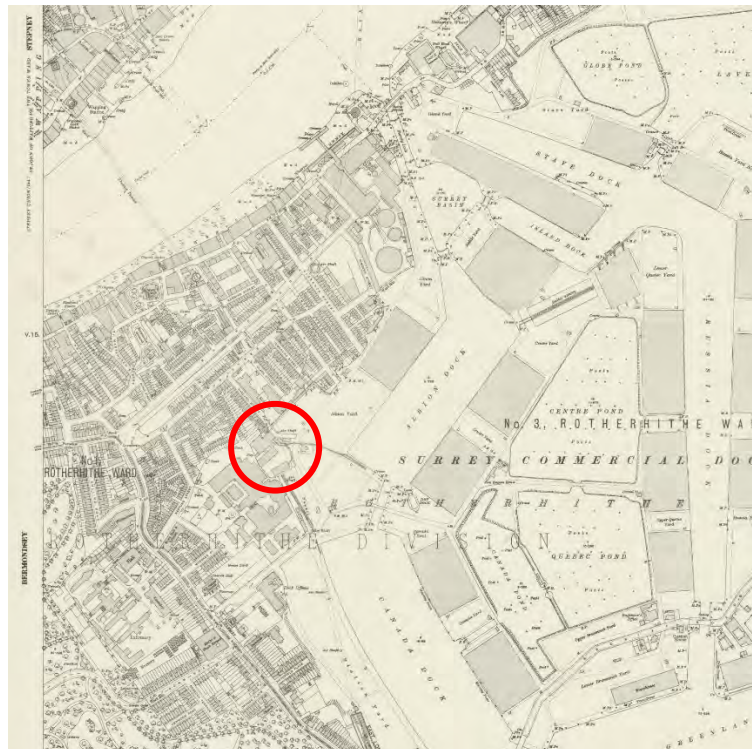
In a map surveyed in 1914 (see figure 9 below), the Pump Station is eventually represented. The context around has not changed much, besides some additional buildings between the docks, in Canada Yard, Albion Yard, Centre Yard.

Figure 9 London V.16 - revised 1914 - published 1916

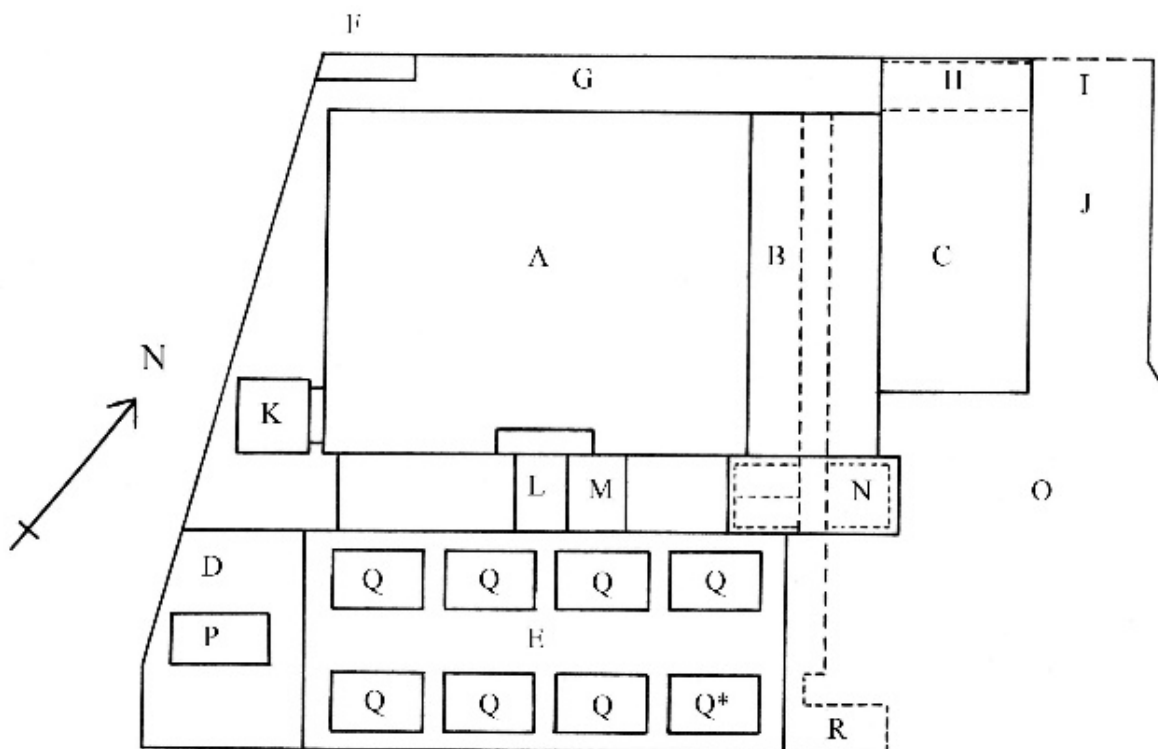
Figure 10

Plan of the main buildings from the Greater London Industrial Archaeology Society website: A Boiler House, B Filter House, C Coal Store, D Workshop, E Engine House, F LEB Sub-station, G Lower ground level yard, H Passageway under coal store, I Gate, J Roadway up to upper ground level yard, K Chimney, L Passage, M WC, N Accumulator Power, O Upper ground level yard.

The Greater London Industrial Archaeology Society⁶ (GLIAS), in its article by Tim R Smith, offers a quite complete description of the complex of buildings constituting the Pumping Station as shown in the map below (see Figure 10).

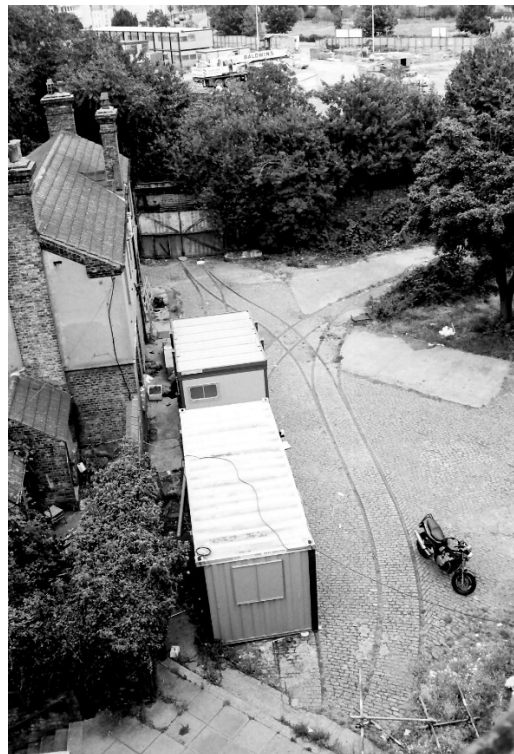
Figure 12 The yard to the south, before the conversion works (Tim R Smith, Greater London Industrial Archaeology Society, 1999), showing the Pump House Master's Cottage (currently 7 Pump House Close) to the left, and the 3-foot gauge tramway from Albion Dock, which entered the site through the gates at top left. The branch to the right led to the strategic coal store, which was added in 1907 to hold strategic reserve of coal in case of shortage of supply caused by, for example, strikes, and that has been demolished. Underneath the portacabin the tramway ran over a weighbridge. This photo has been probably taken from the water tank on the top of the Station Coal Store.

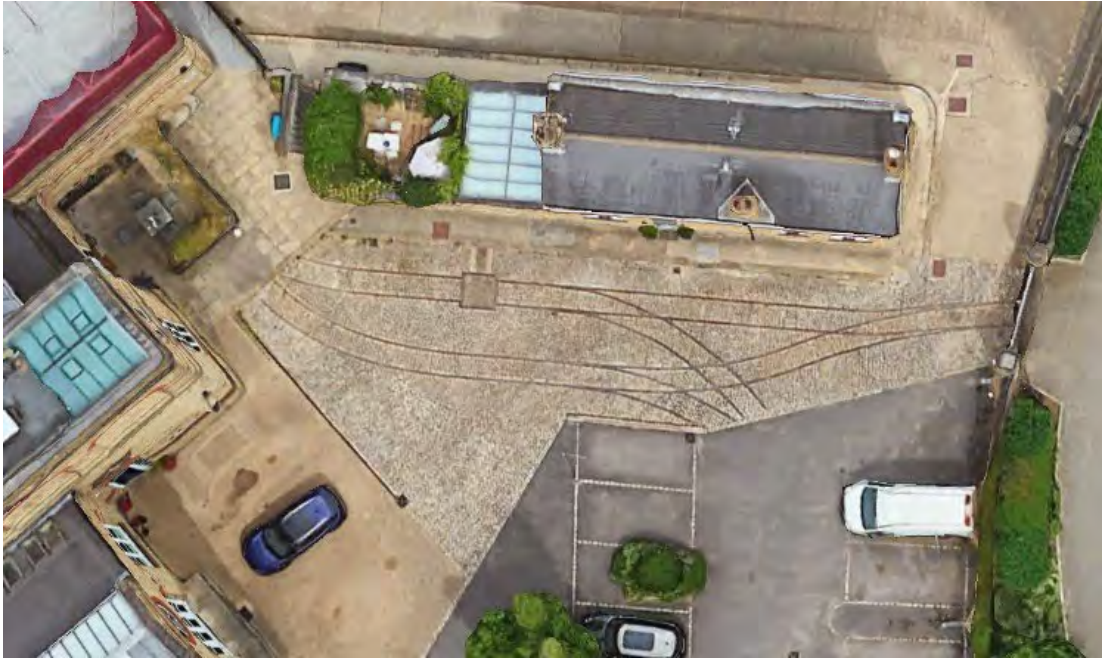
Figure 13 Satellite image showing the remaining of the original pavement and rails. The building on the top of the image is the Pump House Mater's Cottage (original building), now corresponding to nr. 7 Pump House Close.

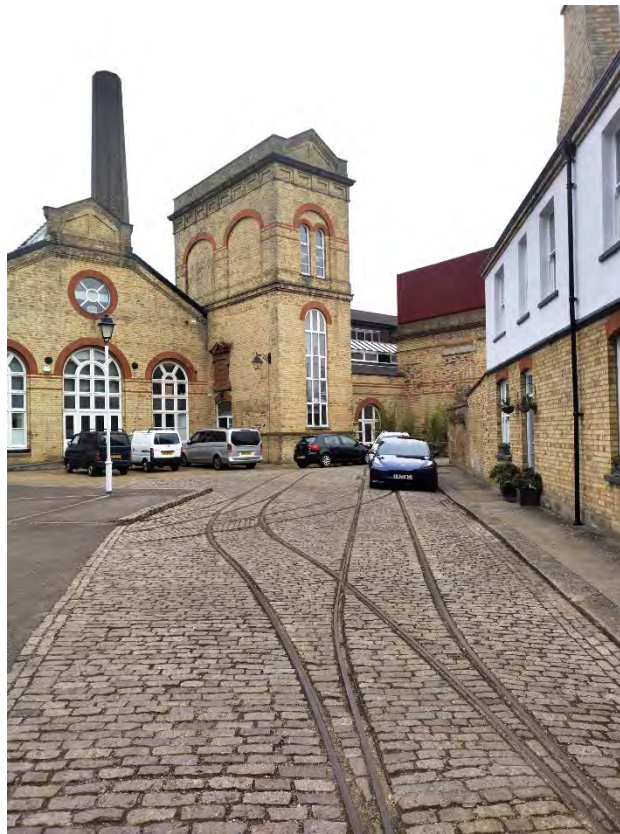
Figure 14 The communal courtyard as it appears today. The tall opening starting at ground floor level to the North-East façade of the Accumulator Tower was created with the conversion in 2001.

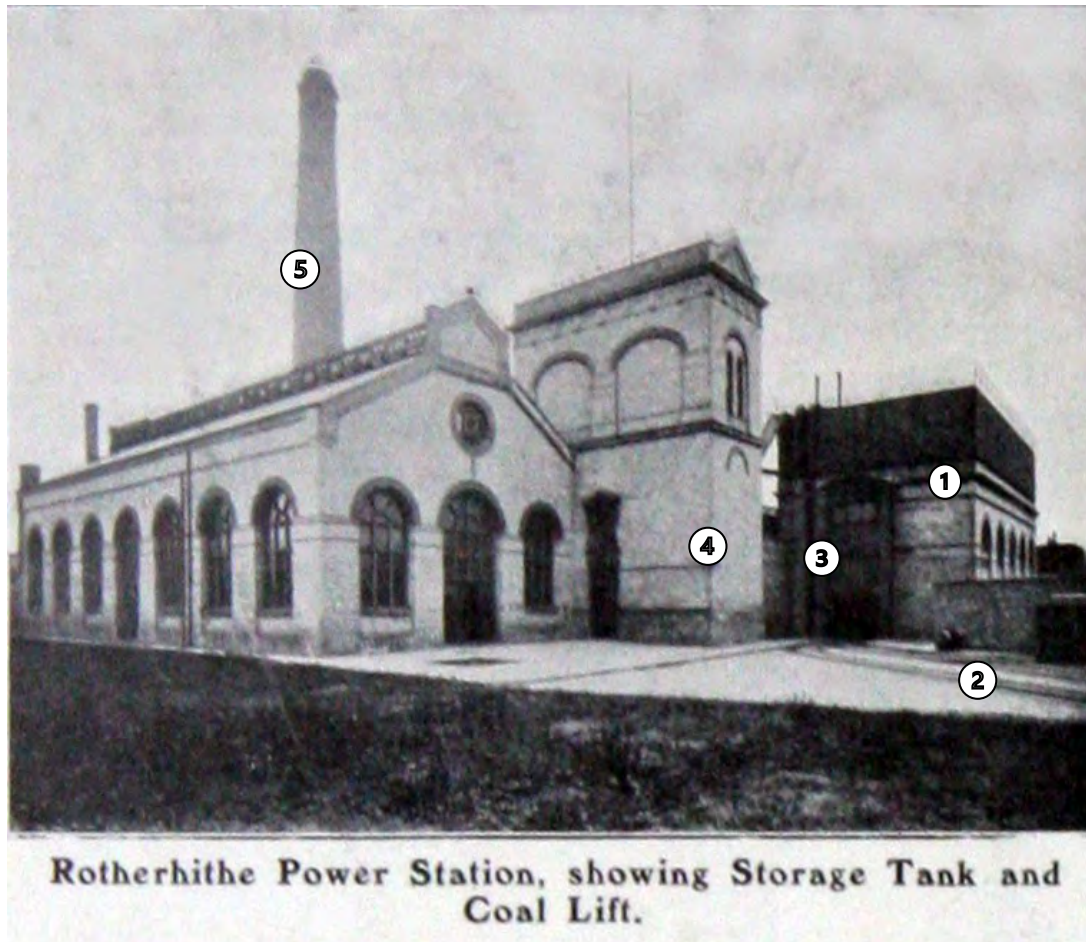
Figure 15

This photo shows the Station when it was in operation. To the side of the Coal store (1), just at the end of the tramway line (2), there is a superstructure which was the Coal lift (3), with an opening to unload the coal into the building. This photo could be dated before 1907 as it seems that the branch of rail leading to the strategic coal store (built that year) is still missing. To be noted: the accumulator tower has no opening at ground floor level except the entrance door. In the background, the octagonal chimney (4). The walls of the Engine House and the Accumulator Tower seem to be plastered or at least painted, and the windows frames seem to be painted with a darker colour than today.

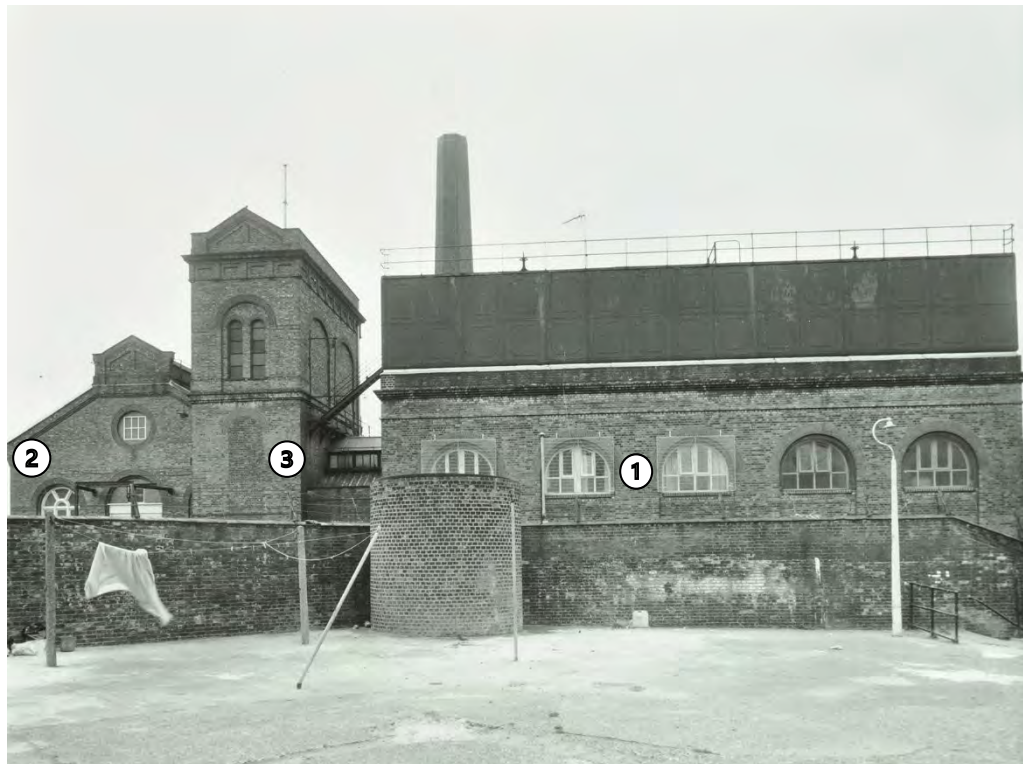
Figure 17 London Hydraulic Power Company pumping station in Renforth Street, 1975, © London Metropolitan Archives (City of London). The North-East facade of the Coal Store. The openings are limited to the top arch. The frames to these openings (1) are different from those to other openings, like the window to the Engine House (2), that – besides the colour – seems consistent with the picture dated pre-1907 (see figure 15). The lower opening to the Accumulator Tower's façade is still missing (3) and a different colour/texture of the bricks seems suggesting that there was originally an opening there.

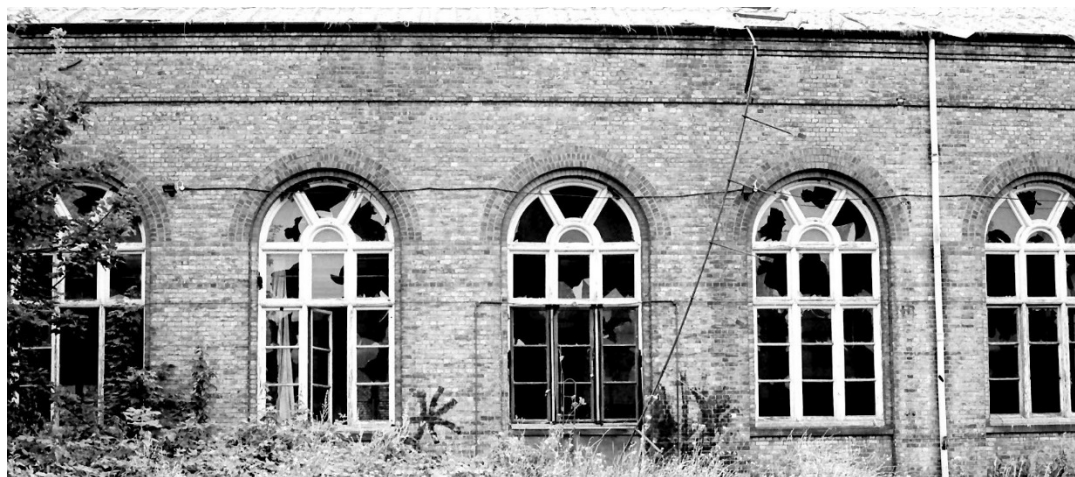
Figure 18 The five semi-circular arched openings have a lower sill than 1975 (see Figure 17). The frames have been changed to be consistent with those to the Engine House. (photo by Tim R Smith, Greater London Industrial Archaeology Society, 1999).

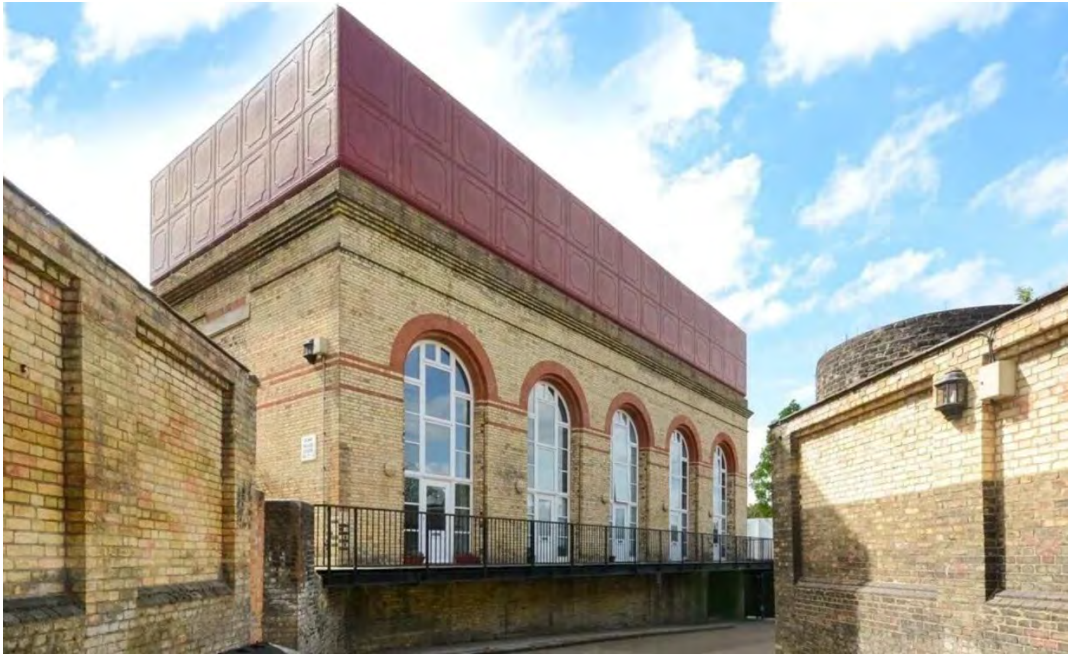
Figure 19 Besides the change of the opening's sill level (which has been dropped down to create the access), the design of the frame has been changed again, losing the curved and the radial elements at the top.

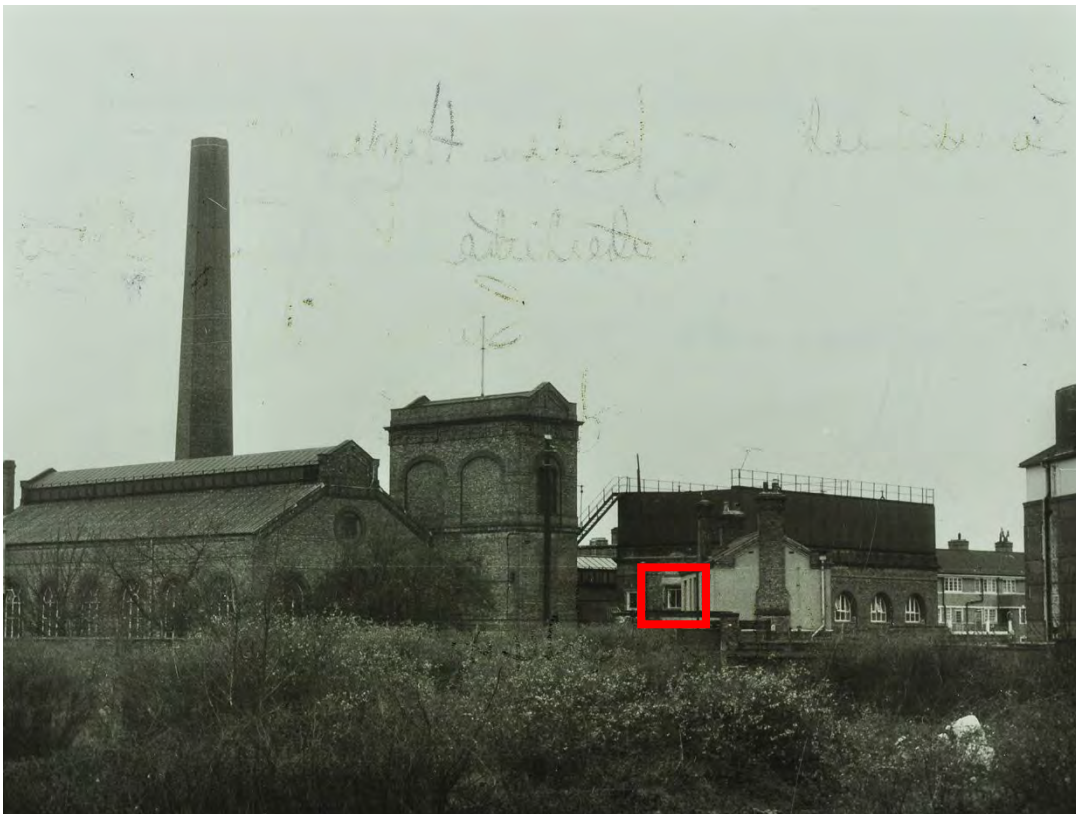
Figure 20 Rotherhithe Pumping Station, Swan Road: exterior, 1975, © London Metropolitan Archives (City of London). In the red square, the opening to the side façade of the Coal Store, which at the time had glazed frames. To be noted: the opening seems to be square rather than rectangular and the concrete lintel is already in place.

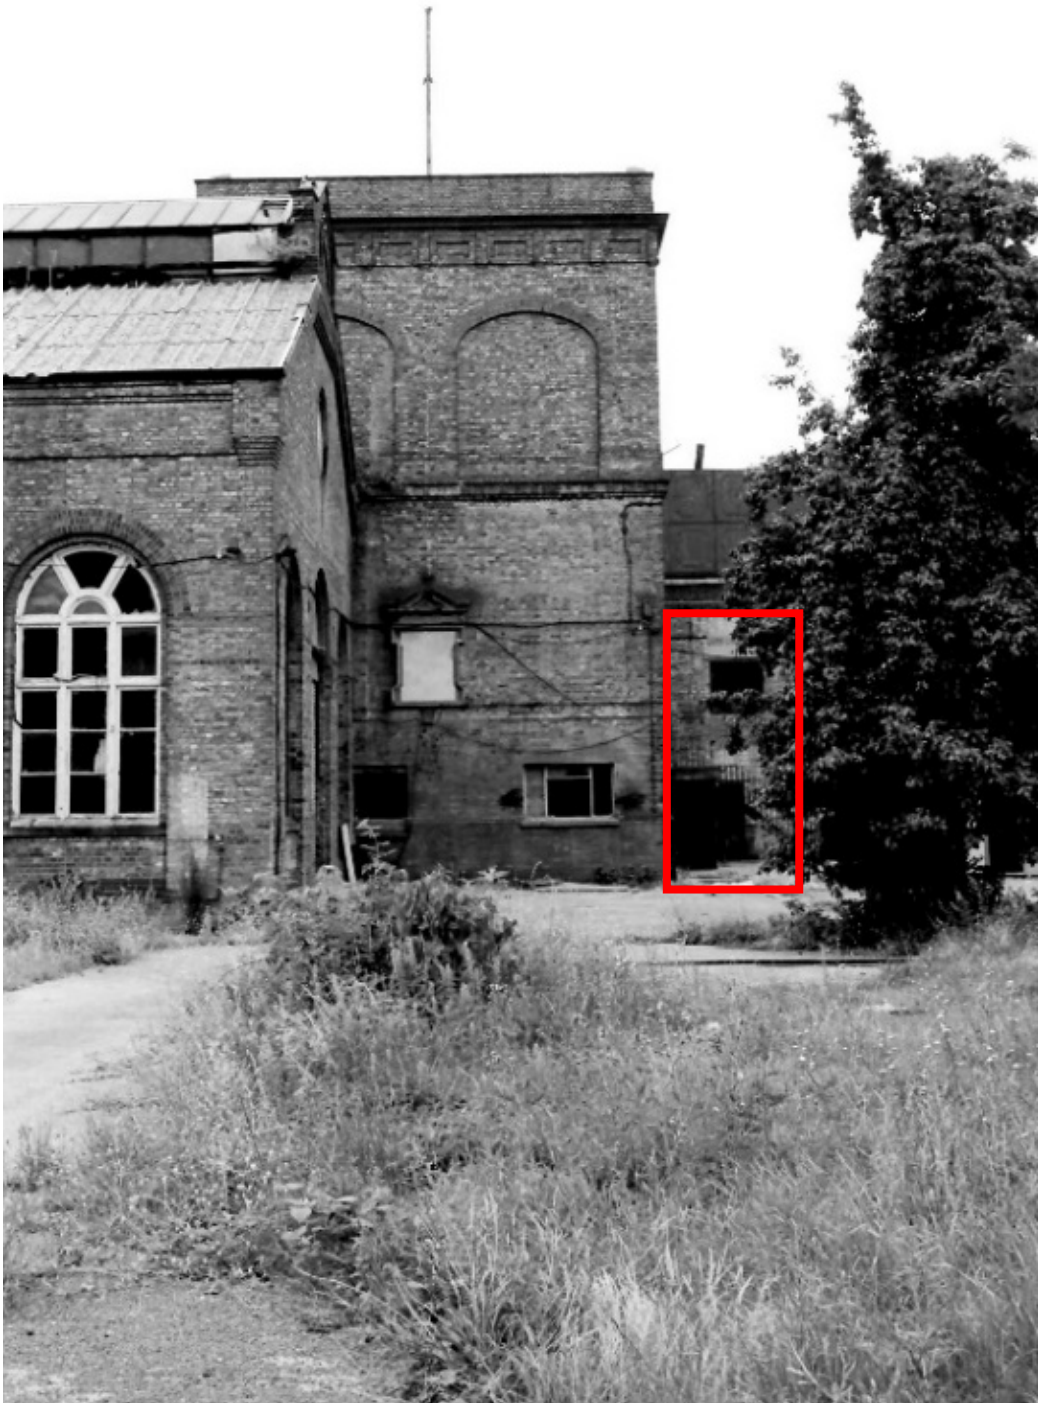
Figure 21

(Tim R Smith, *Greater London Industrial Archaeology Society*, 1999). In the red square it is visible the opening at the upper level before it was bricked up at the time of the most recent conversion in 1999. This opening was behind the coal lift (see Figure 14) to unload the coal from the tramway. It is also visible a metal staircase leading to a door at first level. In comparison with 1975, the gazed frame is missing. To be noted: as in the 1975 photo, the sill of the window seems to be higher than the original.

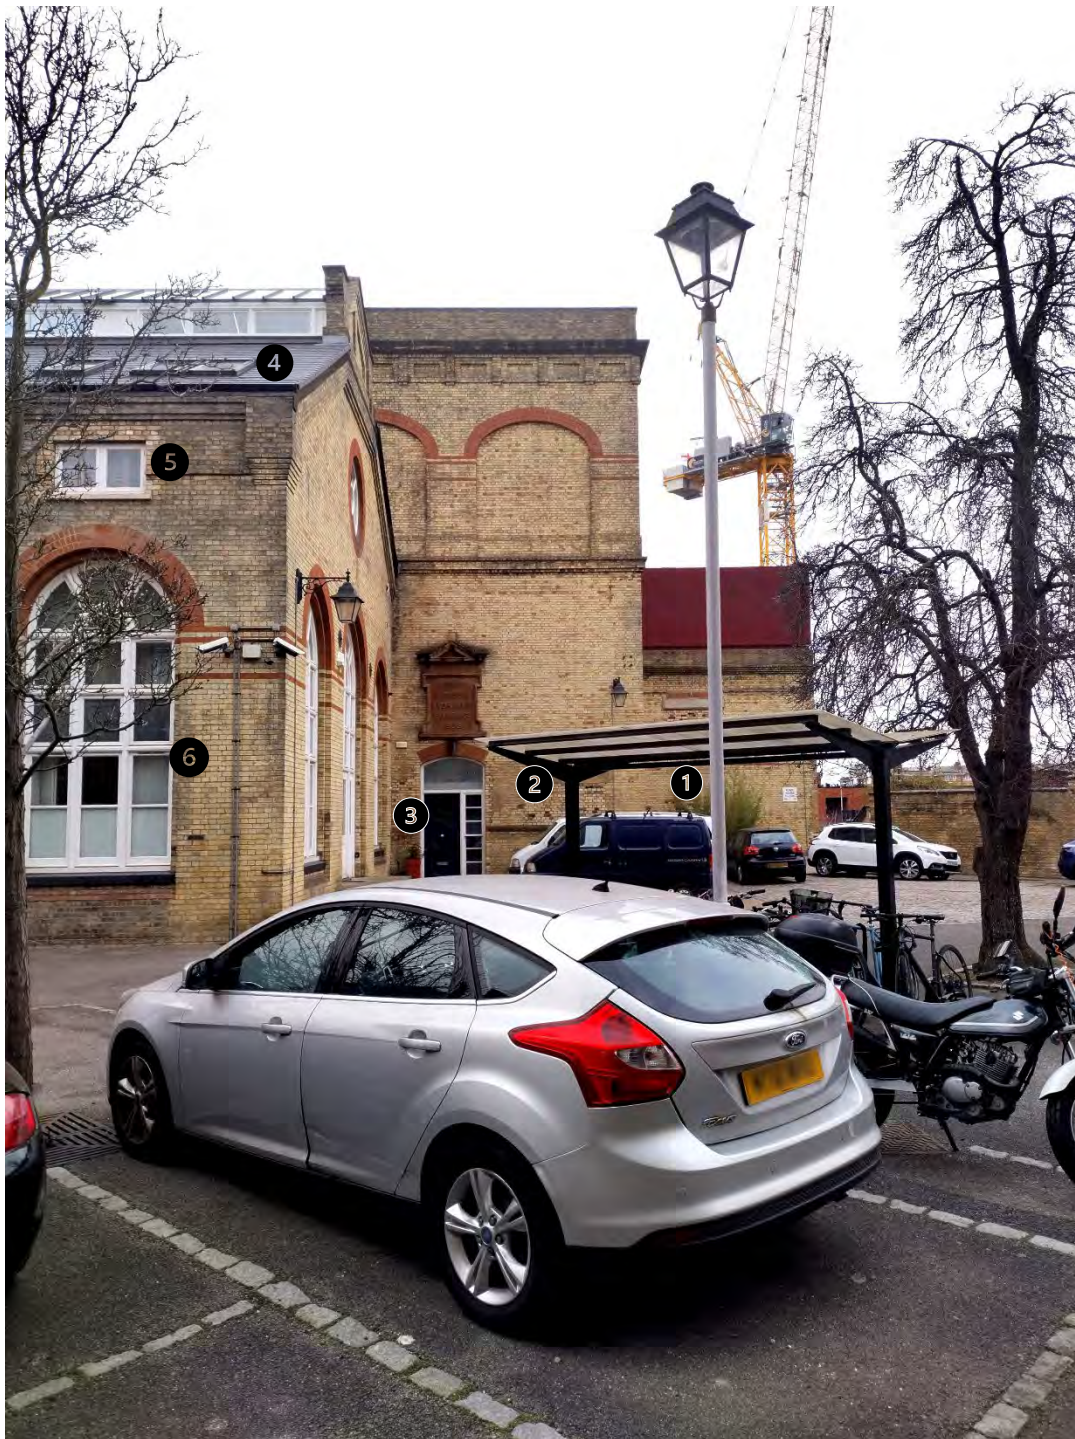
Figure 22

Photo taken from the same spot of Figure 21, showing the buildings as they appear today and the differences with the status before the conversion works. The opening to the side of the Coal store (1) has been bricked up like the window to the Accumulator Tower (2). The access to the Accumulator Tower (3), which was partially closed in 1999, has been opened up again. There are new rooflights (4) and upper floor windows (5) to the front of the Engine building, while the frames to the arched openings (6) have changed to accommodate the internal split floor.

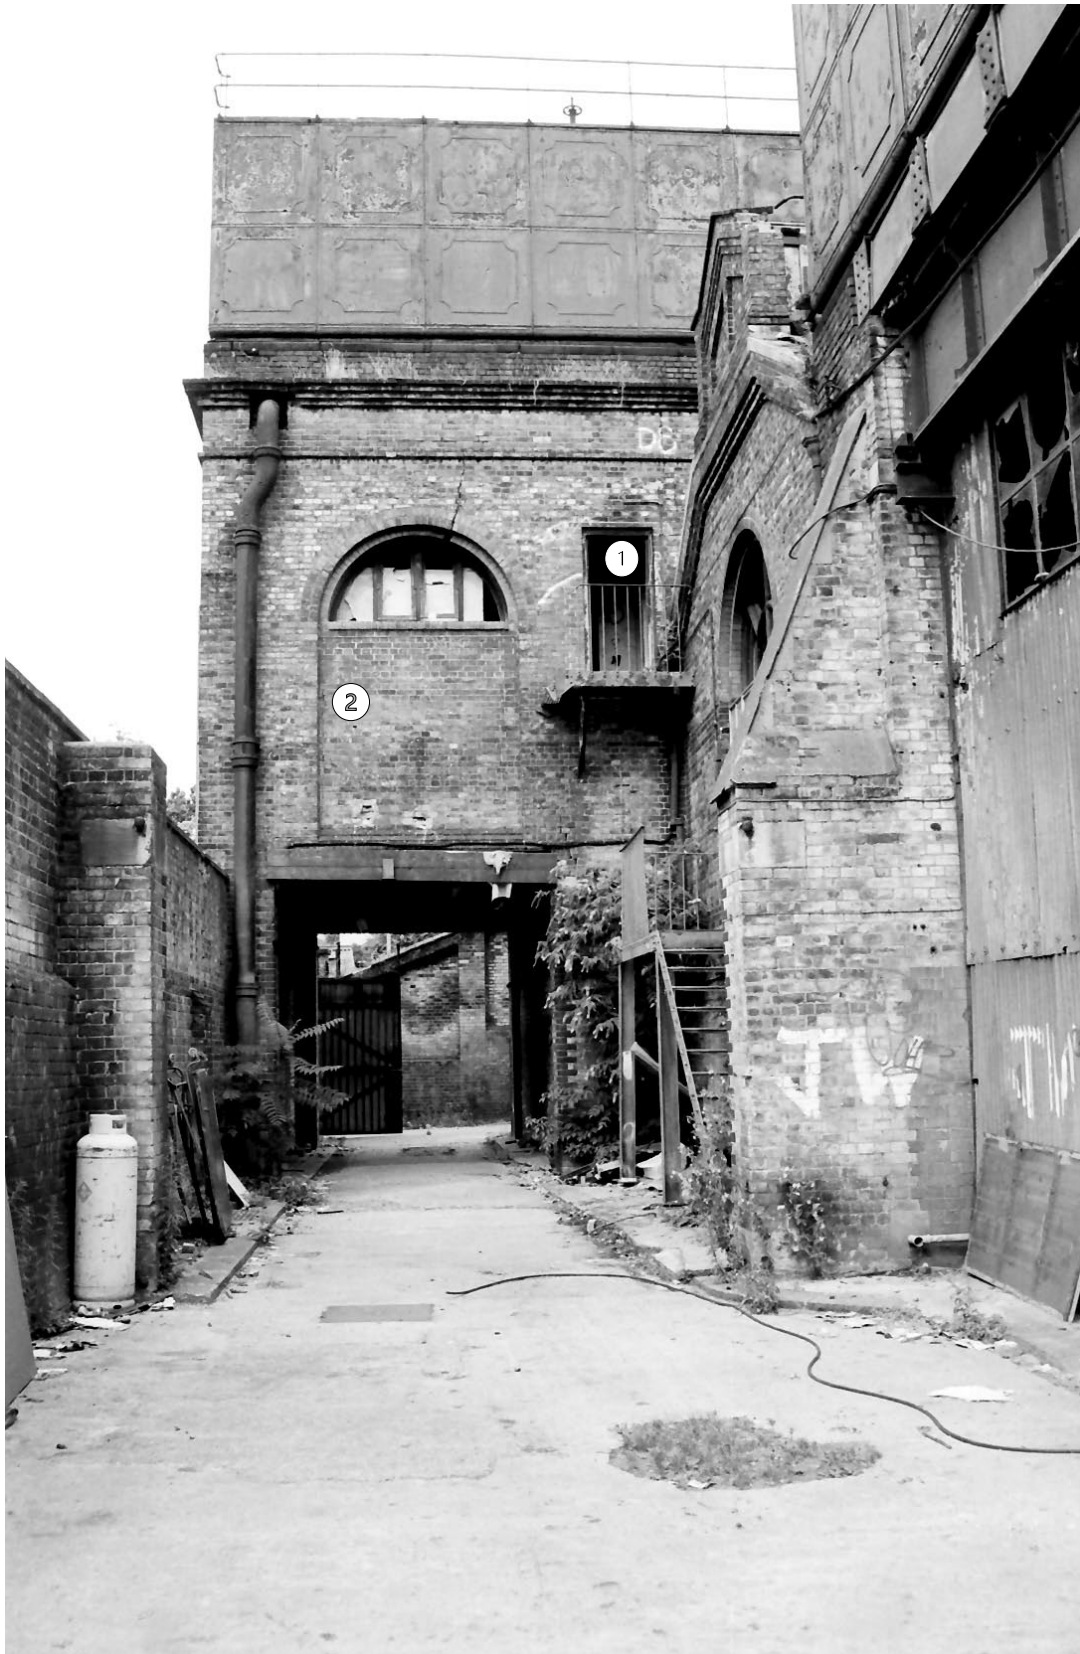
Figure 23

The rear of the Coal Store in 1999, taken from the low courtyard accessible from Renforth Street. There is an upstairs door (1), and the wall underneath the arched window (2) is recessed. The bonding is consistent with the rest of the original wall (English bond).

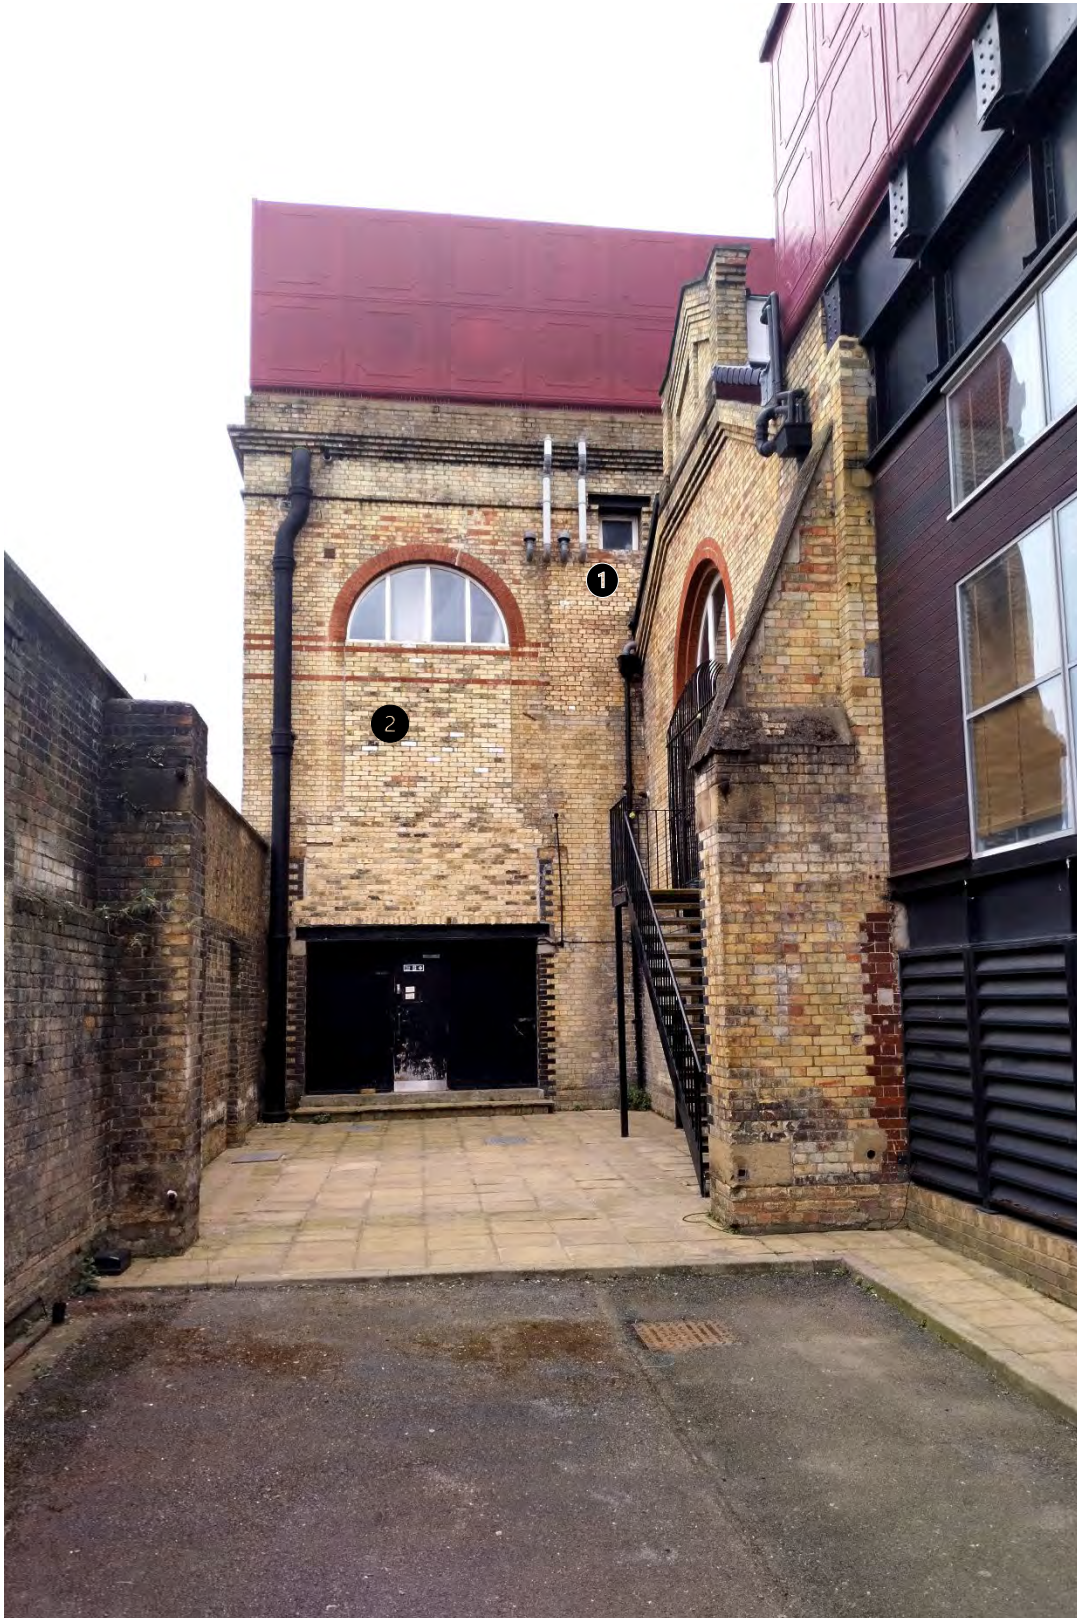
Figure 24

Photo taken from the same spot of Figure 23. There is a new square window (1), same as all the square windows at the same level created to the five units with the conversion works in 2001. The recess underneath the arched window has been flattened (2) with stretched bond new bricks.

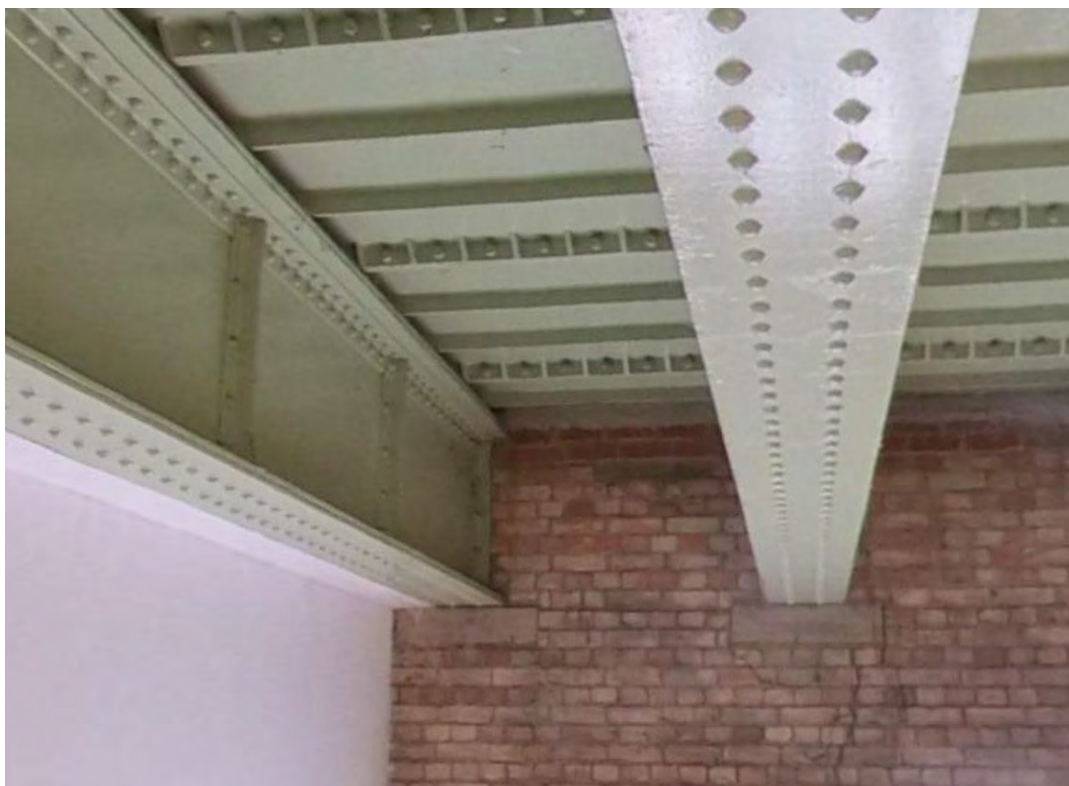
Figure 25: The giant "I" beams supporting the roof and the water tank above it.

Externally, the most peculiar feature is the external top roof which is characterised by the original red cast iron water tank on top, supported, internally, by wrought iron 'I' beams, spaced at 1.4 m (centre to centre), stiffening plates at 1.3 m, and extra rivetted plates at top and bottom.

"A simple rolled wrought iron 'I' beam or a simple plated girder was generally assumed to have a span capability of about 20 times its depth"⁹: in that case the ratio between depth and span is 1/10. All these features testify about the great load capacity of those beams which were built to support a load of 3 tons per square meter (the water in the tank above it).
