1 Pump House Close, London SE16 7HS

Heritage Statement

Reinstatement of pre-existing window to side facade and enlargement of existing window to the rear.

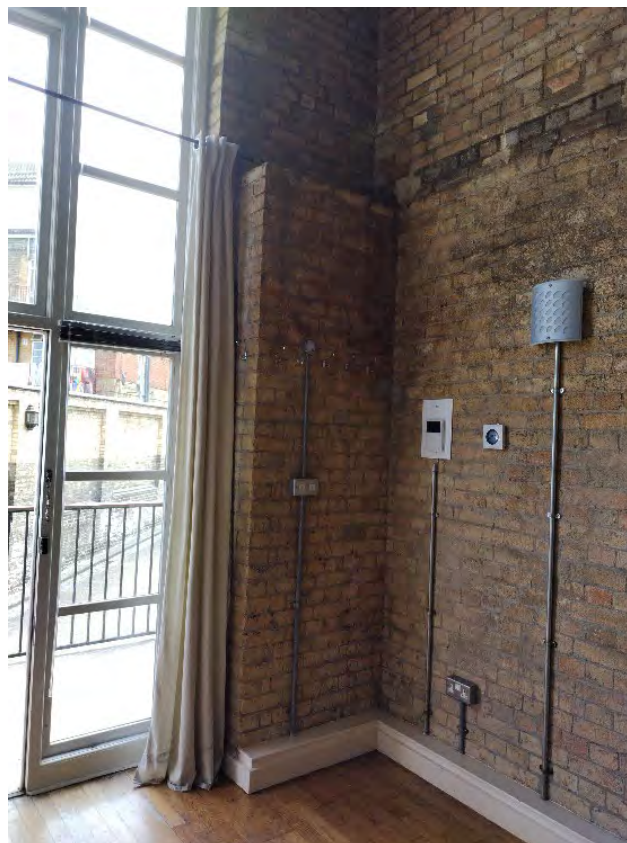
Figure 26: corner of the building with a brick pillar and marks on the wall which seems suggesting the presence of a mezzanine level.

Originally, as a coal storage, the whole building was an open void volume, even though some marks on the walls and the brick columns at the corners, suggest the presence of a mezzanine level, which may have been adapted before the last conversion in 2001 and after that the building was dismissed as Coal store.

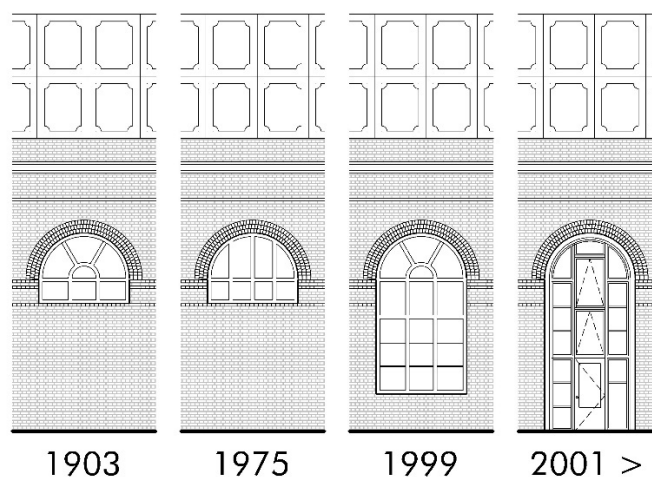
Figure 27

Drawing illustrating the alterations to the large arched openings to the North-West facade of the Coal Store over the years. Please note that the frame illustrated in 1903 is just a hypothesis as it has not been possible to recover photos of this side before 1975.

The 5.3 m tall arched openings are certainly another important feature of the building, even though, as shown by the photos and as described in the previous paragraphs, they have been modified several times over the years.

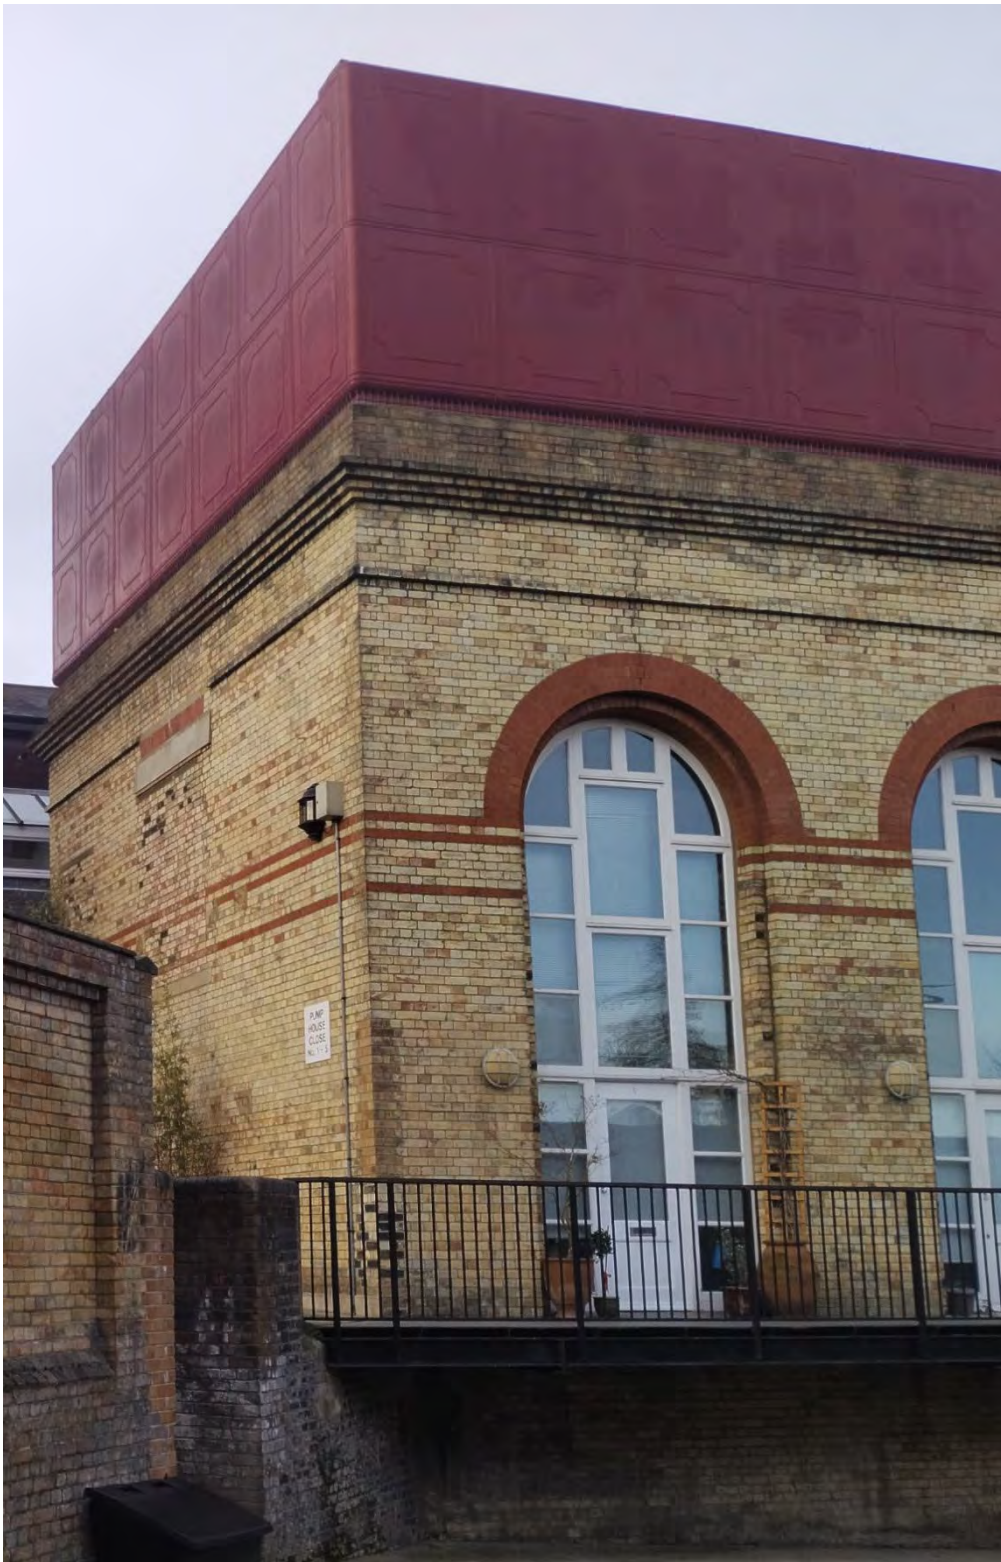
Figure 28: The original opening was with the sill at the level of the first course of red bricks, 9 courses below the start of the arch itself. The frame is not of significance as it is modern, and it has changed several times as shown by the photos taken in 1975 and 1999 and as illustrated in Figure 27.

To be noted: the lower lintel at the bottom of the infilled opening to the side façade is just below the first course of red bricks, a detail consistent with the idea that the opening was used to unload the coal up to this level.

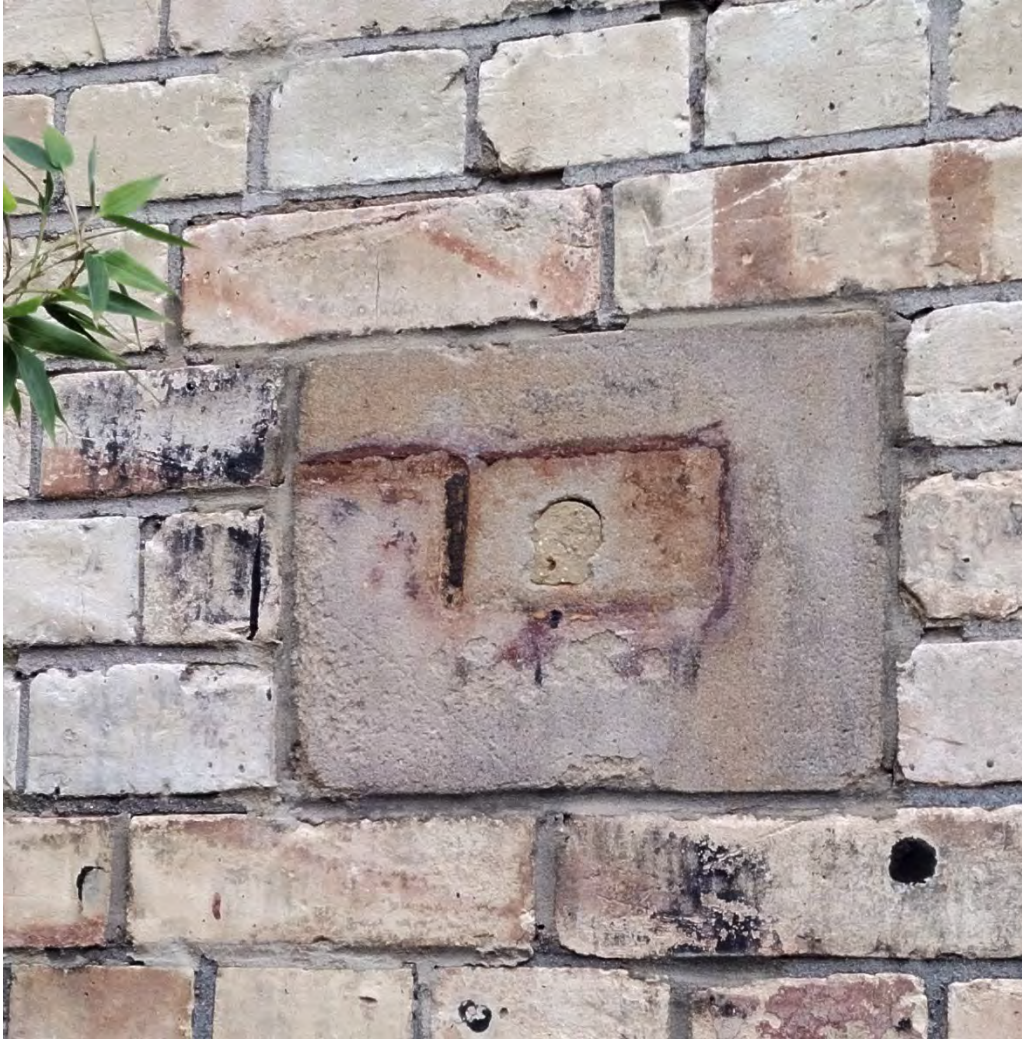
Figure 30 One of the spots where the metal structure of the coal lift was fixed to the wall.

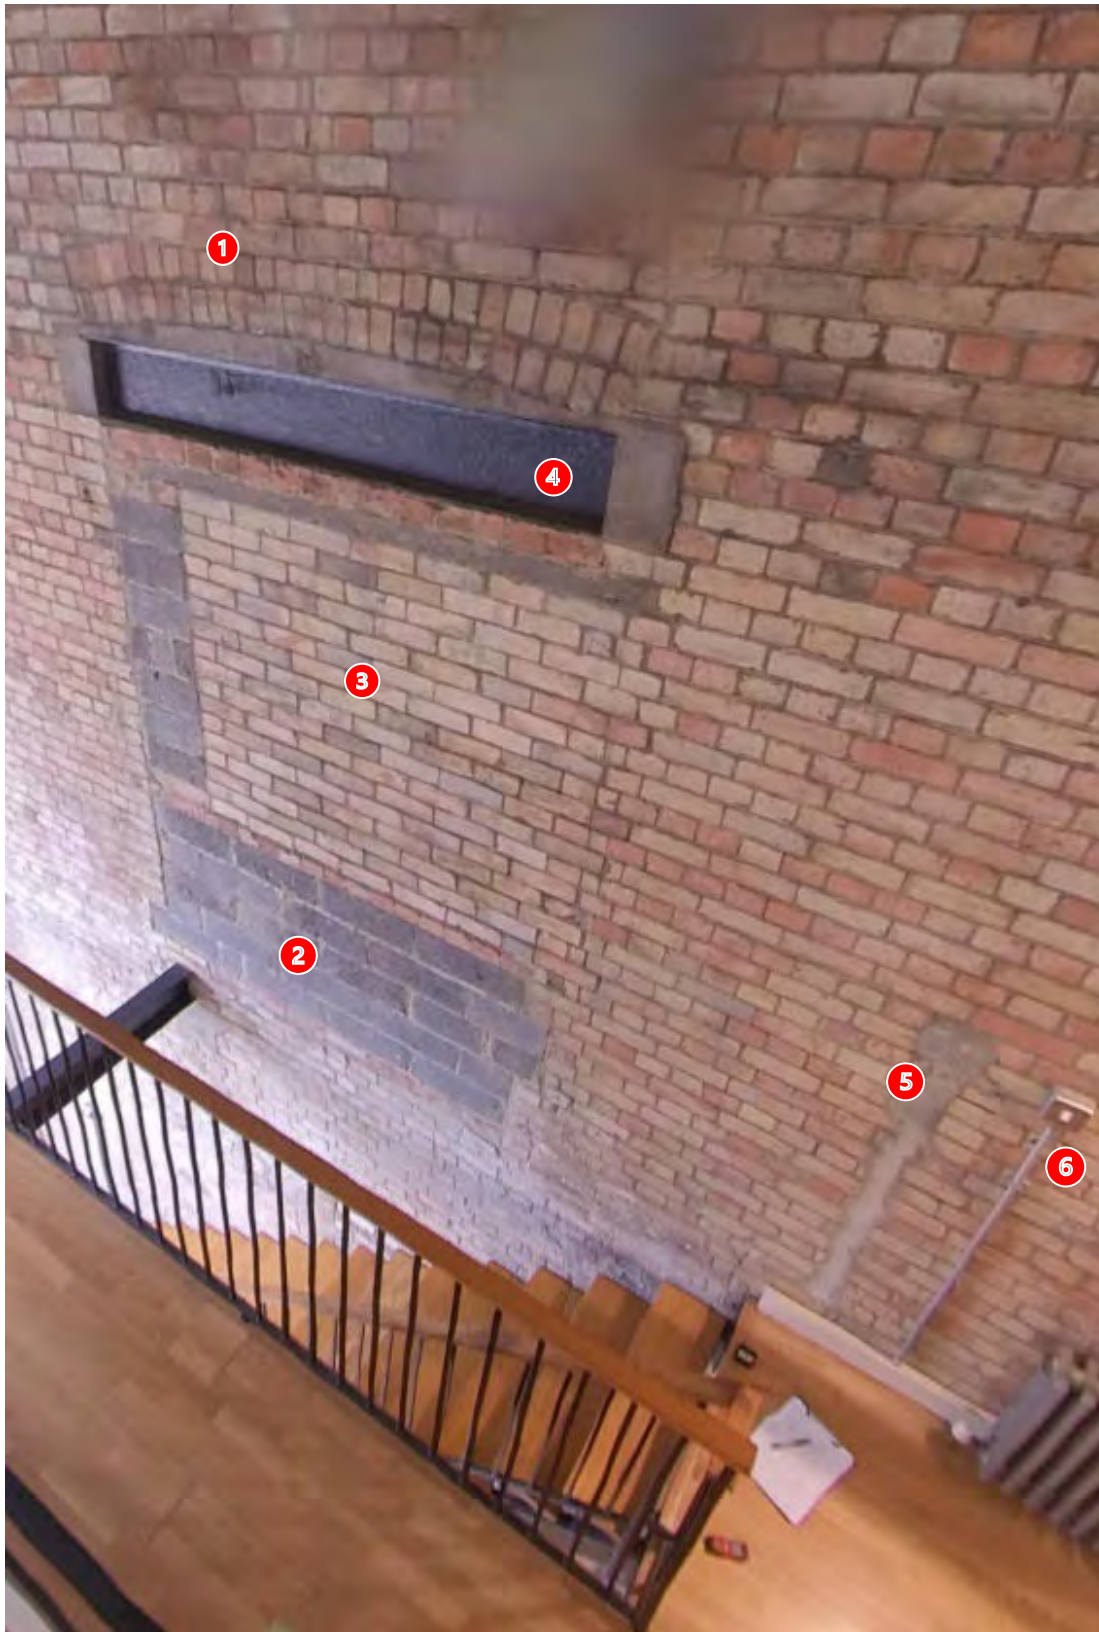
Figure 31: The side wall from the inside (1) the original bricked lintel, (2) the first infill with blocks, made probably before 1975, (3) the second infill made at the time of the conversion in 2001, (4) the steel lintel, made probably in 2001 as well, (5) cement infill to grooves into the wall next to wall mounted switches (6).

From the inside, the infill of this opening has been badly executed with blocks, and brickworks with stretcher bond instead of English bond, suggesting that the infill itself has been done in at least two stages.

As shown in figure 31, where the original size of the opening is perfectly legible, 5 courses of concrete blocks raised the sill, while a column of block to the side reduced its width. This infill is consistent with the photos from 1975 where the opening appears to be square rather than rectangular and it correspond with the time when the building was apparently used as flats, before the 2001 conversion.

The second round of infill made with bricks (stretcher bond), closed completely the opening and it dates back to the conversion as the opening was still there in 1999.

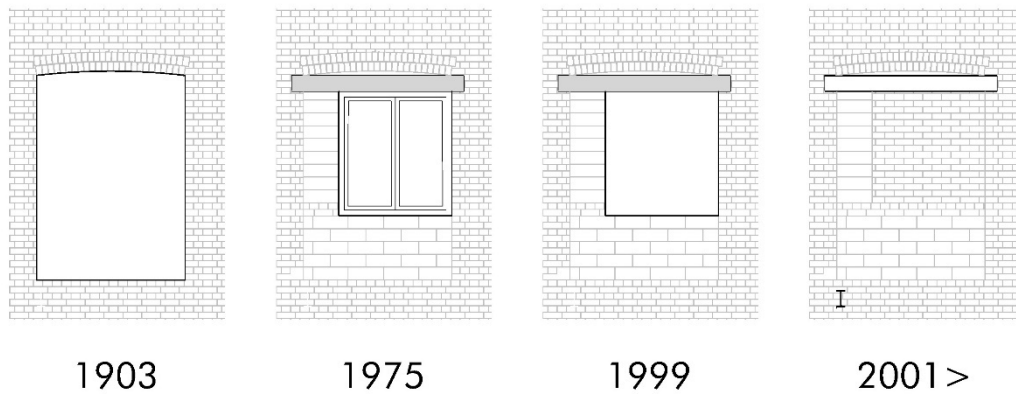
Figure 32

Drawing illustrating the alterations to opening to the South-West facade of the Coal Store over the years. In 1903 there was not probably any frame as externally the opening was protected by the coal lift. The first infill and the concrete lintel below the original one has been made before 1975 (compare with Figure 20). In 1999 any frame was missing (see figure 21). With the conversion in 2001 the opening was infilled, and a steel lintel put internally.
