Emery Pioneer Church Restoration

Phase 1 2019 Belfry restored

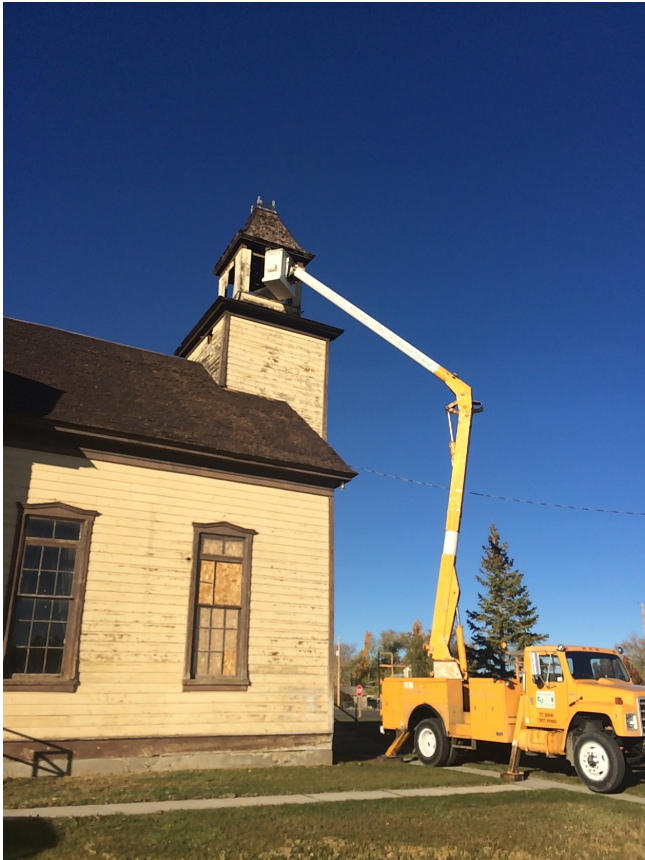
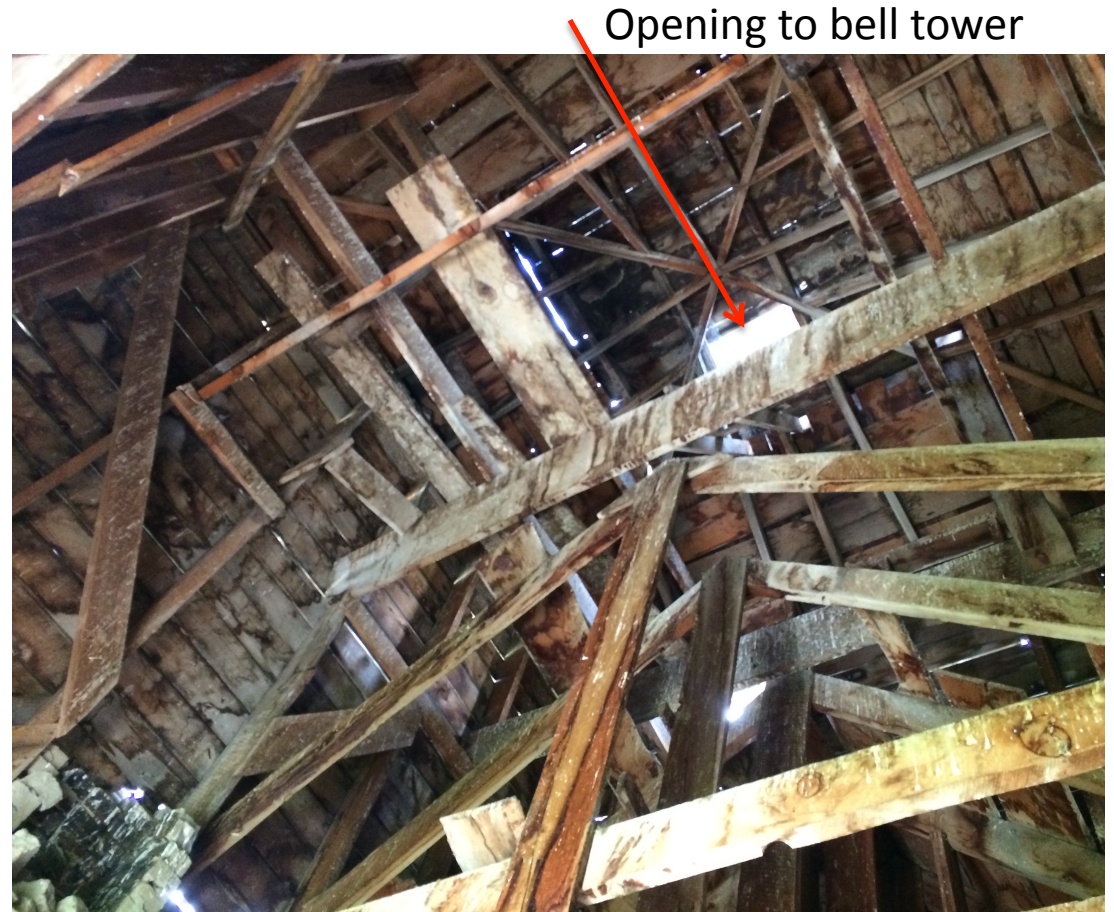
Upward view of inside the steeple

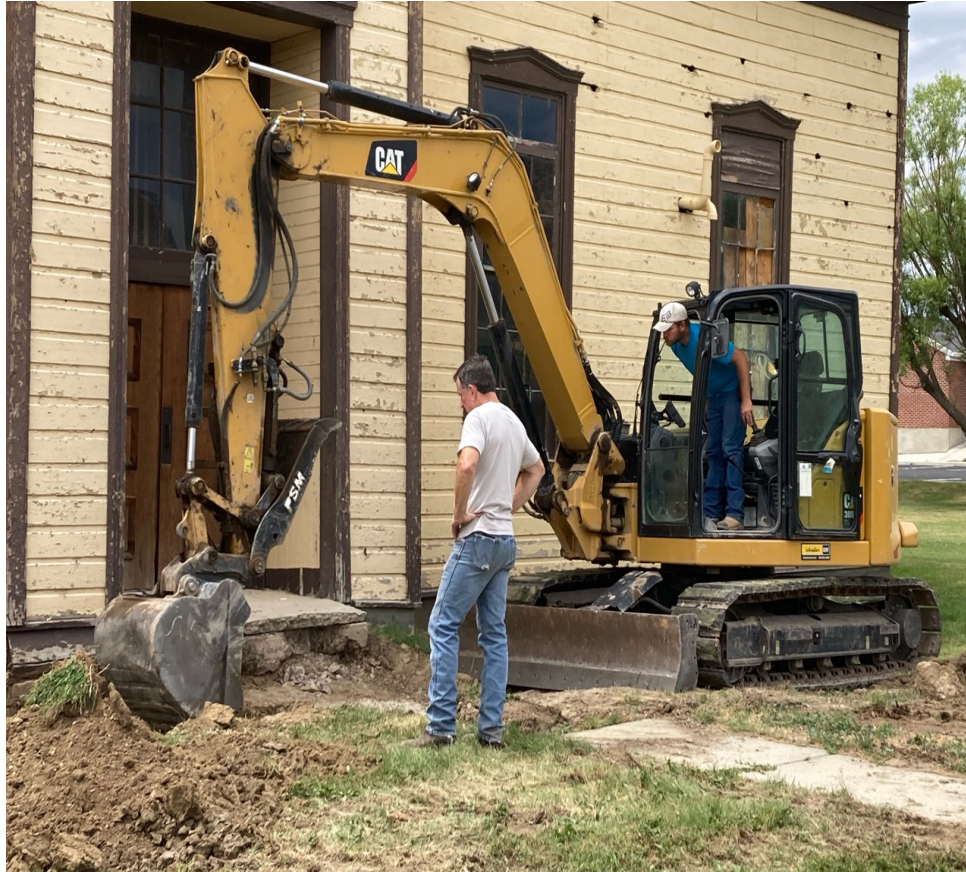
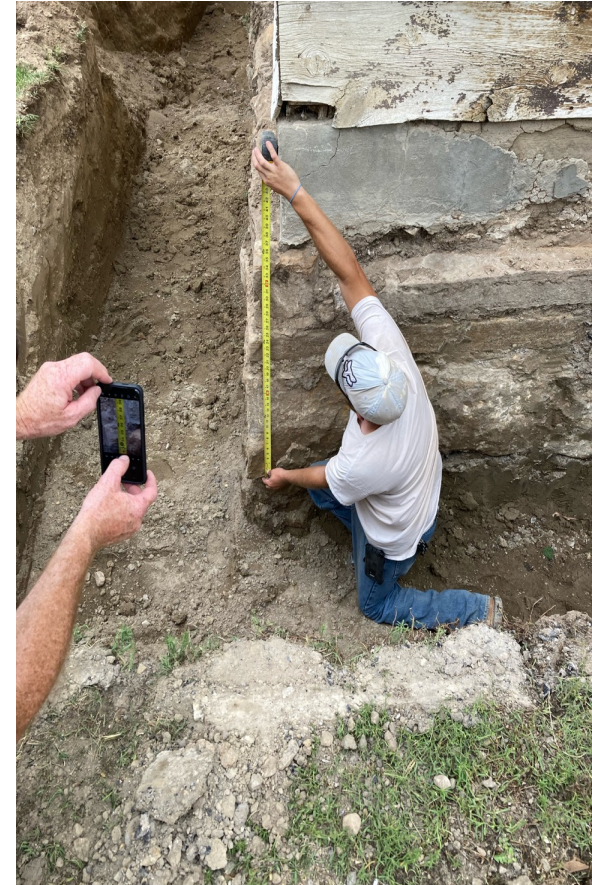
2022 Trench to expose old rock foundation

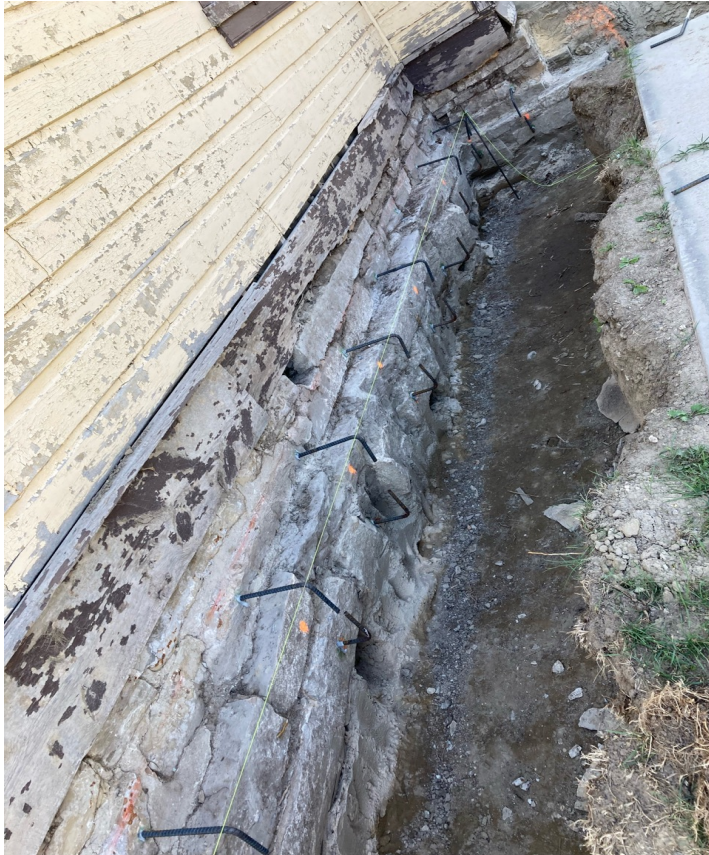
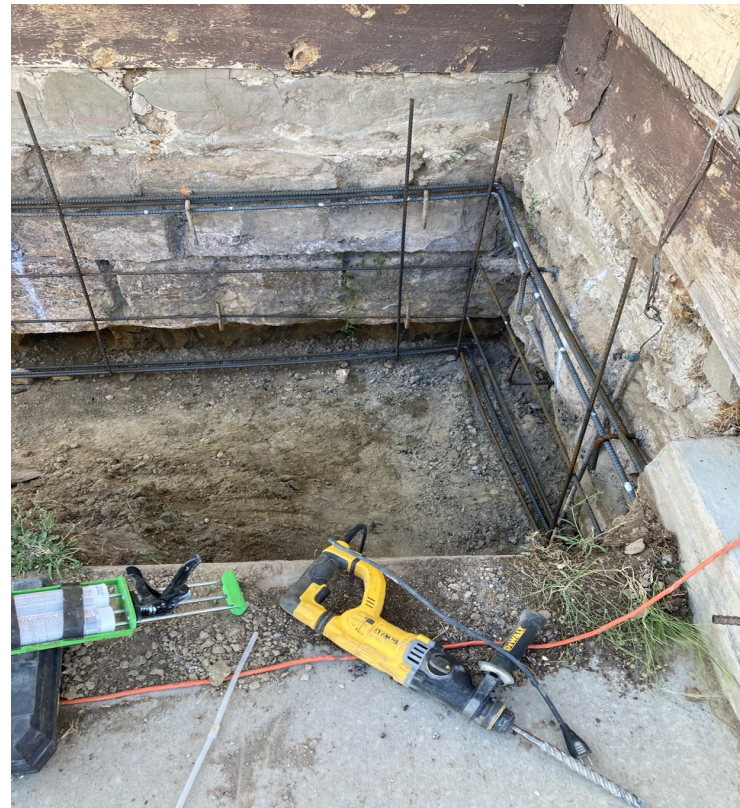
2022 Rebar into sandstone foundation

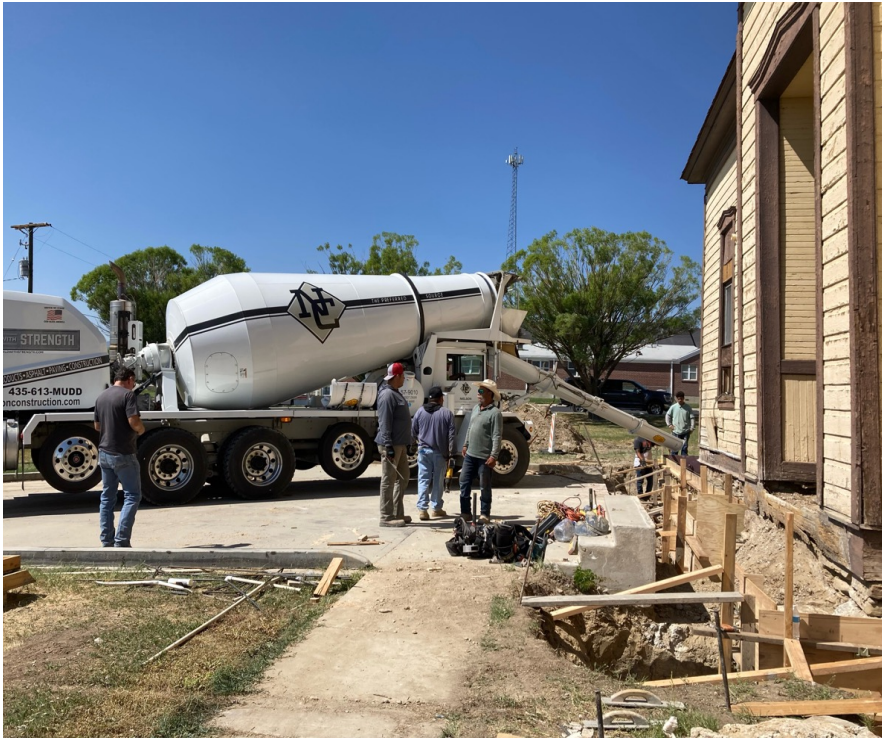
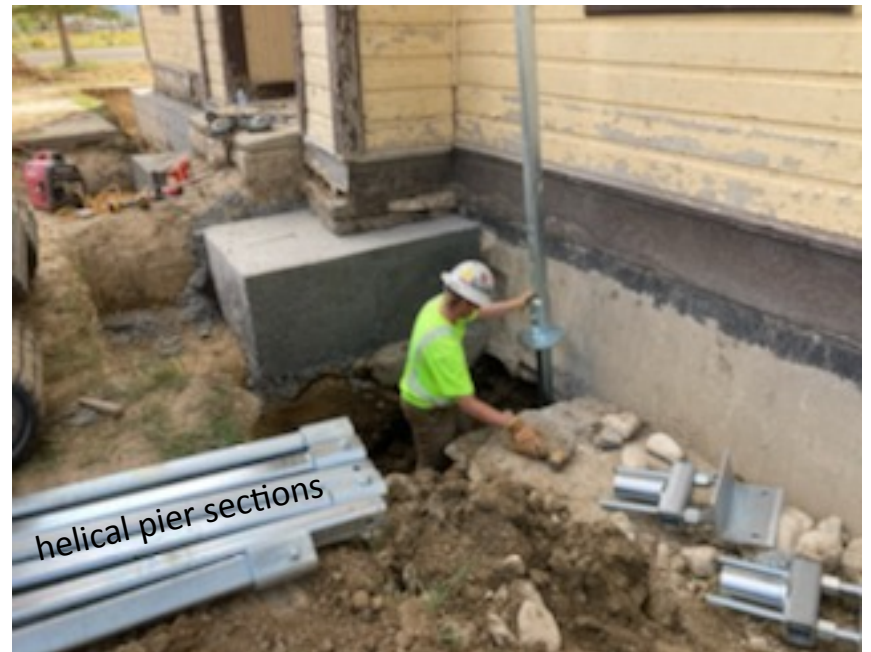
2022 New foundation & 26 helical piers installed
