REPORT NO: MT-17/684-A

LOAD TESTING OF A 12" PARALLEL POOL GRATE FOR CLASS A

CLIENT: **DALDORADO**
ATTENTION: ROBERT LAWSON
5/99 HUMPHRIES ROAD
FRANKSTON SOUTH VIC 3199

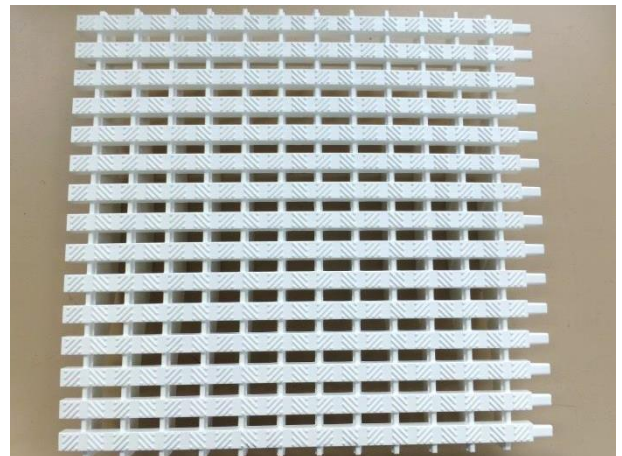
FIG. 1
'PARALLEL' POOL GRATE
SECTION AS DELIVERED

Specimen I.D.:	'Parallel' Grate
Grate Width:	304.8 mm (12")
Module Length:	304.8 mm (12")
Material:	PVC
Longitudinal Members:	304.8 × 12 × 8 mm
Transverse Members:	304.8 × 45 × 4 mm stiffeners
Grid Apertures:	8 × 20 mm
Circular Opening (CO):	241 mm

Interlocking modular pool grate sections were delivered to the MTS laboratory for load testing (see Fig. 1). At the request of the client, DALDORADO, a single grate section was to be Type Tested for **Class A** in accordance with AS 3996 — 2006 ACCESS COVERS AND GRATES; CLAUSE 4.2.1.2 and APPENDIX C. Following testing to AS 3996, the grate was to be loaded until failure in order to determine the ultimate strength capacity of the specimen.
