Mechanical Testing

REPORT NO: MT-18/064-A

LOAD TESTING OF A TILED 12" PARALLEL POOL GRATE FOR CLASS A

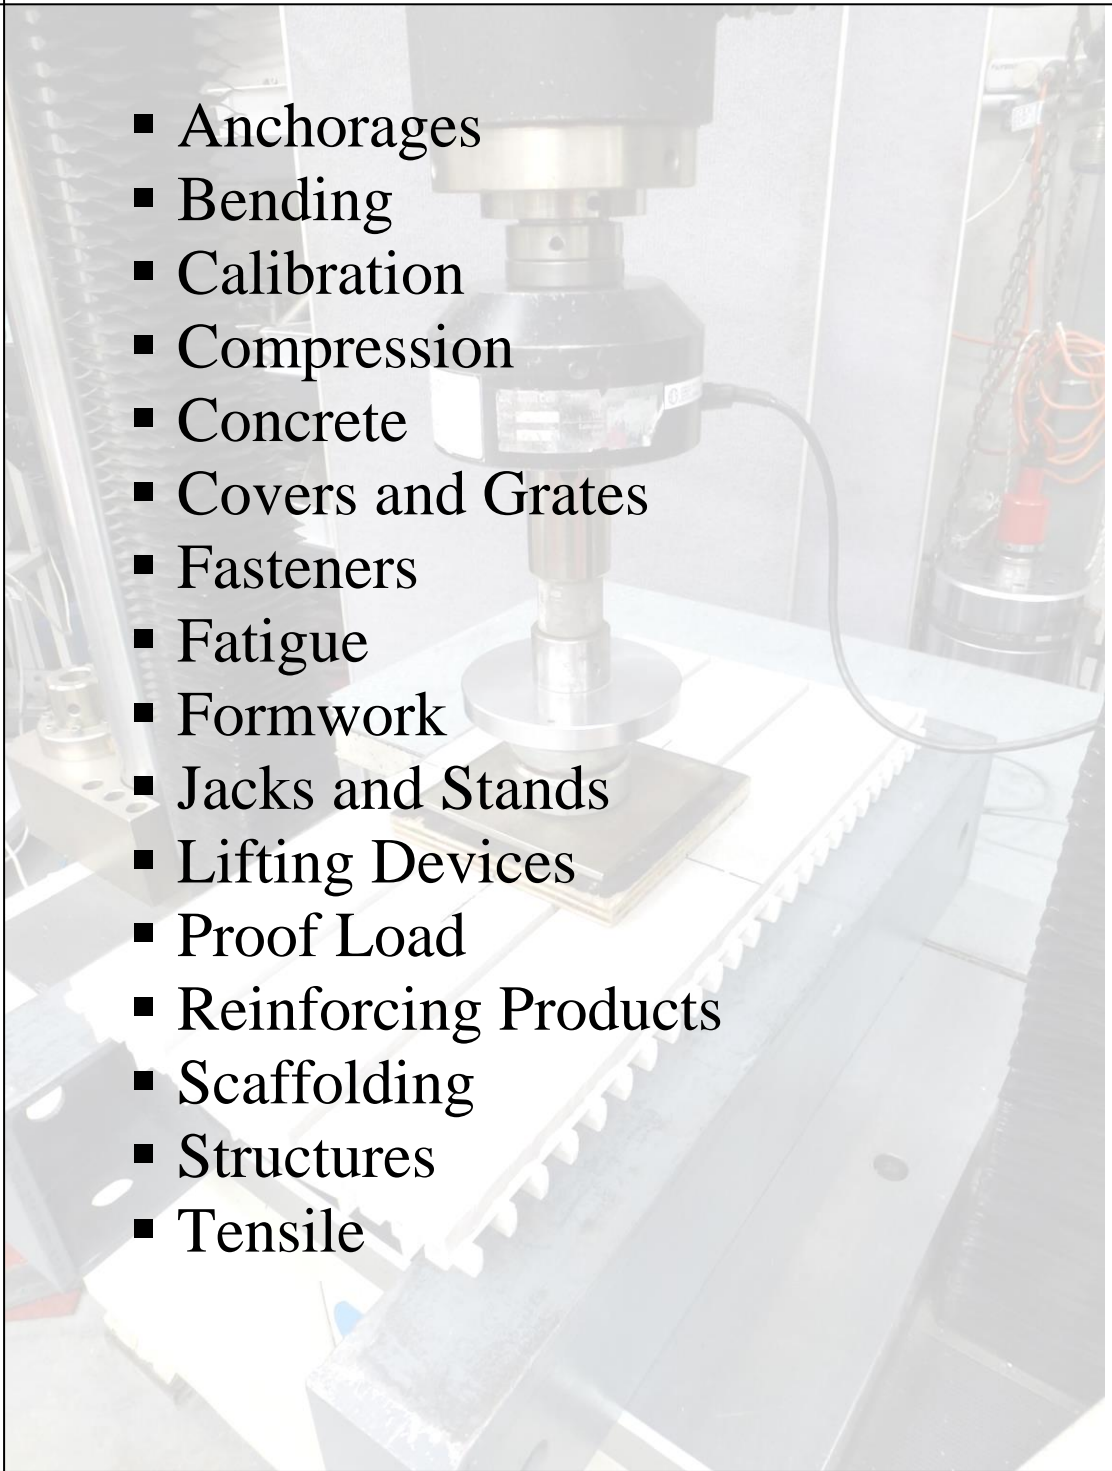
- Anchorages
 - Bending
 - Calibration
 - Compression
 - Concrete
 - Covers and Grates
 - Fasteners
 - Fatigue
 - Formwork
 - Jacks and Stands
 - Lifting Devices
 - Proof Load
 - Reinforcing Products
 - Scaffolding
 - Structures
 - Tensile

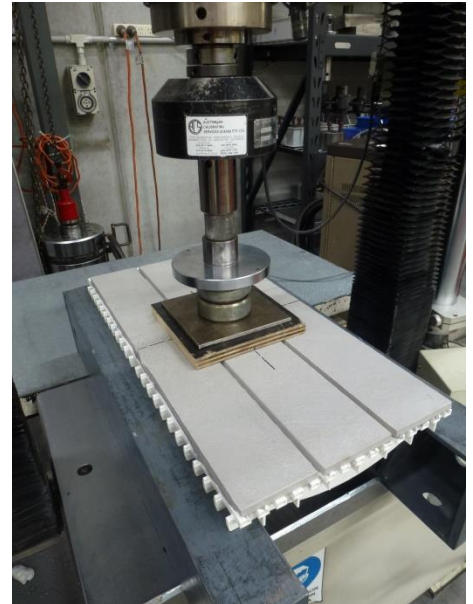
The tiled access cover grate was aligned centrally under the actuator of a calibrated universal testing machine (UTM). The grate was rigidly supported on two (2) parallel edges with a free span of 241 mm to replicate the bearing conditions typically seen in service (see Fig. 2). A series of displacement transducers was used to measure the net deflection at the centre of the cover throughout testing. All compressive test loads were applied vertically to the centre of the cover grate via a 180 × 180 mm square loading platen. Test load and deflection were recorded autographically during testing using a computerised data acquisition system.

FIG. 2
GRATE TEST SET-UP

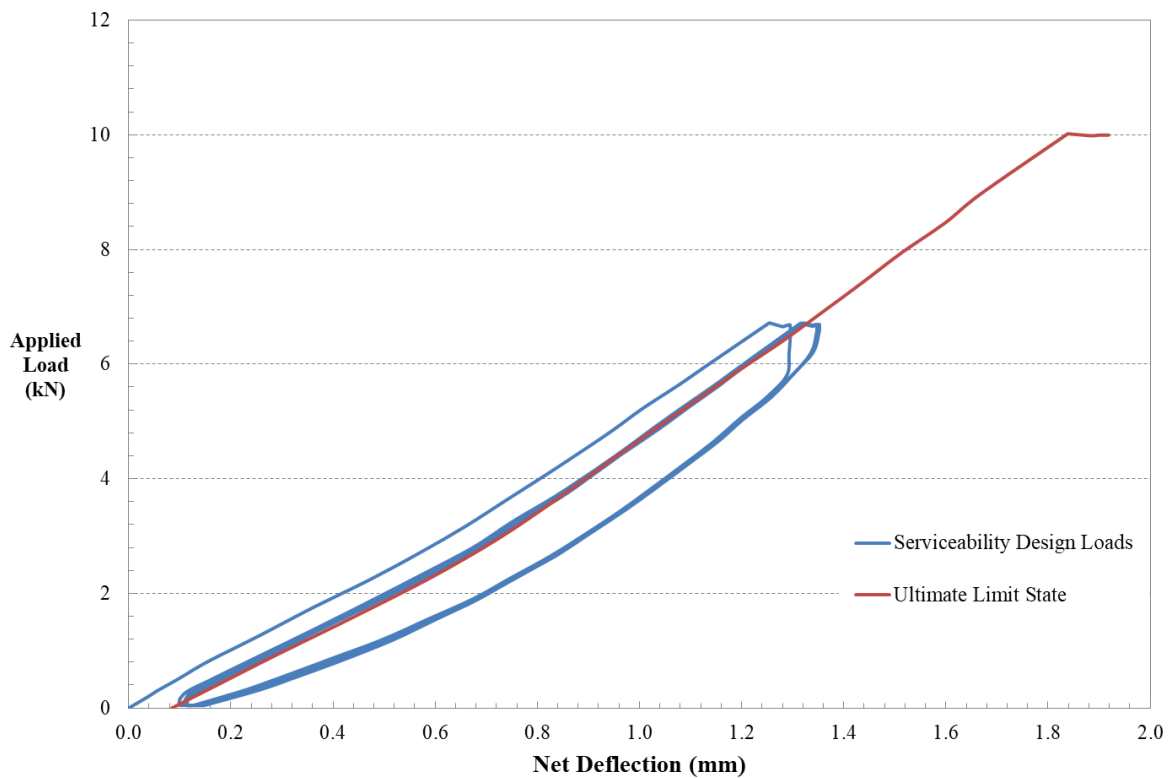
Test curves for the Serviceability Design Load and Ultimate Limit State are provided in Figure 4. A summary of the displacement and force at the onset of cracking in the bonded tiles is presented in Table 1.

FIG. 4
TEST CURVES

During the initial SDL application of 6.7 kN, the loaded net deflection was recorded to be **1.3 mm** at the centre of the cover which is less than the maximum allowable deflection of 5.4 mm, as required by TABLE 4.2 of AS 3996 – 2006 for a Class A access cover grate with a circular opening of 241 mm.

Upon conclusion of the SDL test, the net permanent set at the centre of the grate was recorded to be **0.1 mm** which is less than the maximum allowable permanent set of 2.4 mm, as required by TABLE 4.2 of AS 3996 – 2006 for a Class A access grate with a circular opening of 241 mm.
