# LEVEL 2 REPLACEMENT RESERVE REPORT FY 2023 LONGHILL GATE HOMEOWNERS ASSOCIATION, INC.

# REPLACEMENT RESERVE REPORT

## LONGHILL GATE HOMEOWNERS ASSOCIATION, INC.

WILLIAMSBURG, VIRGINIA  
October 17, 2022

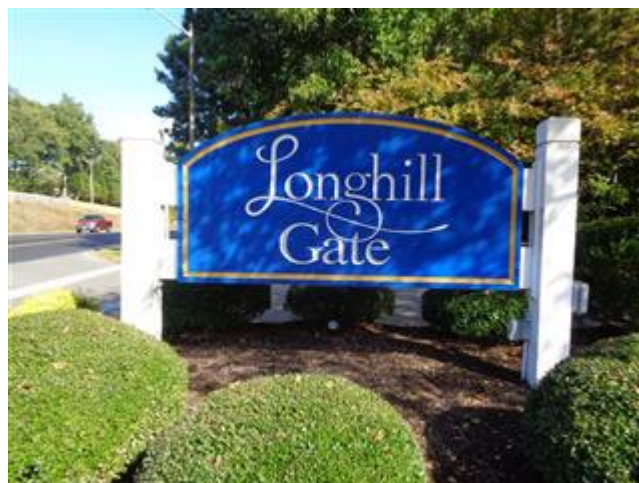
**Entry Monument and Signage.** The Association maintains an entry monument with wood posts and a synthetic sign as well as other neighborhood street signs. These are in good condition. Other small miscellaneous signs are not considered in this study and should be replaced using other funds.

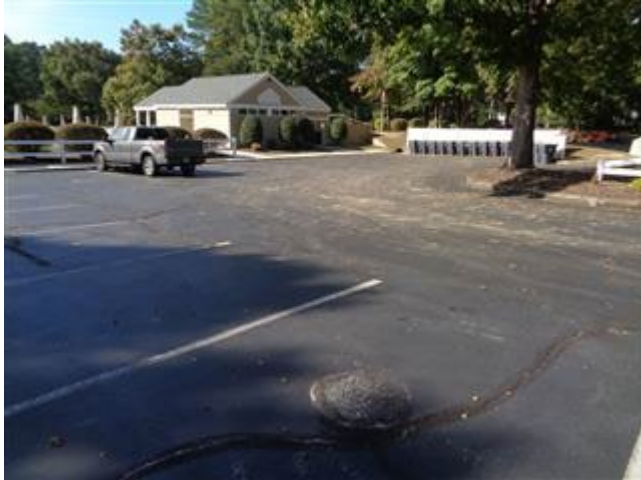
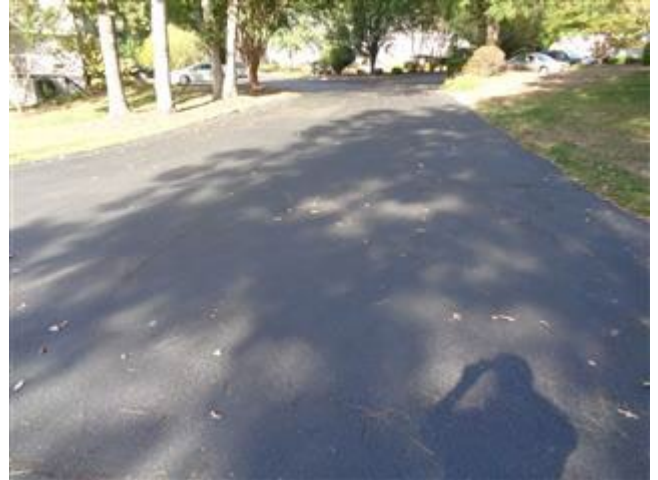
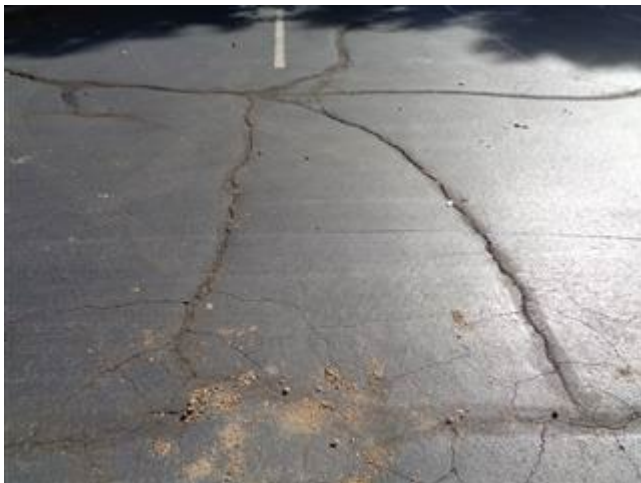
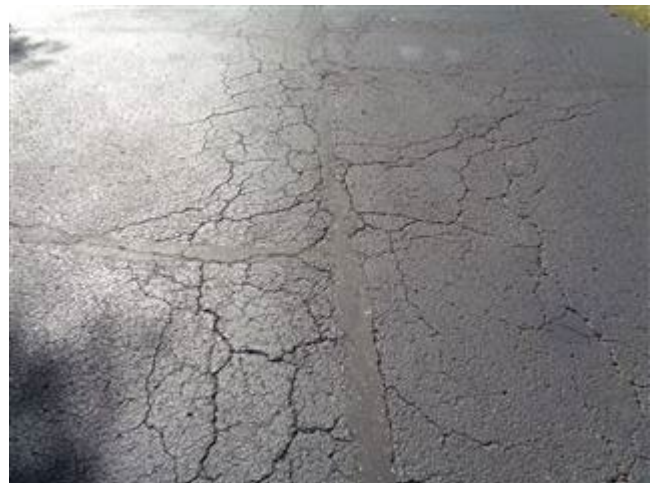
**Asphalt Pavement.** The Association is responsible for the roadways and clubhouse parking areas within the community. Other roadways (Longhill) are maintained by the City, County, or other municipality. In general, the Association's asphalt pavements are in varying conditions from good to poor. We understand Tower Hill will be the next road asphalt replaced. We have included funding for asphalt replacement on an incremental basis according to the current road conditions.

The Defects noted include the following:

- **Open Cracks.** There are multiple locations where open cracks are allowing water to penetrate to the asphalt base and the bearing soils beneath. Over time, water will erode the base and accelerate the deterioration of the asphalt pavement. If cracks extend to the base and bearing materials, remove the damaged areas, and replace defective materials. As a part of normal maintenance, clean and fill all other cracks.
- **Alligatoring.** There are multiple locations where the asphalt has developed a pattern of cracking known as alligatoring. The primary cause of alligatoring is an unstable base. Once these cracks extend through the asphalt, they will allow water to penetrate to the base, accelerating the rate of deterioration, and eventually leading to potholes. The only solution is to remove the defective asphalt, compact the base, and install new base materials and asphalt.

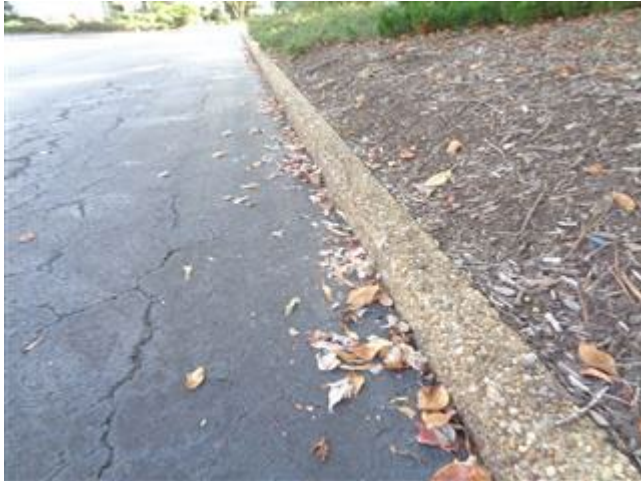
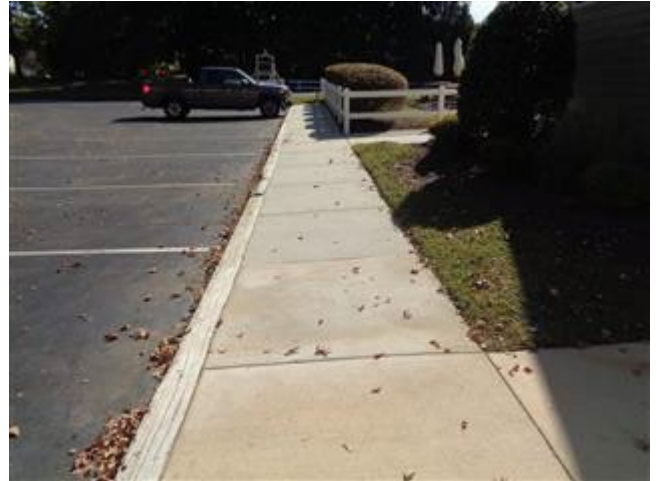
**Concrete Work.** The concrete work includes the community curb and gutter and sidewalks. The clubhouse and pool flatwork are covered in the recreational section of this report. We have modeled for curb replacement when the asphalt pavement is overlaid. The overall condition of the concrete work is good. Some cracking was noted.

The standards we use for recommending replacement are as follows:

- Trip hazard, ½ inch height difference.
- Severe cracking.
- Severe spalling and scale.
- Uneven riser heights on steps.
- Steps with risers in excess of 8¼ inches.

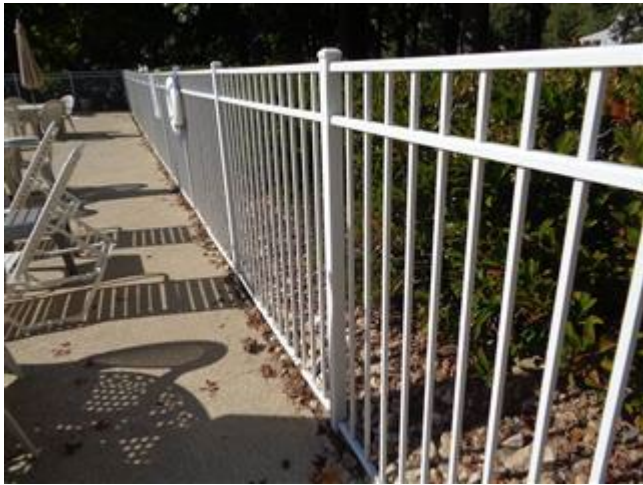
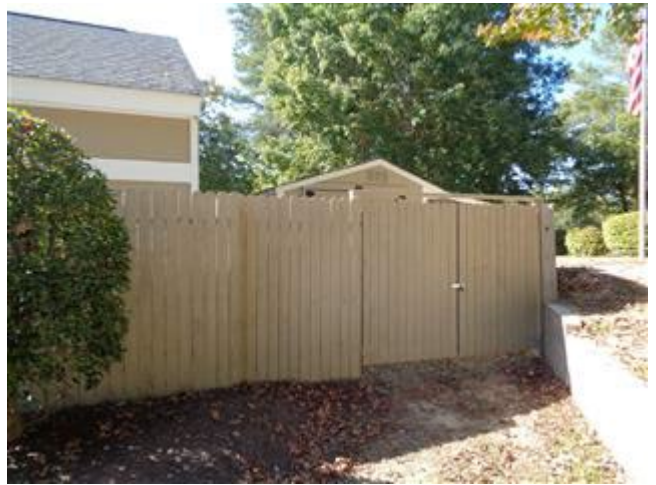
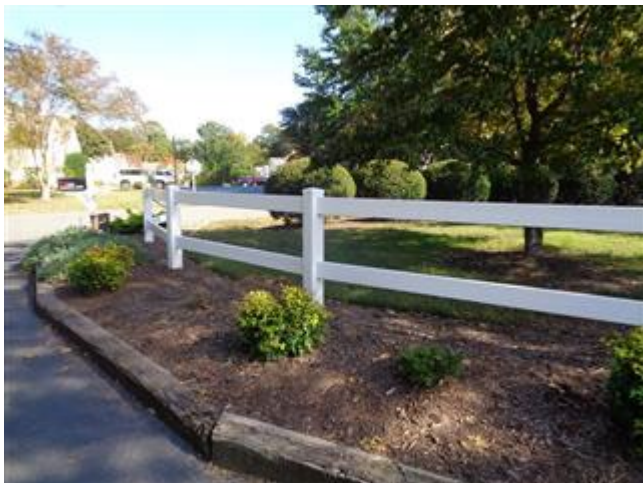
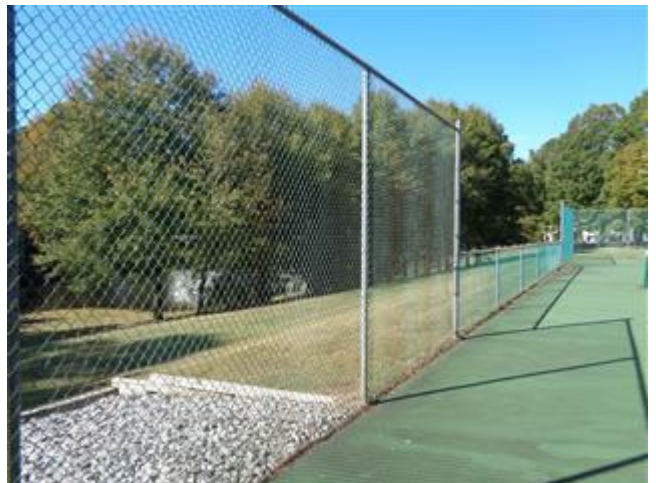
**Fencing.** The Association maintains various types of fencing which appears to be in good condition. Fencing systems have a large number of configurations and finishes that can usually be repaired as a maintenance activity by replacing individual components as they become damaged or weathered.

Protection from string machine damage during lawn maintenance can extend the useful life of some fence types. Protection from this type of damage is typically provided by applying herbicides around post bases or installing protective sheathing.

Pressure treated wood fencing should be cleaned and sealed every year or two. Typically the least cost fencing option, this type of fence can last 15 to 20 years if maintained properly.

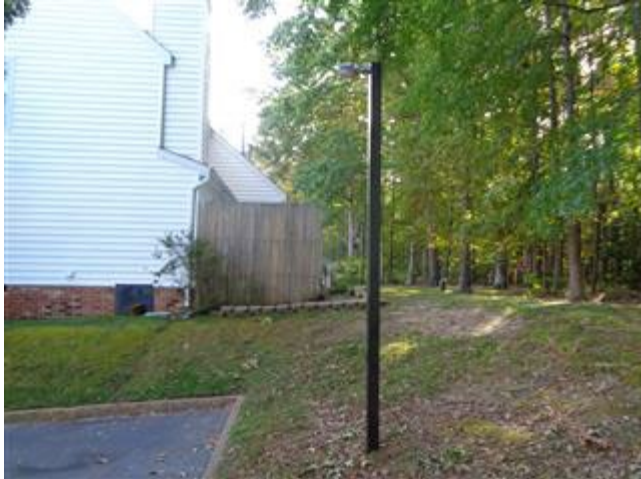
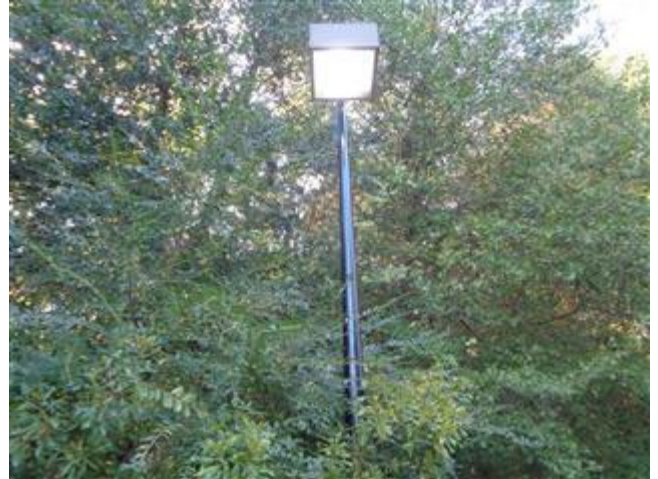
When a whole-scale lighting replacement project is called for, we recommend consulting with a lighting design expert. Many municipalities have design codes, guidelines, and restrictions when it comes to exterior illumination.

Additionally, new technology such as LED and LIFI, among others, is considered. The Association should consider factors such as environmental sustainability, longevity, and cost when they look at the replacement of their lighting.

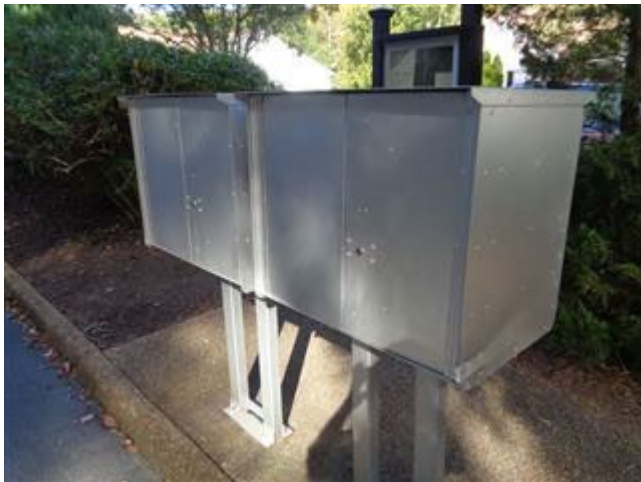
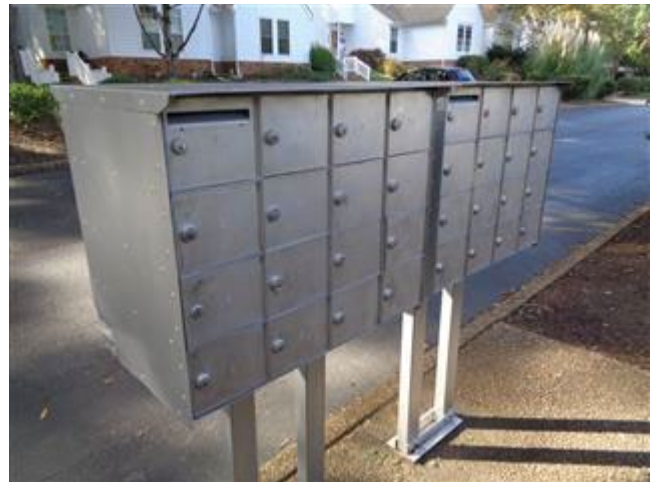
**Mailboxes.** Cluster mailboxes are located throughout the community and are in good condition.

Mailboxes should be maintained to the extent that rust does not develop on the structure or pedestal, and all mail slot doors remain intact with operable hinges and locks. Our replacement estimate assumes that these units will be replaced with fiberglass or composite units in the future.

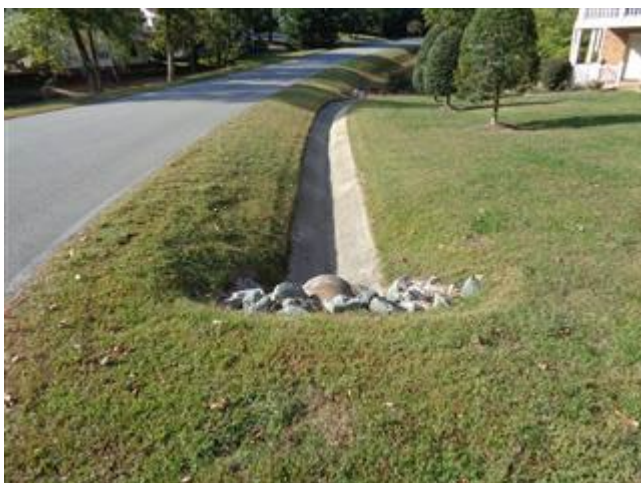
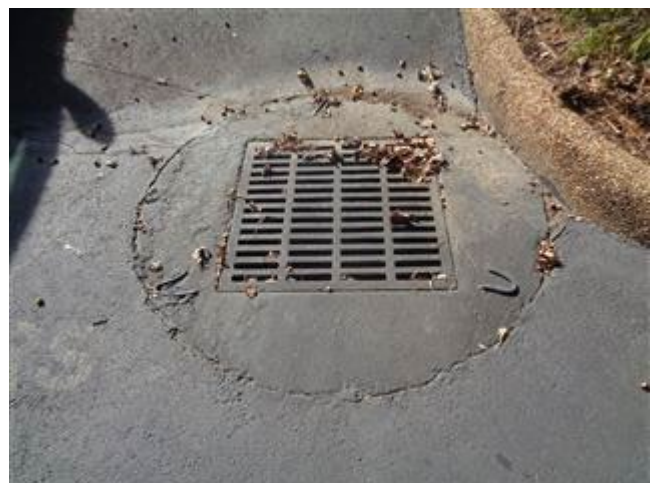
**Underground and above ground utilities.** The Association is responsible for the underground and above ground utility maintenance and replacement, including surface water control ditches and piping.

Engineering drawings were not used in the determination of these components. Instead, we have provided an estimate of the approximate replacement costs based on our experience with other facilities of similar size and configuration. The inspection and evaluation of underground lines and structures are beyond the scope of work for this study.

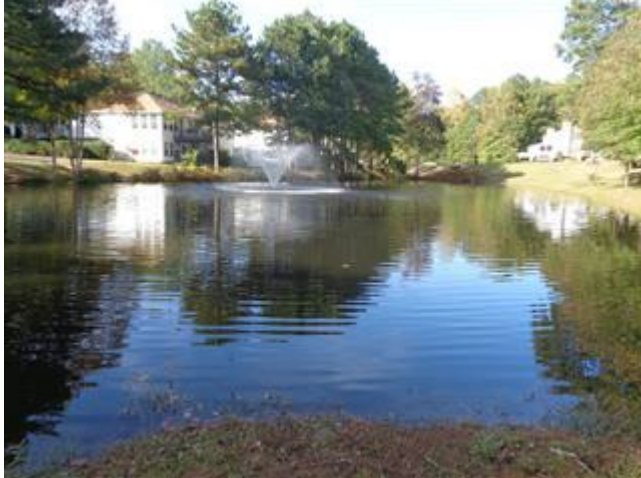
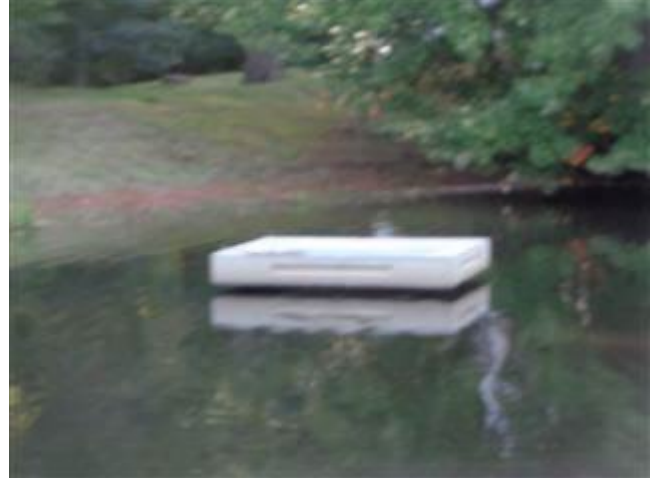
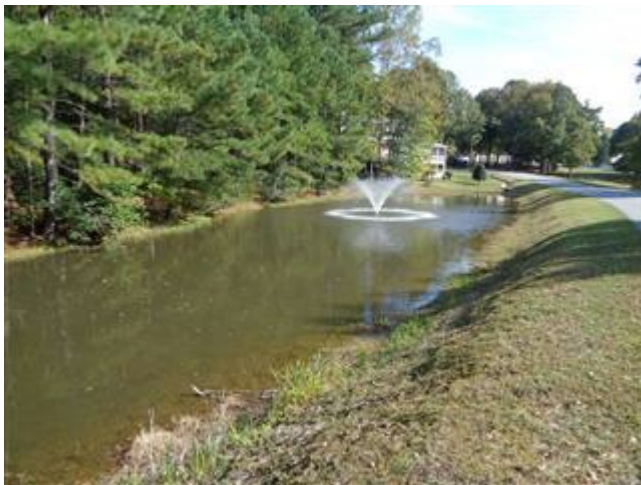
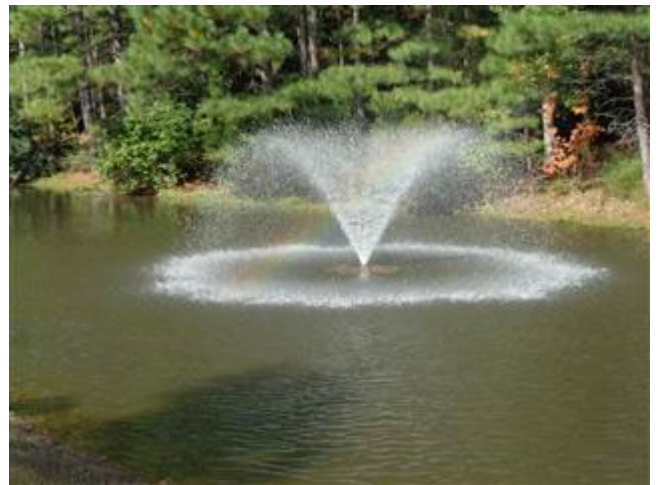
**Stormwater Ponds.** The community is served by two stormwater (BMP) ponds which appear to be in good condition.

Ponds will accumulate silt over time and lose the ability to store stormwater at design levels, which could result in overflows and minor local flooding. In addition, water quality can be negatively affected by increased siltation and debris accumulation. Accordingly, ponds require periodic dredging.

Estimates of cost and the frequency of dredging ponds are a function of many variables, including the volume of the pond, the siltation rate, the nature of the material being removed, the method of removal, and the haul distance to a site that will accept the spoil material. Most of this information is unknown and must be assumed for the purpose of reserve study planning. The siltation rate and cost of periodic dredging are speculative, varying greatly depending on local conditions.

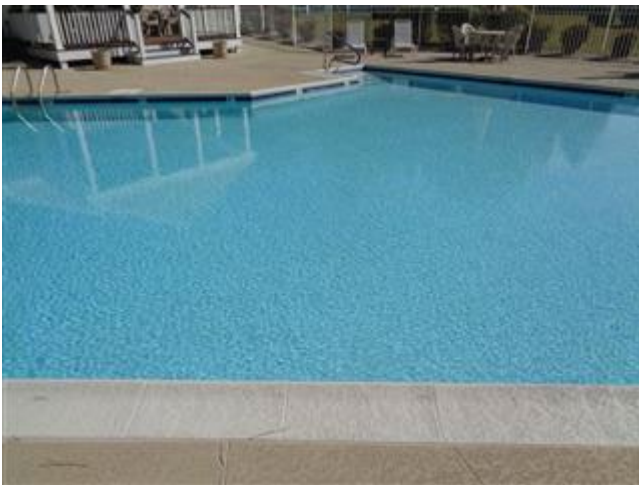
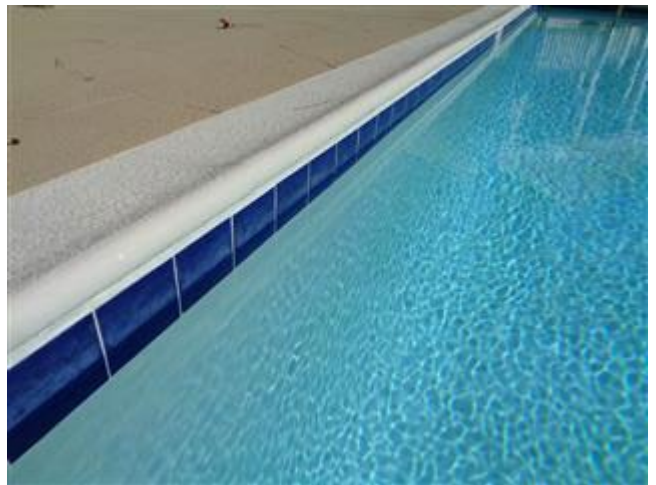
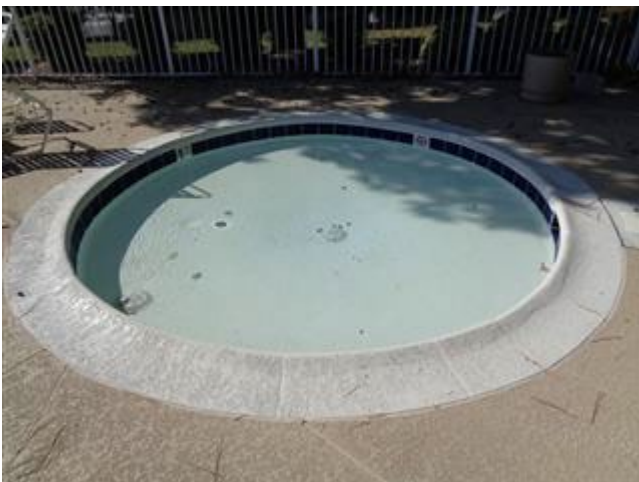
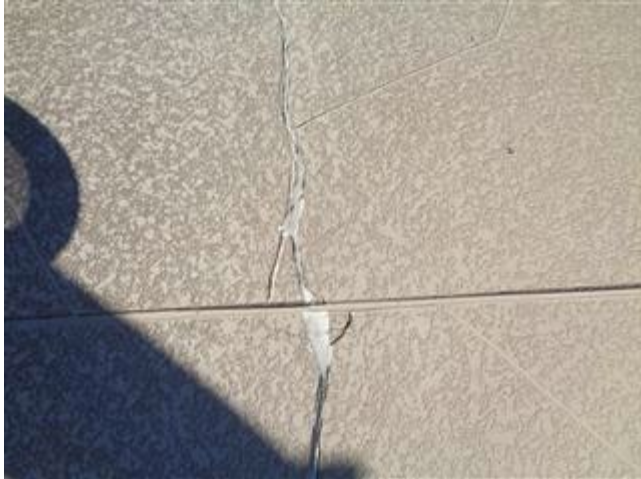
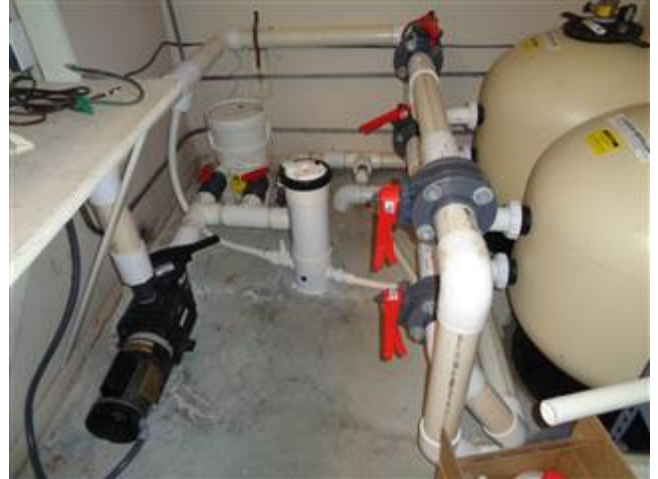
**Swimming Pool.** The community operates an outdoor pool and wading pool of concrete construction. The pools appeared to be in good condition. We did note some cracking in the concrete pool decking.

- Pool Shell. The shell for the swimming pool is in good condition.
- Pool Deck. The pool has a concrete deck. The overall condition of the deck is good with some cracking but no major settlement or trip hazards.
- Whitecoat. The pool whitecoat is in good condition. We have assumed a service life of eight to ten years for the pool whitecoat.
- Waterline Tile. The waterline tile is in good condition. We have assumed that the waterline tile will be replaced or restored when the pool is whitecoated.
- Coping. The pool is edged with masonry concrete coping. The coping is in good condition.
- Pump and Filter System. The pump and filter system is in good operating condition.
- Pool Fence. The swimming pool is enclosed by a metal fence that is in good condition.
- Pool furniture. The furniture appears to be in good condition. It has been re-strapped or replaced incrementally.

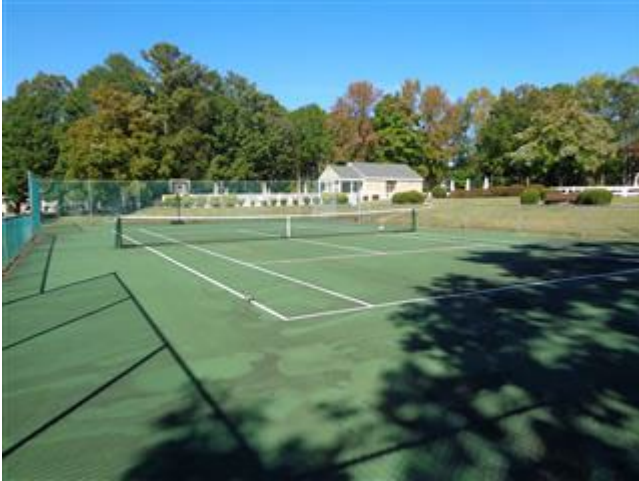
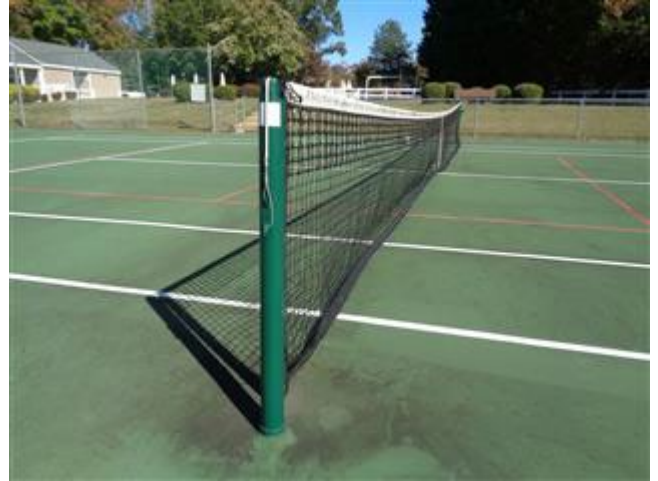
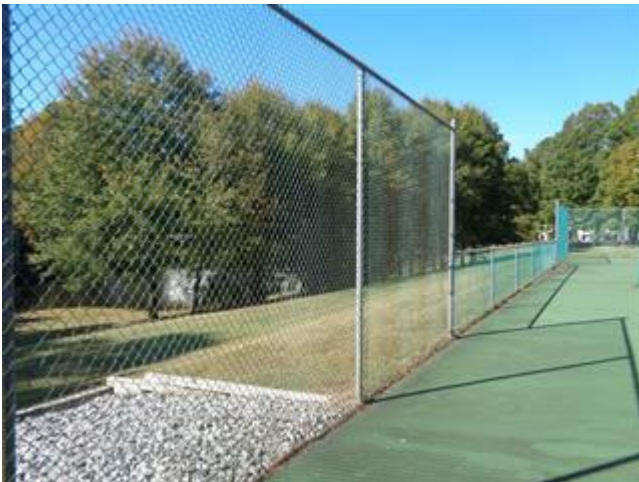
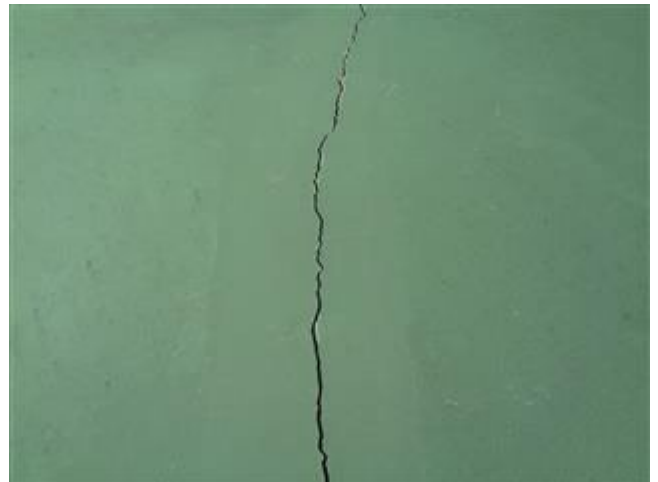
**Tennis Court.** The community maintains a single tennis court. The overall condition of the court is good. We understand it was resurfaced recently but we did note some surface cracking. These should be sealed to prevent water penetration and further deterioration.

- Fencing. We have assumed that the fencing will be replaced when the asphalt pavement is replaced. Posts and fencing should be inspected, repaired, and painted as needed to prolong their economic life. Periodic inspection of the posts, gates, hinges, and latches is also recommended, and it is important that posts and footings be protected to prevent soil erosion. In addition, care should be taken so that damage from string trimmers is minimized.
- Net Posts. We have assumed that the net posts will be replaced when the asphalt pavement is replaced.

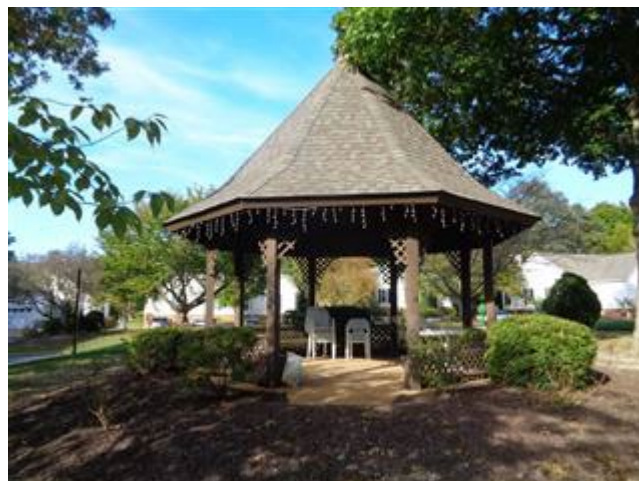
**Gazebo.** The Association maintains a large wood gazebo with an asphalt shingle roof in the Cheswick Park area. This remains in good condition.

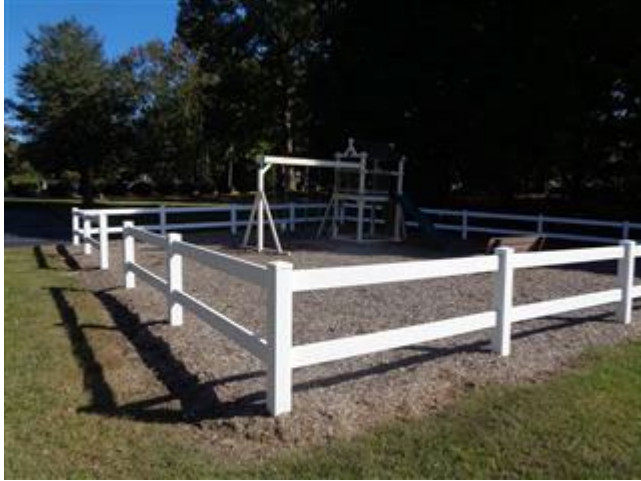
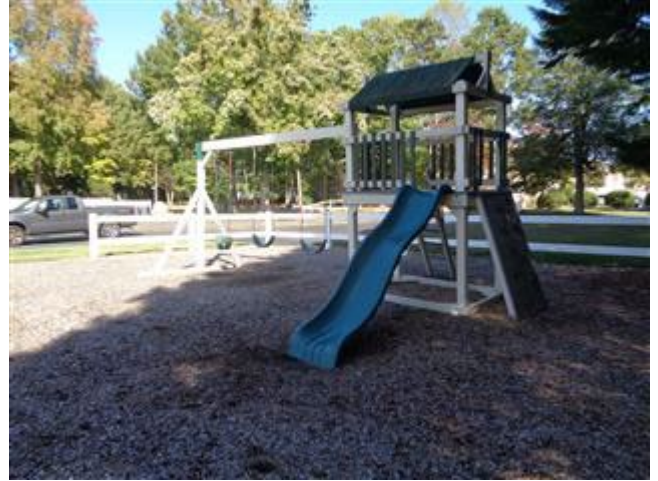
**Tot Lot.** The community maintains one tot lot. This includes play structures and a wood chip surface. The facility is in generally good condition with minor wear in relation to age. The wood chip surface is displaced or missing in spots.

The safety of each individual piece of playground equipment, as well as the layout of the entire play area, should be considered when evaluating a playground for safety. The installation and maintenance of the protective surfacing under and around all equipment are crucial. Please note that the evaluation of the equipment and these facilities for safety is beyond the scope of this work.

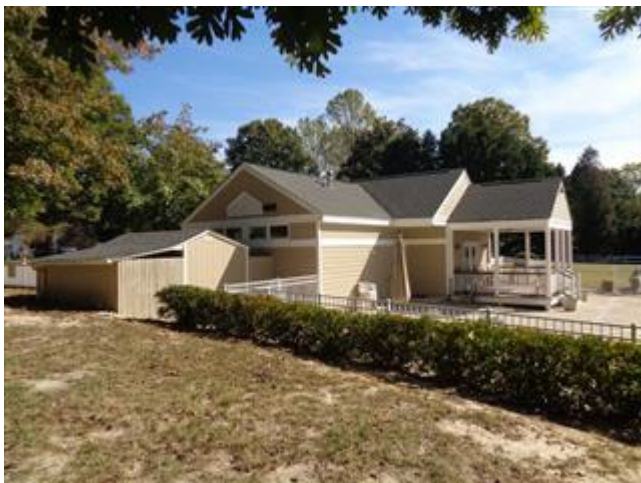
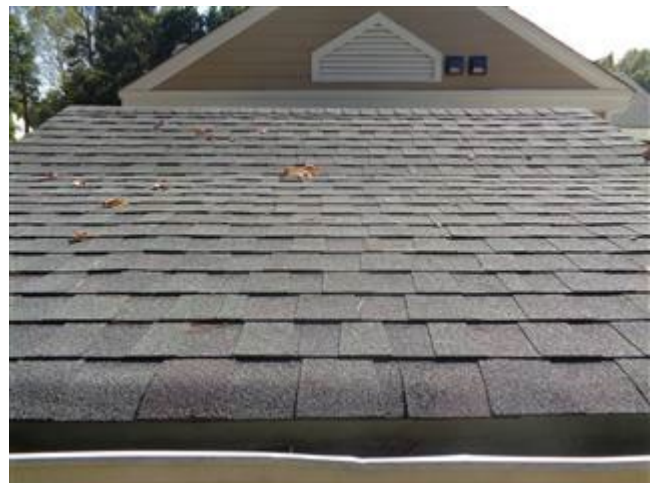
**Building Roofing.** The clubhouse and attached shed dimensional asphalt shingle roofing are in good condition with no reported leaking or other problems.

Asphalt shingle roofs can have a useful life of 20 to 40 years depending on the weight and quality of the shingle. Weathered, curled, and missing shingles are all indications that the shingles may be nearing the end of their useful life.

Annual inspections are recommended, with cleaning, repair, and mitigation of vegetation performed as needed. Access, inspection, and repair work should be performed by contractors and personnel with the appropriate access equipment who are experienced in the types of roofing used for the facility.

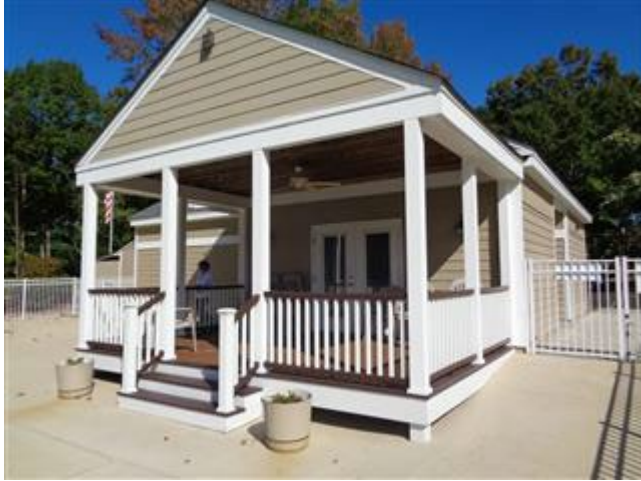
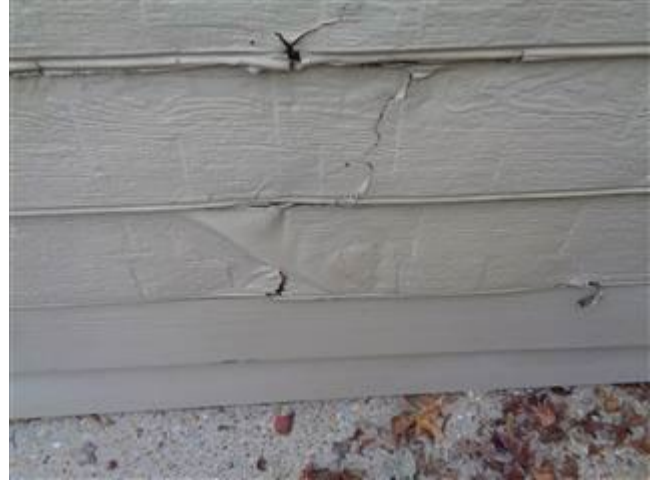
**Siding and Trim.** The clubhouse exterior siding, wood trim, windows, and doors are in good condition with the exception of the composition siding on the wall beside the HVAC unit. Deterioration was noted there.

Wooden exterior materials are typically repaired as needed during normal painting cycles. Painting cycles for wooden exteriors vary between five and ten years depending on the grade of wood and the quality of the materials and finish work. In this study, we have modeled for an incremental wood material replacement to coincide with the painting cycle of the facility.

Hardboard materials are constructed from wood fiber, wax, and resins that are compressed under heat and pressure. Many of these types of materials have a history of problems and premature failure. As the hardboard material ages, some of the compression is relieved, resulting in localized swelling. Water can enter these swollen areas, accelerating the degradation process, and resulting in delamination, and blistering. Once damaged, the hardboard material cannot be repaired. Additionally, the Association may discover that there is significant damage to the underlying sheathing and building structure if the damaged hardboard has allowed moisture to gain access to these underlying elements over a long period. Structural repairs and latent damage are not accounted for in this study.

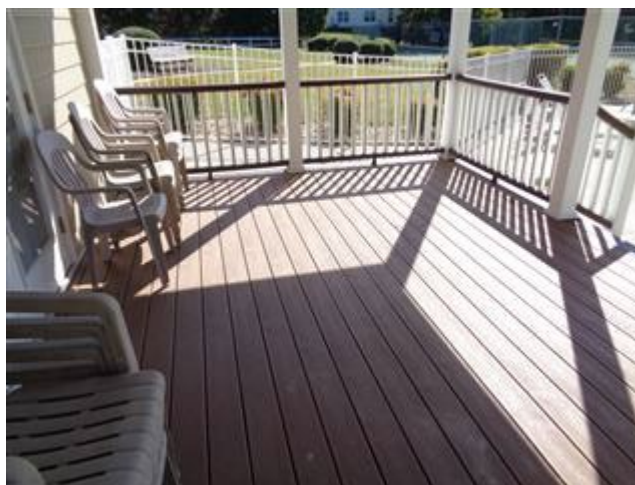
**Deck.** The wood deck and railing at the clubhouse is in good condition.

We recommend for the Association implement an annual inspection program. We also recommend power washing and the application of a wood sealer with UV protection every two to three years. Installation of carpet or other water trapping coverings should be prohibited, and potted plants should be placed on raised feet to allow for proper air circulation and drying of wooden components.

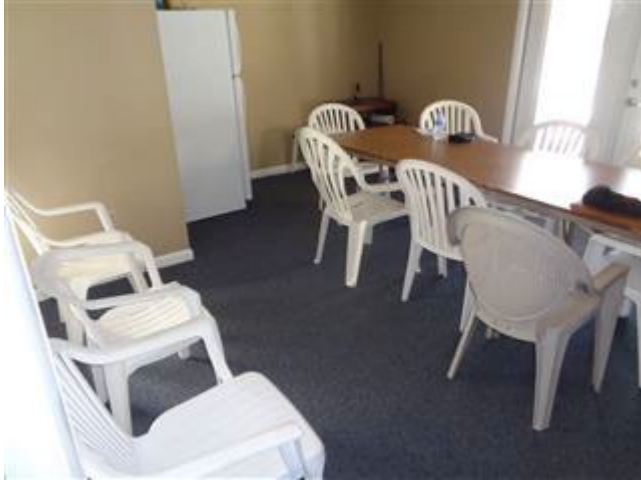
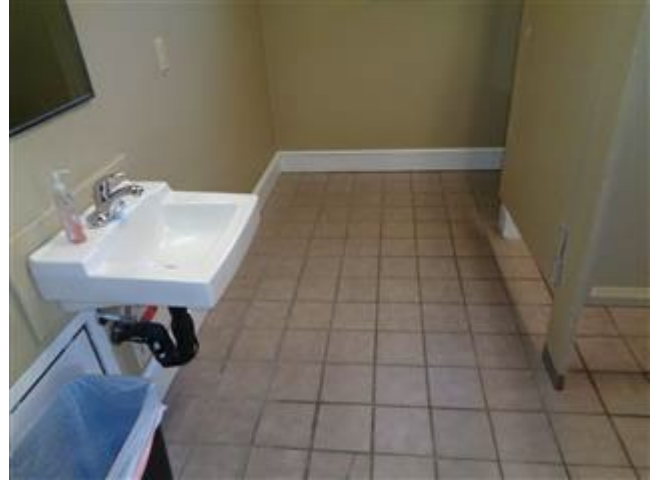
**Clubhouse interior** The clubhouse interior is in good condition. Some wear is apparent but is consistent with age and use. The sauna is not in use and is not intended to be returned to use per BOD. We have included funding for refurbishments on an incremental basis.

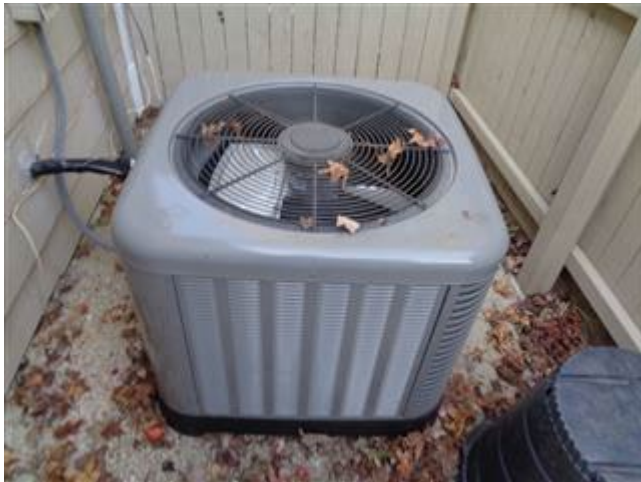
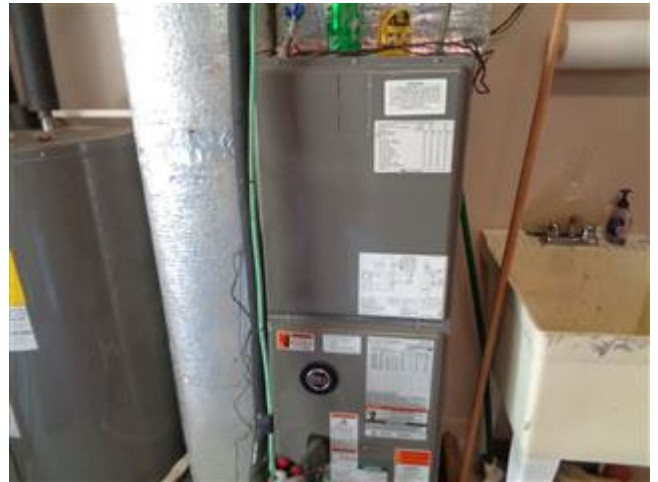
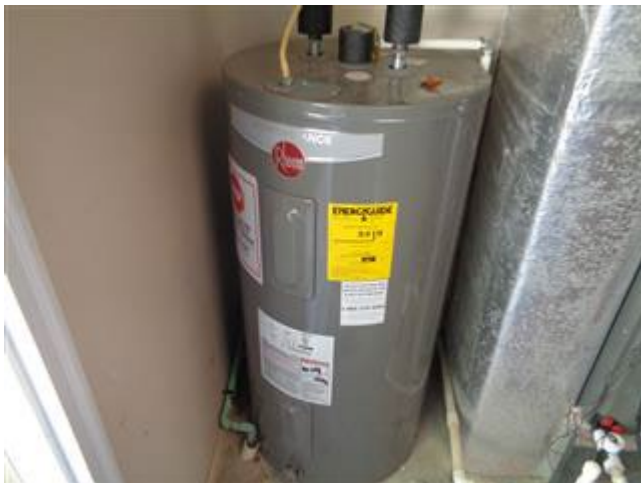
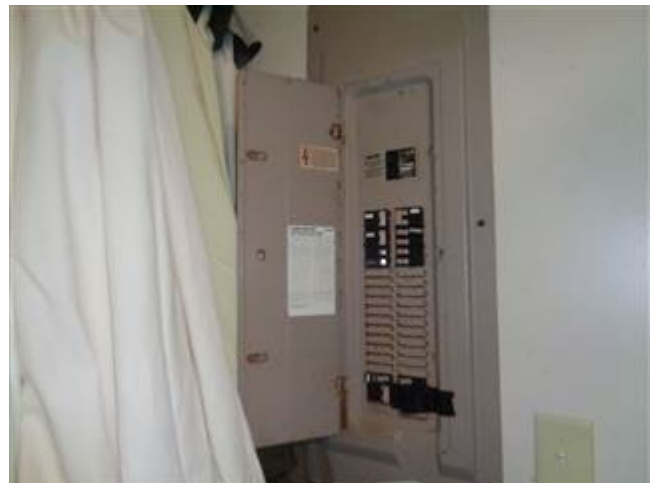
**Mechanical** The heating ventilation and air conditioning (HVAC) of the facility are reported to be in good operating condition. The heat pump was replaced in 2019. Detailed inspection and testing of these systems is beyond the scope of this study. The water heater, electrical and plumbing are all in good condition at this time.

As is the case with most equipment, to achieve a maximum useful economic life, proper maintenance is essential. In some cases, proper and proactive maintenance can greatly extend the useful life of these components.
