Uniform Mitigation Verification Inspection Form

Inspection Date: 04-10-2025		
Owner Information Waterside at Suntree Country Club Condo		
Owner Name: Waterside at Suntree Country Club Condo		Contact Person: Sue Geier
Address: 401, 405, 409, 413, 417 & 421 Entrance Way		Home Phone: 321-259-0502
City: Melbourne, FL	Zip: 32940	Work Phone: 321-259-0502
County: Brevard		Cell Phone:
Insurance Company:		Policy #:
Year of Home: 1984	# of Stories: 2	Email: sgeier6633@gmail.com

401 Entrance Way through 421 Entrance Way (Building “D”)

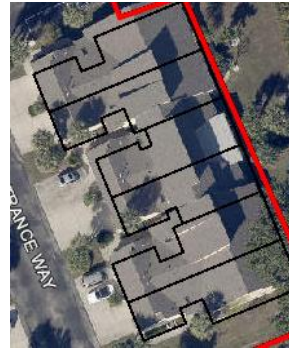
Roof to wall connection

- ☐ B. Clips
 - ☒ Metal connectors that do not wrap over the top of the truss/rafter, **or**
 - ☐ Metal connectors with a minimum of 1 strap that wraps over the top of the truss/rafter and does not meet the nail position requirements of C or D, but is secured with a minimum of 3 nails.
