**RE: URGENT — Formal Environmental Complaint — Breck Athletic Complex, Tax Parcel  
BBV 2022999002, Village of Big Bend, Waukesha County — Request for Independent Review  
and DNR Intervention**

— **DOCUMENTED FLOODING — SITE AREA PHOTOGRAPHS** —

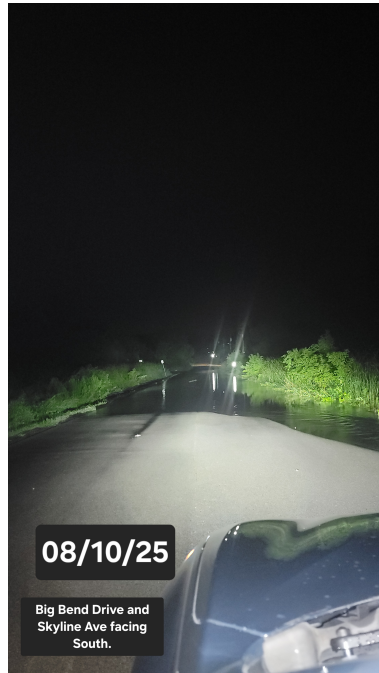
*Photo 1: Big Bend Drive and Skyline Ave facing South — dated 08/10/25. Standing water visible on roadway and adjacent areas consistent with active flooding event.*

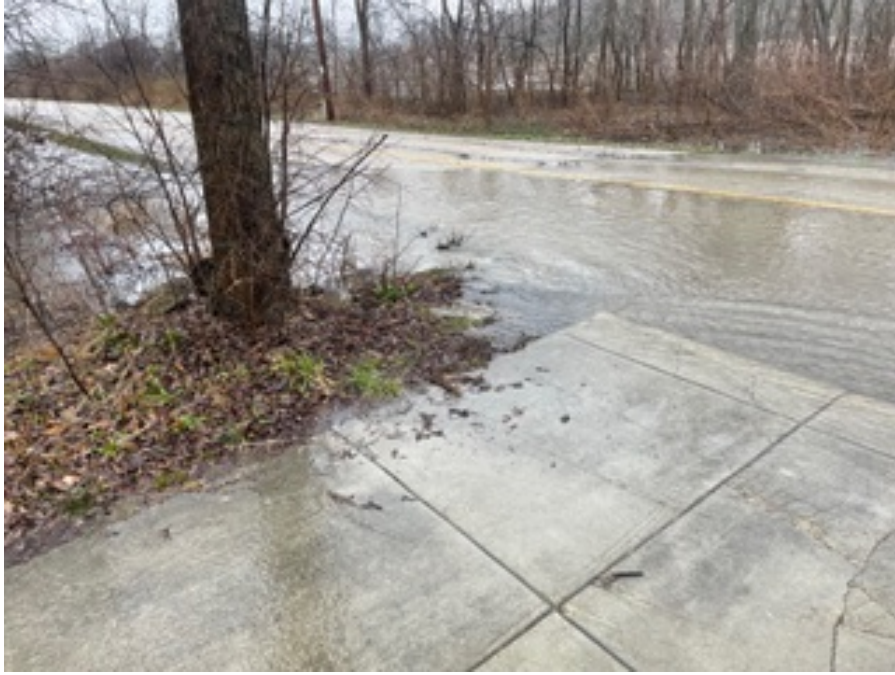
*Photo 2: Town Line Road flooding — water flowing across roadway surface and into adjacent ditch, demonstrating insufficient drainage capacity in existing infrastructure.*

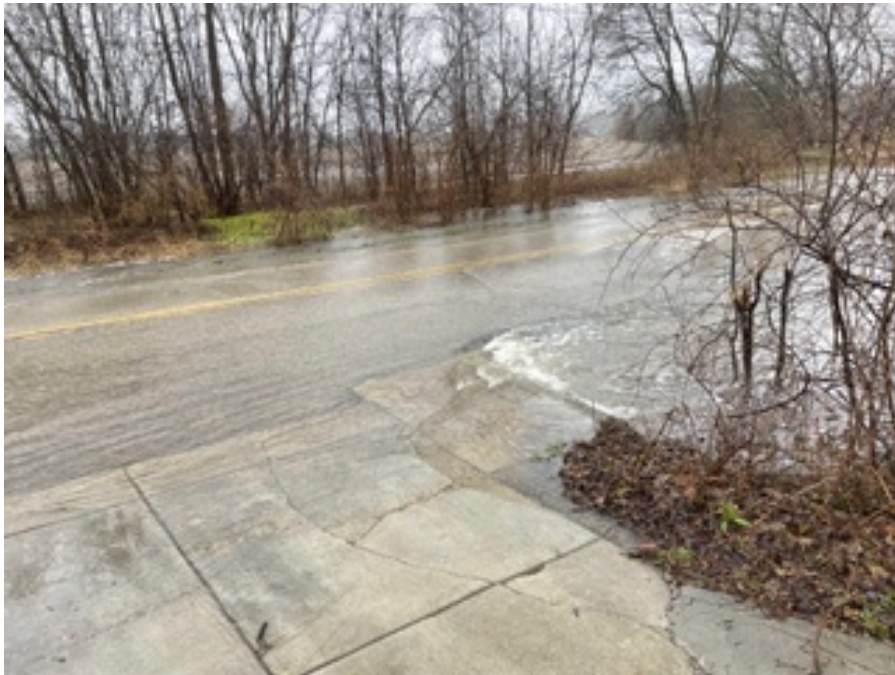
*Photo 3: Town Line Road flooding — additional view showing extent of road inundation and standing water in surrounding area.*

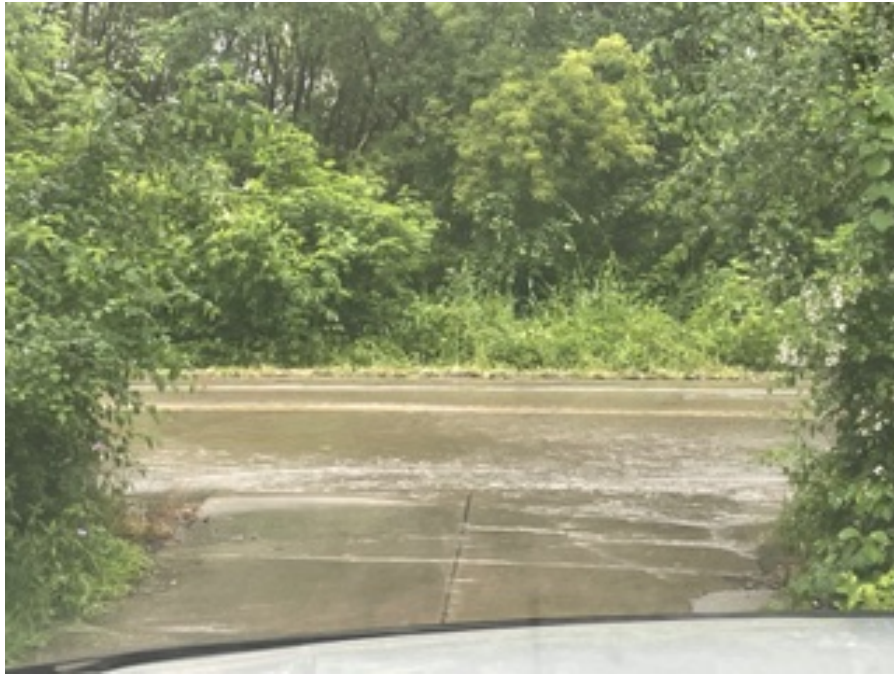
*Photo 4: Site area flooding — standing water and saturated conditions adjacent to the proposed development parcel, consistent with Hydrologic Soil Group D conditions documented in the geotechnical record.*
