BRAVO ZULU

RESIDENTIAL INSPECTIONS

Home Inspection Report

<i>Street Address</i>	102 Main Dr
<i>City, State, Zip</i>	Simpsonville, SC
<i>Building Style</i>	House, Foundation: Slab
<i>Sq. Ft.</i>	1,779
<i>Client</i>	A. GB
<i>Real Estate Agent</i>	
<i>Inspector</i>	David Vigil
<i>Inspection Date</i>	3/20/2024

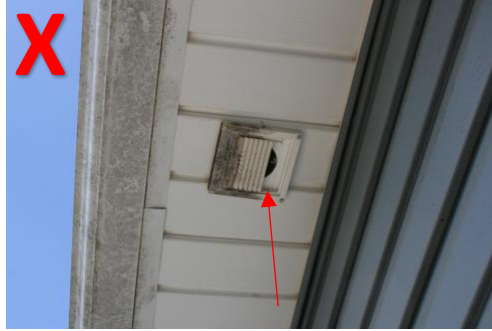
NOTES:			
Steps	<input checked="" type="checkbox"/>	<input type="checkbox"/>	<input type="checkbox"/>	<input type="checkbox"/>
	NOTES:			
Eaves	<input checked="" type="checkbox"/>	<input type="checkbox"/>	<input type="checkbox"/>	<input type="checkbox"/>
	NOTES:			
Soffits	<input type="checkbox"/>	<input checked="" type="checkbox"/>	<input type="checkbox"/>	<input type="checkbox"/>
	NOTES: Soffiit vent broken back yard above HVAC Unit, recommend replacement to avoid pest infiltration

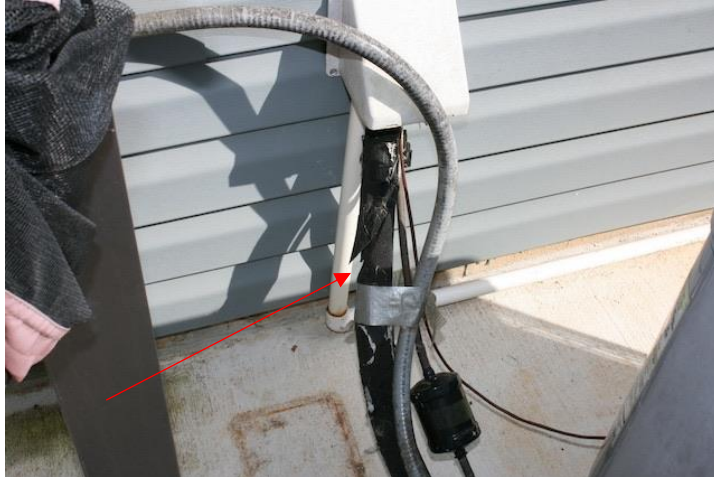
DESCRIPTION	Satisfactory	Fair	Poor	NA
HeatingCooling Hardware	<input type="checkbox"/>	<input checked="" type="checkbox"/>	<input type="checkbox"/>	<input type="checkbox"/>
	NOTES: HVAC line isulation cut in small areas, no immediate concern, monitor			
Heating System	<input checked="" type="checkbox"/>	<input type="checkbox"/>	<input type="checkbox"/>	<input type="checkbox"/>
	NOTES:			
Venting / Chimney	<input checked="" type="checkbox"/>	<input type="checkbox"/>	<input type="checkbox"/>	<input type="checkbox"/>
	NOTES:			
Heating System Operation	<input checked="" type="checkbox"/>	<input type="checkbox"/>	<input type="checkbox"/>	<input type="checkbox"/>
	NOTES:			
Ductwork / Piping	<input checked="" type="checkbox"/>	<input type="checkbox"/>	<input type="checkbox"/>	<input type="checkbox"/>
	NOTES:			
Cooling System	<input checked="" type="checkbox"/>	<input type="checkbox"/>	<input type="checkbox"/>	<input type="checkbox"/>

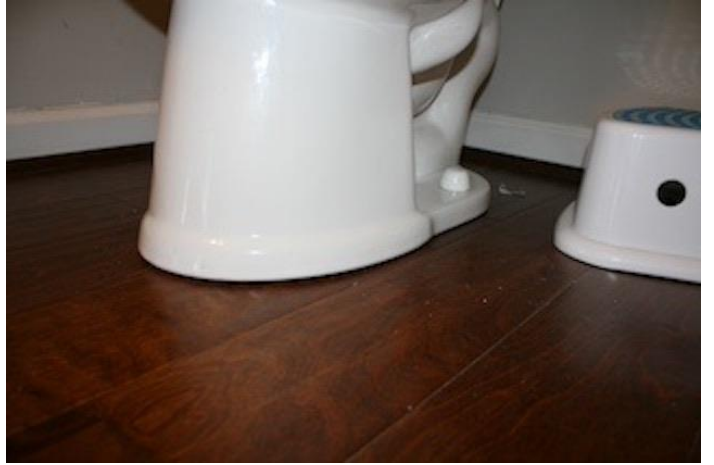
Photo 16

Asphalt shingle, Roof shows signs of wear and granule loss due to age
Portion of roof rafter shows signs of separation in one spot but does not indicate any movement or uneven roof sheathing. Recommend monitoring over time.
Double sink, right sink hot water flow is minimal
A Bead of seal should be placed around the base of all toilets
Doors should have a 3/4" space between bottom and floor for proper air distribution
Couldn't access reasonable amount of outlets due to clutter in Master Bedroom
Dining room outdoor upper trim sehow some separation, (cosmetic) recommend reseal
Master bath hot water low pressure
HVAC line isulation cut in small areas, no immediate concern, see photos 16, 17
