Mantua Township Black Brook Flood Study

FINAL
JULY 2023

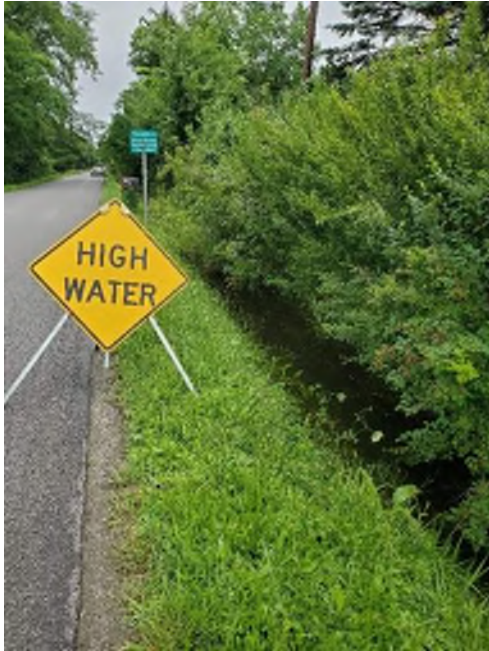
Mantua Center Road is paved with asphalt in good condition. The road is 24 feet wide with deep ditches running parallel to the road on either side. The ditches convey the southeast and southwest branches of Black Brook (see photographs 2.1 and 2.2). During heavy rain events, Mantua Center Road often overtops with flood water and, at times, becomes impassable. The Mantua Township Road service department maintains the road which includes periodic removal of sediment from the ditches, roadside mowing, filling of potholes, and other maintenance. Frequent flooding along the road causes the road embankments to erode and requires periodic repairs to maintain integrity.

Photo 2.1 – Mantua Center Road and East Side Ditch

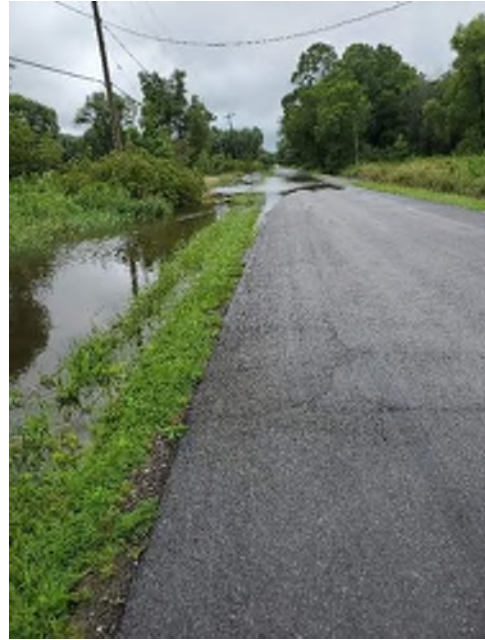
Photo 2.2 – Mantua Center Road Overtopped with Flood Waters

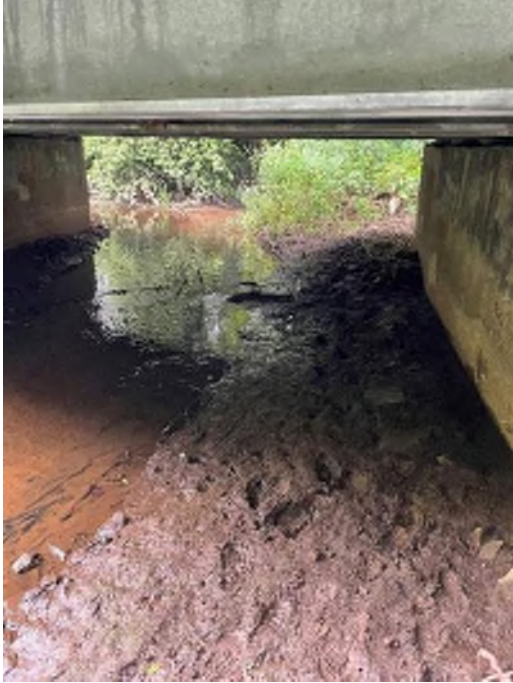
The Mantua Center Road bridge is located at the north end of the study area approximately 350 feet south of Herman Road. The bridge conveys the west branch of Black Brook and spans approximately 21 feet (Figure 1). Ditches located on each side of Mantua Center Road which convey the southeast of southwest branches of Black Brook intersect the west branch of Black Brook and drains to the east. The bridge appeared to be well maintained and in good condition (see photographs 2.1 through 2.4).

Photo 2.3 – Bridge Abutments

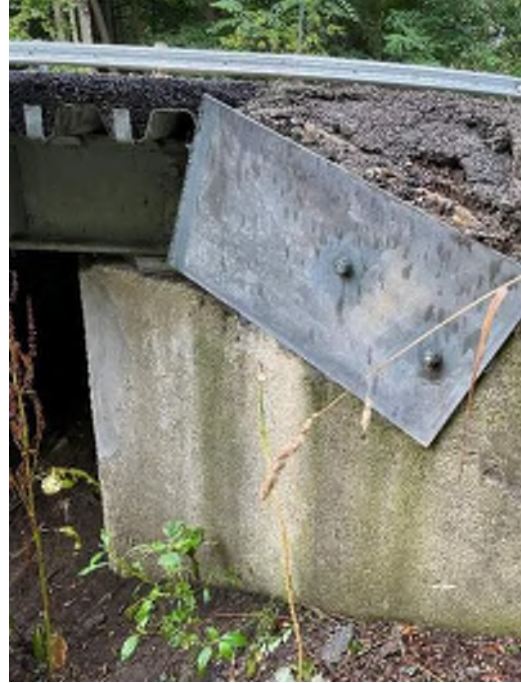
Photo 2.4 – Bridge Abutment

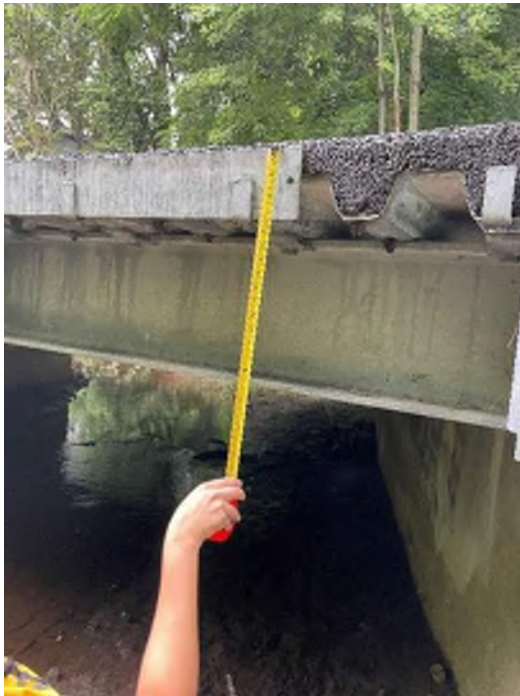
Photo 2.5 – Bridge Girder and Decking

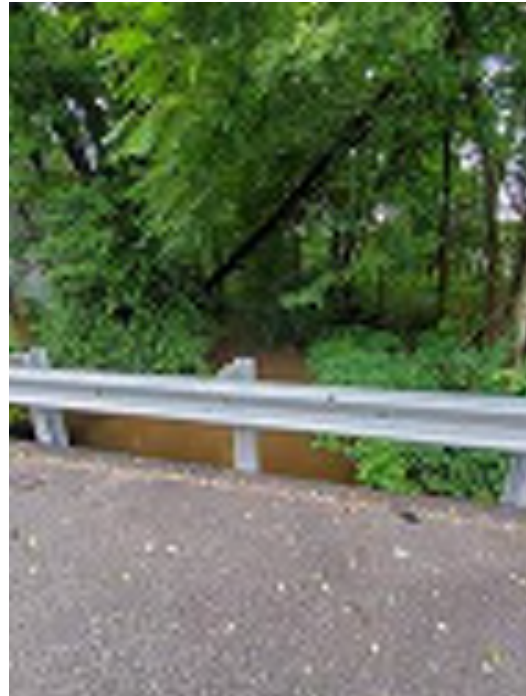
Photo 2.6 – Bridge Guard Rail and West Branch of Black Brook

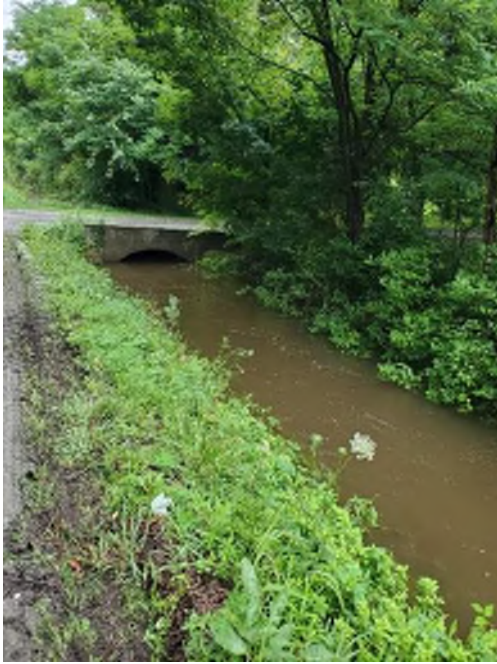
There are 15 driveway culverts on the east side and 14 driveway culverts on the west side of Mantua Center Road along the one-mile stretch within the study area. The culverts are constructed of various materials including concrete, corrugated metal pipes, steel girders, and wood. The culverts are maintained by the homeowners. The conditions of the culverts vary widely. Some are in need of repair or replacement and others are in good condition.

Photo 2.7 – Concrete Driveway Culvert

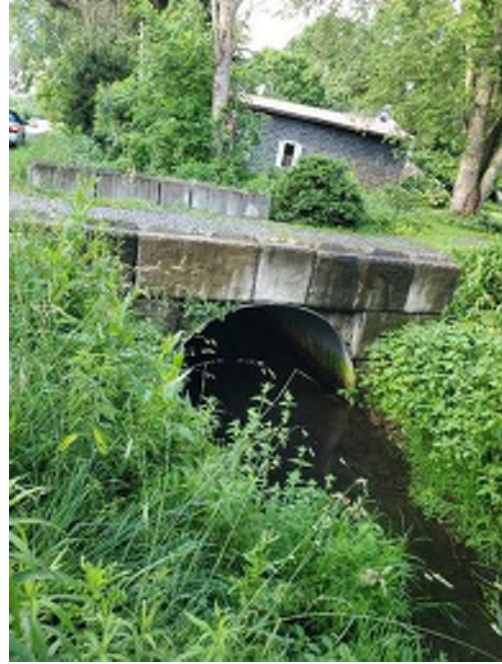
Photo 2.8 – Corrugated Metal Pipe Driveway Culvert

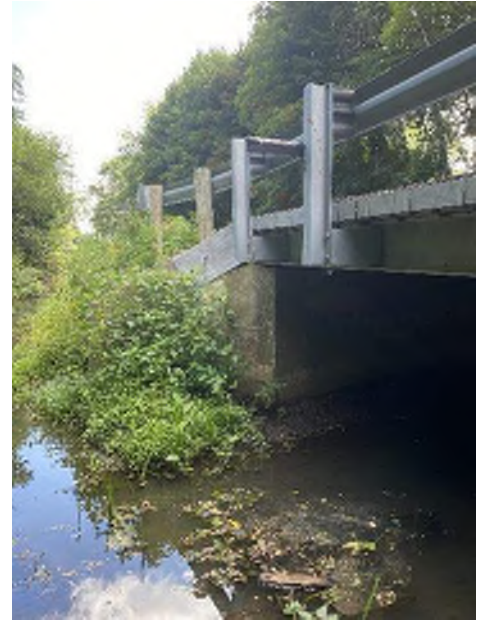
There are no USGS stream gages on Black Brook. However, two water level sensors were installed by hyfi through a Great Lakes Protection Fund grant. One sensor is mounted to the bridge on Mantua Center Rd. where the east and west ditches intersect the Black Brook (41.330057966, -81.245251903). This sensor measures water level data that combines the Black Brook and the west ditch. The second sensor measures water level downstream of the study area and is installed on the Winchell Rd. bridge that conveys Black Brook.

Figure 6 - Flow Sensor on Mantua Center Road Bridge

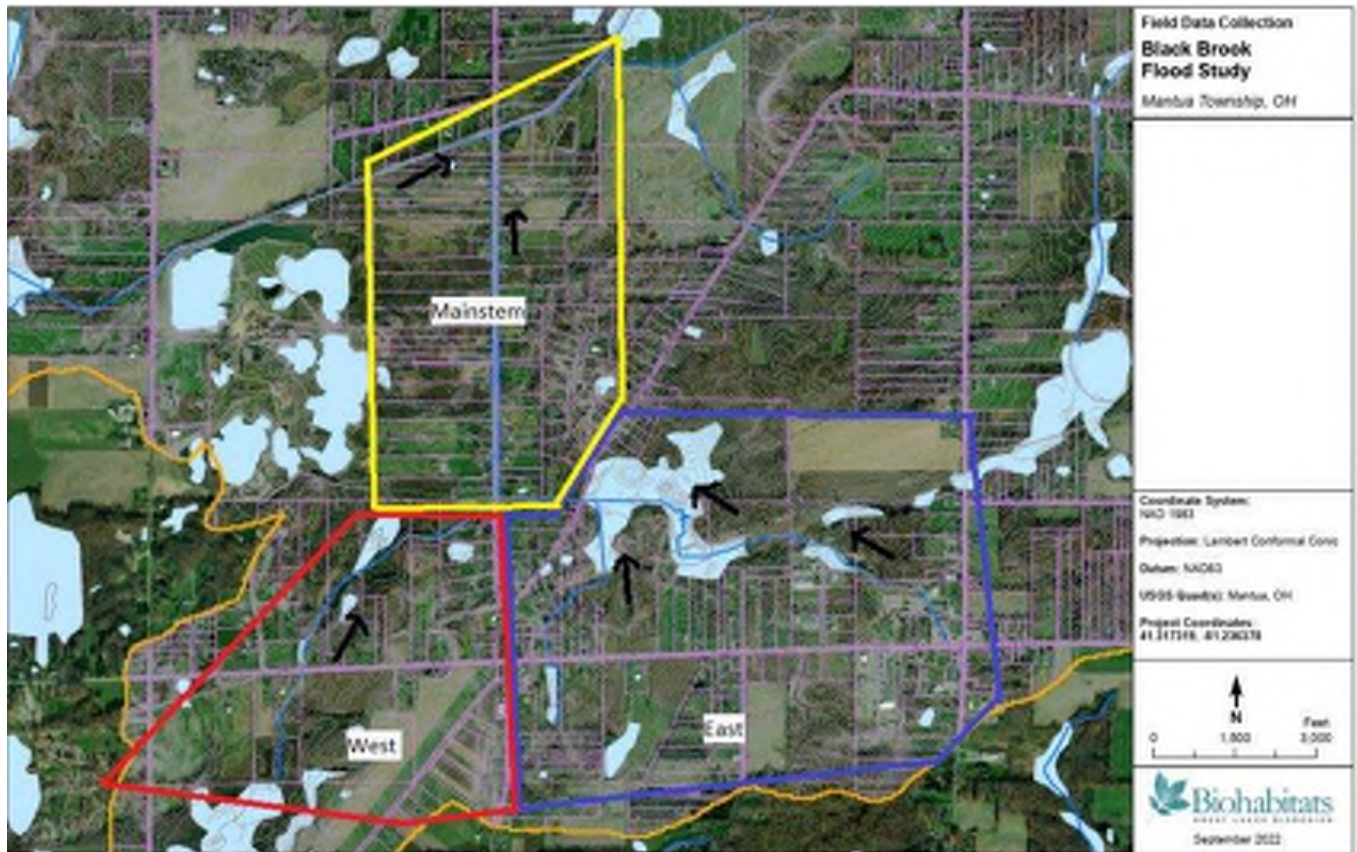
Figure 4. Sections of the Black Brook Study Area

The study area was divided into three areas based on the existing stream network. The valley bottom along Mantua Center Road, where the East Tributary and the West Tributary join, was defined as the Mainstem area. The West area is to the southwest and contains the West Tributary. The East area is to the southeast, contains the East Tributary, and stretches just past the Hwy 44 and 82 intersection. Figure 4 shows for the locations of these three areas. Emphasis was placed on the East area, due to the initial modeling efforts by Osborn Engineering indicating that this sub watershed contributes the largest flow

contributing to the inundation of the Mainstem area. The fieldwork is further described in subsequent subsections below.

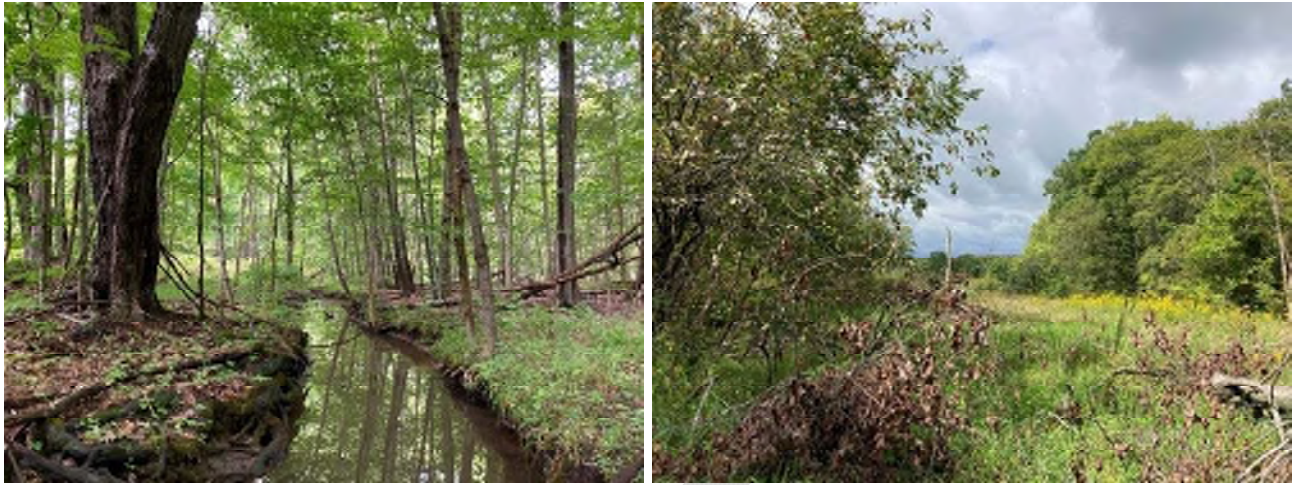
The upper watershed of the East Tributary contains the village of Mantua Corners and the most developed area of the entire watershed. Historic aerial photos show that much of the watershed has been ditched to facilitate drainage before 1952. Most flow paths through the landscape have been modified, through ditching, channelization, and impoundment. Starting at the upstream end of the watershed near Hwy 44, the East Tributary runs under Hwy 44 in two culverts- a 22" RCP and a 24" CPP. The northern branch has no defined channel and is a long linear wetland mixture of scrub-shrub and emergent wetlands. It is located directly south of the old railroad line location that ran southwest to northeast through Mantua Center. The southern branch is a defined channel that has been channelized and disconnected from its floodplain.

Figure 5. South Branch channelized stream through forest (left) confluence South and North Branch (right)

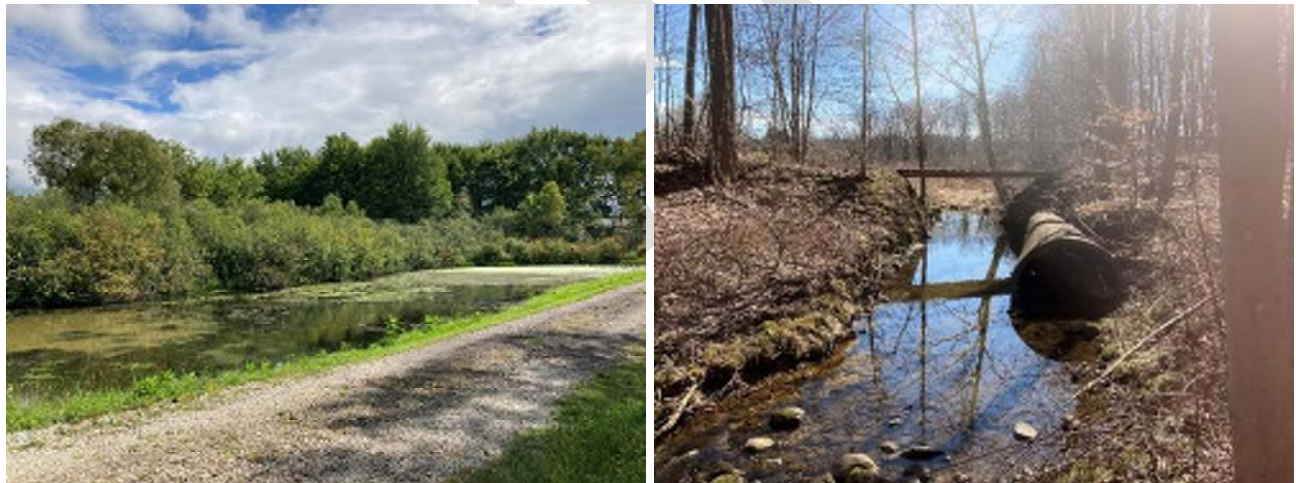
Figure 6. Poned area upstream of driveway embankment (left) and blown out culvert at old railroad line crossing (right)

On both sides of this crossing, there is ponded water. Approximately 900 feet downstream, the tributary takes a northern turn through a break in the railroad embankment. The culvert has blown out at this location, draining an upstream former pond.

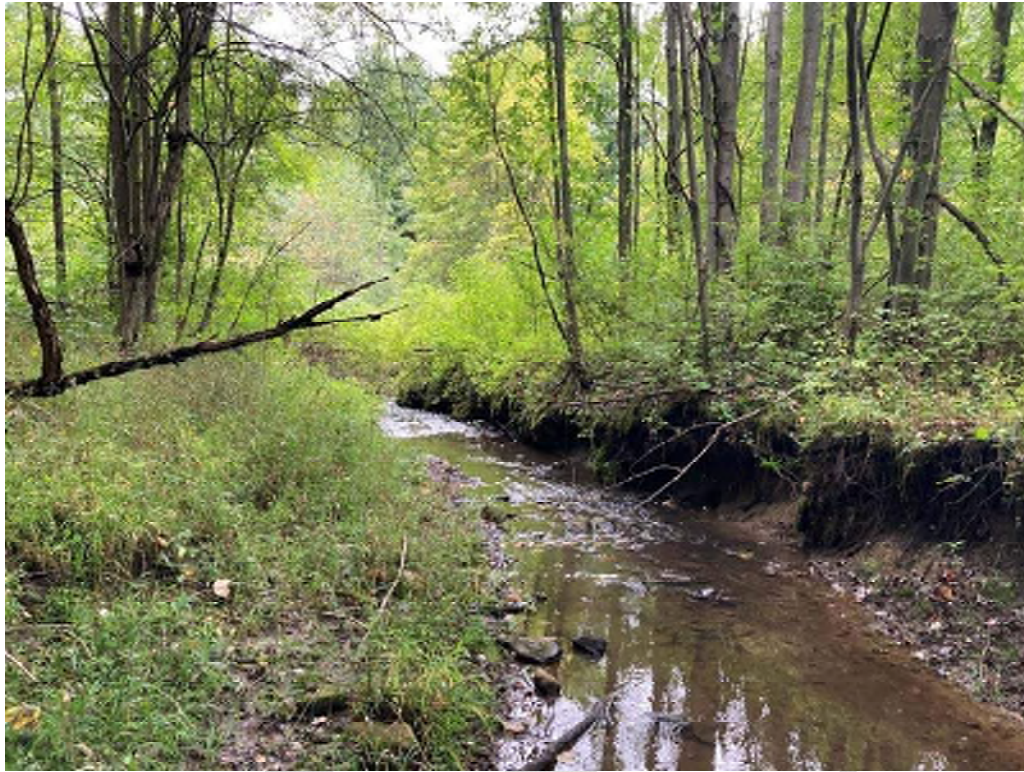
Figure 7. Entrenched channelized stream in East Section upstream of Wayne Road

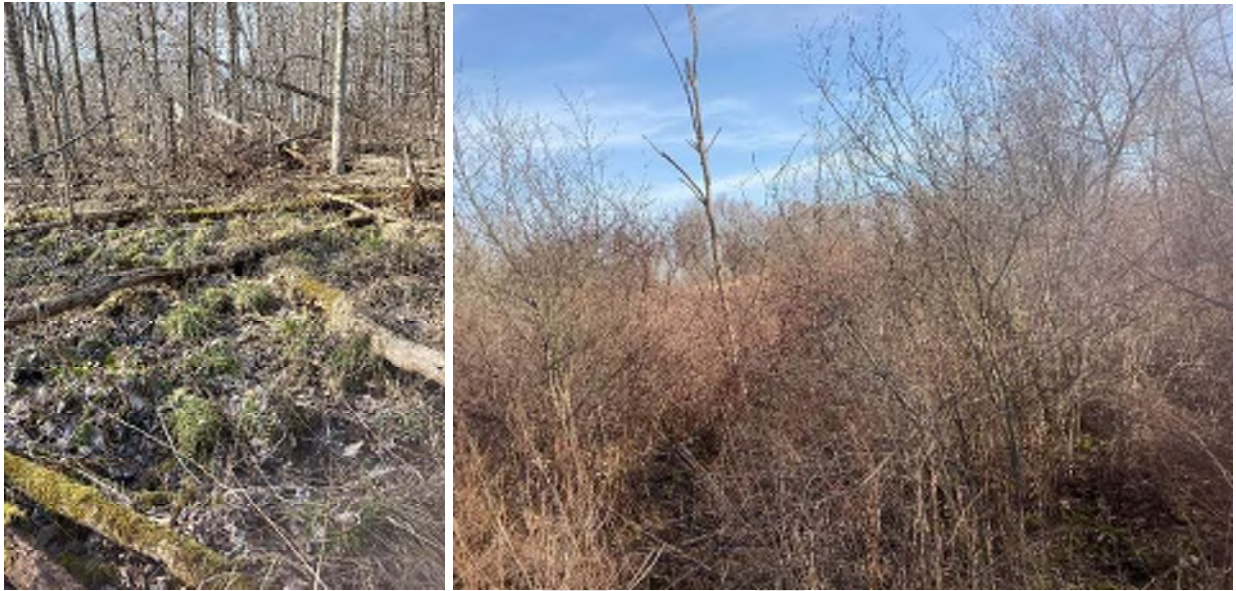
The upper watershed of the West Tributary is primarily agricultural in land use. The flow path starts in a large wetland south of HWY 82 and west of Mantua Center and drains northeast toward Mantua Center. Near Hwy 82, the stream has been channelized and impounded on both sides of the highway. Downstream of the impoundment on the north side of the West Tributary enters a large scrub-shrub/emergent wetland complex, surrounded by forested wetlands.

Figure 8. Forested wetland (left) and scrub shrub wetland (right) in West Section

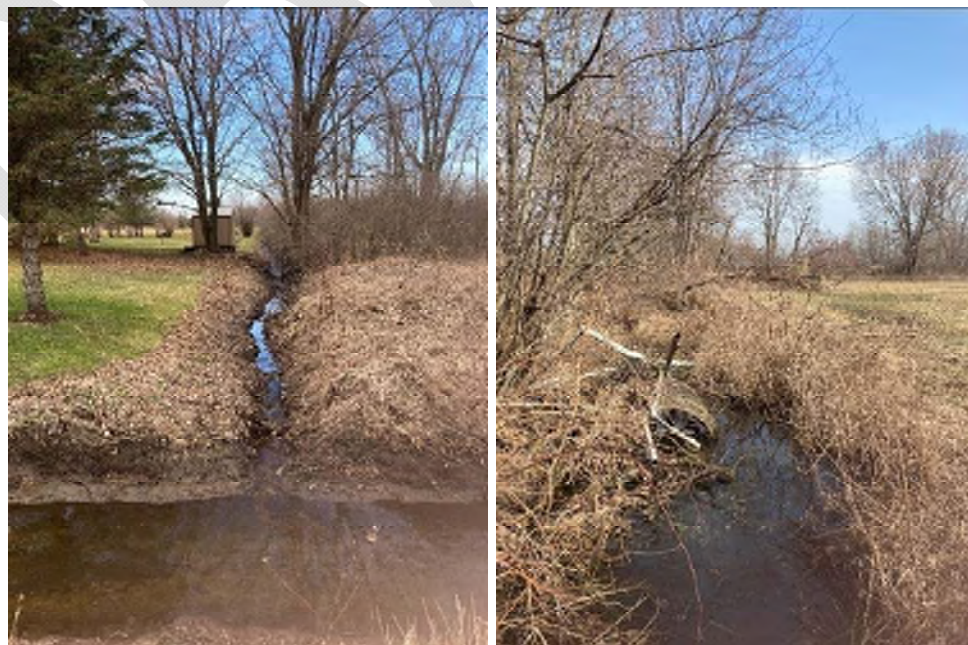
At the upstream end of the mainstem section, the East Tributary and the West Tributary join by a culvert under Mantua Center Road. The flow travels north parallel to Mantua Center Road in two large ditches adjacent to the road, which connect to Black Brook. Due to prior land use (sod farm), ditches have been excavated perpendicular to the ditches throughout the site, and an additional parallel ditch to the road can be found on the west side of the valley next to the quarry.

Figure 9. Mainstem and side ditch (left) along Mantua Center Road and far west ditch (right)

Within the far west ditch, there is evidence of beaver activity. Much of the valley is fallow and portions of it have been allowed to revert to scrub/shrub wetlands with patches of forest and emergent wetlands. Other portions of the valley are maintained as periodically mown meadows, with a few properties in the far north being used for agriculture. Some of the properties have tile drains that outlet into the Mainstem drainage ditch. Even with all the ditching and the tile drains present, the section has a very high-water table in the spring, with water evident on the surface or within the upper foot of the soil. Within the wetland areas, hummocking is present.
