FIRE AND RESCUE DEPARTMENTS OF NORTHERN VIRGINIA FIREFIGHTING AND EMERGENCY OPERATIONS MANUAL

# FIRES IN GARDEN-TYPE APARTMENTS

Second Edition

Issued: January 2008 Revised: January 2013

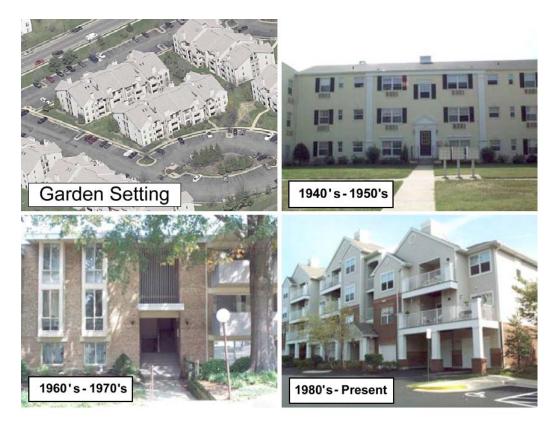
Companies may find buildings that have a combination of construction materials.

Figure 1: Changing construction methods.

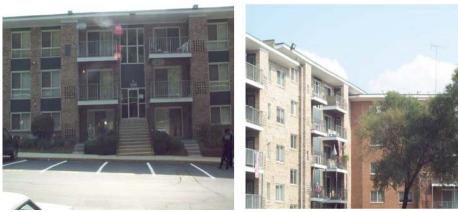
Grading of the building site may provide for a greater number of floors on one side than on another. An example, as seen in Figure 6, is a garden apartment building with three floors on the front (or side A) and four floors on the rear (or side C). It is critical that every company/command officer is aware of this when transmitting location information. Using phrases like "third floor balcony on the rear (or side C)" or "second floor level on the front (or side A)" is appropriate for identifying location.

Figure 6: Garden apartment building viewed from front and rear demonstrating differences in the level of floors visible.

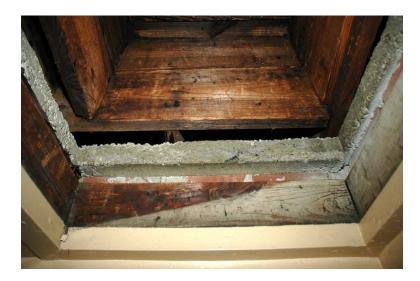
In some buildings you may find a thin layer of concrete separating the top floor ceiling from the attic or cockloft space, Figure 9.

Figure 9: View from scuttle hole showing layer of concrete ceiling.

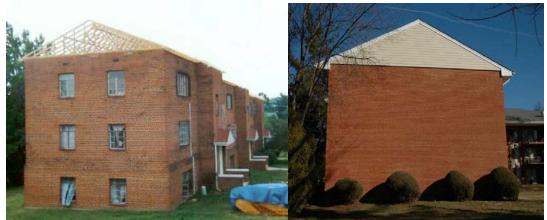
Sometimes a pitched roof is constructed over a flat roof because the flat roof is in disrepair. Lightweight wood trusses are laid front to back on top of the bearing walls and covered in the standard lightweight format. Ventilating the pitched roof may have little effect on the fire in the cockloft of the old flat roof. Conversely, hooking ceiling from the top floor to access the cockloft will have little effect on fire in the area under the pitched roof. HVAC units may also be placed on top of the flat roof, under the gable roof. This add-on roof situation requires prior knowledge of such a condition but may be characterized by a new lightweight roof over bearing exterior brick walls. At times, the addition of the new roof can be identified by the difference in siding at the gable ends of the building or a building with a pitched roof that has cockloft vents (Figure 10).

Figure 10: A renovation showing gable over flat roof; vinyl over brick may be an indication of renovation.

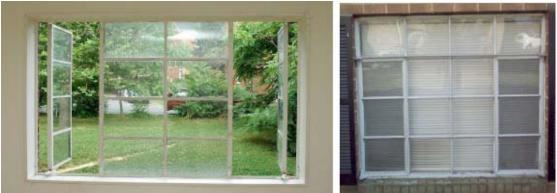
The use of old style steel casement windows was very prevalent in the 1940s early construction and these windows pose their own unique hazards, Figure 12. The windows have steel frames set in concrete or masonry. While breaking all the glass in the windows will ventilate the affected area, entrance and exit through the remaining window frame is physically blocked. The window must physically be opened by lifting a latch and rotating a crank. Removing the frame with force will be very difficult under adverse conditions and would require the use of heavy forcible entry tools (such as a sledge or power saw). Firefighters and officers should make note of these windows with pre-fire planning or in their size-up upon arrival at a structure fire. A flashover in a building with this type of windows creates an extremely dangerous situation in which members would be unable to quickly bailout of the area.

Figure 12: Examples of casement windows.

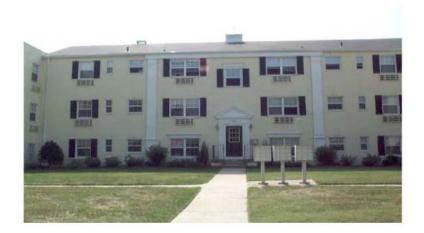
Typically the stairwells in ordinary construction buildings are enclosed masonry with concrete or steel steps and risers. Windows in the stairwells are typically casement or double-hung, Figure 14.

Figure 14: Ordinary construction enclosed stairwell.

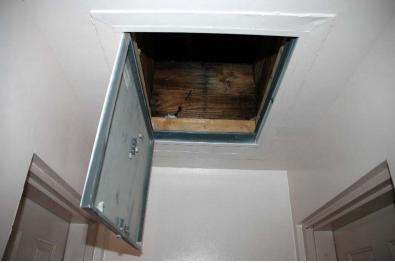
There may be a scuttle at the top of the stairs that goes directly out onto the roof (flat roof) or into the attic (pitched roof), Figure 15.

Figure 15: Scuttle hole.

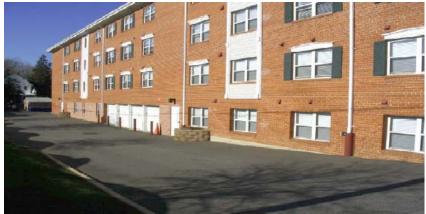
The swinging door from the common area or stairwell to the garage may be a rated assembly. A vehicle or contents fire in a garage may allow for rapid fire/smoke extension to other areas of the structure. The presence of a finished living area over the garage presents a serious life hazard, Figure 18.

Figure 18: Garages under apartments.

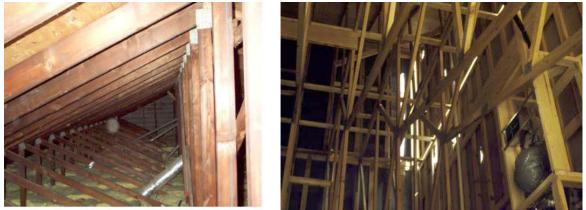
The roofs of these wood/lightweight frame apartment buildings are typically flat or gable. Although not as common, firefighters may find mansard, hip, or other style roofs. Cathedral interior ceilings are also popular. These roofs are considered lightweight construction (as opposed to conventional) with 2"x 4" trussed supports with gusset plates as attachment joints, Figure 19. Sheathing is plywood with tarpaper and shingles. Trusses typically run from front to back. Trussed roofs, both flat and gable, present a problem of rapid-fire spread throughout the attic space because of the open area created by the trusses.

Figure 19: Common attics from 1960-1970s construction (left) and 1980s to the present construction (right).

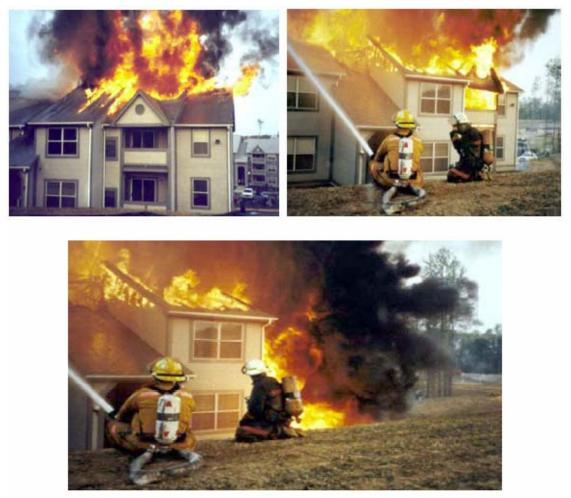
Many roofs constructed in the 1980s or later have an additional hazard of dormers and cross gables. The windows in these dormers may not serve living areas of the building (false dormers). This creates a concentrated load on the roof in the area of the dormer and can accelerate a collapse, Figure 20. If they are dormers that serve as living areas they may create a 'knee wall' void space.

Figure 20: Dormer collapse.

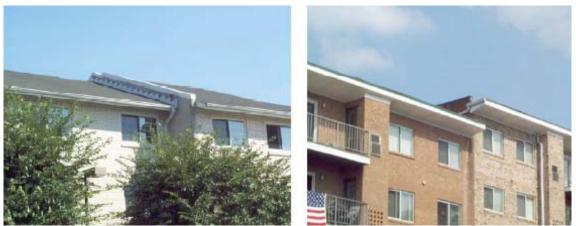
Masonry firewalls extending beyond the roofline are typically very effective. The roof overhang, as seen in Figure 24, can be a source of extension. Combustible trim located on the firewall may reduce its effectiveness, Figure 25.

Figure 24: Exterior clues to the location of a firewall.

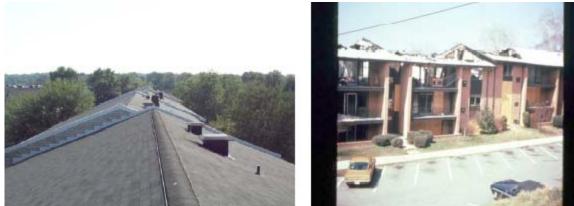
Figure 25: Ineffective firewalls.

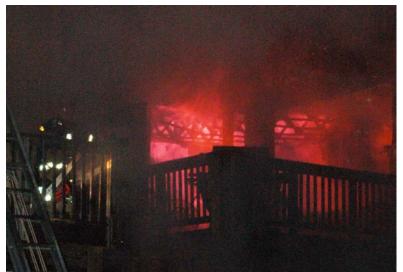
The typical wood frame floor consists of 2"x 8" or 2"x 10" joist covered with plywood. The plywood is normally covered with carpet, tile, vinyl, or hardwood. More common in the light frame constructed (1980s to current) garden apartments are wood-trussed floors. These are tongue-and-grooved plywood and 2"x 4" chord beams known as factory, manufactured, or engineered wooden "I" beams. Another type truss is the manufactured 2"x 4" parallel chord truss. Both truss systems are typically covered with plywood or particleboard. Floors may have numerous vertical openings for utilities and plumbing. Joists may have numerous horizontal openings for ductwork and electrical wiring. The potential for rapid fire spread and early collapse of lightweight floors is great if fire enters the truss floor space, Figure 26.

Figure 26: Collapse of light frame truss floor.

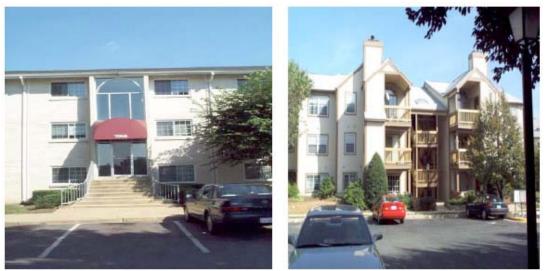
Stairwells in 1980s and later construction are typically non-enclosed/open to the outside and constructed of wood. Some disadvantages may be that the stairwell itself is combustible. Steel or wood framing with open risers and concrete treads may be found in the open stairwell environment. These stairwells also have the inherent feature of being accessed from front and rear. Some buildings may have a dry standpipe.

Figure 30: Wood frame enclosed stairwell and light frame open stairwell.

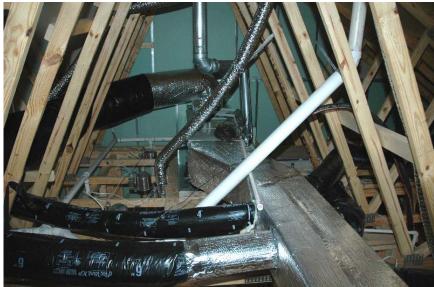
In recent years the hot water and/or HVAC units have been located in the attic space and/or on the roof, particularly over the stairwells, Figure 32. These units are supported by wooden lightweight systems and pose a significant collapse hazard.

Figure 32: HVAC in attic space.

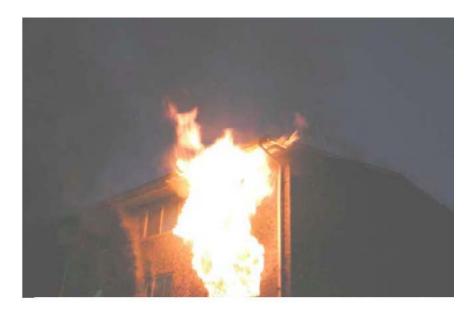
Fire spread to exposure apartments adjacent to and above is a major concern. Fire issuing out of a window may quickly be communicated up the exterior traveling floor to floor and into the attic via the soffit vent (which may be located directly over the top floor window), Figure 35.

Figure 35: Exterior fire spread.

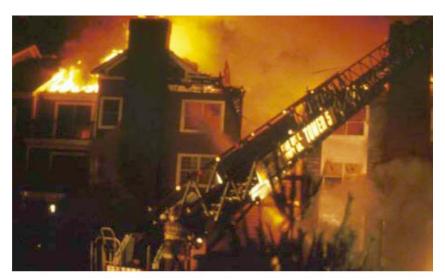
Collapse is always a concern, Figure 38. However interior crews must realize that localized collapse of the roof members (trusses) onto the top floor may occur during an attic fire. Due to the level of compartmentalization, the top-floor walls may support the section of a collapsed roof assembly. Rather than abandoning the entire building, a tactical withdrawal from the collapsed area may be all that is required.

Figure 38: Light wood frame collapse under fire conditions

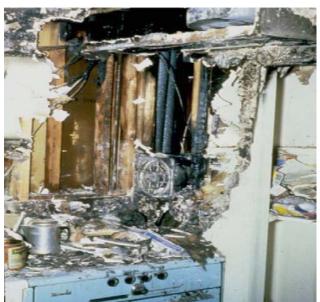
A fire in the kitchen of ordinary, frame or light wood frame construction may spread behind cabinets and into the void space, Figure 39. It can then spread into the ceilings, to the floor above, or vertically to the cockloft/attic and weaken structural members in all locations in between.

Figure 39: A minor kitchen fire extends into void space.

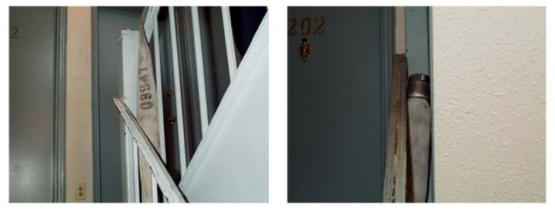
Officers and hose-line crews should evaluate the width of the stairwell railings before committing to well-hole style hose advancement. Although this technique is effective under many circumstances, narrow railings can catch the hose couplings making the hose-line advancement very difficult, Figure 48. Engine crews should ensure that extra hose is available on the fire floor landing prior to opening the door and advancing into the fire apartment, Figure 49.

Figure 48: Hose coupling jammed during hoseline advancement.

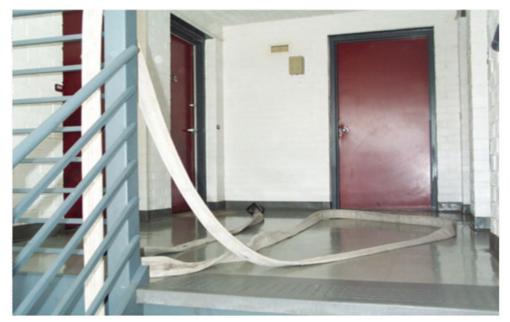
Figure 49: Extra hose on landing/foyer.

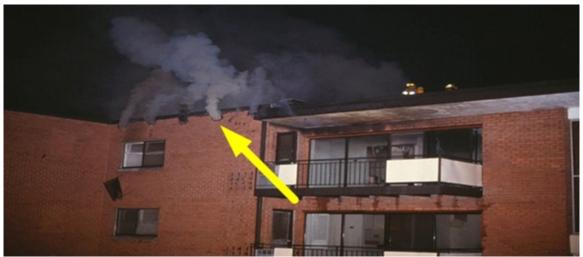
Figure 70: Smoke showing from the cockloft.

Company officers need to communicate the conditions in the attic to command. Command needs to keep companies on the top floor advised of changing exterior conditions. Fires in this particular area have a tendency to show differently, meaning that conditions on the interior do not "match" the exterior, and vice versa.

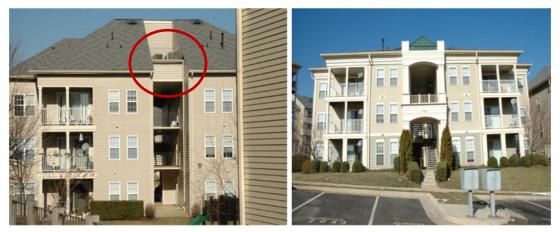
Figure 73: A concentrated load over the stairwell. Notice it is not evident from the front of the structure.

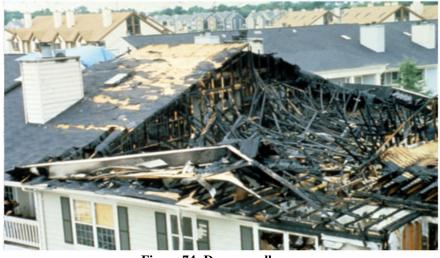
Figure 74: Dormer collapse.

In more modern occupancies, due to the presence of water heaters and HVAC units in the attic space, as well as cosmetic dormers, the collapse potential is significant when fire is in possession of the attic space, Figure 74. Companies should not be operating directly under the involved area in these instances.

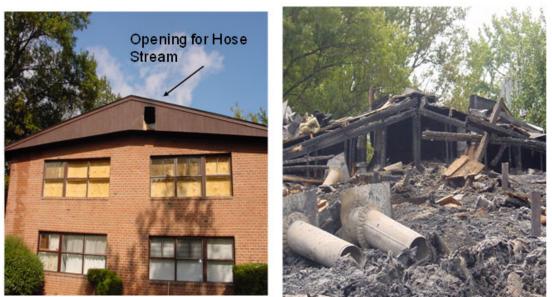
Figure 76: Fire involving a gable roof placed over an existing roof.

If a new gable-style roof has been placed over a flat roof, firefighters are faced with a multilayered cockloft and attic fire within the same building, Figure 76. Fires involving the cockloft and newly created attic space simultaneously are very challenging and difficult to extinguish. The application of streams through the gable ends and/or through the cockloft vents or openings made by firefighters have proven to be effective.

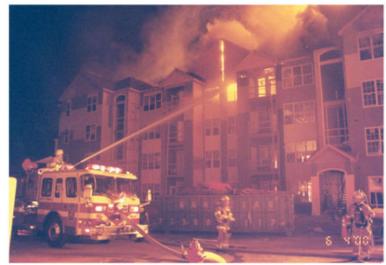
Figure 77: Large volume fire.

Master stream devices are very effective on large volume fires in garden apartments, Figure 77. Unfortunately, apparatus positioning on arrival is usually for offensive operations and may not be conducive to positioning for defensive operations. It is difficult, if not nearly impossible, to re-position apparatus when switching from offensive to defensive operations. With the common narrow streets and parking areas, greater alarm vehicles should be staged as soon as possible.

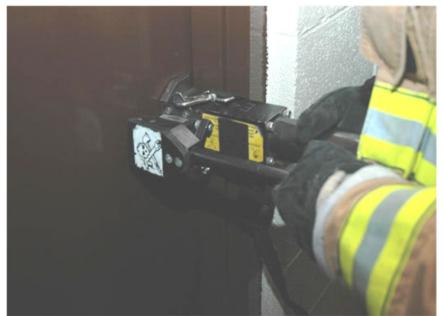
Figure 79: Hydraulic forcible entry tool.

Hydraulic-style door forcing tools, Figure 79, were developed and designed for inward opening metal frame doors and works very well on them. Crews should still take conventional entry tools with them (Haligan bar/axe). Hydraulic tools may not be effective on older wooden doors with wood frames.

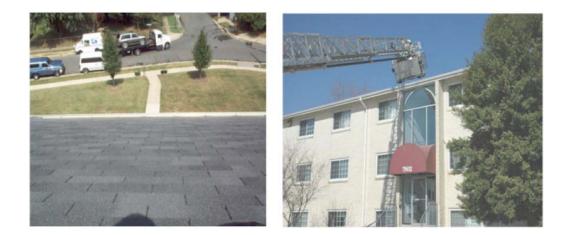
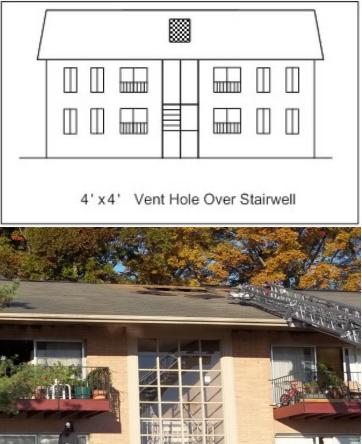
Figure 81: Venting an enclosed stairwell.

Ventilation of the enclosed stairwell is the next priority, Figure 81. This can be accomplished by several means:

Some stairwells do not extend to the center of the building. In cases where they do, there may be considerable depth (16 inches or greater) from the peak to the ceiling below. In general, the ceiling below should be able to be reached with the 6-foot or 8-foot pike pole (carried at the tip of most aerials). The sidewalk leading to the entrance should be used for orientation. Ideally, the hole should be 5 to 8 feet from the eave.

In flat roof construction, the hole should be 5 to 8 feet from the edge of the roof on the side of the building where the entrance is located. Again, the sidewalk should be used for orientation. Some stairwells in flat roof construction have a hatch over the stairwell that leads to the top floor. Opening this area will vent the stairwell but not the cockloft.

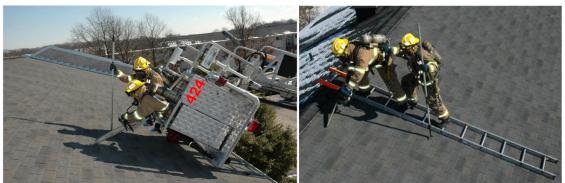
Figure 83: Venting from a tower and a roof ladder.

Rooftop ventilation, Figure 83, may depend on whether the roof support system is of conventional or lightweight construction. Conventional construction may allow a hole to be cut in the roof without fire department members being independently supported. The location and intensity of the fire must be evaluated along with the integrity of the roof itself.

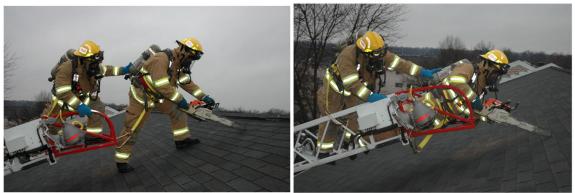
Figure 84: Venting from an aerial device while tethered.

If fire has entered the attic in lightweight truss construction, fire department members should be supported or tethered via aerial device or tower ladders, to avoid falling through the roof, Figure 84.

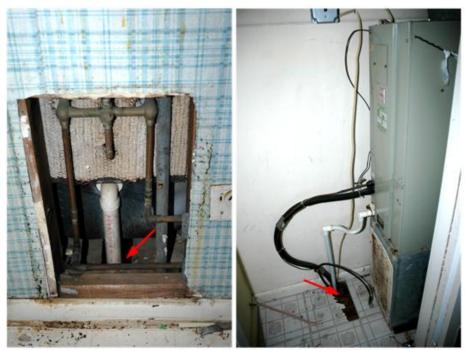
Figure 88: Examples of plumbing voids.

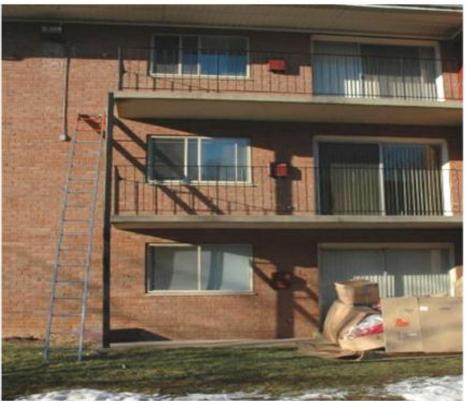
Figure 90: Ladder next to balcony.

Balconies may be laddered for hose line deployment, rescue, entry, escape, ventilation and/or as a backup to laddering windows, Figure 90. Consideration should be given to the integrity of the balcony and railing when ladders are deployed. It may be safer to place the ladder on the wall

next to the balcony instead of directly on the railing. By using a steeper climbing angle, firefighters may access several (cantilevered) balconies. The tip should be secured when using this method.
