Inspection Report

Veterans Plus Home Solutions

Will Greene HI0087

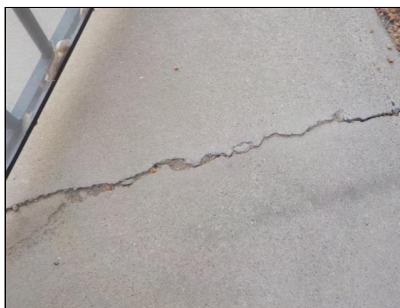
1.5

- (1) Property has minor slope. Drainage around the home appeared to be generally adequate at the perimeter of the dwelling.
- (2) Concrete driveways commonly experience minor cracking, shrinkage, separation, etc. Normal maintenance will be required in the future to extend its designed life span. Sealing any cracks is important; water infiltrates cracks and causes the sub-strate to break down, resulting in deterioration of the asphalt.
- (3) **Minor cracking observed at front walkway. Recommend regular maintenance and repairs to prolong the useful life of the surface.**

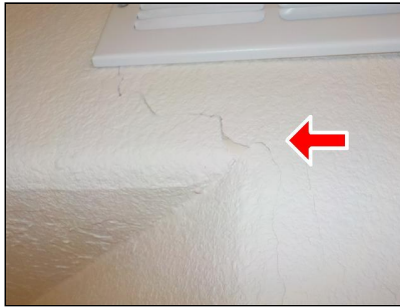
2.1

(2) Minor cracking observed at living room. Appears to be from settling. Recommend review and repair by a qualified professional.

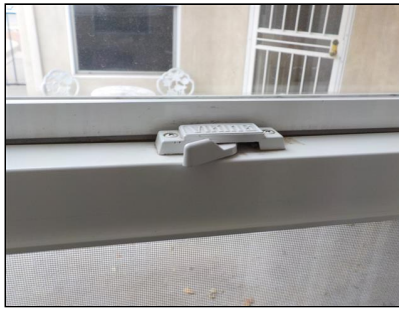
2.4

(2) Window at guest bedroom is difficult to lock. Recommend repair as needed for proper security.

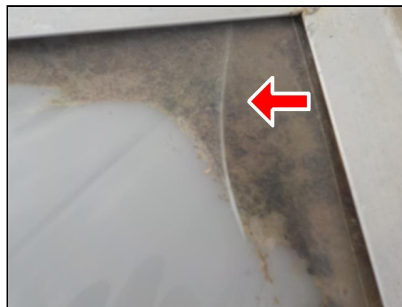
4.2

(2) Protective outer shield at skylight #3 is cracked in the corner. Review for replacement as needed by a qualified professional is recommended.

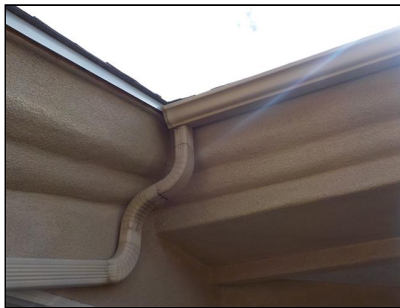
4.4

A partial gutter system is present. Client may wish to consider installing a full gutter system for proper drainage away from structure.

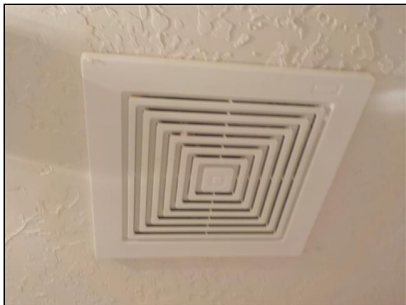
- 6.0 Exhaust fan
- Comments: Repair or Replace
- Fan was inoperable. Recommend review and repair by a qualified professional.

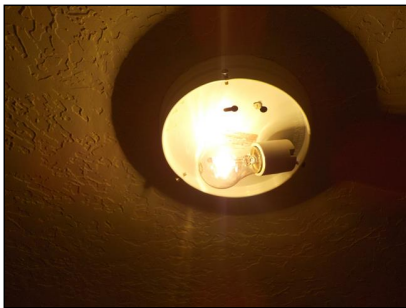
- 6.1 Electrical
- Comments: Repair or Replace
- Globe missing at fixture. Recommend replacement as needed.

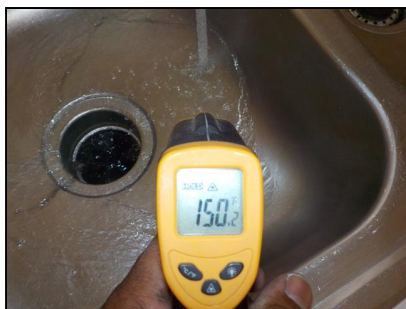
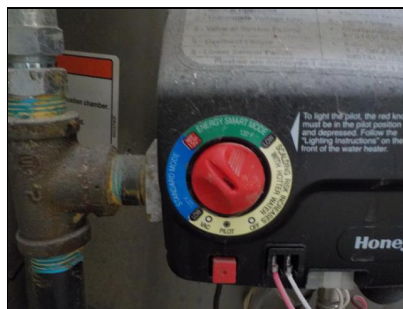
7.2

(2) **Safety. Water heater thermostat was set to its highest setting. This is a safety issue due to possible scalding water, and may be an indication that water heater is nearing the end of its useful life. Recommend review by a qualified professional.**

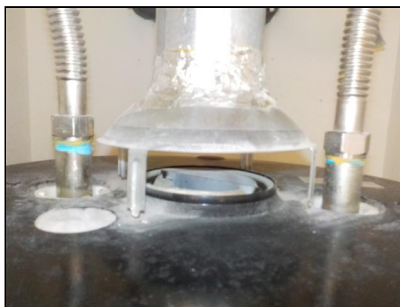
7.2

(3) **Draft hood is disconnected or poorly fitted which is a safety concern. Recommend review and repair by a licensed professional.**

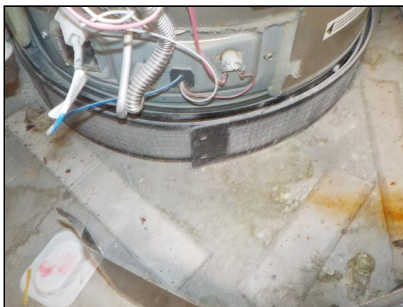
7.2

(4) **The water heater appeared to be functioning as intended at the time of inspection. However, due to the age (16 yrs) /condition of this system anticipate on-going maintenance. Replacement may become necessary in the not too distant future.**

(5) Water heater is located indoors without an overflow pan/drain line. This may not have been required when the home was built or may be impossible due to interior location.

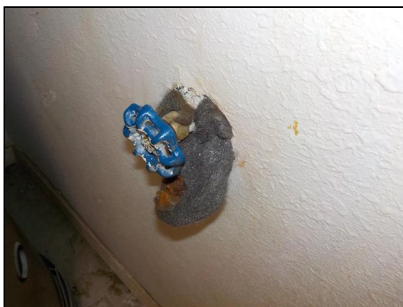
7.3

(1) Main shut-off is at the hall closet. Since main shut-off valves are operated infrequently, it is not unusual for them to become frozen over time. They often leak or break when operated after a period of inactivity. For this reason main shut-off valves are not tested during a home inspection. We suggest caution when operating shut-offs that have not been turned for a long period of time.

(2) Water pressure measured 76 PSI at time of inspection; 40 to 80 PSI is the acceptable operating range.

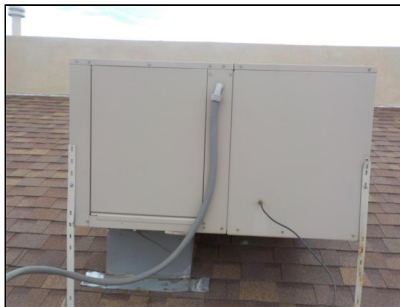
8.7

Evaporative cooler was not operated due to being winterized. This is only a visual of the condition of cooler. Recommend further review by a qualified professional if there are concerns.

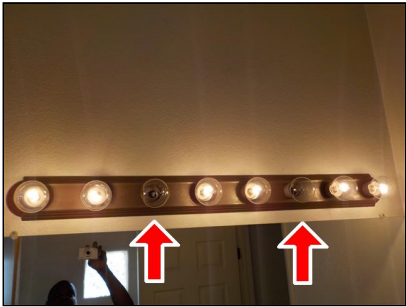
11.1.A

(2) Light fixture at vanity was inoperable at time of inspection. Possible spent bulb. Recommend client verify fixture for proper operation.

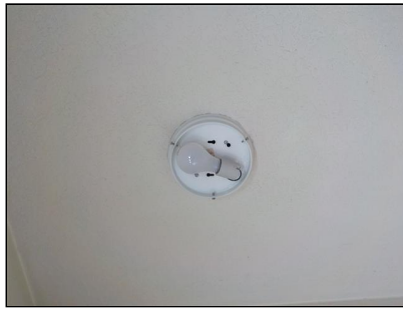
11.1.A

(3) Fixture at ceiling is missing its globe. Recommend replacement as needed.

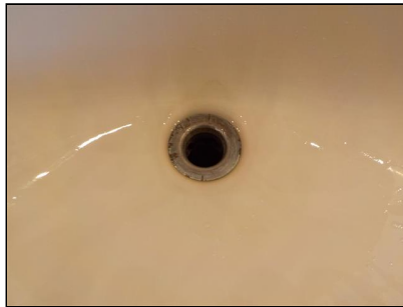
11.2.A

Sink stopper is missing. Recommend corrections for proper operation.

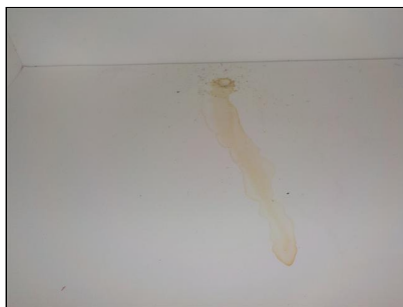
11.4.A

Evidence of prior leak observed at under sink cabinet. No leak observed at time of inspection. Recommend client verify repairs have been made.

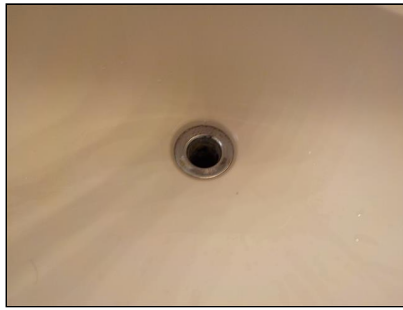
11.2.B

Sink stopper is missing. Recommend corrections for proper operation.

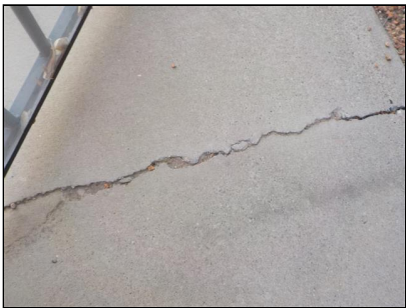
1.5

(3) Minor cracking observed at front walkway. Recommend regular maintenance and repairs to prolong the useful life of the surface.

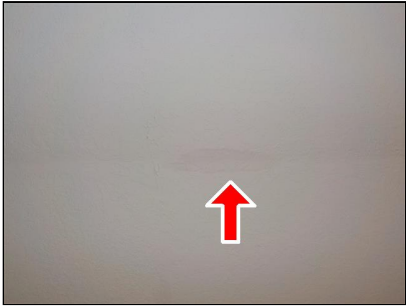
2.0

(3) Dry moisture stains observed at hallway ceiling. No moisture detected at the time of inspection. Recommend review and repair as needed.

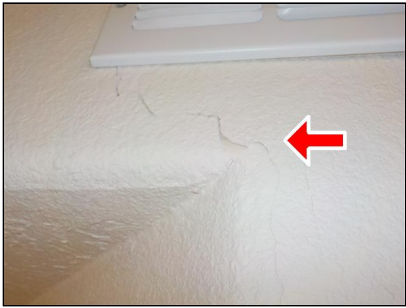
2.1

(2) Minor cracking observed at living room. Appears to be from settling. Recommend review and repair by a qualified professional.

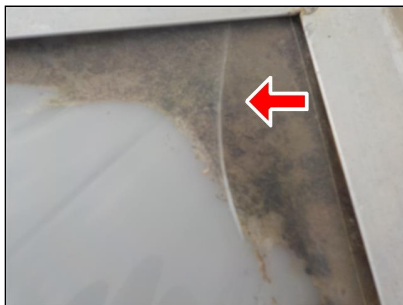
4.2

(2) Protective outer shield at skylight #3 is cracked in the corner. Review for replacement as needed by a qualified professional is recommended.

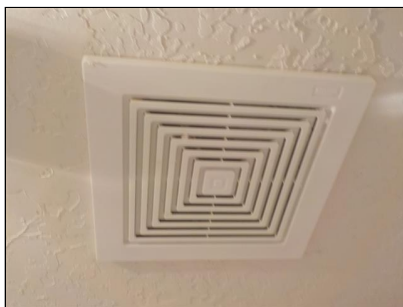
6.0

Fan was inoperable. Recommend review and repair by a qualified professional.

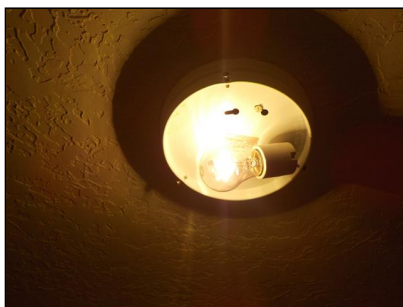
6.1

Globe missing at fixture. Recommend replacement as needed.

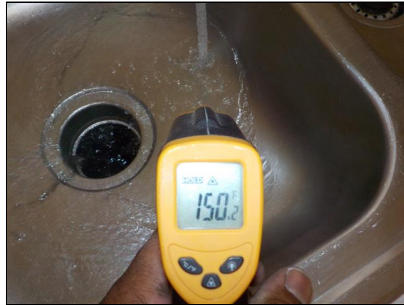
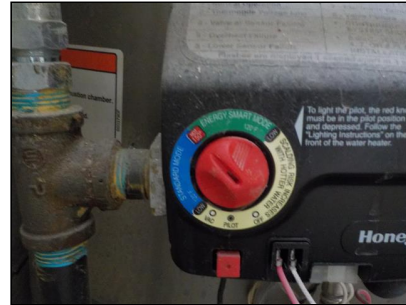
7.2

(2) **Safety. Water heater thermostat was set to its highest setting. This is a safety issue due to possible scalding water, and may be an indication that water heater is nearing the end of its useful life. Recommend review by a qualified professional.**

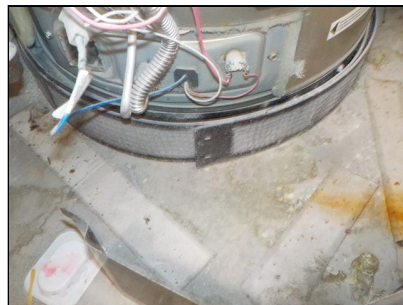
7.2

(4) **The water heater appeared to be functioning as intended at the time of inspection. However, due to the age (16 yrs) /condition of this system anticipate on-going maintenance. Replacement may become necessary in the not too distant future.**

(5) **Water heater is located indoors without an overflow pan/drain line. This may not have been required when the home was built or may be impossible due to interior location.**

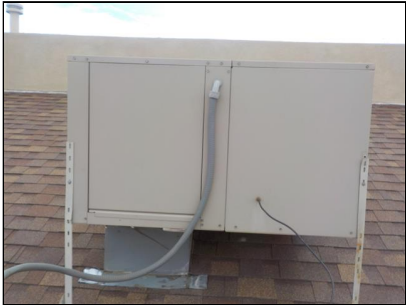
8.7

Evaporative cooler was not operated due to being winterized. This is only a visual of the condition of cooler. Recommend further review by a qualified professional if there are concerns.

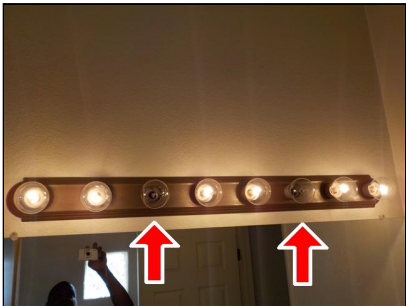
11.1.A

(2) Light fixture at vanity was inoperable at time of inspection. Possible spent bulb. Recommend client verify fixture for proper operation.

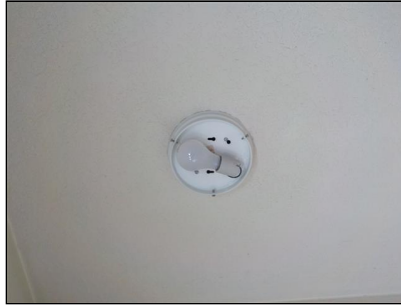
11.1.A

(3) Fixture at ceiling is missing its globe. Recommend replacement as needed.

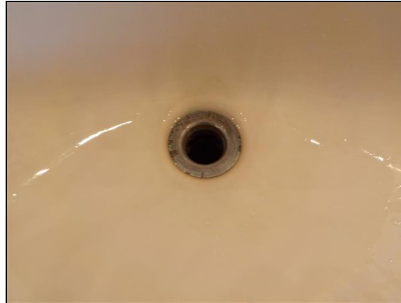
11.2.A Sink**Repair or Replace****Sink stopper is missing. Recommend corrections for proper operation.**

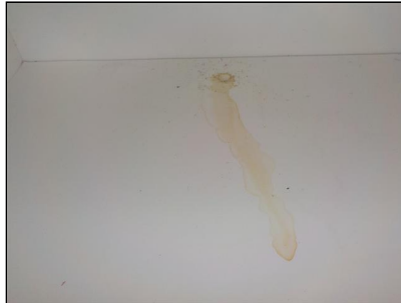
11.4.A Counter top/Cabinets**Repair or Replace****Evidence of prior leak observed at under sink cabinet. No leak observed at time of inspection. Recommend client verify repairs have been made.**

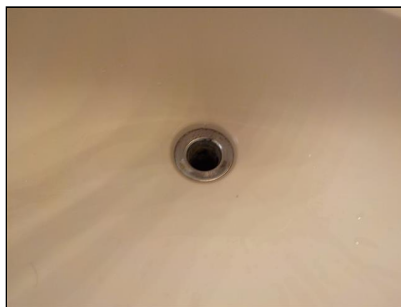
11.2.B

11(B) . Hall Bath**11.2.B Sink****Repair or Replace****Sink stopper is missing. Recommend corrections for proper operation.**
