Inspection Report

5138 W. 46th Ave
Denver Co 80212

A Happy House Home Inspection, LLC

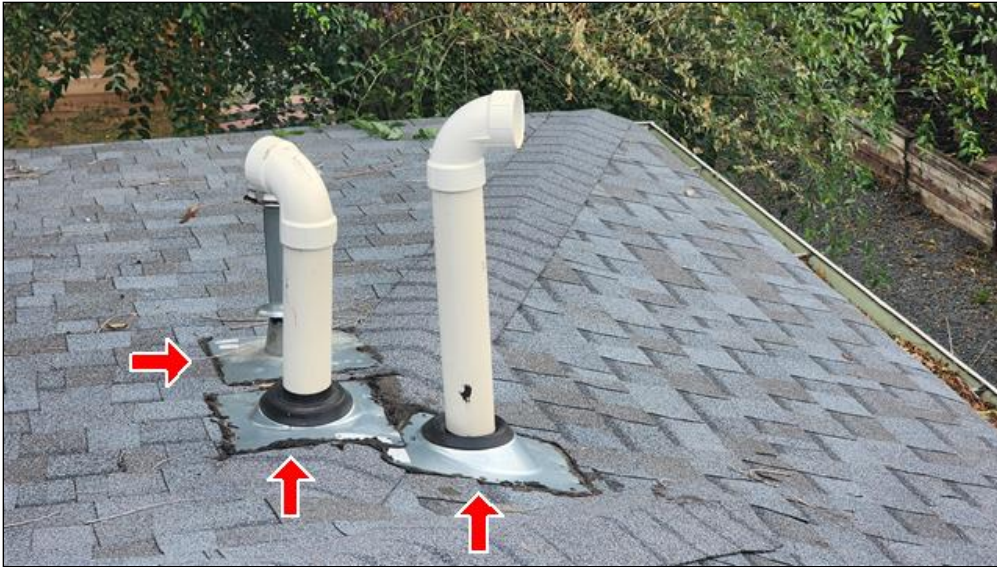
1.2 Item 1(Picture)

1.2 (1) The exhaust and air vents for the furnace and the water heater coming up out of the roof are installed improperly. These boots need to be underneath the shingles not sitting directly on top of them and not caulked. This could cause roof leaks over time and absolutely needs to be fixed by a roofing contractor.

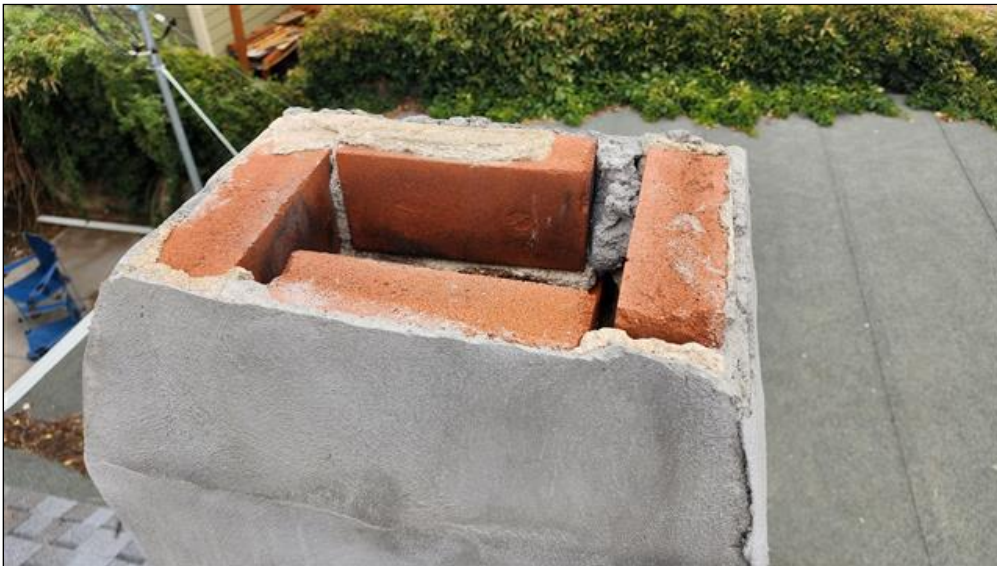
1.2 Item 2(Picture)

(2) Chimney is missing the weather protective cap.

Chimney crown is cracked and could start letting moisture into the bricks causing further cracking. Suggest repair of the cap

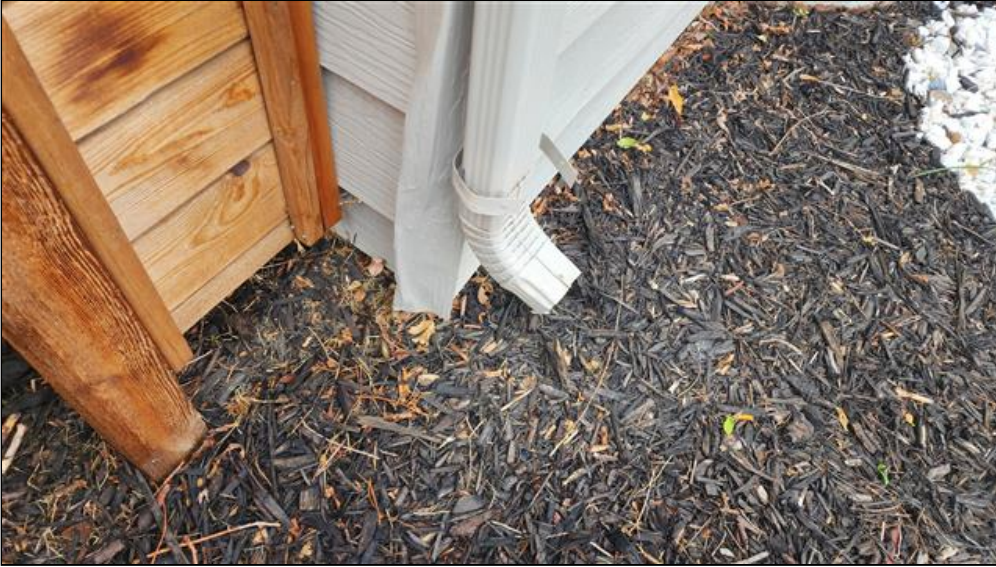
2.0 Item 1(Picture)

2.0 (1) Suggest extensions or splash backs be placed on the downspouts

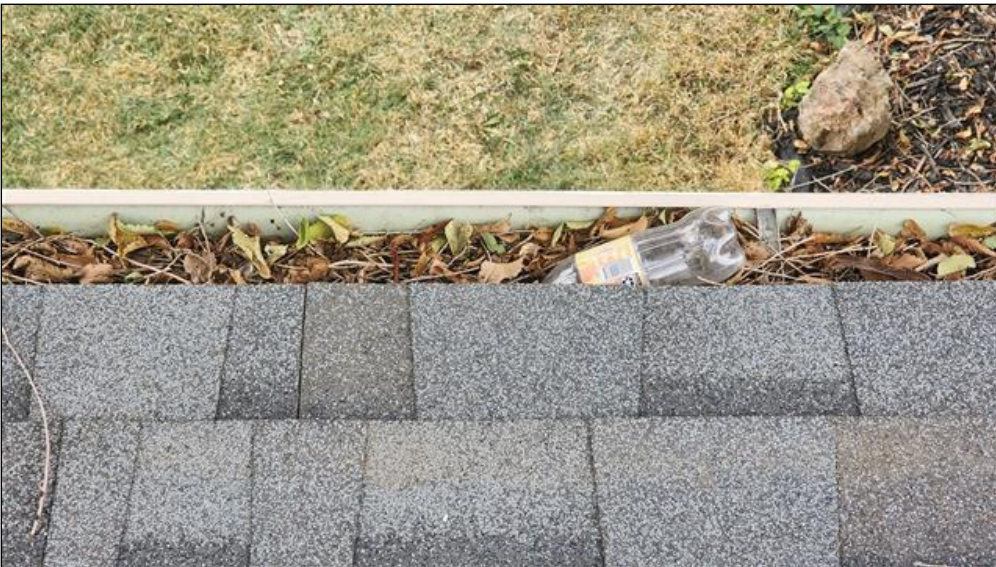
2.0 Item 2(Picture)

(2) The gutters are full of debris in areas and needs to be cleaned. The debris in gutters can also conceal rust, deterioration or leaks that are not visible until cleaned, and I am unable to determine if such conditions exist.

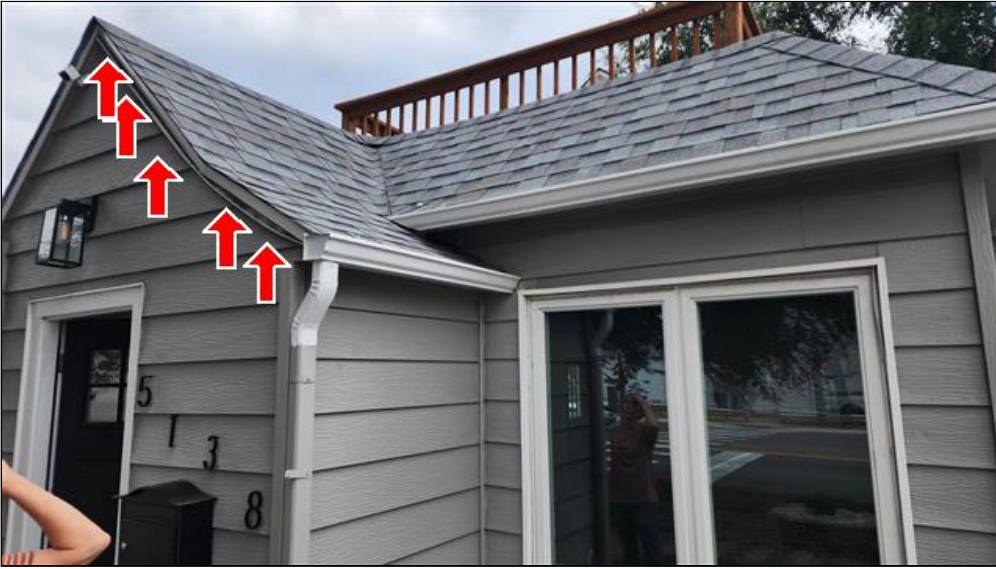
2.1 Item 1(Picture)

2.1 Trim for the vinyl siding in multiple places specifically above the front door the trim piece on the vinyl is coming off.

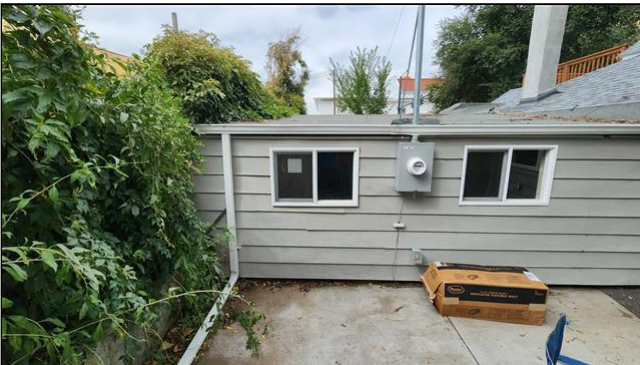
2.6 Item 1(Picture)

2.6 Any vegetation that is in contact with the house like the vines like the vines over the garage section and some of the tree limbs need to be cut back and away from the house

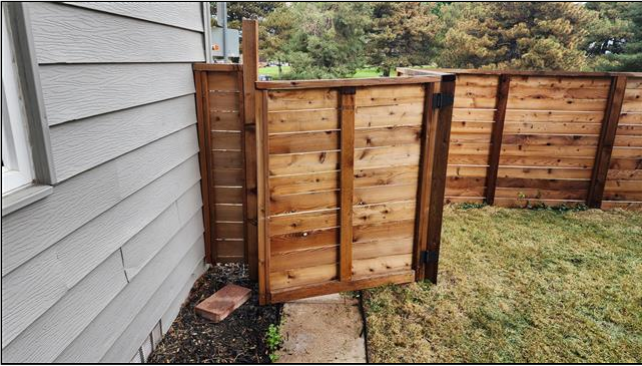
2.8 Item 1(Picture)

2.8 Side gate on the left side of the house is not secured to the post correctly and just rubs up against the ground.

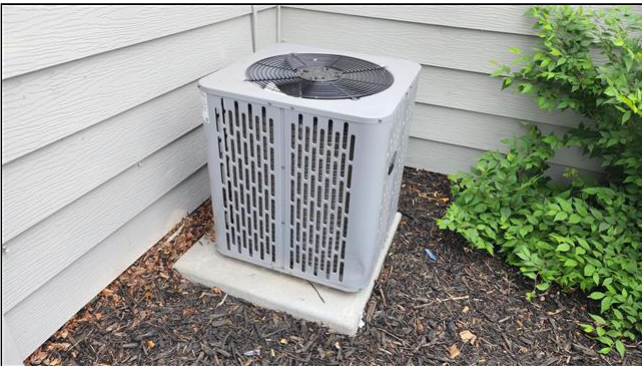
2.12 Item 1(Picture)

2.12 A/C unit should be on a level surface. Air conditioning unit should be on a level surface to keep the bearings from wearing unevenly.

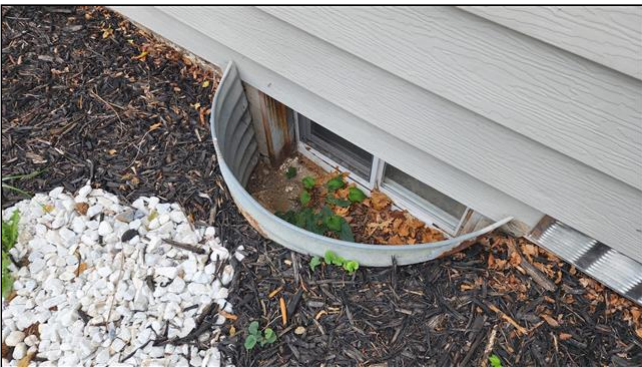
2.15 Item 1(Picture)

2.15 Window well covers are missing, this is not a code requirement however FHA, VA loans and home inspectors see it as a safety issue that should be fixed with a well cover that can support human weight.

Remove debris from well(s) as the water needs to be able to drain.

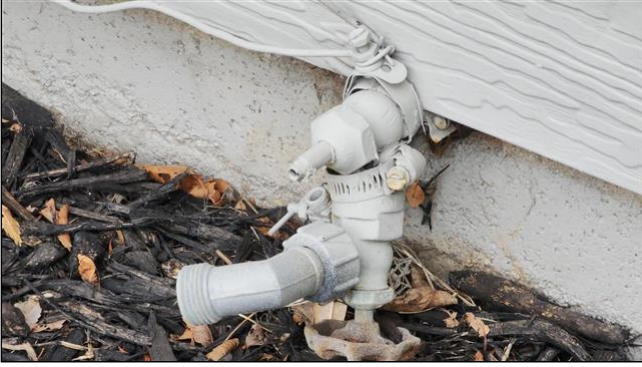
2.16 Item 1(Picture)

2.16 (1) Hose bib on the left side of the house facing the front is missing it's shut off dial.

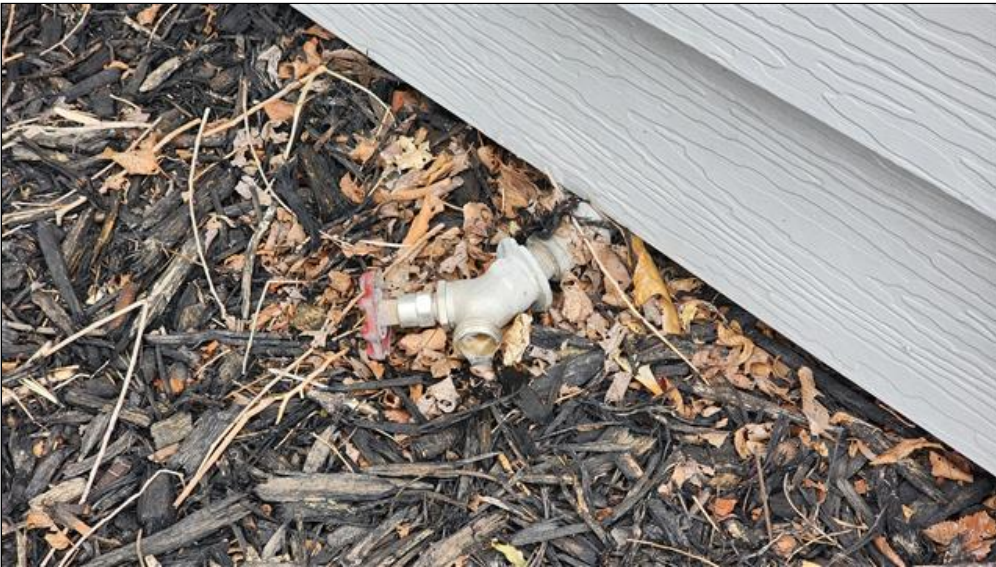
2.16 Item 2(Picture)

(2) The hose bib that is on the right side of the front door is coming out of the ground. This would be a great place for it to freeze being that it is not a frost proof bib

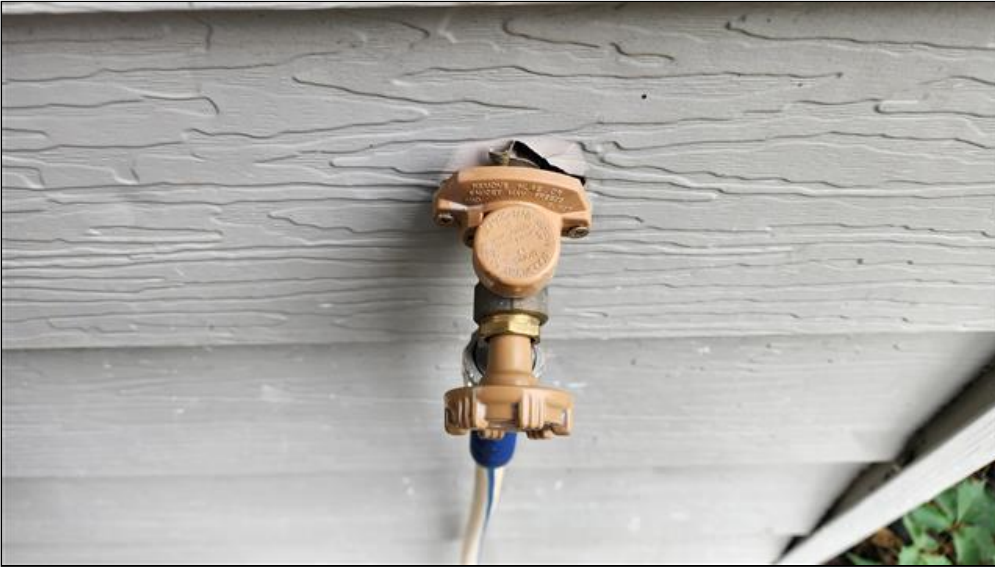
2.16 Item 3(Picture)

(3) Ho's bib at the back of the house is not properly secured to the home and has a gap between the siding and the bib itself. This could let moisture and very cold air into the Bay bib causing it to freeze

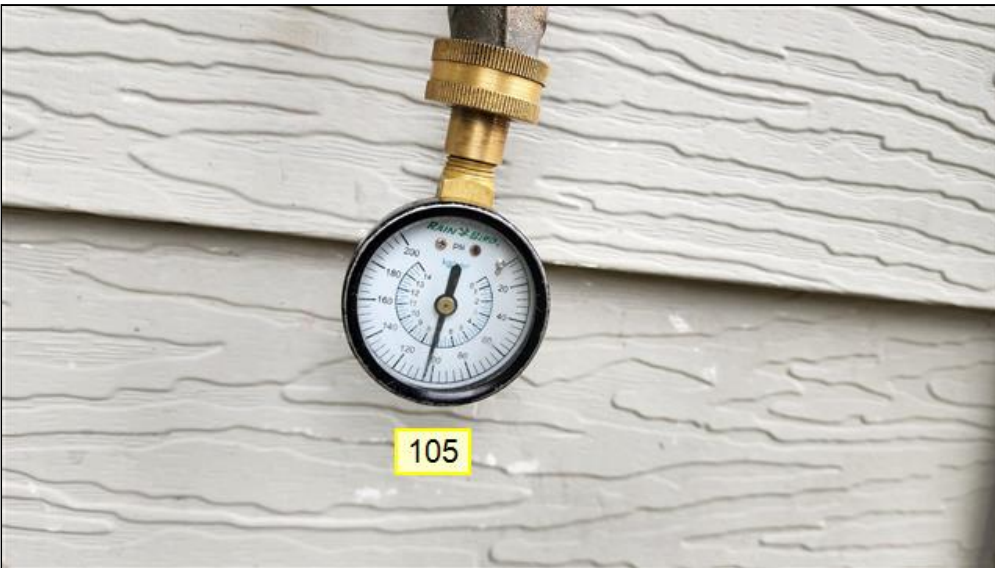
2.16 Item 4(Picture)

(4) House water pressure for copper pipes is too high. Your water pressure is between >81-100 PSI (Too High for Copper Pipes). This could cause pipes to burst as plumbing is turned on and off. Pressure needs to be reduced so it is between 60-80 PSI.

House water pressure starting is 105PSI. Once 2 items are turned on either sink or a shower, the house drops all the way down to 45PSI this is too high of a pressure loss. Have a plumber check and fix as needed

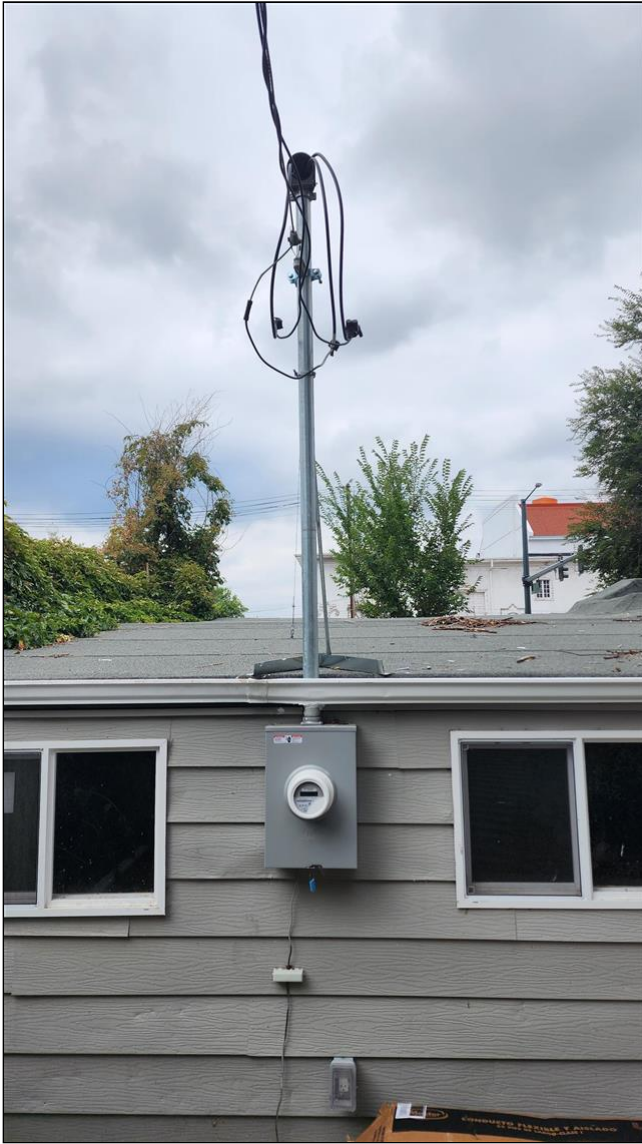
3.0 Item 1(Picture)

3.0 (1) Tree interfering with service lines and should be cut away from lines 5 feet. I suggest that you have them removed. You can use 'Limb Walkers' 720-298-5477 or of course you could use anyone that you want to.

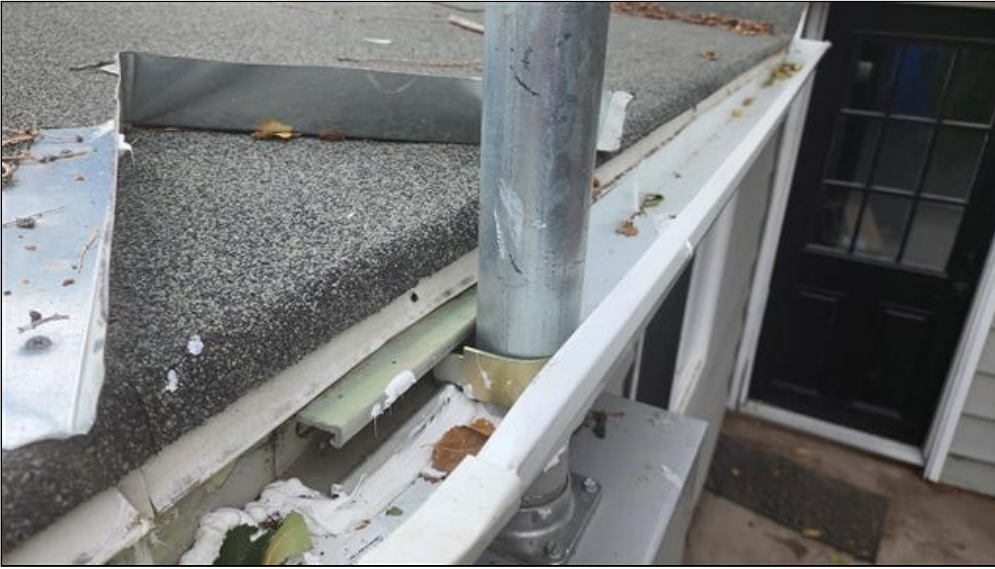
3.0 Item 3(Picture)

(2) Electrical service mast should be bent at a 45° angle to go around the gutters. Not going directly through the gutter.

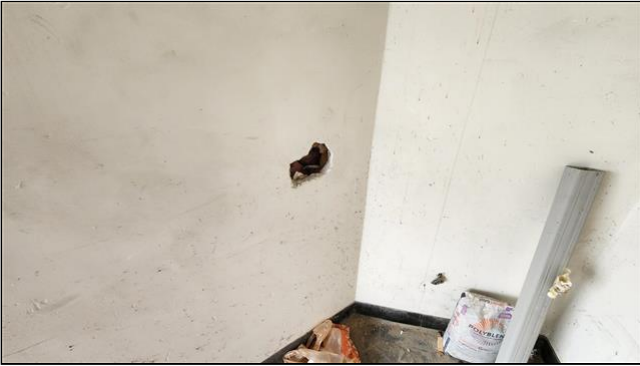
4.2 Item 1(Picture)

4.2 The fire protection wall that separates garage from heated space is compromised. This is considered unsafe until corrected. A qualified person should correct for proper fire safety.

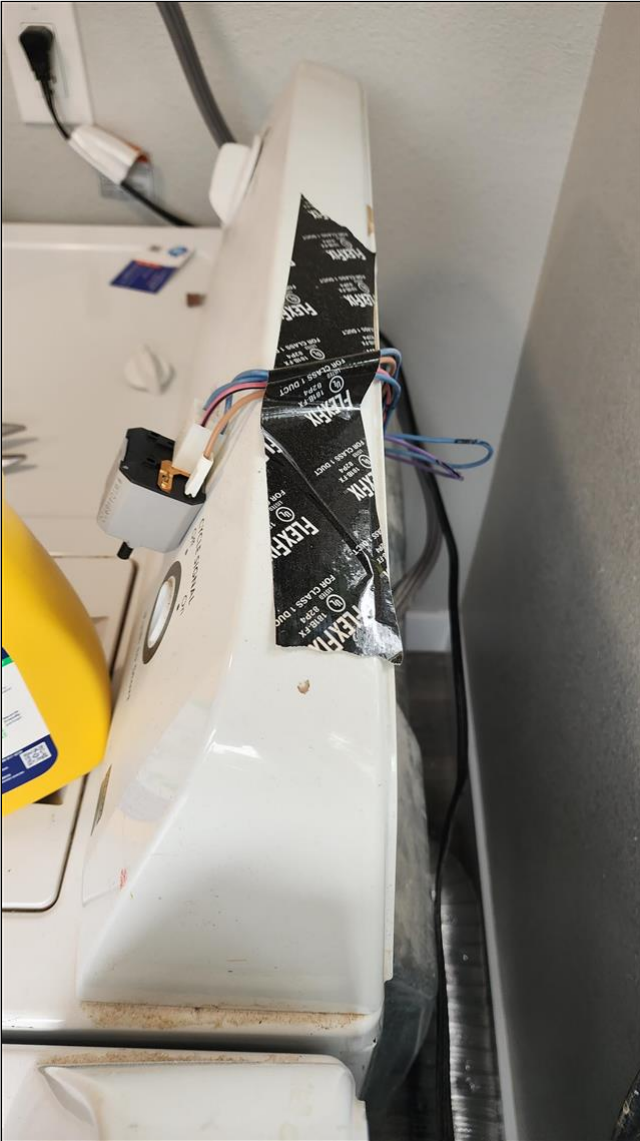
5.1 Item 1(Picture)

5.1 If the dryer is staying at the house the unit does work however the start button for start button for it is broken

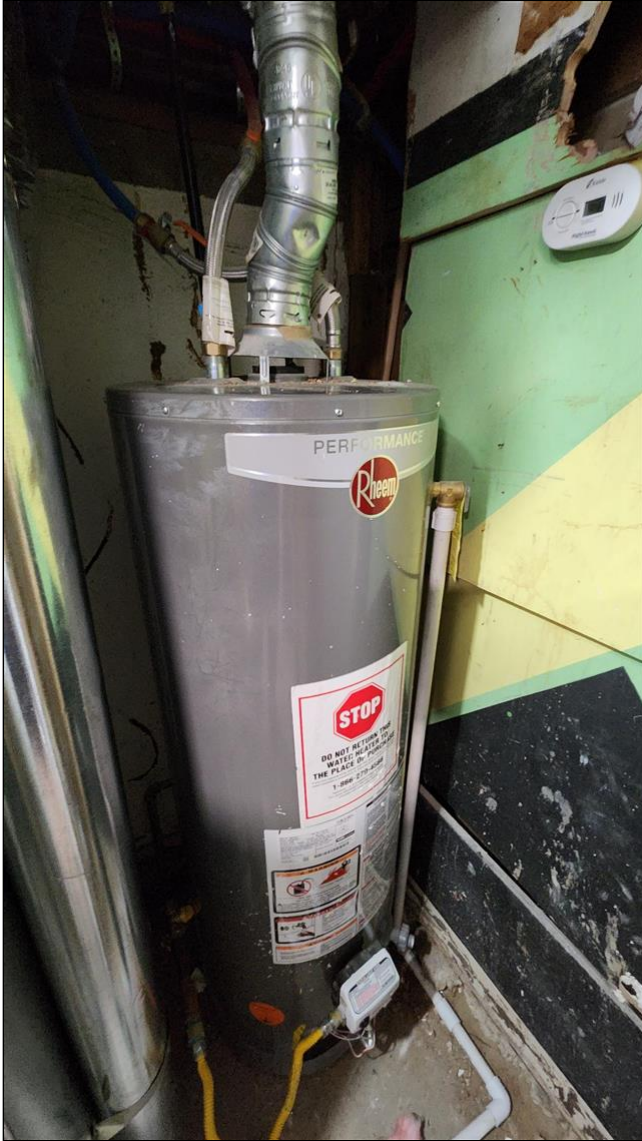
7.2 Item 1(Picture)

7.2 Being that the water heater is in the basement in a finished area it has been code since 2014 for the water heater to be Installed with a drip pan at the bottom of the unit..

Since 2014 on all new water heaters an Expansion tank is required, This water heater is Missing the Expansion tank. This tells me that this water heater was not permitted.

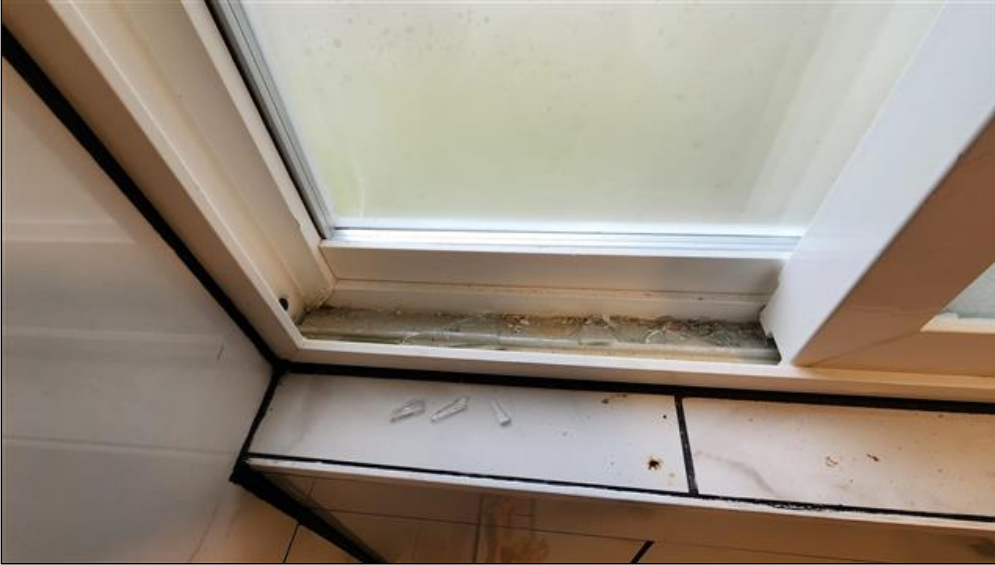
9.2 Item 1(Picture)

9.2 Window to the top floor bathroom is broken. And shards of glass still in the frame.

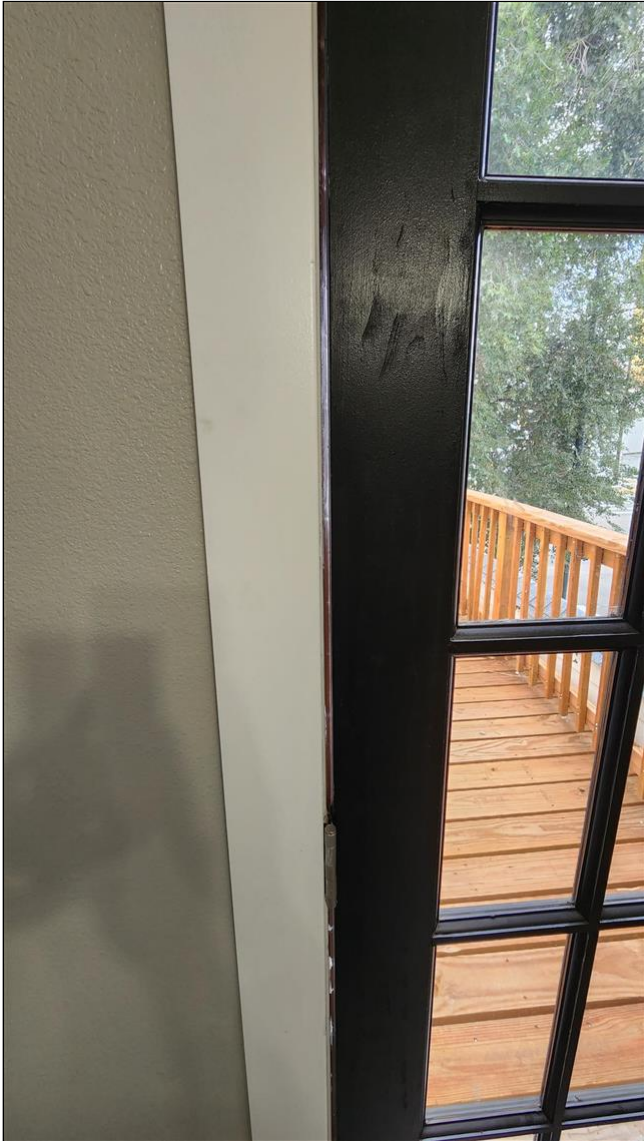
10.4 Item 1(Picture)

10.4 The door to the top floor balcony is just a little too small. That door has some pretty big air gaps in it which is going to cause a lot of cold air to come in during the Winter time.

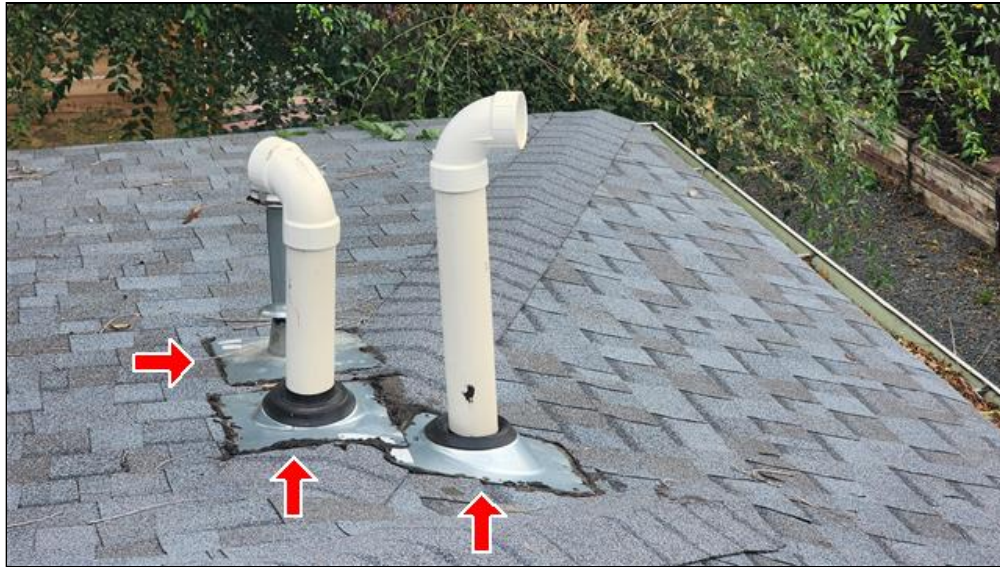
1.2 Item 1(Picture)

- (1) The exhaust and air vents for the furnace and the water heater coming up out of the roof are installed improperly. These boots need to be underneath the underneath the shingles not sitting directly on top of them and not caulked. This could cause roof leaks over time and absolutely needs to be fixed by a roofing contractor.

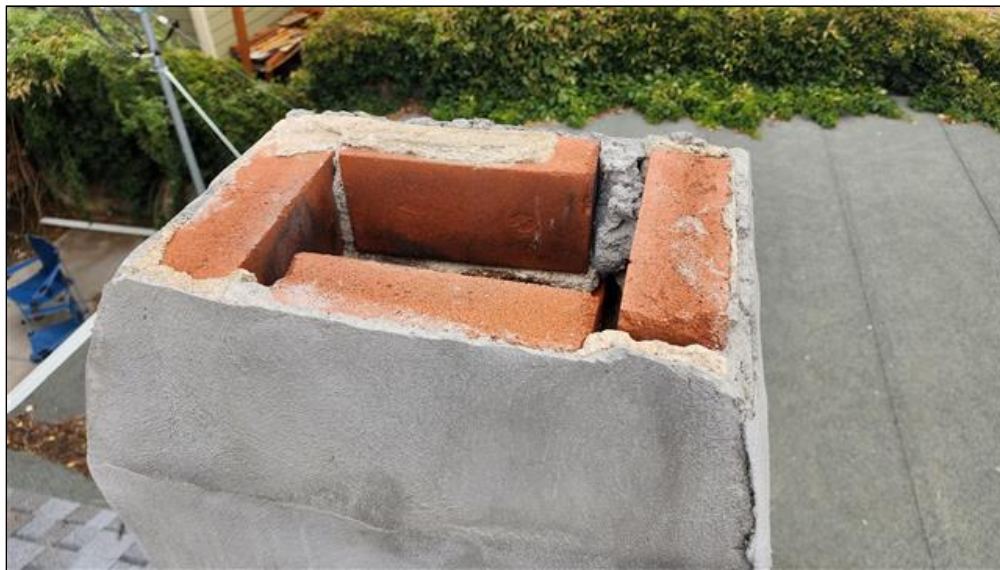
1.2 Item 2(Picture)

(2) Chimney is missing the weather protective cap.

Chimney crown is cracked and could start letting moisture into the bricks causing further cracking. Suggest repair of the cap

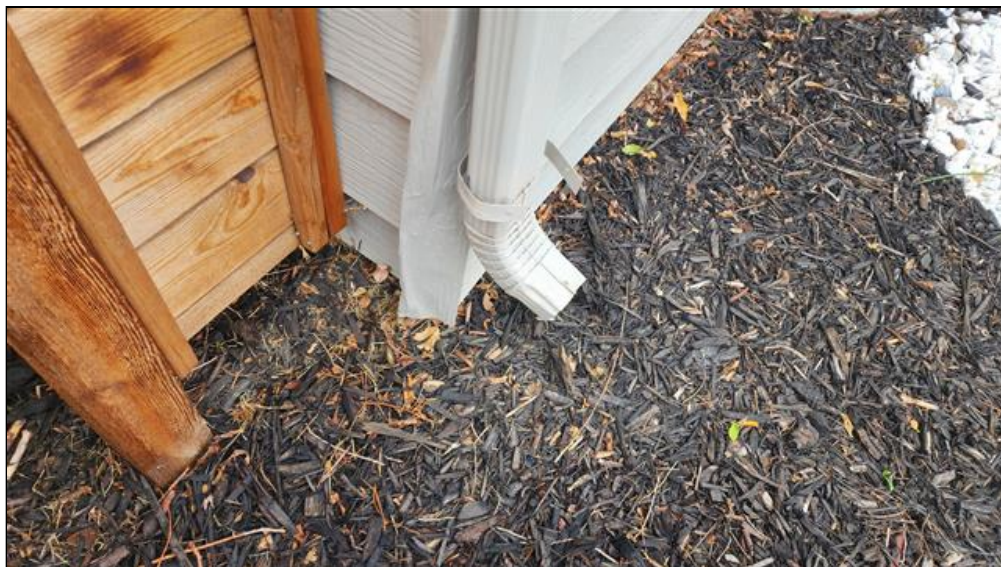
2.0 Item 1(Picture)

(1) Suggest extensions or splash backs be placed on the downspouts

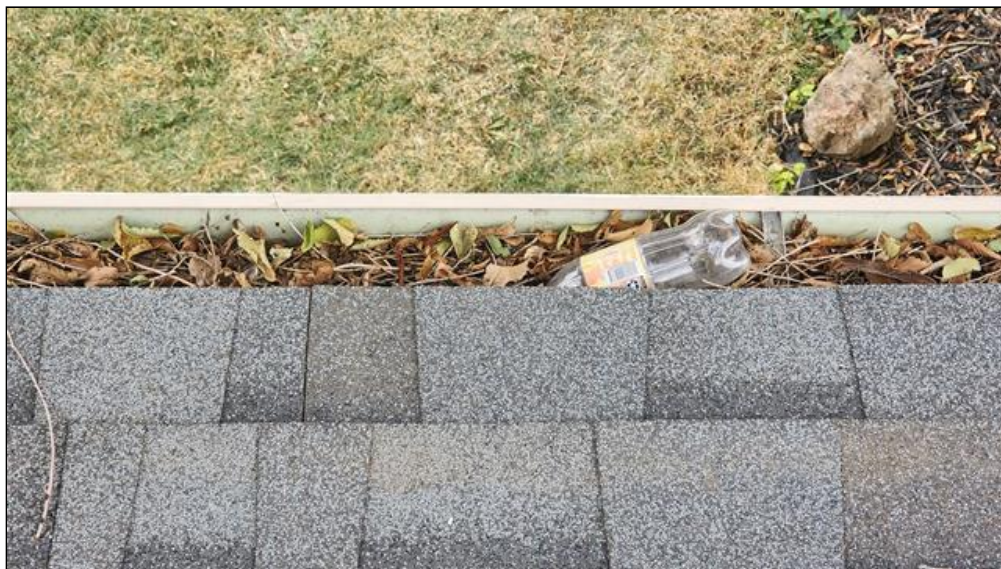
2.0 Item 2(Picture)

(2) The gutters are full of debris in areas and needs to be cleaned. The debris in gutters can also conceal rust, deterioration or leaks that are not visible until cleaned, and I am unable to determine if such conditions exist.

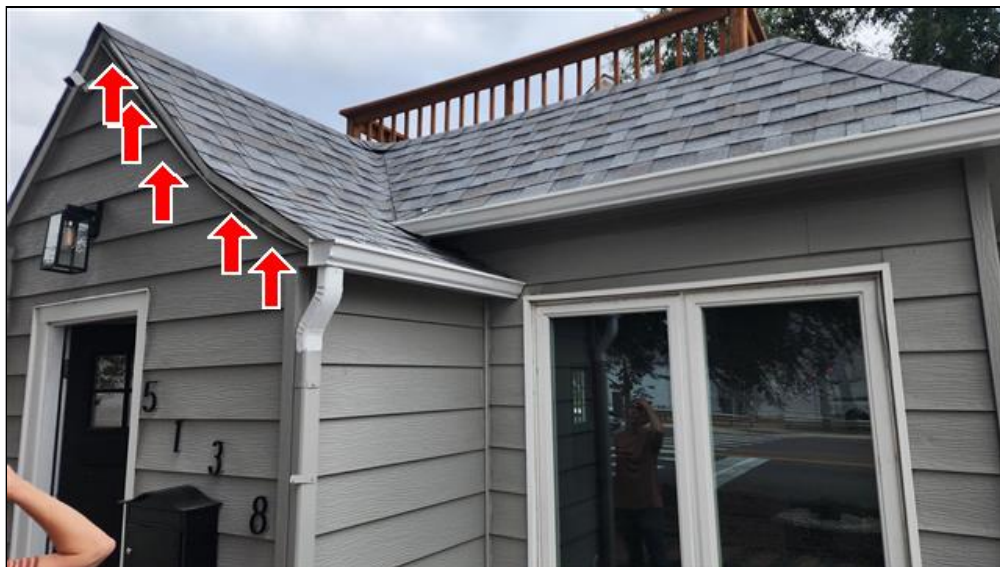
2.1 Item 1(Picture)

Trim for the vinyl siding in multiple places specifically above the front door the trim piece on the vinyl is coming off.

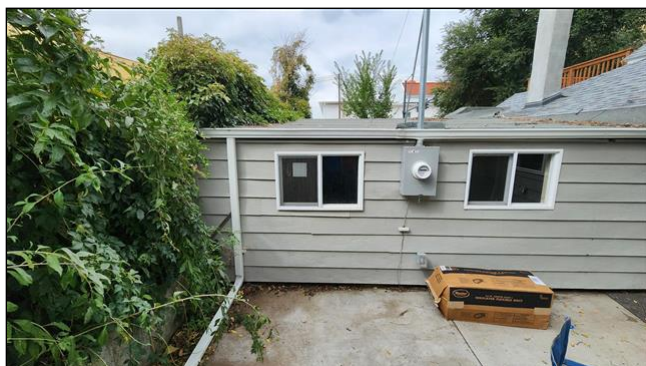
2.6 Item 1(Picture)

Any vegetation that is in contact with the house like the vines like the vines over the garage section and some of the tree limbs need to be cut back and away from the house

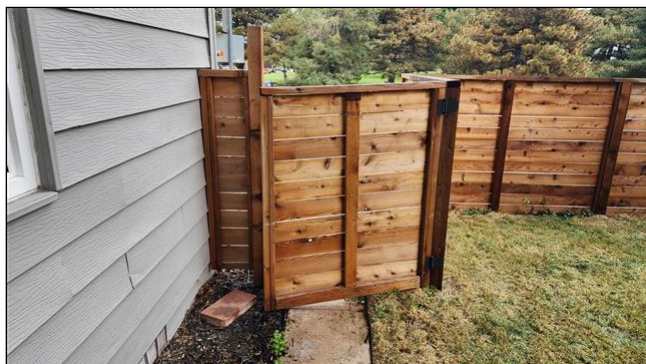
2.8 Item 1(Picture)

Side gate on the left side of the house is not secured to the post correctly and just rubs up against the ground.

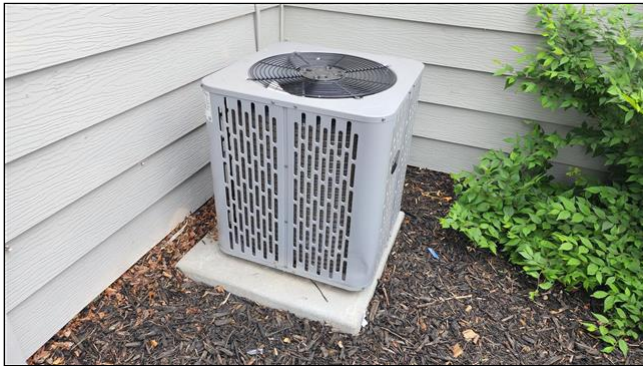
2.12 Item 1(Picture)

A/C unit should be on a level surface. Air conditioning unit should be on a level surface to keep the bearings from wearing unevenly.

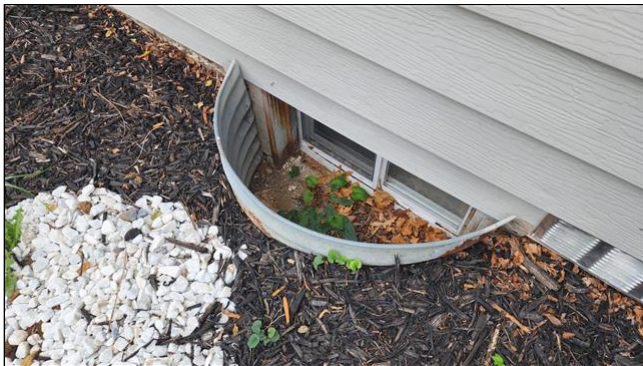
2.15 Item 1(Picture)

Window well covers are missing, this is not a code requirement however FHA, VA loans and home inspectors see it as a safety issue that should be fixed with a well cover that can support human weight.

Remove debris from well(s) as the water needs to be able to drain.

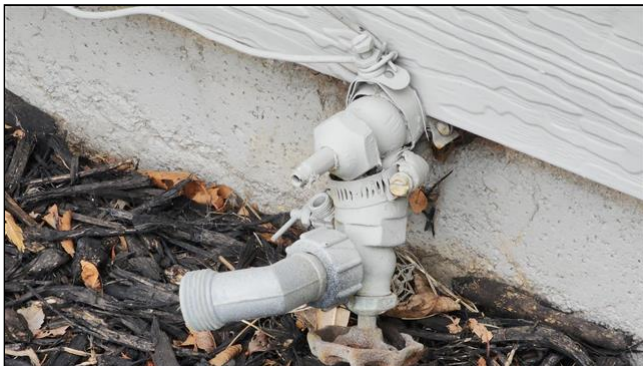
2.16 Item 1(Picture)

(1) Hose bib on the left side of the house facing the front is missing it's shut off dial.

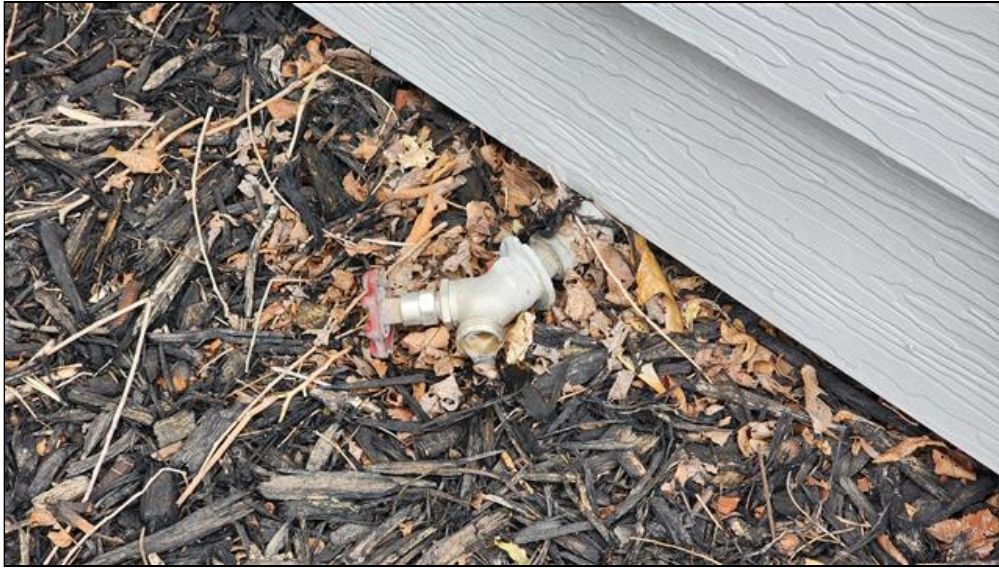
2.16 Item 2(Picture)

(2) The hose bib that is on the right side of the front door is coming out of the ground. This would be a great place for it to freeze being that it is not a frost proof bib

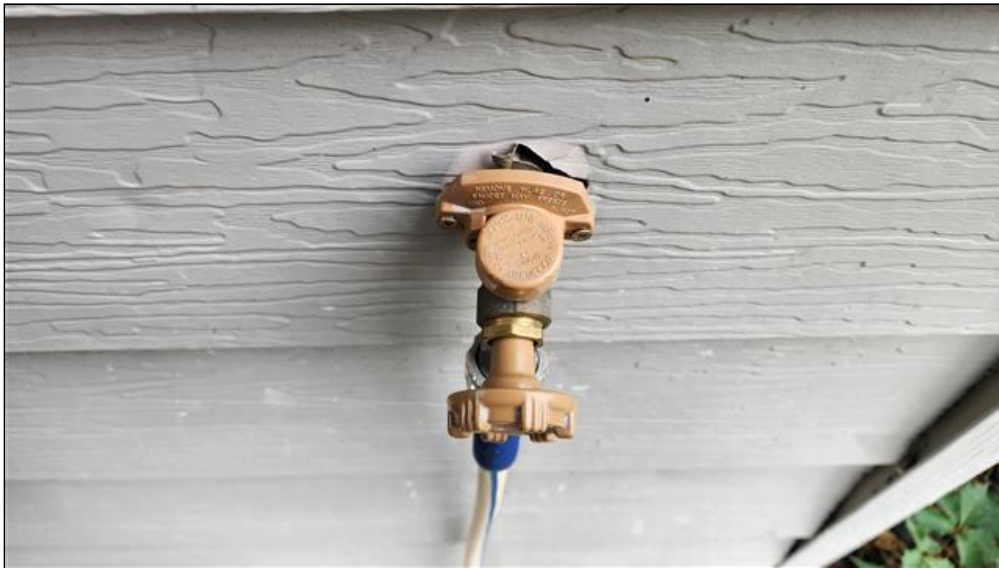
2.16 Item 3(Picture)

(3) Ho's bib at the back of the house is not properly secured to the home and has a gap between the siding and the bib itself. This could let moisture and very cold air into the Bay bib causing it to freeze

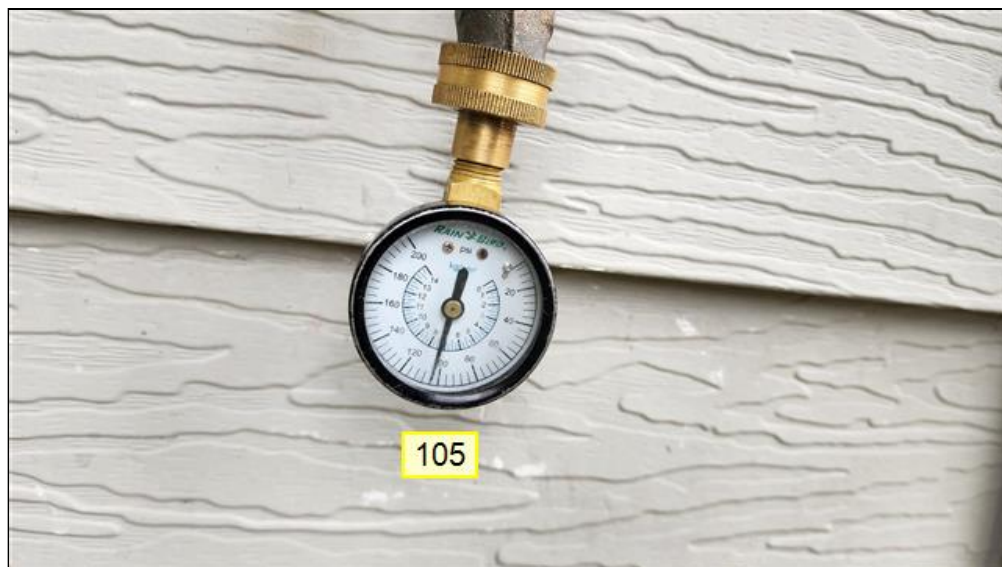
2.16 Item 4(Picture)

(4) House water pressure for copper pipes is to high. You water pressure is between >81-100 PSI (To High for Copper Pipes). This could cause pipes to Burst as plumbing is turned on and off. Pressure needs to be reduced so it is between 60-80 PSI.

House water pressure starting is 105PSI. Once 2 items are turned on either sink or a shower, the house drops all the way down to 45PSI this is too high of a pressure loss. Have a plumber check and fix as needed

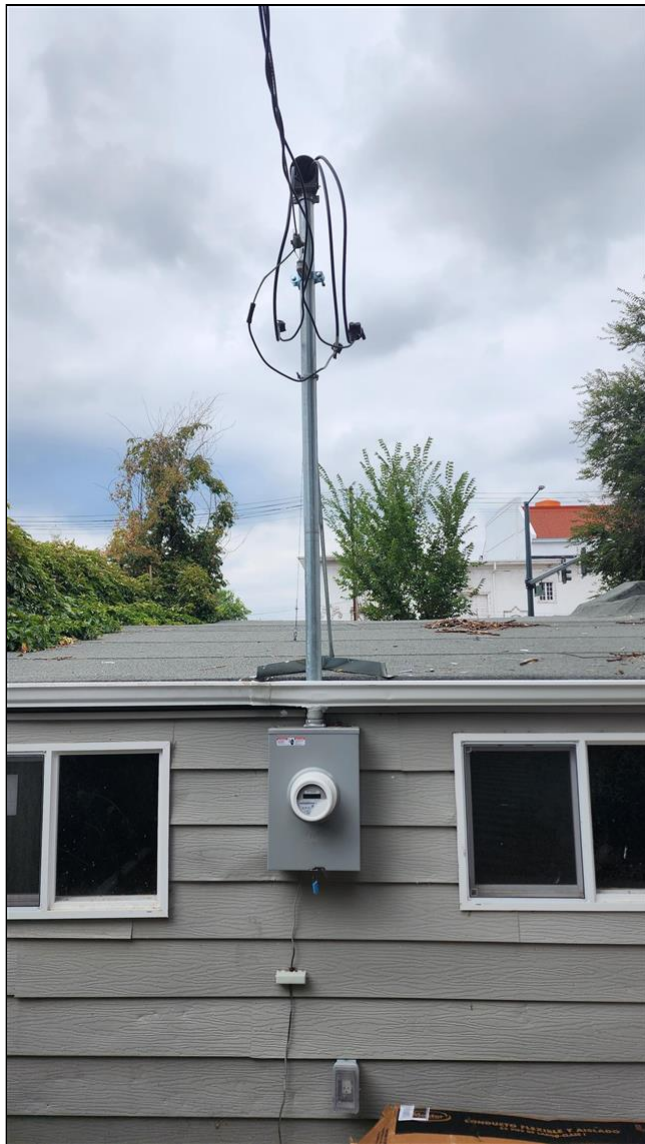
3.0 Item 1(Picture)

(1) Tree interfering with service lines and should be cut away from lines 5 feet. I suggest that you have them removed. You can use 'Limb Walkers' 720-298-5477 or of course you could use anyone that you want to.

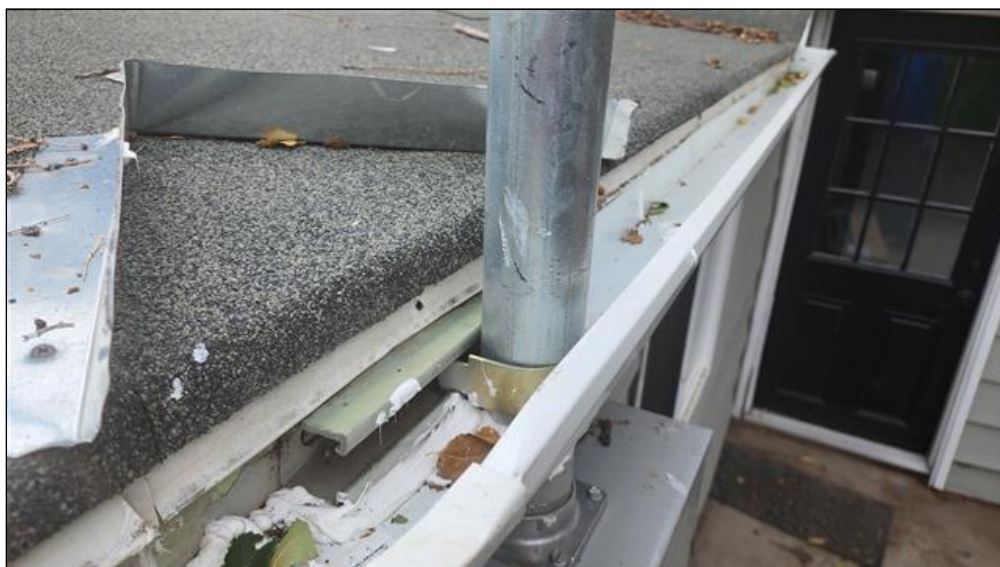
3.0 Item 3(Picture)

(2) Electrical service mast should be bent at a 45° angle to go around the gutters. Not going directly through the gutter.

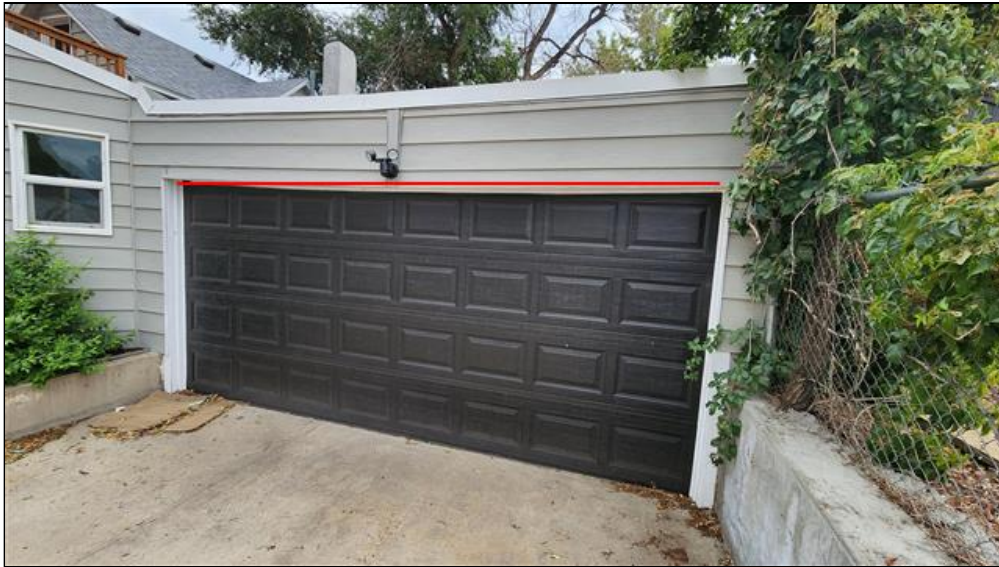
4.0 Item 1(Picture)

Directly above the garage door it does look like the garage is sagging. But I have noticed around the house that there are multiple pieces of the citing that is sagging as well. This could be just deciding but unfortunately the home inspector is not able to determine why it is sagging just to tell you that there is an issue. Strongly suggest you have a contractor check and fix as needed

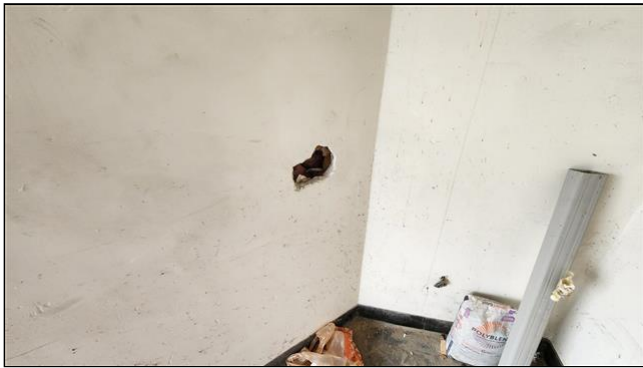
4.2 Item 1(Picture)

The fire protection wall that separates garage from heated space is compromised. This is considered unsafe until corrected. A qualified person should correct for proper fire safety.

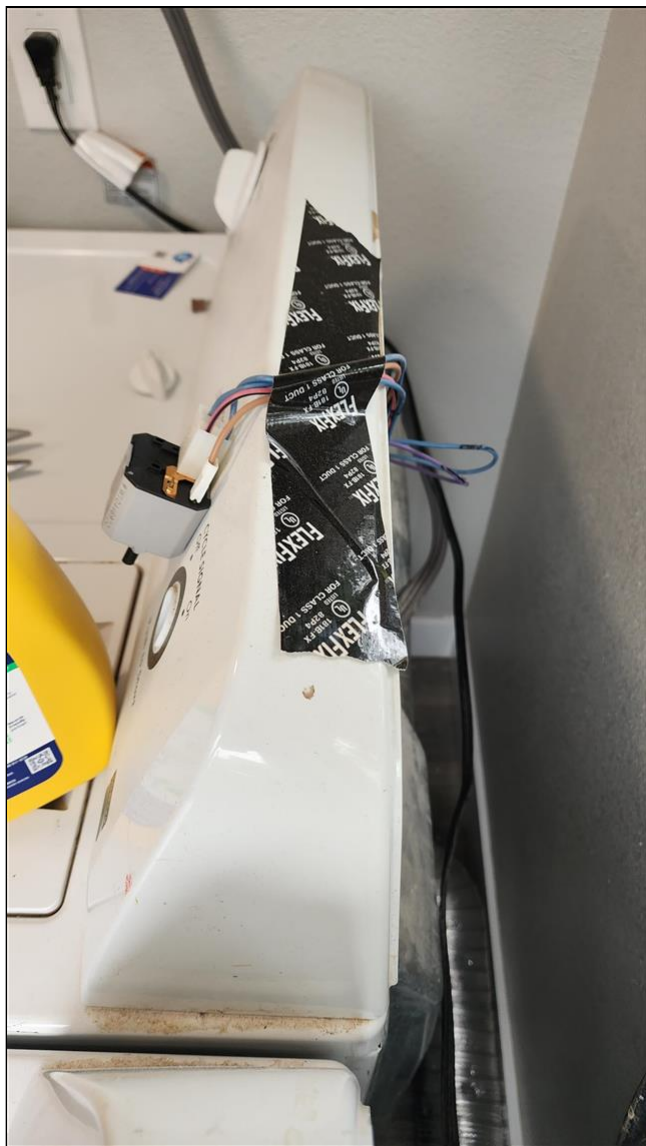
5.1 Item 1(Picture)

If the dryer is staying at the house the unit does work however the start button for start button for it is broken

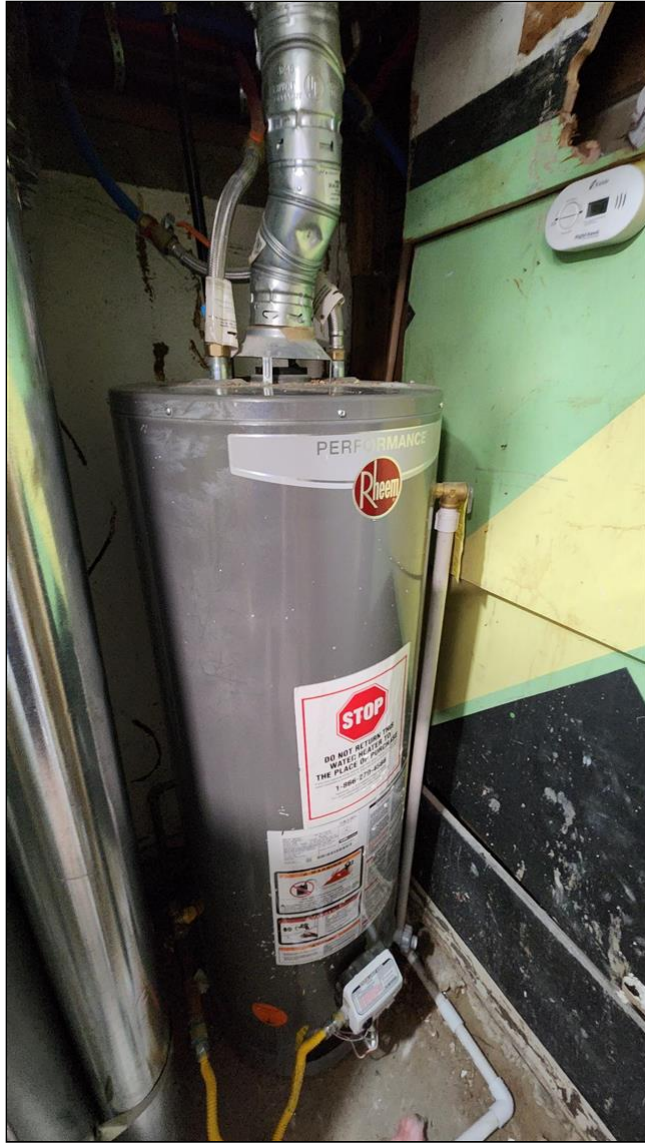
7.2 Item 1(Picture)

Since 2014 on all new water heaters an Expansion tank is required, This water heater is Missing the Expansion tank. This tells me that this water heater was not permitted.

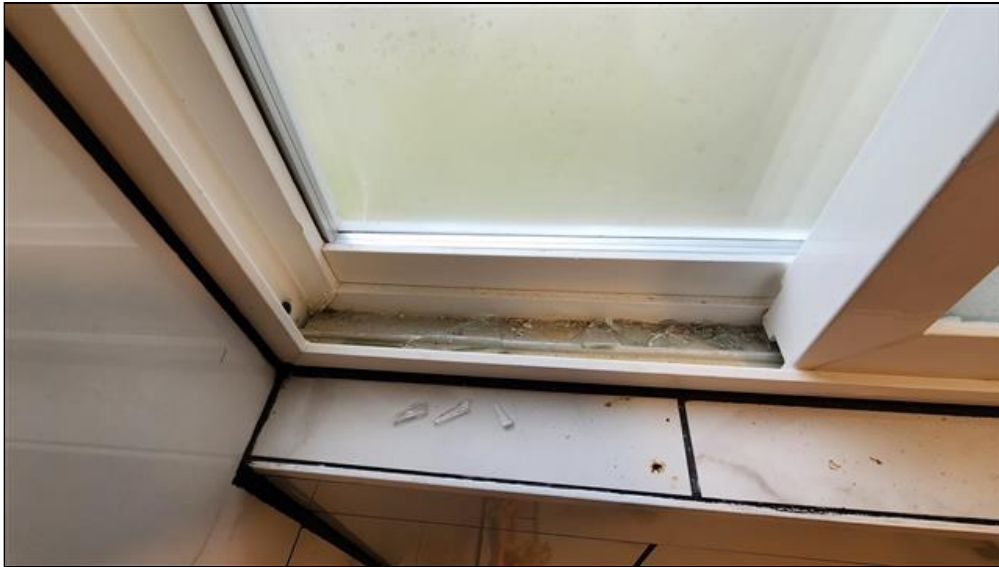
9.2 Item 1(Picture)

Window to the top floor bathroom is broken. And shards of glass still in the frame.

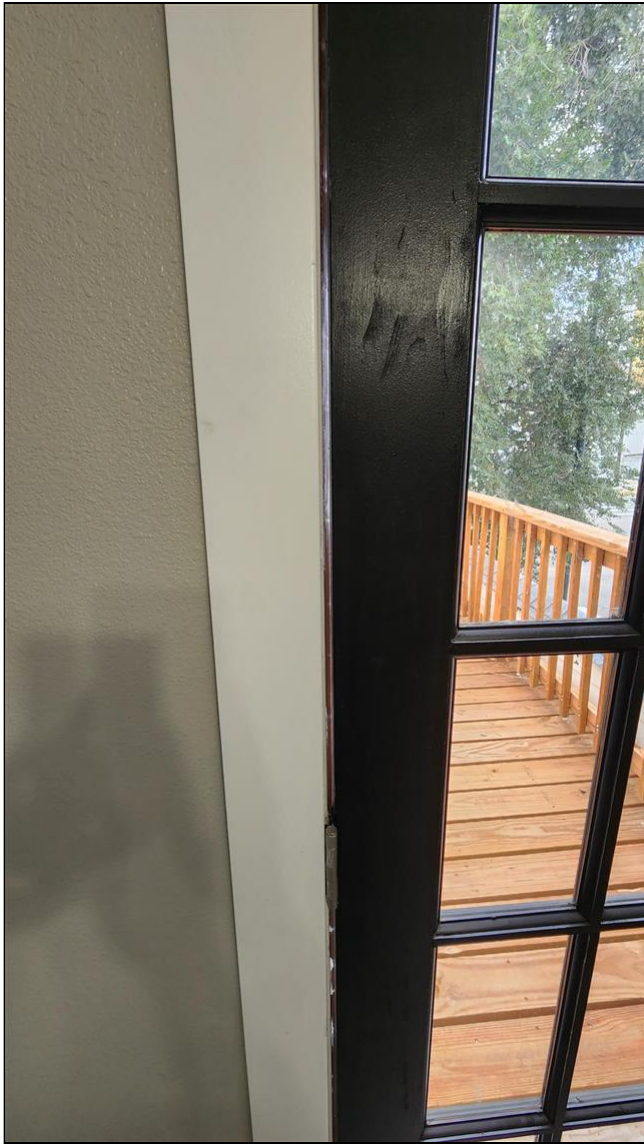
10.4 Item 1(Picture)

The door to the top floor balcony is just a little too small. That door has some pretty big air gaps in it which is going to cause a lot of cold air to come in during the Winter time.
