Inspection Report

5138 W. 46th Ave
Denver Co 80212

A Happy House Home Inspection, LLC

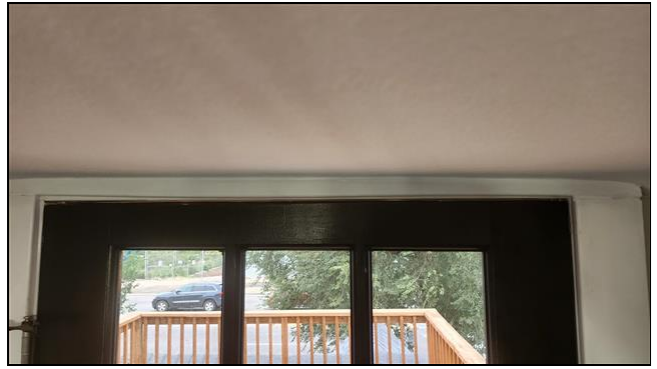
10.4 Item 2(Picture)

The door to the top floor balcony is just a little too small. That door has some pretty big air gaps in it which is going to cause a lot of cold air to come in during the Winter time.
