**Kapton™/Polyimide**

**JSWAG**

**DECEMBER 2025**

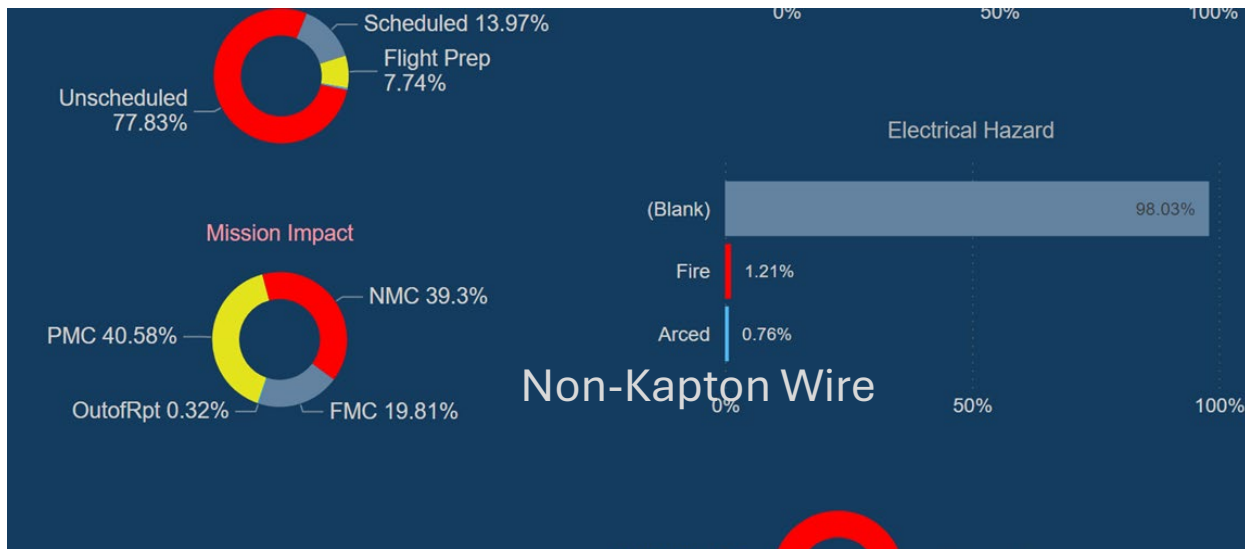
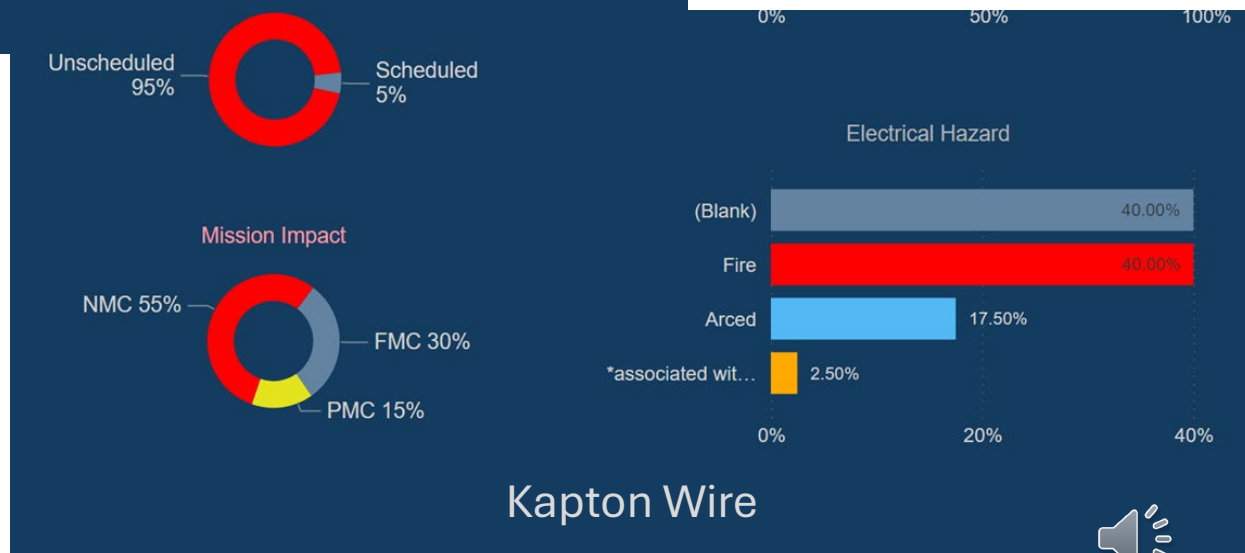
Fire/arcing is 50 times more likely with degraded Kapton.

\*Data source: DECKPLATE E-6B 2012-2024

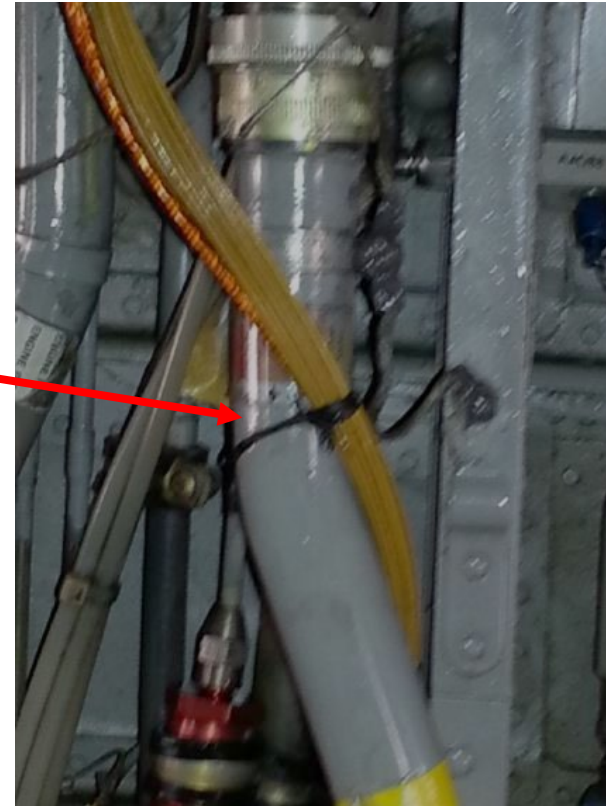
Kapton chafing on fuel line.  
Point of origin.

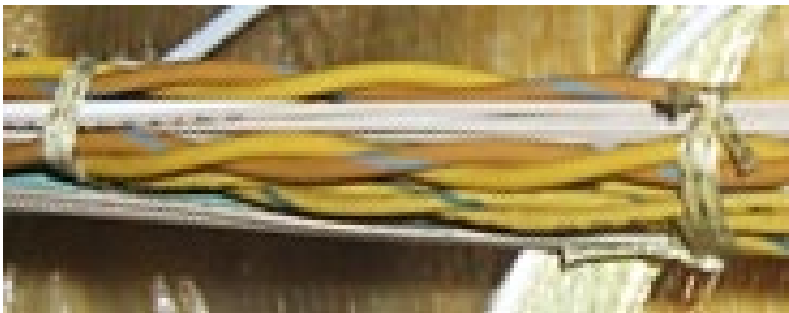
- Polyimide-insulated electrical wire (MIL-DTL-81381)
  - Outer coating (topcoat): Modified Aromatic Polyimide Resin.
  - Inner coating: Fluorocarbon Polyimide Tape.
- Developed in the 1960's by DuPont – Kapton is the brand name.
- Found in: Apollo Lunar Module and Space Shuttle orbiter class, civilian and military aerospace, and wide-range of electronics manufacturing.

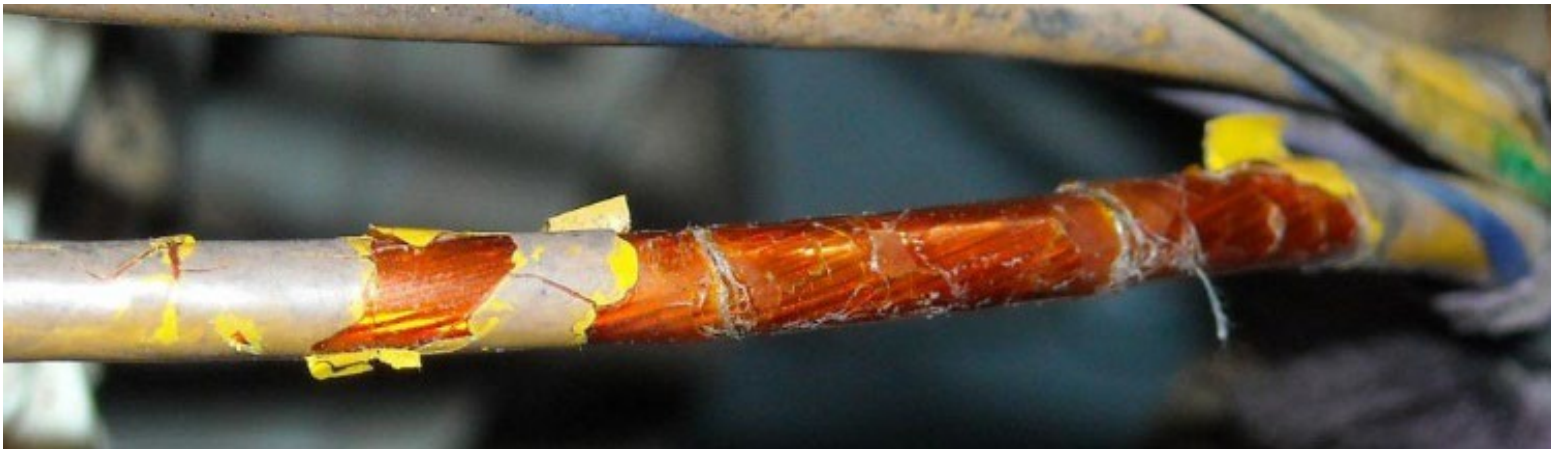
Polyimide film degrades very quickly when exposed to a combination of heat, humidity and mechanical strain. Degradation accelerates when this film is wrapped around a conductor.

Kapton can become brittle in less than 6 years.

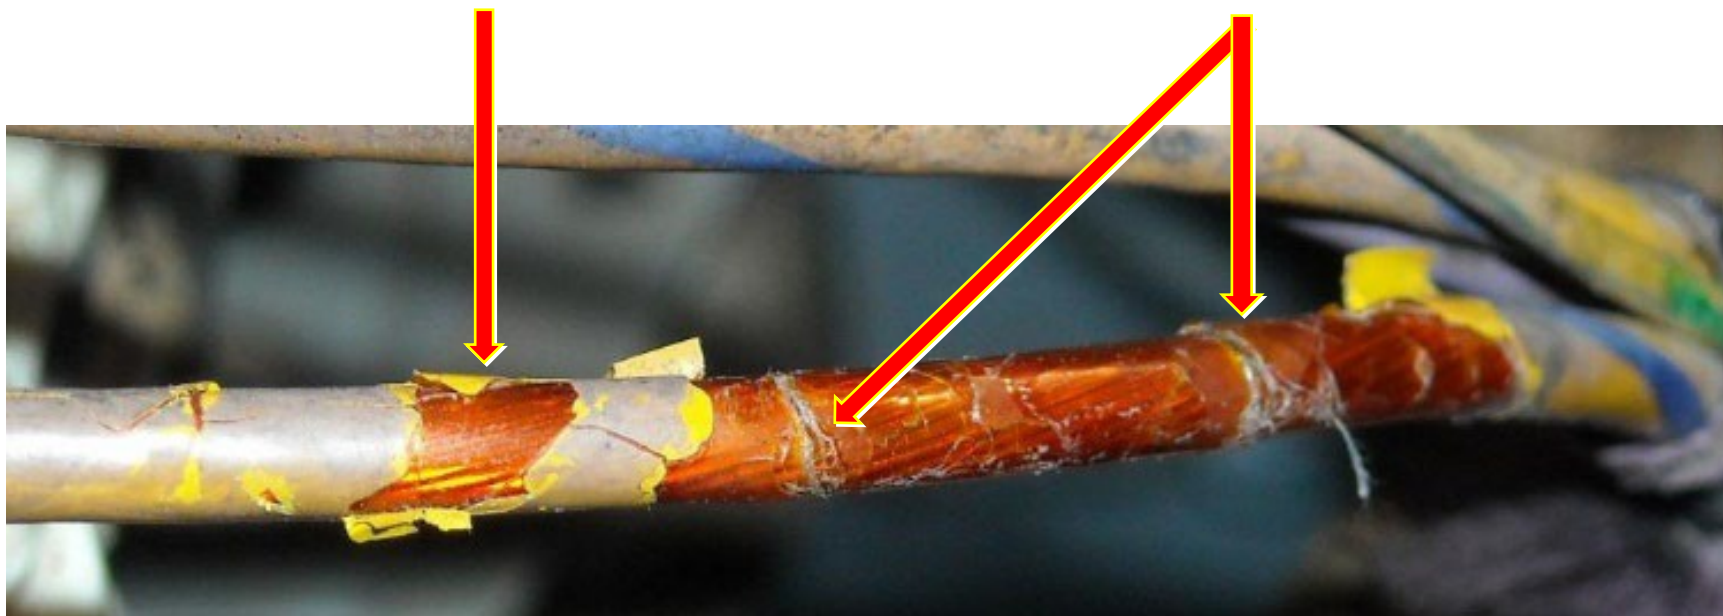
Slight flaking of the topcoat does not require repair or replacement

Topcoat flaking    Radial cracks

Brittle insulation

**Any cracking, or other damage (cuts, chafing, etc.) of the Kapton® polyimide film requires repair or replacement in accordance with WP 014 00 and WP 004 01.**
