**Exhibit K**  
**Geotechnical Investigation Report**

**Subject: Geotechnical Investigation Report  
Birch Solar Project  
Allen and Auglaize Counties, Ohio**

**GEOTECHNICAL INVESTIGATION REPORT  
BIRCH SOLAR PROJECT  
ALLEN AND AUGLAIZE COUNTIES, OHIO  
KLEINFELDER PROJECT NO. 20212135.001A**

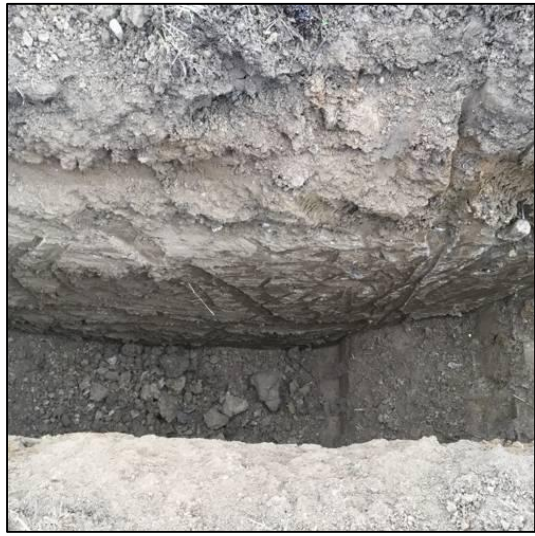
PROJECT NO.: 20212135.001A	TEST PIT LOG TP-10  Lightsource bp Birch Solar Project Allen and Auglaize Counties, OH	EXPLORATION
	DRAWN BY: DH CHECKED BY: DEP DATE: 12/8/2020		TP-10  PAGE: 1 of 1

The test pit was terminated at approximately 8 ft. below ground surface. The test pit was backfilled with excavated material on October 30, 2020.

**GROUNDWATER LEVEL INFORMATION:**  
 Groundwater was not observed during excavation or after completion.  
**GENERAL NOTES:**  
 The exploration location and elevation are approximate and were estimated by Kleinfelder.  
 A handheld GPS unit was used to locate the exploration with an accuracy of 5 meters.

**Date Begin - End:** 10/30/2020 **Excavation Company:** Terra Testing  
**Logged By:** D. Huntsman **Excavation Crew:** B. Kirkpatrick  
**Hor.-Vert. Datum:** WGS 1984 - NAVD88 **Excavation Equip.:** Bobcat E45  
**Plunge:** -90 degrees **Excav. Dimensions:** 4 x 8 ft  
**Weather:** 45°F Partly Cloudy

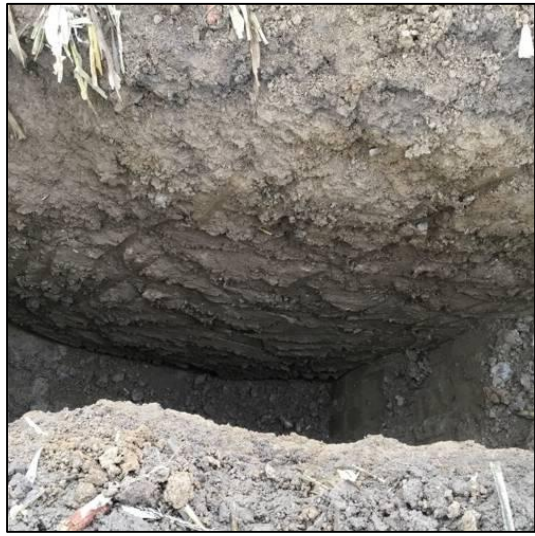
TEST PIT LOG TP-14  
 Lightsource bp  
 Birch Solar Project  
 Allen and Auglaize Counties, OH

The test pit was terminated at approximately 8 ft. below ground surface. The test pit was backfilled with excavated material on October 30, 2020.

**GROUNDWATER LEVEL INFORMATION:**  
 Groundwater was not observed during excavation or after completion.  
**GENERAL NOTES:**  
 The exploration location and elevation are approximate and were estimated by Kleinfelder.  
 A handheld GPS unit was used to locate the exploration with an accuracy of 5 meters.

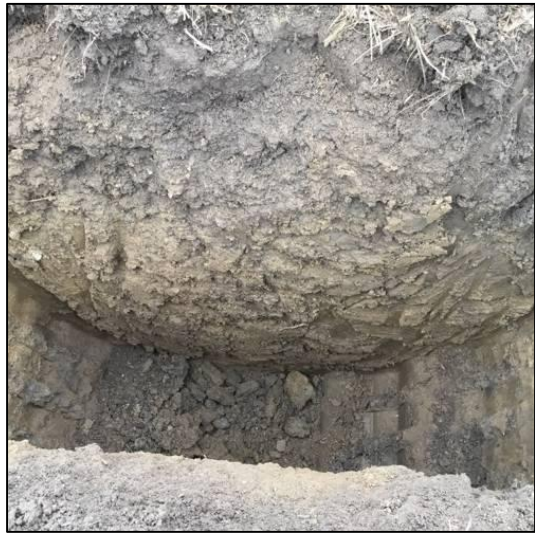
PROJECT NO.: 20212135.001A	TEST PIT LOG TP-18	EXPLORATION
	DRAWN BY: DH CHECKED BY: DEP DATE: 12/8/2020		
			PAGE: 1 of 1

The test pit was terminated at approximately 8 ft. below ground surface. The test pit was backfilled with excavated material on October 30, 2020.

**GROUNDWATER LEVEL INFORMATION:**  
Groundwater was not observed during excavation or after completion.  
**GENERAL NOTES:**  
The exploration location and elevation are approximate and were estimated by Kleinfelder.  
A handheld GPS unit was used to locate the exploration with an accuracy of 5 meters.

**Date Begin - End:** 10/30/2020 **Excavation Company:** Terra Testing  
**Logged By:** D. Huntsman **Excavation Crew:** B. Kirkpatrick  
**Hor.-Vert. Datum:** WGS 1984 - NAVD88 **Excavation Equip.:** Bobcat E45  
**Plunge:** -90 degrees **Excav. Dimensions:** 4 x 8 ft  
**Weather:** 45°F Partly Cloudy

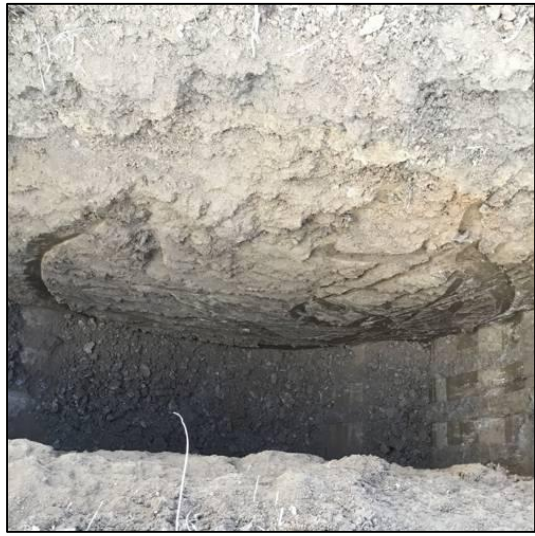
<b>Bright People. Right Solutions.</b>	PROJECT NO.: 20212135.001A	TEST PIT LOG TP-22  Lightsource bp Birch Solar Project Allen and Auglaize Counties, OH	EXPLORATION
	DRAWN BY: DH CHECKED BY: DEP DATE: 12/8/2020		TP-22  PAGE: 1 of 1

The test pit was terminated at approximately 8 ft. below ground surface. The test pit was backfilled with excavated material on October 30, 2020.

**GROUNDWATER LEVEL INFORMATION:**  
 Groundwater was not observed during excavation or after completion.  
**GENERAL NOTES:**  
 The exploration location and elevation are approximate and were estimated by Kleinfelder.  
 A handheld GPS unit was used to locate the exploration with an accuracy of 5 meters.
