Exhibit P
Wetland and Waterbody Delineation Report

Birch Solar Project

Wetland and Waterbody Delineation Report

January 23, 2021

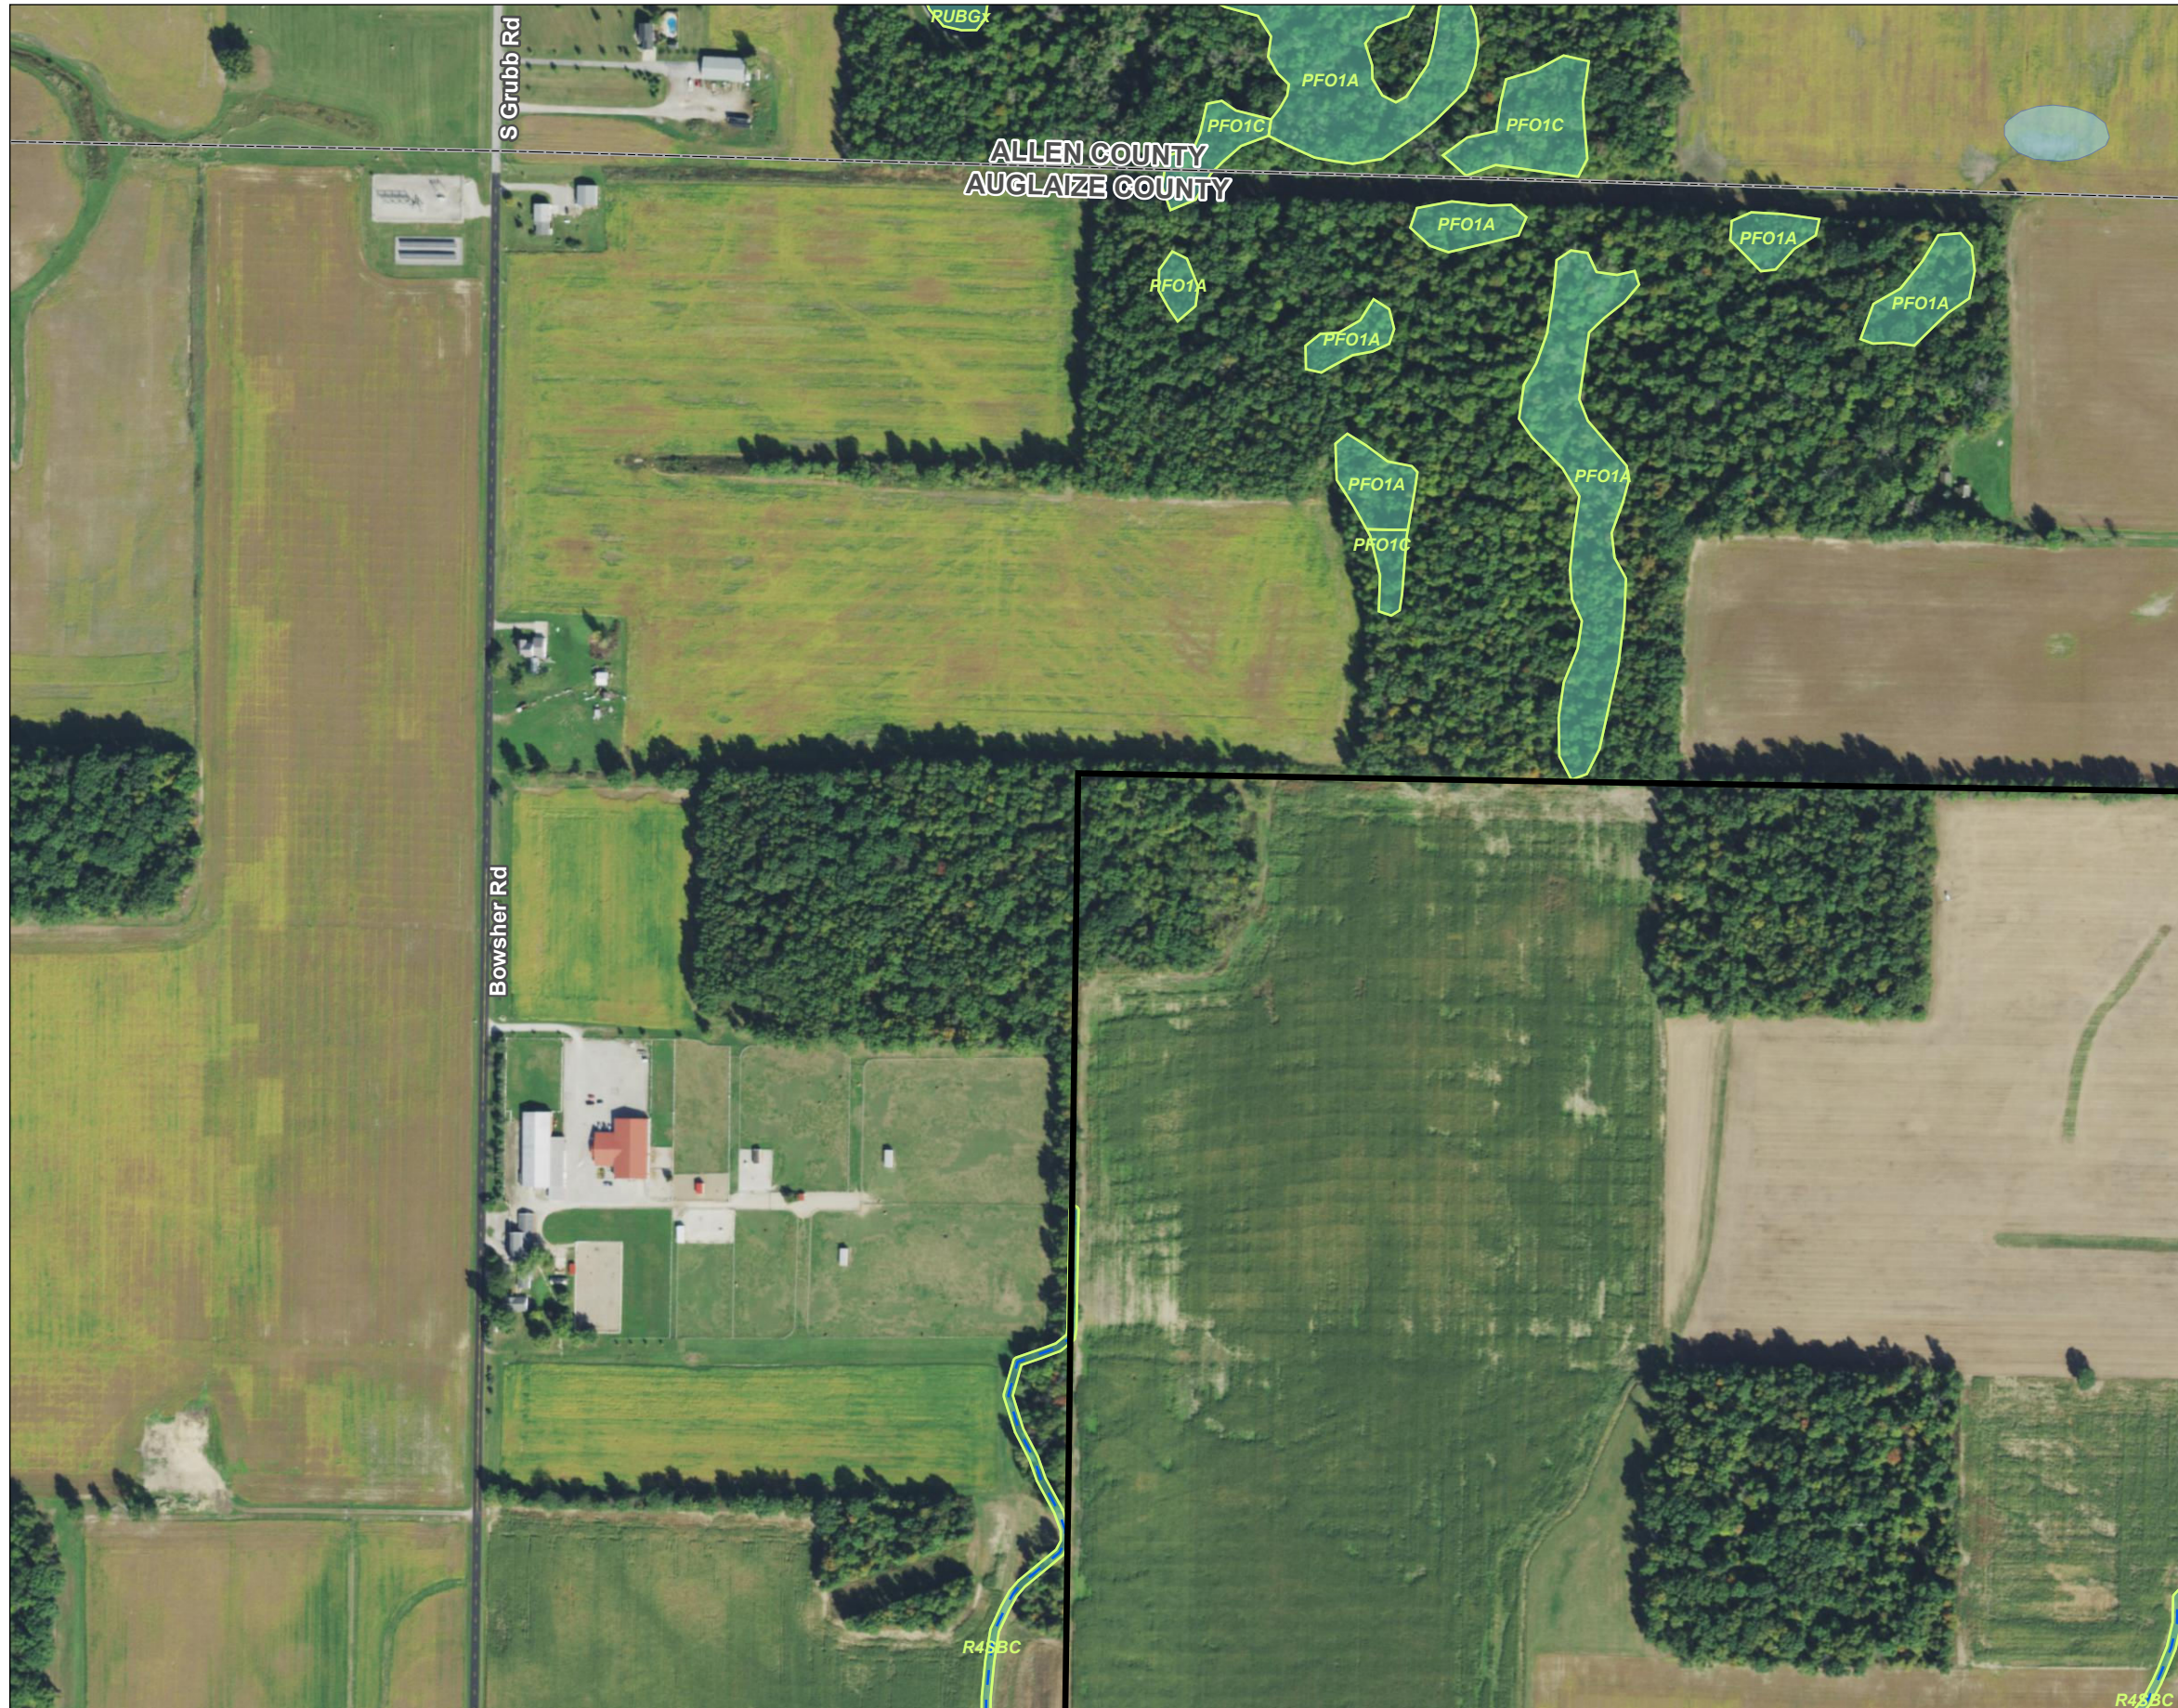
A.3 FIGURE 3 – NATIONAL WETLANDS INVENTORY MAP

Figure No.
3
 Title
National Wetlands Inventory Map

- Legend
- Project Area
 - National Wetlands Inventory Feature
 - National Hydrography Dataset
 - Perennial Stream
 - Intermittent Stream
 - Waterbody

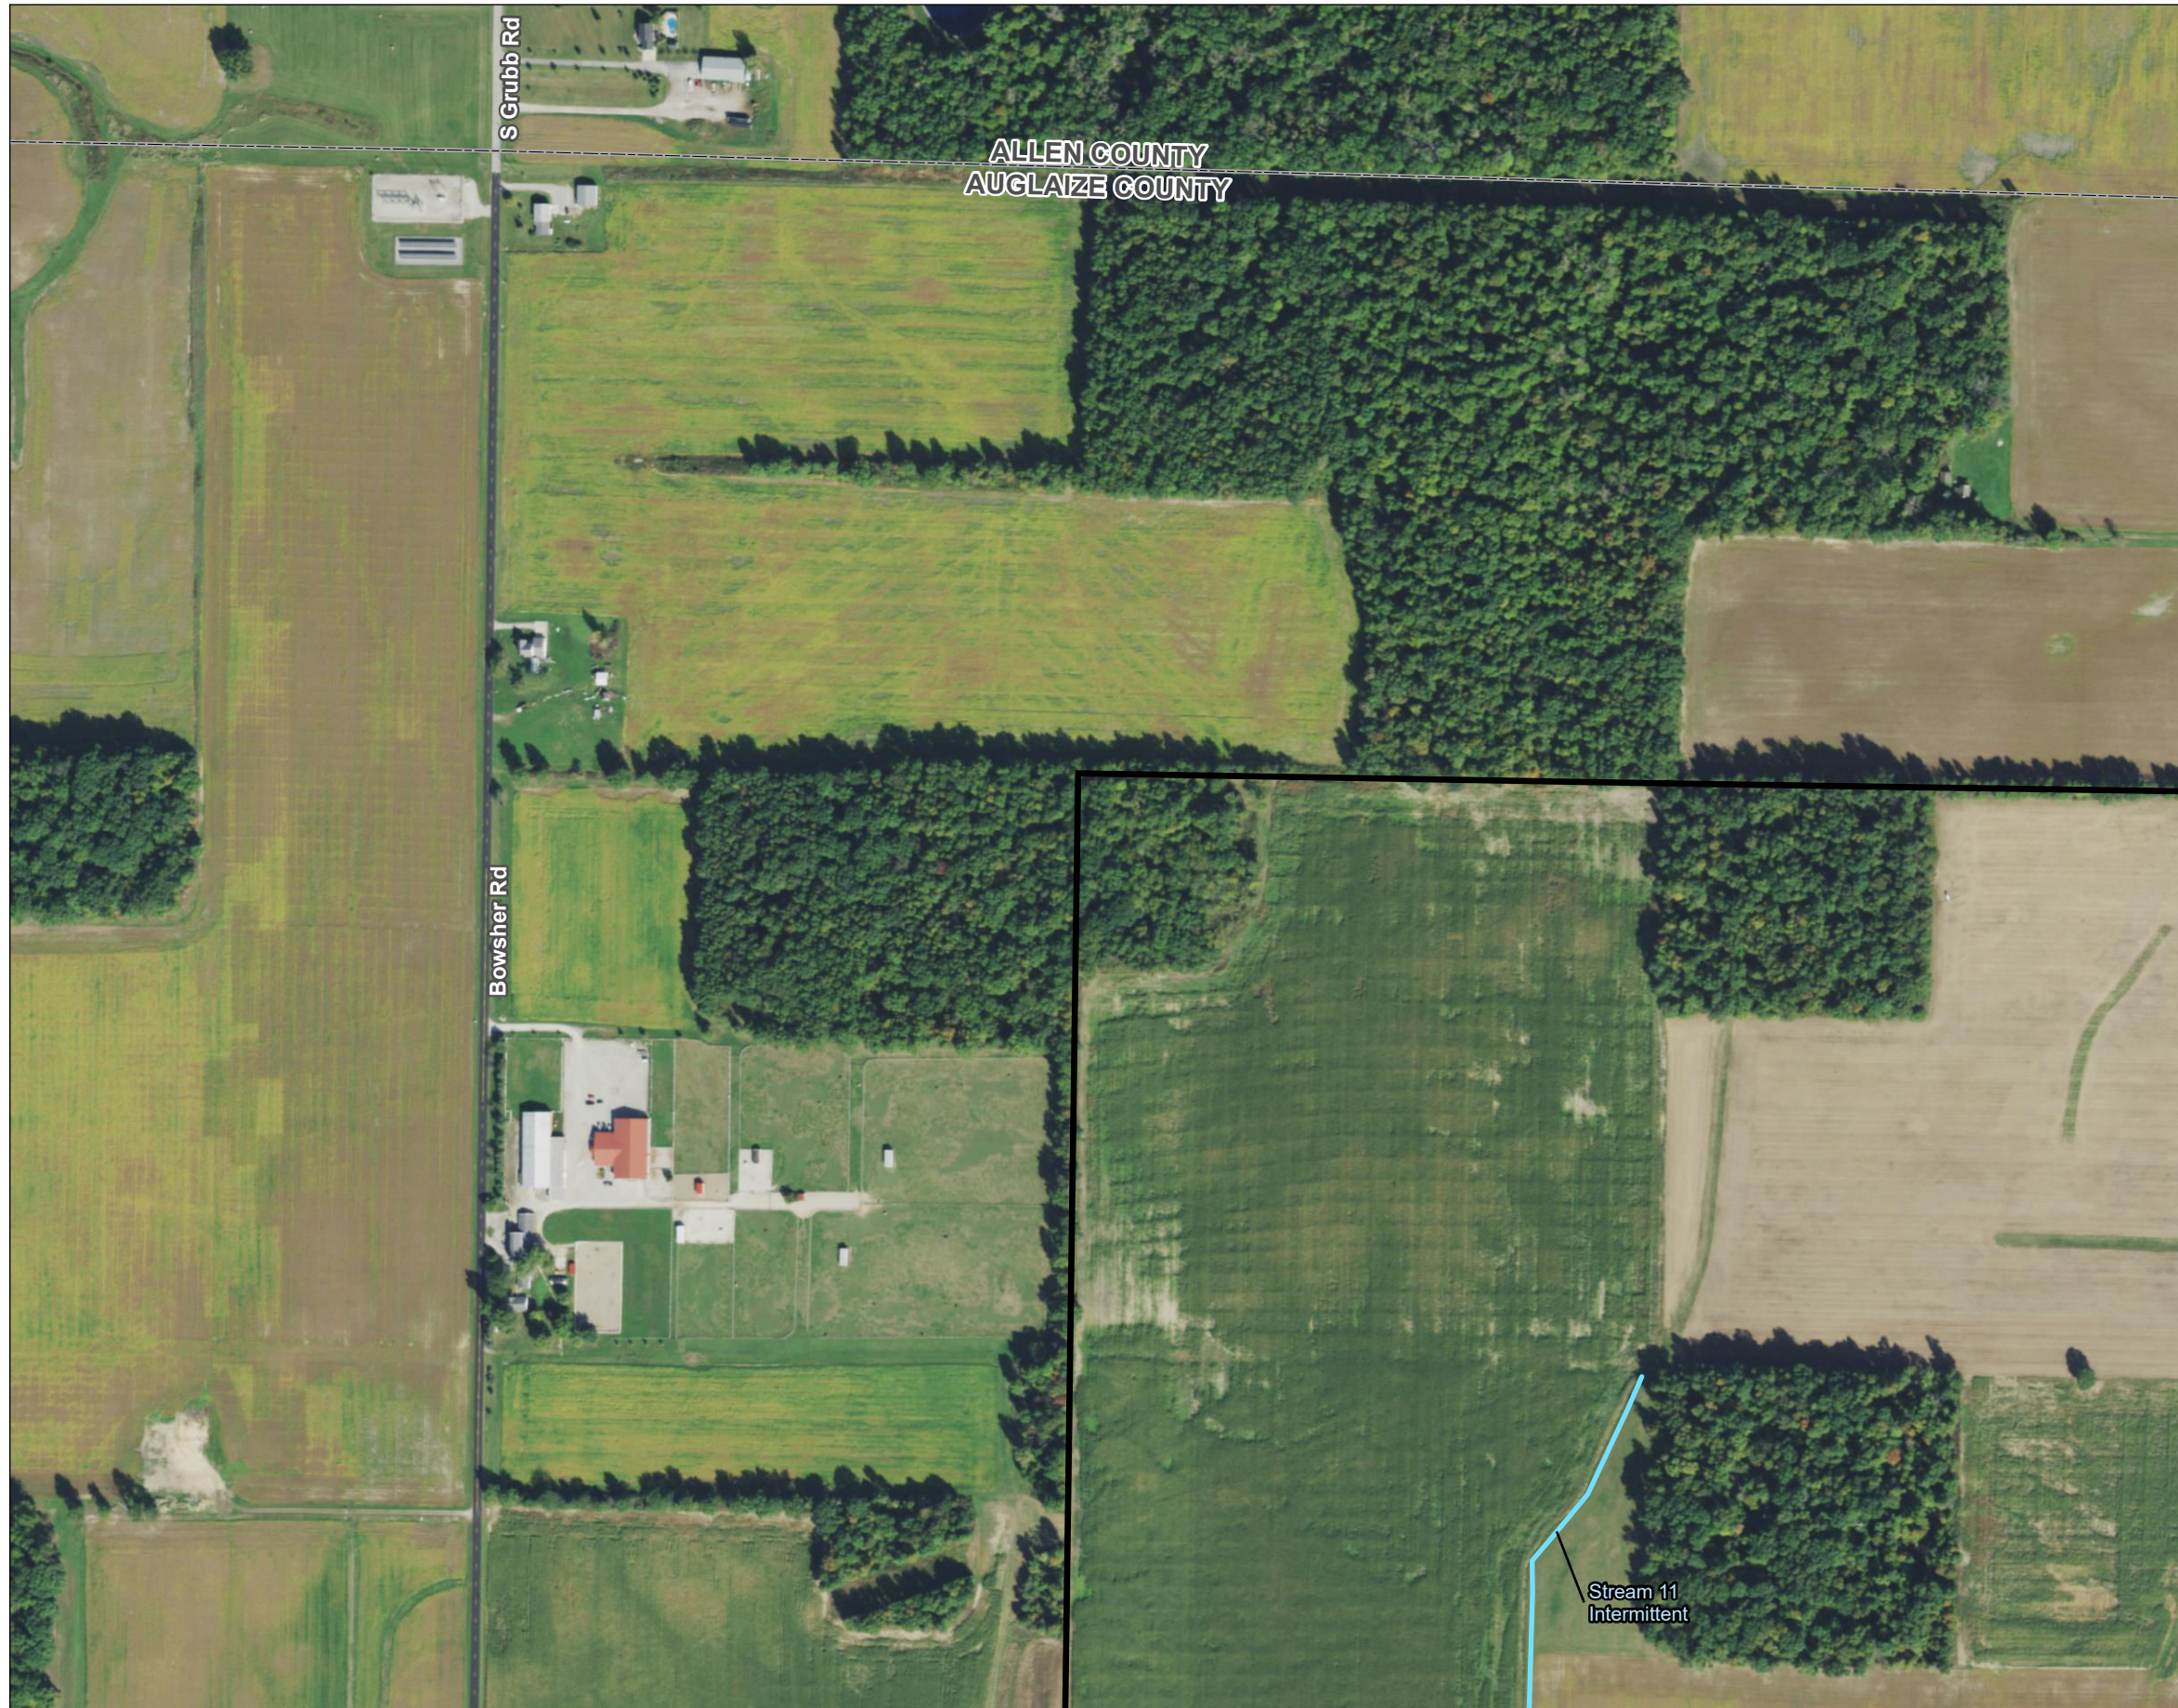
A.4 FIGURE 4 – WETLAND AND WATERBODY DELINEATION MAP

- Project Area
- Photo Location
- Wetland Determination Sample Point
- Field Delineated Waterway
- Field Delineated Open Water
- Field Delineated Forested Wetland
- Field Delineated Scrub Shrub Wetland

Stream 1 is an intermittent stream with approximately 823 linear feet within the Project area. The functional assessment (HHEI) of Stream 1 yielded a score of 51, indicating it is a Class II PHWH stream. The stream had a bankfull width of 10 feet and a bankfull depth of 4 feet and had a moist channel with isolated pools at the time of site visit. Substrates observed were primarily silt and clay. Stream 1 drains into Twomile Creek outside the Project area.

Stream 2 is an intermittent stream with approximately 1,103 linear feet within the Project area. The functional assessment (HHEI) of Stream 2 yielded a score of 56, indicating it is a Modified Class II PHWH stream. The stream had a bankfull width of 12 feet and a bankfull depth of 4 feet and was flowing at the time of site visit. Substrates observed were primarily silt and clay. Stream 2 drains into Twomile Creek outside the Project area.

Stream 3, Little Ottawa River, is a perennial stream with approximately 153 linear feet within the Project area. The functional assessment (QHEI) of Stream 3 yielded a score of 44.25, indicating it is a “fair” quality stream. The stream had a bankfull width of 40 feet and a bankfull depth of 5 feet and was flowing at the time of site visit. The substrates observed were primarily sand and gravel. Stream 3 drains into the Ottawa River outside Project area.

Stream 4 is an ephemeral stream with approximately 1,355 linear feet within the Project area. The functional assessment (HHEI) of Stream 4 yielded a score of 47, indicating it as Modified Class II PHWH stream. The stream had a bankfull width of 12 feet and a bankfull depth of 5 feet and had moist channels with isolated pools at the time of site visit. The substrates observed were primarily silt and clay. Stream 4 drains into Stream 5 within the Project area.

Stream 5 is a perennial stream with approximately 5,672 linear feet within the Project area. The functional assessment (HHEI) of Stream 5 yielded a score of 53, indicating it is a Modified Class II PHWH stream. The stream had a bankfull width of 14 feet and a bankfull depth of 3 feet and was flowing at the time of site visit. The substrates observed were primarily silt and clay. Stream 5 drains into Twomile Creek within the Project area.
