SUCCESS

SPOTLIGHT

JAMAICA

LIMESTONE

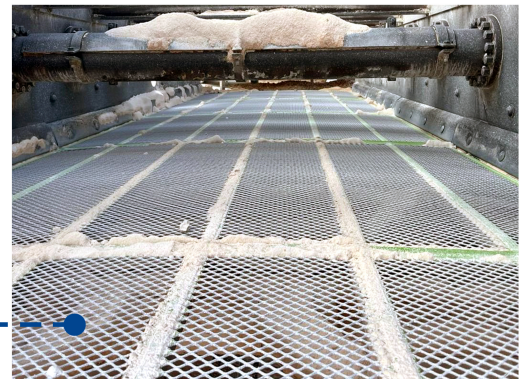
Installing FLEX-MAT® D-1/2" screens resulted in a 20% boost in production, improved efficiency, consistently met production goals and had very little material buildup. Switching to FLEX-MAT® also produced a more consistent specification, eliminating carryover of sized product.

Since installing Flex-Mat® screens at our crushing operation in Jamaica, we've seen a 20% boost in minus 1/2" production, even with the constant wet weather. These screens have greatly improved efficiency, helping us consistently meet production goals despite challenging conditions. This picture is after a 16 hour shift running very damp raw material. Little to no buildup. The performance has been amazing! - J.M., Plant Manager, Jamaica
