ROYAL MAIL HOUSE, TERMINUS TERRACE, SOUTHAMPTON

Heritage Statement

May 2020

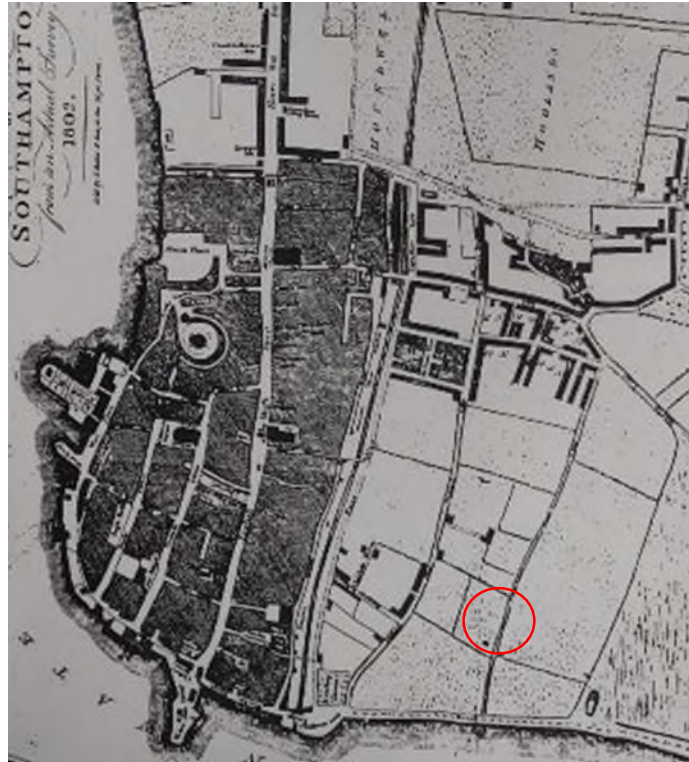
Figure 1 Southampton 1802 with the approximate area of the site circled.

- 2.1 A map of Southampton dated 1802 shows that at that date the developed area of Southampton remained largely within the medieval walled town apart from developments along Above Bar Street to the north of the walled area and to the north-east where a grid plan of streets was beginning to develop, particularly to the south of the continuation of East Street beyond the city wall (Figure 1). The area of Oxford Street was predominantly an area of small paddocks and fields bounded to the east by an area called The Marsh which was unenclosed.

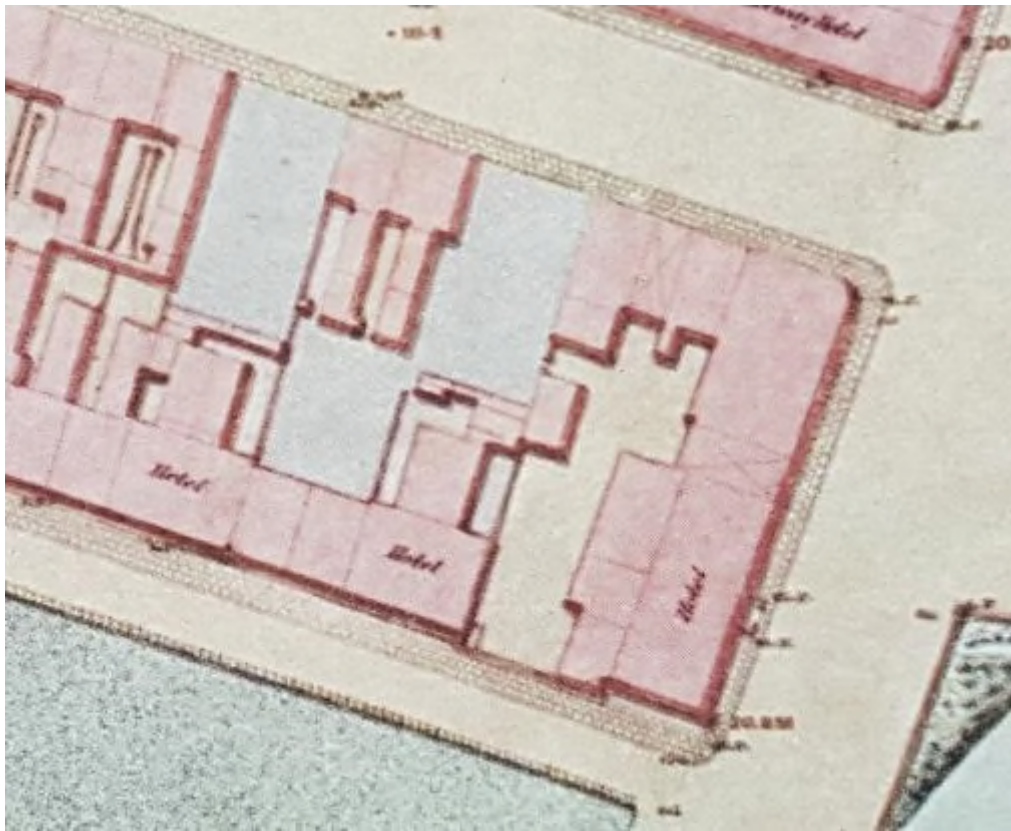
Figure 2 Engineer's map of Southampton, 1846

- 2.2 The next detailed map of the area is the Engineer's Map of 1846 which captures the area of Oxford Street in the process of its development (Figure 2). The map shows the South Western Railway Terminus with its booking office building and a platform building, the main station being set almost directly opposite the junction between Oxford Street and Terminus Terrace. The south eastern end of Oxford Street was largely built-up at this date although there were three gaps in the street frontage between Terminus Terrace and Latimer Street and a large gable between John Street and Latimer Street to the north side of the street.

- 2.3 The block of properties defined Oxford Street to the north, Latimer Street to the west, Terminus Terrace to the east and Queen's Park (then known as Porter's Mead) had a near complete frontage facing south with a continuous frontage from Latimer Street up to a wide gap giving access to the rear of the buildings facing Terminus Terrace. Within Queen's Terrace there were two hotels within double-fronted buildings, the eastern hotel having its side elevation facing onto the yard area behind the buildings to the Terminus Terrace frontage.

- 2.4 Facing onto Terminus Terrace was a building which is generally been regarded as representing Radley's Hotel. However, the 1846 map only marks the southern part of this block as being a hotel. Separating the southern and northern parts of the building facing Terminus Terrace was a carriage arch and there was a further carriage arch slightly narrower than that to the Terminus Terrace frontage, between two small units facing onto Oxford Street.

- 2.5 In addition to the presence of the carriage arches, other notable features of the two parts of RMH facing Terminus Terrace is the fact that they were of differing depths; the northern block being slightly wider than the main range of the southern block which had additional elements a Terminus Terrace ached to its rear elevation. Additionally, to the centre of the

east elevation of the southern block the map shows what appears to be an entrance with a porch supported by two columns. This map raises questions as to whether, in 1846 the Radley Hotel occupied the whole of the Terminus Terrace frontage.

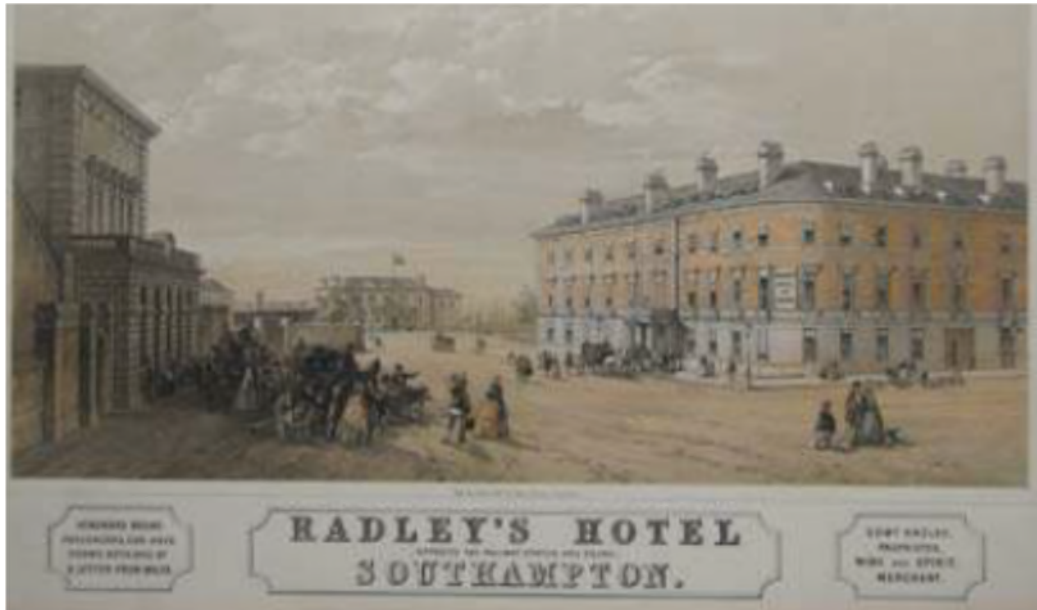
Figure 3 Lithograph of Radley's Hotel looking south along Terminus Terrace. Late 19th century.

- 2.7 A late 19th century lithograph view south to Radley's Hotel shows that the main entrance had moved to the present position at this date but the carriage arch on the Oxford Street frontage was still open (Figure 3). The drawing appears to show dormer windows on the north roof slope of the Oxford Street range but not on the east slope of the Terminus Terrace range. Although care must be taken with the interpretation of illustrations such as this lithograph, it does seem to suggest that there was no break in the line of the roof over the Terminus Terrace range as now exists.

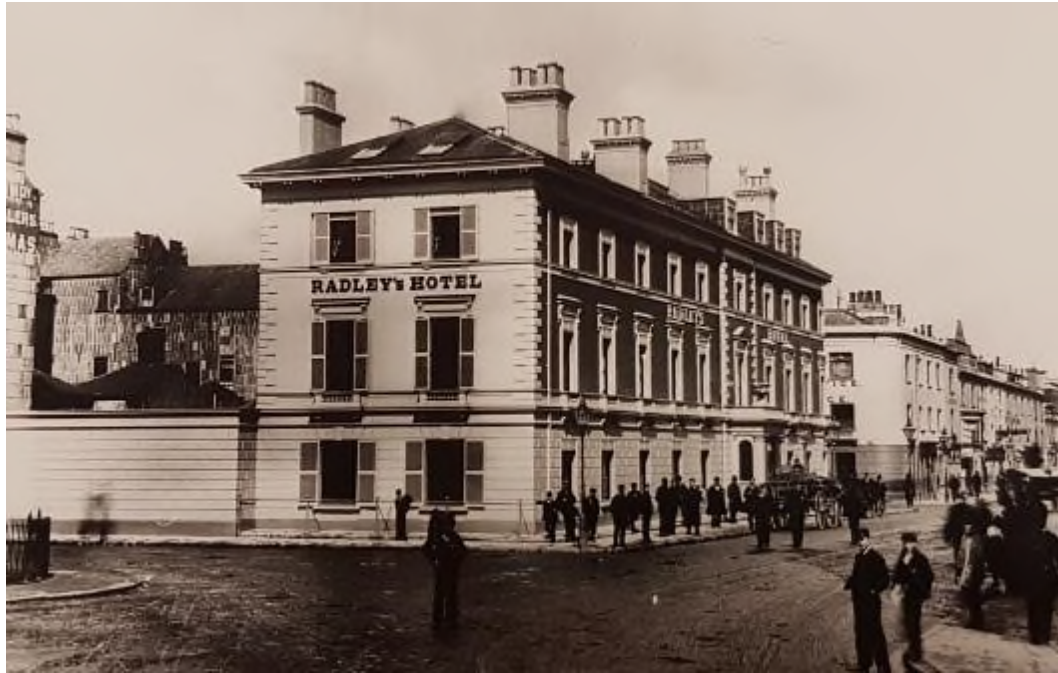
Figure 7 1890s postcard of Radley's Hotel

- 2.9 A late 19th century postcard shows Radley's Hotel as viewed from the south-east (Figure 7). This picture, the earliest photograph currently available of the building, shows the southern and eastern façades largely as at present except for the pediment to the projecting entrance bay on the east elevation. The photograph shows that there was a porch of a similar form to the present, but with a semi-circular headed openings to the sides.

7.12 It is proposed to install two conservation roof lights to the south roof slope. Two rooflights were present on this slope in the late 19th century (see Figure 7). It is not known when they were removed – the roof slope is not visible in the 1940s photograph (see Figure 12). The impact of these rooflights will be minimal – they will only be visible in longer views to the building and by using the original positions, there will be no loss of historic fabric.

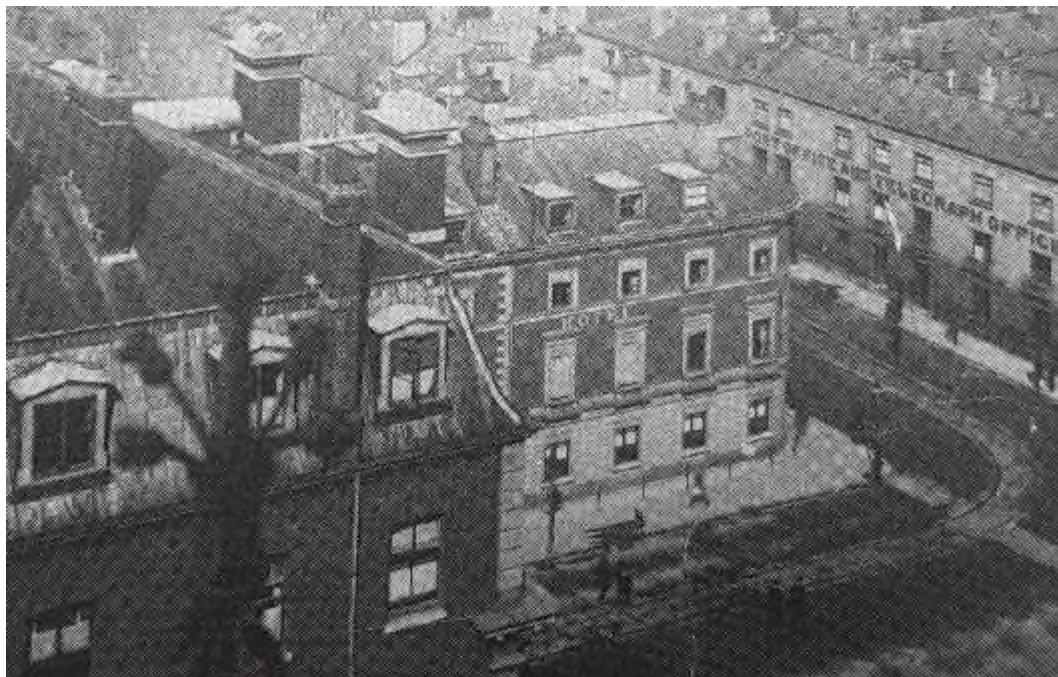
Figure 8 View c.1900 to the north part of Royal Mail House from the roof of a building behind South Western House.

- 2.10 The south elevation was evidently rendered at this time as today and has been subject to little change apart from the loss of the console brackets beneath the hoods to the first-floor windows, the removal of shutters to the windows and an alteration in to the lower part of the first-floor windows. Additionally, there were two small rooflights to the hipped end and the roof. The most striking difference between the building in the late 19th century and the building seen today is the roof which was then dominated by large stacks; 4 to the east roof slope each carrying eight chimney pots with lateral stacks set to the west side, each having four flues. Only the northern part of the range had flat topped dormer windows at this date, three of which survive. There is no evidence in this late 19th century photograph for the apparent former entrance in the central bay of the five bay southern part of the building as suggested on the 1846 plan. A photo of c.1900 taken from a roof behind South Western House shows the northern part of the Terminus Terrace range with the flat-topped ridge of the roof of this part of the building (Figure 8).

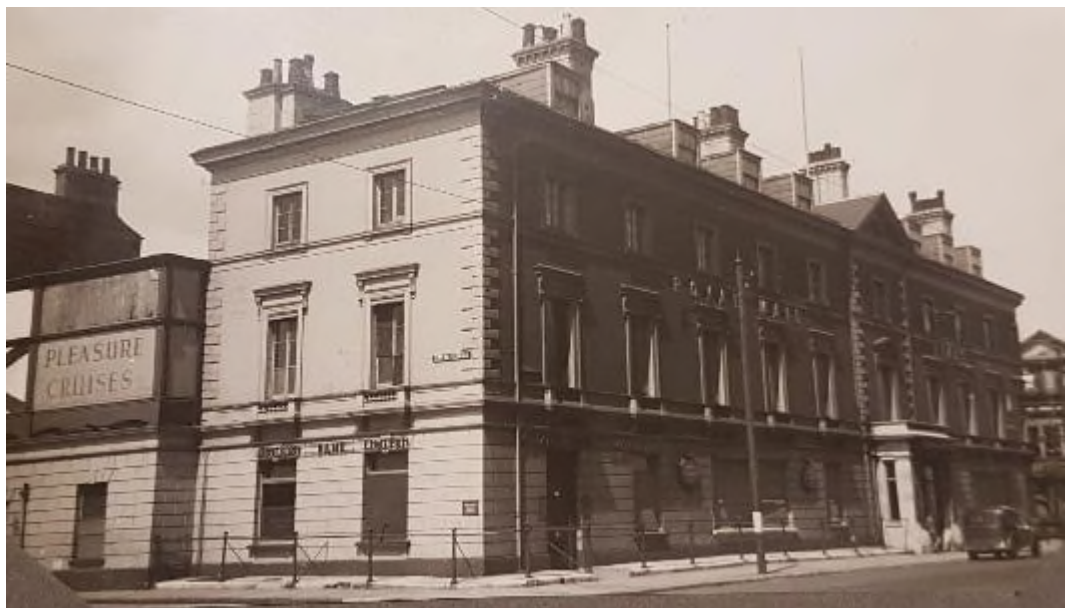
Figure 12 Postcard of the Royal Mail Lines offices c.1940-50, south and east elevations.

- 2.17 There are various photographs of the building in the mid-20th century showing that had been limited changes to the exterior of the building between 1907 and the 1940s (Figure 12). One of the most evident changes was the addition of dormers to the roof of the southern part of the Terminus Terrace range. By the 1940s the Midland Bank occupied the room at the southern end of the building; the door into this office in the east elevation and the partition dividing it off from the larger space to the north evidently having been inserted between 1907 and 1941.

7.11 The present windows to the second floor are modern of non-traditional form and are in poor condition. Their replacement with casements of the same form as those to the east elevation (and as were present in the c.1940s – see Figure 12, above) will represent an improvement to the external appearance of the building and so will be a positive change to both the listed building and the conservation area.

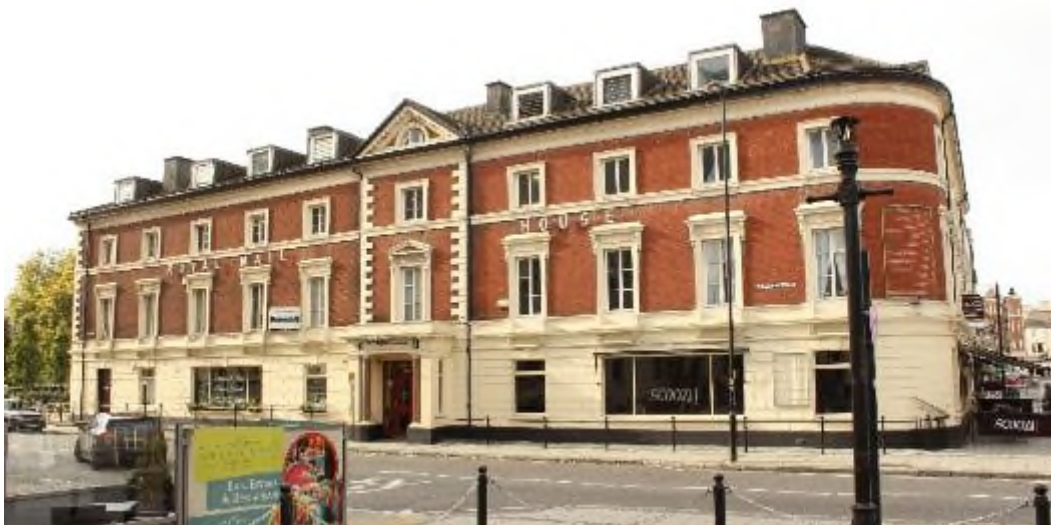
Figure 13 East elevation of the Royal Mail House.

- 3.1 The principal elevation of Royal Mail House faces onto Terminus Terrace, formerly facing onto the railway terminus opposite which brought travellers down to the port from 1839-40. The building is of 3½ storeys in height and 10 bays in length defined by large six-pane casements to the first-floor with stucco architraves and hoods with scroll console brackets (Figure 13). At second floor level are smaller two-light casements, those to the southern façade being of three panes per light. The rhythm of the bays at ground floor level has been disrupted on the Terminus Terrace frontage by the insertion of two large windows in 1907, each of which replaced two windows. The first and second storeys are constructed in a red brick laid in Flemish bond with rusticated stucco to the ground floor. The sixth bay from the south, now having the main entrance, projects slightly from the facade, it's first-floor window having a pediment rather than a hood over and with a pediment projecting from the roof with a lunette window and brackets to the verge of the roof. The roof to this elevation is in two sections, the change occurring on the south side of the entrance bay; to the north the roof is gabled and of a steeper pitch than the fully hipped roof to the south (Figure 14 and also see Figure 8). A simple railing of one horizontal rail runs along the elevation both sides of the porch. At the corners and to the edges of the projecting bay are rusticated stucco quoins. The north-east corner of the building at the junction between Terminus Terrace and Oxford Street sweeps round in a curve and is blind. The frame of a former advertising panel has preserved an area of historic pointing to the brickwork which has otherwise largely been lost across the rest of the brickwork. The north elevation generally matches that of the east with an inserted door in the position of the second window from the east and a door in the western-most bay. However, the regularity of the bays, as defined by the windows is disrupted in the second bay from the west where the spaces between the windows is greater than in the other bays and the first floor window has a pediment over rather than hoods, as on the Terminus Terrace range. In this bay at ground floor level fine, vertical cracks are visible in the stucco either side of the window which reflect the presence of the former carriage arch on the north range.

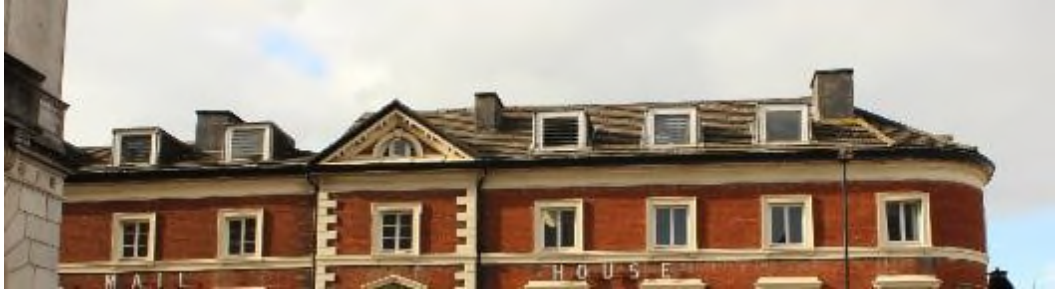
Figure 14 The roofs of the Terminus Terrace range of Royal Mail House showing the change in roof form.

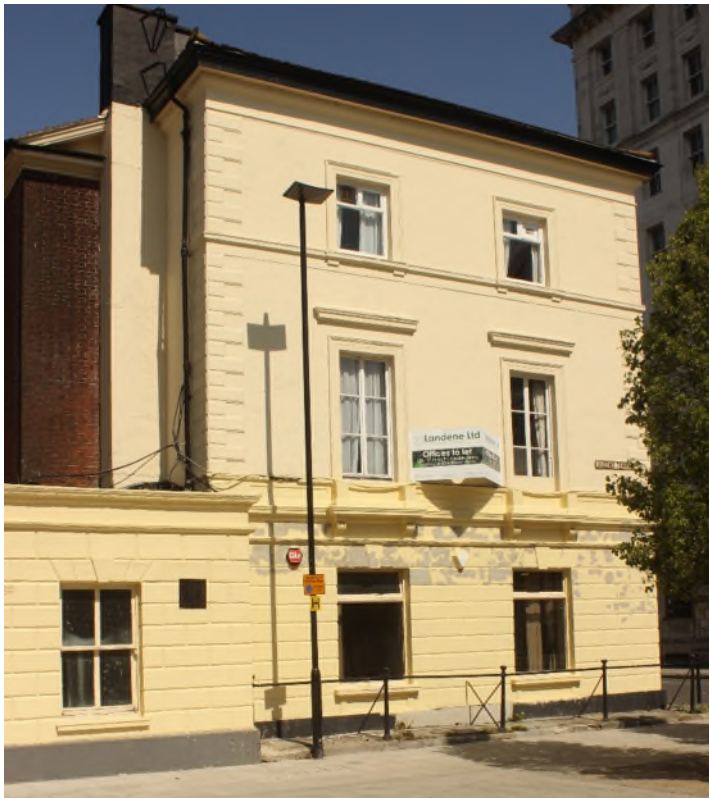
Figure 15
South elevation of the main range.

- 3.2 The south elevation is of two bays width, the brickwork covered with stucco the full height of the building (Figure 15). The roof is hipped to this end. The railing to the front elevation continues to this side of the building. Close examination of the railing shows that from the opening to the door into the southern unit, most of the rails are later replacements fixed by brackets to the posts rather than being set into sockets in the posts. Only the section of the rail at the west end of the railing is fixed directly into the posts.

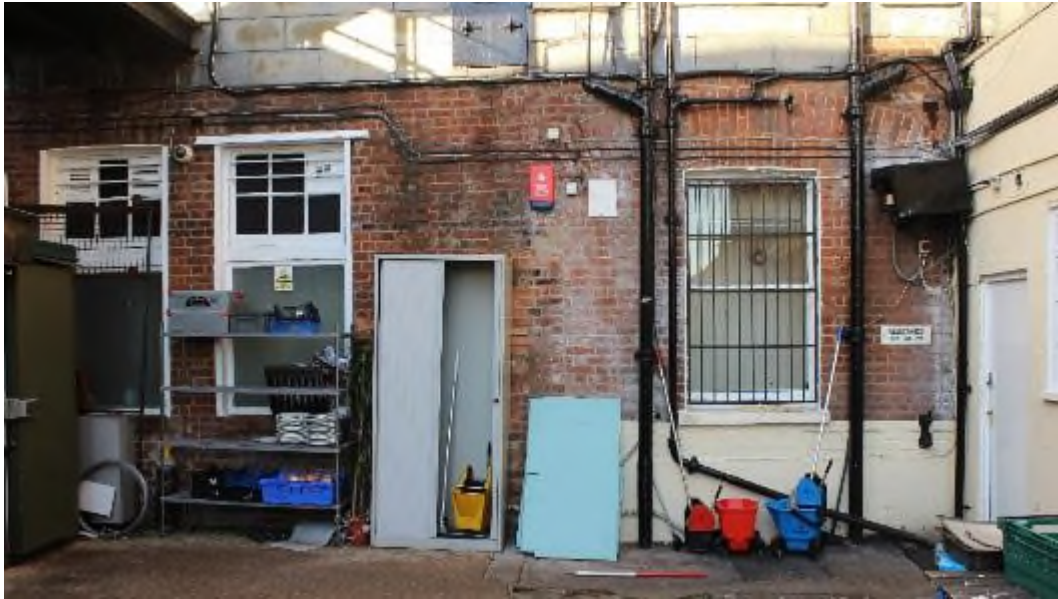
Figure 16 Rear elevation of the Oxford Street range showing the blocked carriage arch opening to the right with a two-pane sash window inserted.

- 3.3 The rear, south-facing elevation of the range facing Oxford Street has brickwork laid in Flemish bond to the ground floor with slate hanging to the remainder of the elevation topped by a moulded stucco cornice. The section of wall to the ground floor has been subject to a number of interventions. Possibly the most significant feature of this section of the elevation is the large segmental arch to a former opening was approximately 3 – 4 m wide which has now been infilled with brickwork with a window to the centre. This archway would accord to the carriage arch shown on the 1846 plan of Southampton (Figure 16). To the left of this is an area of rebuilt brickwork and an inserted window having six panes to the top light and a single pane to the lower light. To the west of this window is an original window opening but

with the same form of window and the shallow segmental brick arch. A steel staircase and walkway gives access to a fire escape at first-floor level to the west part of the elevation.

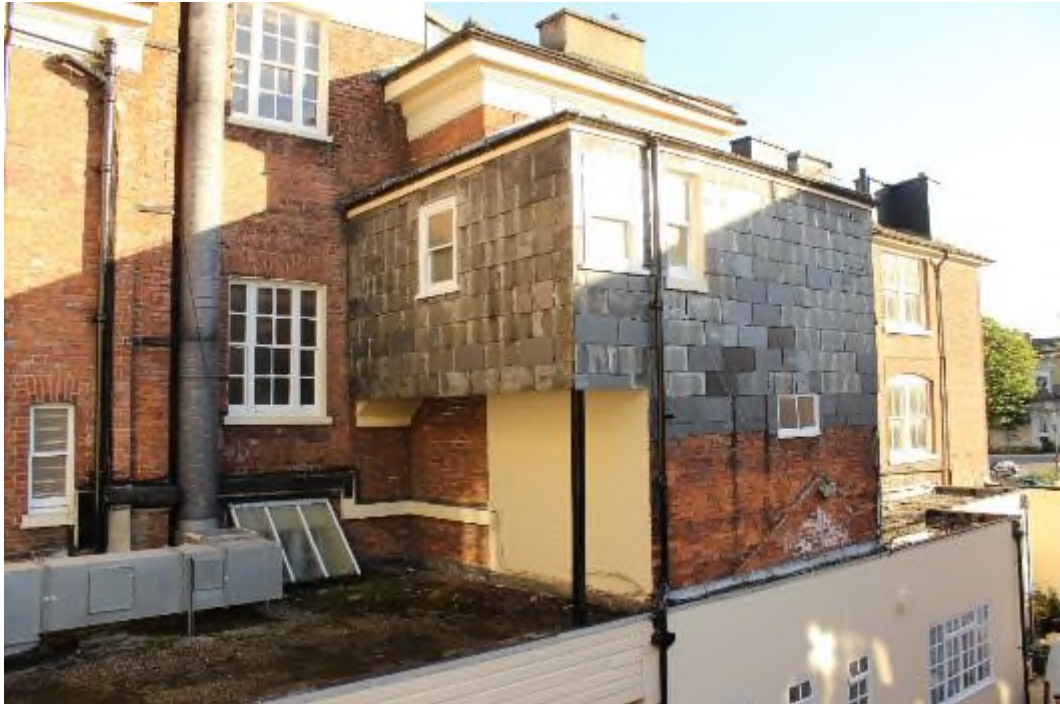
Figure 17 Rear elevation of the Terminus Terrace range, central part.

- 3.5 To the south of the stair compartment is a complex projecting element; rendered at lower level, with brick to the first floor and slate hanging to the second floor which is jettied to the north side. This element is flat-roofed but above, at third floor level is a block that projects from the line of the stair compartment elevation and has the same stucco cornice as the wall to the north of the stair compartment and a shallow hipped slate roof over. (Figure 17).

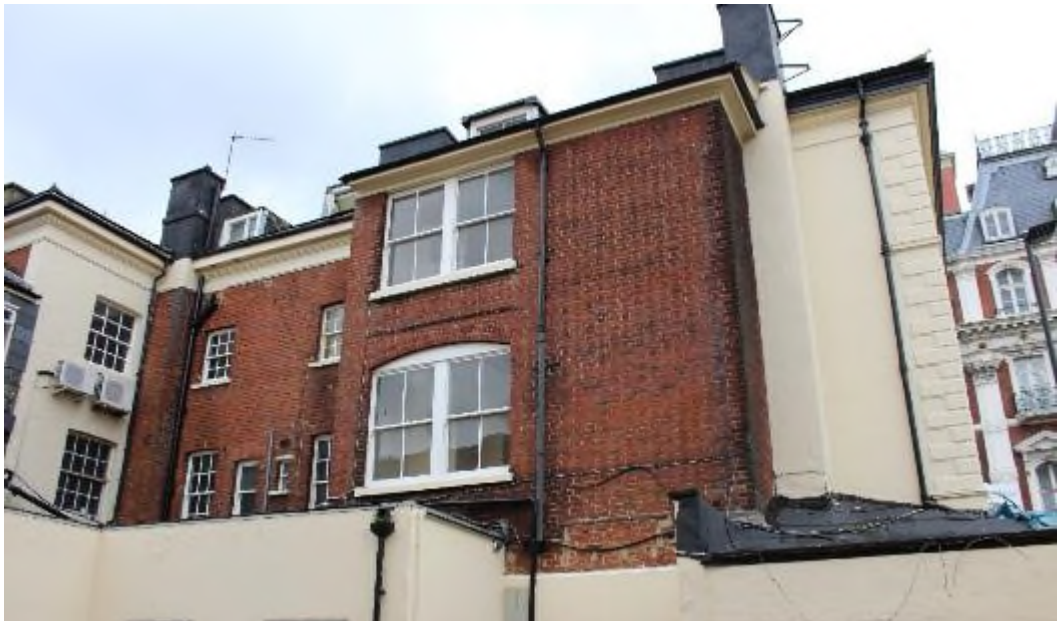
Figure 18 Rear elevation of the southern part of the Terminus Terrace range. The projecting brick element with the double sash windows is the 1907 service stair addition. The recessed brickwork to the left is the original rear elevation of the wider southern part of the building.

To the south of this projecting element is the slightly narrower part of the Terminus Terrace range along which the stucco cornice continues. The original brickwork of the building is visible between the slate hung projection and the service stair extension added in 1907. This brickwork is notably constructed in a different brick to the northern section described in 4.3, the brick being a duller, darker red colour which laid in an irregular Flemish bond in which two headers together between stretchers are used intermittently (Figure 18). At ground floor level there are flat-roofed, single storey elements with rendered elevations.

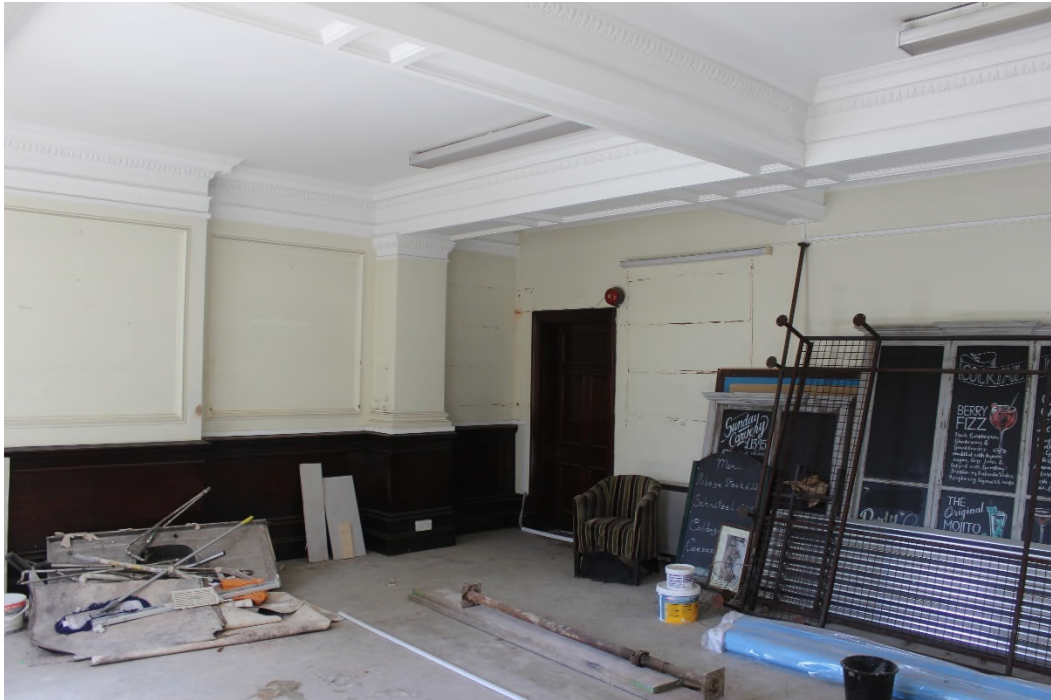
Figure 19 The southern room of the main range, facing north-west.

- 3.9 This southern room is accessed by a door in the east elevation, has one window to the east and two to the south. There is what appears to be a chimney breast on the west wall but the fireplace is blocked. The room has dark brown stained panelling to dado level, above which are large panels formed by applied bolection mouldings (Figures 19 - 21). Internal doors give access to the room to the north and a small store to the west.

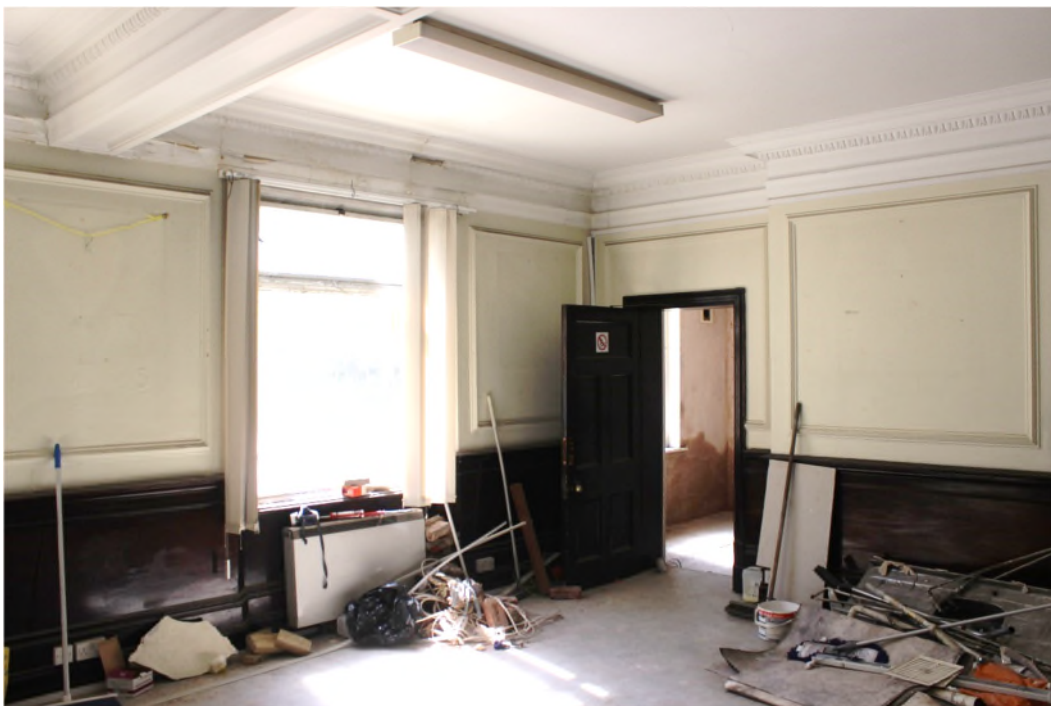
Figure 20 The southern room of the main range, facing south-west.

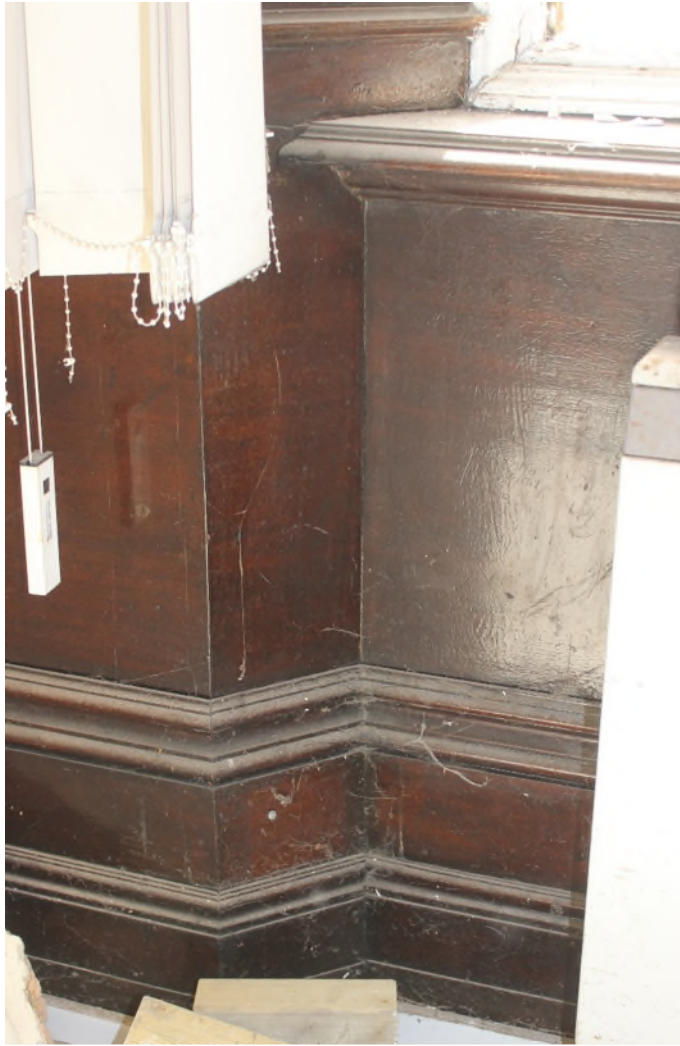
Figure 21
Detail of the panelling to
dada level and below the
windows.

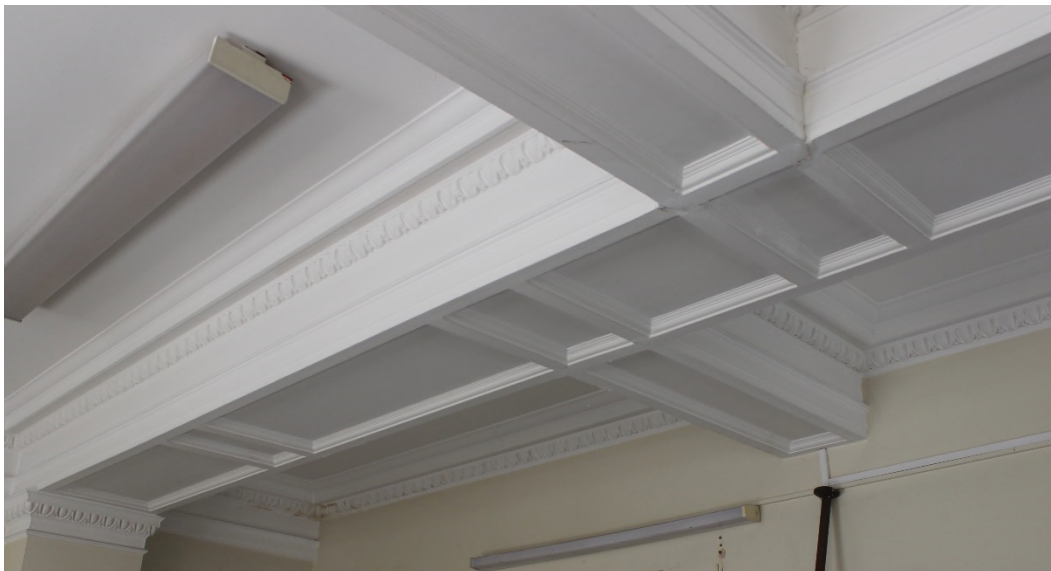
Figure 22 Detail of the downstands to the ceiling over the northern part of the southern room.

- 3.10 The ceiling of the room is divided unequally by the same form of downstands as seen throughout the ground floor, having cornices with egg and dart mouldings and panels to the soffits of the beams. The partition wall to the north of this room is not set on the line of the transverse downstand but is a little further to the north creating a rather awkward, irregular arrangement to the ceiling across the northern part of the room (Figure 22). The transverse downstand is supported by a structural column set awkwardly in front of the window in the east elevation which was added in 1907 – this position being dictated by the need to support the chimney stack at first floor and above.

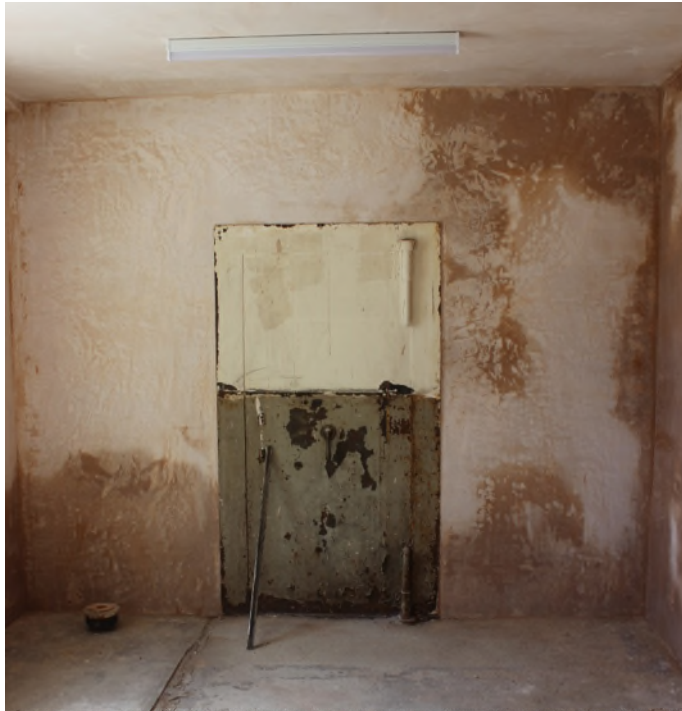
Figure 23
Former safe door within the
small room to the rear of
the southern room.

- 3.11 To the west of this room is a small store within a single-storey addition. This room has no features other than a former safe door in the west wall (Figure 23). The roof of this element has recently been replaced after collapsing and the internal wall surfaces are modern.

7.9 The small store to the west is to be used as a kitchen. Other than the safe door in the west wall, there are no features of interest in this room and the wall finishes are all modern. The bank door will remain in situ, and will, if possible, be left exposed.

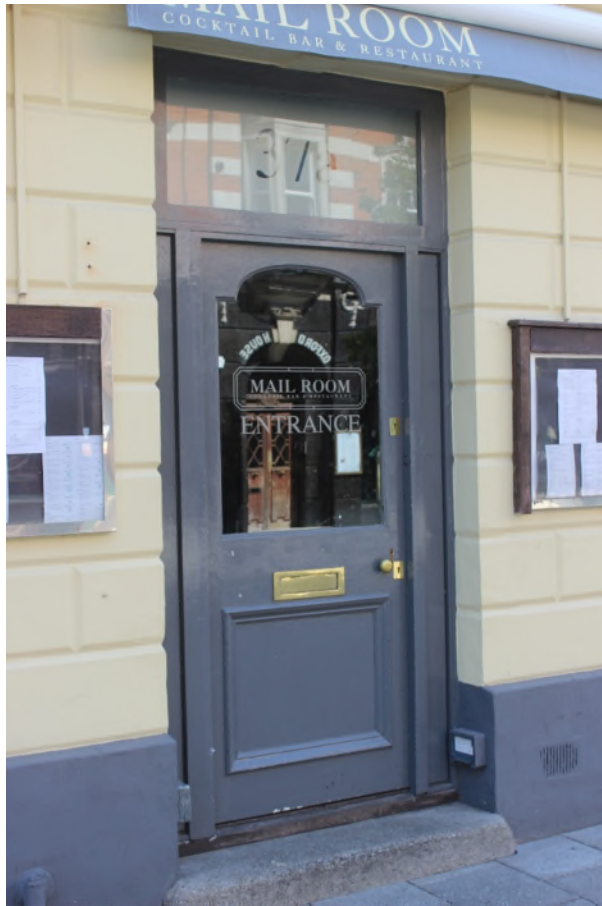
Figure 24
Inserted door replacing a window in
the north, Oxford Street elevation.

7.4 It should be noted that the ground floor elevations of Royal Mail House have been subjected to considerable levels of alteration over time as the building has been adapted to serve different uses including the blocking-up of a door to the central bay of the southern five bay part of the building, the blocking of two carriage arches, the insertion of the door in the east elevation of the southern office unit associated with its subdivision from the larger former office space that occupied the majority of the ground floor and, in more recent times, the successful insertion of a door in place of a window in the north elevation (Figure 24). A key aspect of these alterations is that they have been generally well executed and so they do not readily appear to be alterations and so, with a similar high standard of execution, it is
