Geotechnical Engineering Report

Pea Patch Property
55 Pea Patch Lane
Eastsound, Washington 98245

September 10, 2024
Project No. 24-1958

Regarding: **Geotechnical Engineering Investigation**
Pea Patch Property
55 Pea Patch Lane
Eastsound, Washington 98245
(Parcel No: 271412006000)

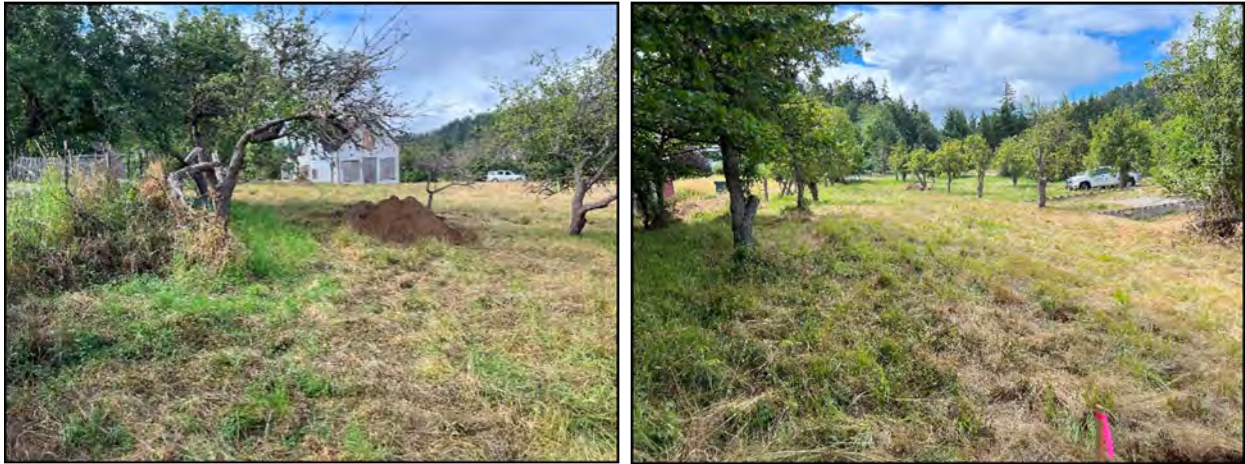
Image 1 (left) and Image 2 (right): Both images depict typical surface conditions at the project site. Note presence of well vegetated, gently sloping topography and existing residence/ concrete foundation. Both images face generally south. Image 1 was taken from near the northeast property corner. Image 2 was captured from the location of TP-4, facing south. Photos taken on July 31, 2024.

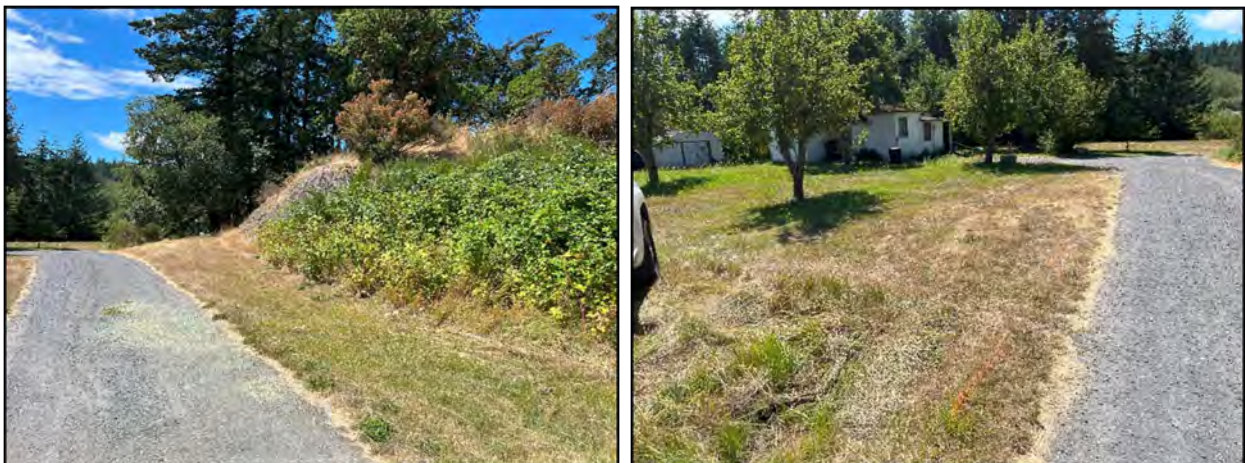
Image 3 (left) and Image 4 (right): Both images depict typical surface conditions at the project site. Note bedrock outcropping in Image 3, to the right (east) of the existing access road. From the approximate location of TP-7, Image 3 faces southeast and Image 4 faces southwest.

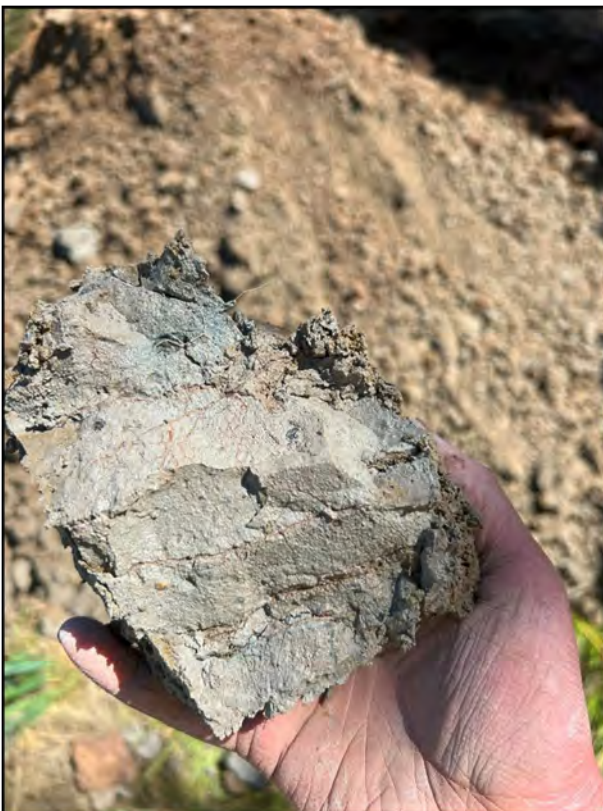
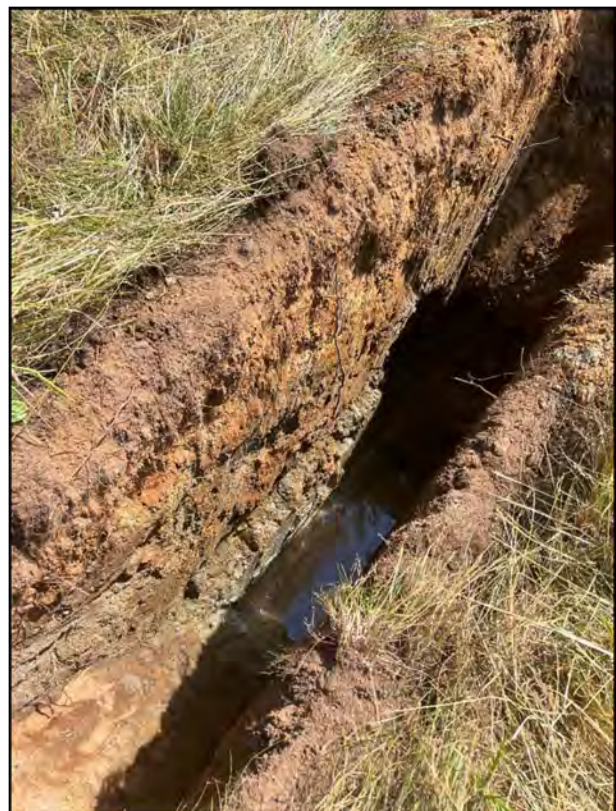
Image 5 (left) and Image 6 (right): Image 5 depicts typical blocky excavated texture and indurated character of the native undifferentiated glacial deposits as observed in the majority of our explorations. Image 6 depicts conditions in TP-11, with topsoil over weathered glacial deposits (undifferentiated) over glacial deposits (undifferentiated). Note seepage collecting in base of excavation.

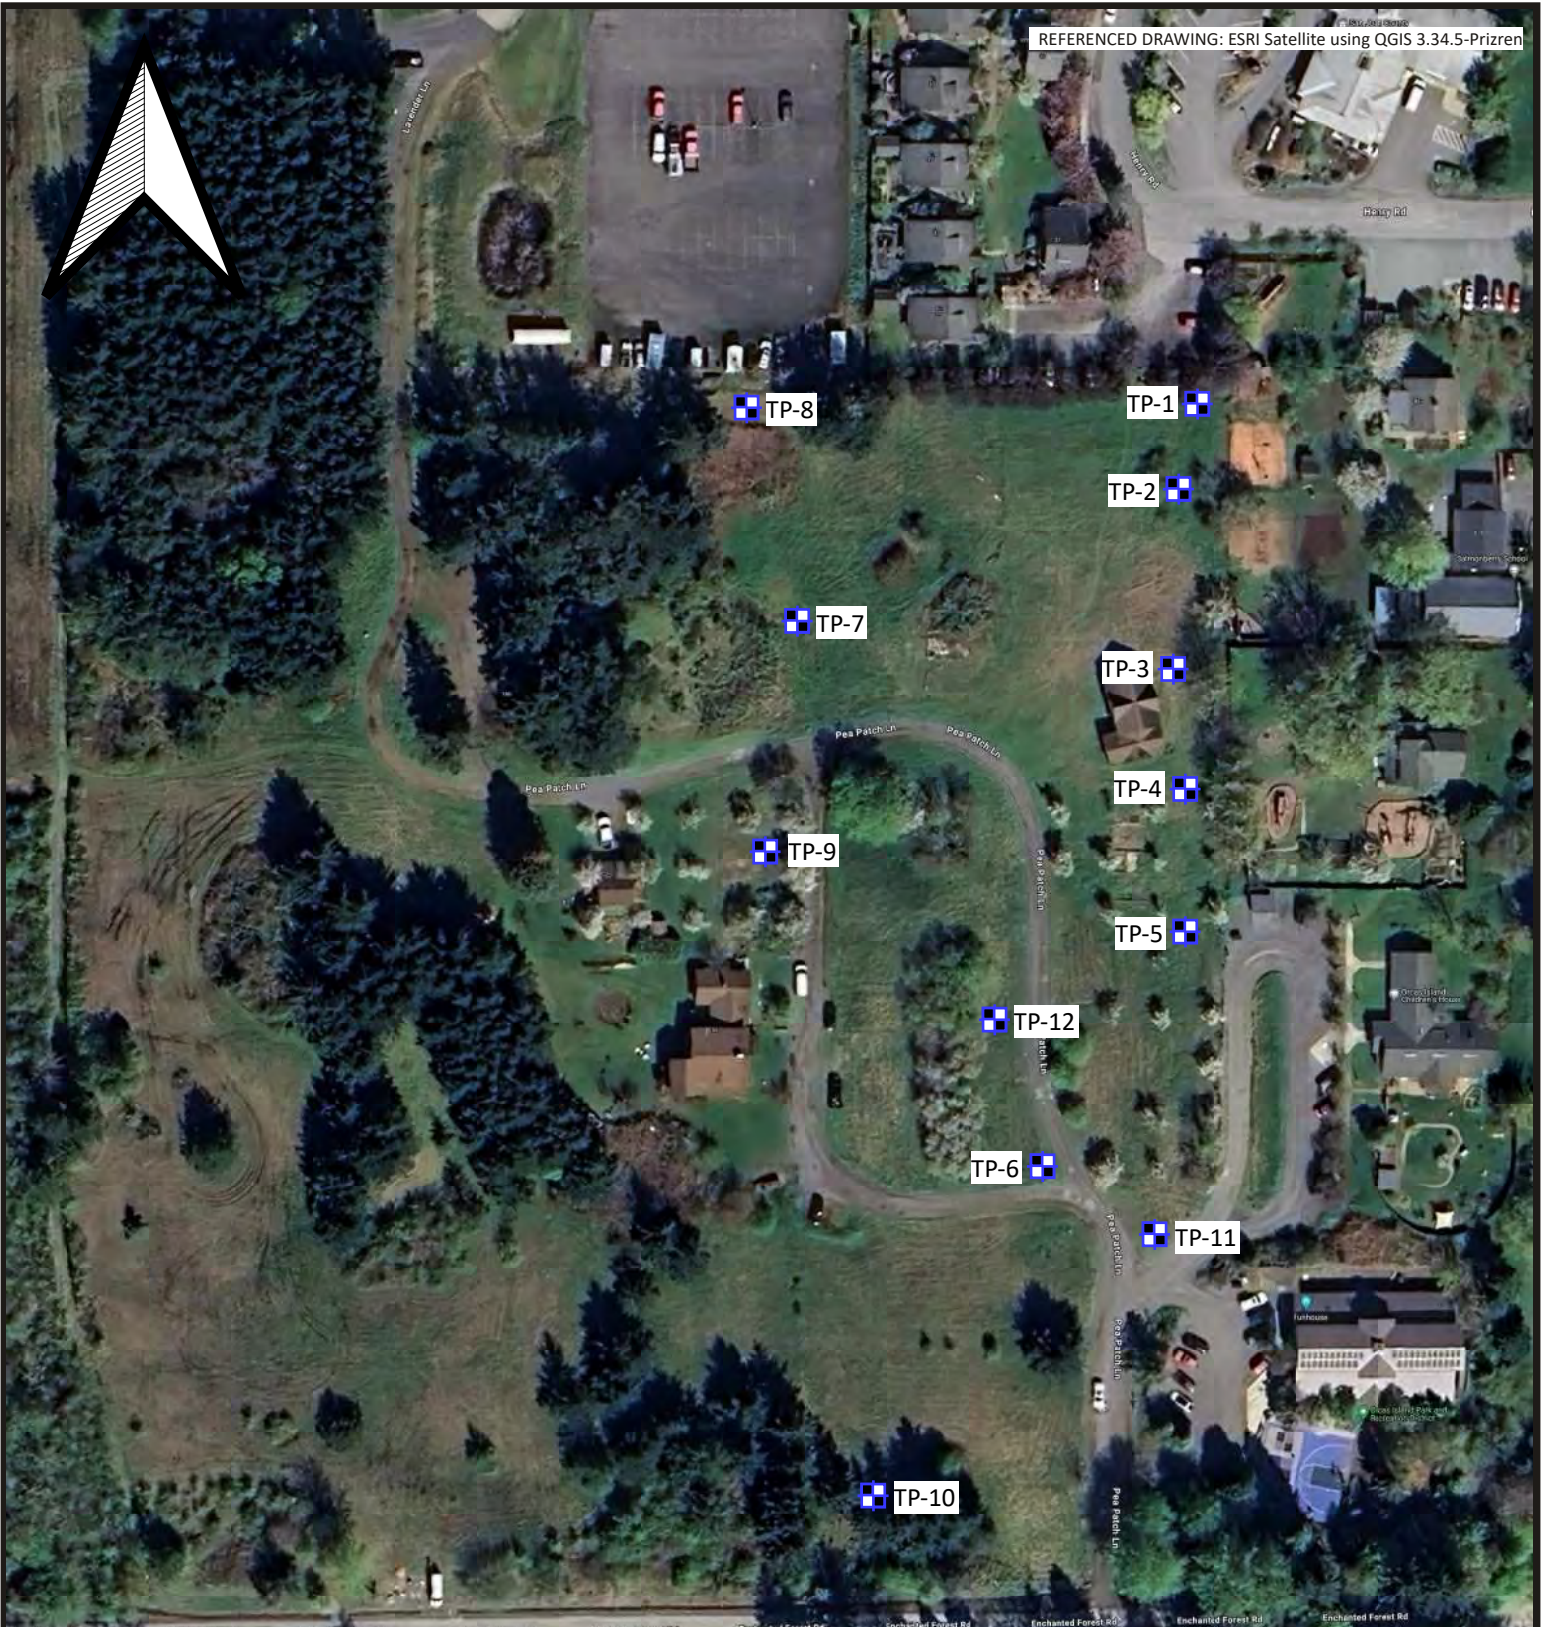
Project 24-1958
Figure 2A

TP-# = Test Pit Location
 0 75 150 ft

Date: 7-30-2024	By: JV	Scale: As Shown
SITE AND EXPLORATION PLAN PEA PATCH PROPERTY 55 PEA PATCH LANE ORCAS ISLAND, WASHINGTON

Subsurface conditions were explored by advancing 12 exploratory test pits (TP-1 through TP-12) on July 31st, 2024. Depths of the test pit explorations ranged from 6 to 8 feet below ground surface (BGS), where contact with very dense soil conditions prevented continued advancement. Due to the generally dense subsurface conditions, explorations were limited in total depth to allow for a full characterization of soil conditions across the project site overall.

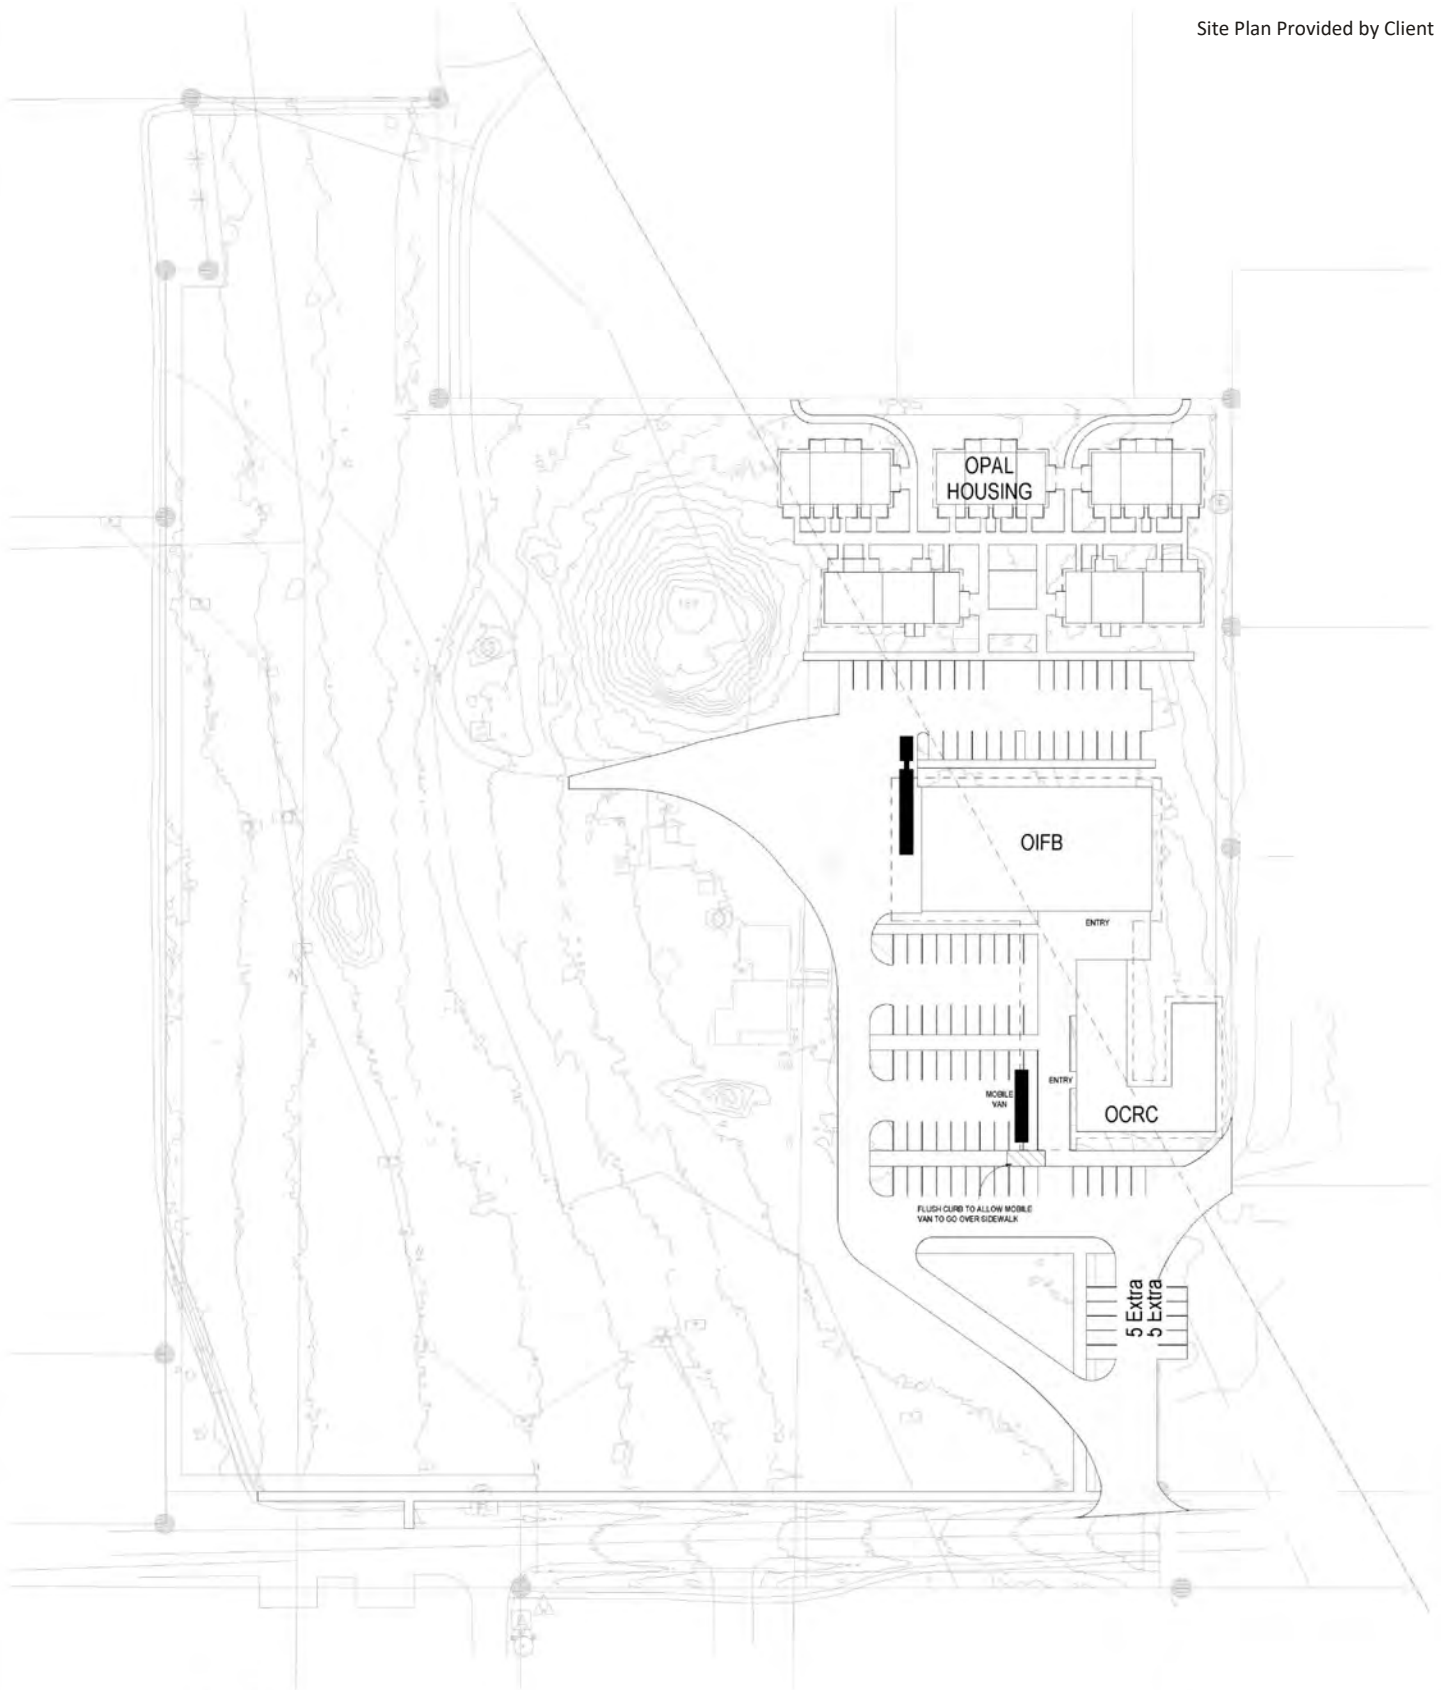
Figure
2B

1 Site Plan
1"-40'

SITE PLAN
PEA PATCH PROPERTY
55 PEA PATCH LANE
ORCAS ISLAND, WASHINGTON

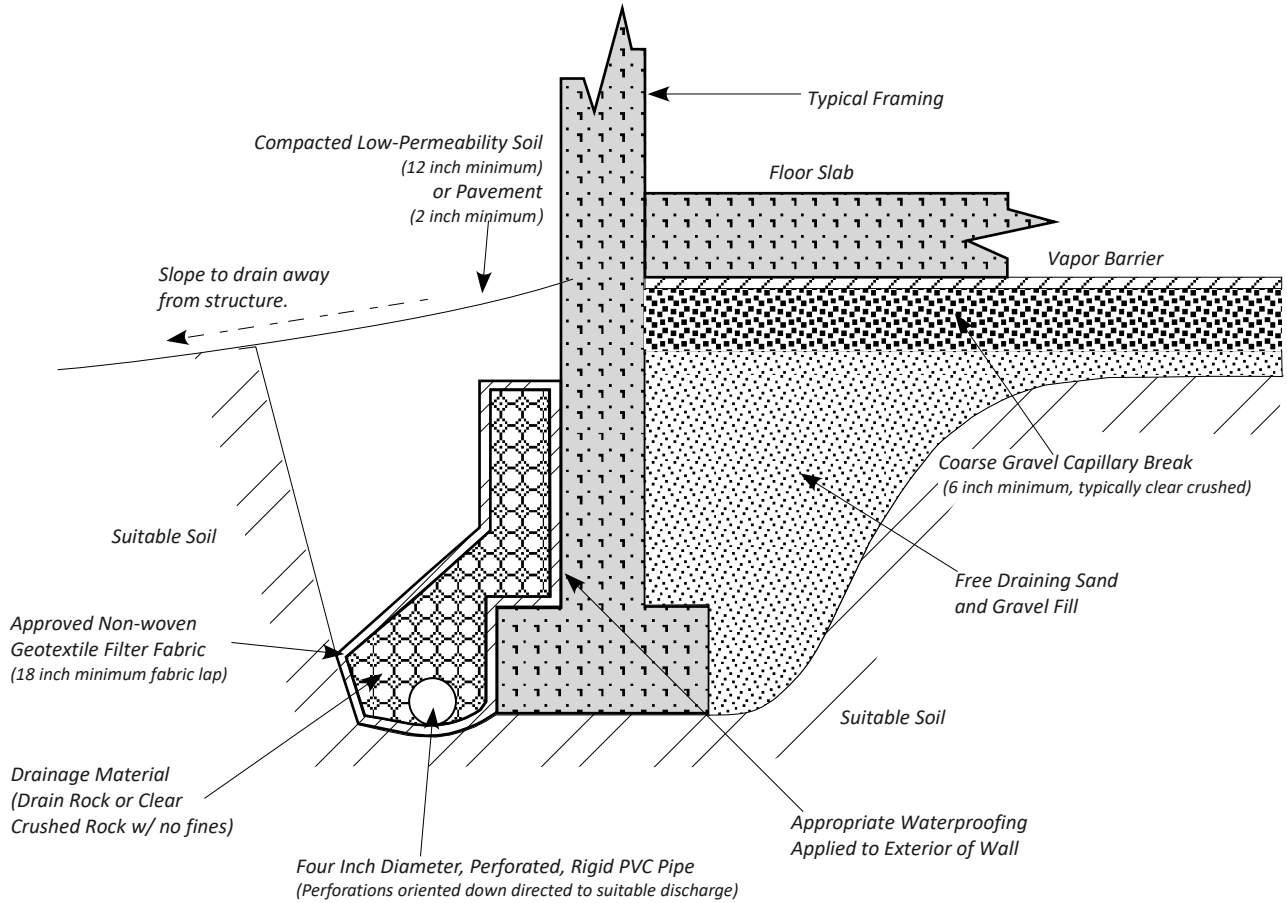
Figure
4A

CONCEPTUAL FOOTINGS WITH INTERIOR SLAB-ON-GRADE

Footings should be properly buried for frost protection in accordance with International Building Code or local building codes (Typically 18 inches below exterior finished grades).

Continuous and isolated spread footings should be founded 18 inches, minimum, below the lowest adjacent final grade for freeze/thaw protection. The footings should be sized in accordance with the structural engineer's prescribed design criteria and seismic considerations.

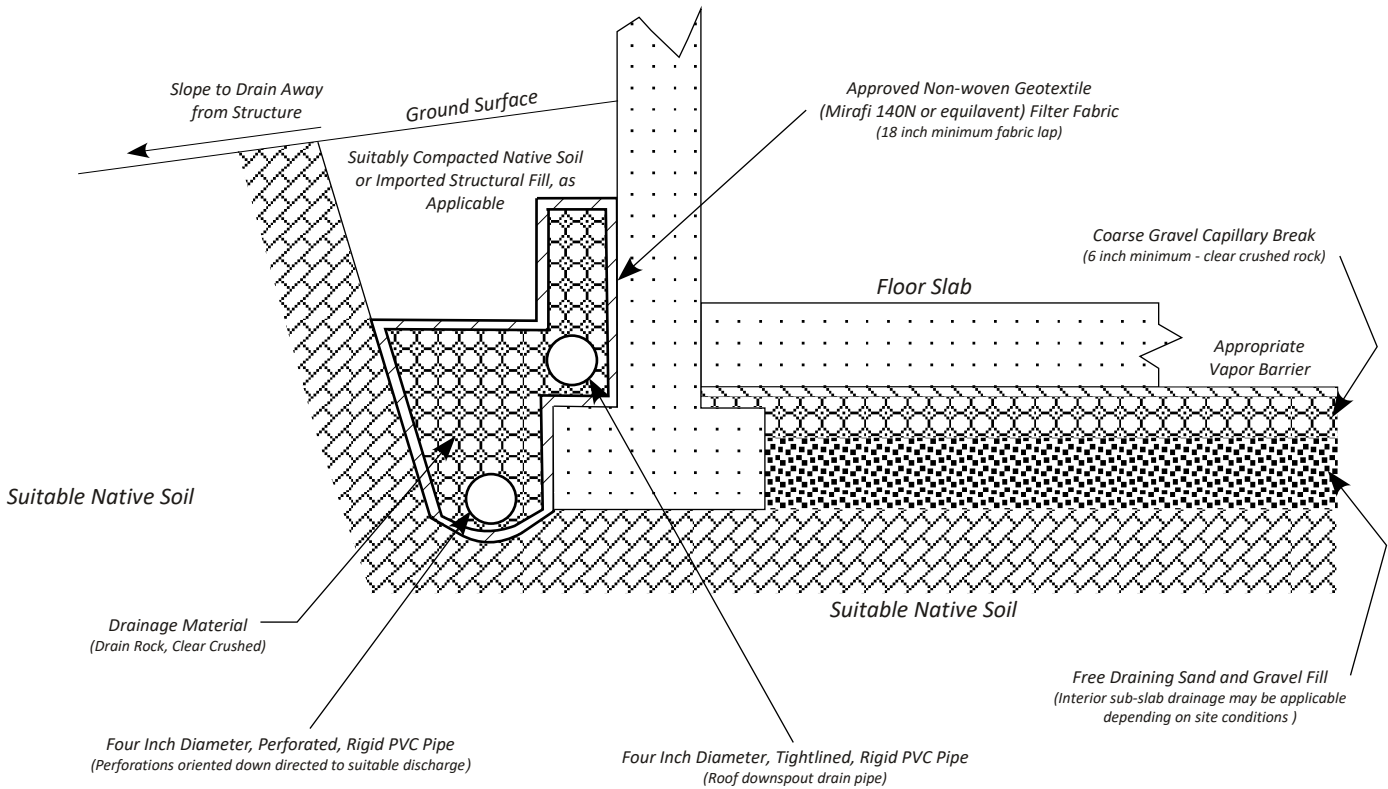
CONCEPTUAL SHALLOW FOOTINGS WITH INTERIOR SLAB-ON-GRADE AND DOWNSPOUT DRAIN

Footings should be properly buried for frost protection in accordance with International Building Code or local building codes (Typically 18 inches below exterior finished grades).

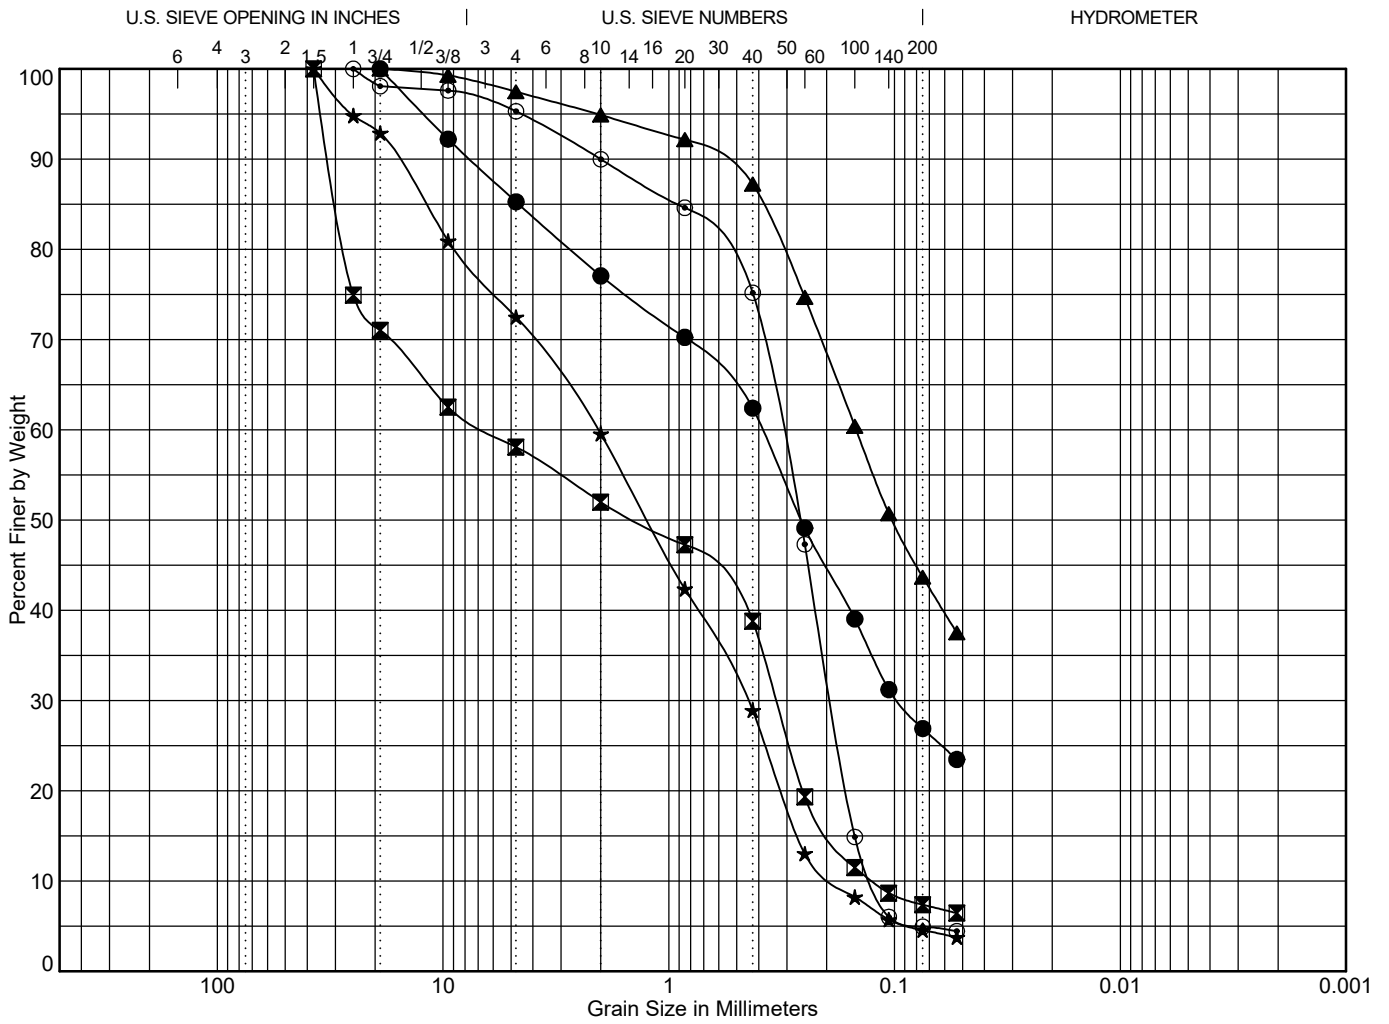
Figure
12

Point	Depth	D ₉₀	D ₆₀	D ₅₀	D ₃₀	D ₁₀	% Coarse Gravel	% Fine Gravel	% Coarse Sand	% Medium Sand	% Fine Sand	% Fines
● TP-1	3.8	7.621	0.386	0.259	0.096		0.0	14.7	8.2	14.7	35.5	26.9
☒ TP-3	6.0	31.898	6.405	1.395	0.334	0.125	29.0	12.9	6.1	13.2	31.4	7.4
▲ TP-5	4.0	0.627	0.148	0.102			0.0	2.5	2.6	7.7	43.6	43.7
★ TP-7	3.0	16.078	2.061	1.243	0.45	0.181	7.1	20.4	12.9	30.6	24.3	4.6
◎ TP-8	2.5	2.006	0.318	0.263	0.19	0.124	1.9	2.8	5.3	14.8	70.2	4.9

Grain Size Test Data

Test pit explorations consisted of the excavation of shallow open pits with the use of a subcontracted excavator, under the direction of a GeoTest Staff Geologist. Select grab samples were obtained based on the encountered changes in soil stratum. Soil classification followed the guidelines of the American Society for Testing and Materials (ASTM) D2487 and D2488. Approximate locations of our explorations have been plotted on the *Site and Exploration Plan* (Figure 2A). A *Soil Classification System Key* can be found as Figure 5 and detailed test pit logs can be found as Figures 6 through 10 and the associated laboratory test results presented as figures 12 through 14.

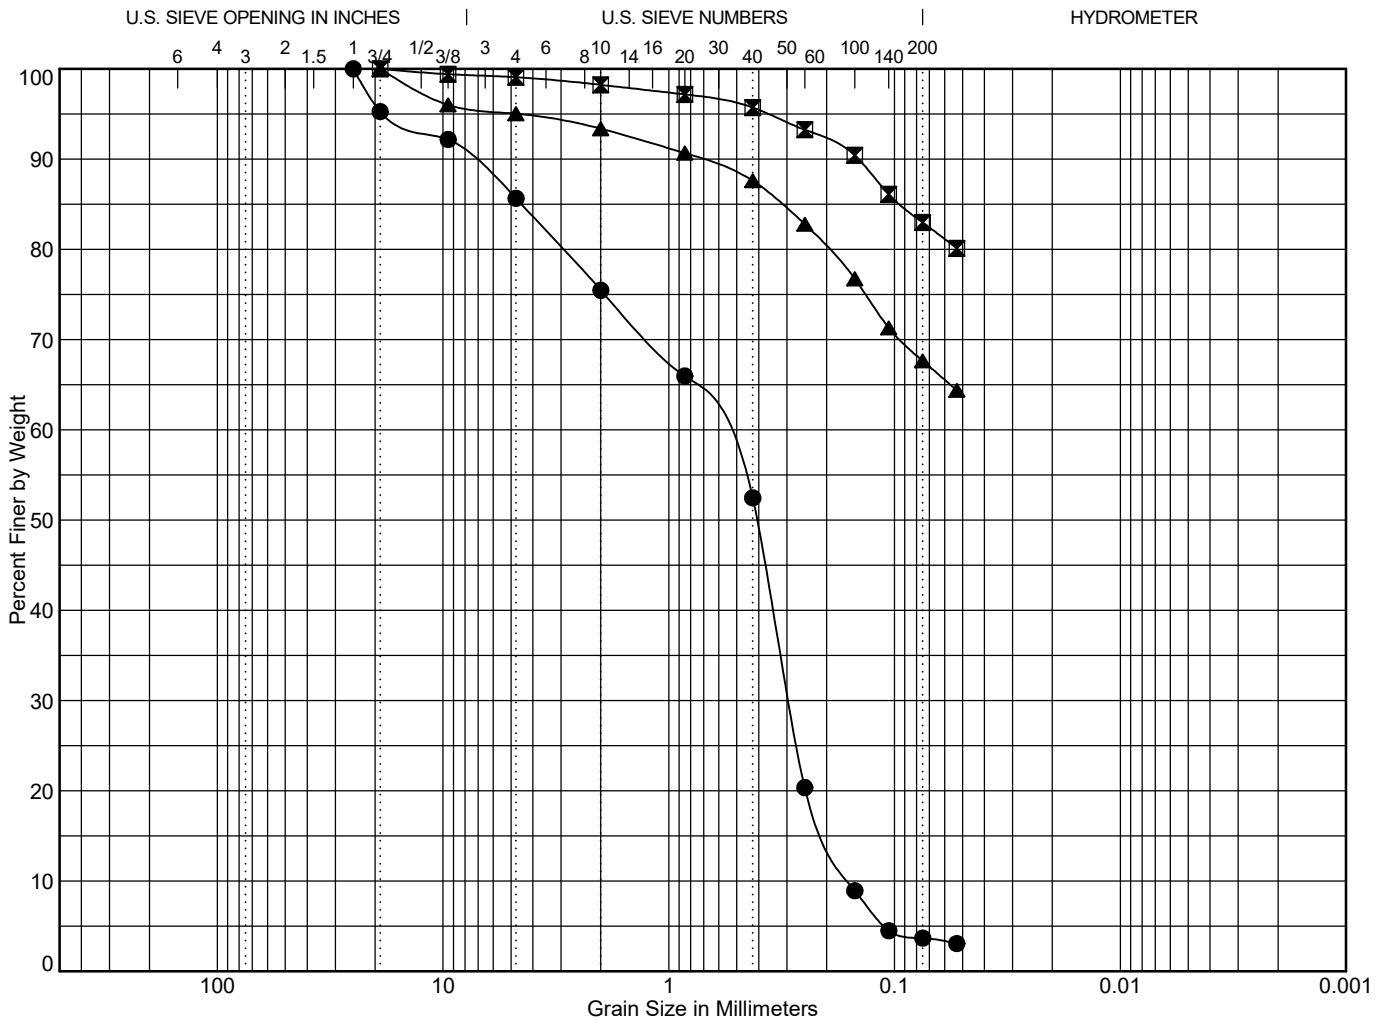
Figure
13

Point	Depth	Classification	LL	PL	PI	C _c	C _u
●	TP-9	3.0	Gravelly SAND (SP)			0.87	3.98
☒	TP-9	9.3	Sandy CLAY (CL)				
▲	TP-10	3.0	Slightly gravelly, sandy SILT (ML)

Grain Size Test Data

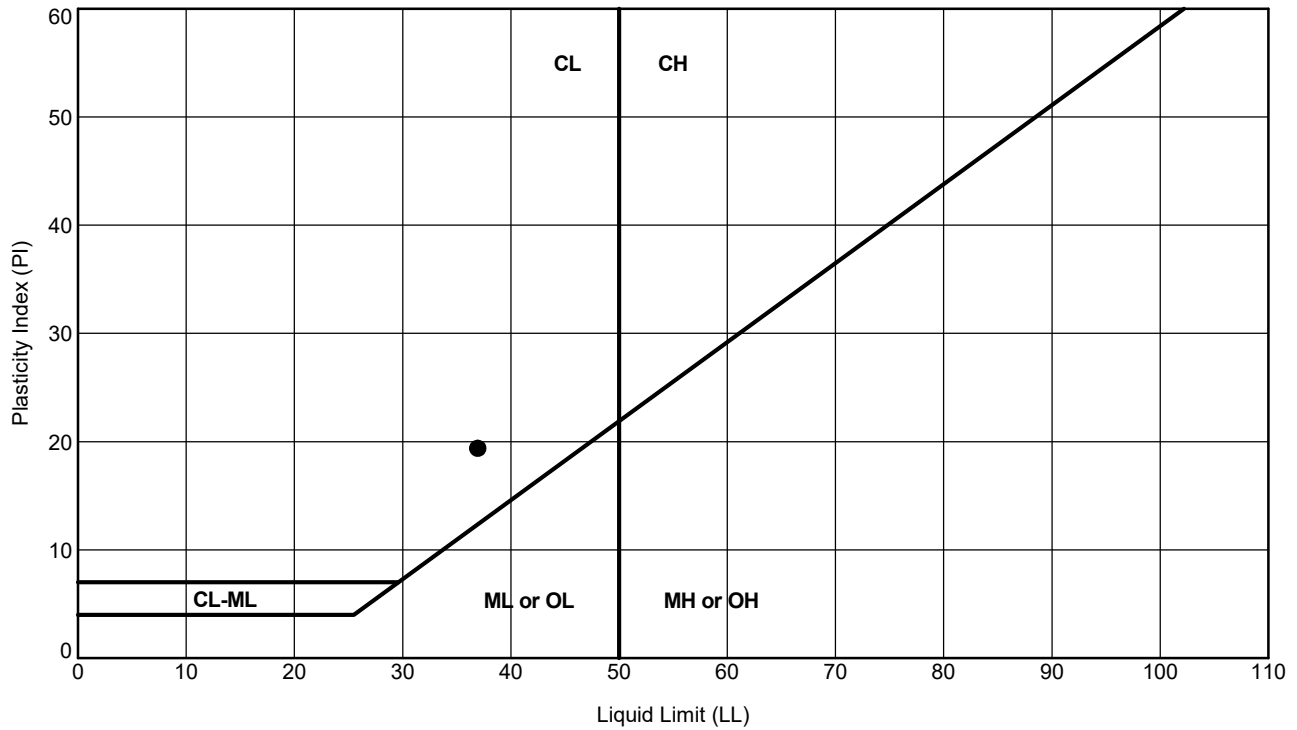
ATTERBERG LIMIT TEST RESULTS

Symbol	Exploration Number	Sample Number	Depth (ft)	Liquid Limit (%)	Plastic Limit (%)	Plasticity Index (%)	Natural Moisture (%)	Soil Description	Unified Soil Classification
●	TP-9	33	6.0	37	18	19		Sandy CLAY	CL
