Inspection Report

KMI Home Inspections, Inc.

Date: 4/9/2025	Time: 09:00 AM	Report ID:
Property: [REDACTED]	Customer: [REDACTED]	Real Estate Professional:

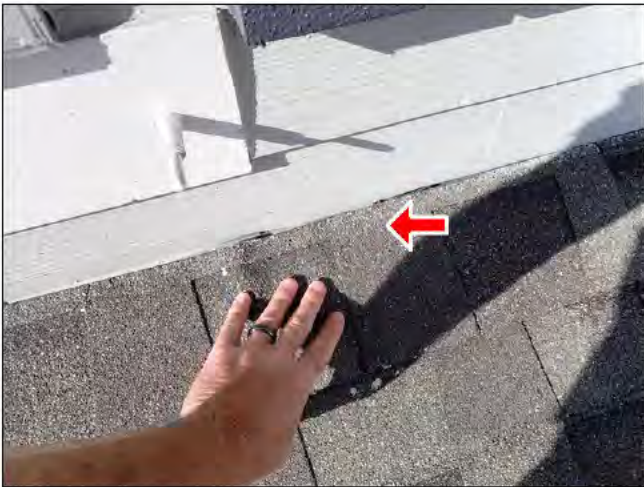
1.0 Item 1(Picture)

1.0 Shingles are holding water near the flashing below the windows on the second story at the front of the home. Recommend correct as needed from a qualified contractor. Several shingles are damaged or missing granuals at the front and left side of the home. Recommend repair as needed from a qualified contractor. Multiple roof anchor points are in place around the upper perimeter of the roof. Recommend remove as needed.

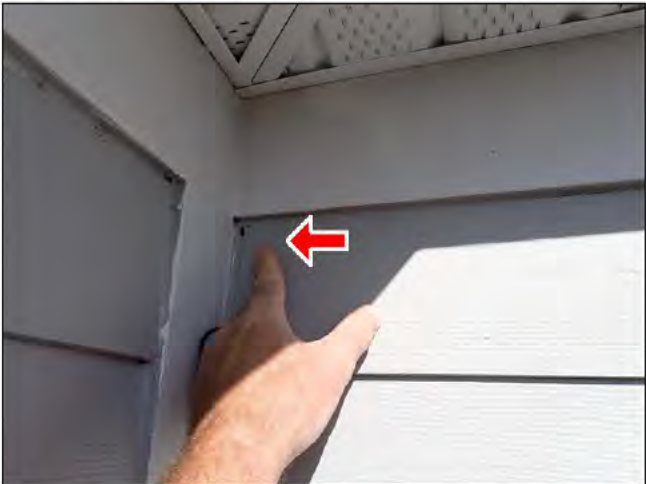
2.0 Item 1(Picture)

2.0 Several areas around the perimeter of the home have gaps in the caulking at end joints of siding, around windows and trim junctions. Recommend seal as needed from a qualified contractor. Multiple nail head penetration points are exposed and need sealing to prevent damage to the siding at various areas around the perimeter of the home. Recommend seal as needed from a qualified contractor.

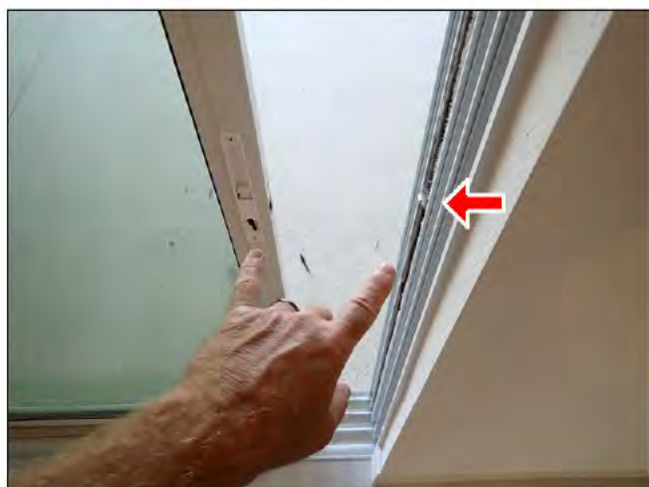
2.1 Item 1(Picture)

2.1 (1) Sliding glass door at the living room has a dented lock enclosure and needs repair to operate properly. Recommend repair as needed from a qualified contractor.

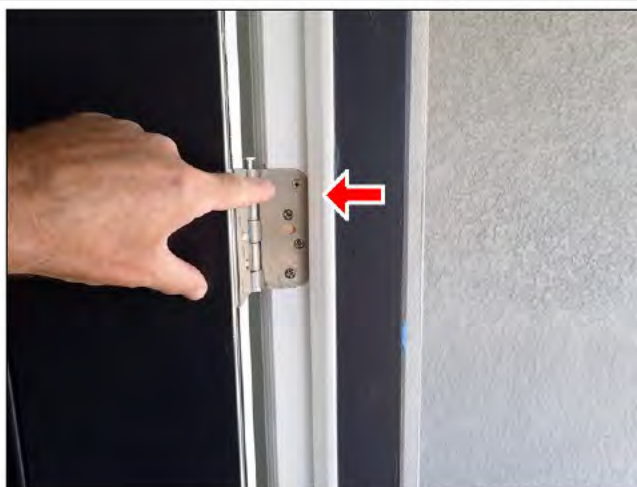
2.1 Item 3(Picture)

2.1 (2) Front entry door is missing a permanent fastener at one hinge to the block structure. Recommend installing missing fastener as needed.

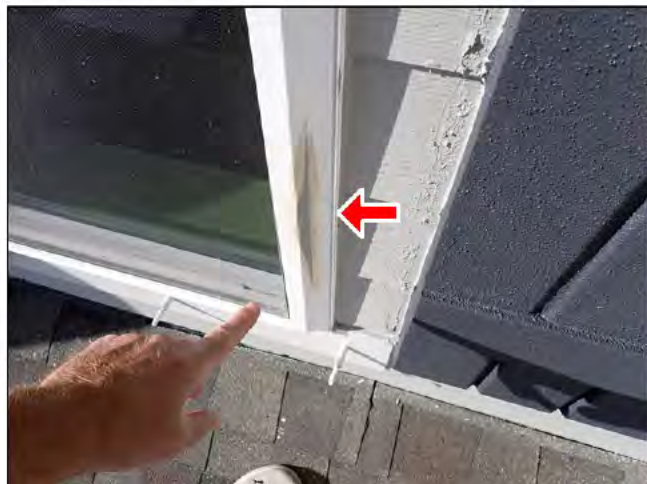
2.2 Item 1(Picture)

2.2 (1) Several windows at the upper level of the home have excessive paint on the frames. Recommend clean as needed.

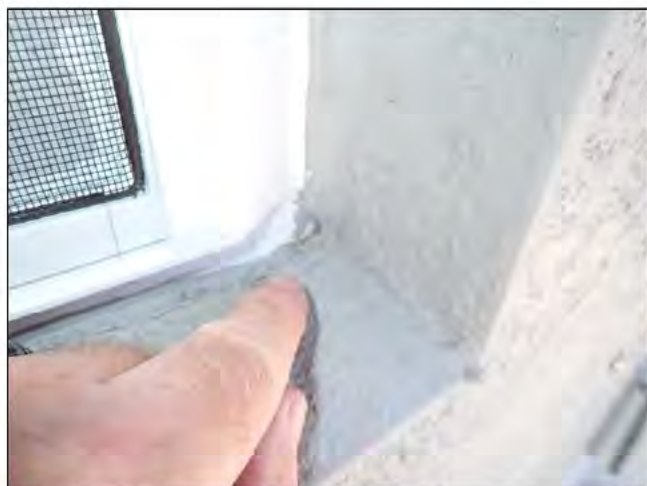
2.2 Item 3(Picture)

2.2 (2) Several windows around the perimeter of the home have areas of loose or missing caulk. Recommend seal as necessary from a qualified contractor to prevent moisture intrusion at these locations.

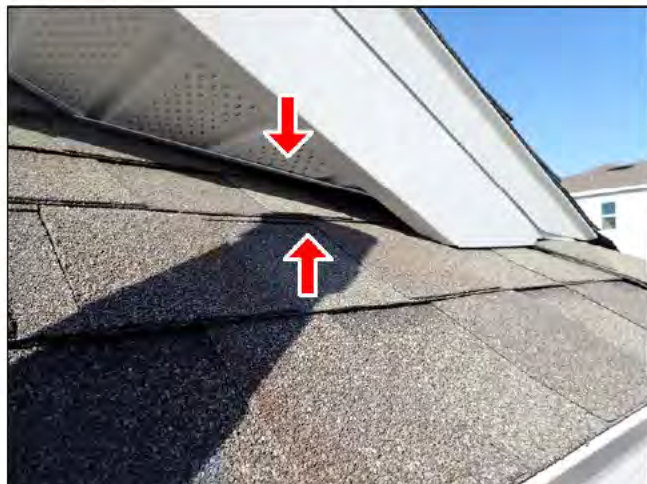
2.5 Item 1(Picture)

2.5 Gaps are present in the soffit areas above the garage at the gable ends. These gaps are large

enough for pests to enter these locations. Recommend seal or correct as needed from a qualified contractor.

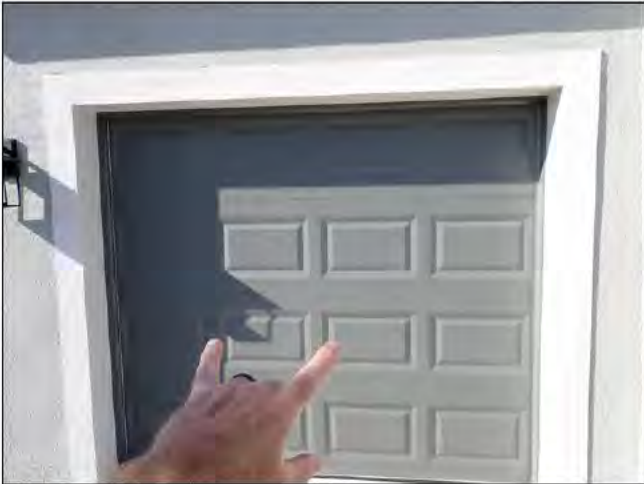
3.3 Item 1(Picture)

3.3 Single garage door at the front of the home is missing the decorative hinges and does not have the garage door opener hooked up. Recommend correct as needed from a qualified contractor.

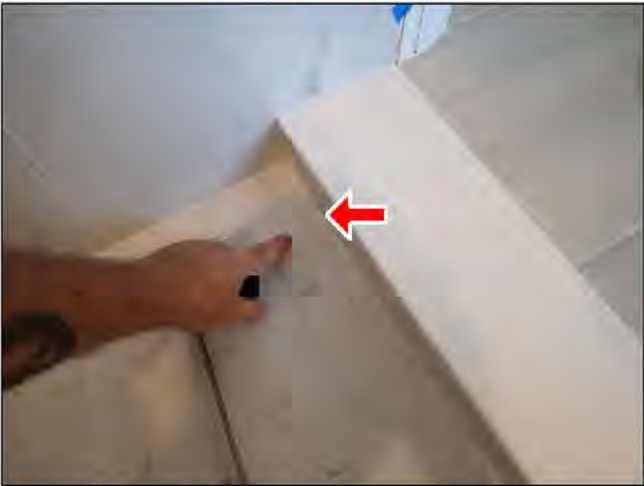
4.2 Item 1(Picture)

4.2 One floor tile is raised at the master bath shower near the right side entry. Recommend correct or adjust as needed.

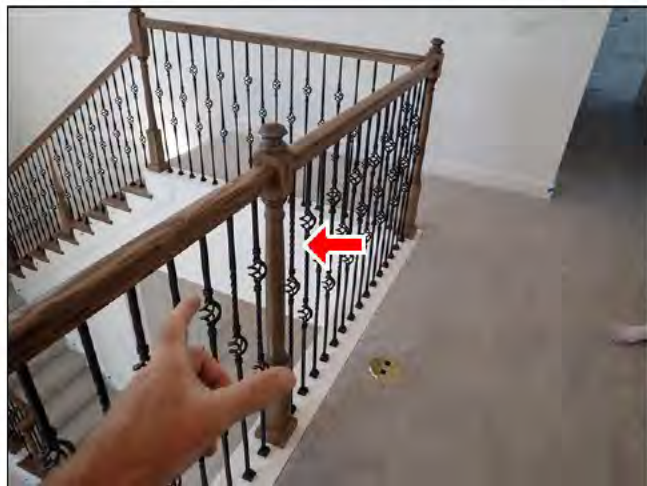
4.3 Item 1(Picture)

4.3 Several posts for the stairs leading to the second floor are loose and need securing. Recommend securing as needed form a qualified contractor.

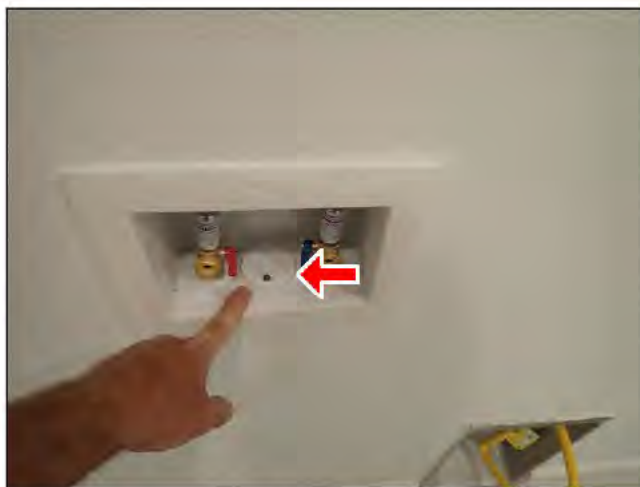
6.0 Item 1(Picture)

6.0 Drain line for the clothes washer needs the drain cap removed prior to clothes washer installation. Recommend remove cap as needed.

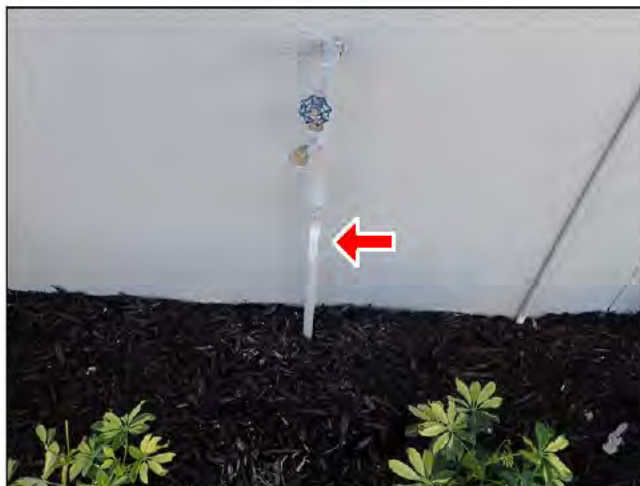
6.3 Item 1(Picture)

6.3 The main shut off is the white lever located outside on the right side of the home (see photo). This is for your information.

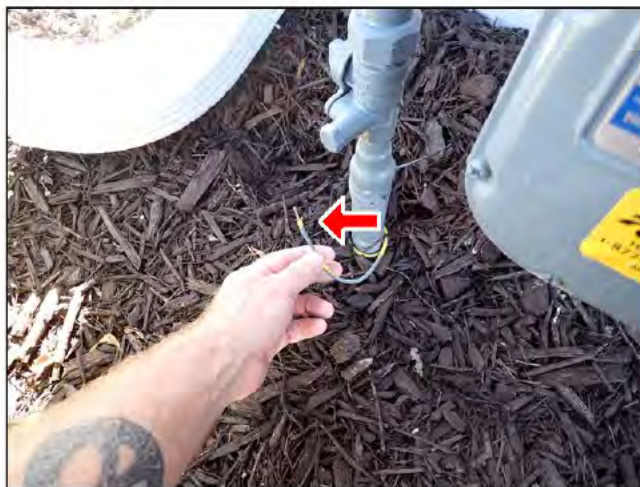
6.4 Item 1(Picture)

6.4 (1) Loose wire end is present at the base of the gas pipe below the gas meter at the right side of the home. Purpose of this is unknown. Recommend correct as needed from a qualified contractor.

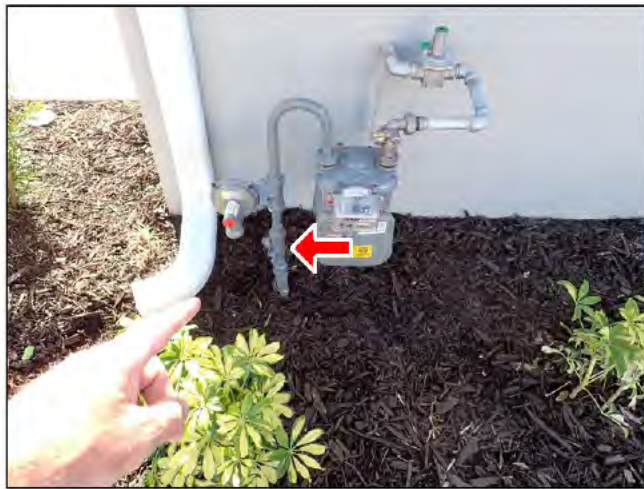
6.5 Item 1(Picture)

6.5 The main fuel shut off is at the gas meter outside on the right side of the home (for your information).

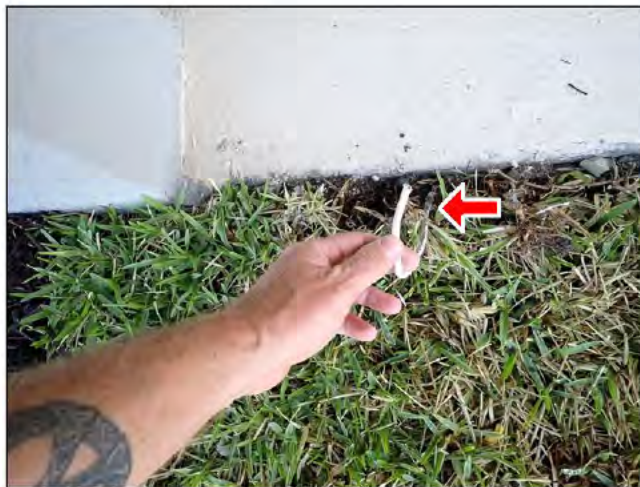
7.3 Item 1(Picture)

7.3 (1) Loose low voltage wire is present at the rear of the home in the ground near the patio. Purpose of this is unknown. Recommend proper termination from a qualified contractor.

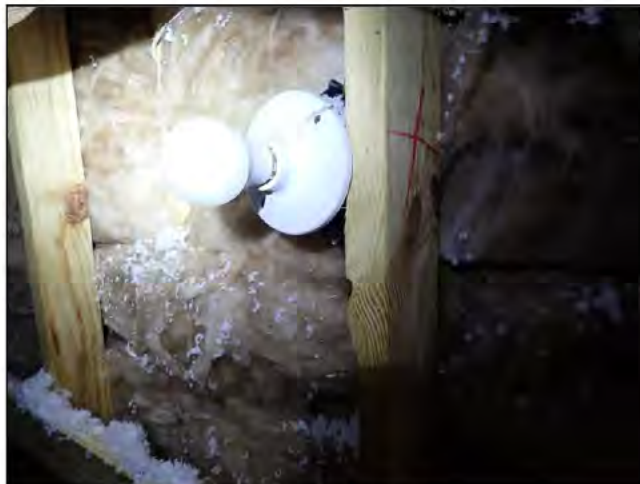
7.3 Item 2(Picture)

7.3 (2) Attic light in the upstairs hall attic access did not work when tested. Recommend correct as needed from a qualified electrical contractor.

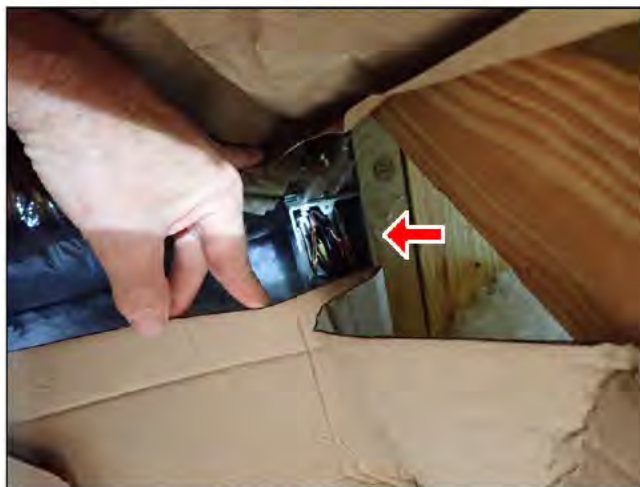
7.3 Item 3(Picture)

7.3 (3) Attic light at the upstairs hall attic access is missing a switch to operate. Recommend a licensed electrical contractor correct as needed.

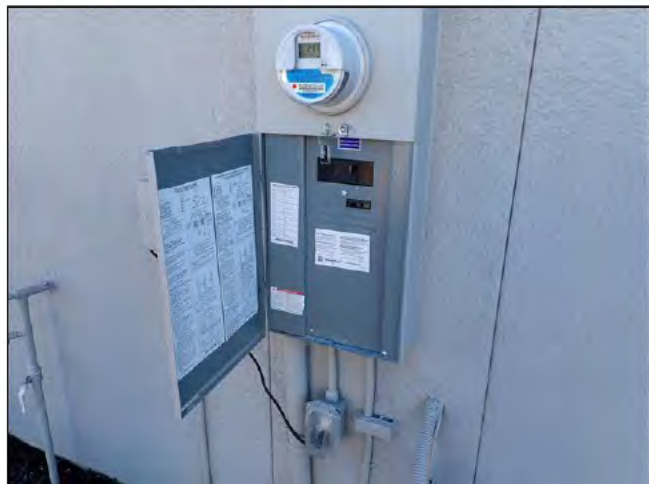
7.7 Item 1(Picture)

7.7 The main shut-off is located outside on the right side of the home near the meterbase. The main distribution panel is located in the garage (for your information).

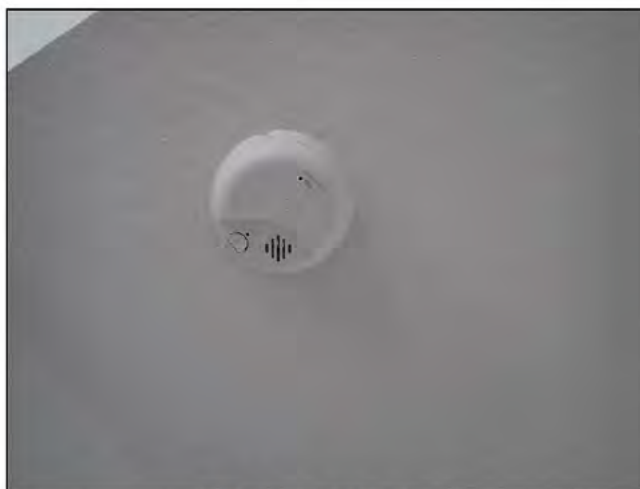
7.8 Item 1(Picture)

7.8 Smoke detectors are present and should be tested upon moving into the home.

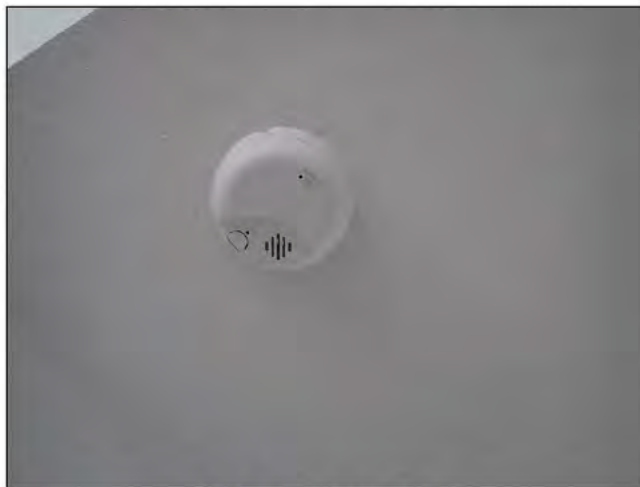
7.9 Item 1(Picture)

7.9 Carbon monoxide detector is present and should be tested upon moving into the home.

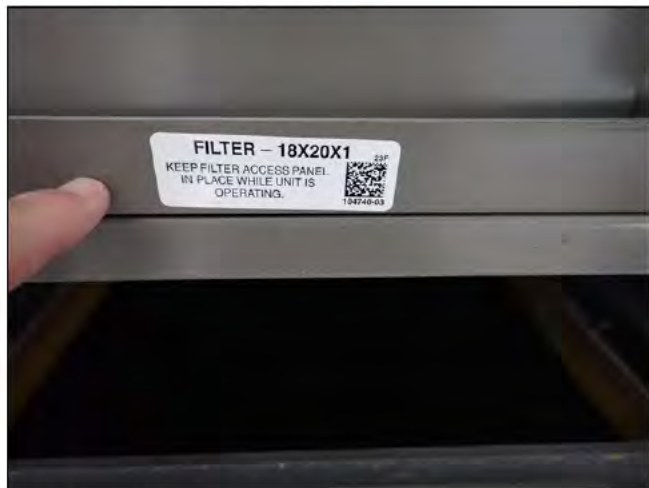
8.3 Item 1(Picture)

8.3 (1) Filter location (see photo)

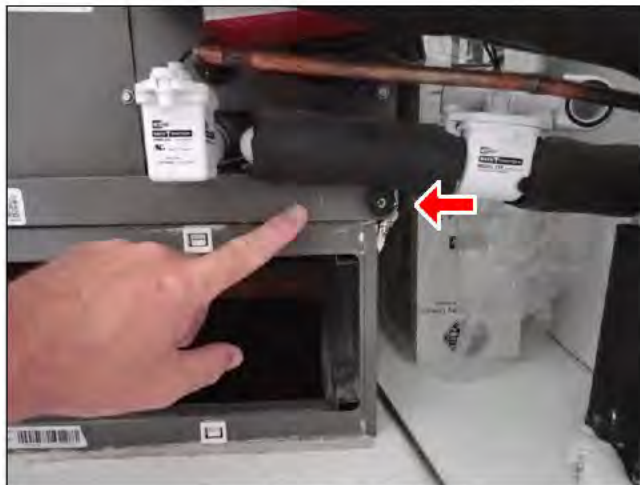
8.3 Item 5(Picture)

8.3 (2) Filter cover at the upstairs air handler is difficult to remove and install. Recommend correct as needed.

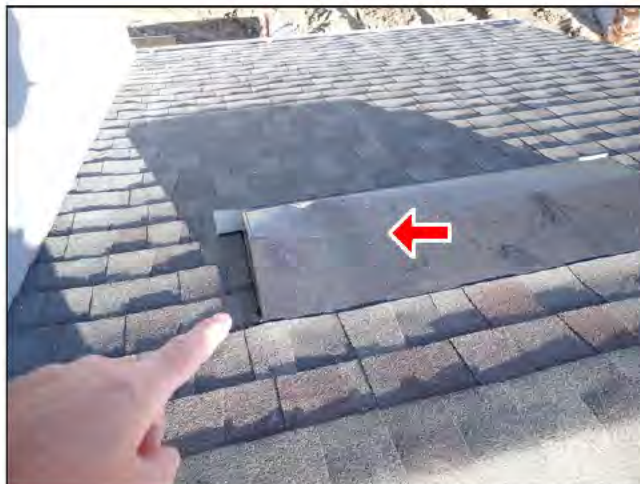
9.3 Item 1(Picture)

9.3 Off ridge roof vent at the front of the home above the garage is dented or damaged. Recommend repair as needed from a qualified contractor.

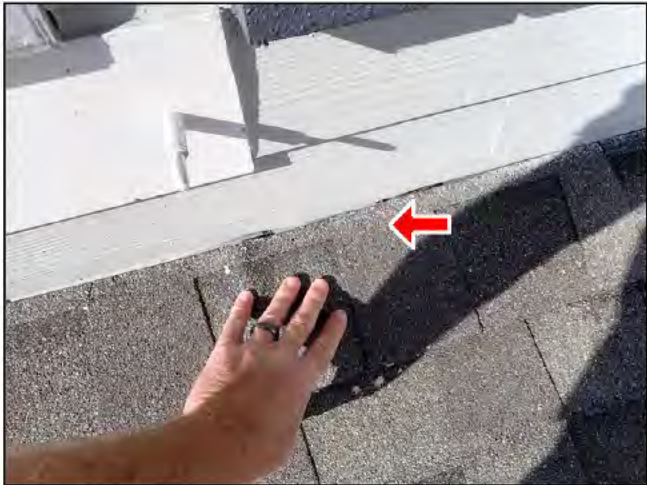
1.0 Item 1(Picture)

Shingles are holding water near the flashing below the windows on the second story at the front of the home. Recommend correct as needed from a qualified contractor. Several shingles are damaged or missing granules at the front and left side of the home. Recommend repair as needed from a qualified contractor. Multiple roof anchor points are in place around the upper perimeter of the roof. Recommend remove as needed.

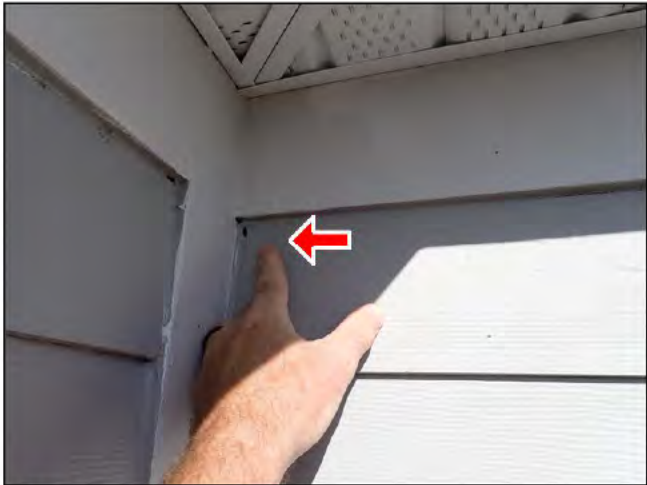
2.0 Item 1(Picture)

Several areas around the perimeter of the home have gaps in the caulking at end joints of siding, around windows and trim junctions. Recommend seal as needed from a qualified contractor. Multiple nail head penetration points are exposed and need sealing to prevent damage to the siding at various areas around the perimeter of the home. Recommend seal as needed from a qualified contractor.

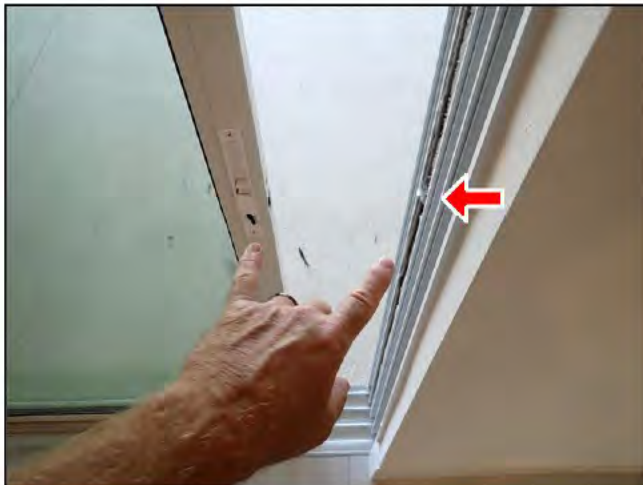
2.1 Item 1(Picture)

(1) Sliding glass door at the living room has a dented lock enclosure and needs repair to operate properly. Recommend repair as needed from a qualified contractor.

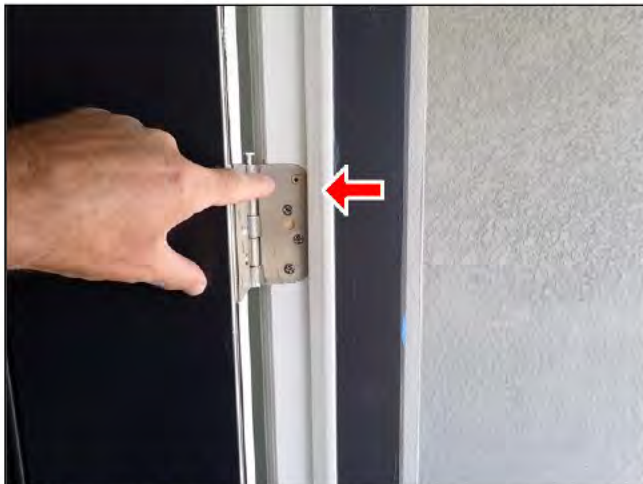
2.1 Item 3(Picture)

(2) Front entry door is missing a permanent fastener at one hinge to the block structure. Recommend installing missing fastener as needed.

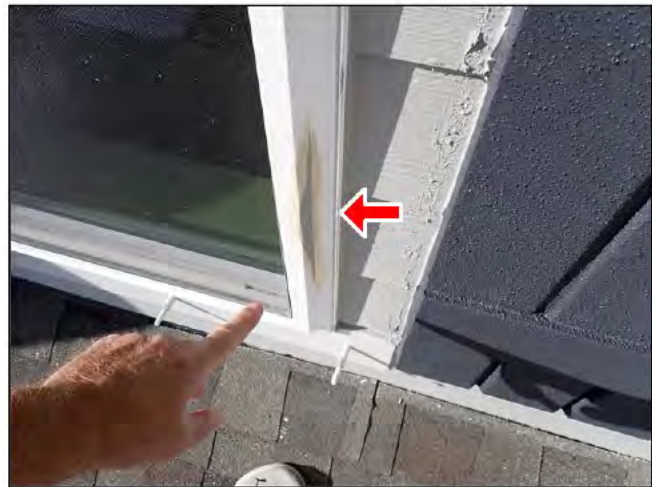
2.2 Item 1(Picture)

(1) Several windows at the upper level of the home have excessive paint on the frames. Recommend clean as needed.

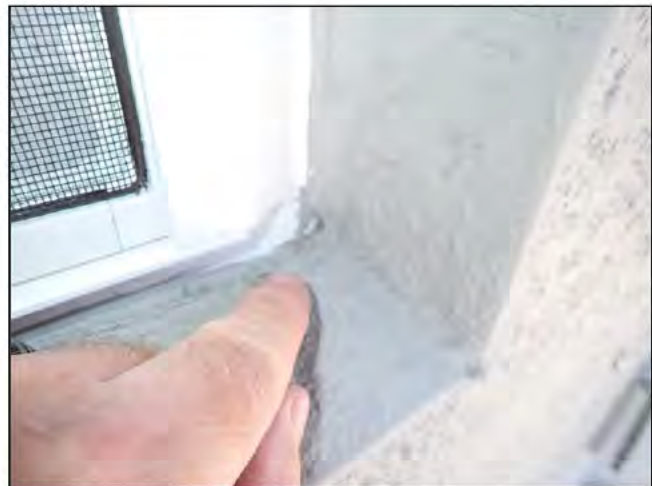
2.2 Item 3(Picture)

(2) Several windows around the perimeter of the home have areas of loose or missing caulk. Recommend seal as necessary from a qualified contractor to prevent moisture intrusion at these locations.

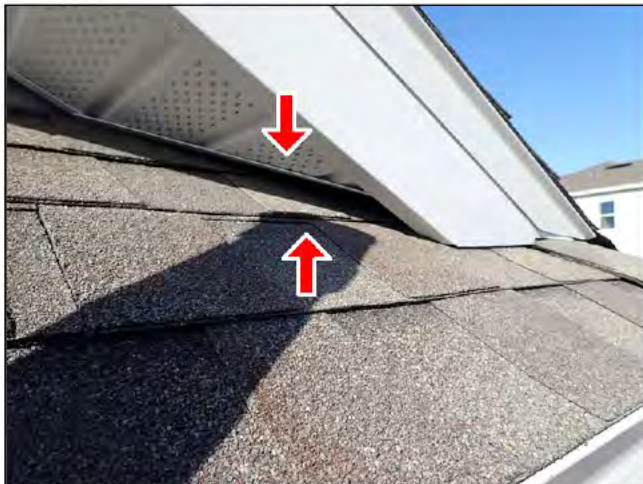
2.5 Item 1(Picture)

Gaps are present in the soffit areas above the garage at the gable ends. These gaps are large enough for pests to enter these locations. Recommend seal or correct as needed from a qualified contractor.

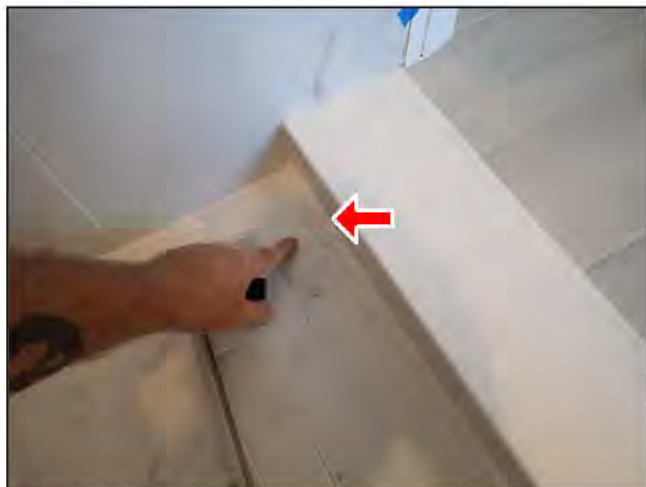
4.2 Item 1(Picture)

One floor tile is raised at the master bath shower near the right side entry. Recommend correct or adjust as needed.

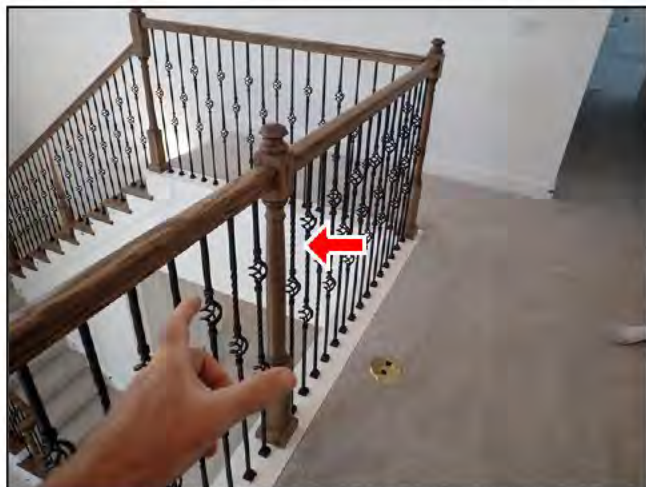
4.3 Item 1(Picture)

Several posts for the stairs leading to the second floor are loose and need securing. Recommend securing as needed from a qualified contractor.

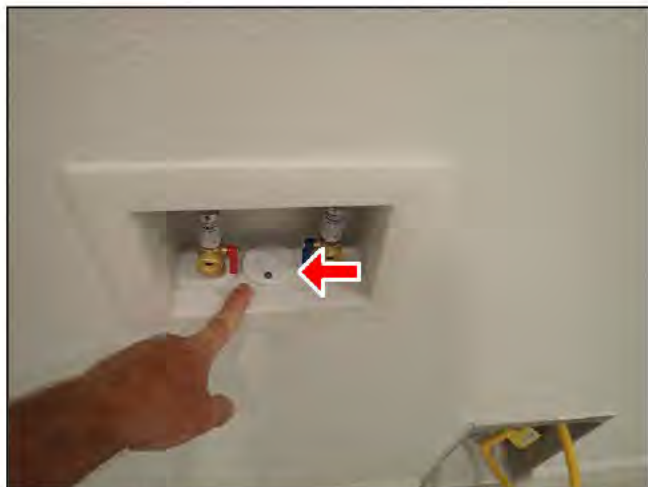
6.0 Item 1(Picture)

Drain line for the clothes washer needs the drain cap removed prior to clothes washer installation. Recommend remove cap as needed.

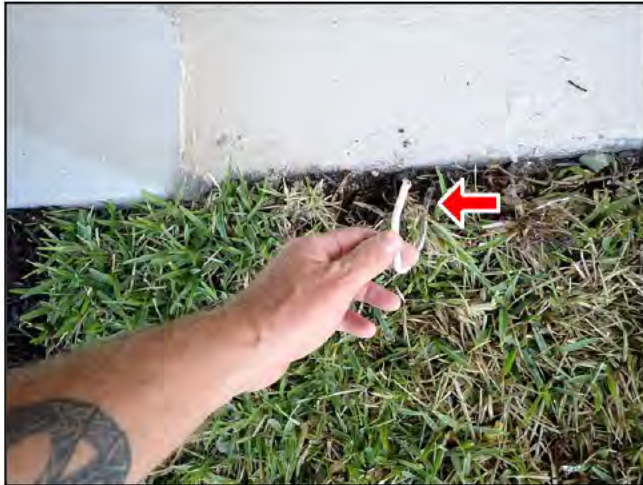
7.3 Item 1(Picture)

(1) Loose low voltage wire is present at the rear of the home in the ground near the patio. Purpose of this is unknown. Recommend proper termination from a qualified contractor.

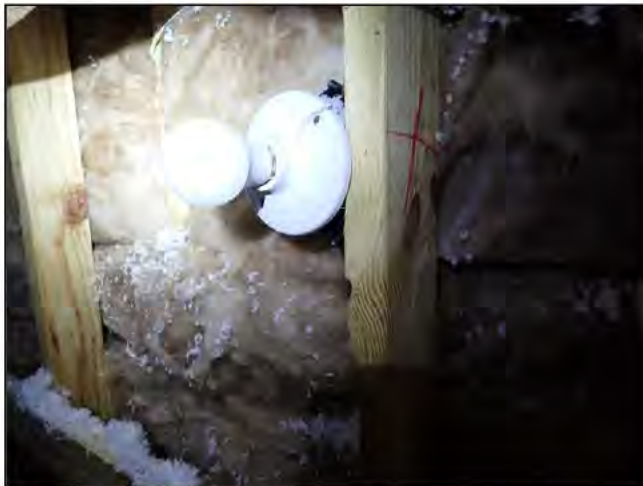
7.3 Item 2(Picture)

(2) Attic light in the upstairs hall attic access did not work when tested. Recommend correct as needed from a qualified electrical contractor.

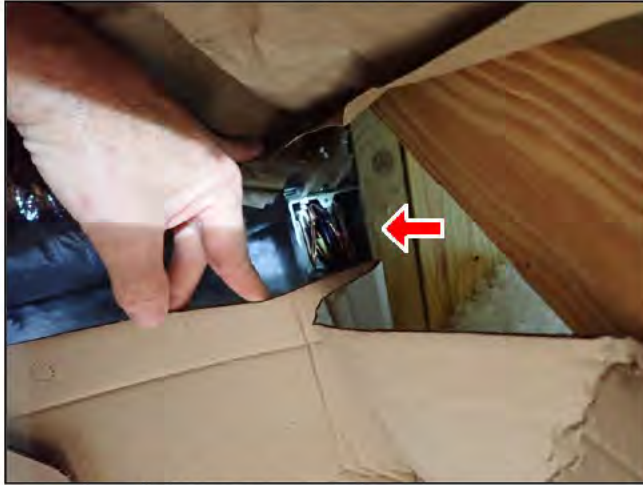
7.3 Item 3(Picture)

(3) Attic light at the upstairs hall attic access is missing a switch to operate. Recommend a licensed electrical contractor correct as needed.

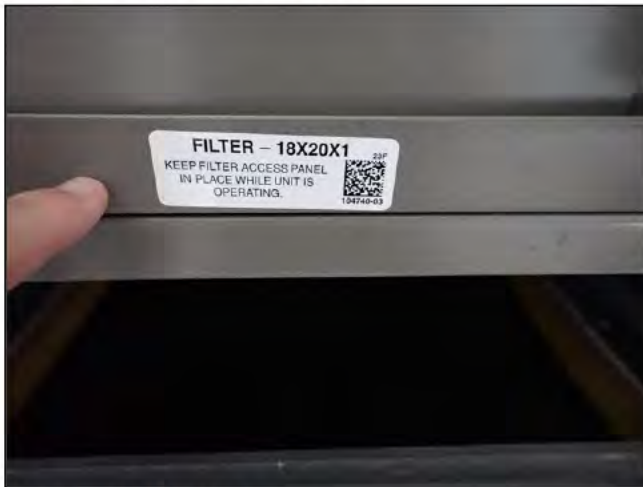
8.3 Item 1(Picture)

(1) Filter location (see photo)

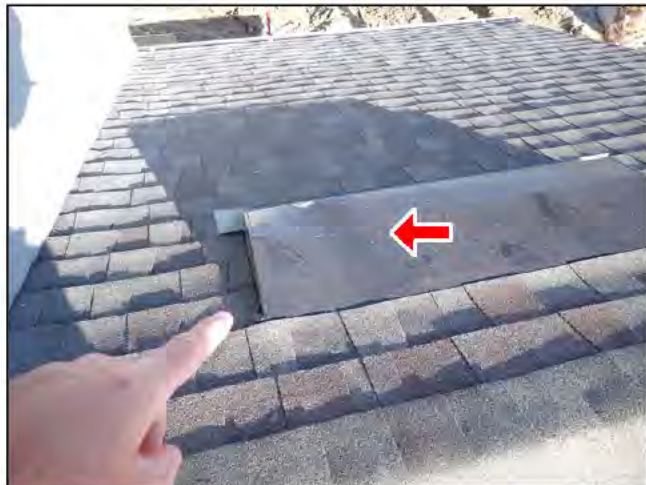
9.3 Item 1(Picture)

Off ridge roof vent at the front of the home above the garage is dented or damaged. Recommend repair as needed from a qualified contractor.
