# Alexis Heights Homeowners Association

## Full Study

Year Beginning: 01/01/2022

**Better Reserve Consultants**

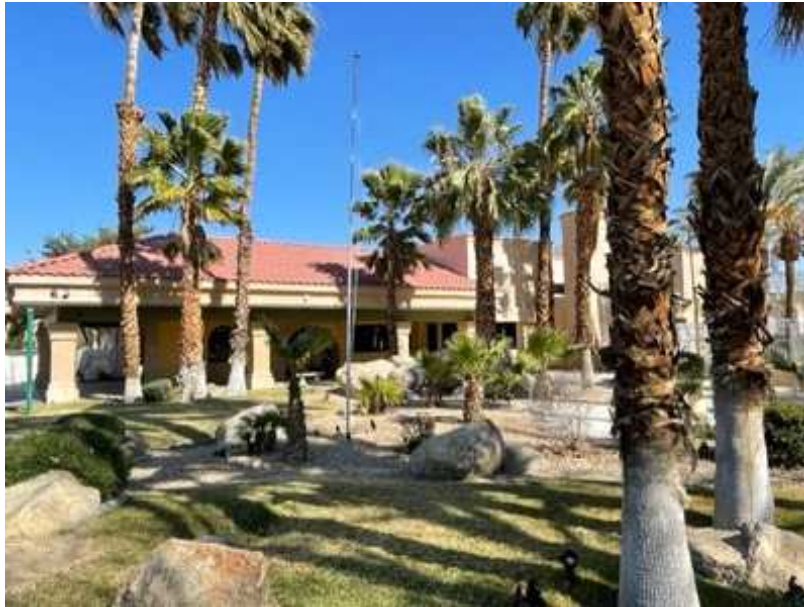
Landscaping and Irrigation includes Tree Removal and Replacement, Major Irrigation Repairs, Rock or Landscaping Renovation to be done as needed. Day-to-day Landscaping is considered an Operational Expense and has not been included in this Study.

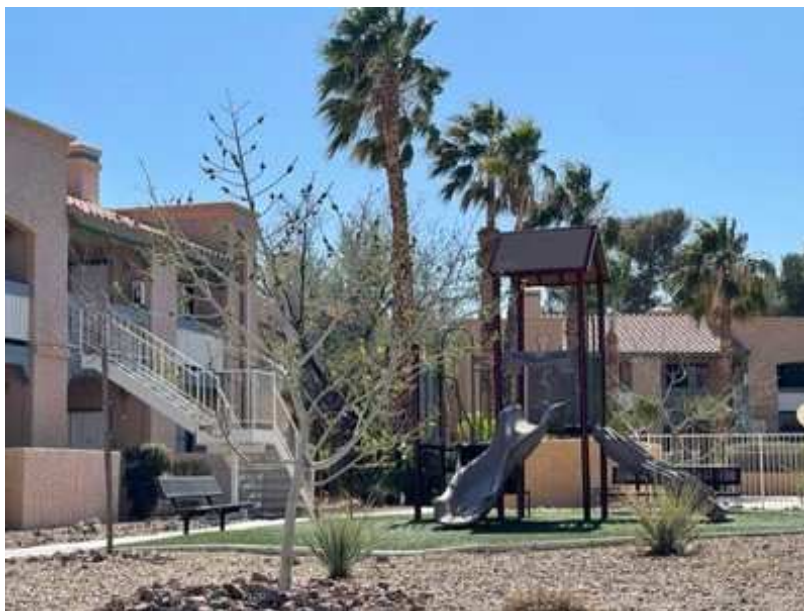
The Playground Equipment has an estimated useful life when new of approximately 20 years. Future Replacement has been included in this Study.

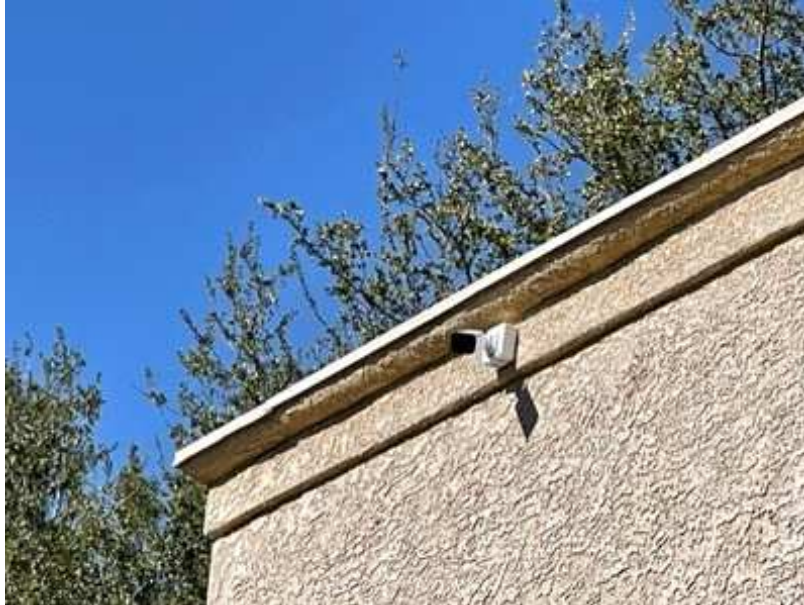
Security Camera Repairs or Replacement has been included in the Reserve Study to be done as needed.

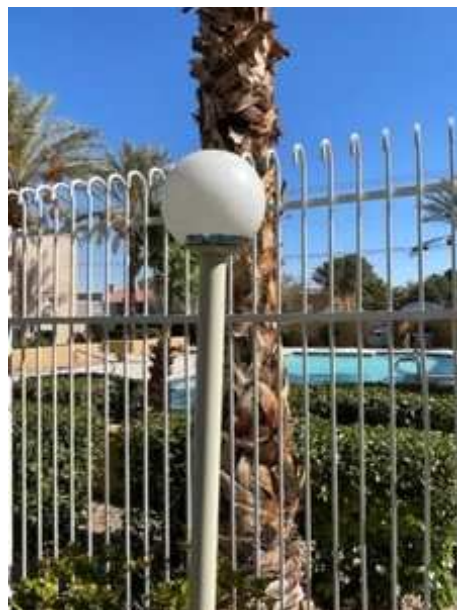
Replacement of the Light Fixtures has been included in the Study. The estimated useful life is approximately 20 years.

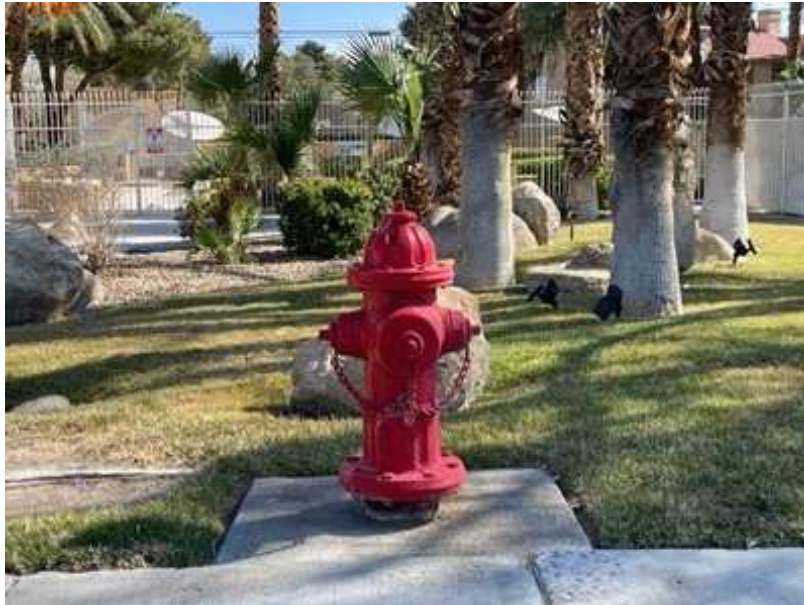
Fire Hydrants are maintained by the Association. Replacement has been included in the Reserve Study.

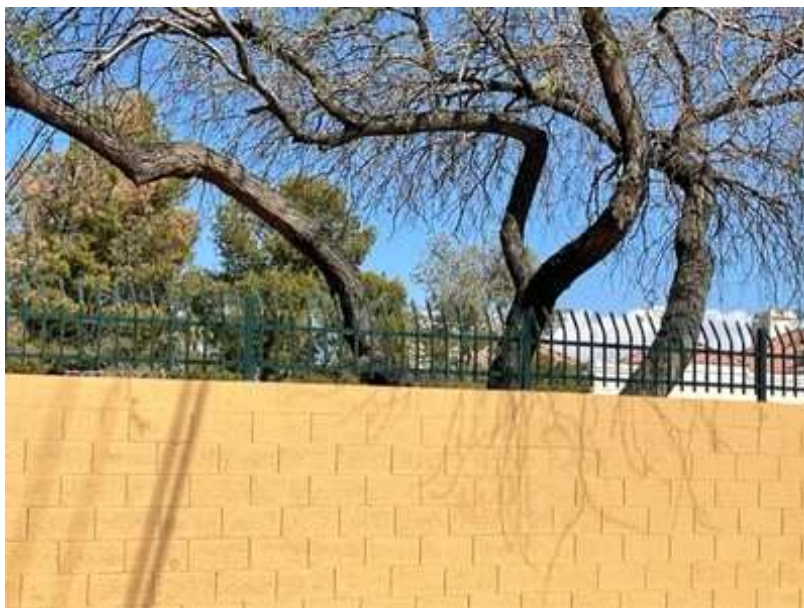
The Perimeter Wall and Landscaping are maintained by the Homeowners Association. Perimeter Wall Repairs have been included in the Study as an allowance, to be done as needed.

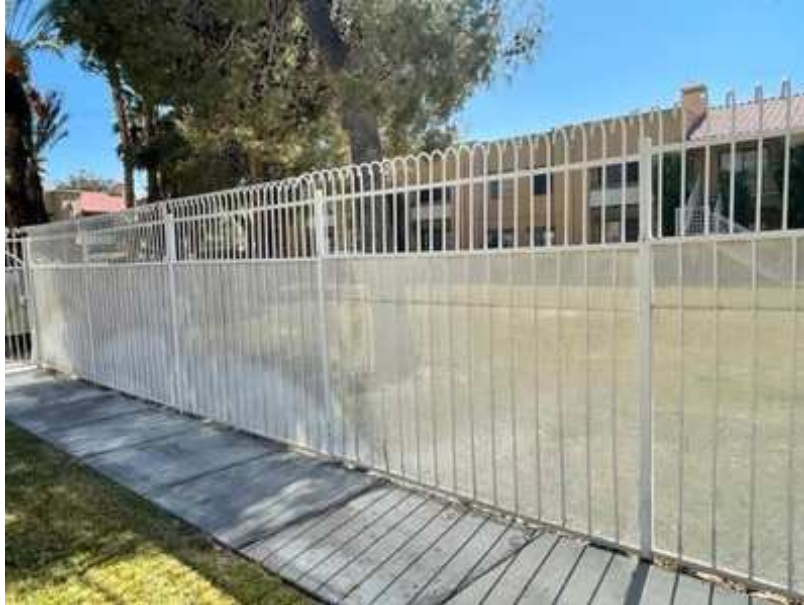
Wrought Iron Fencing Painting, Repairs and Replacement has been included in the Reserve Study to be done as needed.

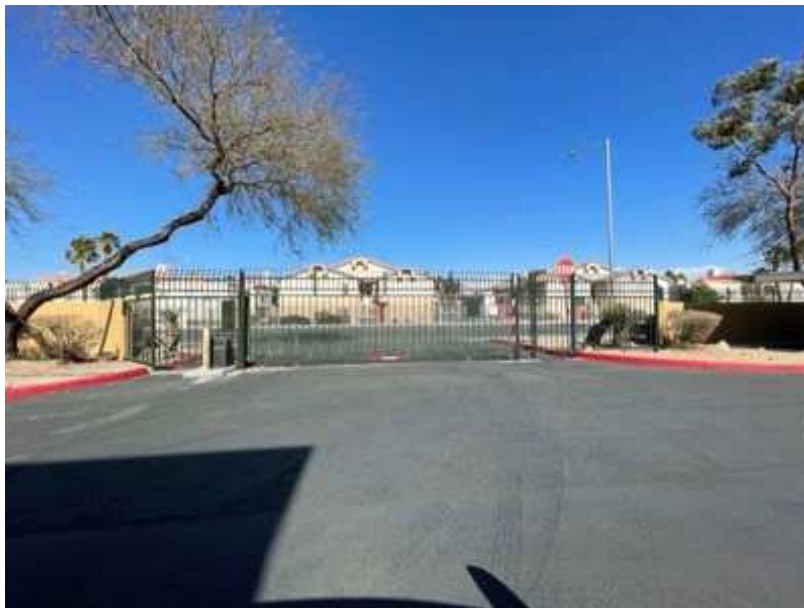
The Entrance Area Category Components include the Gate Replacement, In Ground Loops, Loop Detectors, Motors, Pedestrian Gates and the Key Pad Entry System. The Gate Components Estimated Remaining Useful Life are an estimation only.

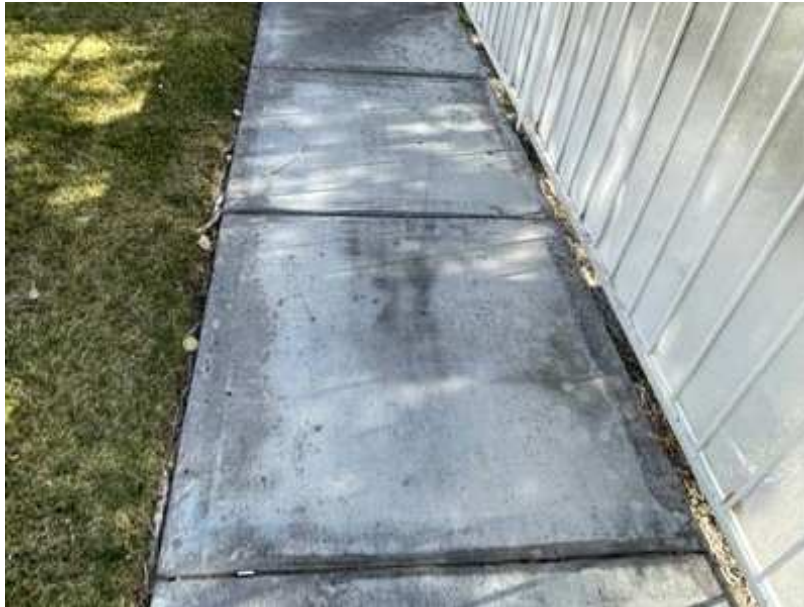
Complete replacement of all Concrete has not been included in the Study. Instead, repair and replacement has been scheduled as an allowance to be done as needed.

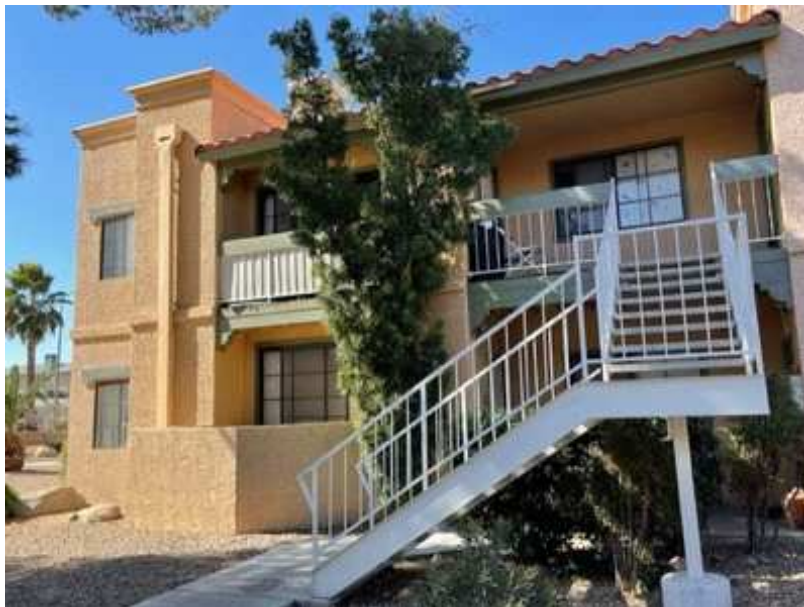
The Exterior of Homes category includes the Roof Replacement, Stucco Painting and Repair, Decks Repair or Replacement, Unit Number Signage, Unit and Building Lighting. The Roof Costs and Remaining Useful Life are an estimation only. A Roof Inspection is strongly recommended and has been included in this Study. This Study should be updated with the results of the Inspection

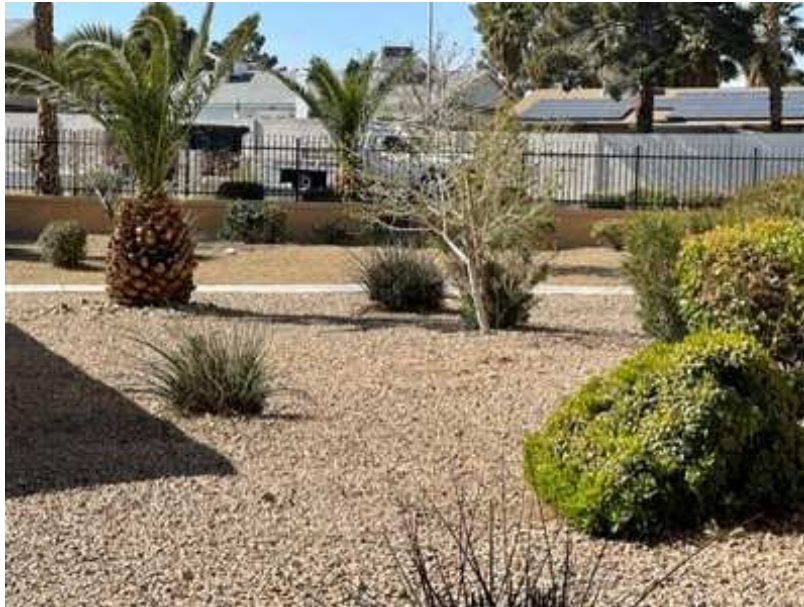
Rock Replenishment has been included in the Reserve Study as an allowance to be done as needed.

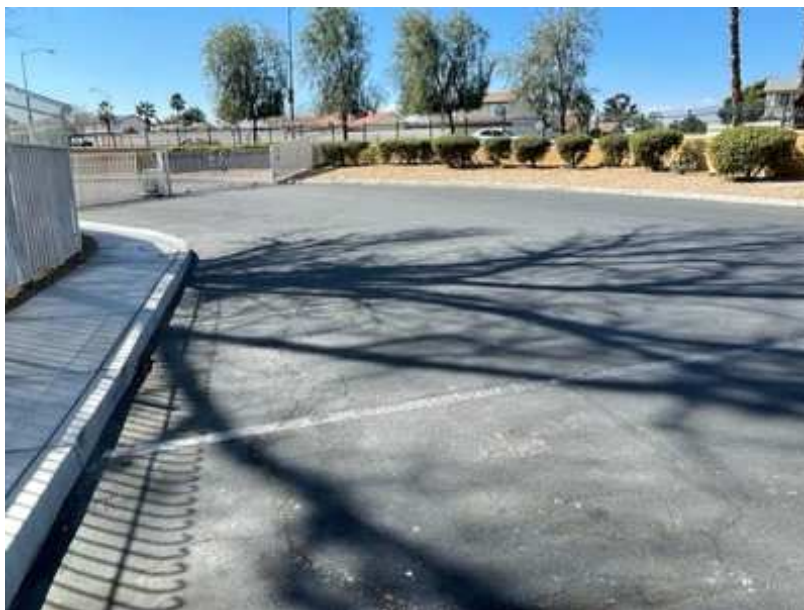
The Asphalt Road Maintenance Schedule includes the Surface Maintenance Treatment, Overlay, Crack Seal, Concrete Curbing Repairs and Striping and Curb Painting. The costs and useful life are an estimation only.

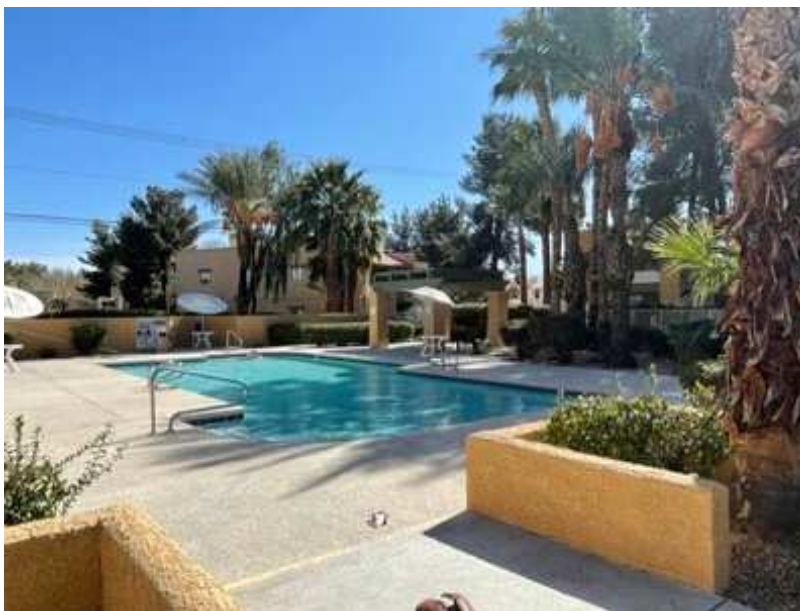
The Pool Components include Pool and Spa Re- surface, Heater, Pump, and Filter Replacement, Pool Furniture, Wrought Iron Fence Painting and Repair as needed. The Pool Restroom Remodel has also been included in the Study along with the Shade Structure Painting and Replacement. The Remaining Useful Life of the Components is an estimation only.

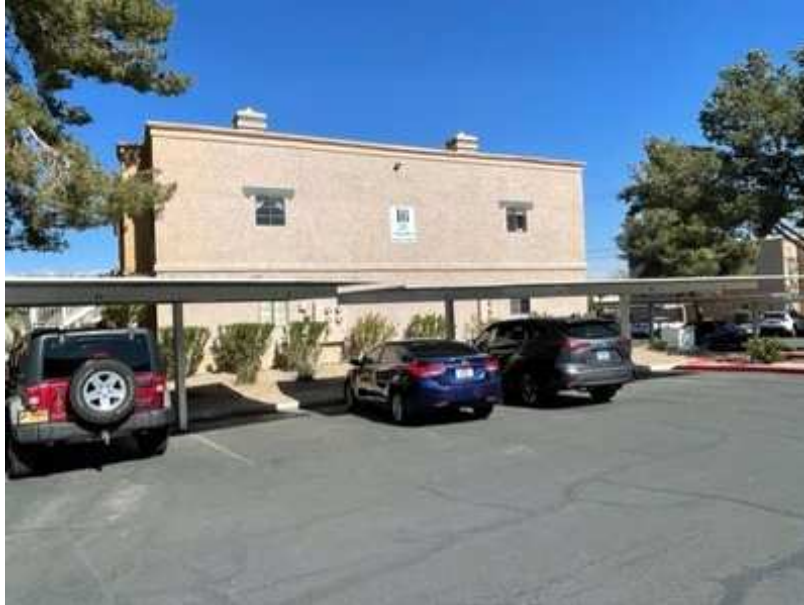
Carports painting and repairs have been included in the Study to be done as needed.

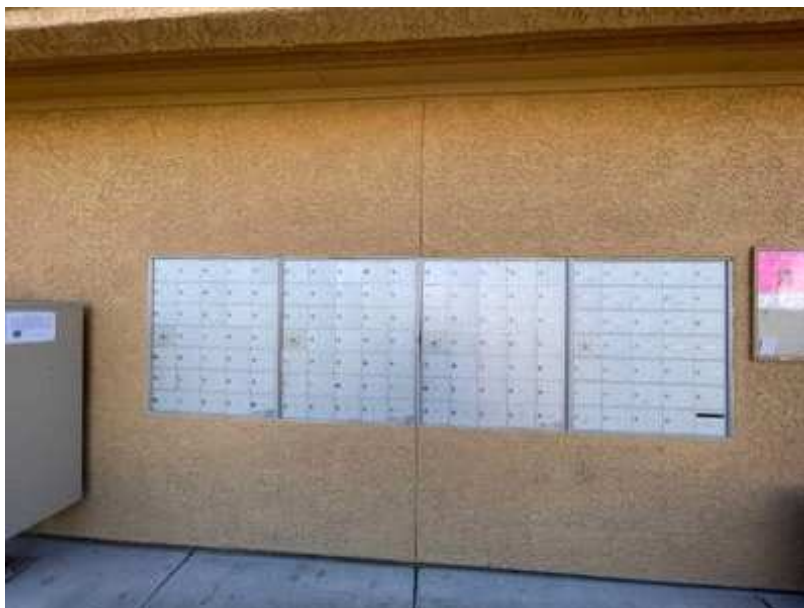
The Mail Boxes are Maintained by the Homeowners Association. The Estimated Useful Life when New is approximately 20 years. Replacement has been included in this Study.

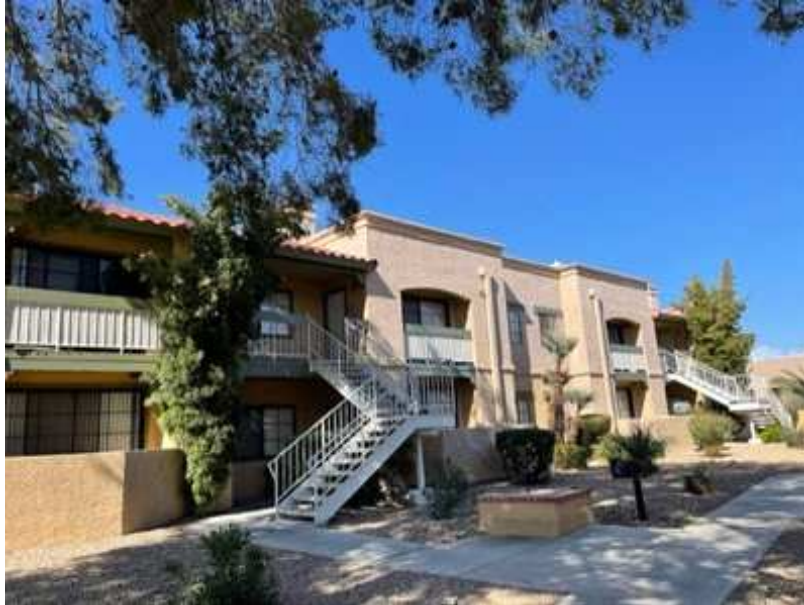
The Association is well maintained and in overall good condition.

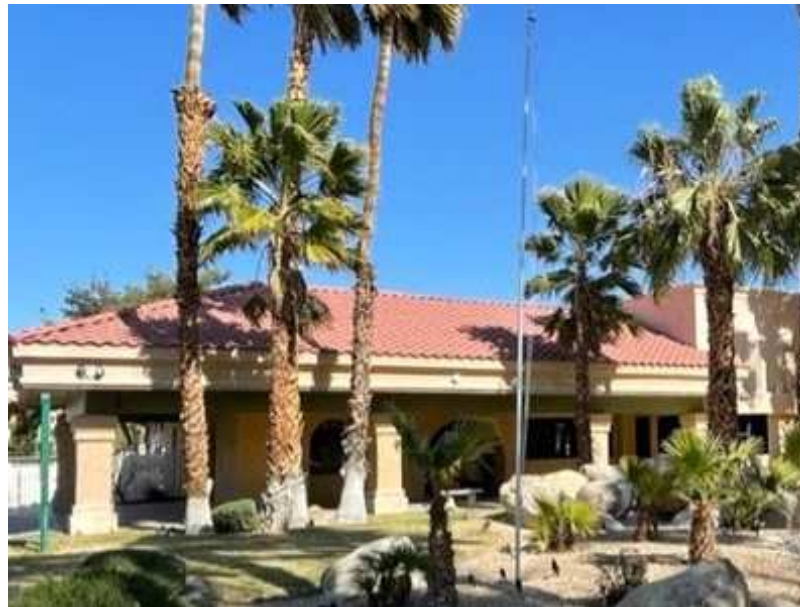
### Clubhouse

Component	Year Scheduled	Quantity	Cost Per Unit	Today's Cost	Estimated Remaining Useful Life (Years)	Estimated Life When New (Years)
1. Drinking Fountain - Water Fountain	2027	1 unit	\$750	\$750	5	20

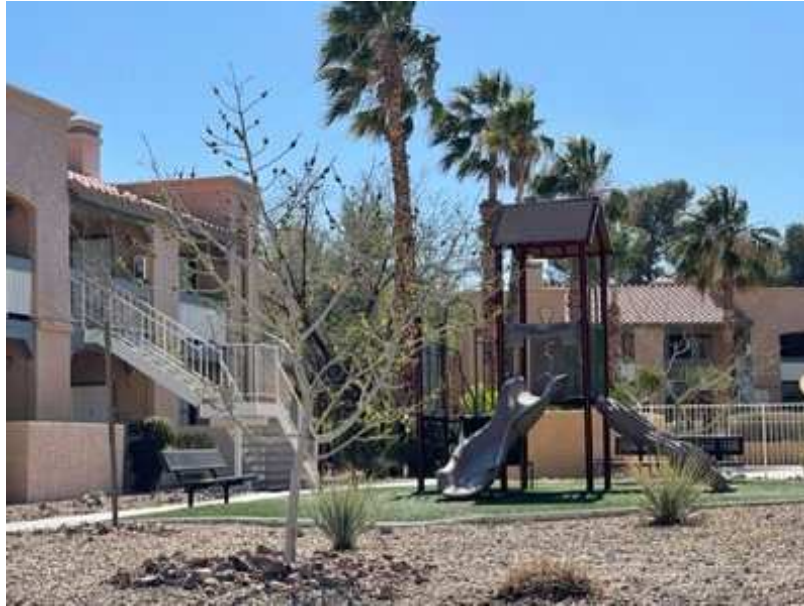
**Common Area**

Component	Year Scheduled	Quantity	Cost Per Unit	Today's Cost	Estimated Remaining Useful Life (Years)	Estimated Life When New (Years)
1. Concrete Repair or Replacement	2024	allowance	\$5,000	\$5,000	2	3

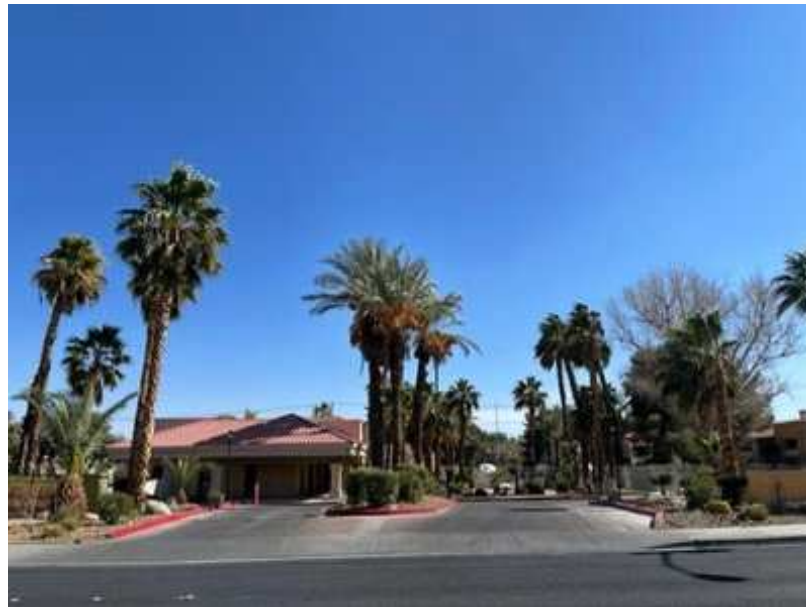
### Entrance Area

Component	Year Scheduled	Quantity	Cost Per Unit	Today's Cost	Estimated Remaining Useful Life (Years)	Estimated Life When New (Years)
1. AVI Detectors	2026	allowance	\$1,500	\$1,500	4	5

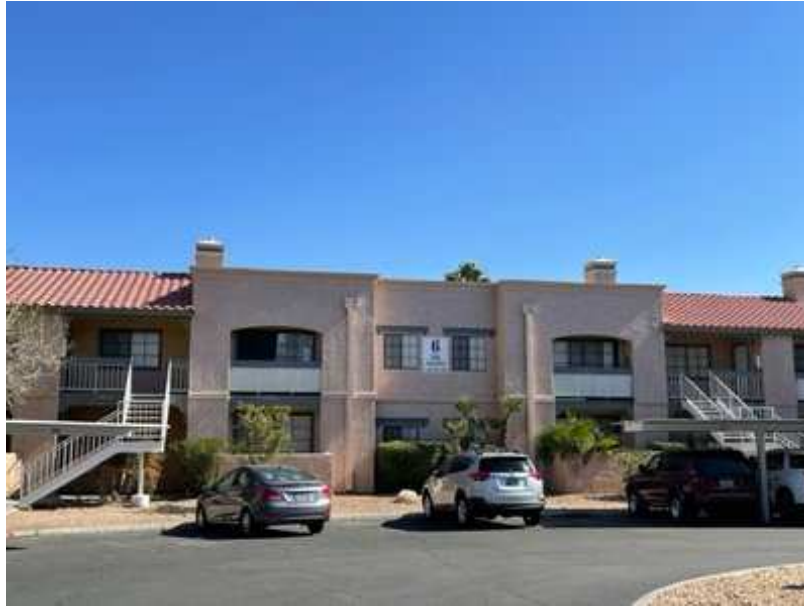
### Exterior of Homes

Component	Year Scheduled	Quantity	Cost Per Unit	Today's Cost	Estimated Remaining Useful Life (Years)	Estimated Life When New (Years)
1. Concrete Step Replacement - Steps to the Upper Level	2026	allowance	\$1,500	\$1,500	4	5
2. Lighting	2035	256 units	\$75/unit	\$19,200	13	30
3. Painting and Stucco Repairs (Done 2017)	2027	256 units	\$1,150/unit	\$294,400	5	10
4. Painting Trim	2025	256 units	\$175/unit	\$44,800	3	5
5. Roof - Flat Replacement (8,100sf x 17 Bldg = 137,700sf)	2032	137700 sq ft	\$4.50/sq ft	\$619,650	10	25
6. Roof - Tile Underlayment Replacement (1600sf x 17bldg = 27,200sf)	2035	27200 sq ft	\$4.50/sq ft	\$122,400	13	30
7. Roof Inspection	2030	as needed	\$250	\$10,000	8	10
8. Roof Repairs	Annual	as needed	\$5,000	\$5,000	0	1
9. Signage -Building Numbers	2030	52 bldg	\$100/bldg	\$5,200	8	20
10. Signage Unit Numbers	2035	256 units	\$25/unit	\$6,400	13	30

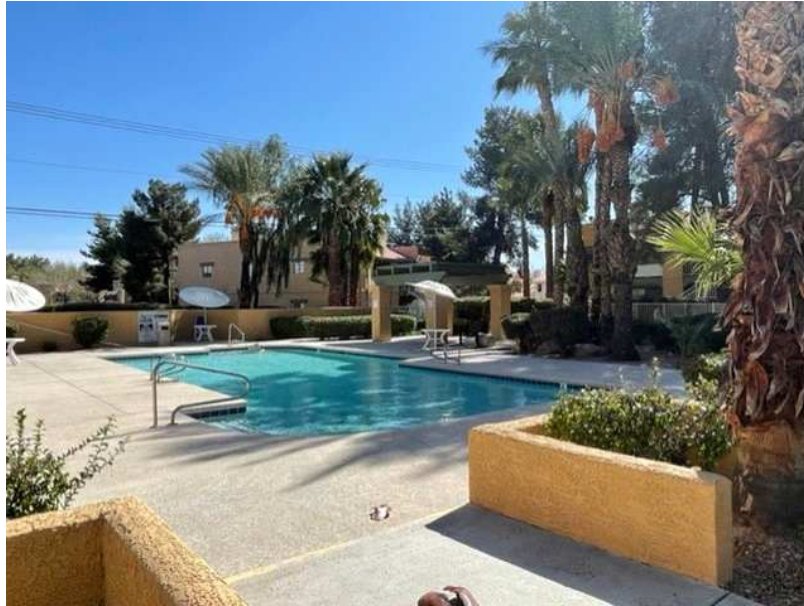
**Pool Area**

Component	Year Scheduled	Quantity	Cost Per Unit	Today's Cost	Estimated Remaining Useful Life (Years)	Estimated Life When New (Years)
1. Pool Filter	2023	2 units	\$2,500/unit	\$5,000	1	7

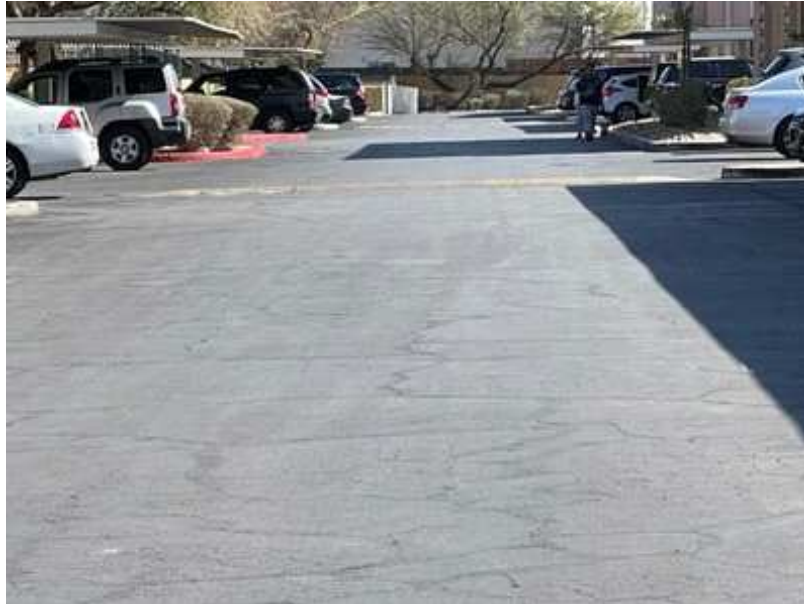
### Roads and Parking

Component	Year Scheduled	Quantity	Cost Per Unit	Today's Cost	Estimated Remaining Useful Life (Years)	Estimated Life When New (Years)
1. Carport - Lighting and Electrical	2025	as needed	\$5,000	\$5,000	3	10
2. Carport Painting and Repairs	Annual	as needed	\$1,500	\$1,500	0	1
3. Concrete to Asphalt Joint Sealing	2023	1 unit	\$5,000	\$5,000	1	4
4. Crack Seal	2023	as needed	\$10,000	\$10,000	1	4
5. Fire Hydrants	2045	8 units	\$9,000/unit	\$72,000	23	40
6. Overlay	2030	173000 sq ft	\$1.50/sq ft	\$259,500	8	30
7. Striping or Curb Painting	2026	as needed	\$3,000	\$3,000	4	5
8. Surface Maintenance Treatment (Done 2015)	2023	173000 sq ft	\$.25/sq ft	\$43,250	1	5
