Civano I, Neighborhood I HOA
Tucson, AZ

Report #: 9304-3
Beginning: January 1, 2024
Expires: December 31, 2024

RESERVE STUDY
Update "With-Site-Visit"

August 7, 2024

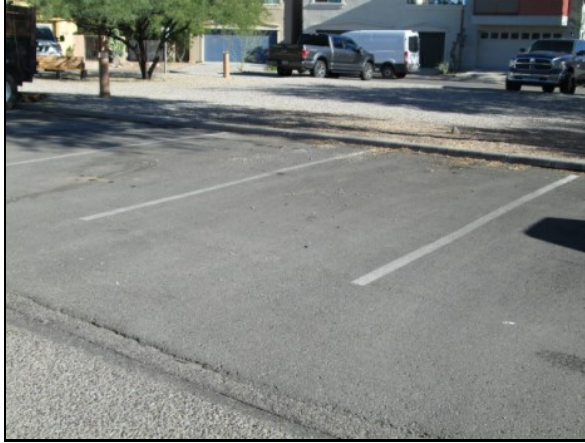
Comments: This asphalt was repaved in 2021 and still has not received its first seal. Asphalt looks dry and needs to be sealed soon. Seal coat asphalt surfaces periodically to prevent premature cracking and deterioration.

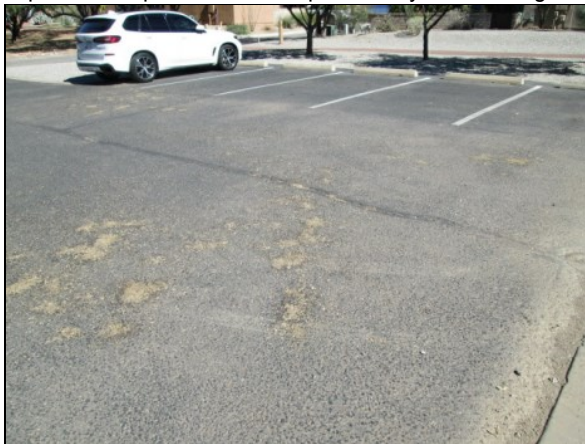
Comments: This component accounts for 16 different parking lots. For the most part, surfaces are rough and raveling. Cracking noted as well. Surfaces have not been well maintained in the past, but they do not appear to need repaving yet. This component funds to remove and repave the asphalt. Life span is based on periodically seal coating and maintaining the surface.

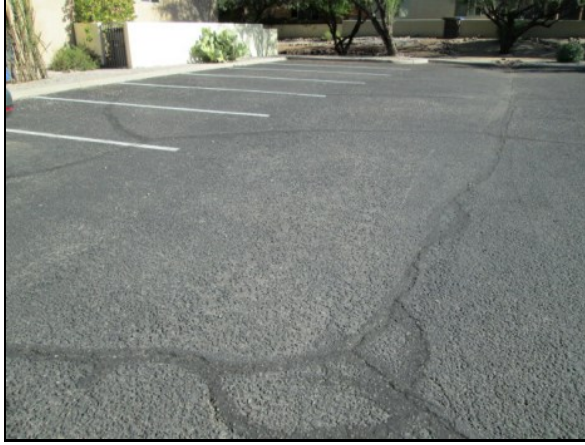
Comments: Seal coat is still dark and in fair condition, so it does not need to be re-applied yet. Recommend planning to crack fill and seal all these parking lots together. Seal coat asphalt surfaces periodically to prevent premature cracking and deterioration.

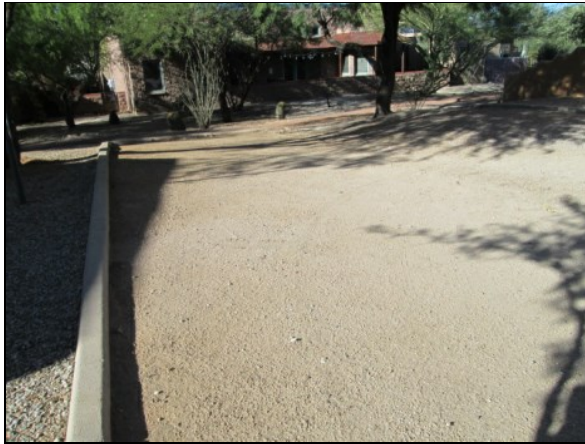
Comments: These dirt/gravel parking lots were never paved, and there is no expectancy to pave them. Per the HOA's request, this component funds an allowance to periodically repair.

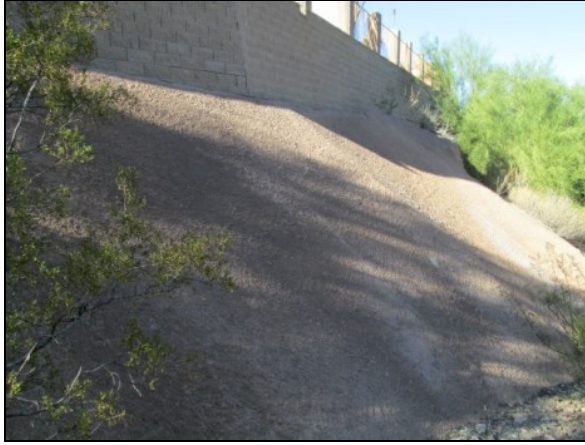
Comments: This component funds periodic engineering inspection to look at erosion issues at the community slopes. Funding has been added at the Board's request.

Useful Life:
4 yearsRemaining Life:
0 years

Best Case: \$ 10,000

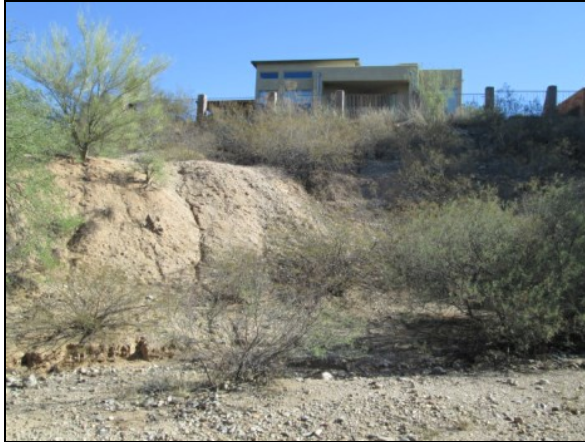
Comments: It is beyond the scope of this Reserve Study to predict the timing, extent, and cost of repairs that will be needed for erosion control. This component funds an allowance for erosion repairs per the HOA's request.

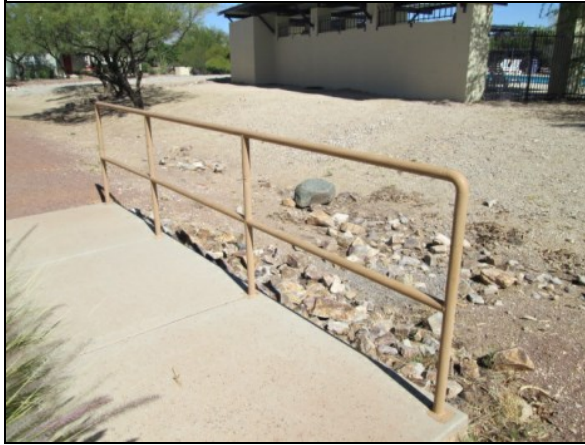
Comp #: 425 Metal Rails (1999) - Replace

Comments: Securely mounted with no significant rusting or deterioration. Still in good condition. Long life expectancy under normal circumstances.

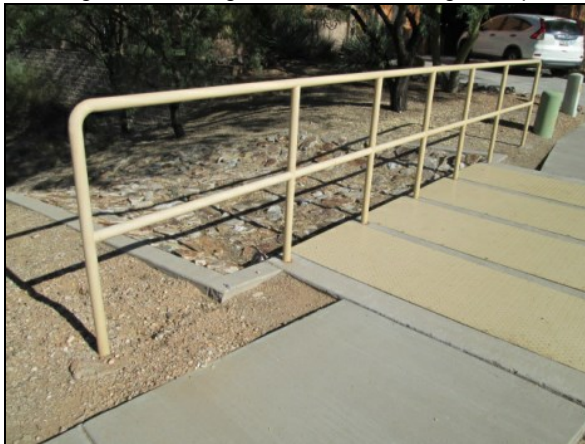
Comp #: 427 Metal Rails (2008) - Replace

Comments: Securely mounted with no significant rusting or deterioration. Long life expectancy under normal circumstances.

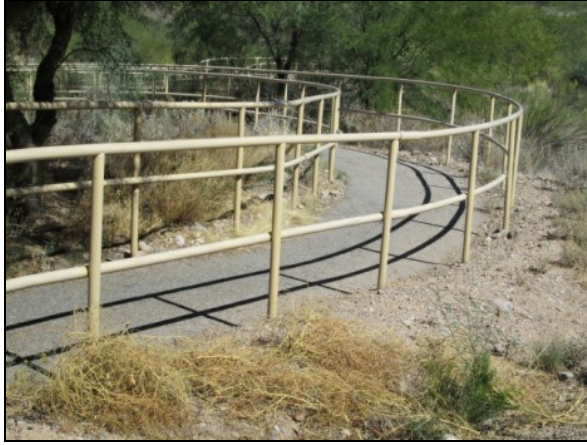
Comments: Both painting projects we have record of did not account for painting all the rails. Recommend painting all rails at the same time. Conditions vary, but surfaces are generally faded and chipping.

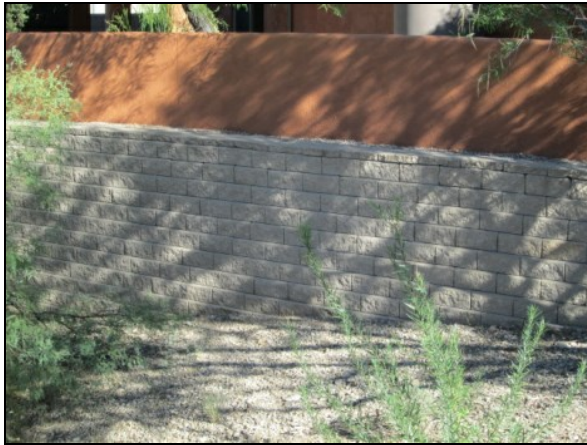
Comments: HOA is reportedly responsible for retaining walls behind homes built on a slope. Walls and fence mounted on top of the retaining walls are the owners responsibility. There is no expectancy to replace these walls under normal circumstances. They should be professionally inspected by an engineer as part of the erosion and slope work. This component funds an allowance for periodic, minor repairs.

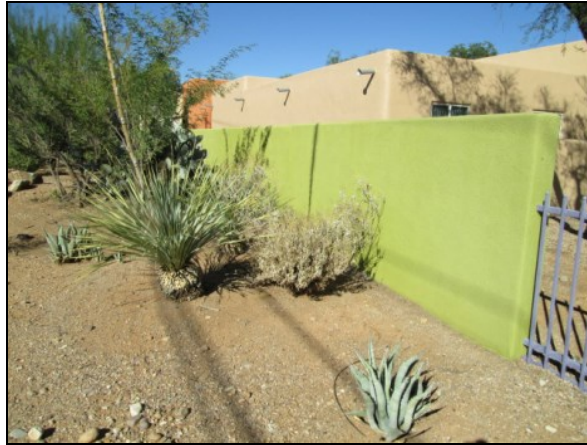
Comments: Per CC&R's section 5.2.15.5, owners are responsible for all wall maintenance, repair, and painting. These are high visibility walls. They were reportedly looking bad, so HOA decided to paint them in 2019 to restore the appearance. Going forward, HOA intends to continue painting to maintain the appearance and uniformity.

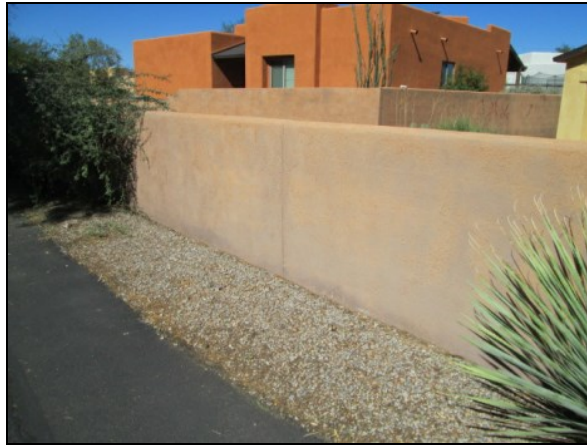
Comments: Per CC&R's section 5.2.15.5, owners are responsible for all wall maintenance, repair, and painting. These are high visibility walls, so the HOA intends to paint them going forward to maintain the appearance and uniformity.

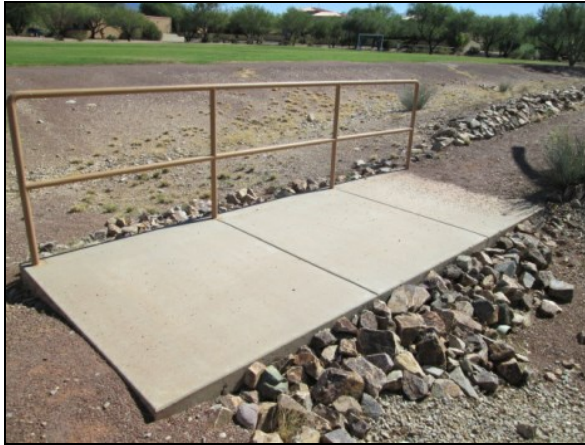
Comp #: 460 Fingerway Bridges - Repair

Comments: The bridges have ~5,400 sq ft of concrete surfaces and 760 LF of metal rails. Rails are included under #425 and 428. There is no expectancy to completely replace these bridges. This component funds an allowance for periodic repairs. HOA reports some repairs are needed soon.

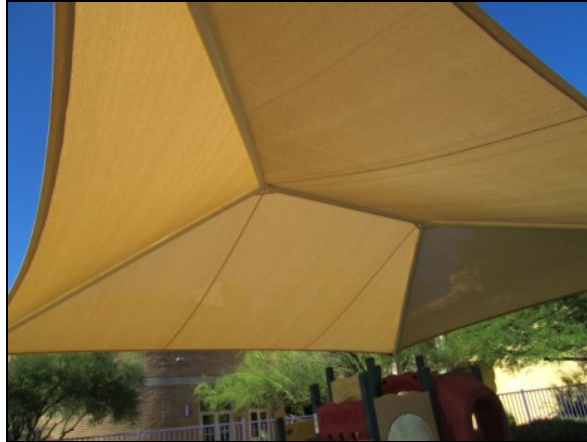
Comp #: 501 Playground Shade - Replace**Quantity: Approx 680 Sq Ft**

Comments: There is no expectancy to replace the structure under normal circumstances. This component funds to periodically replace the shade screen. No holes or tears were noted. Still appears to be in good shape.

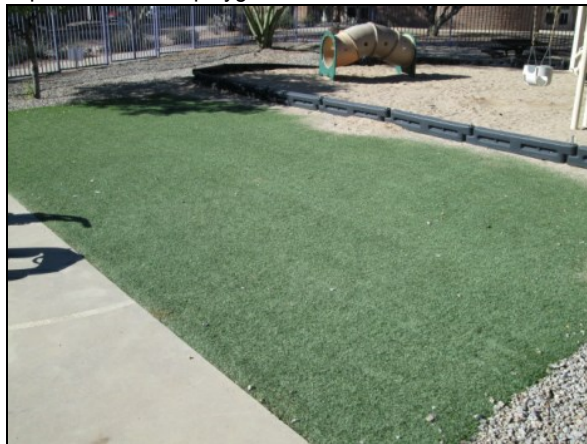
Comp #: 505 Artificial Turf - Replace**Quantity: Approx 850 Sq Ft**

Comments: Turf looked older at the time of inspection. It was replaced in late 2023 after our inspection. Original turf size of ~400 sq ft was increased to 850 sq ft as part of the 2023 playground renovation.

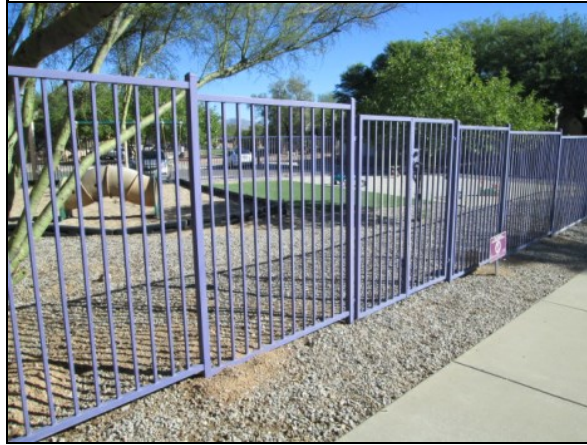
Comments: This is a 6' perimeter metal fence. Securely mounted and in good condition, although some spots, including the gate, are looser than others.

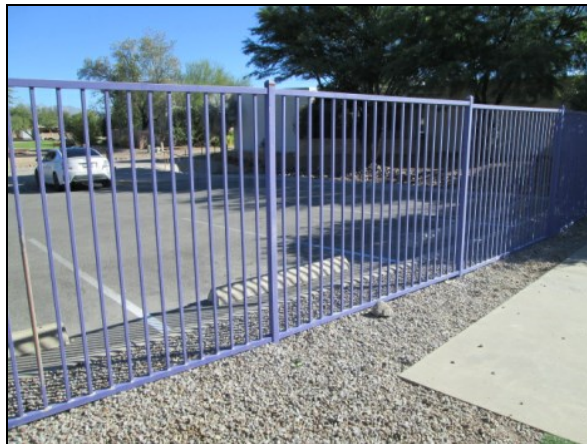
Comments: Still in poor condition. Paint finish is old, oxidized, and peeling off. Some rusting noted too. This component also funds to paint the shade structure.

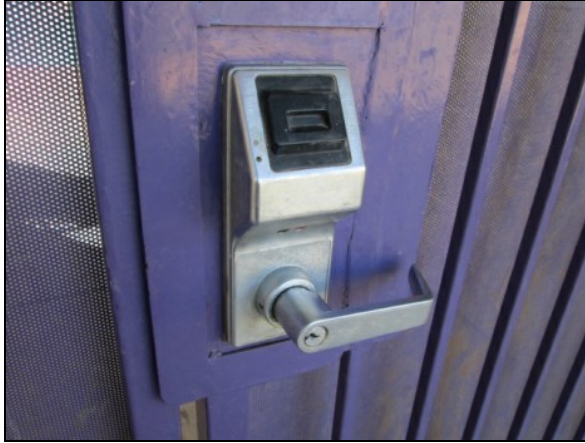
Comments: Although the 2016 invoice only accounts for 3 locks, all of them are a similar age. This component accounts for all readers as one project. HOA plans to replace them with Wi-Fi style readers soon.

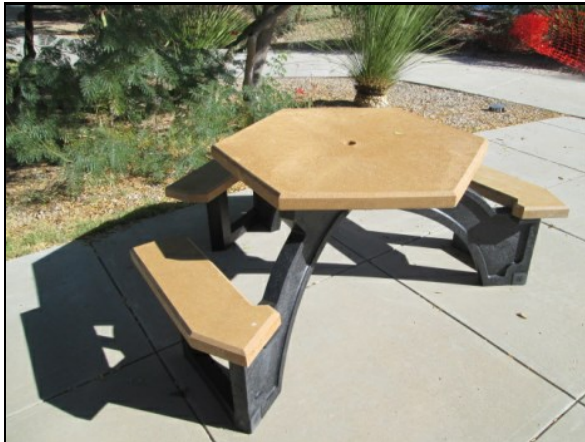
Comp #: 514 Park Furniture - Replace**Quantity: (41) Pieces**

Comments: Quantity includes (24) 6' benches, (6) 5' curved benches, (9) hexagonal picnic tables, and (2) ADA hexagonal picnic tables. All furniture is constructed with recycled plastic. Recommend planning complete replacement to maintain a consistent and uniform quality throughout the community.

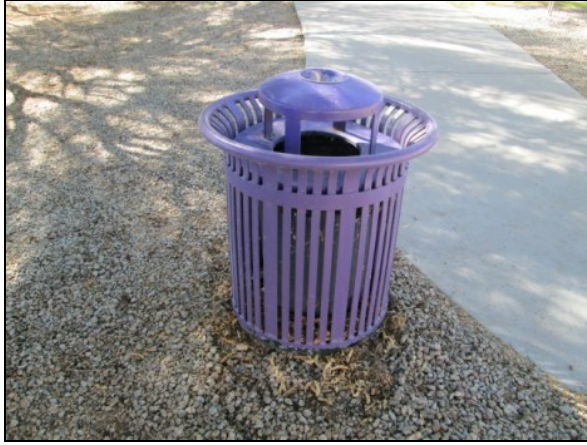
Comp #: 516 Trash Cans - Replace**Quantity: Approx (21) Trash Cans**

Comments: Ages vary along with styles and conditions. HOA replaced all park furniture in 2023, except the trash cans. Recommend planning a complete replacement to maintain a consistent and uniform quality throughout the community.

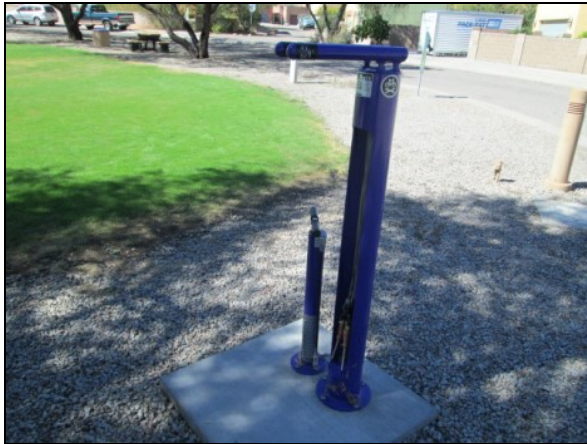
Comp #: 518 Bike Repair Stand - Replace**Quantity: (1) Dero Fix-It Station**

Comments: This is a bike repair station that consists of a stand with tools plus an air pump. Still appears to be in good condition.

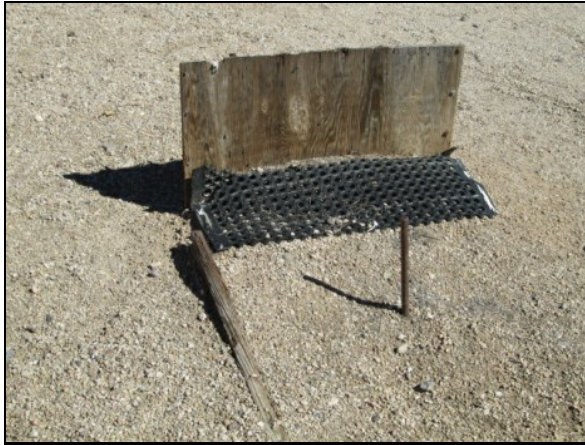
Comp #: 522 Horseshoe Pits - Replace

Comments: Wood backstops are in poor condition and should be replaced.

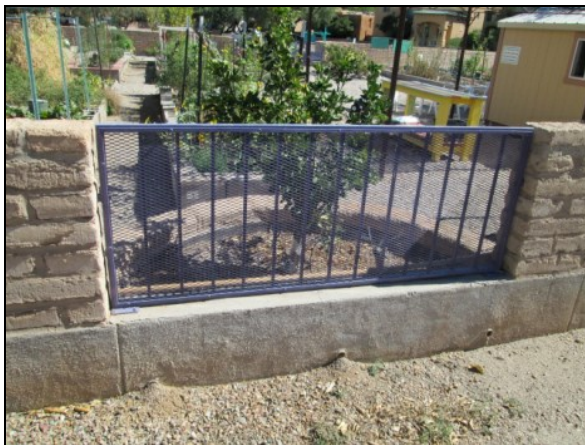
Comp #: 530 Garden Fence - Replace

Comments: Community Garden has sections of metal fence and gates around the perimeter. Still appears intact and in good to fair condition.

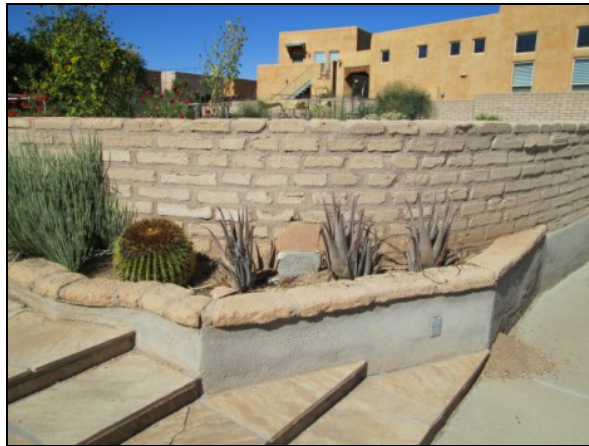
Comp #: 533 Garden Wall - Repair

Comments: This component funds an allowance for repairs to the garden wall beyond the small repairs expected as part of sealing the Adobe.

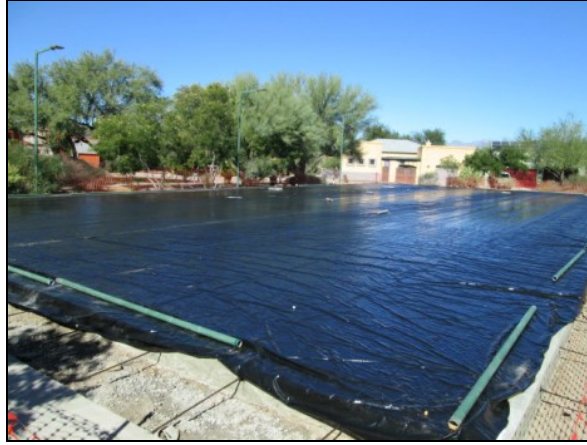
Comments: Tennis court was still in the process of being replaced at the time of inspection. Surface is being reflected as new in 2024 for budget planning.

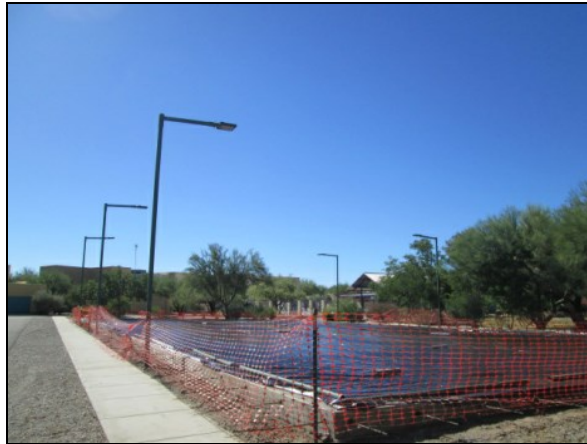
Comments: Tennis fence was still in the process of being replaced at the time of inspection. Fence is being reflected as new in 2024 for budget planning.

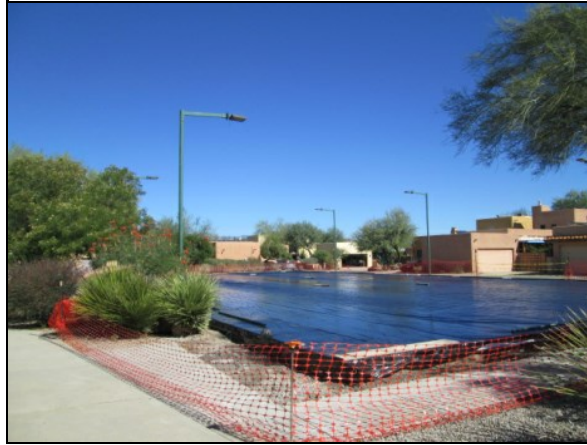
Comments: Fence was still in the process of being replaced at the time of inspection. Surfaces/finishes will be new and in good condition.

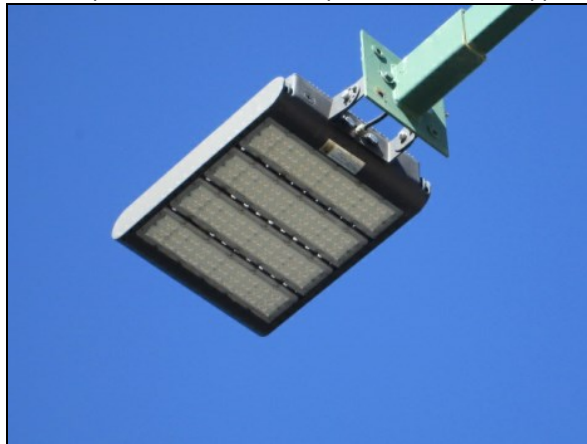
Comments: Only the light fixtures were replaced in 2018, not the poles. Fixtures still appear to be in good condition.

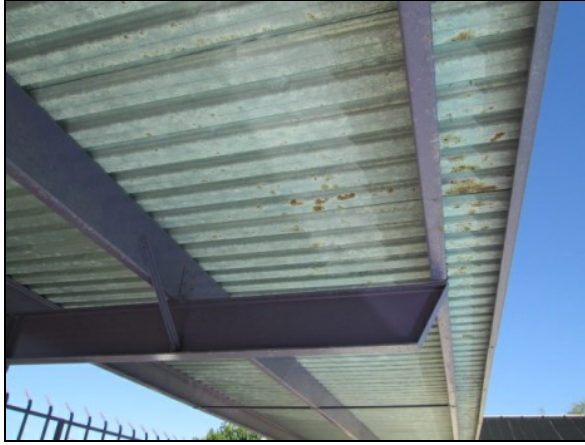
Comments: Roofs still appears to be in good condition overall. No signs of damage or reports of problems. There is still some visible rusting under the roof due to leaking solar panels. Long life expectancy under normal circumstances.

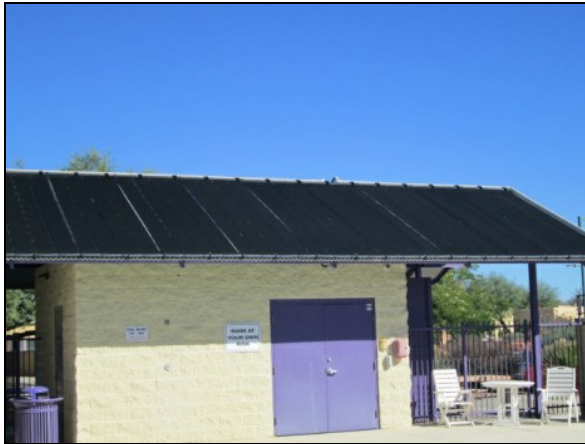
Comments: Solar panels are expected to be in good condition. We expect repairs will be made under warranty or as a maintenance expense. Per the contract, this pool has (13) HC50 4'x12.5' and (16) HC30 4'x8' panels.

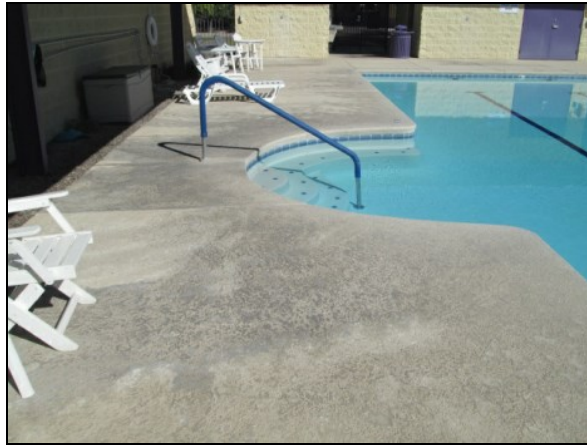
Comp #: 742 Pool Deck - Seal/Repair**Quantity: Approx 2,520 Sq Ft**

Comments: Deck coating is in fair condition. It is already stained and discolored though. Heavy staining noted at the pool entry/exit. This component funds to periodically patch cracks and paint/seal the deck to cover stains and restore the appearance.

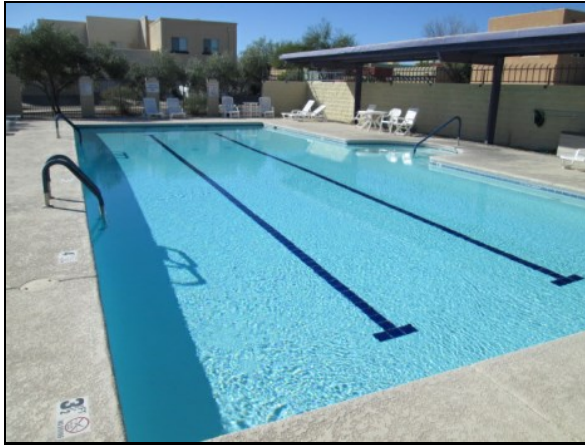
Comments: Pool has a white plaster surface with waterline tile and (2) lights. It still appears clean and in good condition.

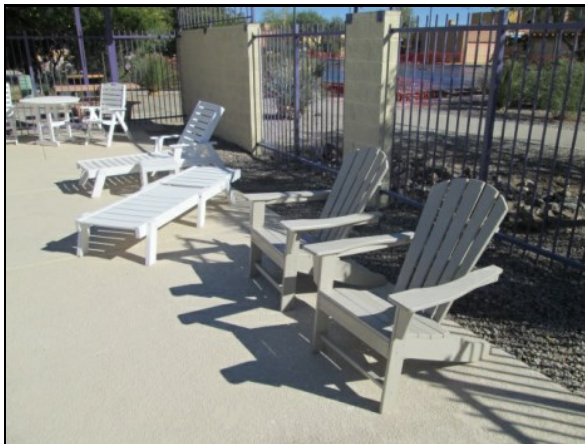
Comp #: 750 Pool Furniture - Replace**Quantity: (38) Pieces**

Furniture is generally older, but still functional and in fair condition. Plan for complete replacement to restore the quality and consistency.

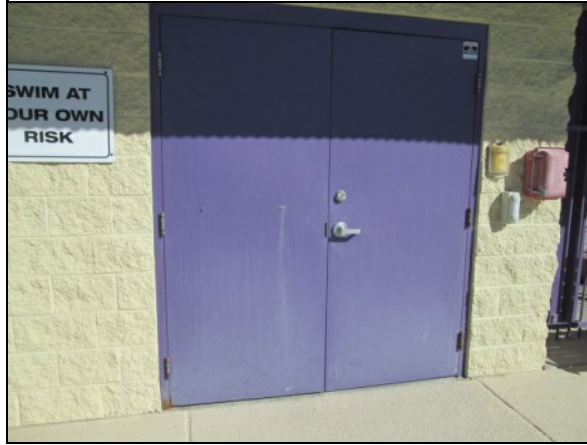
Comp #: 760 Equip Doors - Replace**Quantity: (2) Metal Doors**

Comments: Equipment room has steel doors that are rusted. Frame is also rusting out. Replacement will be needed at some point in the near future.

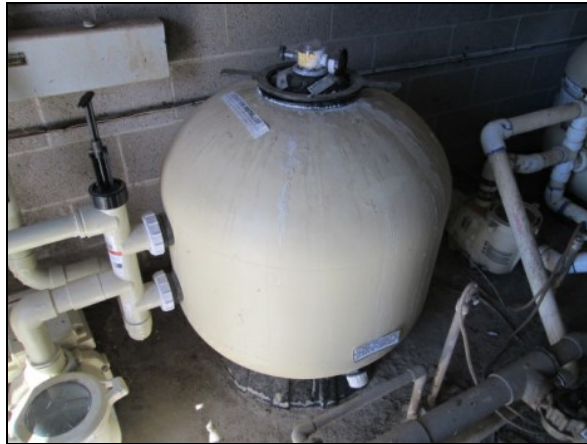
Comp #: 761 Pool Filter #1 - Replace**Quantity: (1) Pentair, 4.90 Sq Ft**

Comments: This filter is newer and in good condition. No problems observed or reported.

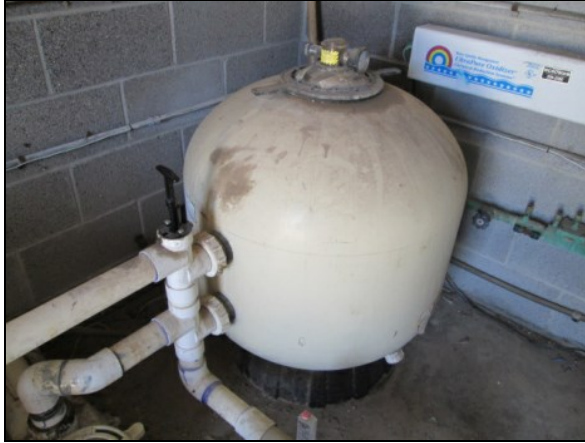
Comp #: 762 Pool Filter #2 - Replace**Quantity: (1) Pentair, TR-100**

Comments: This filter is older and should be nearing time for replacement. No issues were observed or reported though.

*Model: TR-100, Serial #0101156080079B, Mfg date: 6/2008

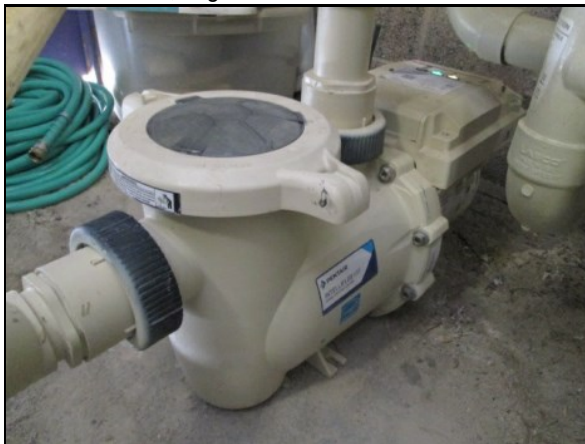
Comp #: 764 Pool Pump #1 - Replace**Quantity: (1) Pentair, 3-HP**

Comments: This pump works with filter #1. Periodic repair and motor replacement should be addressed as a maintenance issue.

*Model: Intelliflo 3-VSP, Serial #0332315220166S, Mfg date: 11/11/2022

This component funds for replacement of the pump and motor assembly.

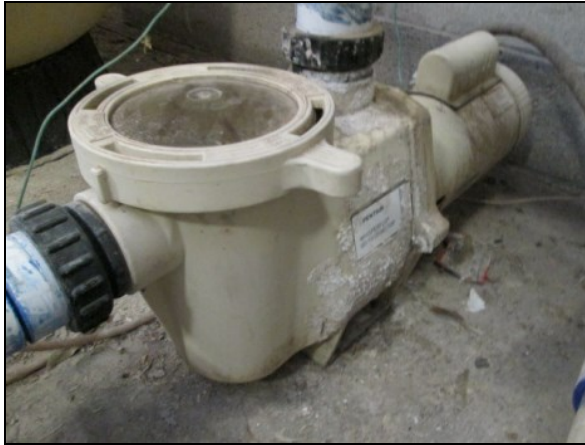
Comp #: 765 Pool Pump #2 - Replace**Quantity: (1) Pentair, 2-HP**

Comments: This pump works with filter #2. Periodic repair and motor replacement should be addressed as a maintenance issue. This component funds for replacement of the pump and motor assembly.

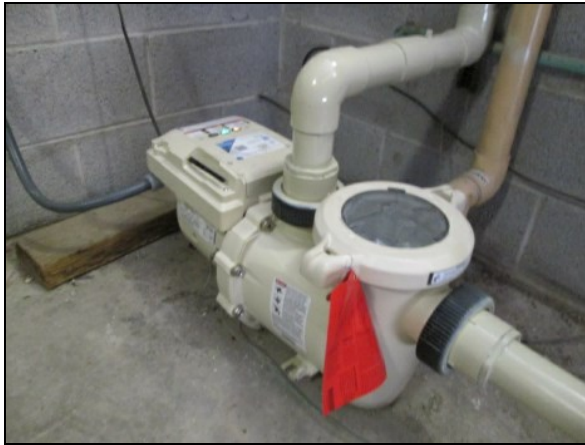
Comp #: 766 Solar Pump - Replace**Quantity: (1) Pentair, 3-HP**

Comments: This pump circulates water between the pool and solar panels. Periodic repair and motor replacement should be addressed as a maintenance issue. This component funds for replacement of the pump and motor assembly.

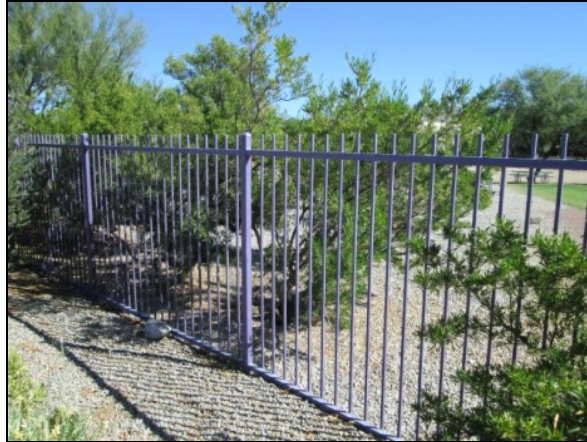
Comp #: 901 Metal Fence - Replace (A)**Quantity: Approx 270 LF**

Comments: Quantity includes 270 LF of pool fence & gates plus (4) 3 LF gates at the enclosure in front of the pool area and trash enclosure next to the parking lot. Fence still feels securely mounted, but some of the posts are rusted out at the base.

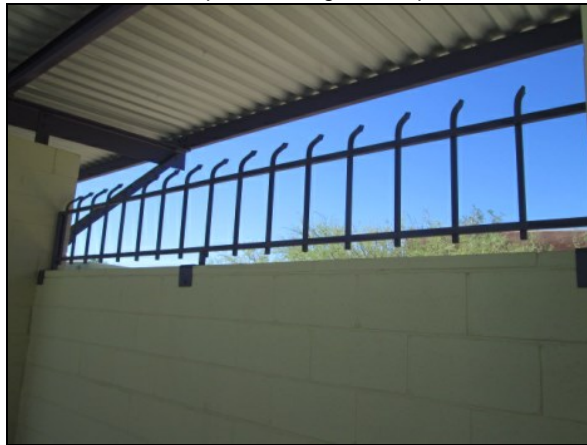
Comp #: 902 Metal Fence - Replace (B)**Quantity: Approx 74 LF**

Comments: This component accounts for the 24" tall spike fence extensions mounted to the top of pool walls. Total project accounted for 148 LF of fence between both pool areas. For simplicity, we have divided the quantity and cost in half and allocated it to each pool area. These fence sections are not exposed to irrigation or pool water, so a long life span is anticipated.

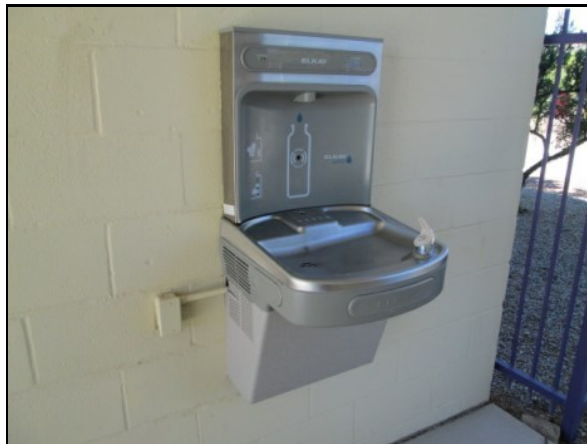
Comp #: 912 Drinking Fountain - Replace**Quantity: (1) Sunroc Fountain**

Comments: This is a single dispenser, chilled water drinking fountain with a bottle filler. Good conditions observed.

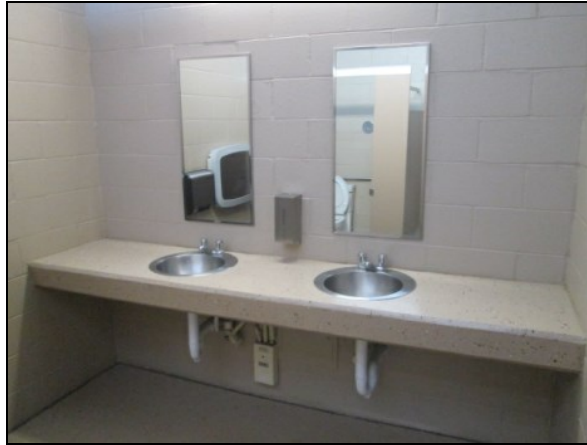
Comments: Restrooms are relatively basic. A sizable restoration or remodel project was recently completed. Restrooms have coated concrete floors and counters, steel sinks, mirrors, soap dispensers, hand dryers, changing stations, instant water heaters, toilets, laminate stalls, and a urinal. This component funds a longer-term allowance to replace and refurbish these restroom items.

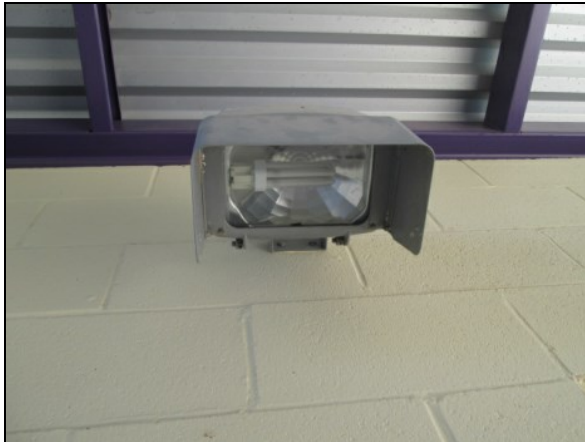
Comp #: 918 Exterior Lights - Replace

Comments: These lights are not original with the pool area. They look old and should be updated with fixtures similar to the North Pool. Repair or replace individually as a maintenance expense when needed.

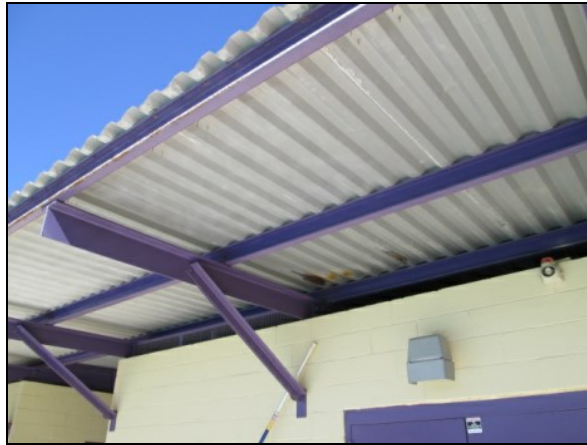
Comp #: 930 Metal Roofs - Replace**Quantity: Approx 3,740 Sq Ft**

Comments: Still appear to be in good condition. No signs of damage, or reports of problems. Long life expectancy under normal circumstances.

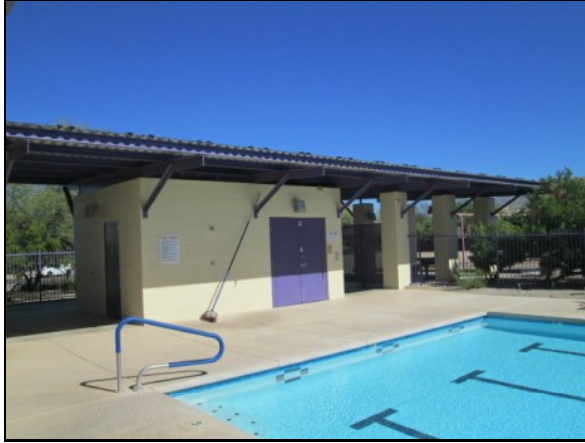
Comp #: 936 Solar Panels - Replace**Quantity: (40) Panels: 1,920 Sq Ft**

Comments: Solar panels are expected to be in good condition. We expect any repairs or corrections will be made under warranty or as a maintenance expense. Per the contract, this pool has (30) HC50 4'x12.5' and (10) HC40 4'x10.5' panels.

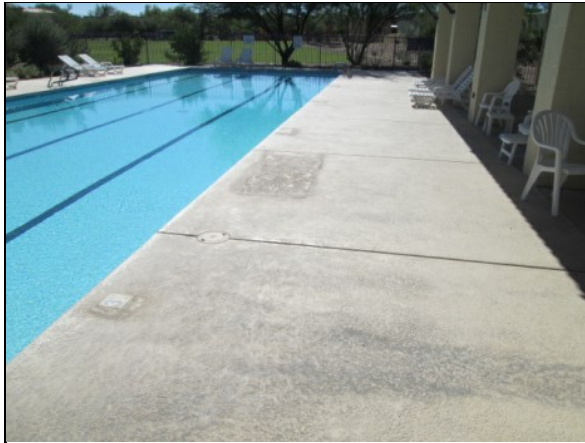
Comments: Deck coating is old and sections are smooth with no texture remaining. Visible patched spots and some cracks noted. There is no expectancy to replace the underlying concrete deck under normal circumstances. This component funds to grind off the existing top surface and re-coat with a new, acrylic coating. Combined cost with the seal/repair component accounts for the total estimated resurface budget.

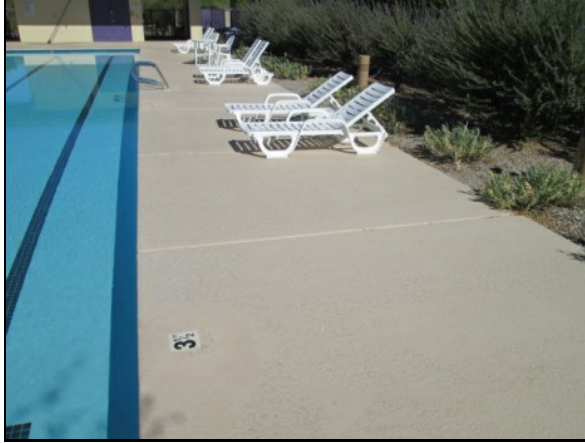
Comp #: 942 Pool Deck - Seal/Repair**Quantity: Approx 2,510 Sq Ft**

Comments: Surface is old and generally worn. It is due for a complete resurface, not just a seal/repair. This component funds to periodically patch cracks and paint/seal the deck to cover stains and restore the appearance.

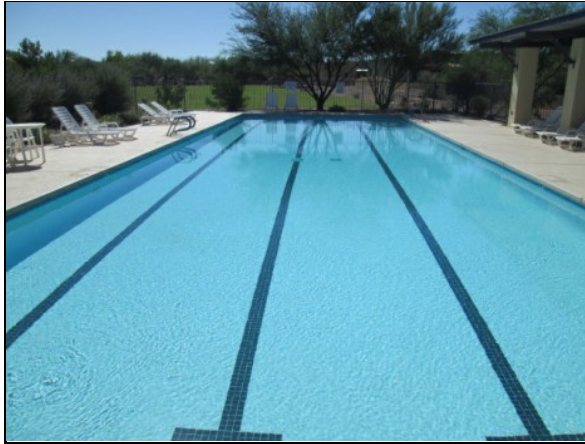
Comments: Pool has a white plaster surface with waterline tile and (2) lights. Surface is still in good condition.

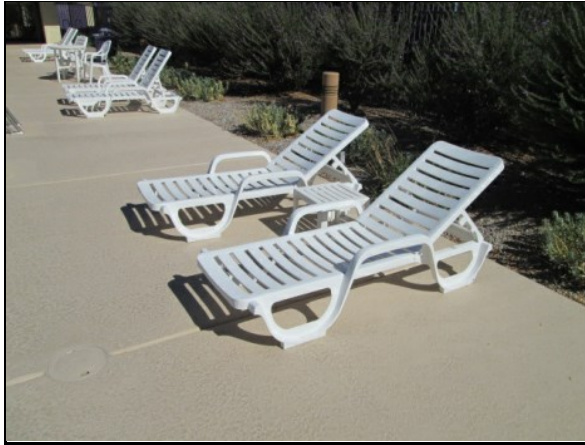
Comp #: 950 Pool Furniture - Replace**Quantity: (23) Pieces**

Comments: Furniture includes (10) lounges, (8) chairs, (2) tables, and (3) side tables. Some of this furniture is recycled plastic manufactured by Polywood. HOA also replaced some of the furniture with inexpensive plastic pieces in 2022. Plan for complete replacement to restore the quality and consistency.

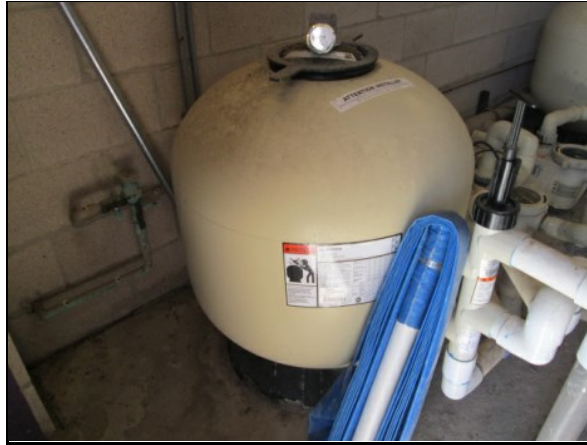
Comp #: 961 Pool Filters - Replace**Quantity: (2) Pentair 4.90 Sq Ft**

Comments: Filters appear to be functional and in decent shape. No problems observed or reported.

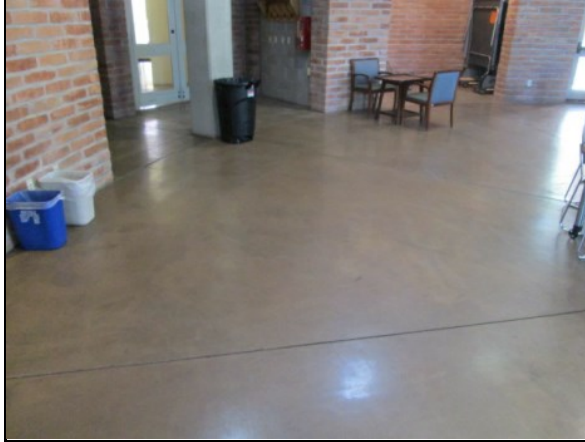
Comments: There is stained concrete flooring throughout the building. Periodic refinishing should be planned to restore the appearance. Surfaces still appear to be in fair condition, but refinishing should be planned again.

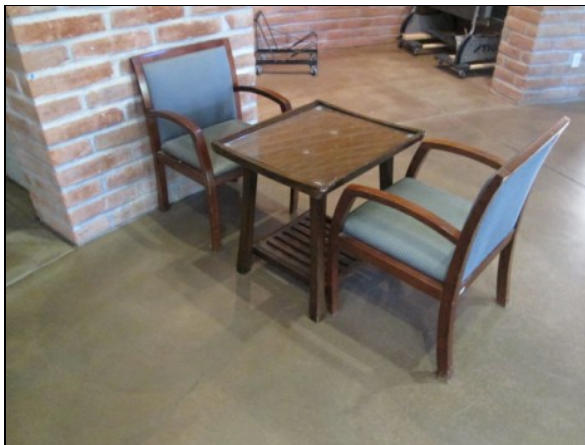
Comments: This furniture was replaced after our inspection. Quantity at the time included (10) chairs, (1) coffee table, (2) end tables, and (1) 3-in-one game table. This furniture was older and worn. Lots of surface scratches visible.

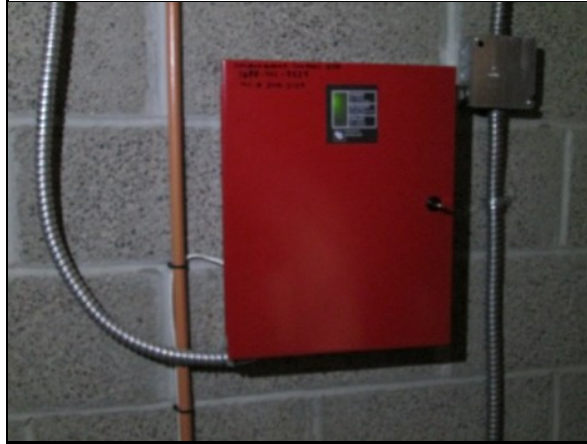
Comp #: 1128 Fire Sprinkler System - Repair**Quantity: (1) System**

Comments: Simplex Grinnell reports that the Activity Center does not have a fire alarm system, but it has a fire sprinkler system. The Silent Knight panel is a digital alarm communicating transmitter, not an alarm panel. It is required to be professionally inspected annually. There is no expectancy to completely replace this system. Funding is an allowance for repairs and parts replacement.

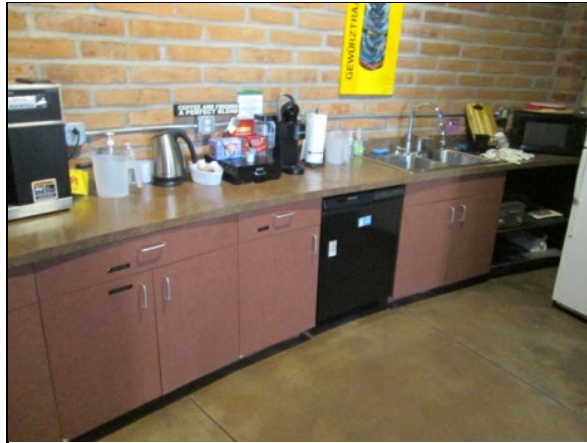
Comments: Kitchen has laminate cabinets and counters, (1) refrigerator, (1) dishwasher, (2) coffee makers, and (1) microwave. There is some visible wear and chipped spots. Looking older and dated.

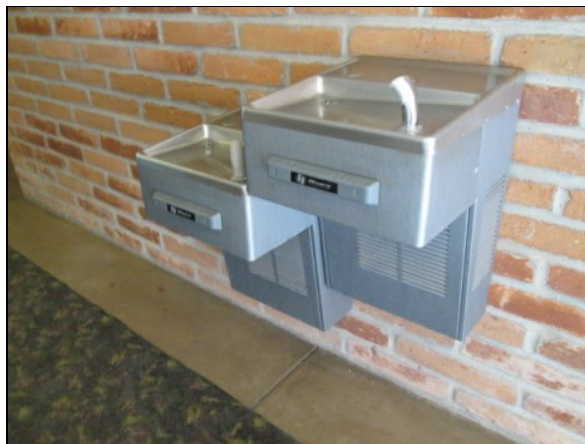
Comp #: 1146 Drinking Fountain - Replace**Quantity: (1) Haws**

Comments: This is a chilled water, bi-level drinking fountain. Still functional and looks fair. However, it is old and had low water flow or pressure. It should be nearing time for replacement.

*Model: HWBFA8L, Serial #98483444

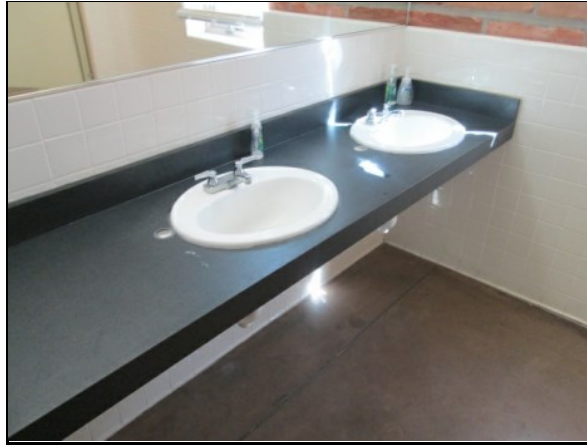
Comp #: 1147 Restroom Counters - Replace**Quantity: (2) Counters, ~18 LF**

Comments: HOA is planning to replace just the counters in 2024, so this component funds to replace the counters and sinks. Existing counters are laminate with counter mounted sinks. Replacement with granite or another upgraded type of material is likely.

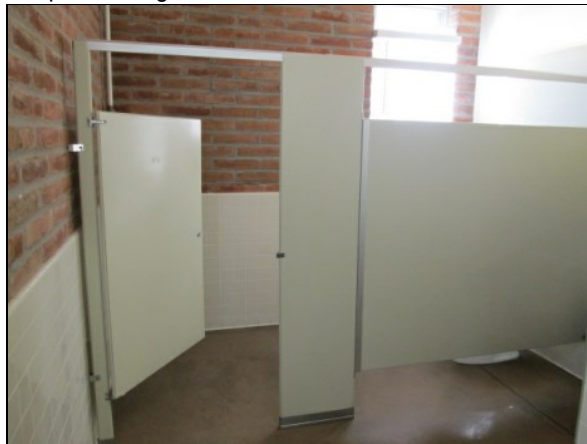
Comments: These are relatively basic and simple restrooms. Still clean but older and dated. No signs of excessive wear or damage. This component funds to replace the lights, mirrors, toilets, stalls, and urinals.

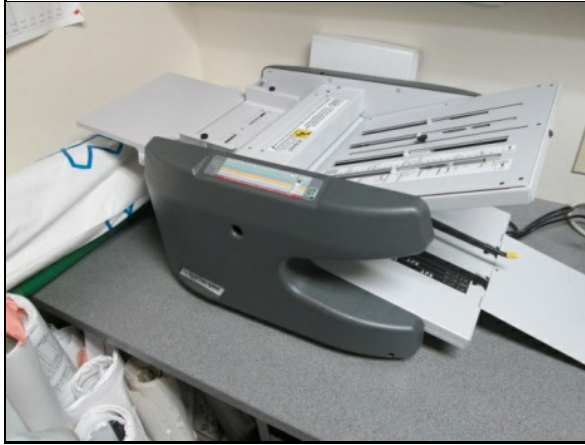
Comp #: 1155 Folding Machine - Replace**Quantity: (1) Martin Yale**

Comments: Appears newer and in good working condition. No problems were reported.

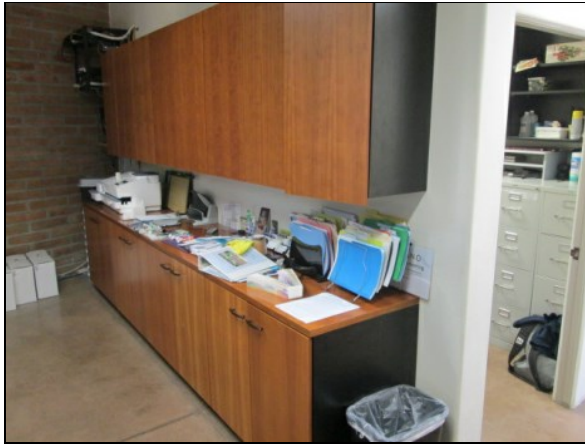
Comp #: 1156 Office Cabinetry - Replace**Quantity: Cabinets & Counters**

Comments: Cabinetry consists of a wood counter with wood base and upper cabinets. Still appears to be in fair condition, but HOA intends to replace in the near future.

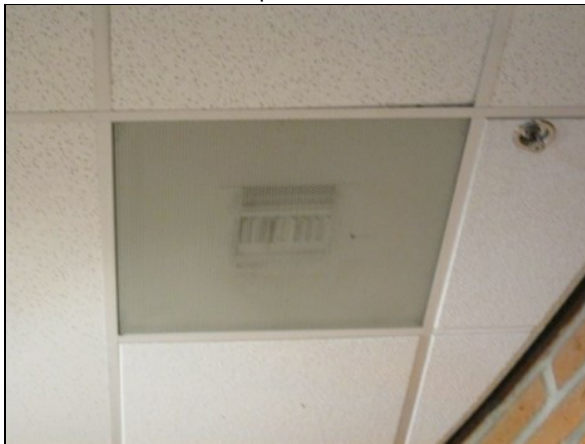
Comp #: 1160 Fan Coils - Replace**Quantity: (5) Fan Coils**

Comments: Fan coils work with the hydronic heating and cooling systems. No access to inspect, but no significant problems have been reported. Based on age, these fan coils should be replaced soon.

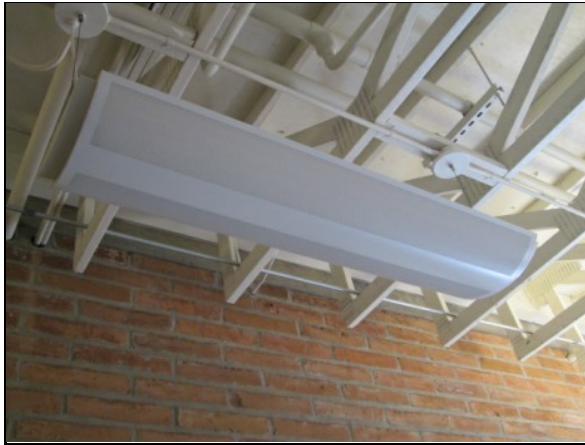
Comp #: 1164 Interior Lights - Replace**Quantity: Approx (50) Lights**

Comments: Lights include (8) ceiling spot lights, (8) recessed can lights, (1) Rotunda chandelier, (1) office hanging light, (22) fluorescent ceiling lights, (5) emergency lights, and (5) exit lights. Still functional and in fair condition. Replacement should be expected to update the lighting throughout this building.

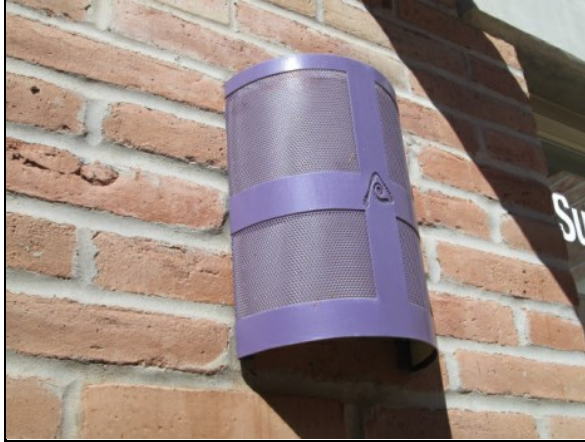
Comp #: 1166 Exterior Lights - Replace**Quantity: (9) Wall Lights**

Comments: These are large fixtures with custom metal covers. They are decorative, but the surfaces are faded. There is also some surface rust. Recommend painting them as a maintenance project or combining with other painting projects.

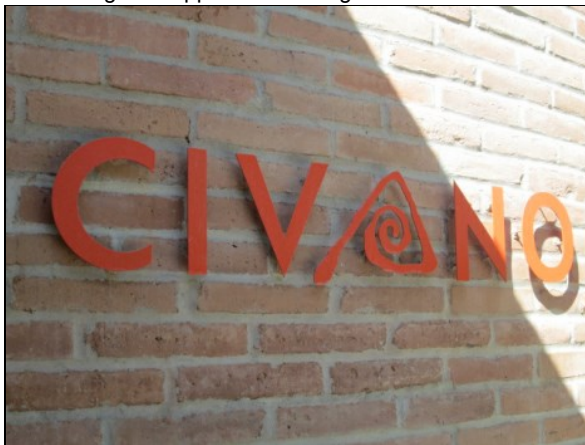
Comp #: 1168 Signage - Replace**Quantity: (1) Sign**

Comments: This is a set of metal letters that spell out 'Civano' mounted on the Activity Center. This component funds to periodically replace and update the lettering. Still appears to be in good condition.

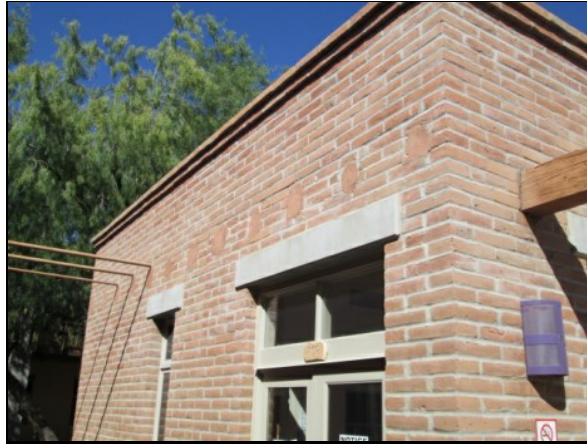
Comments: Exterior building walls are primarily Adobe block (~6,100 sq ft). This component also includes another ~3,100 sq ft of Adobe block walls at the Community Garden. These surfaces need to be periodically inspected, repaired as needed, and sealed. This component funds primarily just the sealing work. Based on timing of the last project, HOA should consider sealing again in the near future.

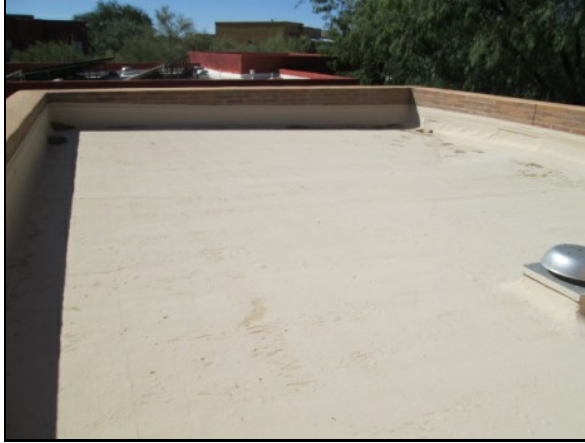
Comments: This roof has a white coating. Coating looks fine, but there were several small bubbles noted plus a couple cracks in the lower roof area. Surfaces should be periodically re-sealed/coated to protect the roof.

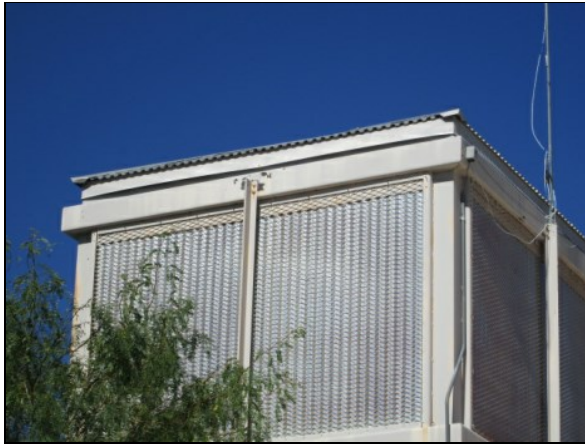
Comments: Top of the building and the cool tower both have a small section of corrugated metal roof. Long life expectancy under normal circumstances. Could not closely access the upper roof section during the inspection.
