ALL STAR HOME INSPECTION SERVICES, LLC

CONDOMINIUM INSPECTION

19655 E Country Club Dr 6204
Aventura, FL 33180

JUNE 28, 2023

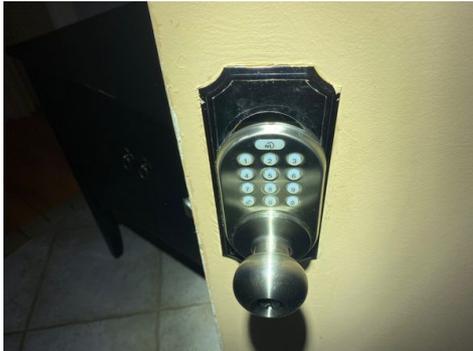
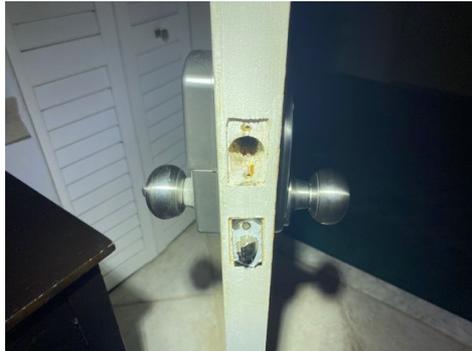
5.5.1 DOORS/ WINDOWS

DOORS - LOCK SETS DAMAGED OR INCORRECTLY INSTALLED

Locksets are damaged and/or deteriorated. Locksets should be replaced as necessary.

Contact a handyman or DIY project

\$150 - \$200

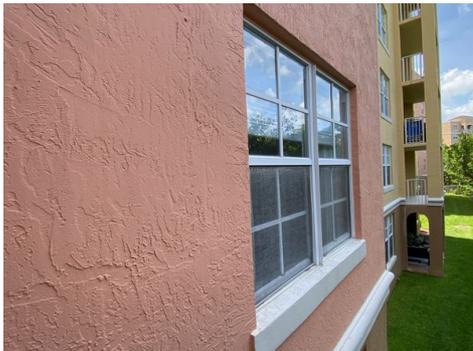
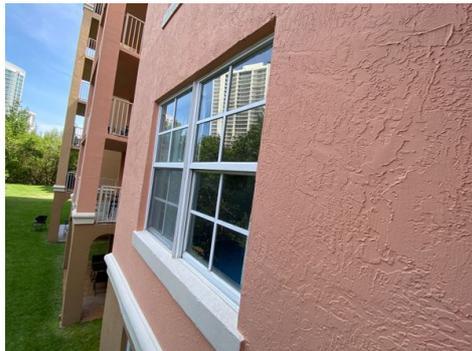
5.5.2 DOORS/ WINDOWS

WINDOWS - SCREENS DAMAGE HOLES AND/ OR TEARS

Screen(s) in windows are damaged, torn, or have holes in them. Screens should be replaced where necessary.

Contact a handyman or DIY project

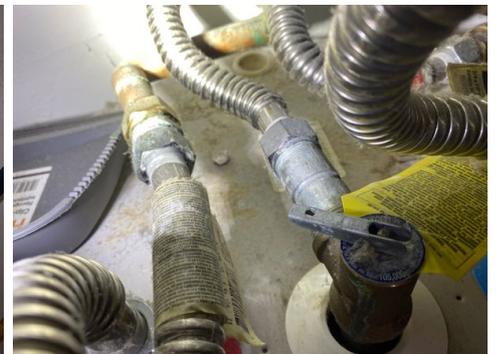
WATER HEATER

The estimated useful life for most water heaters is 8 to 12 years. This water heater appears to be at this age and may need replacing at any time. Recommend budgeting for a replacement in the near future.

Recommend monitoring.

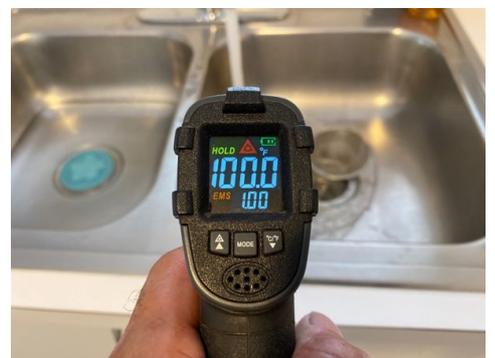
9.6.1 WATER TEMPERATURE

WATER TEMPERATURE

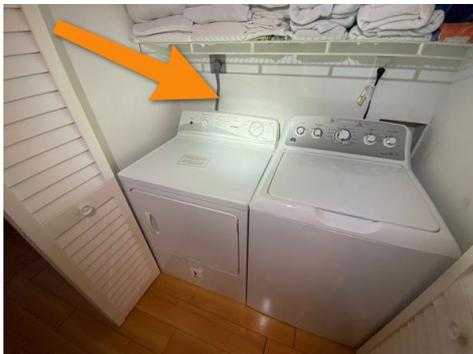
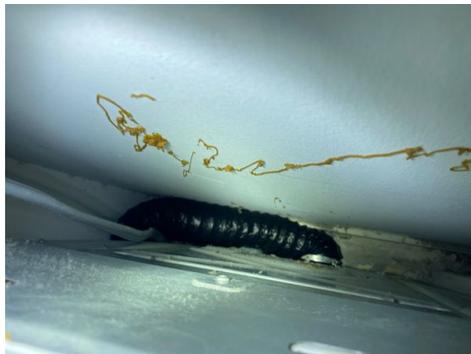
10.6.1 WASHER/ DRYER

The clothes dryer is equipped with a vinyl or foil, accordion-type, flexible exhaust duct. The U.S. Consumer Product Safety Commission considers these types of ducts to be unsafe, and a fire hazard. These types of ducts can trap lint and are susceptible to kinks or crushing, which can greatly reduce the air flow. This duct should be replaced with a rigid or corrugated semi-rigid metal duct, and by a qualified contractor if necessary. Most clothes dryer manufacturers specify the use of a rigid or corrugated semi-rigid metal duct. For more information, visit:<http://www.cpsc.gov/CPSCPUB/PUBS/5022.html>

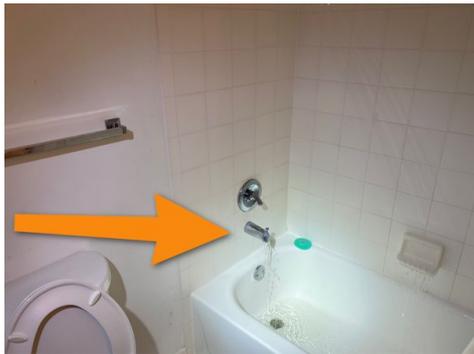
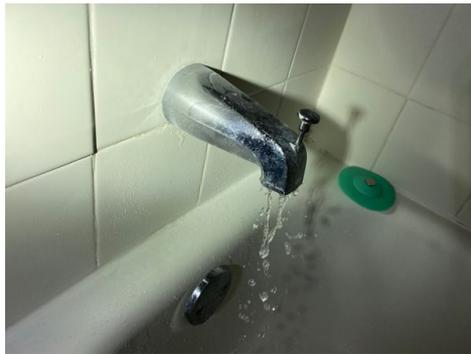
11.2.2 BATHTUBS/ SHOWERS

FAUCET - LEAKS WHEN ON

The shower head or tub spout leaks by handle(s) or at their base when turned on. A qualified plumber should evaluate and repair as necessary.

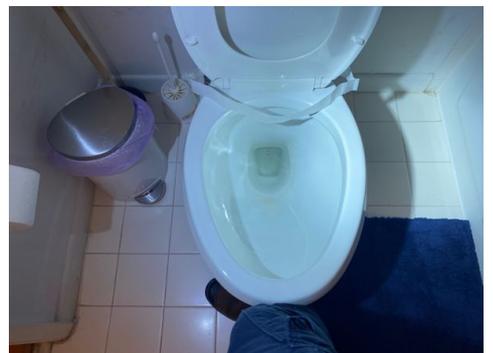
11.3.1 TOILETS

LOOSE

The toilet is loose. A qualified contractor should remove the toilet for further evaluation and repair if necessary. A new wax ring should be installed and toilet should be securely anchored to the floor to prevent movement and leaking.

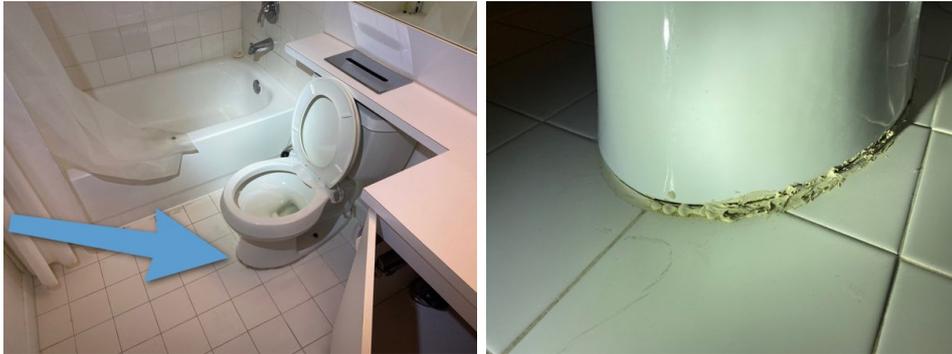
11.3.2 TOILETS

CAULKING DETERIORATED

The caulking around the base of the toilet is deteriorated and/or missing. Recommend replacing caulking where needed.

Contact a handyman or DIY project

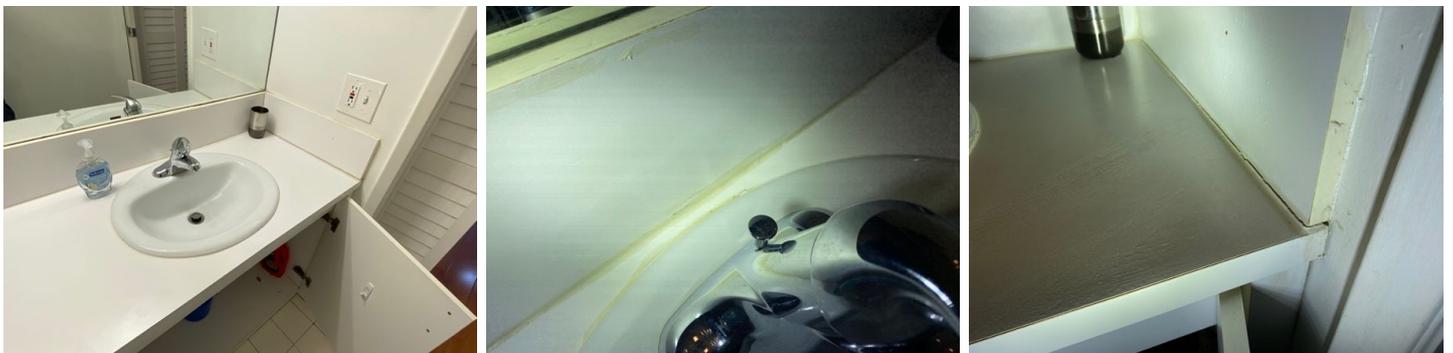
11.4.1 VANITIES/ SINKS

COUNTERTOPS - NEED CAULK AT BACKSPLASH

Caulk and/or grout is missing and/or deteriorated where countertops meet backsplashes in wet areas, such as around sinks. Caulk & grout should be replaced where deteriorated and/or applied where missing to prevent water damage. For more information on caulking, visit: [The Ins and Outs of Caulking](#).

Contact a handyman or DIY project

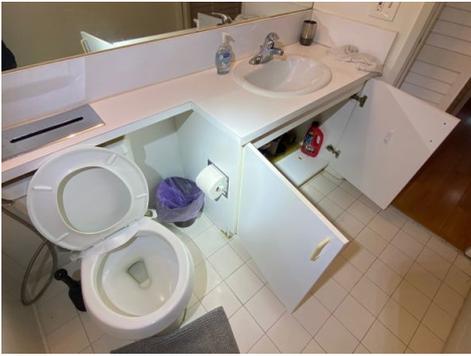
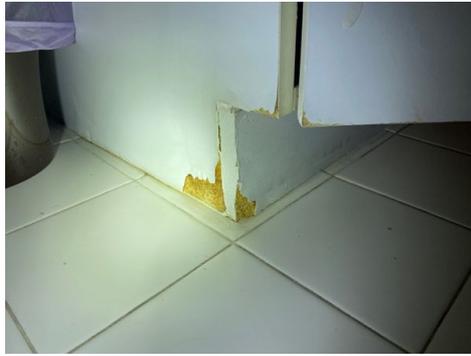
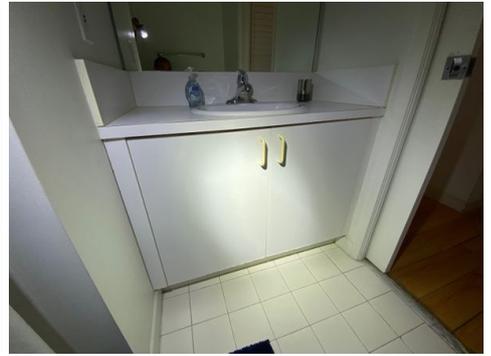
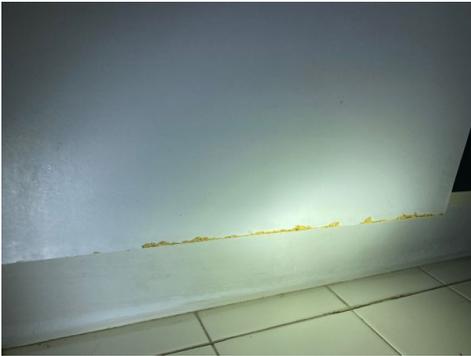
11.4.2 VANITIES/ SINKS

CABINETS - DETERIORATED

The cabinets and/or drawers are damaged and/or deteriorated. A qualified contractor should evaluate and repair or replace cabinets and/or components as necessary.

\$250 - \$350

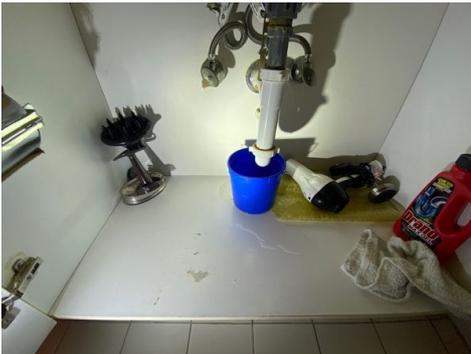
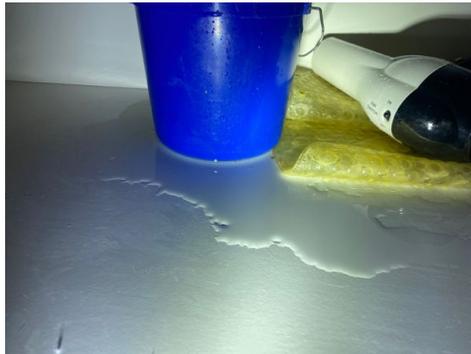
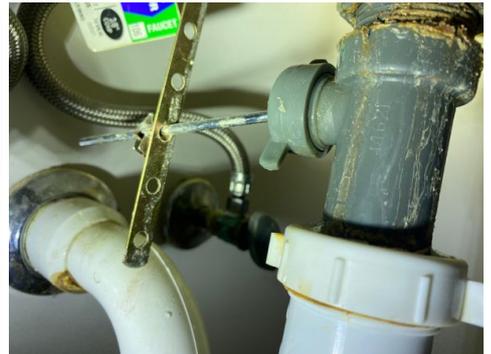
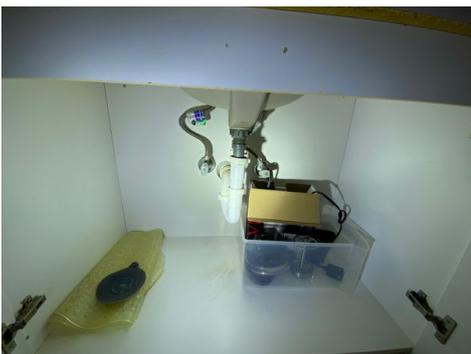
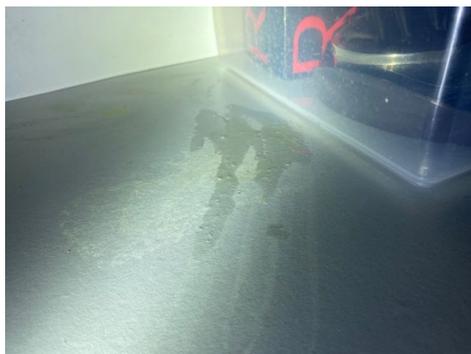
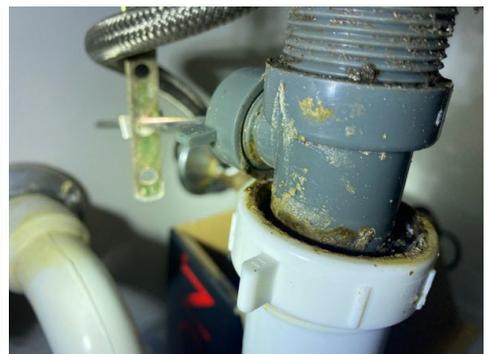
Sink drains have an active leak. For example, at pipe fittings and/or junctions between pipe and sink. A qualified plumber should evaluate and repair as necessary.

Recommendation

\$100 - \$300

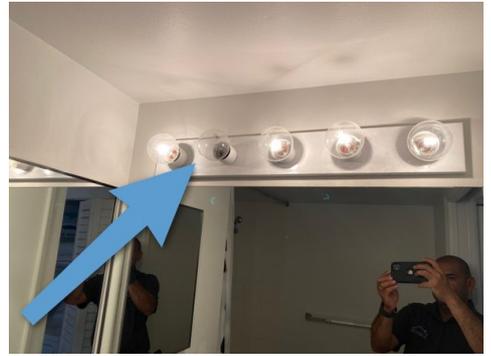
The light fixtures appear to be fully or partially inoperable. Recommend further evaluation by replacing bulb(s) and/or consulting with the property owner(s). Repairs or replacement of the light fixture by a qualified electrician may be necessary.

Contact a handyman or DIY project

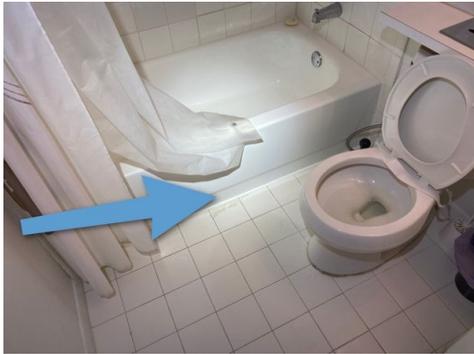
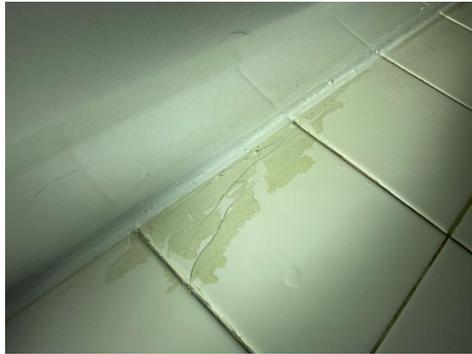
11.6.1 CEILINGS/ FLOORS/ WALLS

FLOOR - TILES - DAMAGED, CRACKED, AND/OR LOOSE

Deteriorated and/or Loose floor tiles were present at the time of inspection. Recommend having a qualified contractor evaluate, re-install, and seal.

Contact a qualified handyman.

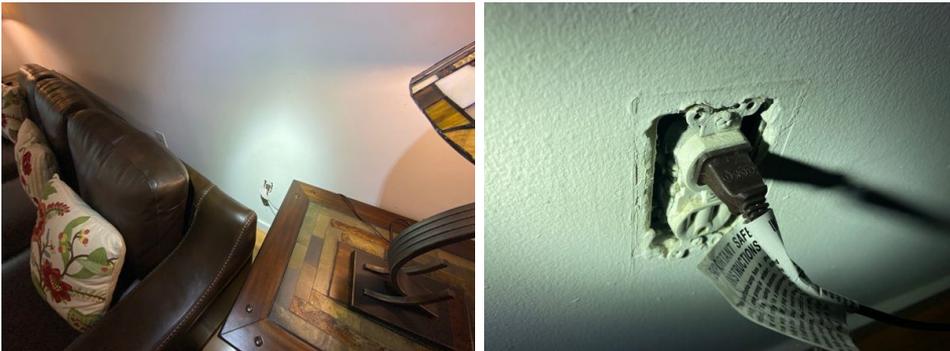
12.4.1 ELECTRICAL

COVER PLATES - MISSING

Cover plate(s) are missing from electric boxes, such as for receptacles, switches and/or junction boxes. They are intended to contain fire and prevent electric shock from exposed wires. This is a safety hazard due to the risk of fire and shock. Cover plates should be installed where missing.

\$10 - \$50

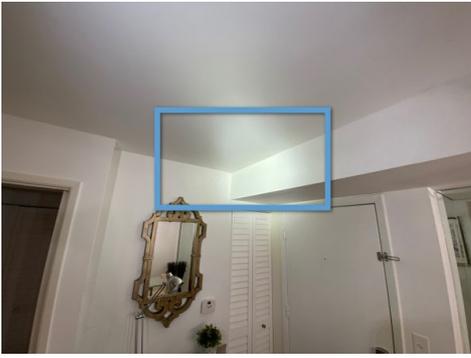
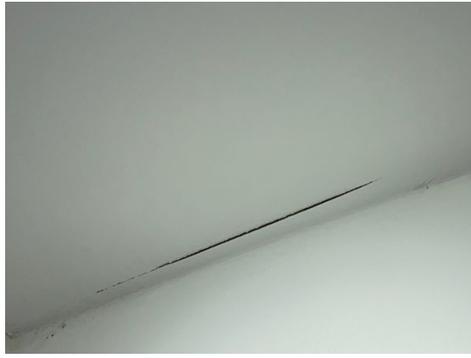
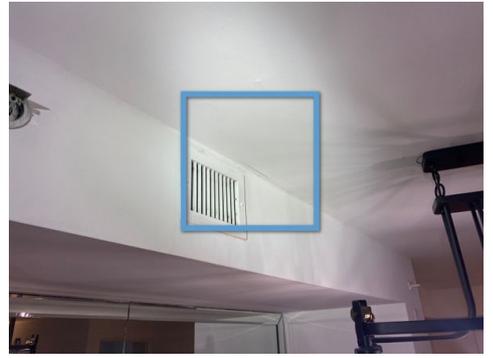
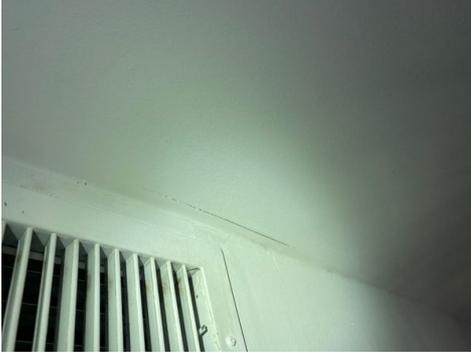
12.5.1 CEILINGS/ FLOORS/ WALLS

CEILINGS/WALLS - CRACKS - MINOR/MODERATE

Minor to moderate cracks were found in ceilings or walls. They do not appear to be a structural concern, but the client(s) may wish to have evaluated by a structural engineer or repair for aesthetic reasons.

Contact a qualified professional.

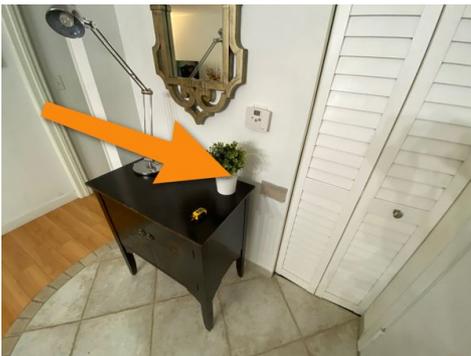
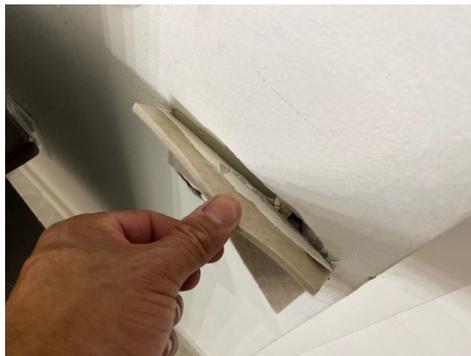
12.5.2 CEILINGS/ FLOORS/ WALLS

CEILINGS/WALLS - DAMAGE - MODERATE

Moderate damage was found on ceilings or walls. Recommend a qualified contractor evaluate and repair damaged areas.

\$100 - \$150

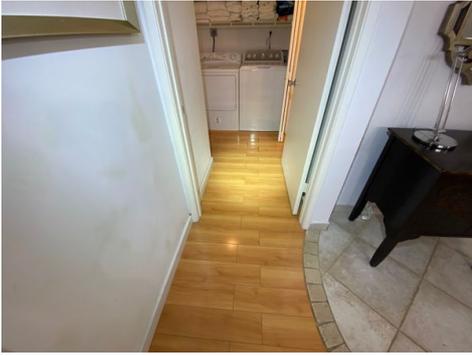
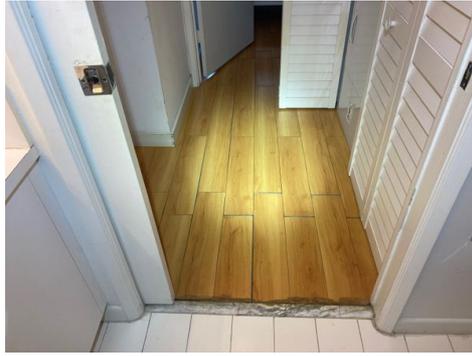
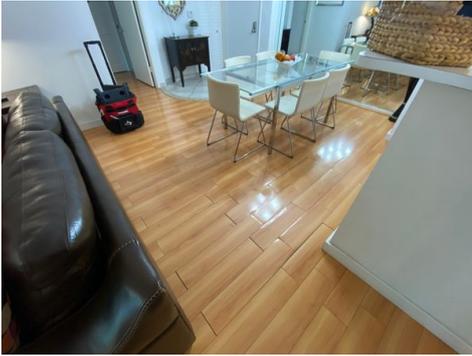
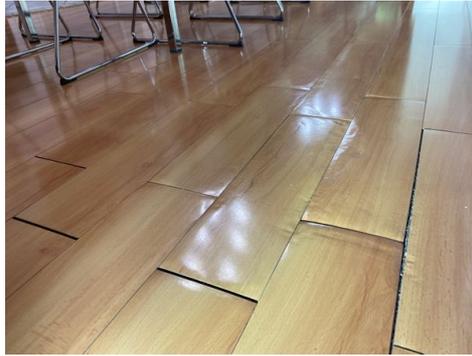
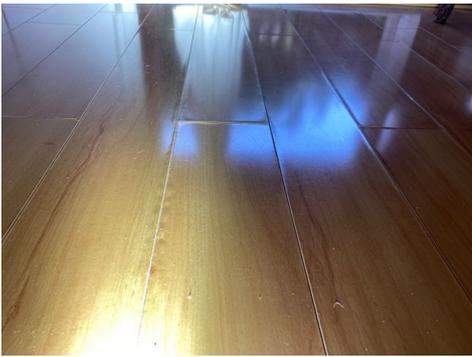
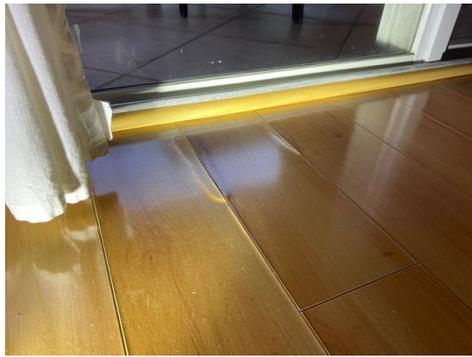
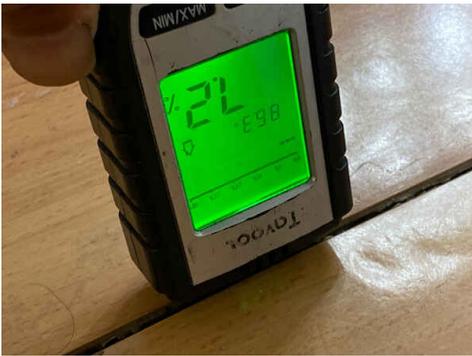
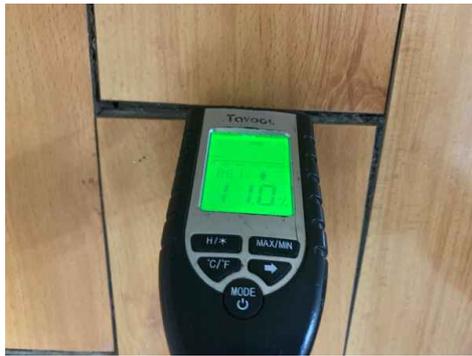
Vinyl or Laminate flooring is damaged and/or deteriorated. A qualified contractor should replace or repair the damaged flooring.

Contact a qualified flooring contractor

Estimated Cost
\$1,500 - \$1,700

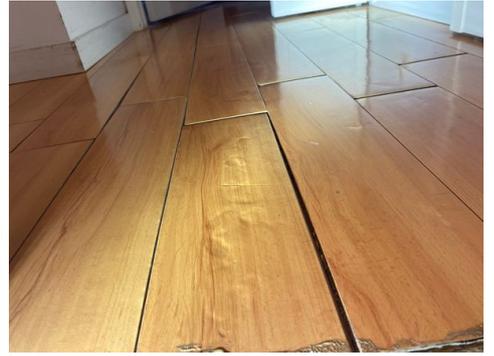
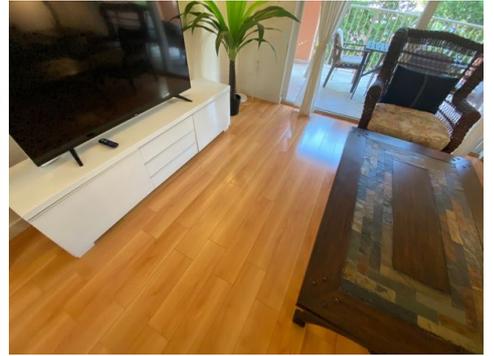
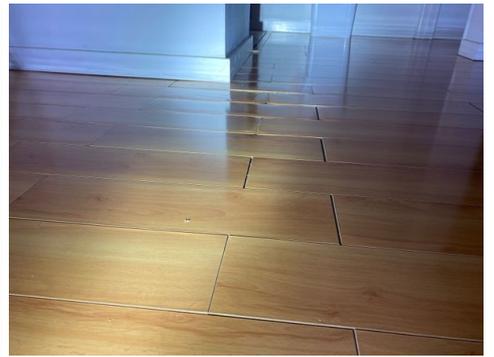
12.5.3 CEILINGS/ FLOORS/ WALLS

FLOOR - VINYL/LAMINATE FLOORING DETERIORATED

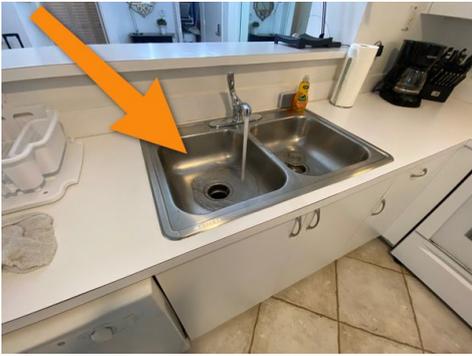
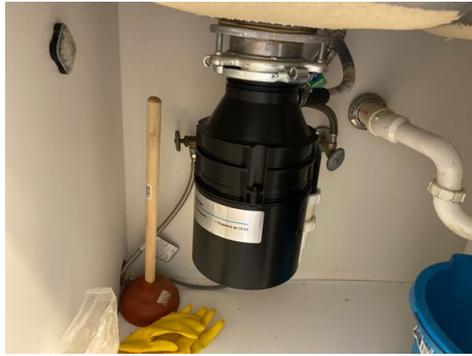
13.4.1 APPLIANCES

The under-sink food disposal is noisy. A qualified plumber or contractor should evaluate and repair or replace the food disposal as necessary.

Contact a qualified appliance repair professional.

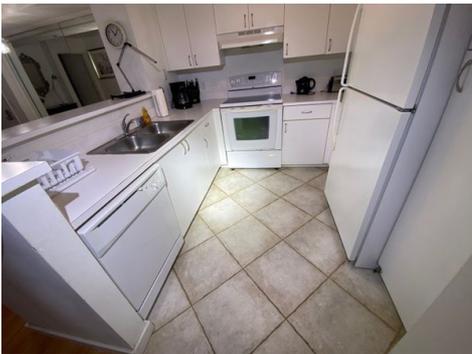
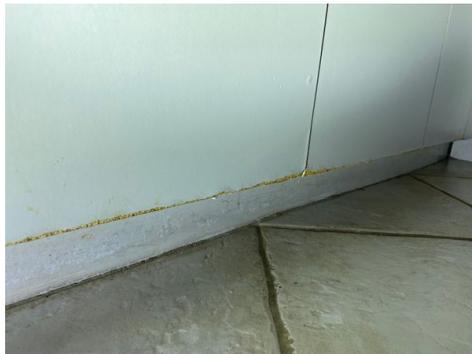
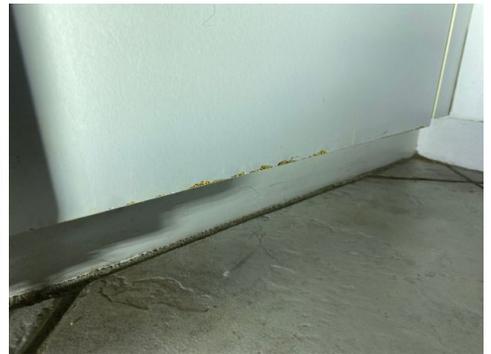
CABINETS - DETERIORATED

The cabinets and/or drawers are damaged and/or deteriorated. A qualified contractor should evaluate and repair or replace cabinets and/or components as necessary.

\$200 - \$600
