RESIDENTIAL INSPECTION

4524 Monarch Way
Coconut Creek FL 33073

MAY 25, 2021

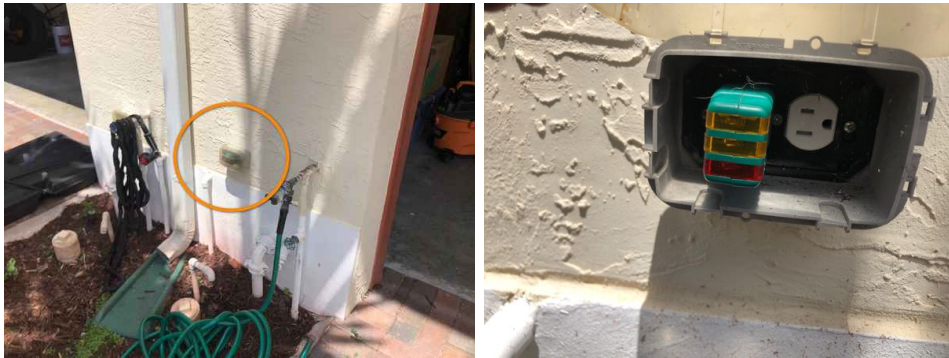
5.8.1 ELECTRICAL

RECEPTACLES - NO POWER

NORTHWEST

The electric receptacles appear to have no power. Recommend asking the property owner(s) about this. Switches may need to be operated to make some receptacles energized. If necessary, a qualified electrician should evaluate and make repairs as necessary.

Contact a qualified electrical contractor.

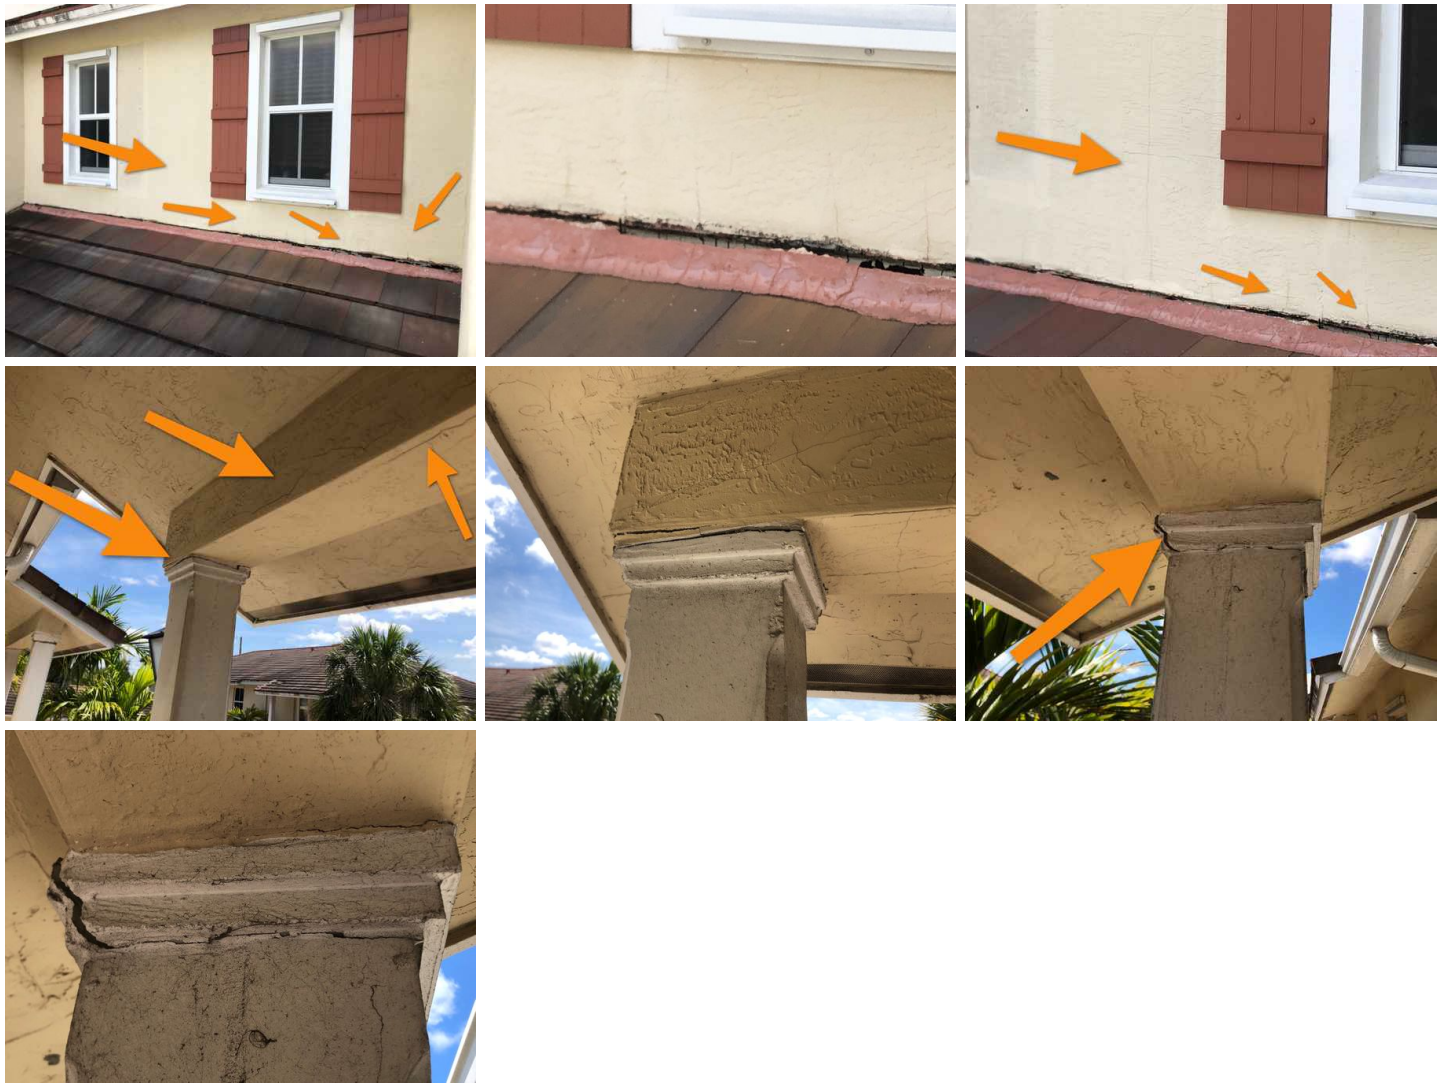
5.11.1 SIDING/ WALL COVERING

SIDING - STUCCO - MINOR CRACKS/ DETERIORATION

EAST, WEST

Minor cracks were found in sections of Stucco. The cracks do not appear to be structural. A qualified contractor should evaluate and make repairs as necessary, such as repairing stucco to prevent water intrusion and further deterioration in the future.

Contact a qualified masonry professional.

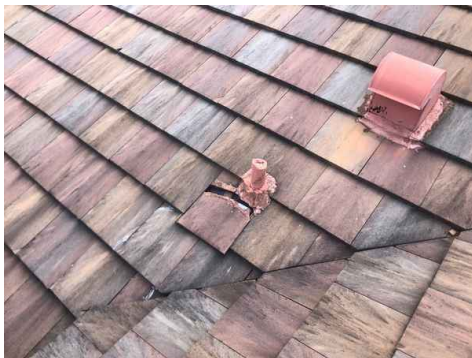
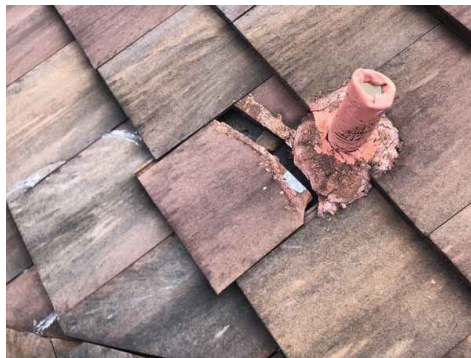
6.3.1 CONCRETE OR CLAY TILE DEFECTS

CHIPPED, CRACKED OR DAMAGED

WEST

Roofing tiles are chipped and/or cracked/Damaged. Photos may just be a sampling of what is actually on the roof. A qualified roofing contractor should evaluate and replace tiles as necessary.

Contact a qualified roofing professional.

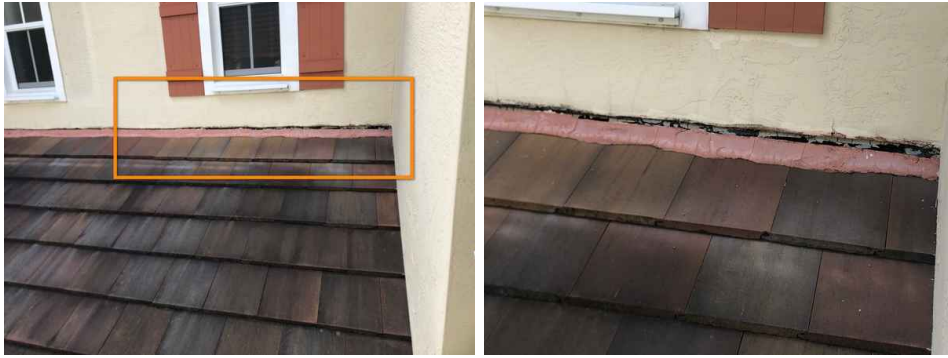
6.3.2 CONCRETE OR CLAY TILE DEFECTS

LOOSE TILES

EAST

Roofing tiles have slipped, and are loose. Photos may just be a sampling of what is actually on the roof. A qualified roofing contractor should fully evaluate and repair as necessary.

Contact a qualified roofing professional.

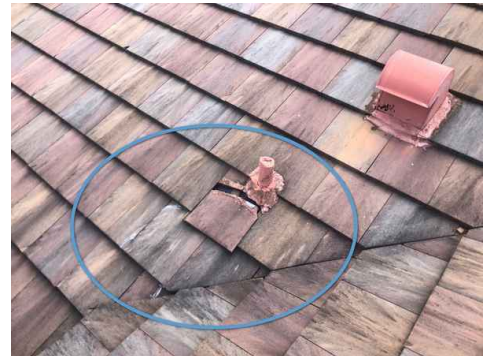
6.3.3 CONCRETE OR CLAY TILE DEFECTS

PREVIOUS REPAIRS

EAST

The roof shows signs of previous repairs. The could be from ordinary maintenance or from a more serious repair. Recommend asking current homeowners about this.

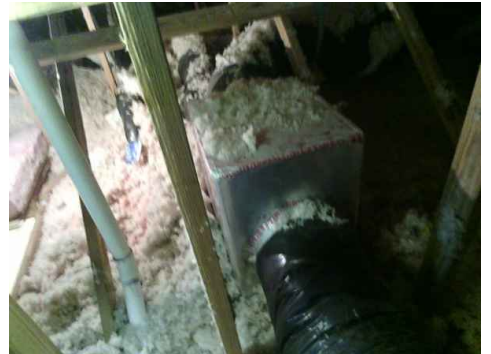
7.2.1 LIMITATIONS

ATTIC SPACE - SOME AREAS INACCESSIBLE

ATTIC

Some attic areas were inaccessible due to lack of permanently installed walkways, the possibility of damage to insulation, low height, deep insulation and/or stored items. These areas are excluded from this inspection.

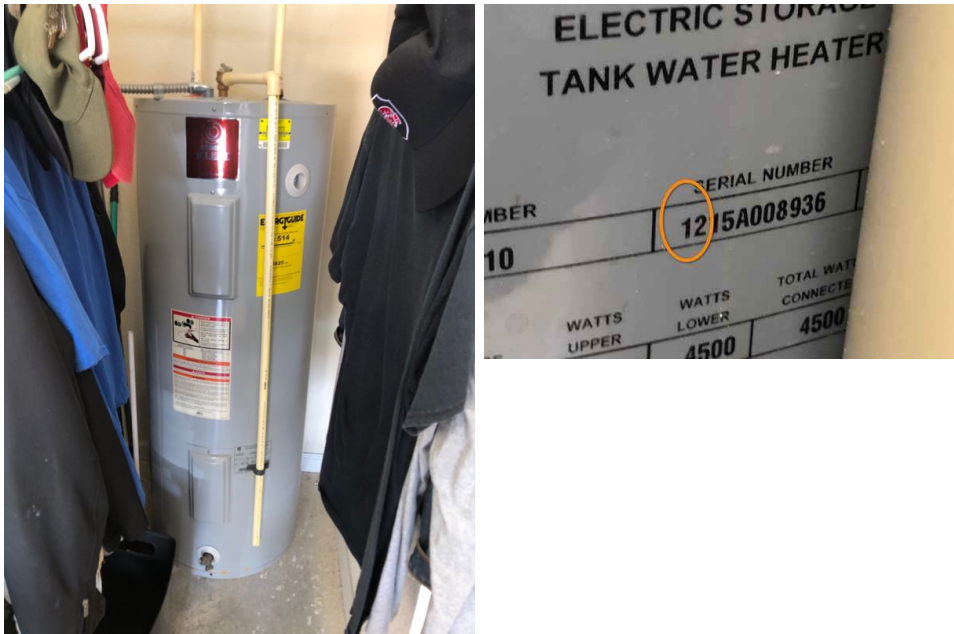
11.5.1 WATER HEATER
AGE - AT 8-12 YEARS

The estimated useful life for most water heaters is 8 to 12 years. This water heater appears to be at this age and may need replacing at any time. Recommend budgeting for a replacement in the near future.

Recommend monitoring.

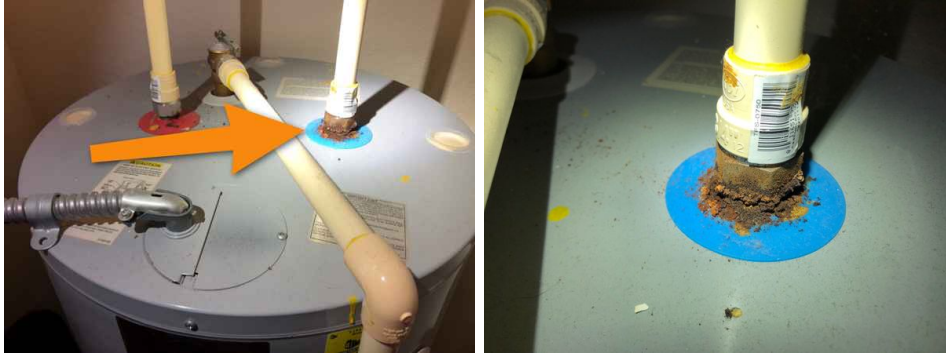
11.5.2 WATER HEATER

WATER HEATER - SIGNS - CORROSION ON FITTINGS

Corrosion was found on fittings and/or water supply lines for the water heater. Leaks may exist. A qualified plumbing contractor should evaluate and repair or replace as necessary.

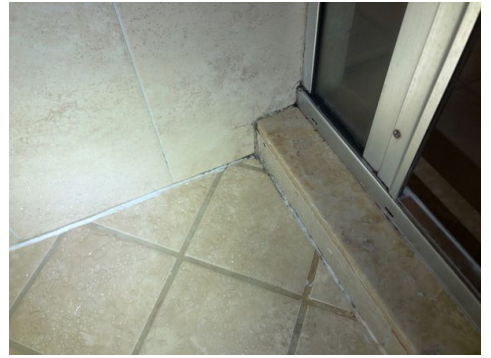
CAULK - DETERIORATED/MISSING AROUND SURROUND

Caulk is missing or deteriorated around the shower/bathtub surround. It should be replaced where deteriorated and/or applied where missing to prevent water intrusion and damage to the wall structure. For more information on caulking, visit: [The Ins and Outs of Caulking](#).

Contact a handyman or DIY project

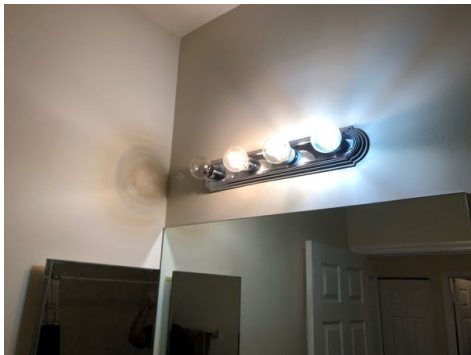
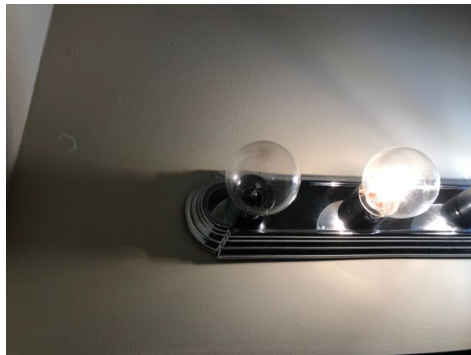
13.2.1 ELECTRICAL

LIGHTING - INOPERABLE

The light fixtures appear to be fully or partially inoperable. Recommend further evaluation by replacing bulb(s) and/or consulting with the property owner(s). Repairs or replacement of the light fixture by a qualified electrician may be necessary.

Contact a handyman or DIY project

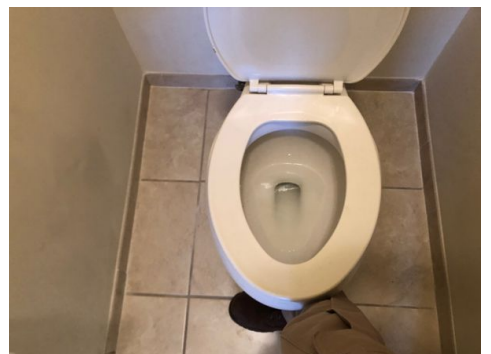
13.3.1 TOILETS

LOOSE

The toilet is loose. A qualified contractor should remove the toilet for further evaluation and repair if necessary. A new wax ring should be installed and toilet should be securely anchored to the floor to prevent movement and leaking.

Contact a qualified plumbing contractor.

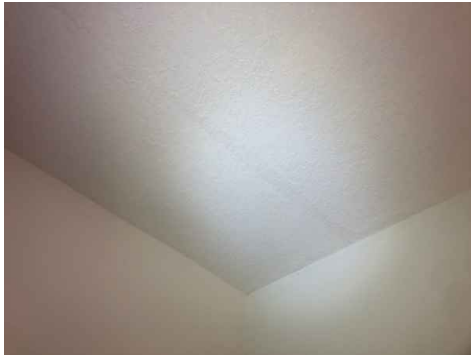
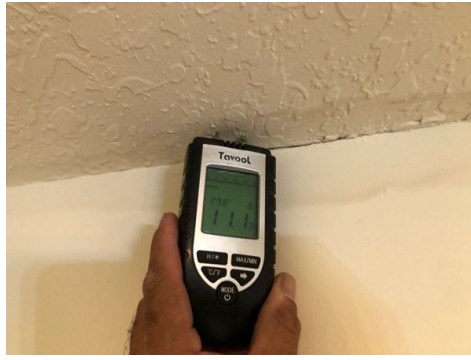
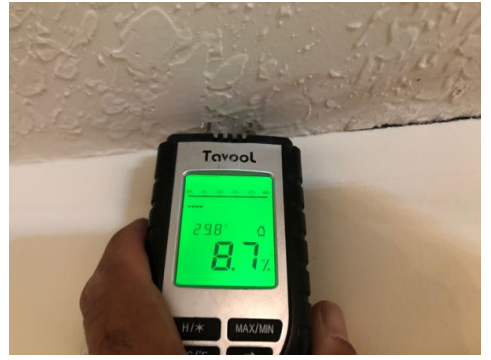
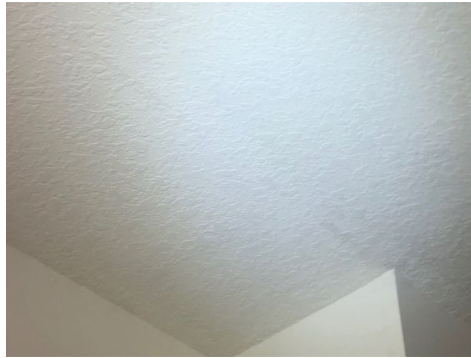
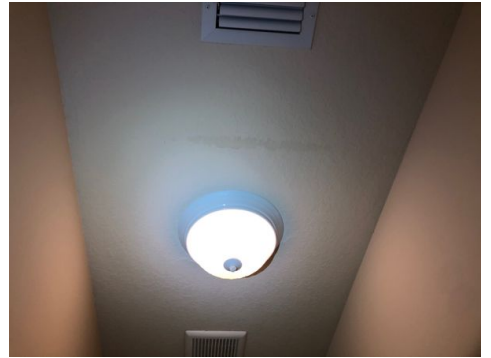
13.4.1 CEILINGS/ FLOORS/ WALLS

CEILINGS/WALLS - STAINS - DRY - MONITOR

Stain(s) were identified in ceilings or walls, however, no elevated levels of moisture were found at the time of the inspection. The stain(s) may be due to past roof and/or plumbing leaks. Hidden mold may exist in wall cavity, which could require remediation and drive up repair costs. Recommend asking the current owner(s) about this and monitoring the stained area(s) in the future, especially after heavy or prolonged rain. If elevated moisture is identified in the future, a qualified contractor should evaluate and repair as necessary.

Recommend monitoring.

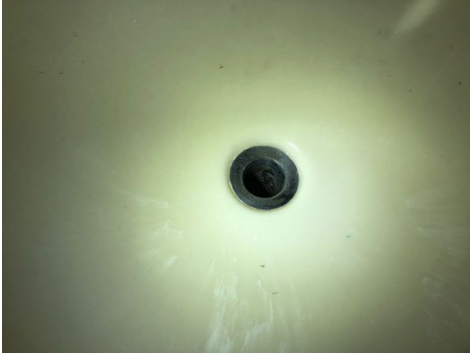
13.5.1 VANITIES/ SINKS

SINK - STOPPER MISSING OR DEFECTIVE

The sink stopper mechanism is missing, or needs adjustment or repair. Stopper mechanisms should be installed where missing and/or repairs should be made so sink stoppers open and close easily.

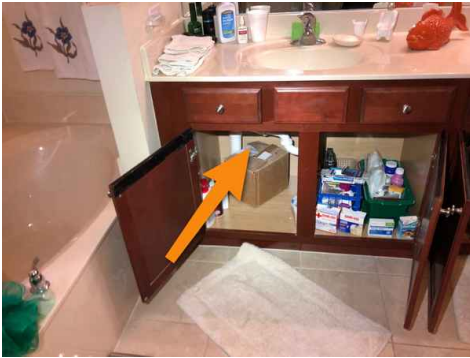
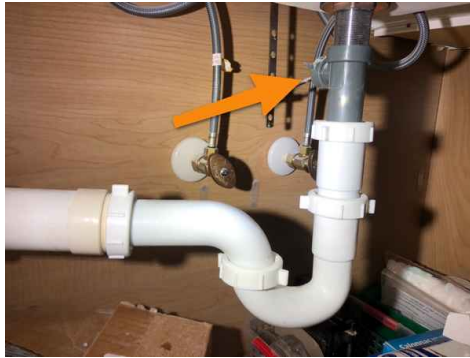
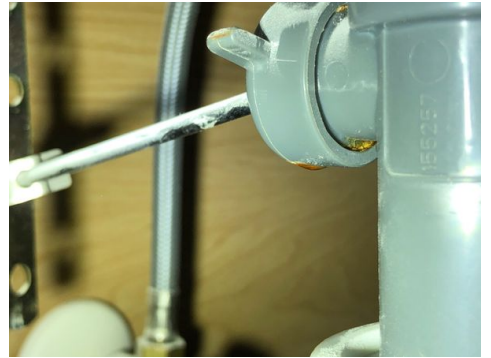
13.5.2 VANITIES/ SINKS

PLUMBING - LEAK IN DRAIN LINE

Sink drains have an active leak. For example, at pipe fittings and/or junctions between pipe and sink. A qualified plumber should evaluate and repair as necessary.

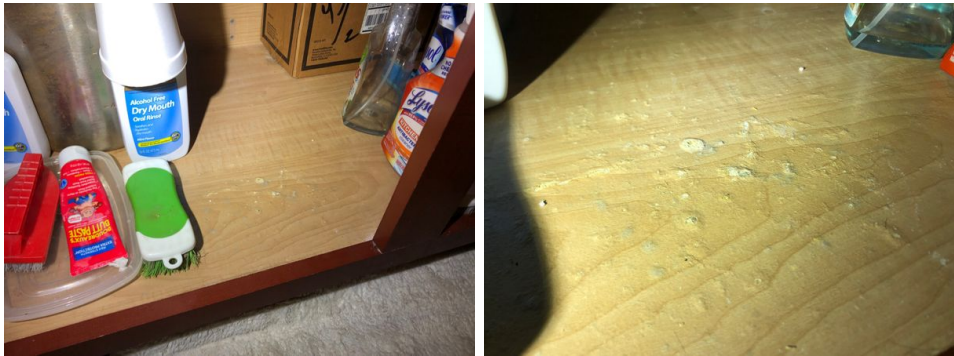
13.5.3 VANITIES/ SINKS

WATER DAMAGE - MINOR

Water stains and/or minor water damage was found in the shelving or cabinet components below the sink. The client(s) should evaluate and consider having repairs made.

Contact a qualified carpenter.

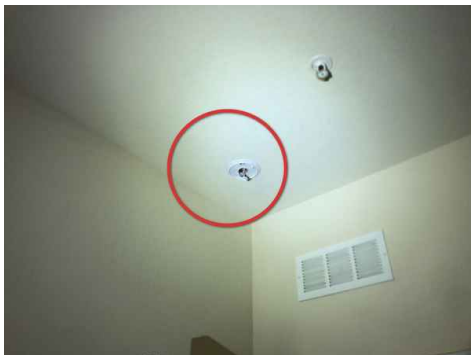
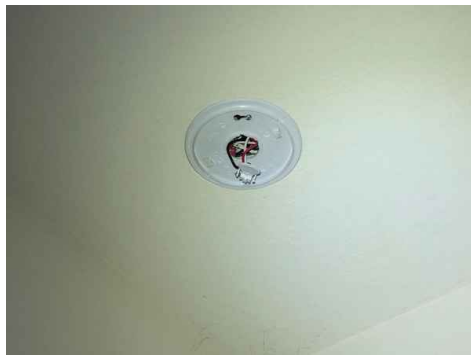
14.2.1 SMOKE AND CARBON MONOXIDE ALARMS

SMOKE ALARMS - DAMAGED/MISSING AND TOO FEW

Smoke alarms are damaged or missing from their mounting brackets, and an insufficient number of smoke alarms are installed. Damaged and/or missing smoke alarms should be replaced as necessary so a functioning one exists in each hallway leading to bedrooms, and in each bedroom. For more information, visit: <http://www.cpsc.gov/cpscpub/pubs/5077.html>

Recommended DIY Project

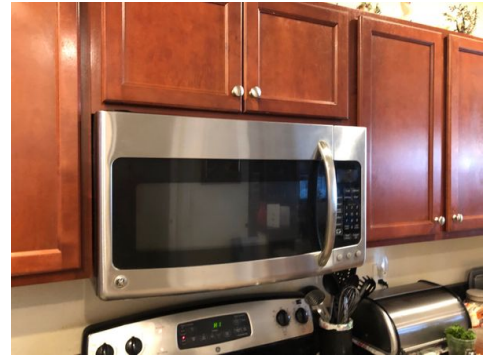
The microwave oven appears to be inoperable. A qualified appliance technician should evaluate and repair as necessary.

Contact a qualified appliance repair professional.

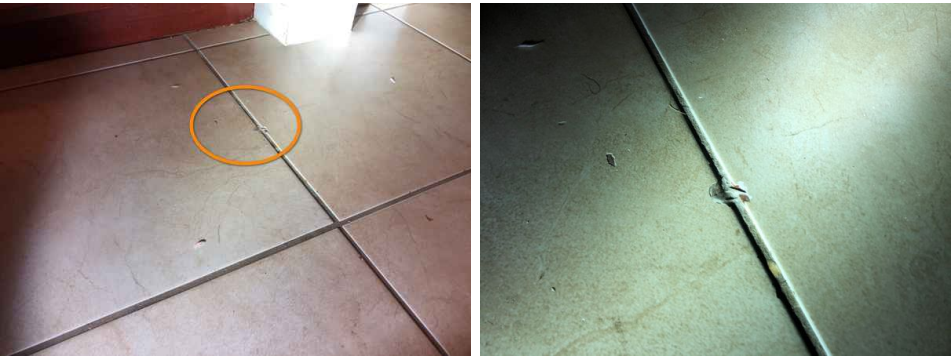
15.6.1 FLOORS

TILE/STONE AND GROUT - DETERIORATED

Tile, stone and/or grout flooring is damaged and/or deteriorated. A qualified contractor should evaluate and make repairs as necessary. For example, replacing broken tiles and deteriorated grout, and resealing grout.

Contact a qualified tile contractor
