# ALL STAR HOME INSPECTION SERVICES, LLC

## RESIDENTIAL INSPECTION

4524 Monarch Way  
Coconut Creek FL 33073

Mike Lopez  
MAY 25, 2021

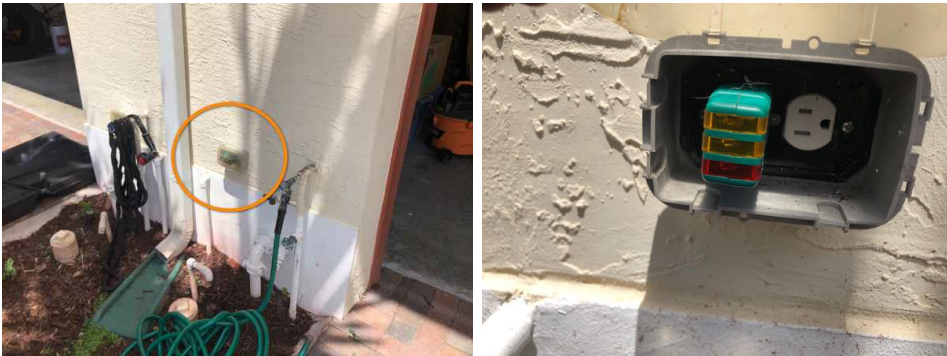
### 5.8.1 ELECTRICAL

#### **RECEPTACLES - NO POWER**

##### NORTHWEST

The electric receptacles appear to have no power. Recommend asking the property owner(s) about this. Switches may need to be operated to make some receptacles energized. If necessary, a qualified electrician should evaluate and make repairs as necessary.

Contact a qualified electrical contractor.

\$0 - \$250

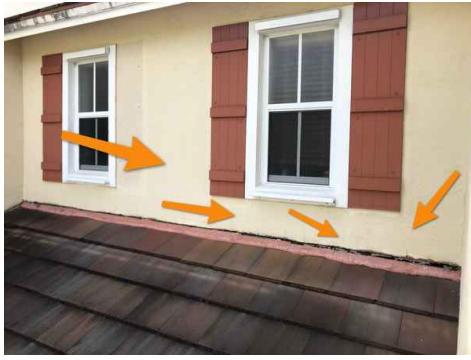
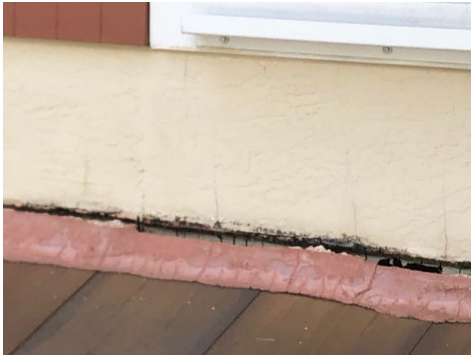
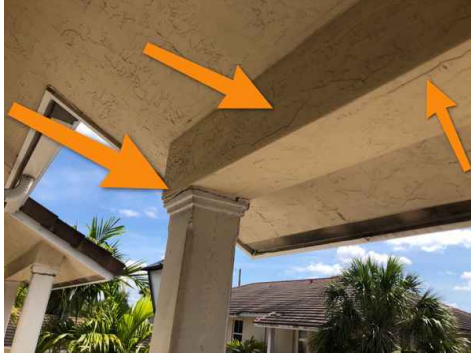
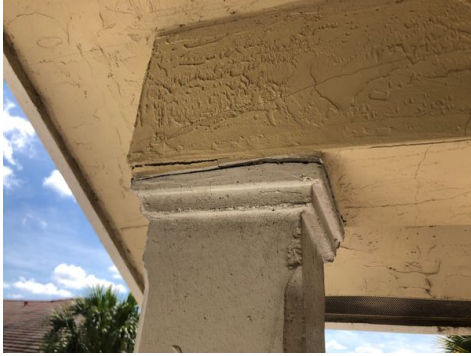
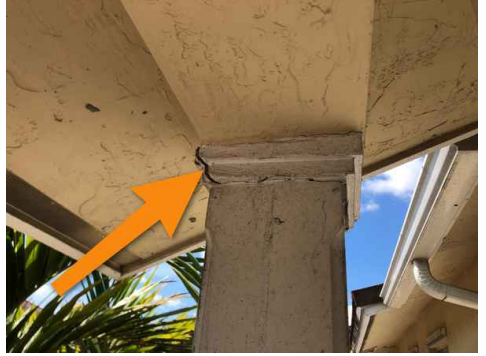
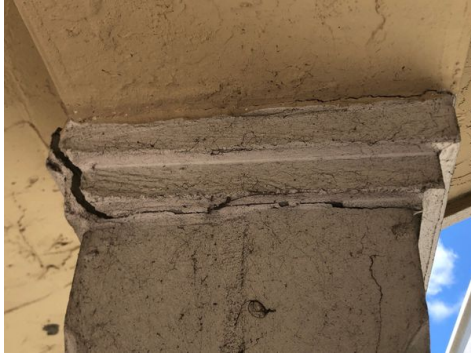
#### **SIDING - STUCCO - MINOR CRACKS/ DETERIORATION**

Minor cracks were found in sections of Stucco. The cracks do not appear to be structural. A qualified contractor should evaluate and make repairs as necessary, such as repairing stucco to prevent water intrusion and further deterioration in the future.

##### Recommendation

\$250 - \$350

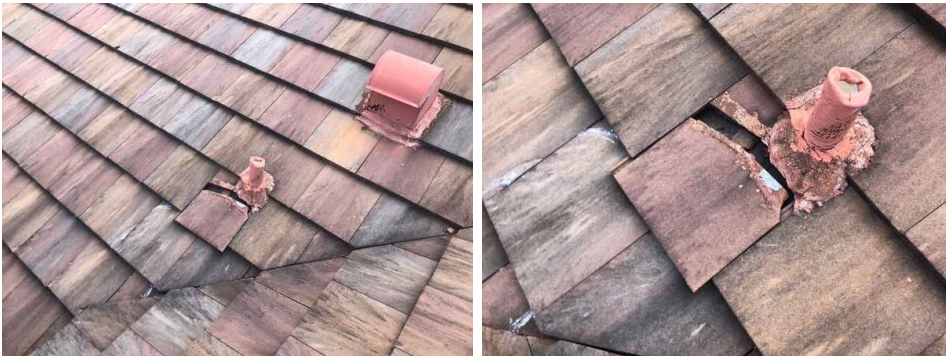
### 6.3.1 CONCRETE OR CLAY TILE DEFECTS

#### **CHIPPED, CRACKED OR DAMAGED**

WEST

Roofing tiles are chipped and/or cracked/Damaged. Photos may just be a sampling of what is actually on the roof. A qualified roofing contractor should evaluate and replace tiles as necessary.

Contact a qualified roofing professional.

\$350 - \$550

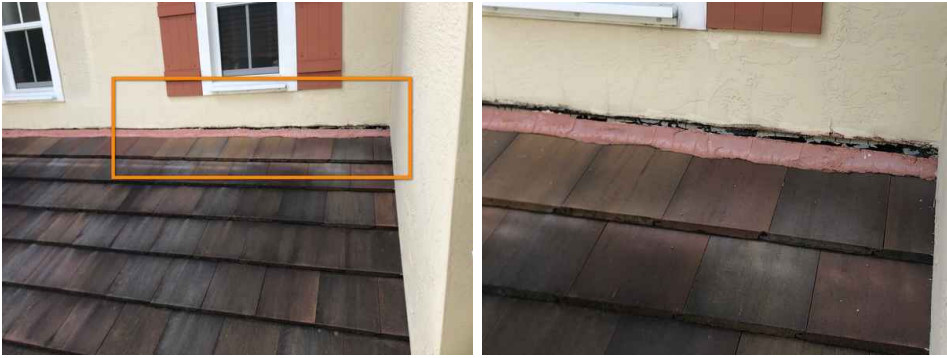
### 6.3.2 CONCRETE OR CLAY TILE DEFECTS

#### **LOOSE TILES**

EAST

Roofing tiles have slipped, and are loose. Photos may just be a sampling of what is actually on the roof. A qualified roofing contractor should fully evaluate and repair as necessary.

Contact a qualified roofing professional.

\$450 - \$550

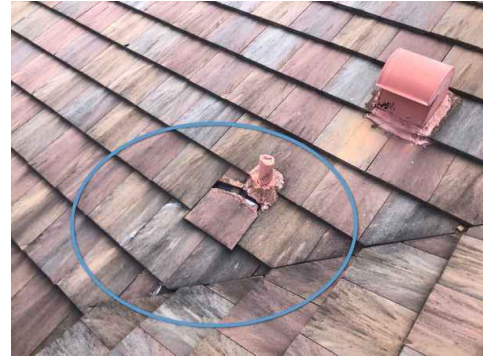
6.3.3 CONCRETE OR CLAY TILE DEFECTS

**PREVIOUS REPAIRS**

EAST

The roof shows signs of previous repairs. The could be from ordinary maintenance or from a more serious repair. Recommend asking current homeowners about this.

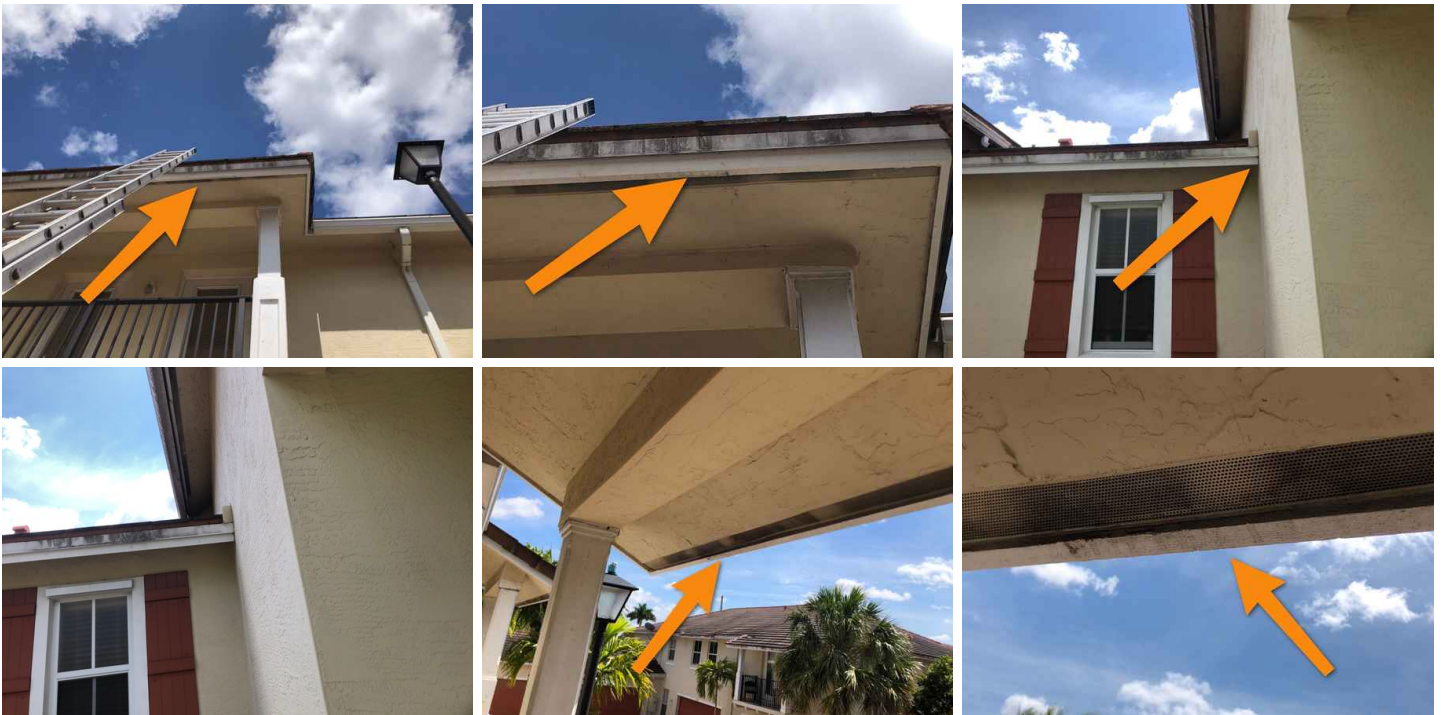
6.6.1 GENERAL ROOFING

**ROOF - VISIBLE EAVE LEAK**

EAST, WEST

There are visible leaks from the roof around the perimeter and eaves. Recommend qualified roofer evaluate and repair

Contact a qualified roofing professional.

\$300 - \$600

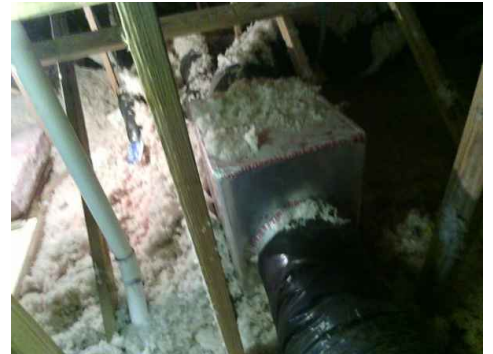
### 7.2.1 LIMITATIONS

#### **ATTIC SPACE - SOME AREAS INACCESSIBLE**

##### ATTIC

Some attic areas were inaccessible due to lack of permanently installed walkways, the possibility of damage to insulation, low height, deep insulation and/or stored items. These areas are excluded from this inspection.

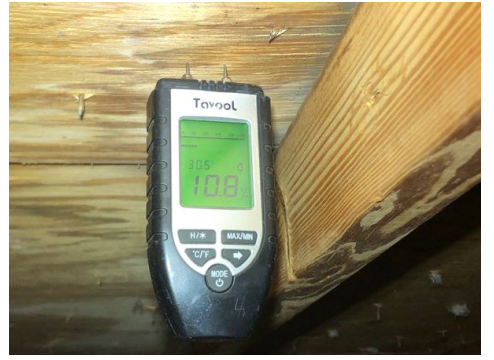
### 7.5.1 ROOF STRUCTURE

#### **STAINS - DRY**

##### ATTIC

Stains were visible on the roof structure. These areas were dry at the time of the inspection. The stains may be caused by a past leak or a leak that only occurs during heavy, wind driven or prolonged rain. Recommend asking the property owner(s) about past leaks. The client(s) should monitor these areas in the future, especially after heavy rains, to determine if active leaks exist. If leaks are found, a qualified roofing contractor should evaluate and repair as necessary.

Recommend monitoring.

\$350 - \$450

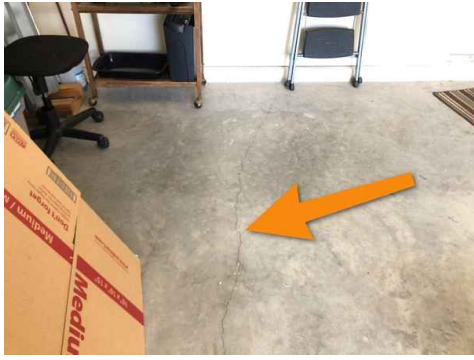
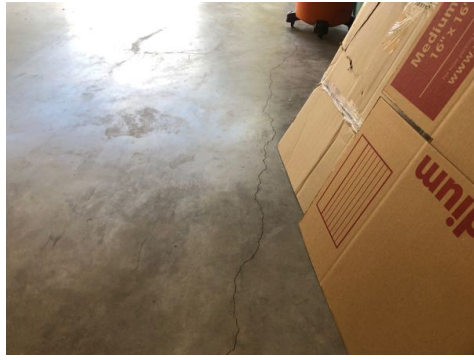
**FLOORS - CRACKS - MINOR**

There were minor cracks and/or cosmetic blemishes found in the garage floor. These don't appear to be a structural concern, but recommend sealing them to prevent water infiltration and monitoring them in the future. Numerous products exist to seal such cracks including: Hydraulic cement. Requires chiseling a channel in the crack to apply. Resilient caulks (easy to apply). Epoxy sealants (both a waterproof and structural repair).

Recommend monitoring.

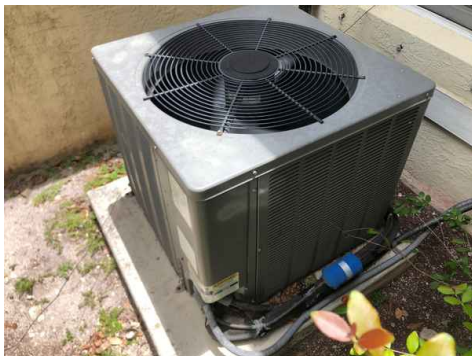
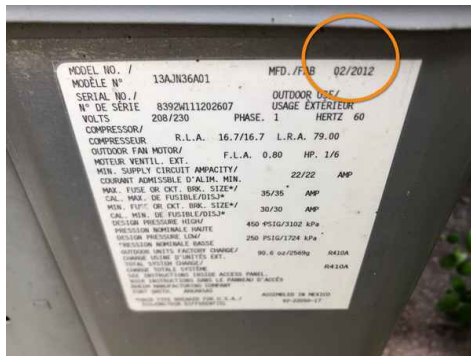
10.4.1 AC

The estimated useful life for air conditioning condenser/compressors is 8 to 15 years. This unit appears to be at this age and may need replacing at any time. Recommend budgeting for a replacement in the near future.

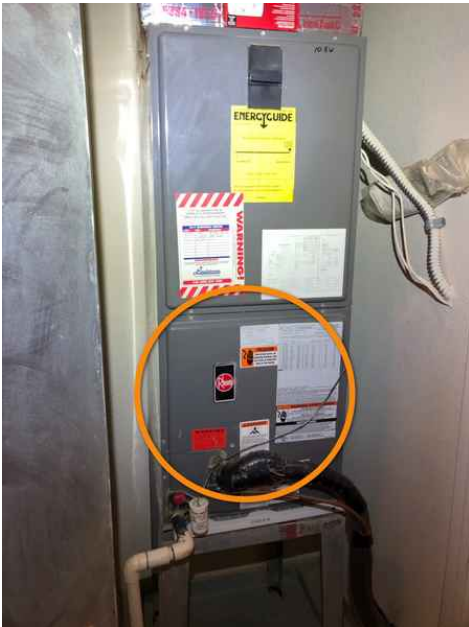
**COOLING FINS - DIRTY/DETERIORATED**

The cooling fins on the air handler's evaporator coils are dirty and bent, damaged and/or deteriorated. This may result in reduced efficiency and higher energy costs. Some sources claim that energy efficiency is degraded by about five percent each year as the coils get dirtier due to accumulated dust and grime. A qualified heating and cooling contractor should evaluate and make repairs as necessary, and clean the evaporator coils.

Recommendation

\$750 - \$850

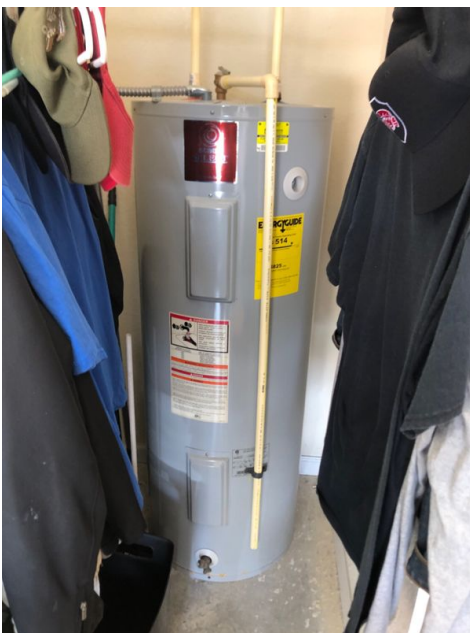
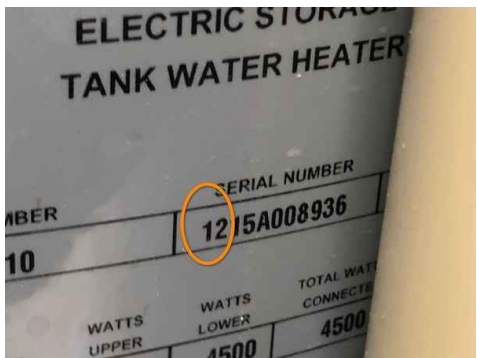
### 11.5.1 WATER HEATER

The estimated useful life for most water heaters is 8 to 12 years. This water heater appears to be at this age and may need replacing at any time. Recommend budgeting for a replacement in the near future.

Recommend monitoring.

\$1,200 - \$1,700

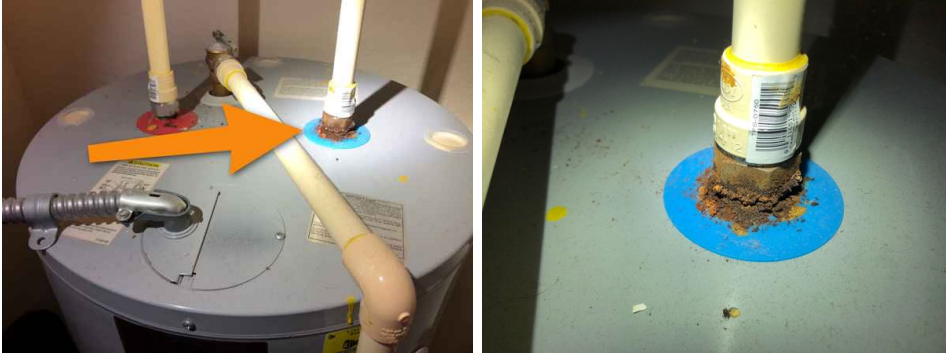
## 11.5.2 WATER HEATER

**WATER HEATER - SIGNS - CORROSION ON FITTINGS**

Corrosion was found on fittings and/or water supply lines for the water heater. Leaks may exist. A qualified plumbing contractor should evaluate and repair or replace as necessary.

Recommendation

\$300 - \$400

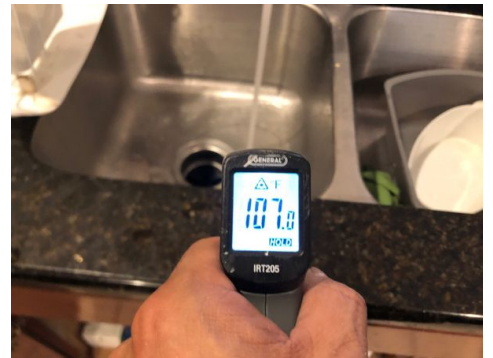
## 11.6.1 WATER TEMPERATURE

**WATER TEMPERATURE**

KITCHEN

Water temperature in good range - below 120F. For more info on safe temperatures see: [CSPC.gov](http://CSPC.gov) Avoiding Tap Water Scalds

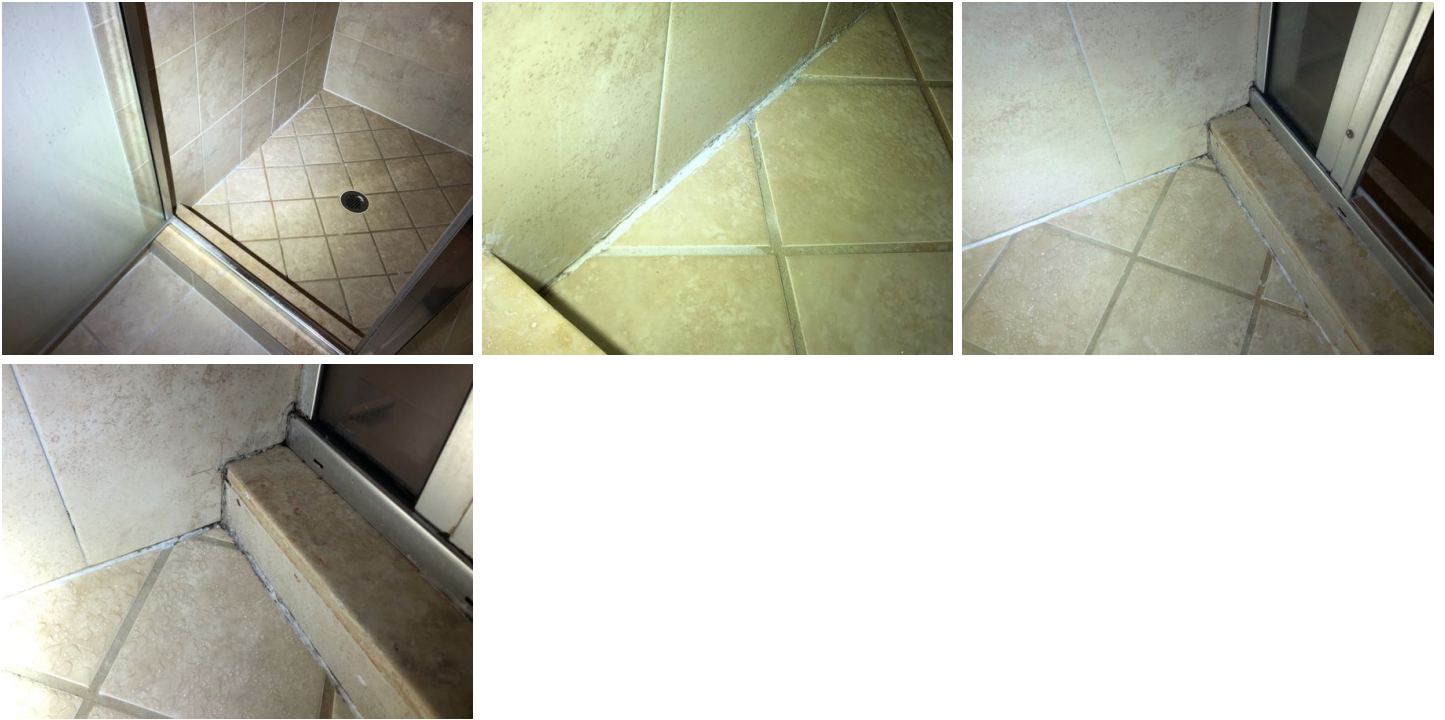
## 13.1.1 BATHTUBS/ SHOWERS

**CAULK - DETERIORATED/MISSING AROUND SURROUND**

Caulk is missing or deteriorated around the shower/bathtub surround. It should be replaced where deteriorated and/or applied where missing to prevent water intrusion and damage to the wall structure. For more information on caulking, visit: [The Ins and Outs of Caulking](#).

Contact a handyman or DIY project

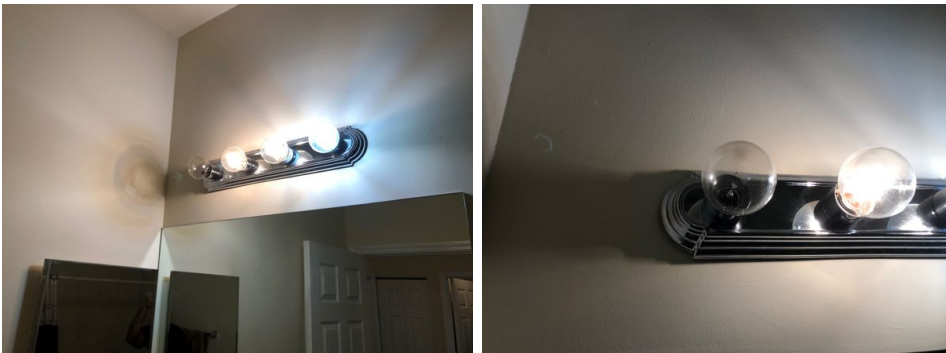
### 13.2.1 ELECTRICAL

#### **LIGHTING - INOPERABLE**

The light fixtures appear to be fully or partially inoperable. Recommend further evaluation by replacing bulb(s) and/or consulting with the property owner(s). Repairs or replacement of the light fixture by a qualified electrician may be necessary.

Contact a handyman or DIY project

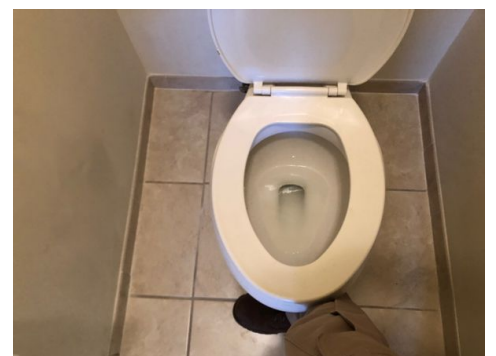
### 13.3.1 TOILETS

#### **LOOSE**

The toilet is loose. A qualified contractor should remove the toilet for further evaluation and repair if necessary. A new wax ring should be installed and toilet should be securely anchored to the floor to prevent movement and leaking.

Contact a qualified plumbing contractor.

Estimated Cost  
\$100 - \$300

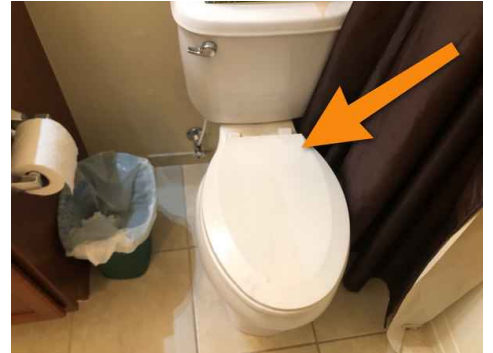
13.3.2 TOILETS

**SEAT LOOSE OR DETERIORATED**

The toilet seat is not secured on one side in Master Bath and the wrong size for the toilet in the east bathroom. Recommend repairing or replacing as needed.

Contact a handyman or DIY project

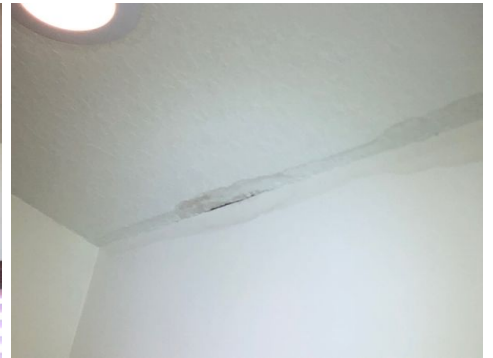
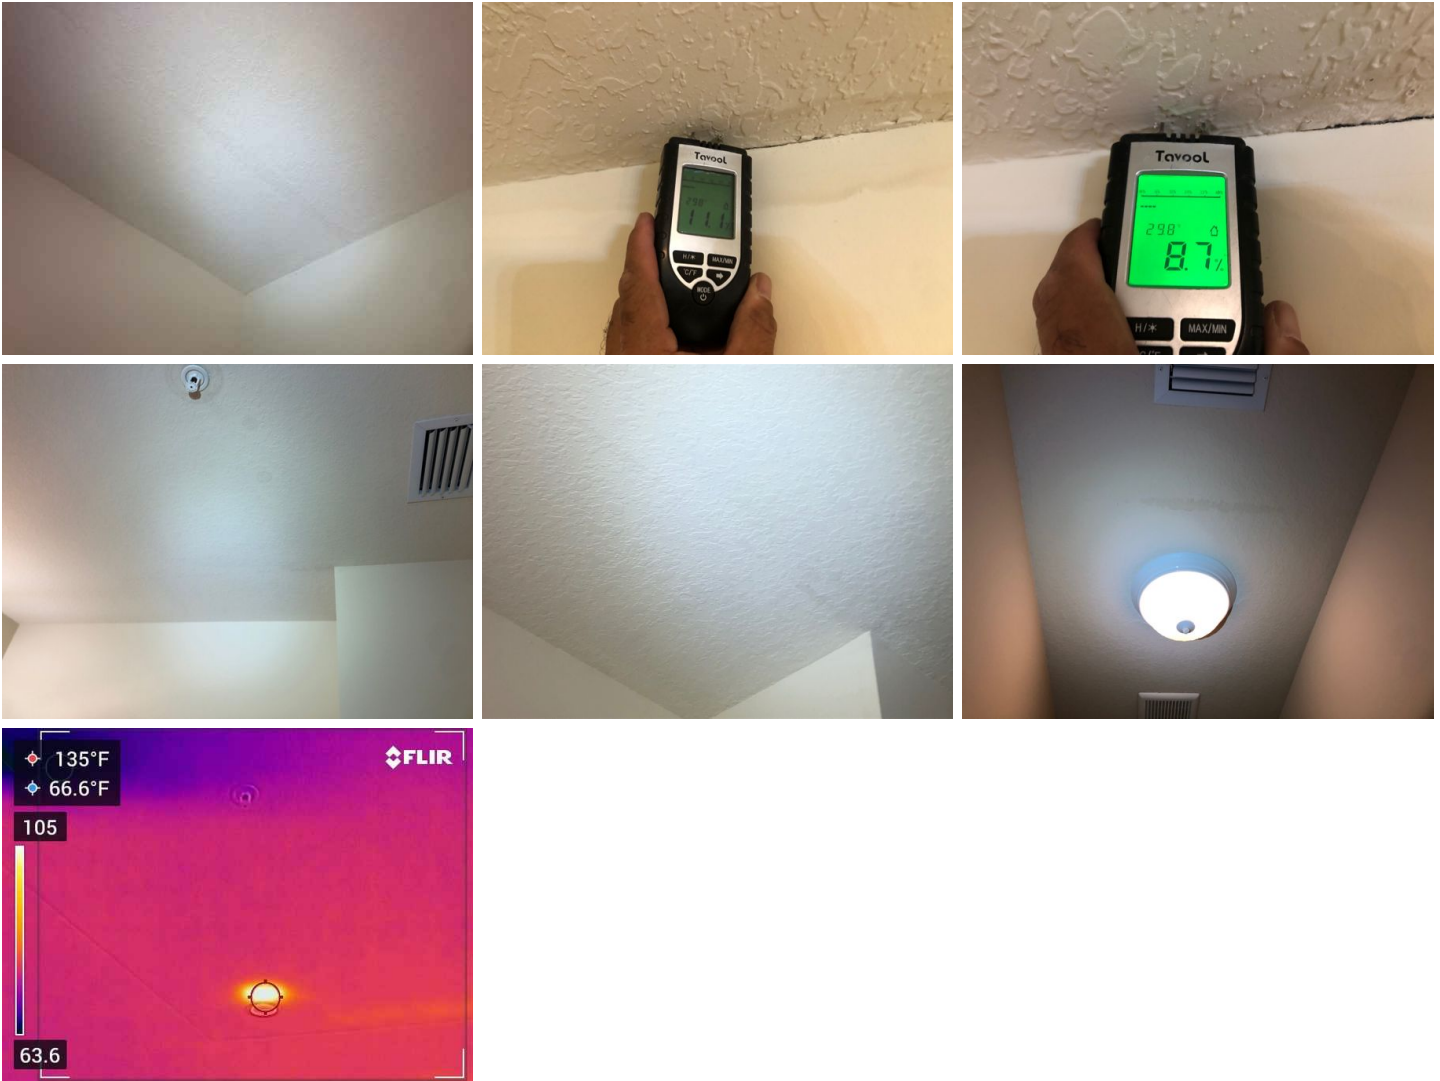
13.4.1 CEILINGS/ FLOORS/ WALLS

**CEILINGS/WALLS - STAINS - DRY - MONITOR**

Stain(s) were identified in ceilings or walls, however, no elevated levels of moisture were found at the time of the inspection. The stain(s) may be due to past roof and/or plumbing leaks. Hidden mold may exist in wall cavity, which could require remediation and drive up repair costs. Recommend asking the current owner(s) about this and monitoring the stained area(s) in the future, especially after heavy or prolonged rain. If elevated moisture is identified in the future, a qualified contractor should evaluate and repair as necessary.

Recommend monitoring.

\$50 - \$250

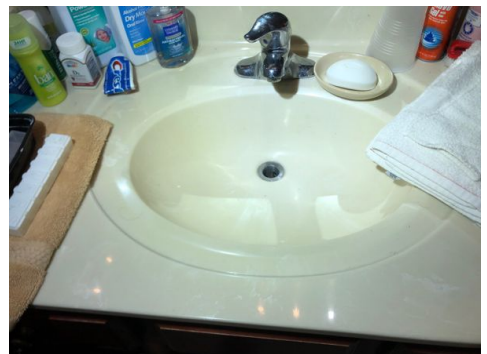
## 13.5.2 VANITIES/ SINKS

**PLUMBING - LEAK IN DRAIN LINE**

Sink drains have an active leak. For example, at pipe fittings and/or junctions between pipe and sink. A qualified plumber should evaluate and repair as necessary.

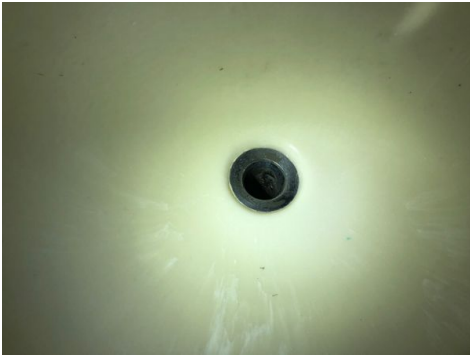
13.5.1 VANITIES/ SINKS

**SINK - STOPPER MISSING OR DEFECTIVE**

The sink stopper mechanism is missing, or needs adjustment or repair. Stopper mechanisms should be installed where missing and/or repairs should be made so sink stoppers open and close easily.

\$50 - \$75

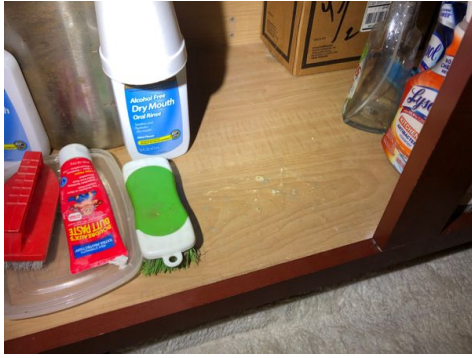
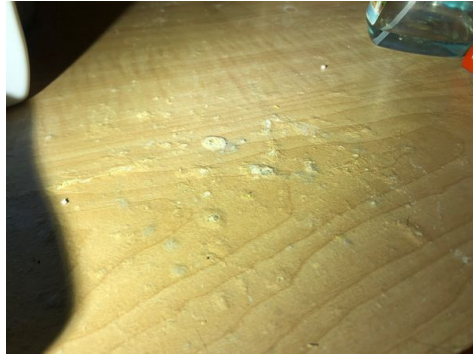
**WATER DAMAGE - MINOR**

Water stains and/or minor water damage was found in the shelving or cabinet components below the sink. The client(s) should evaluate and consider having repairs made.

Contact a qualified carpenter.

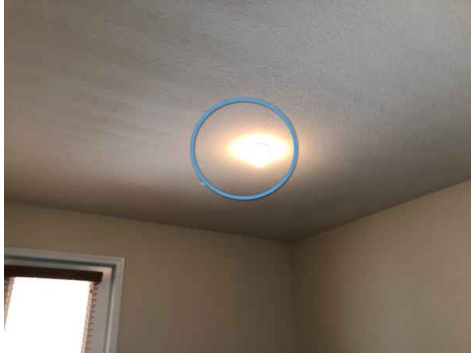
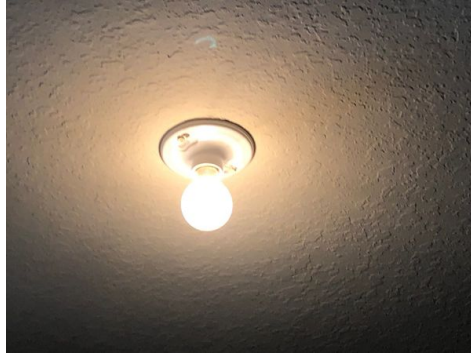
14.4.1 ELECTRICAL

**LIGHT FIXTURE - COVER MISSING**

The light fixture cover is missing. Cover should be installed. Repair or replace light fixtures where necessary.

Contact a qualified handyman.

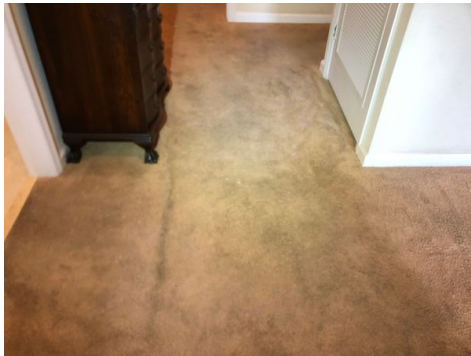
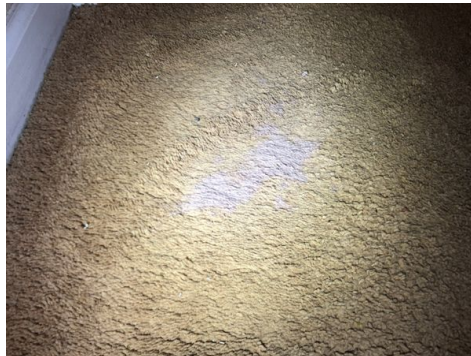
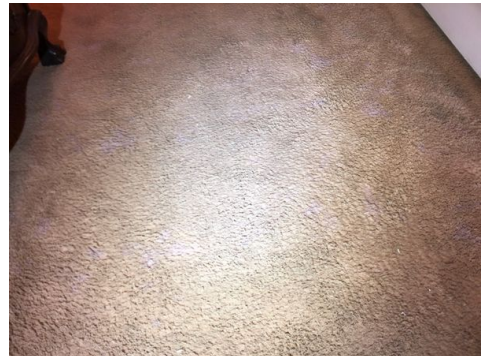
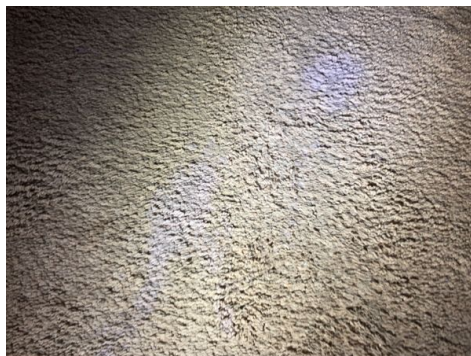
**CARPET - STAINS AND/ OR DETERIORATION**

Carpet had areas of deterioration, staining, or discoloration. Recommend a repairs, replacement, or a thorough steam clean by a qualified carpet cleaning company.

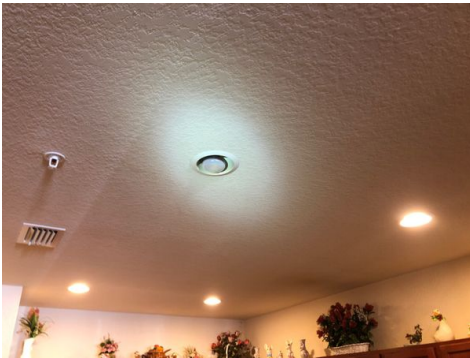
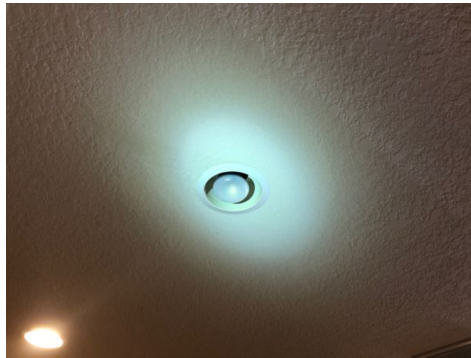
The light fixtures appear to be fully or partially inoperable. Recommend further evaluation by replacing bulb(s) and/or consulting with the property owner(s). Repairs or replacement of the light fixture by a qualified electrician may be necessary.

Contact a handyman or DIY project

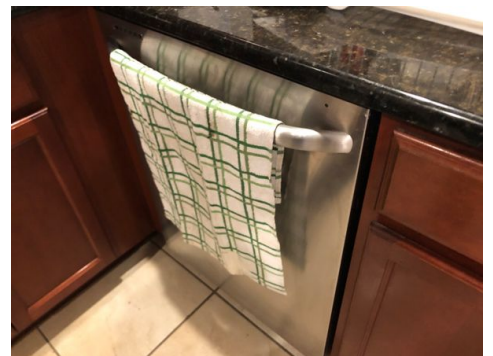
The dishwasher appears to be inoperable. The client(s) should ask the property owner(s) about this, and if necessary, the dishwasher should be replaced, or a qualified appliance technician should evaluate and repair.

Contact a qualified appliance repair professional.

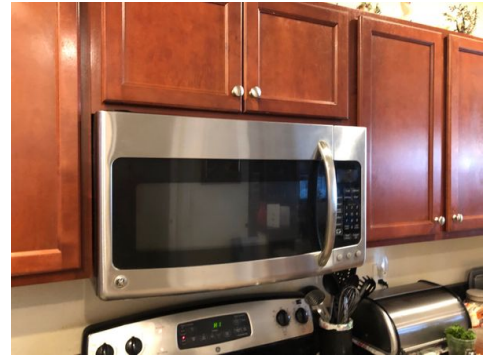
The microwave oven appears to be inoperable. A qualified appliance technician should evaluate and repair as necessary.

Contact a qualified appliance repair professional.

\$350 - \$550

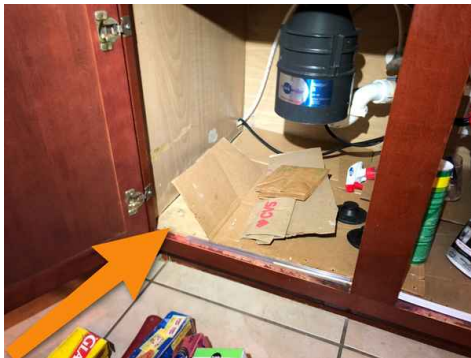
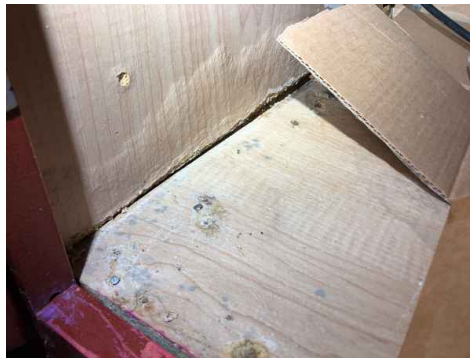
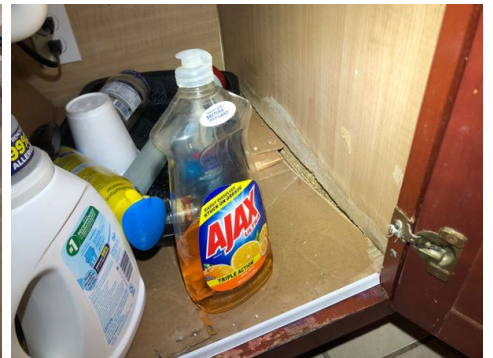
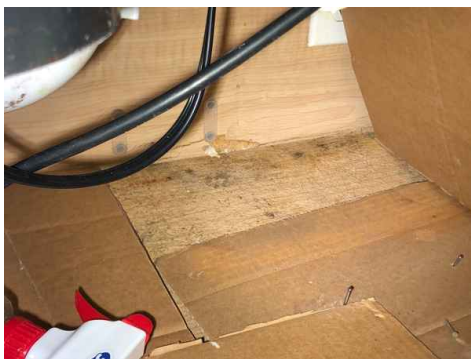
#### 15.5.1 COUNTER TOPS AND CABINETS

### **WATER DAMAGE - MINOR**

Water stains and/or minor water damage was found in the shelving or cabinet components below the sink. The client(s) should evaluate and consider having repairs made.

\$350 - \$450

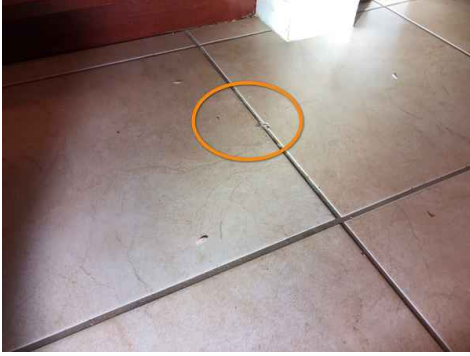
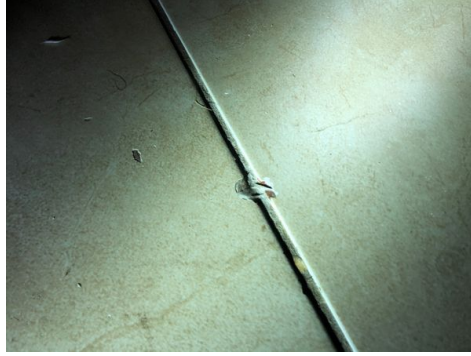
#### 15.6.1 FLOORS

### **TILE/STONE AND GROUT - DETERIORATED**

Tile, stone and/or grout flooring is damaged and/or deteriorated. A qualified contractor should evaluate and make repairs as necessary. For example, replacing broken tiles and deteriorated grout, and resealing grout.

Contact a qualified tile contractor

Estimated Cost  
\$100 - \$150
