ALL STAR HOME INSPECTION SERVICES, LLC

CONDOMINIUM INSPECTION COPY

18790 NW 84th AVE
Hialeah FL 33015

Omar Brown
OCTOBER 2, 2021

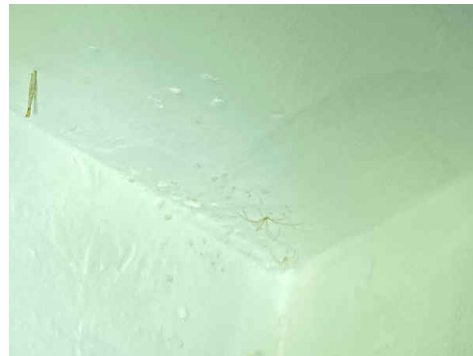
Spiders were present and pervasive inside the home. Recommend a qualified pest control company treat the affected areas.

Contact a qualified pest control specialist.

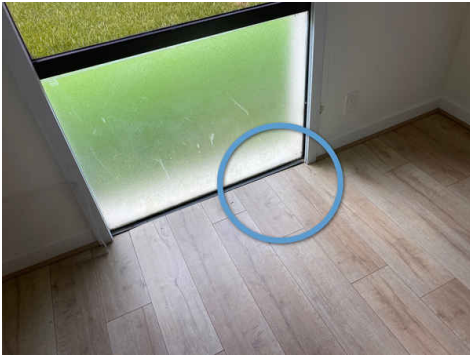
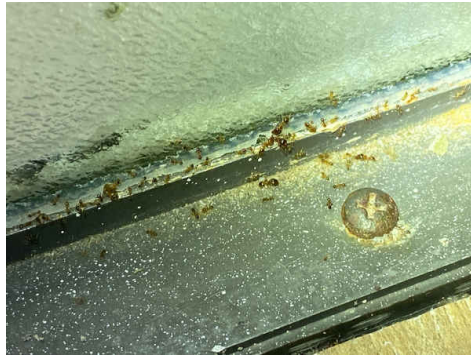
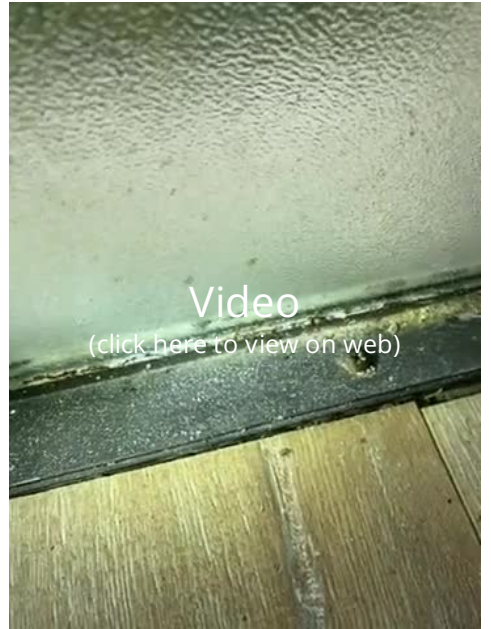
1.2.2 GENERAL OBSERVATIONS

PESTS - EVIDENCE OF PEST ACTIVITY

Recommendation

Contact a qualified pest control specialist.

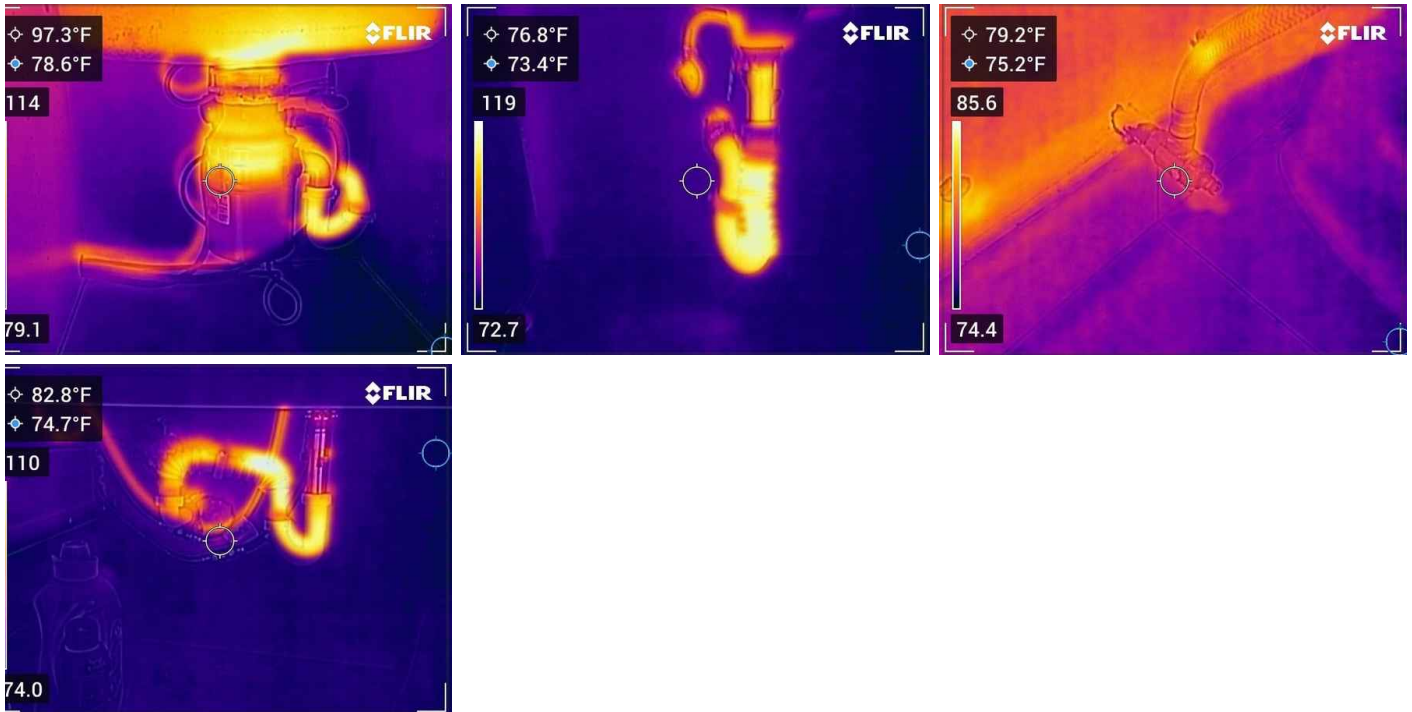
THERMAL: 3. Interior Images

The following thermal images were collected during the thermal image inspection of the indoors. No anomalies were identified in these images. Images with anomalies (if any) will be under the appropriate defect section of the report.

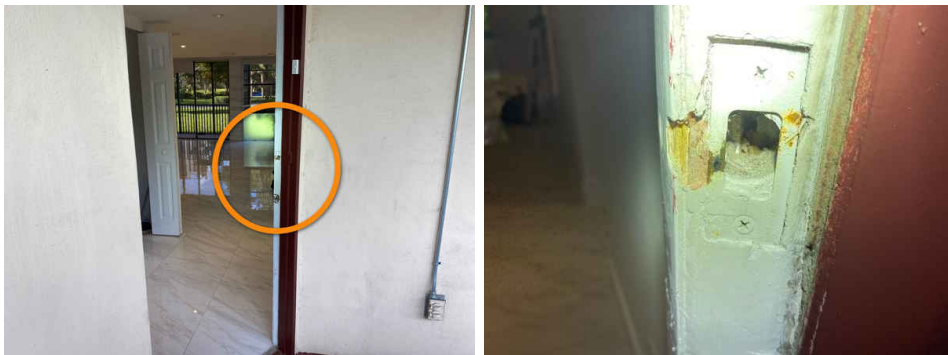
The exterior doors frame is damaged and/or deteriorated and should be repaired or replaced by a qualified contractor.

Contact a qualified handyman.

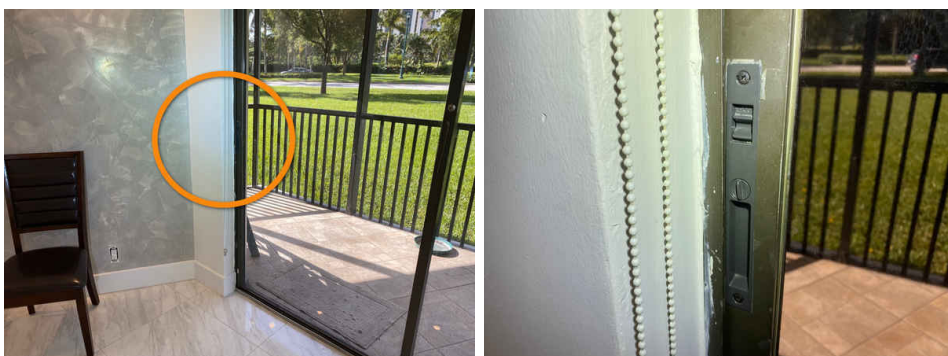
The lock mechanisms on sliding glass doors are inoperable and/or difficult to operate. A qualified contractor should evaluate and repair as necessary.

Contact a handyman or DIY project

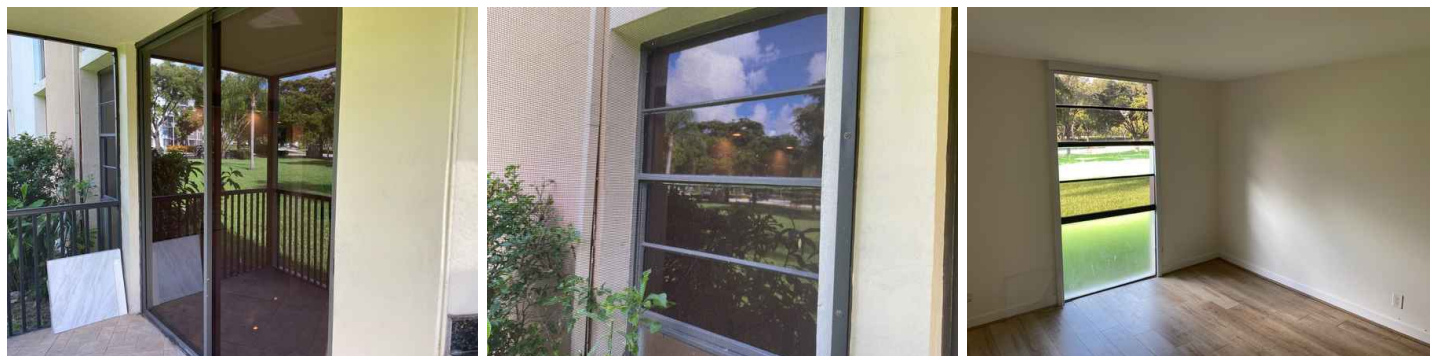
Most of the windows and glass doors are original and/or show signs of aging. Not all of the windows tested worked as expected. Recommend budgeting for replacement windows in the future.

Contact a qualified window repair/installation contractor.

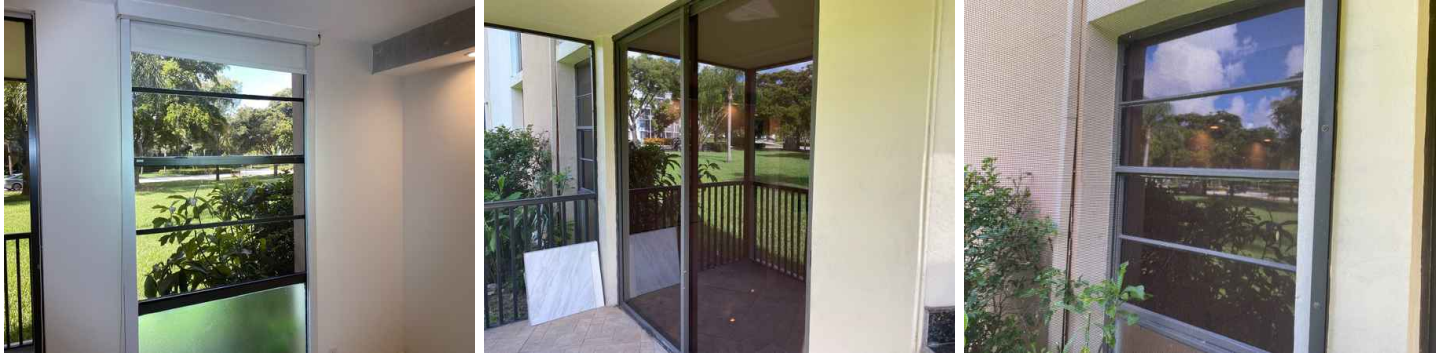
Exterior openings with glass are not impact rated. This could affect insurance rates. Recommend budgeting for opening protection for any glass openings that are not protected

Contact a qualified handyman.

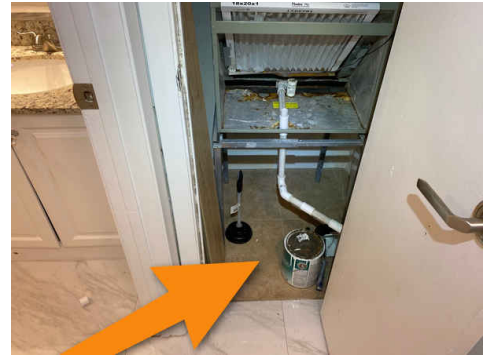
The air handler is located above a finished living space and no catch pan is present. As a result, condensation from the air handler may leak onto finished living spaces below and cause damage. Recommend having a qualified heating and cooling contractor install a catch pan per standard building practices or place a moisture alarm on the floor below the unit.

Contact a qualified HVAC professional.

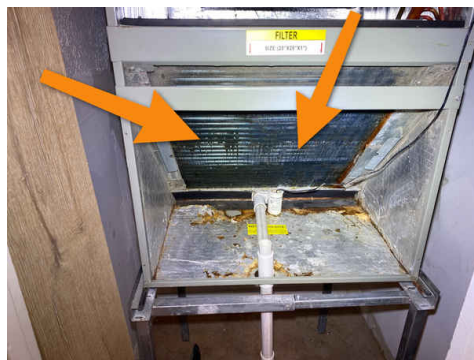
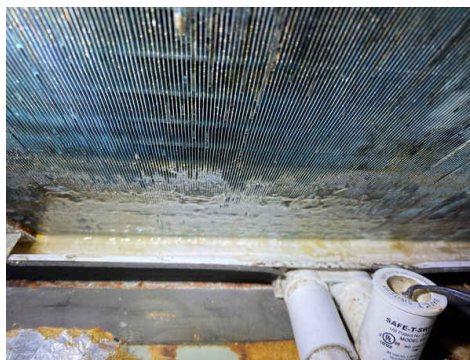
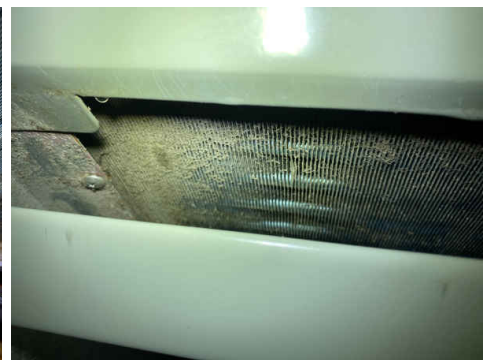
The cooling fins on the air handler's evaporator coils are dirty. This may result in reduced efficiency and higher energy costs. Some sources claim that energy efficiency is degraded by about five percent each year as the coils get dirtier due to accumulated dust and grime. A qualified heating and cooling contractor should clean the evaporator coils as necessary.

Contact a qualified HVAC professional.

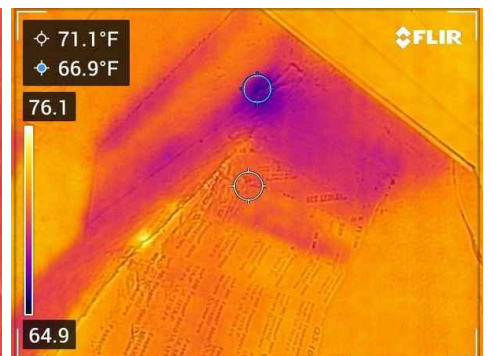
Moisture was detected in and around the A/C ductwork. Recommend a qualified HVAC contractor evaluate ductwork for air leaks and repair as needed.

Contact a qualified HVAC professional.

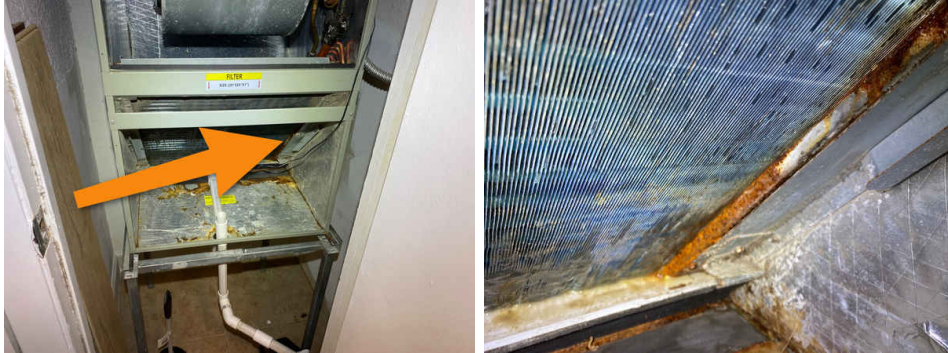
The air handler shows signs of corrosion and build-up. Recommend a qualified HVAC contractor evaluate clean unit.

Contact a qualified HVAC professional.

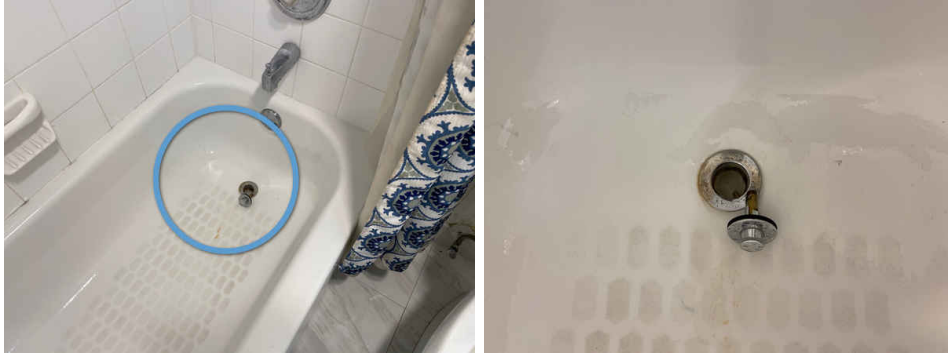
The tub stopper mechanism is missing, or needs adjustment or repair. Stopper mechanisms should be installed where missing and/or repairs should be made so tub stoppers open and close easily.

Contact a qualified plumbing contractor.

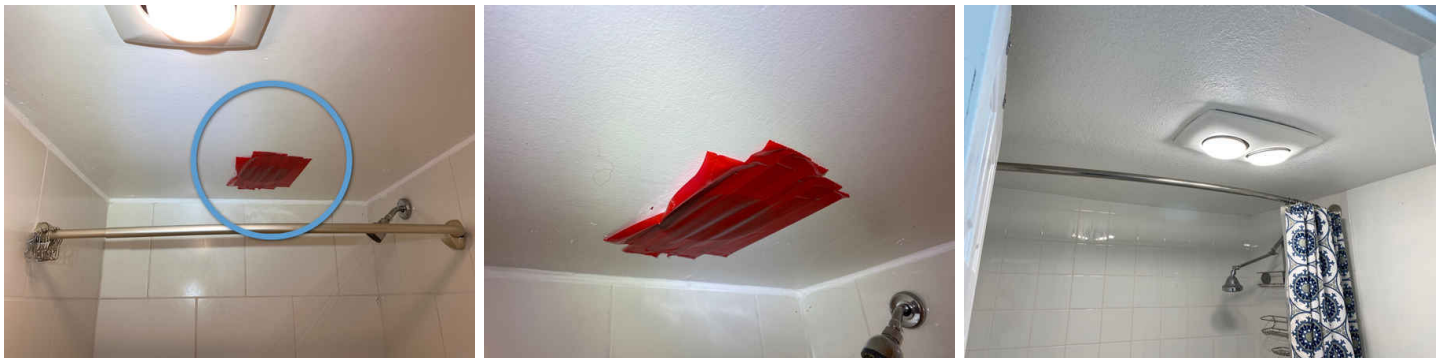
This bathroom does not have an exhaust fan installed. While not required, per-say, as long as there is a window, it is still a smart idea to prevent the buildup of moisture which can lead to excess moisture and even mold, potentially. Consider installing an exhaust fan that exhausts all the way to the exterior.

Contact a qualified handyman.

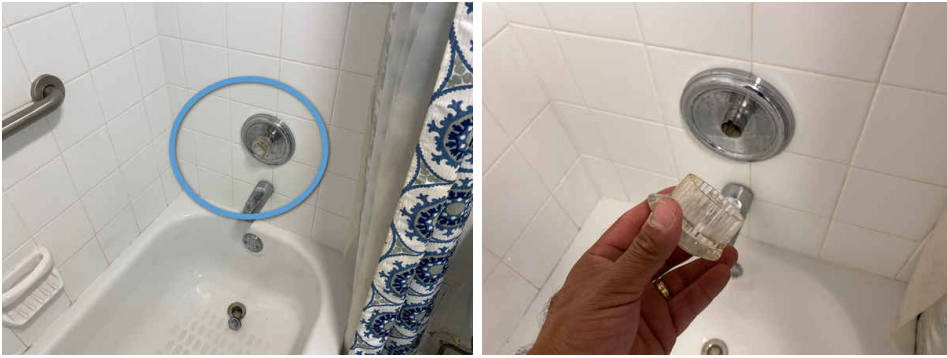
The fixtures are loose, missing or difficult to operate and should be repaired or replaced as necessary.

Contact a qualified plumbing contractor.

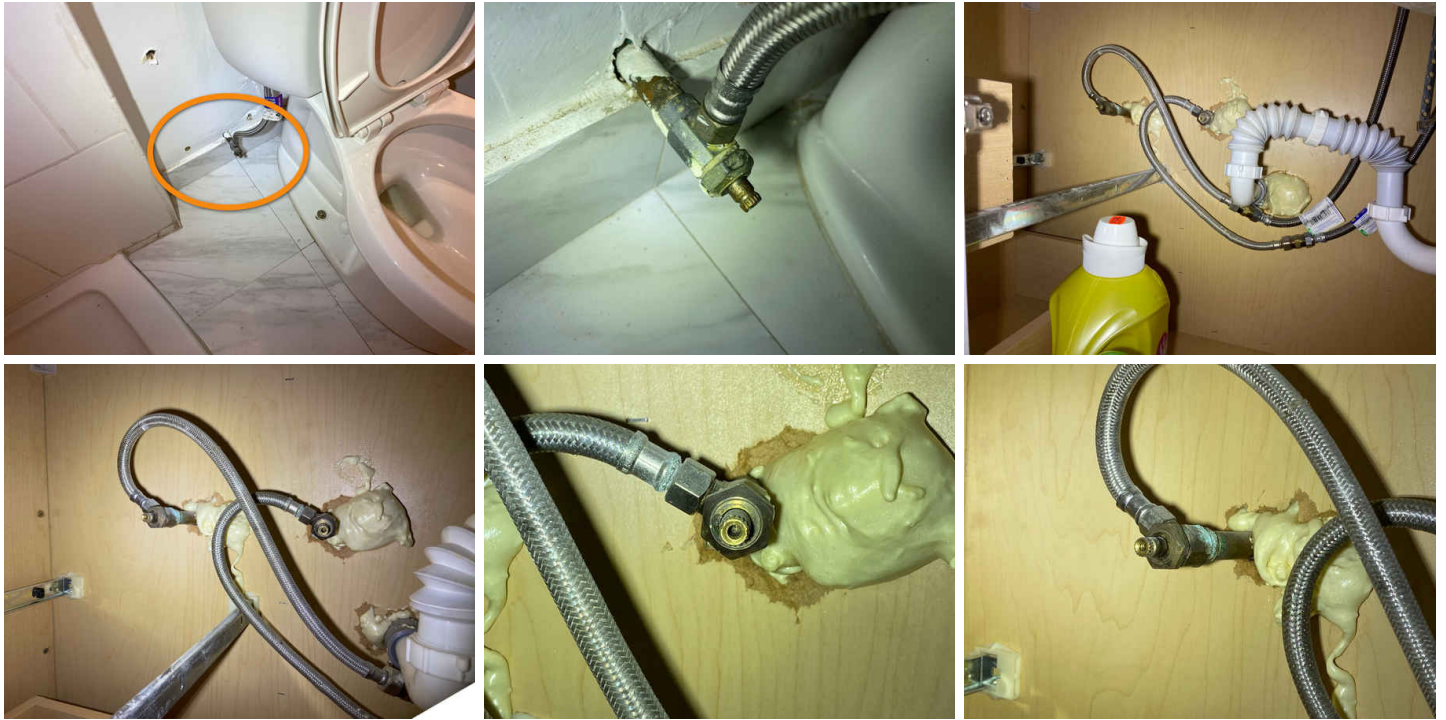
PLUMBING - SHUT-OFF VALVE HANDLE MISSING

The handles are missing from water shut-off valves. Handles should be replaced where missing.

Recommendation

Contact a qualified plumbing contractor.

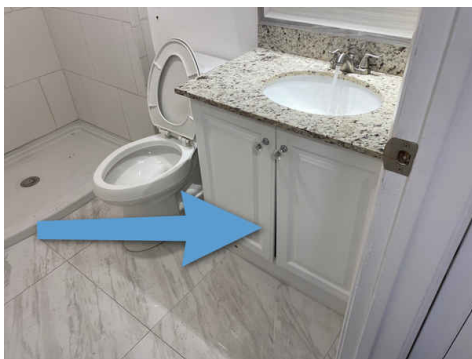
Cabinet doors appear to be misaligned and should be reinstalled and or replaced by a qualified contractor if necessary.

Contact a handyman or DIY project

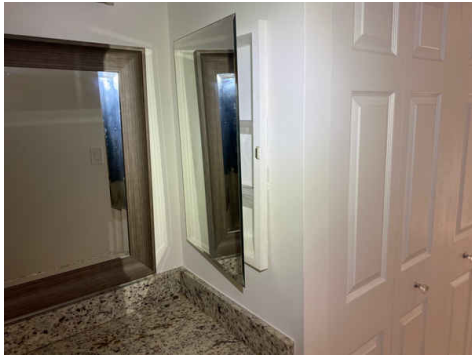
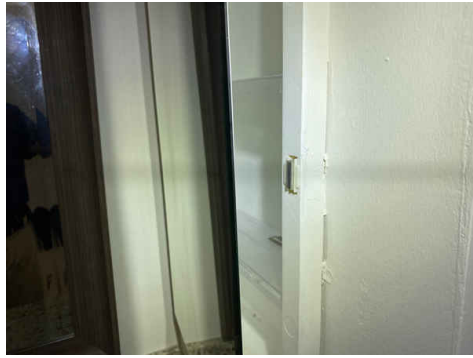
MIRROR - DETERIORATED

The bathroom mirror or the mounting hardware is damaged or needs to be reinstalled. Client may wish to repair/replace for aesthetic reasons.

Recommendation

Contact a qualified handyman.

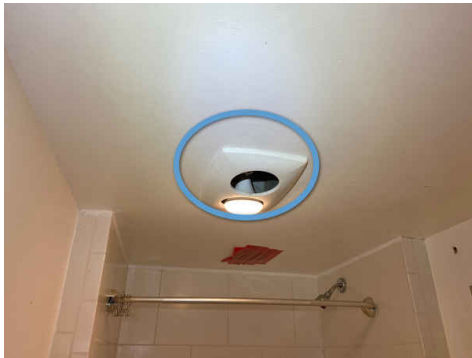
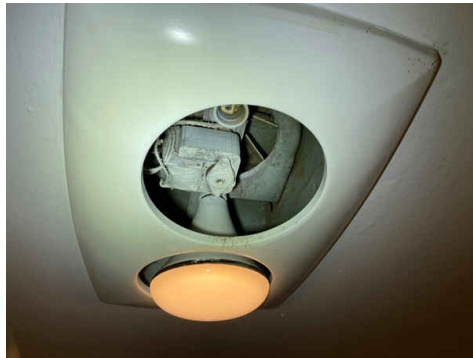
Light fixtures have missing bulbs and could not be fully evaluated. Bulbs may simply need to be installed, or repairs or replacement may be necessary.

Contact a handyman or DIY project

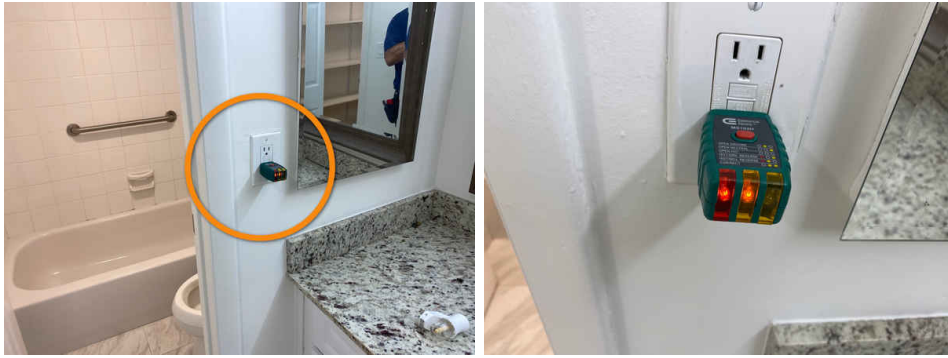
Electric receptacles have reverse-polarity wiring, where the hot and neutral wires are reversed. This is a safety hazard due to the risk of shock. A qualified electrician should evaluate and make repairs as necessary.

Contact a qualified electrical contractor.

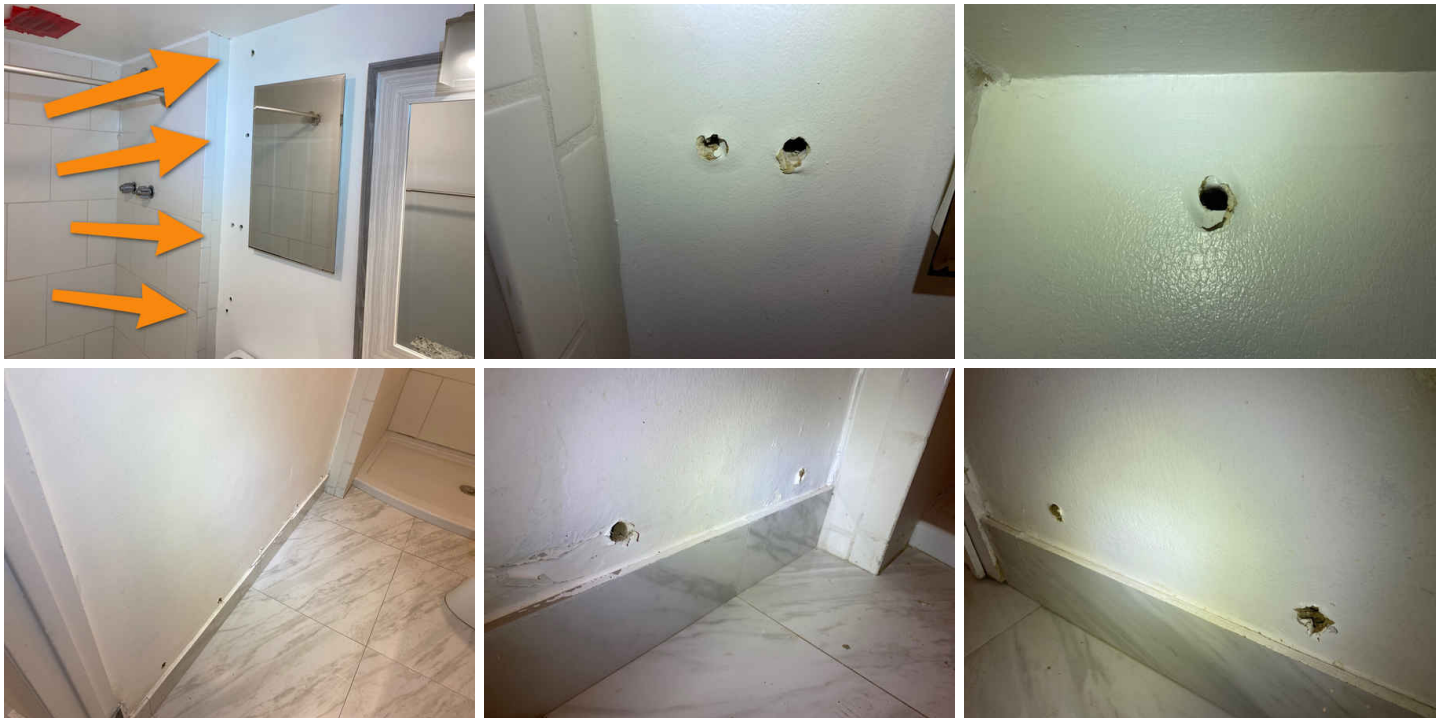
Significant damage was found on ceilings or walls. Recommend having a qualified contractor perform repairs and/or replacements as necessary.

Contact a qualified drywall contractor.

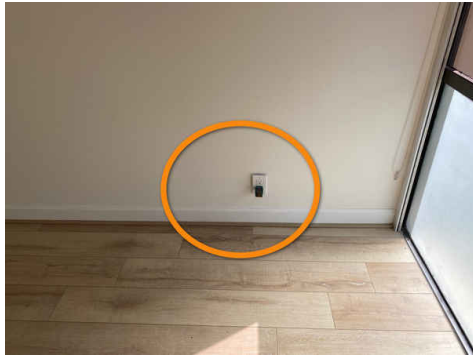
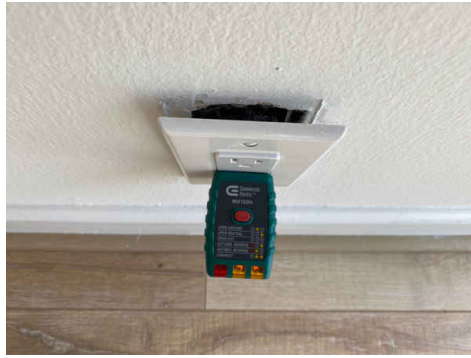
Electric receptacles and/or the boxes they are installed in are loose and/or not securely anchored. Wire conductors may be damaged due to repeated movement and/or tension on wires, or insulation may be damaged. This is a safety hazard due to the risk of shock and fire. A qualified electrician should evaluate and repair as necessary.

Contact a qualified electrical contractor.

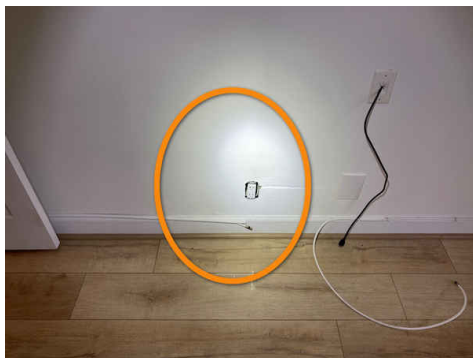
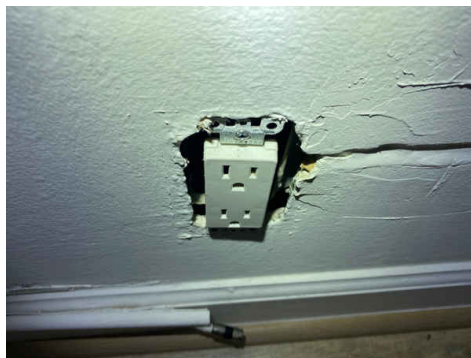
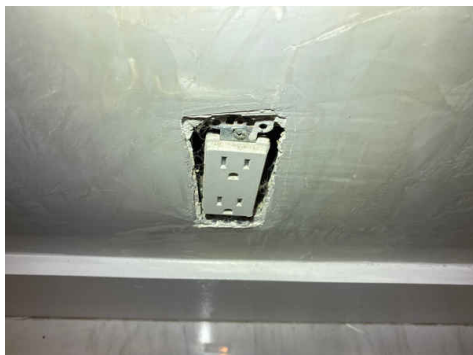
Cover plate(s) are missing from electric boxes, such as for receptacles, switches and/or junction boxes. They are intended to contain fire and prevent electric shock from exposed wires. This is a safety hazard due to the risk of fire and shock. Cover plates should be installed where missing.

Contact a handyman or DIY project

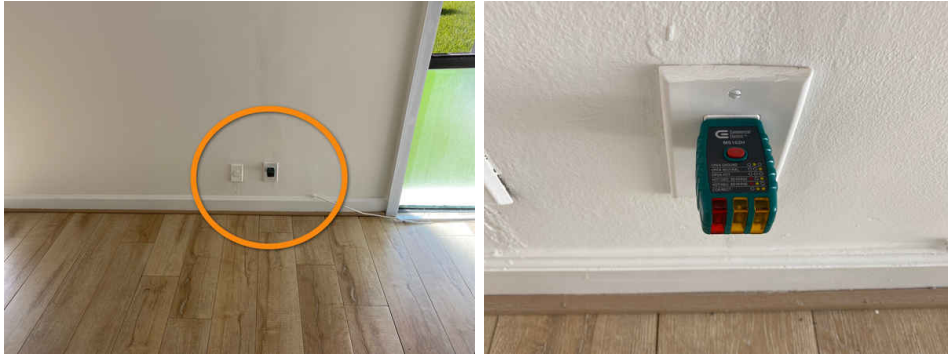
Electric receptacles appear to have no power. Recommend asking the property owner(s) about this. Switches may need to be operated to make some receptacles energized. If necessary, a qualified electrician should evaluate and make repairs as necessary.

Contact a qualified electrical contractor.

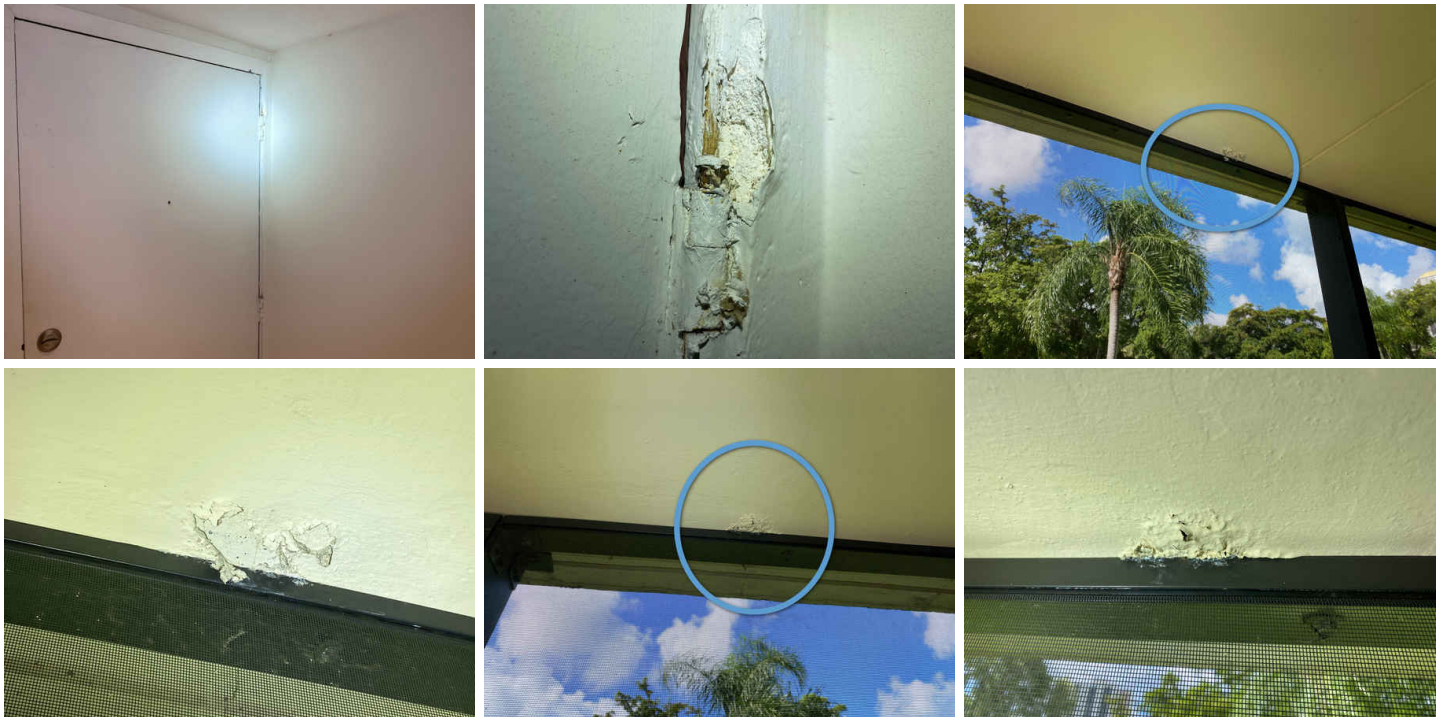
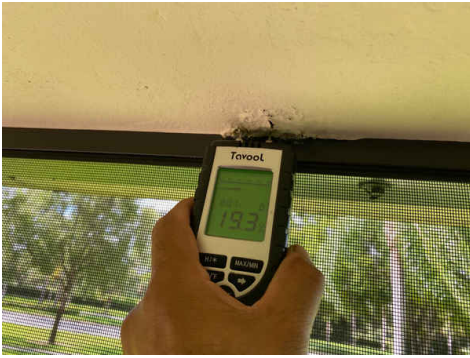
Minor damage was found on ceilings or walls. The client(s) may wish to repair for aesthetic reasons.

Contact a handyman or DIY project

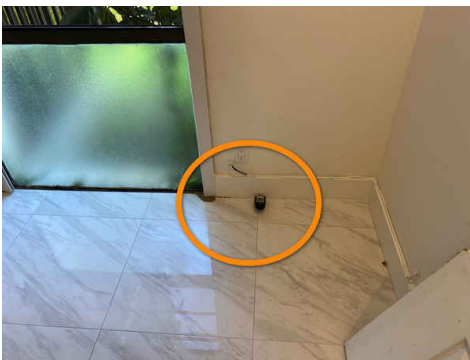
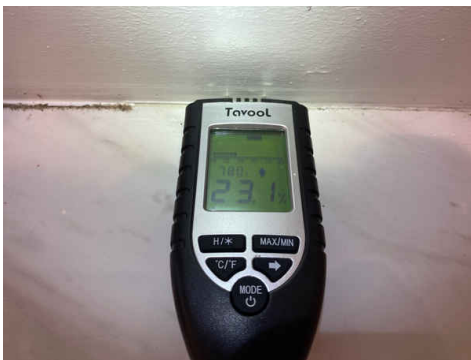
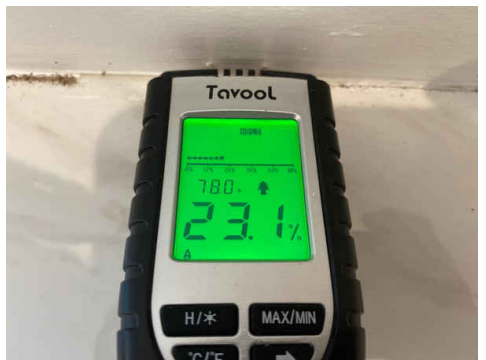
Floors had areas of visible moisture damage. Recommend a qualified flooring contractor evaluate & repair areas of moisture.

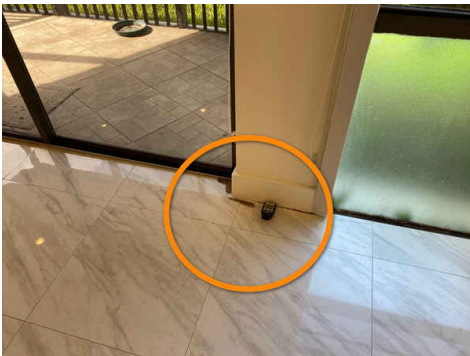
CEILINGS/WALLS - DAMAGE - MINOR

Recommendation

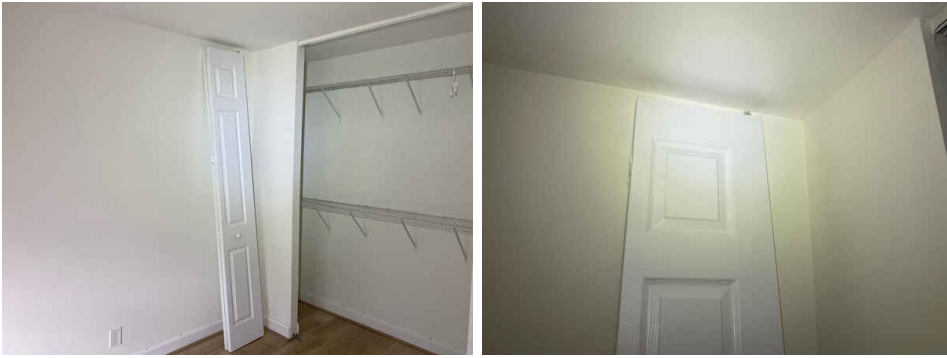
12.6.1 DOORS/ WINDOWS

DOORS - CLOSET DOOR(S) DETERIORATED OR OFF TRACK

Maintenance Item

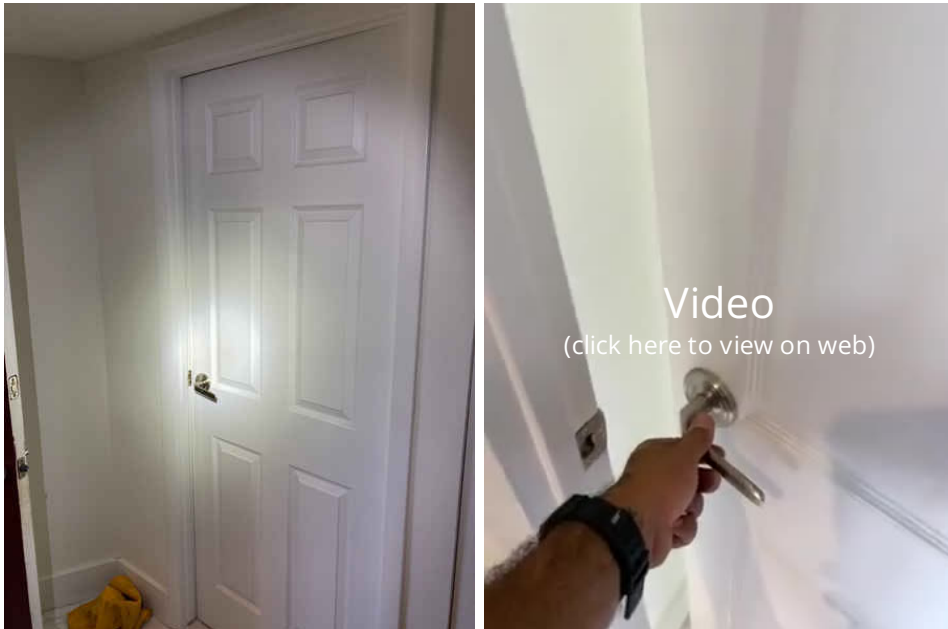
Interior doors do not latch properly. Recommend handyman repair latch and/or strike plate.

Contact a qualified handyman.

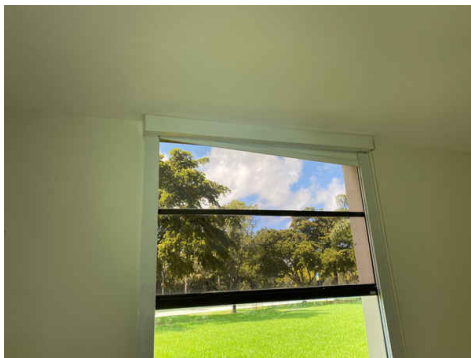
Window treatments are damaged/deteriorated and/or inoperable. The client may wish to repair or replace these for aesthetic reasons.

Contact a handyman or DIY project

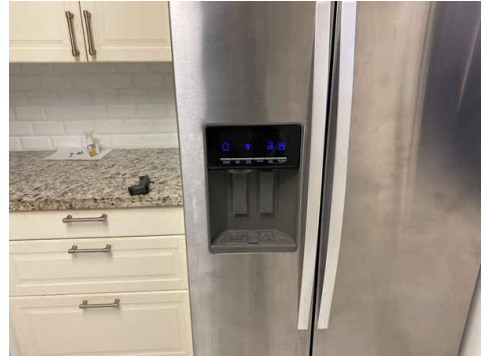
The refrigerator ice maker is not dispensing ice, despite being in the on position. The system may need to be defrosted. The inspector was unable to evaluate this component. The client(s) should ask the property owner(s) about this, and if necessary, the ice maker should be replaced, or a qualified appliance technician should evaluate and repair.

Contact a qualified appliance repair professional.

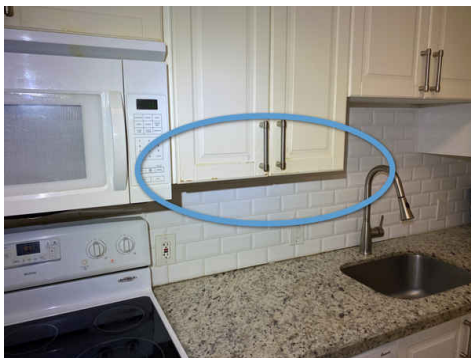
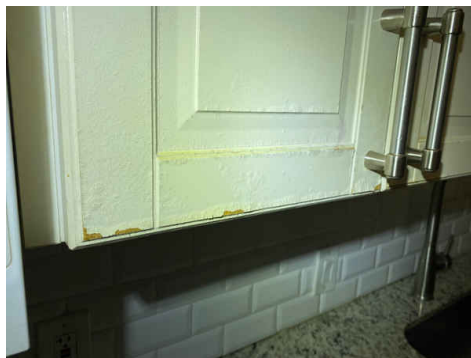
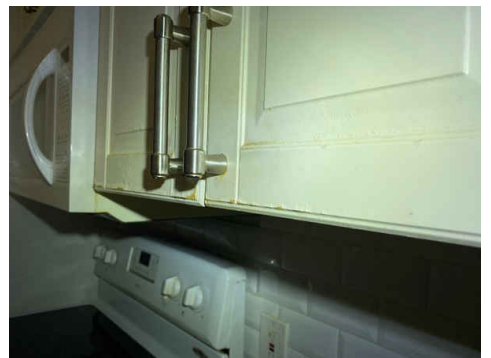
Laminate cabinet material is loose or delaminating. A qualified contractor should evaluate and repair as necessary.

Contact a qualified carpenter.

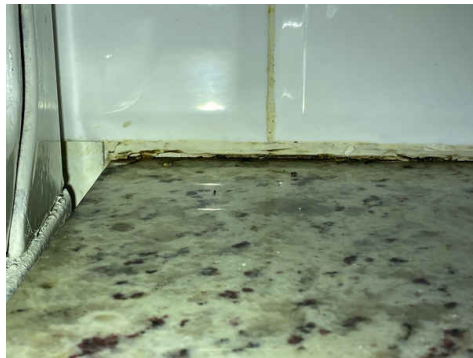
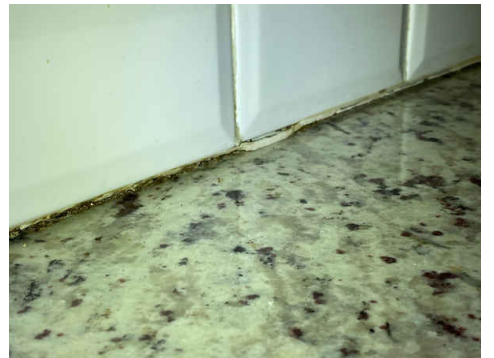
Caulk and/or grout is missing and/or deteriorated where countertops meet backsplashes in wet areas, such as around sinks. Caulk & grout should be replaced where deteriorated and/or applied where missing to prevent water damage. For more information on caulking, visit: [The Ins and Outs of Caulking](#).

Contact a handyman or DIY project

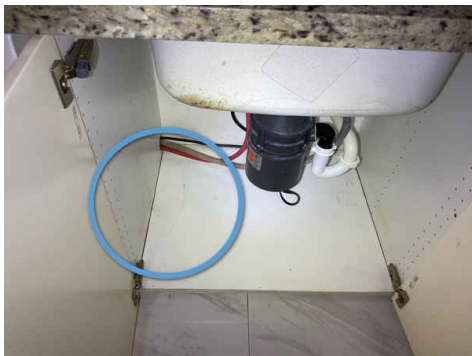
Water stains and/or minor water damage was found in the shelving or cabinet components below the sink. The client(s) should evaluate and consider having repairs made.

Contact a handyman or DIY project
