# Lake Mallalieu Lake Management Plan

FEBRUARY 17, 2022

Prepared for:  
Lake Mallalieu Association

Prepared by:  
The Lake Mallalieu Association  
and  
Resource Environmental Solutions

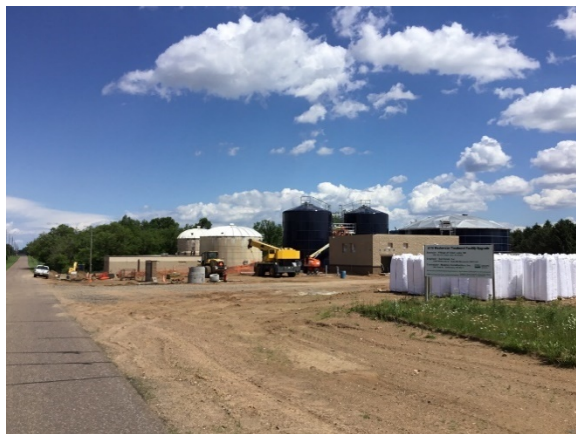
These wastewater treatment facilities are considered “point” sources or discharges, which contribute nutrients (e.g., phosphorus) to surface waters and fall under regulation by the Lake St. Croix TMDL and Wisconsin’s statewide phosphorus rule. Of the two largest dischargers, New Richmond is practicing adaptive management to manage its facility discharges, and the Clear Lake plant is currently undergoing a significant facility upgrade.

*Clear Lake wastewater treatment plant upgrade (under construction).*

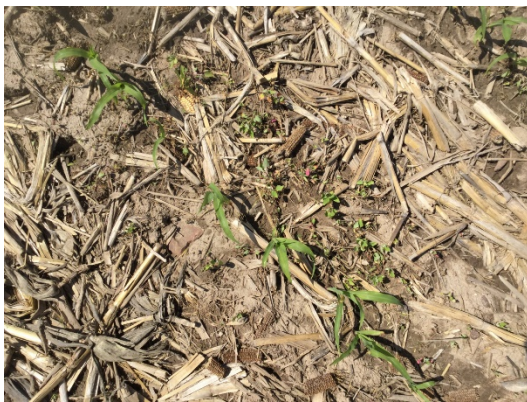
- a. No till farming appeared to be used on perhaps 5-10% of the annually cropped land in the watershed.

*No till field with 50% crop residue.*

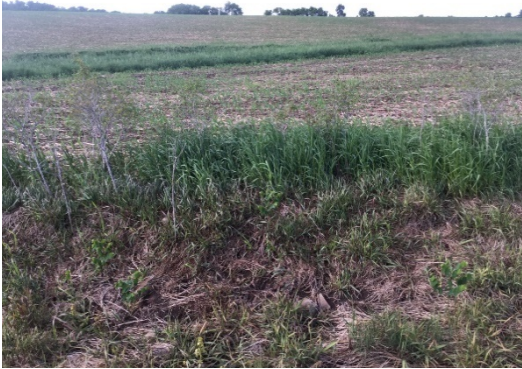
- b. Soil surface disruptions from extensive corn stover harvesting was occurring widely.
- c. Harvesting appeared to be removing 70-90% of the corn stover (possibly for farm animal bedding), and the remaining crop residue (estimated at 5-10% cover of remaining stover after harvesting at most farms, with an occasional farm having ~20-30% cover) is inadequate to control soil erosion.
- d. Few farmers used cover crops in the watershed. As a result of large acreages with soil disruptions from conservation tillage (e.g., chisel plowing) and stover harvesting, we observed significant rill soil erosion in crop fields, including fields with stressed vegetation and sediment deposits at field margins and in road ROW.

*Steep, erodible corn field.*

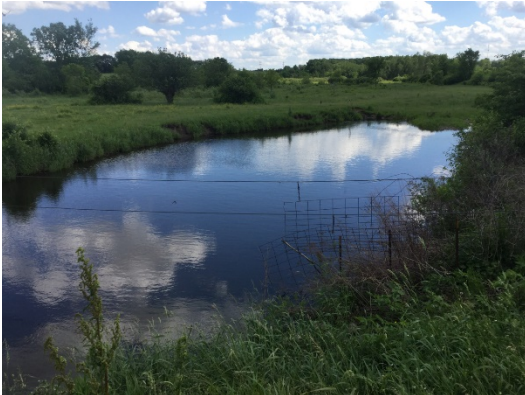
- e. Significant stream bed and bank erosion, sedimentation of fine substrates in the streams, high turbidity and suspended solid loads, very high levels of filamentous green algae (benthic growth attached to rocks and woody debris), and backwater areas had indications of excessive nutrient levels (e.g., blue-green algae (*Anabaena* sp.) and duckweed (*Lemna minor*)). These indications of nutrient enrichment are notable as they occurred already in late spring.

*Streambank erosion.*

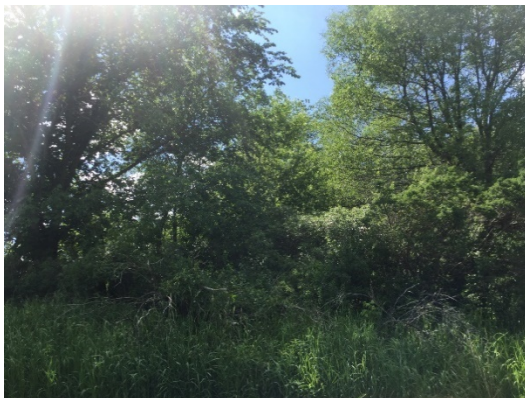
- g. Declining upland ecosystems included historical, semi-open oak savanna and forest systems that have been degraded by invasive European Buckthorn (*Rhamnus cathartica*), non-native honeysuckles (*Lonicera* spp), native (but aggressive) Boxelder (*Acer negundo*), and other non-native species. This condition now represents a large percentage of farm woodlots, but also is seen in semi-natural floodplain and riverbank environments. Where these dense non-native shrubs and Boxelder occur, dense shading results in the collapse of soil-stabilizing native grasses, sedges, and other wildflowers. This in turn contributes to the significant soil erosion observed in the watershed's riparian areas, similar to what we have documented elsewhere (e.g., see the book *Restoring Ecological Health to Your Land*, Apfelbaum and Haney 2012). This erosion contributes to degraded habitat quality and declining regional wildlife populations (e.g., native birds, insects).

*Degraded, overgrown oak savanna.*

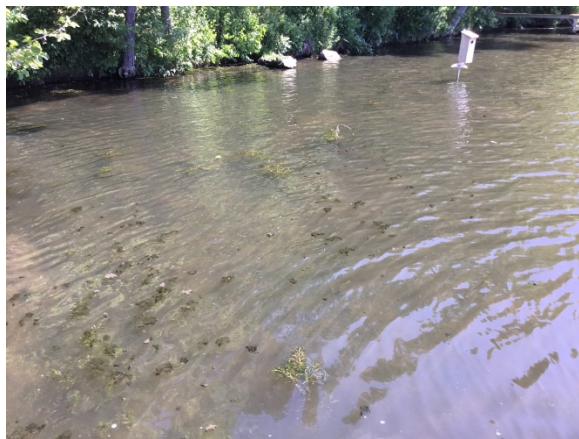
Following the upstream dam breaches between 2017 and 2019, much of the Lake bottom now consists of silts and mucks. While organic deposits are formed naturally by the accumulation and slow decomposition of plant matter in a nutrient-rich environment, much of Lake Mallalieu's organic sediments appear to have originated from the upstream dam breaches.

*Algae and shallow, turbid water.*

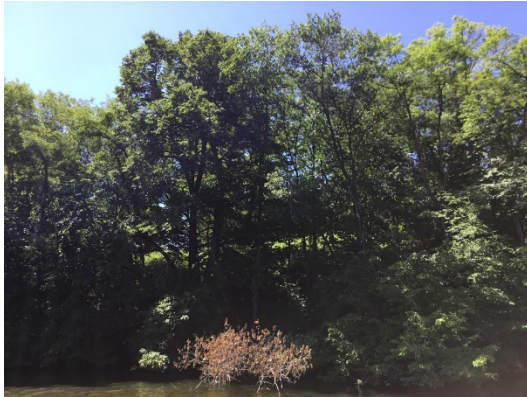
closing in, causing increasingly dense shade. *Several locations were observed where the shoreline's stabilizing native vegetation is suffering from shade suppression, leading to bare and erodible soils.*

*Historical oak savanna, currently overgrown.*

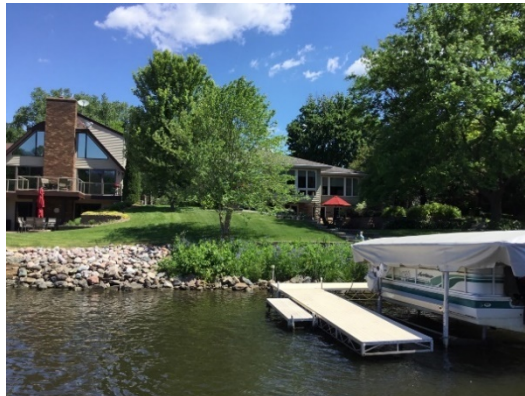
*Shorelines: rip rap (left) and natural/restored (right).*

7. Encourage natural buffer zones, including plantings in existing rip rap.
8. Encourage emergent vegetation along lakeshore.
9. Eradicate purple loosestrife using biocontrol methods.
