VIBRATION ANALYSIS REPORT

ABC PLANT

APRIL 2019

Prepared by: *PdM360*

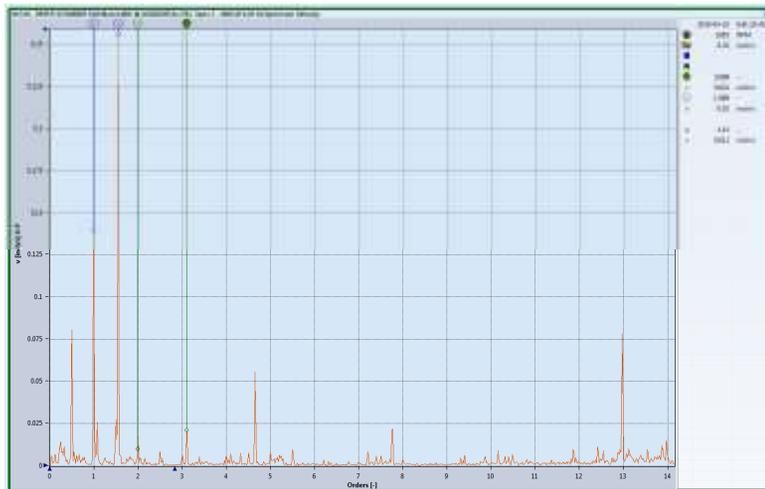
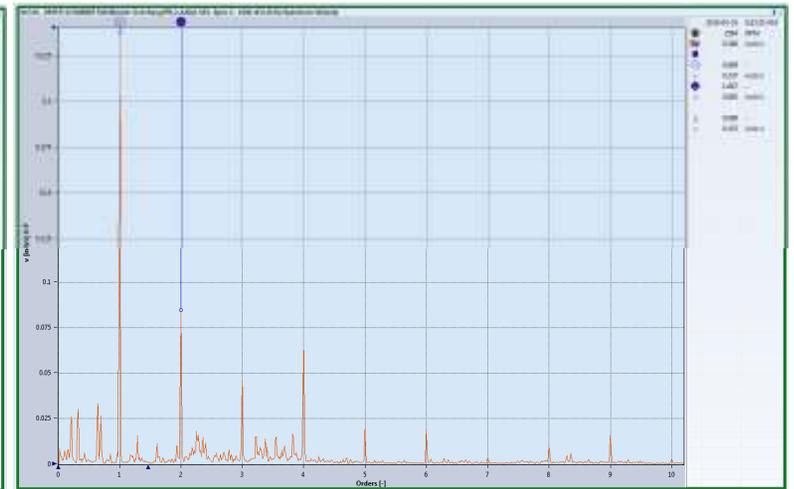
UNIT B

Observations: Spectrum graph shows 1x harmonic peaks at the electric motor and shaft Pellow Blocks.

Recommendations: Check pulley unit for tooth and/or belt signs of wear/damage.

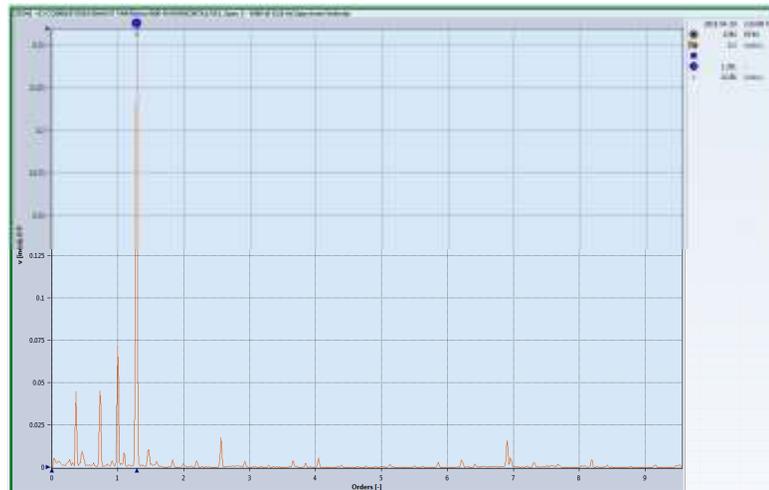
UNIT C

Observations: Overall vibration is stable since last monitoring test.

Recommendations: No service action is required.

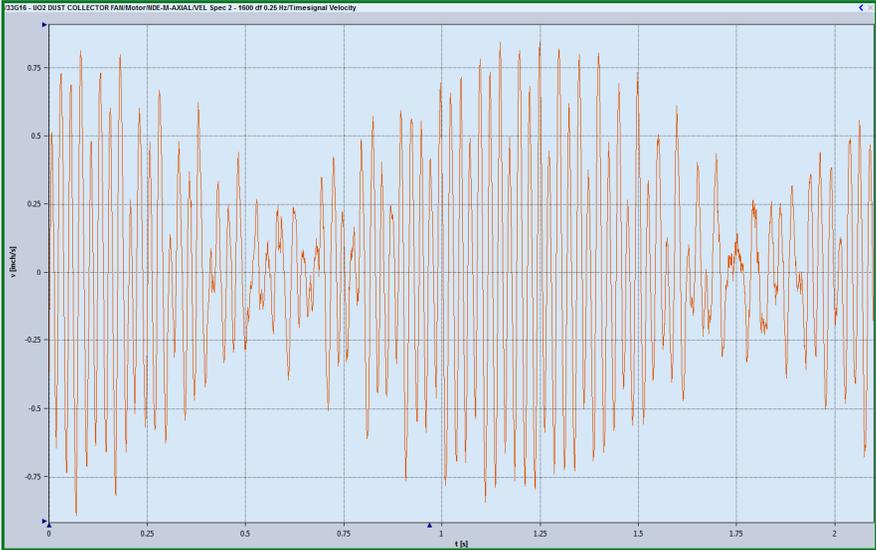
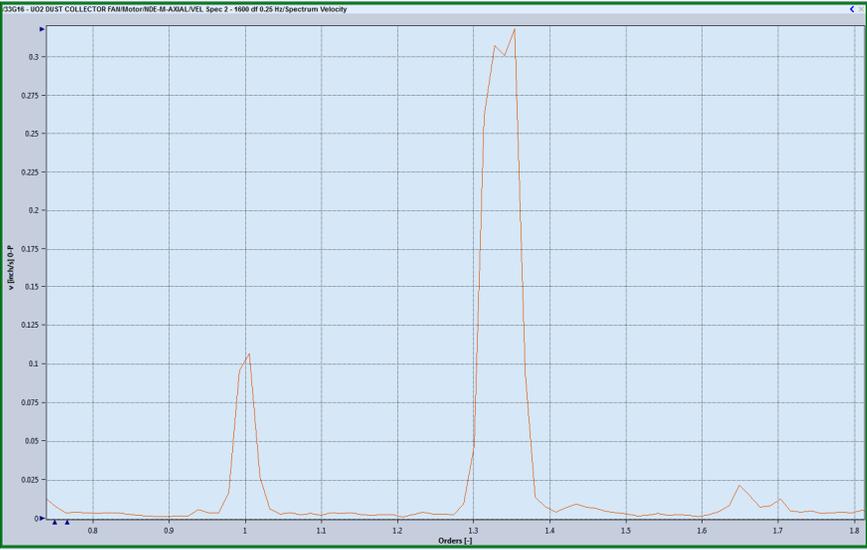
UNIT D

Observations: TimeWave form shows a beating vibration pattern every 10 Hz with a 0.8 side band. More information on the belt/pulley is needed as well as the number and speed of fan blades.

Recommendations: Check pulley unit for tooth and/or belt signs of wear/damage.

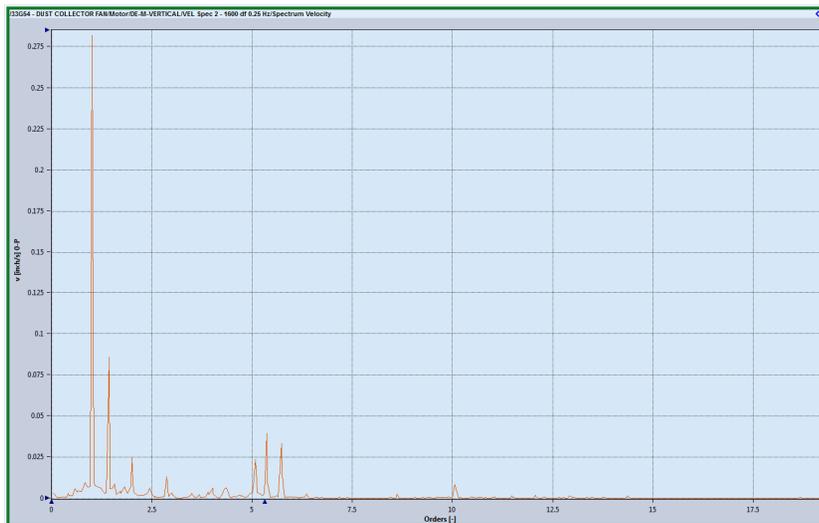
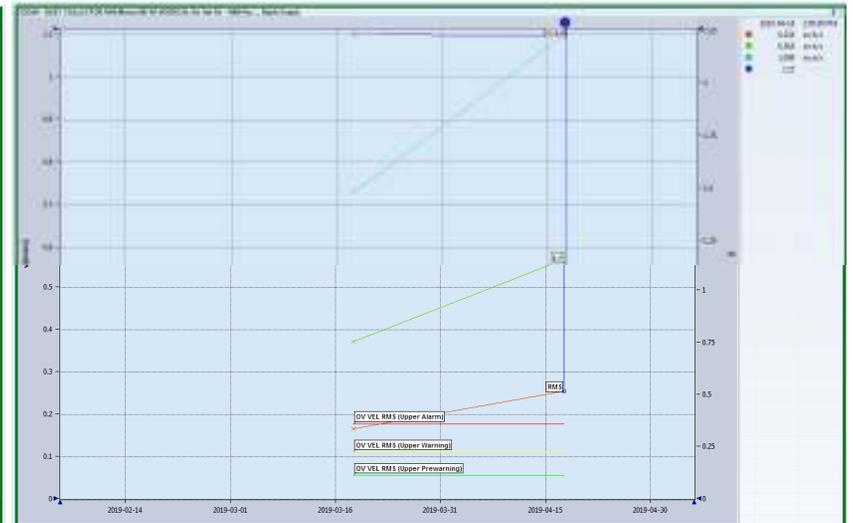
UNIT E

Observations: Overall vibration and Shock Pulse are stable since last monitoring test.

Recommendations: Close monitoring is advised during next monitoring test.

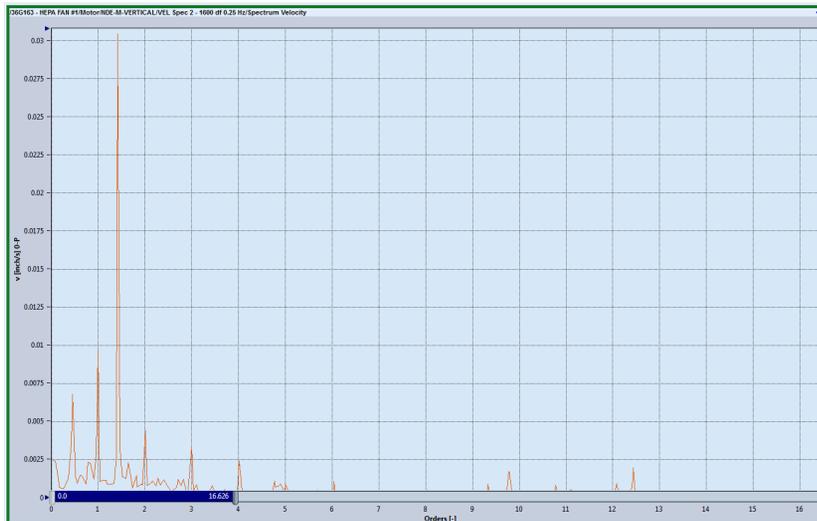
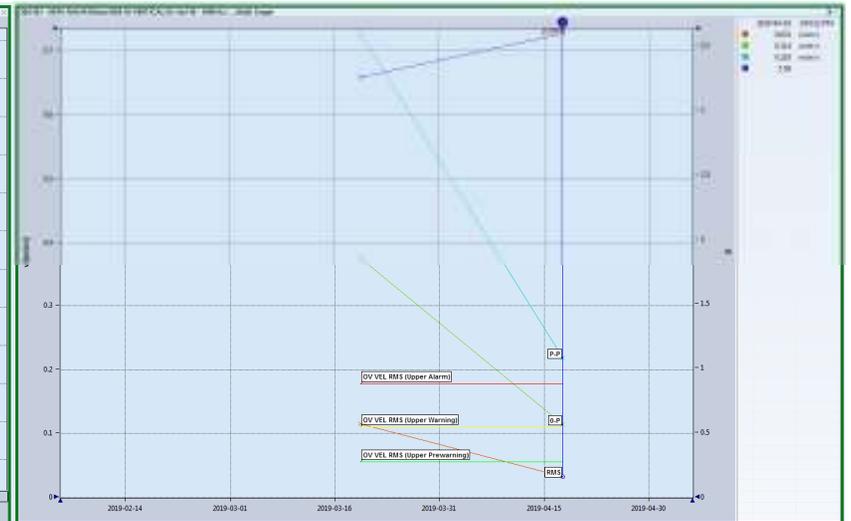
UNIT F

Observations: Overall vibration is stable since last monitoring test.

Recommendations: No service action is required.

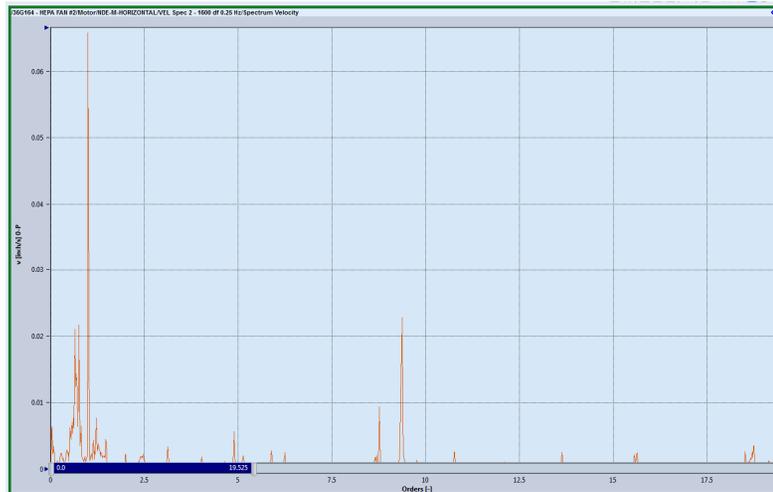
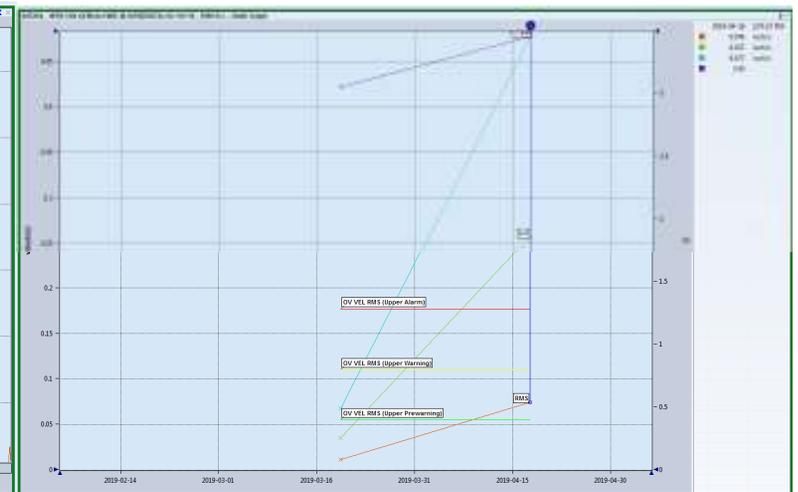
UNIT G

Observations: Overall vibration is stable since last monitoring test.

Recommendations: No service action is required.

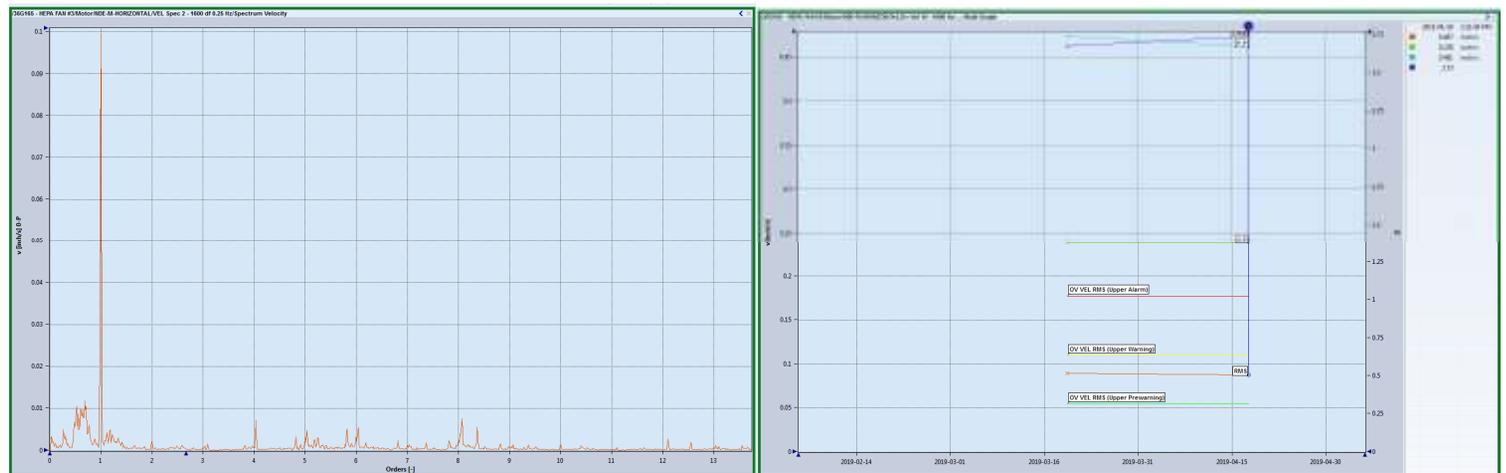
UNIT H

Observations: Overall vibration is stable since last monitoring test.
Recommendations: No service action is required.
