REPORT OF DANIEL HECHTER BRANCH FACADE NANO RESTORATION PROJECT

Egypt

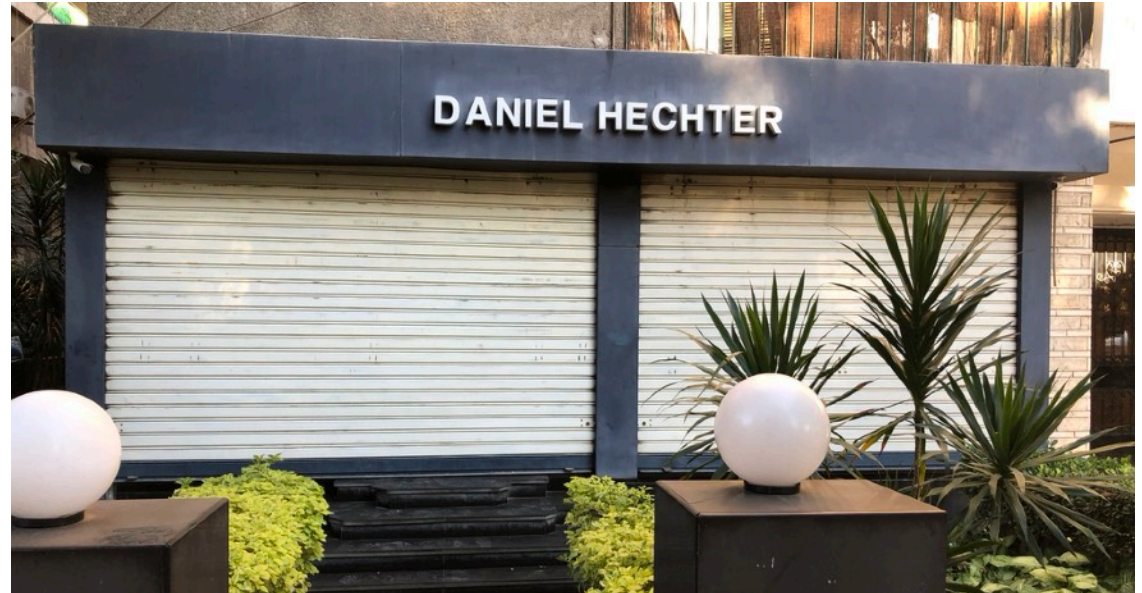
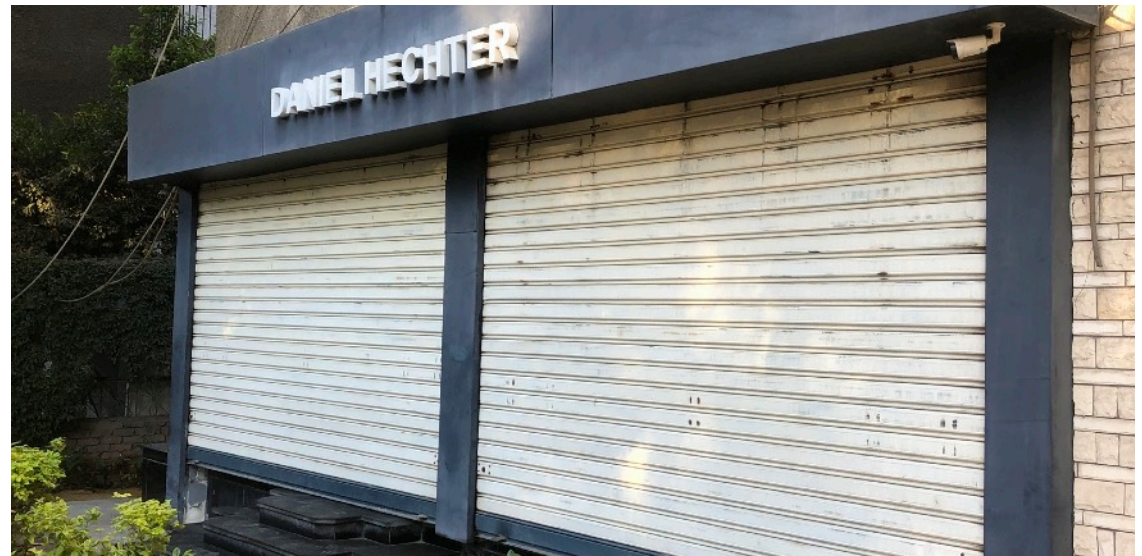
This photo shows the Faded painted metal cladding of external Degla branch facade. The surface tech this result level when substances like water, pollution, chemical materials which are using in regular cleaning process and specific environments conditions react with the pigment of the paint. In other words, the pigment begins to break down, which causes the colour change.

This change usually lightens the colour, but it has been known to darken at first and then completely change specific colours.

Also, it's important to note that panels on the same structure may not even fade uniformly, as every portion is not always subject to the same elements.

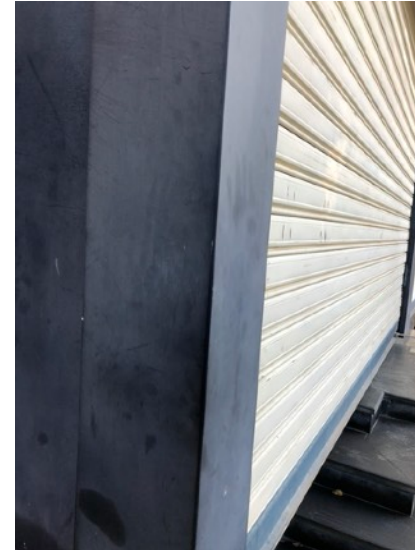
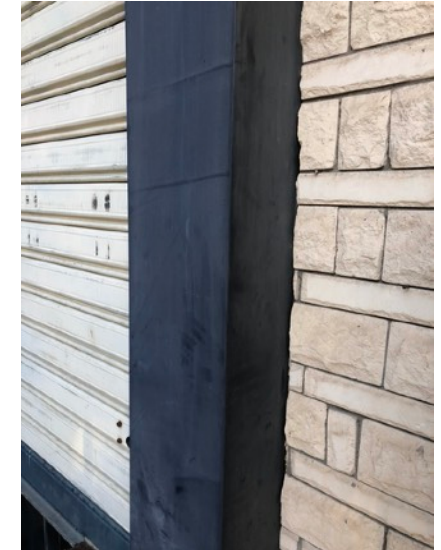
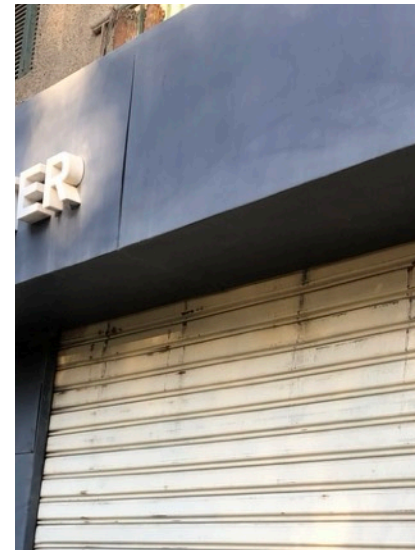
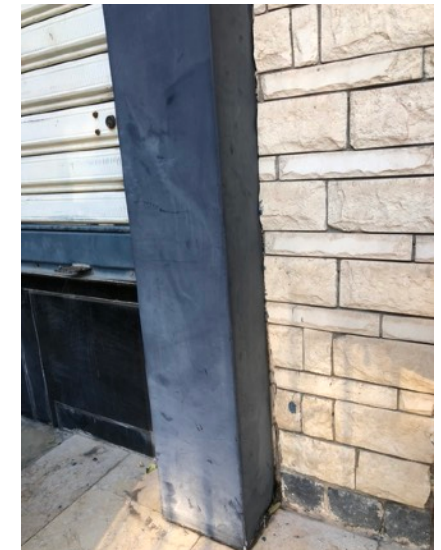
Chalking is the whitish residual that can become visible on a painted or coated metal surface over time.

As a panel is exposed to sunlight and UV rays, the resin begins to break down and degrade. Once the resin starts to break down and continues to be exposed to the sun, oxygen, and other pollutants, it loses its adhesion to the surface and those degraded particles begin to turn white.

These particles will eventually become visible to the naked eye on the metal's surface. Often times, the difference can be subtle; however, if you swipe the panel with your finger, you can not notice the chalky residue on your skin.

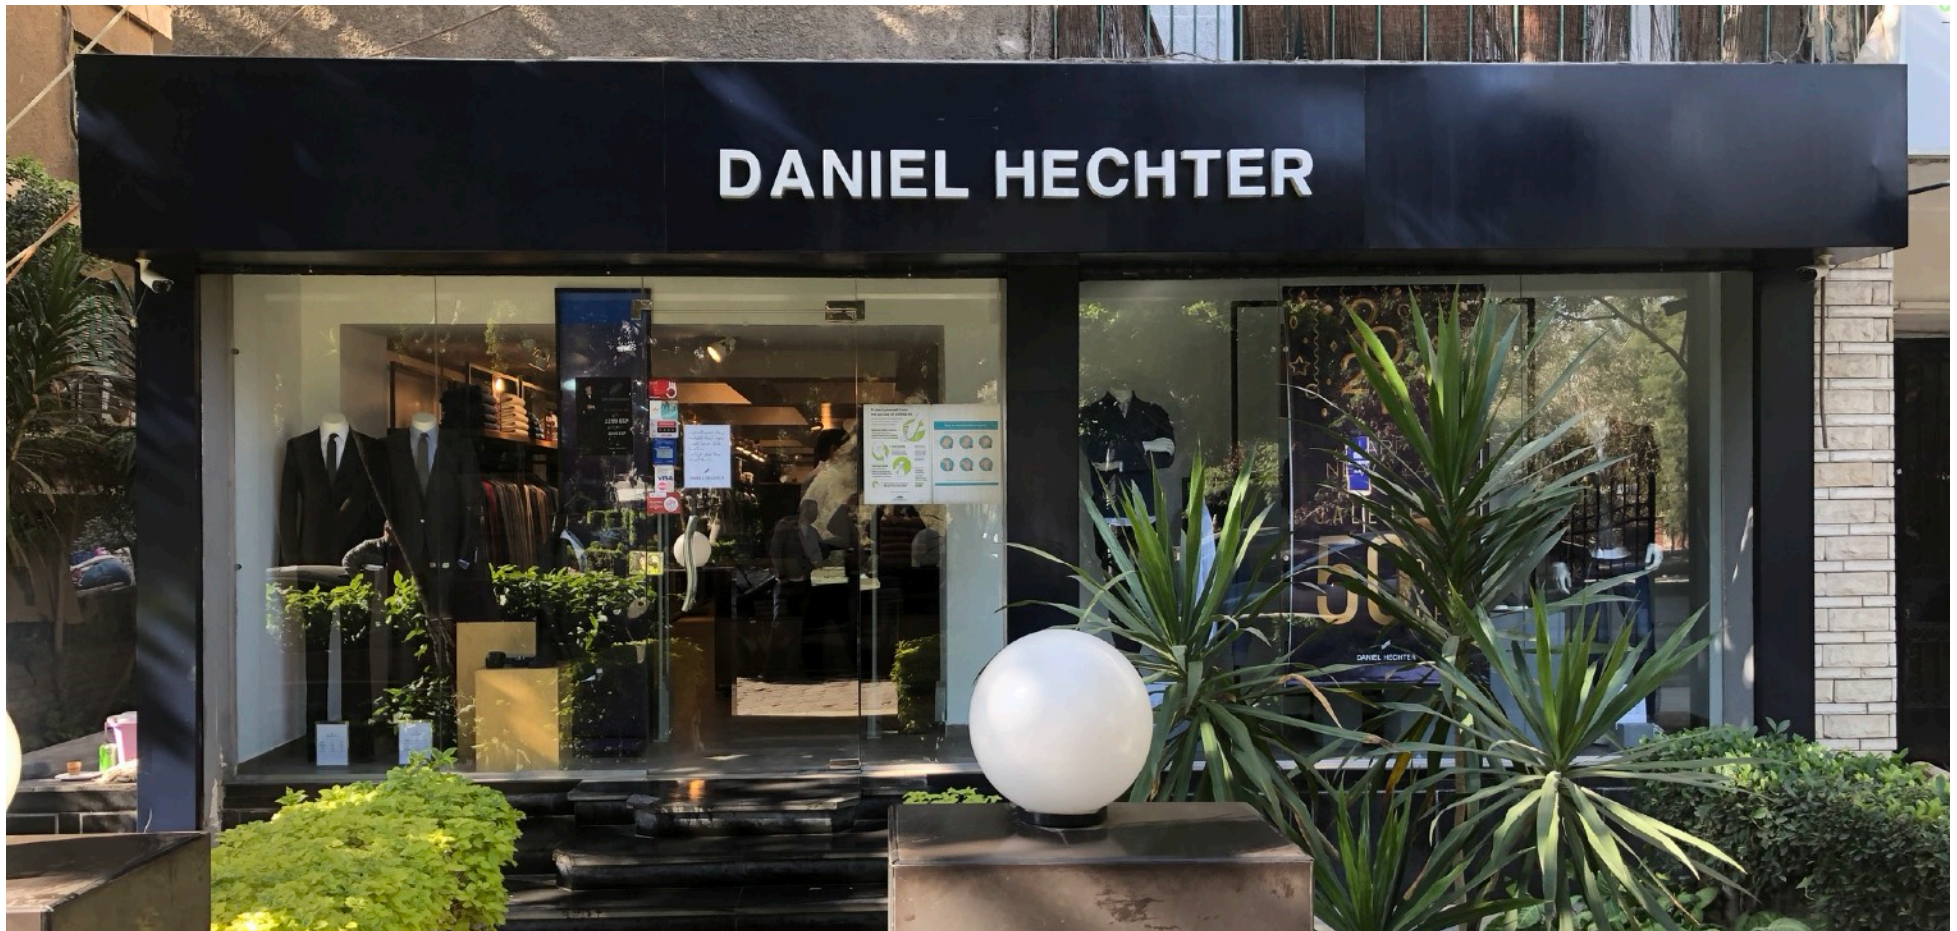
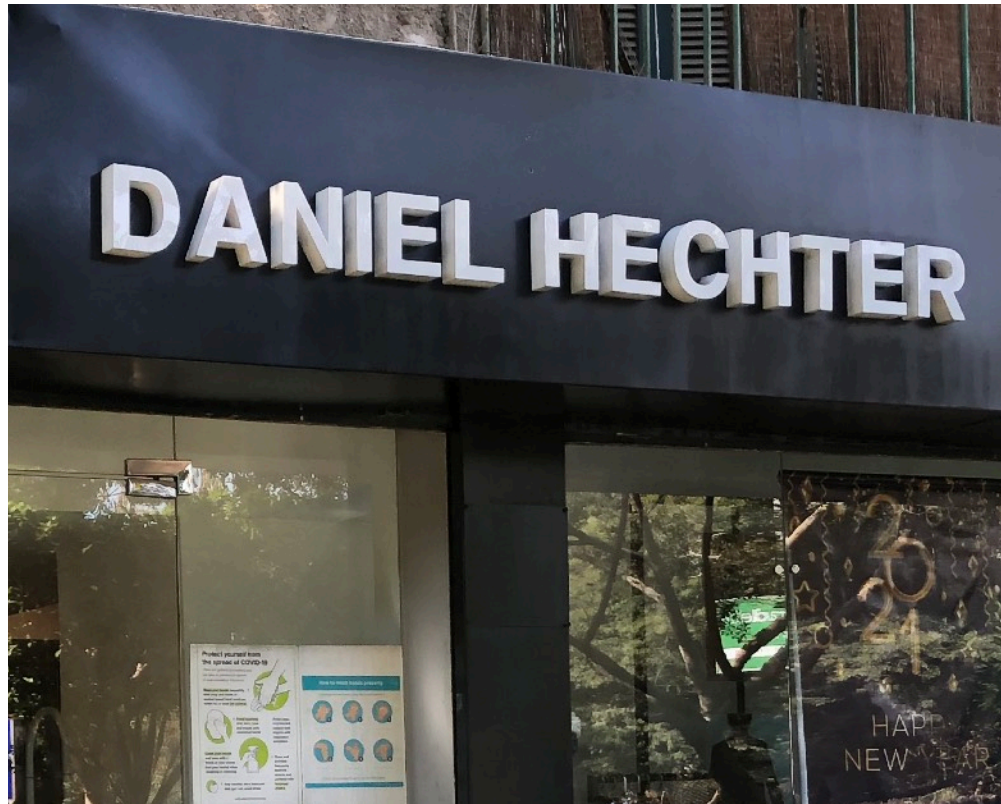
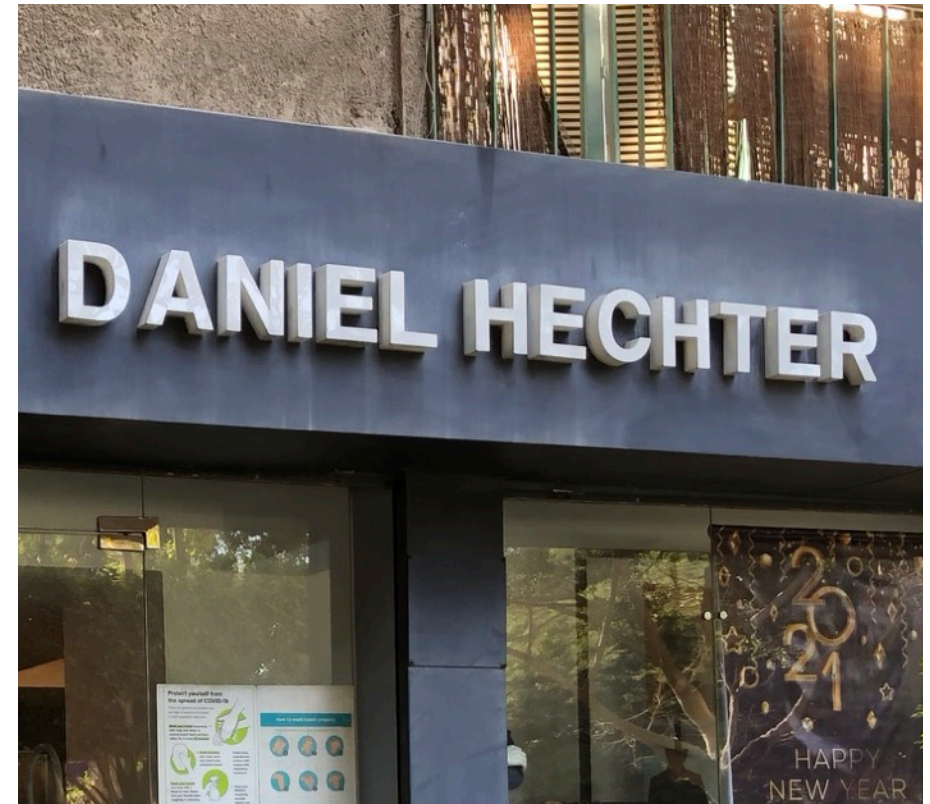
In this photos you will find the deference between coloured metal cladding before & after restoration process and how the nanomaterials restored the external metal cladding to it's original colour and physical properties.
