HOME EDGE INSPECTION

RESIDENTIAL REPORT

1234 Main Street
Bristol, VA 24202

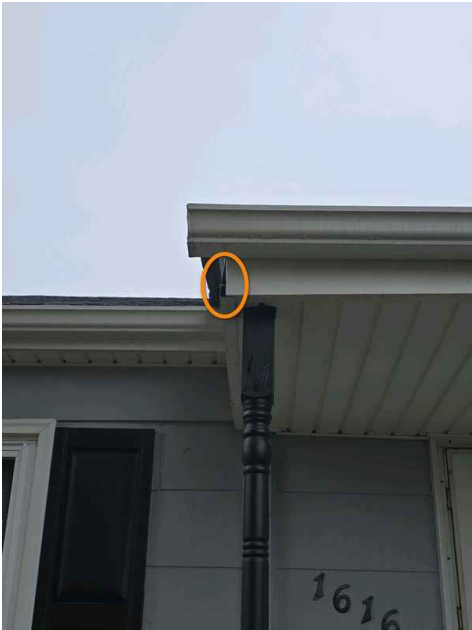
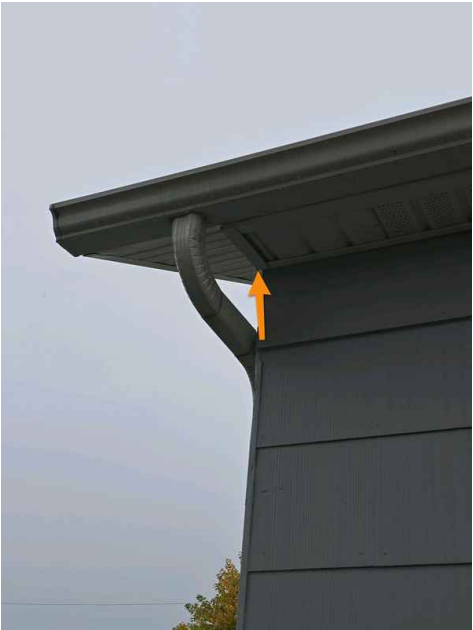
2.2.3 Siding, Flashing & Trim

GAPS/HOLES

Observed Gaps/Holes at one or more locations

Recommend a siding contractor to correct.

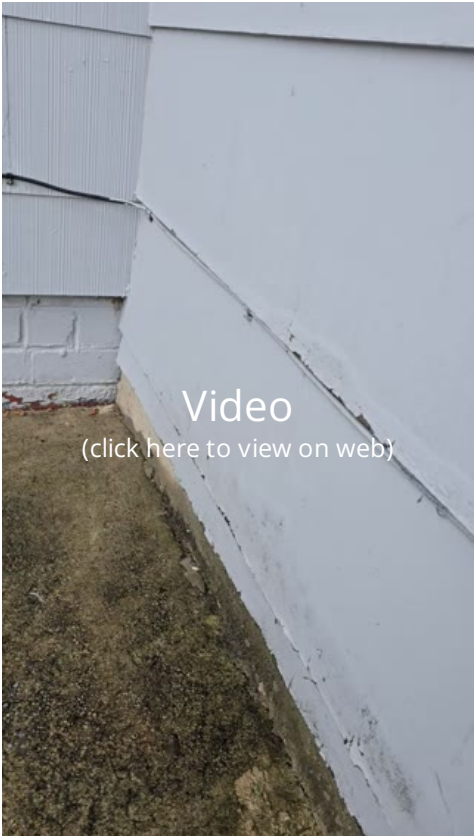
2.2.4 Siding, Flashing & Trim

WATER DAMAGE

Observed one or more areas of exterior siding that show signs of water damage .
Recommend a siding contractor to repair or replace.

Recommendation
Contact a qualified siding specialist.

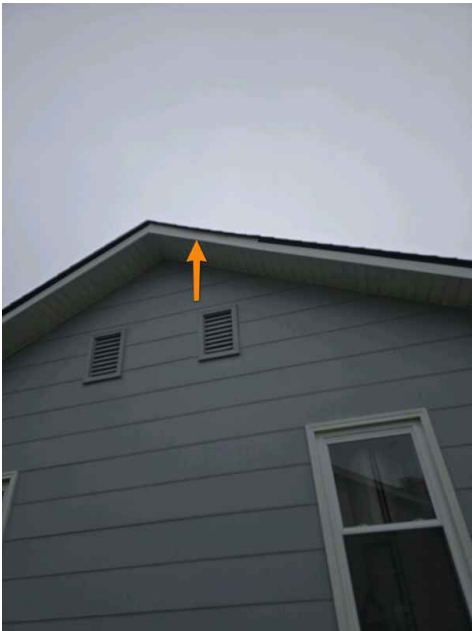
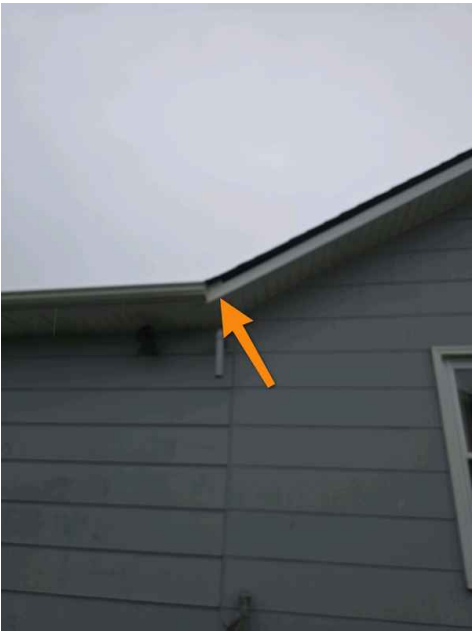
2.2.5 Siding, Flashing & Trim

FLASHING MISSING

Observed missing flashing, recommend a professional roofer to further inspect and remedy.
Recommendation
Contact a qualified roofing professional.

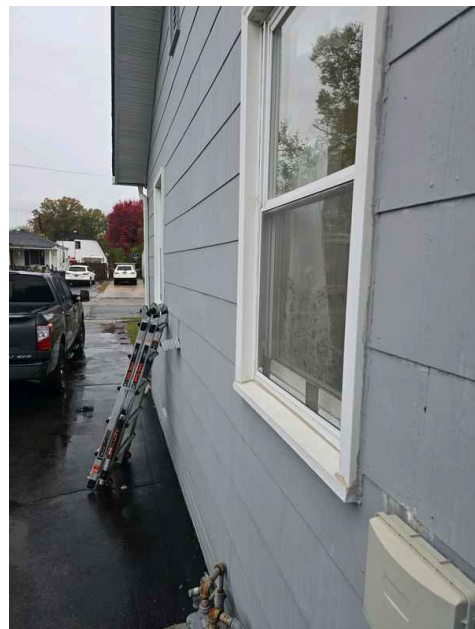
2.2.6 Siding, Flashing & Trim

POSSIBLE ASBESTOS SIDING

Observed exterior siding that appears to be older fiber cement board that may contain possible asbestos. This was commonly used material. If asbestos materials are disturbed they can release fibers that may pose health risks. Recommend further testing by a qualified professional .

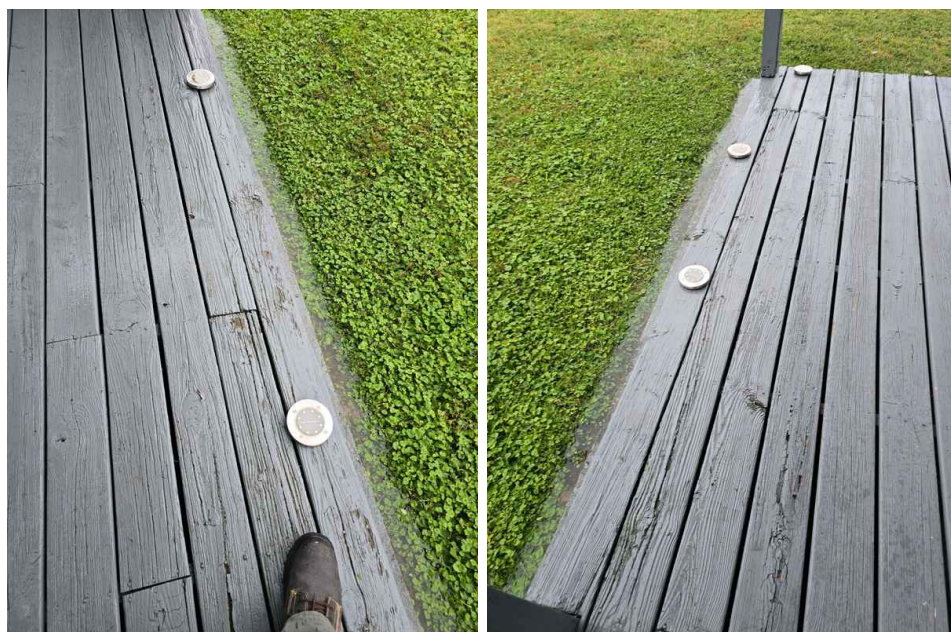
2.3.1 Decks/Balconies/Porches/Steps

DECK - WATER SEALANT REQUIRED

Deck is showing signs of weathering and/or water damage. Recommend water sealant/weatherproofing be applied.

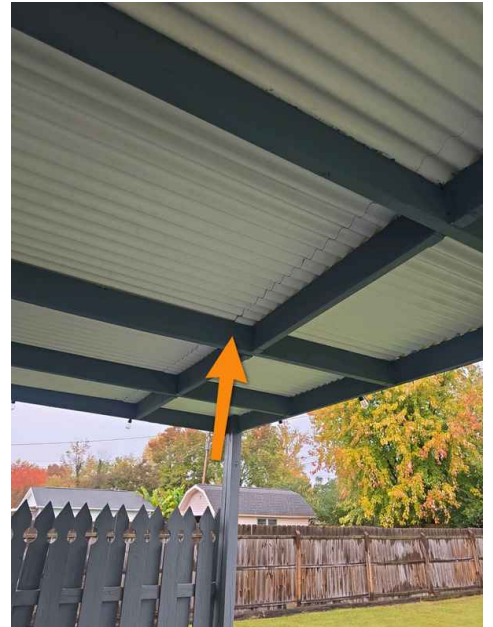
2.3.4 Decks/Balconies/Porches/Steps

WATER LEAK

Noted areas of back deck covering to be leaking/dripping water in areas. Recommend a Roofer to inspect and correct.

Contact a qualified roofing professional.

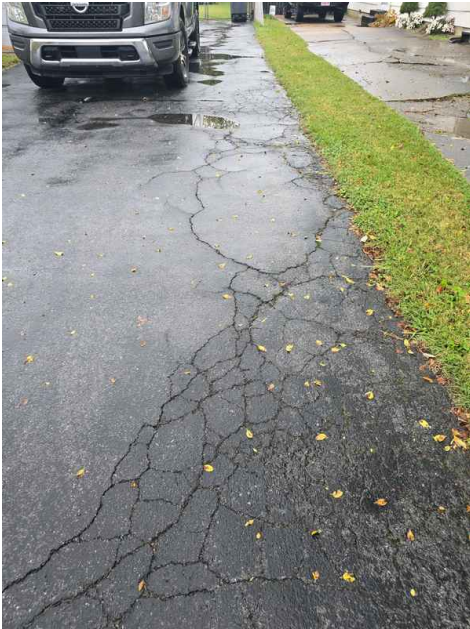
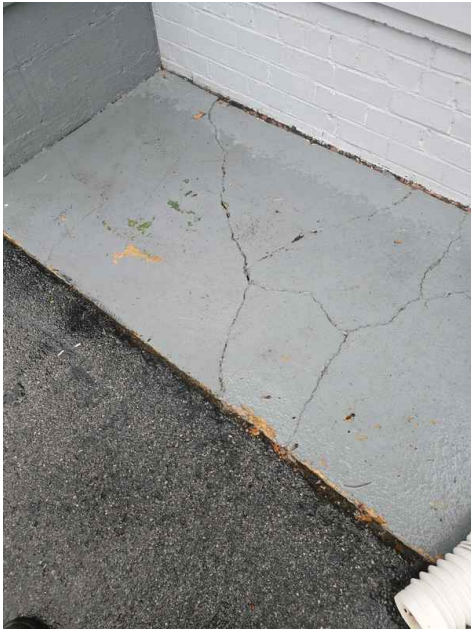
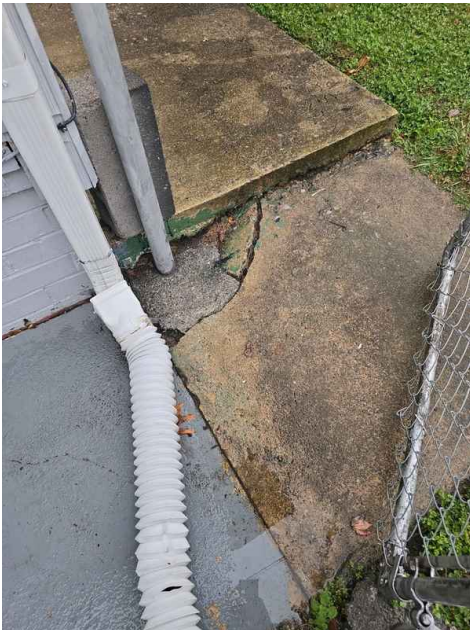
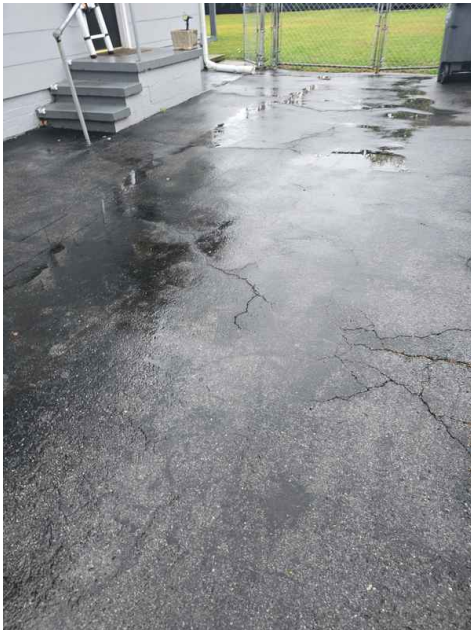
DRIVEWAY/ SIDEWALK CRACKING -

Minor cosmetic cracks observed, which may indicate movement in the soil. Recommend monitor and/or have driveway contractor patch/seal.

Contact a qualified driveway contractor.

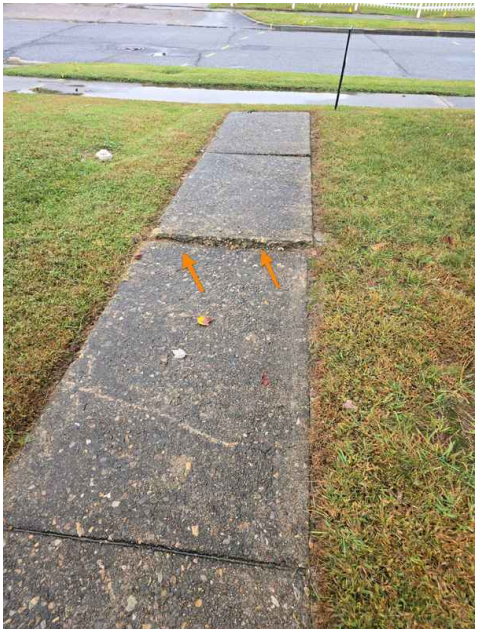
2.5.2 Walkways, Patios & Driveways

SIDEWALK TRIP HAZARD

Observed settling sidewalk which could potentially be a trip hazard. Recommend a concrete contractor to remedy.

Contact a qualified concrete contractor.

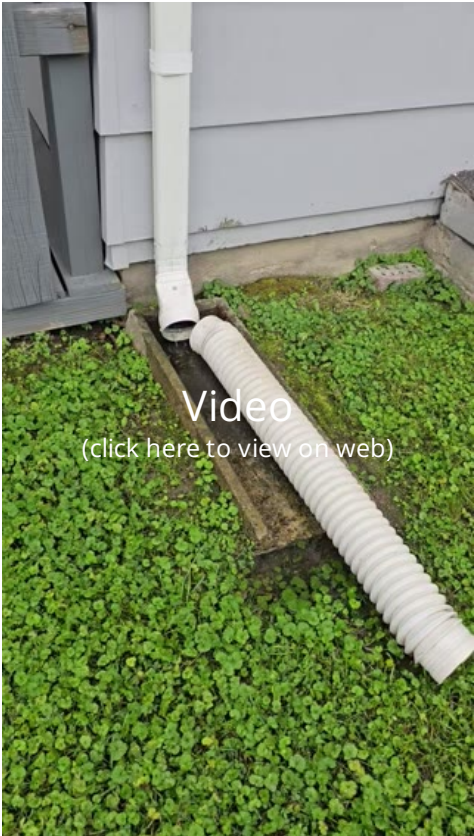
One or more downspouts drain too close to the home's foundation. This can result in excessive moisture in the soil at the foundation, which can lead to foundation/structural movement. Recommend a qualified contractor adjust downspout extensions to drain at least 6 feet from the foundation.

Contact a qualified gutter contractor

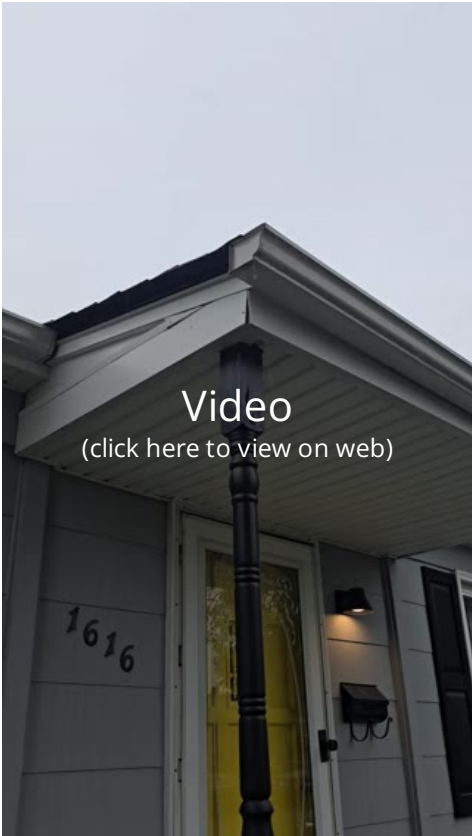
3.2.2 Roof Drainage Systems

GUTTER LEAKAGE

Gutters were observed to be leaking in one or more areas. This can result in excessive moisture in the soil at the foundation, which can lead to foundation/structural movement. Recommend a qualified contractor evaluate and repair gutters to proper functionality.

Contact a qualified gutter contractor

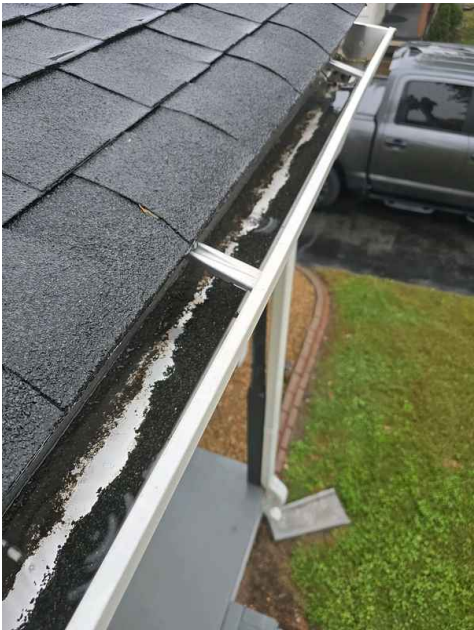
3.2.3 Roof Drainage Systems

Noted one or more gutters were retaining water in areas.
Recommend a gutter contractor to remedy.
Recommendation
Contact a qualified gutter contractor

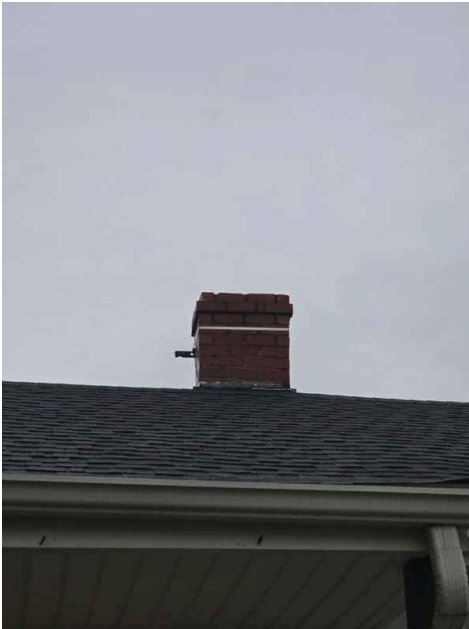
CHIMNEY CAP MISSING

No chimney cap was observed. This is important to protect from moisture intrusion and protect the chimney. Recommend a qualified roofer or chimney expert install.
Recommendation
Contact a qualified chimney contractor.

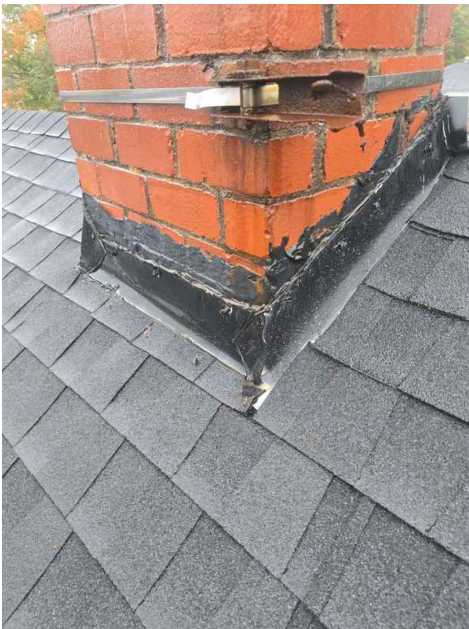
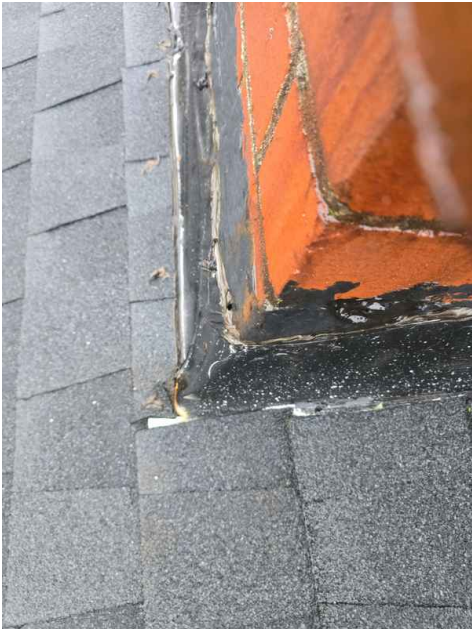
3.3.2 Skylights, Chimneys & Other Roof Penetrations

The chimney flashing is not properly installed and has been attempted to be sealed in multiple areas. Recommend a qualified roofer to further inspect and repair.

Contact a qualified roofing professional.

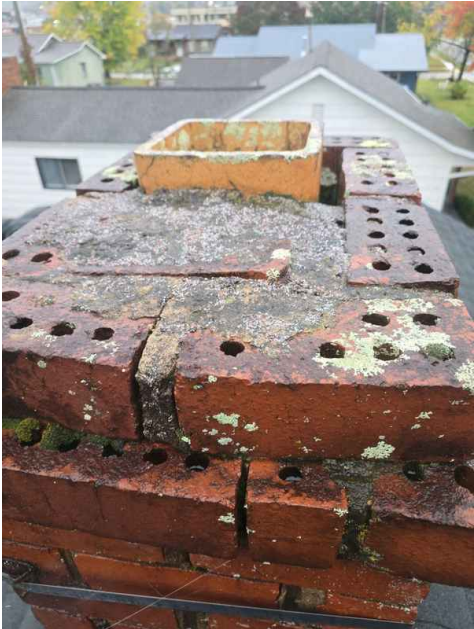
3.3.3 Skylights, Chimneys & Other Roof Penetrations

CROWN DEFECTS

Observed missing or deteriorated chimney crown.

Recommend a qualified chimney contractor to inspect and repair or to install a stainless steel cover.

Contact a qualified chimney contractor.

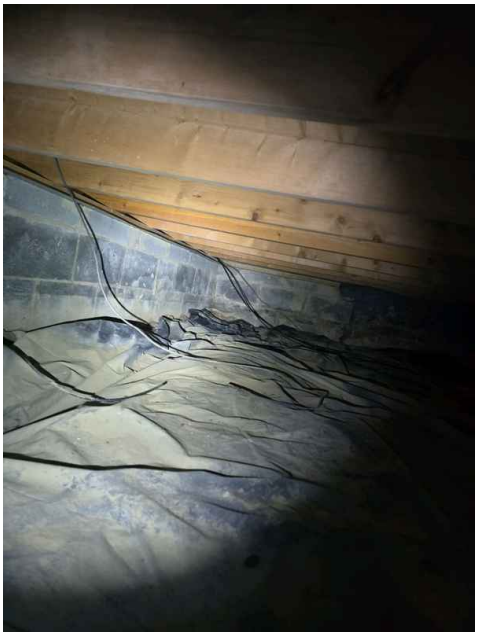
Efflorescence noted on the crawlspace surface. This a white, powdery deposit that is consistent with moisture intrusion. This can compromise the soil's ability to support the home structure and/or lead to mold growth. Recommend a qualified contractor identify source or moisture and correct.

Contact a qualified landscaping contractor

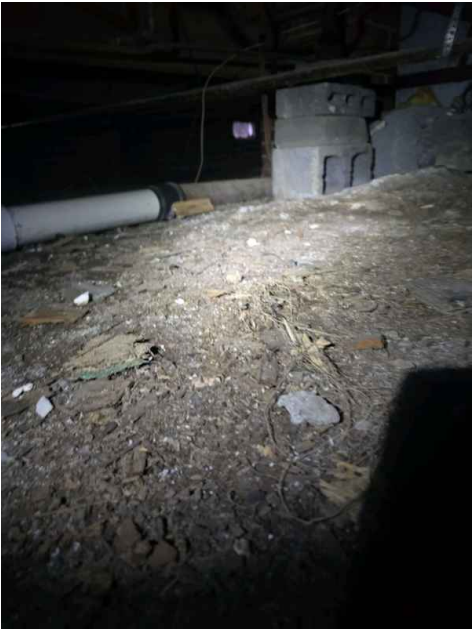
4.2.2 Basements/ Crawlspaces

VAPOR BARRIER-DEFECTS

Observed Vapor Barrier Defects

Crawlspace has improperly installed vapor barrier , this can include but not limited to incomplete, damaged, exposed soil, or insufficient material.

Recommend a qualified contractor to advise and remedy.

Contact a qualified professional.

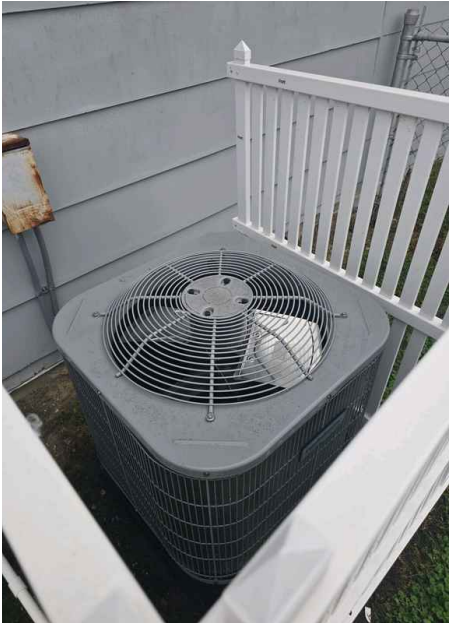
Outdoor Unit

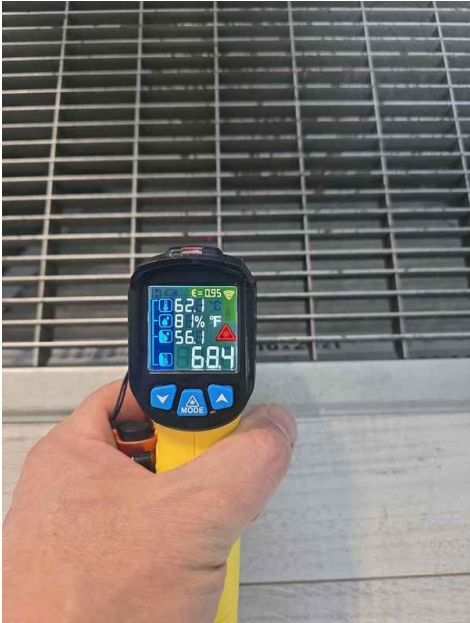
Heat intake temperature

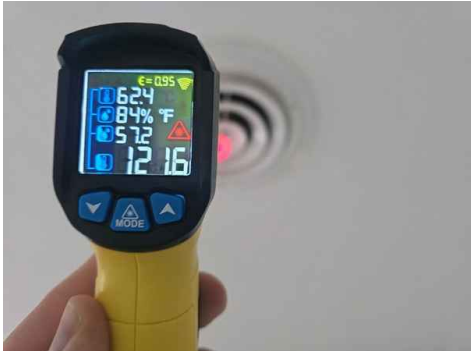
Heat supply temperature

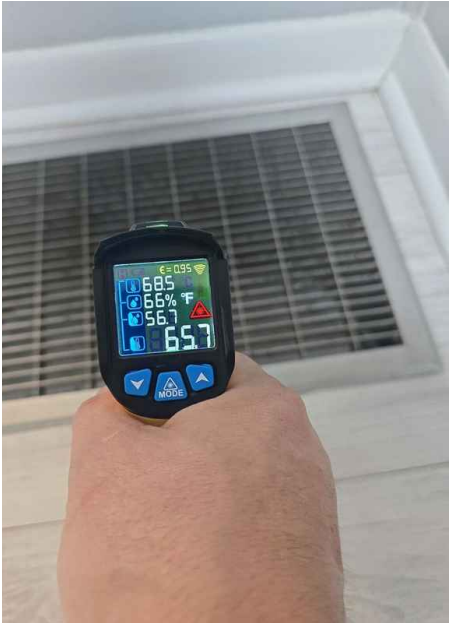
Cold air intake temperature

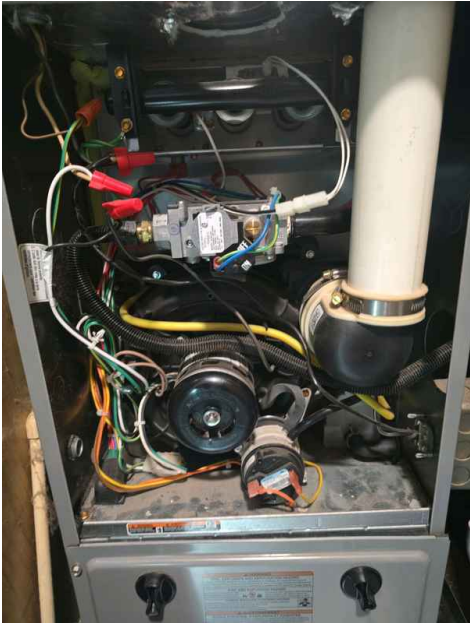
High Efficiency Gas Heater

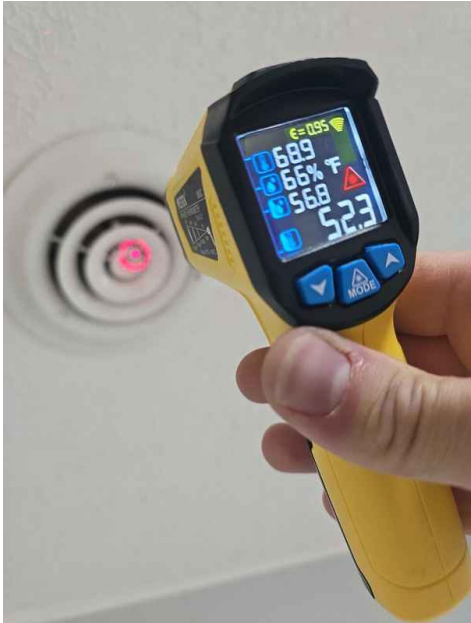
Cold air supply temperature

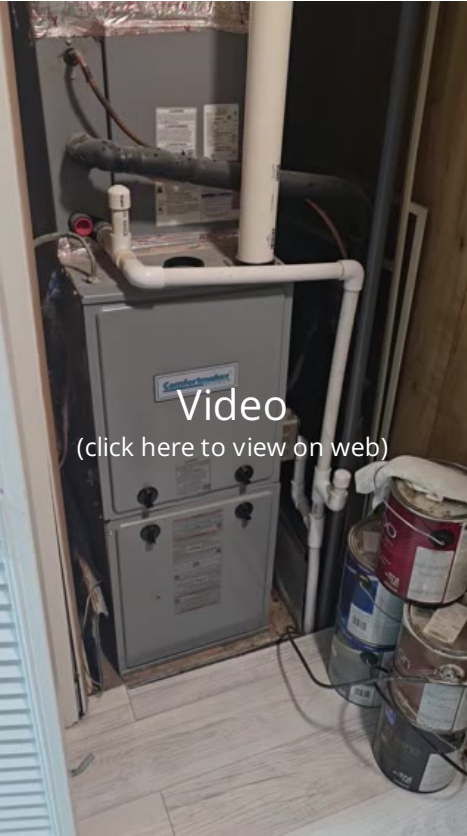
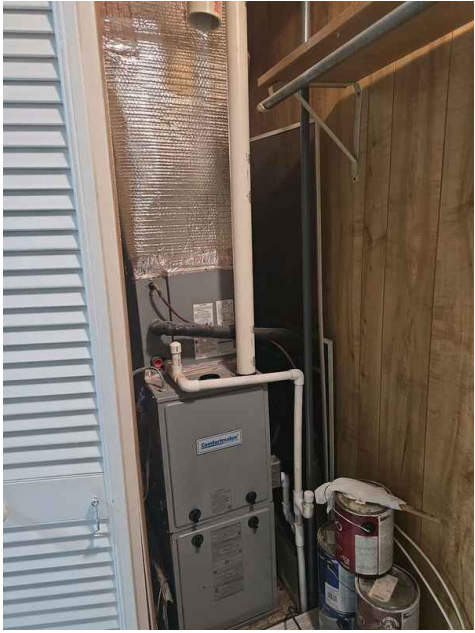
NOTE: This may differ according to manufacture instructions and applicable codes. Recommend a Qualified HVAC contractor to further inspect and correct if required.

Recommendation
Contact a qualified HVAC professional.

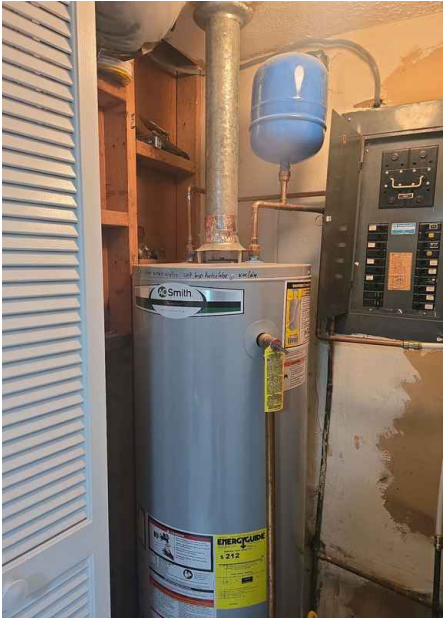
Hot water heater was manufactured in **2017**

Hot water heaters generally have a life expectancy of 8-12 years, proper maintenance, use and water quality can greatly effect its life expectancy.

Recommend replacement within 2-4 years, perform annual flushing to extend life or consider proactive replacement .

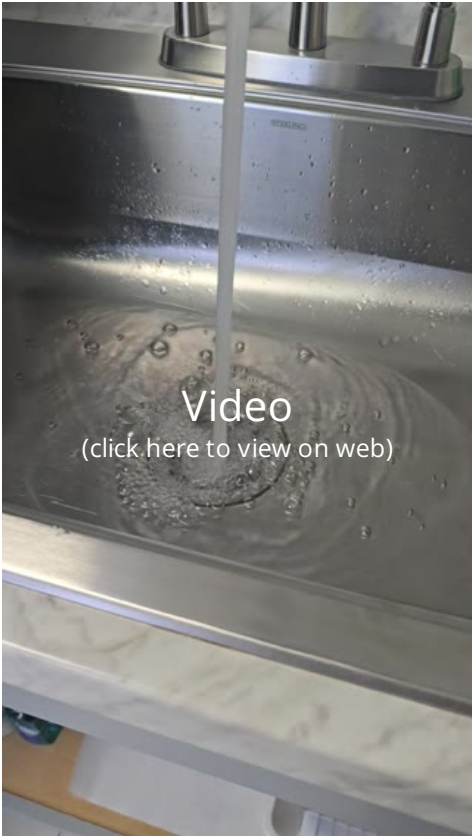
Slow/poor drainage observed at one or more locations.

Recommend a qualified plumber to inspect and repair.

Contact a qualified plumbing contractor.

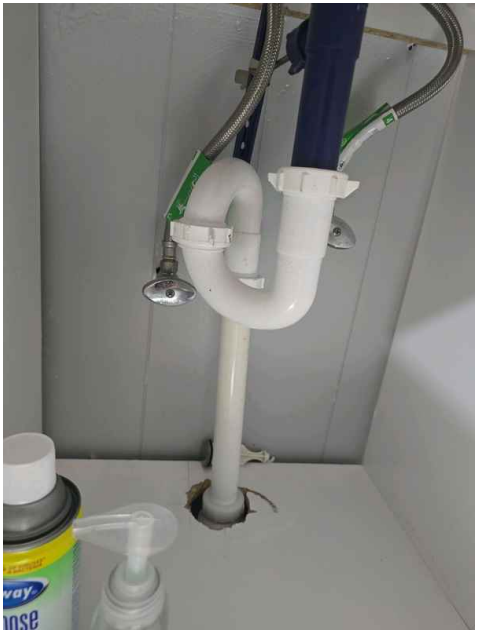
6.2.2 Drain, Waste, & Vent Systems

S-TRAP

Observed improper plumbing S-Trap

S-traps are prone to siphoning which causes sewer gases to leak into the home.

Recommend a qualified Plummer to inspect and remedy.

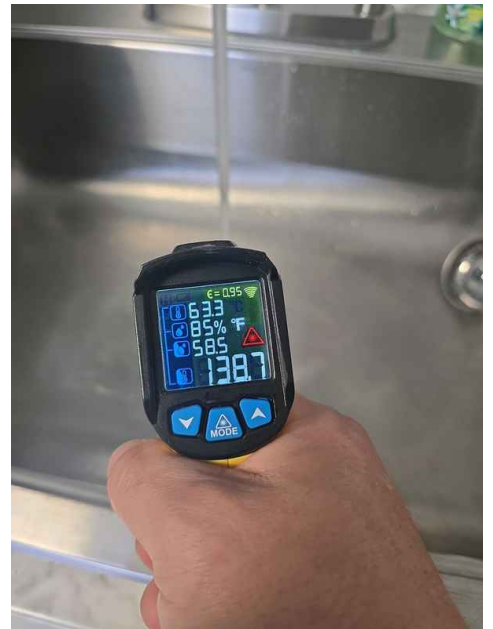
6.4.1 Hot Water Systems, Controls, Flues & Vents

observed temperature to be **138 degrees**

Hot water should be between 120-130 degrees to reduce bacterial growth while not being a potential burn risk.

Recommend a qualified plumber to further inspect and adjust.

Contact a qualified plumbing contractor.

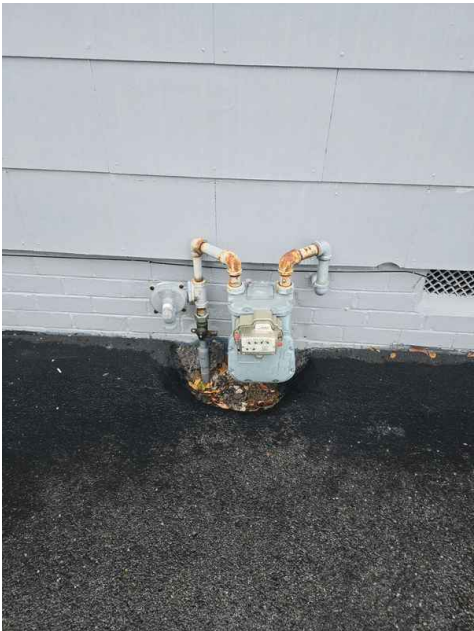
Ground wiring for gas lines was not observed or located at the exterior and was not visible in the crawl space at the time of inspection.

This could be a potential safety hazard .

Recommend qualified electrician to properly ground .

Contact a qualified electrical contractor.

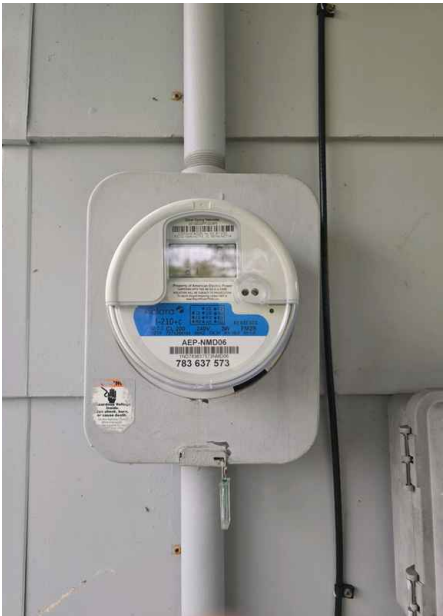
Service Entrance Conductors:
Electrical Service Conductors
Overhead, 220 Volts

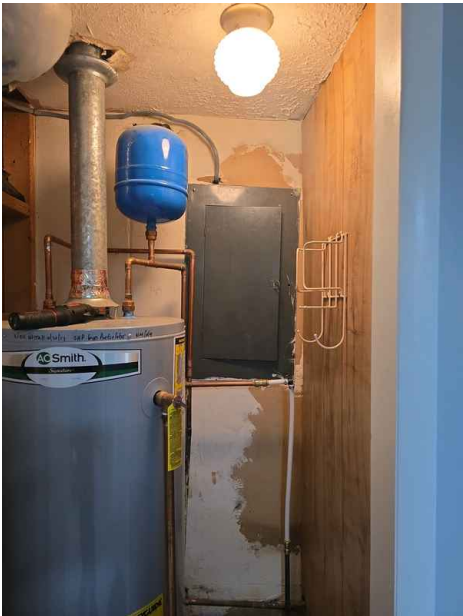
Breaker-box/ Subpanels/
Grounding: Main Panel Location
Hot water heater room

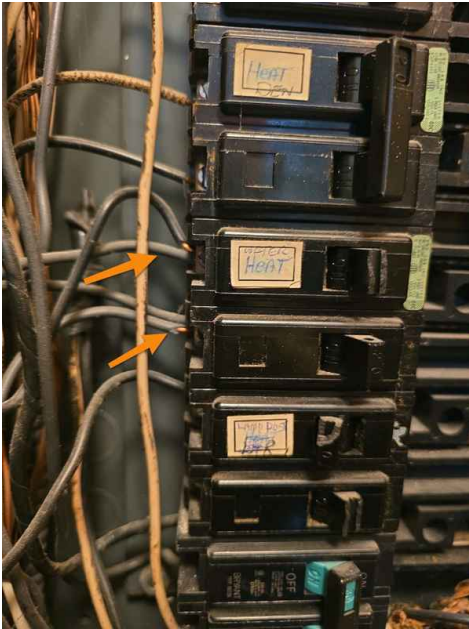
Observed a Double Fed Breaker or Lug.

This is a potential fire hazard.

Recommend a qualified electrician to further inspect and advise.

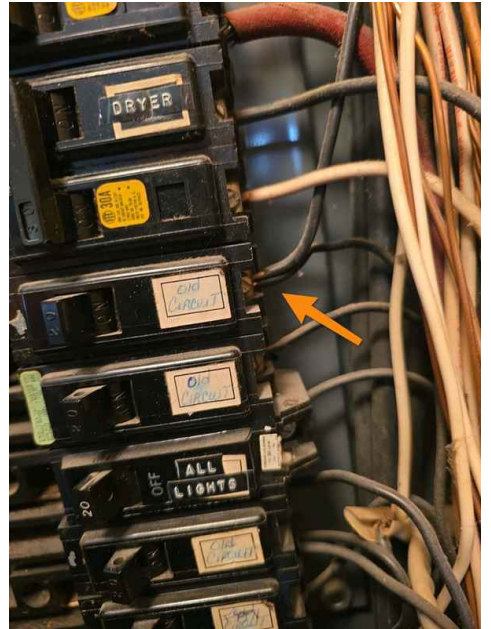
7.2.3 Breaker-box/ Subpanels/ Grounding

BREAKER- DOUBLE TAP (DOUBLE FED LUG)

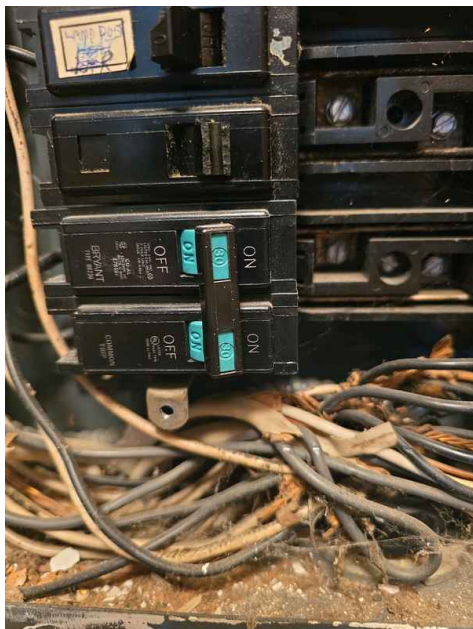
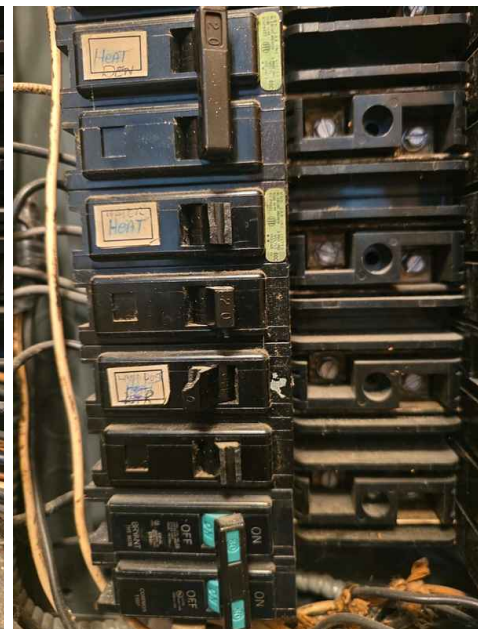
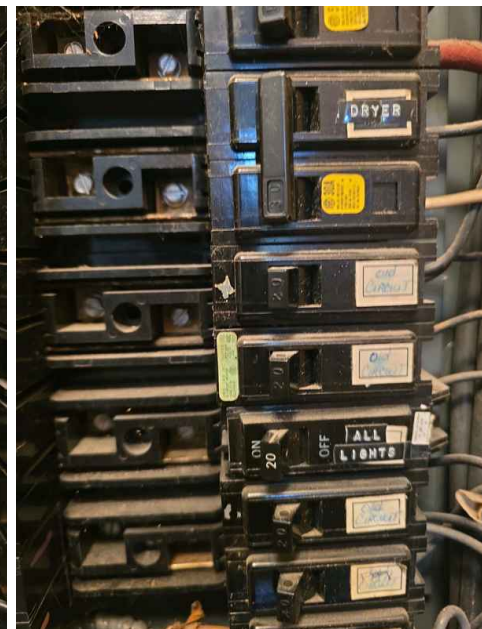
7.2.5 Breaker-box/ Subpanels/ Grounding

BREAKER- MISS-MATCHED

Observed Miss-Matched Breakers.

Some breakers are allowed to be mis-matched to different brands, and may not be a safety risk, others may not be allowed and pose safety hazards.

Recommend a Licensed Electrician to inspect and verify.

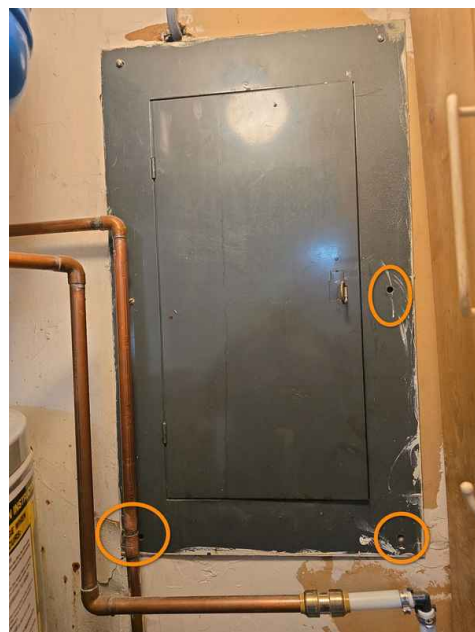
7.2.6 Breaker-box/ Subpanels/ Grounding

SCREWS/FASTENERS- DEFECTS

Observed Screw/Fastener Defects.

Recommend a qualified Professional to Remedy.

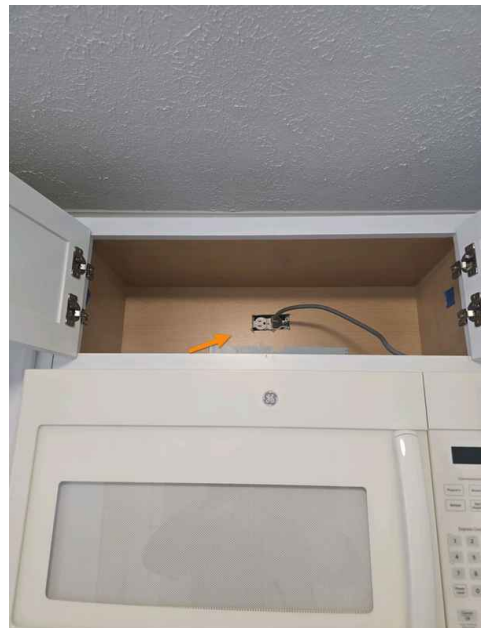
Observed one or more outlets with the following defects.

Missing cover

Recommend a qualified contractor to inspect and remedy.

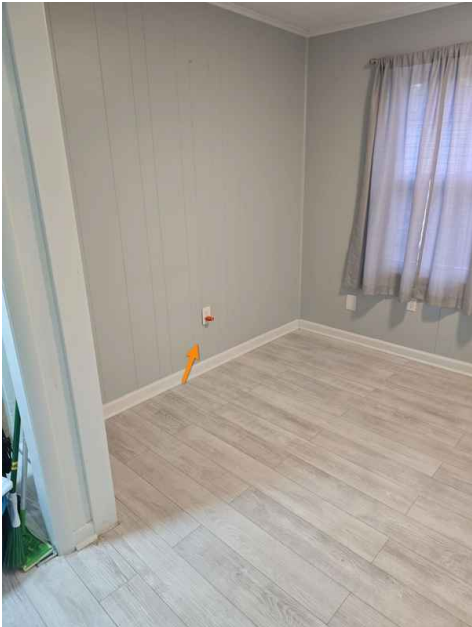
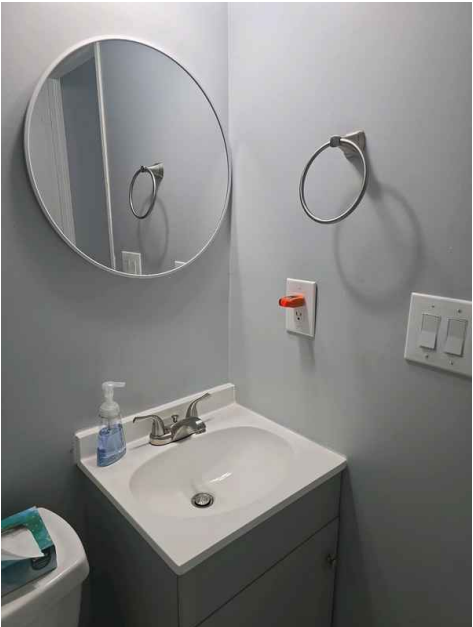
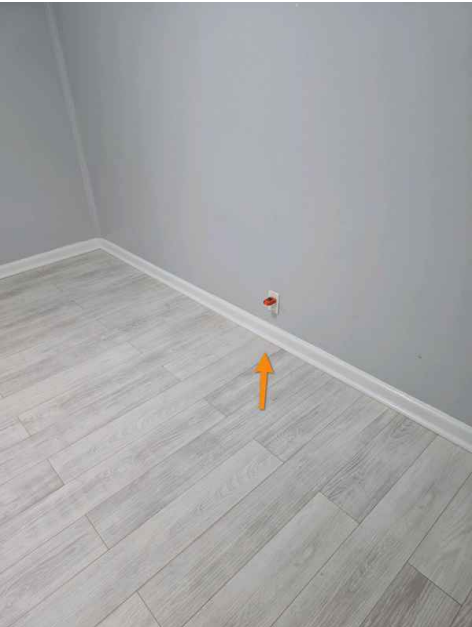
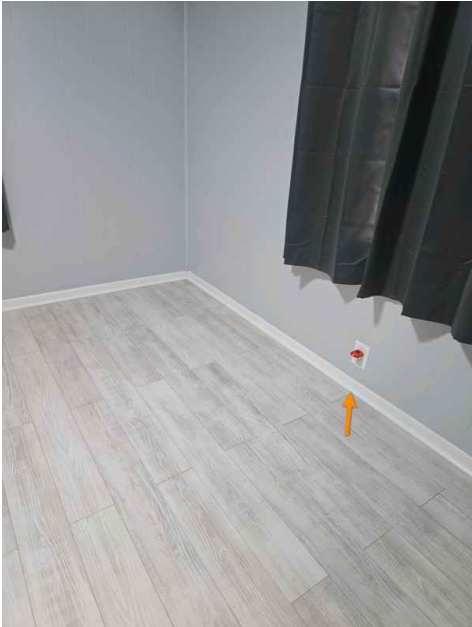
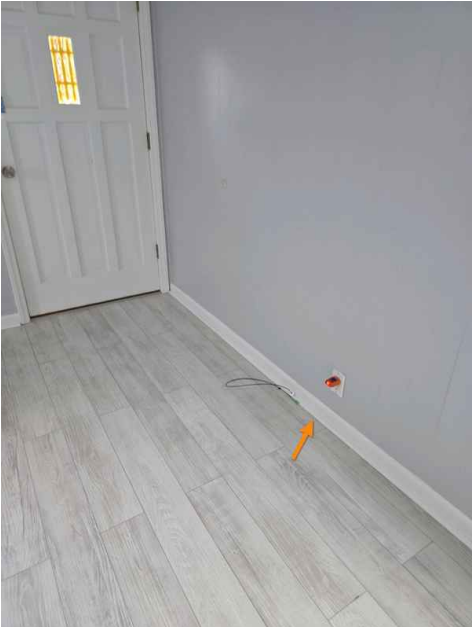
Dining Room- one or more

Common bathroom

Middle left bedroom- one or more

Front left bedroom- one or more

Living Room- one or more

Recommend a qualified electrician to inspect and advise.

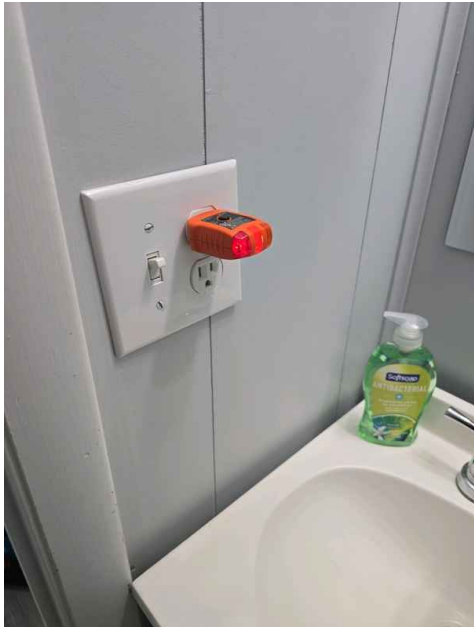
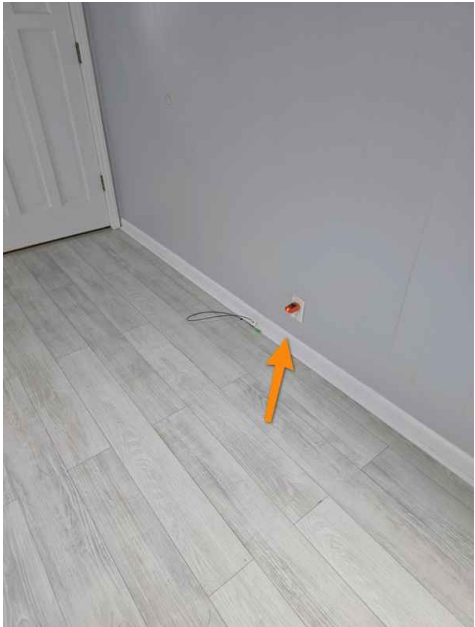
Observed one or more Electrical Outlet to be loose.
Recommend a qualified electrician to inspect and remedy.

Half bathroom

Living Room

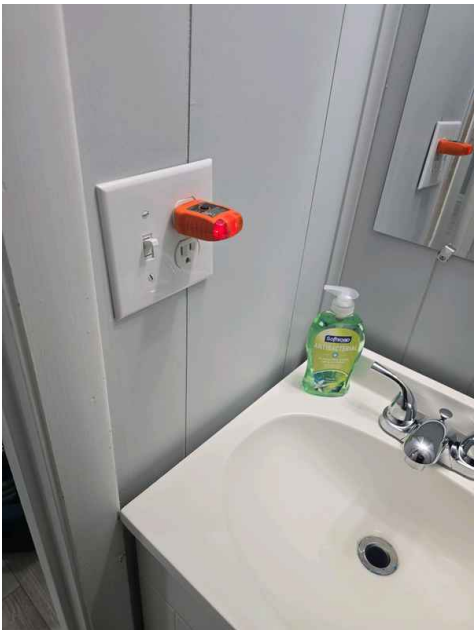
One or more receptacles have been wired with reverse polarity.
This can create a shock hazard.

Half bathroom

Contact a qualified electrical contractor.

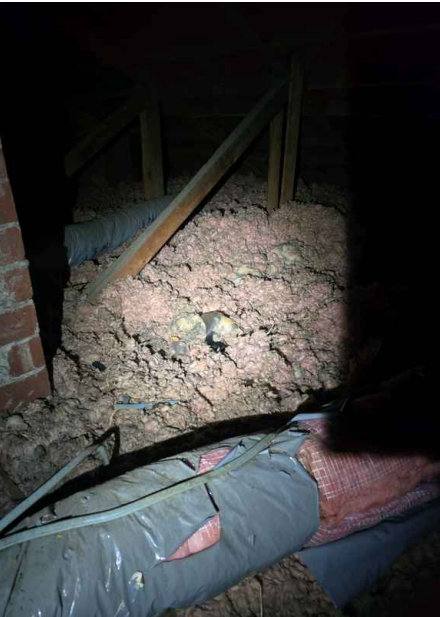
Dryer Power Source 220 Electric	Dryer Vent Foil Flex	Ceiling Insulation None
Attic Insulation: Insulation Type Blown-in Insulation, Fiberglass	Attic Insulation: R-value Approximately R17-R26

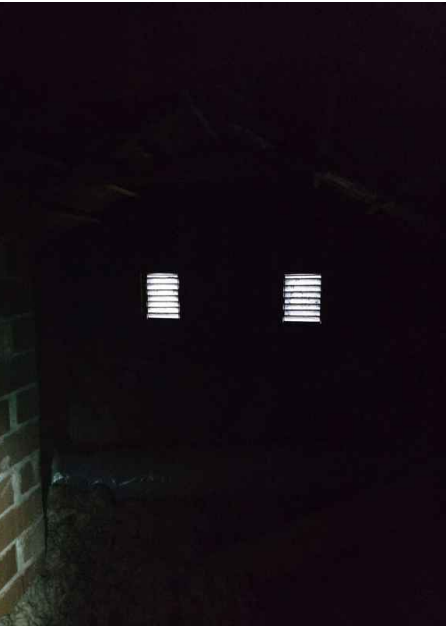
Ventilation/Exhaust: Ventilation Type
Gable Vents

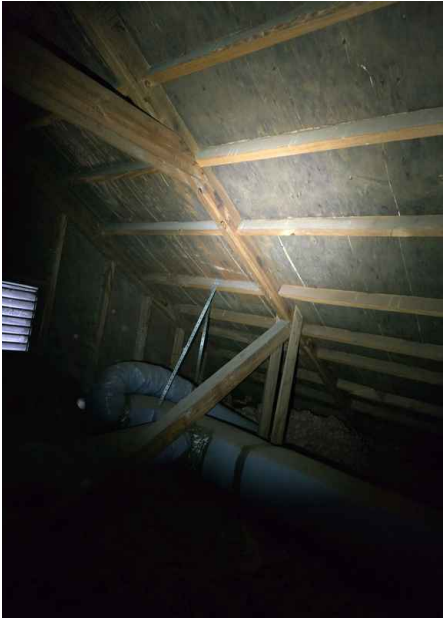
Roof Structure & Attic: Type
Gable

Roof Structure & Attic: Unable to access full attic space.
Was unable to fully inspect one section of attic due to opening limitations.

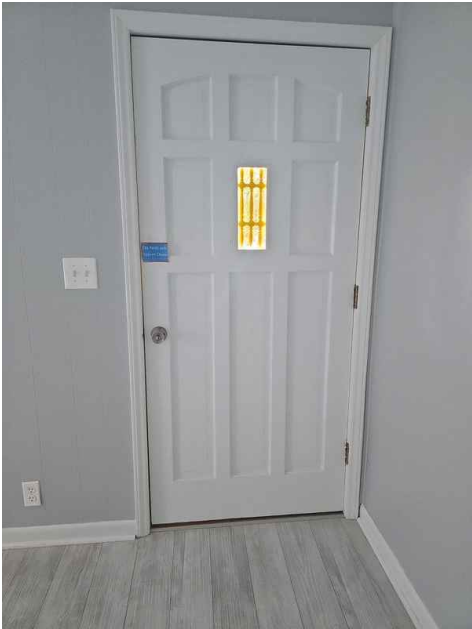
No deadbolt

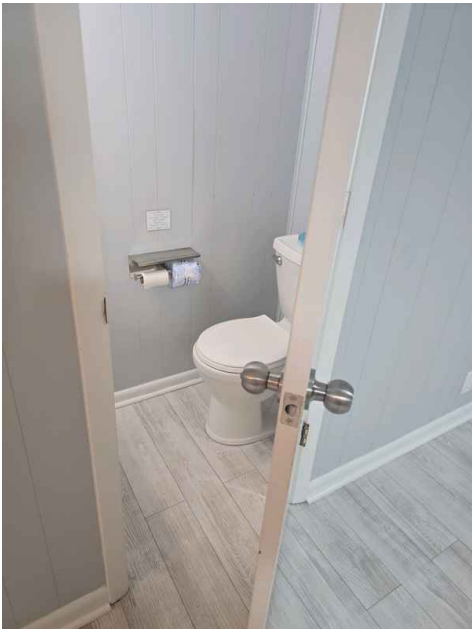
Doesn't latch

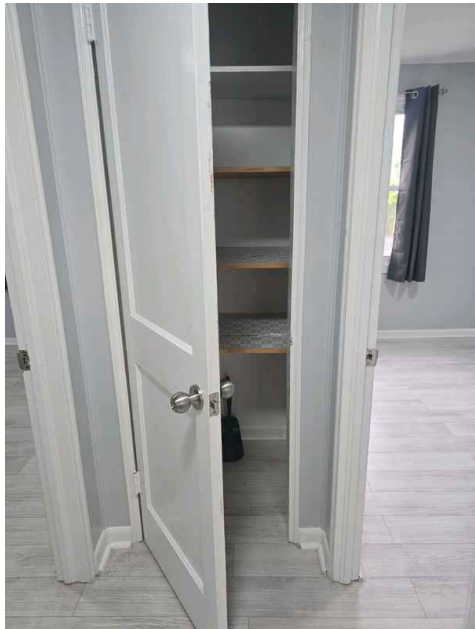
Doesn't latch

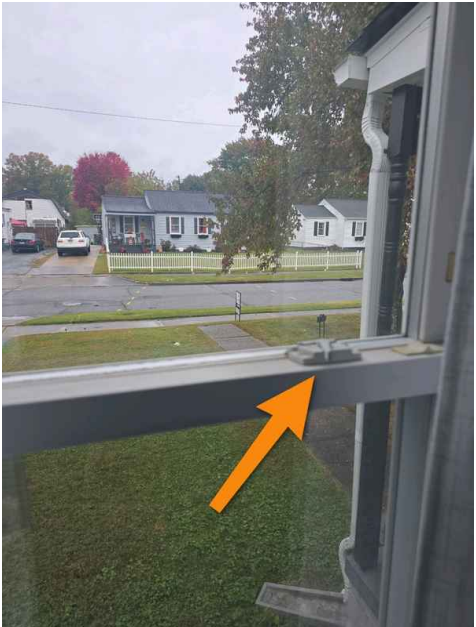
DEFECTS-WINDOW

Observed one or more windows with locking defects
Recommend a window contractor to further inspect and remedy.
Recommendation
Contact a qualified window repair/installation contractor.

Is still functional but doesn't fully engage

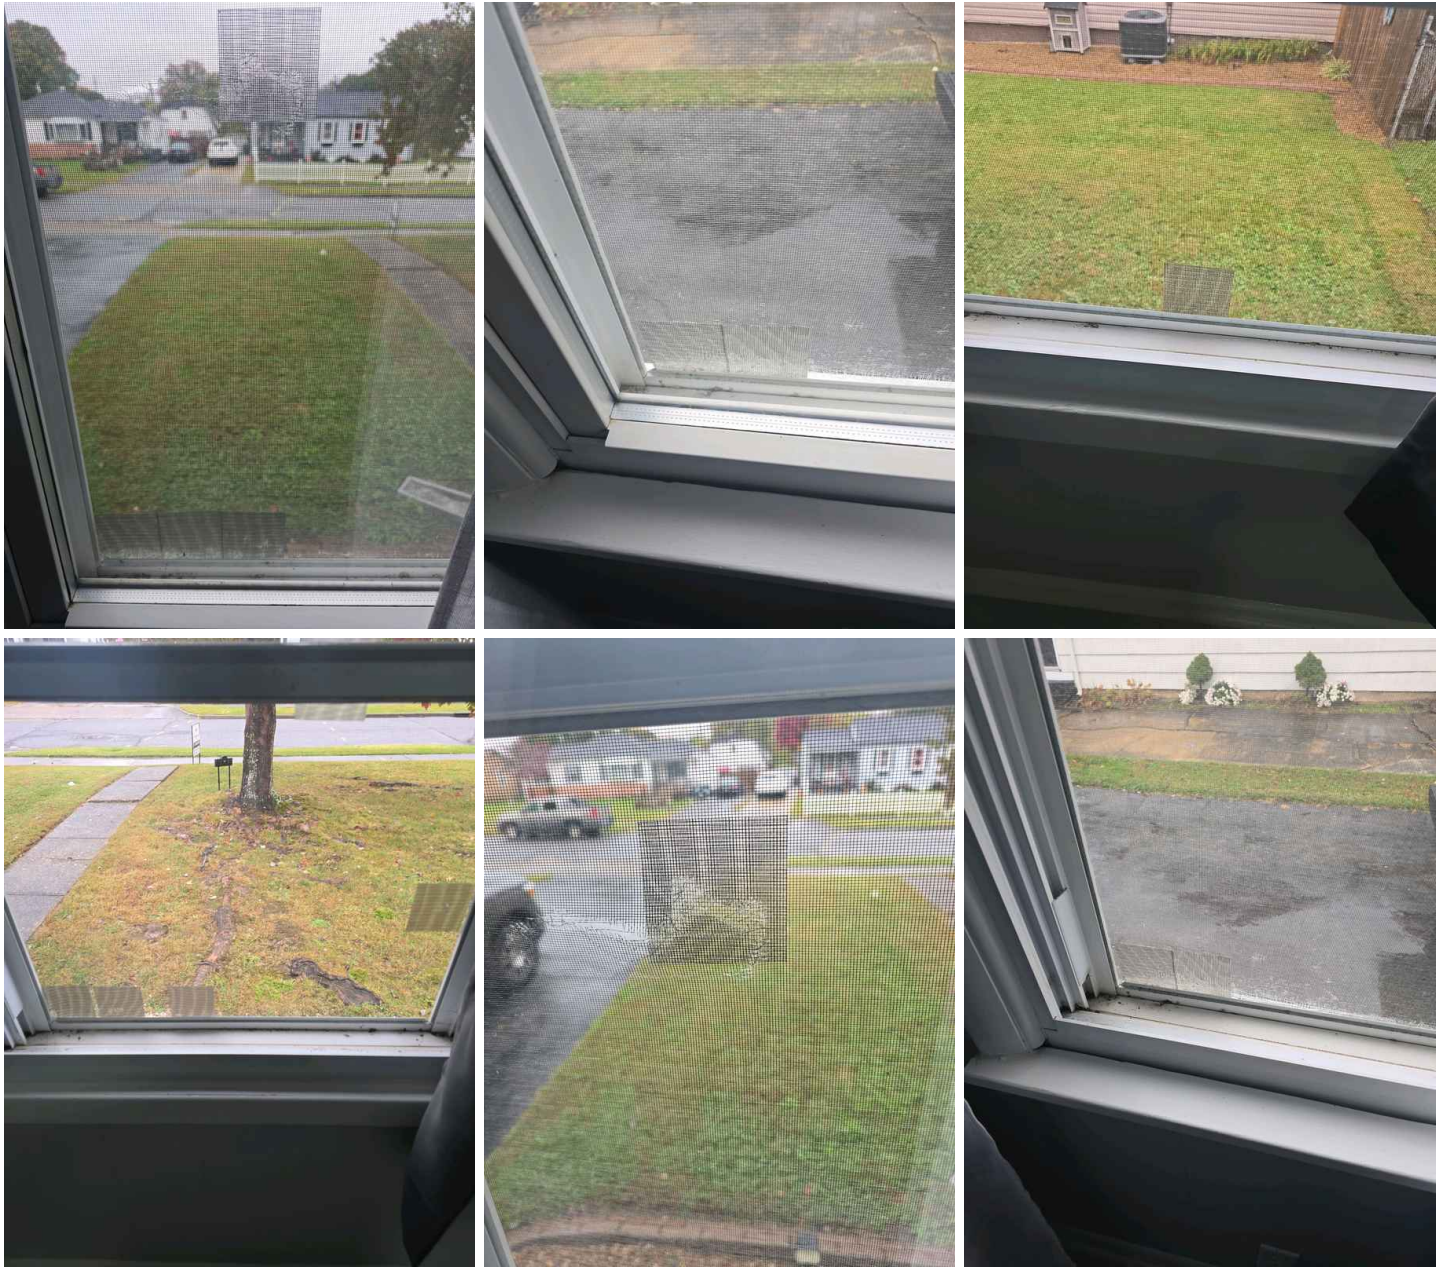
9.3.3 Windows

DAMAGE SCREEN

Observed multiple windows with damaged /patched screens.
Recommend a qualified window contractor to advise.
Recommendation
Contact a qualified window repair/installation contractor.

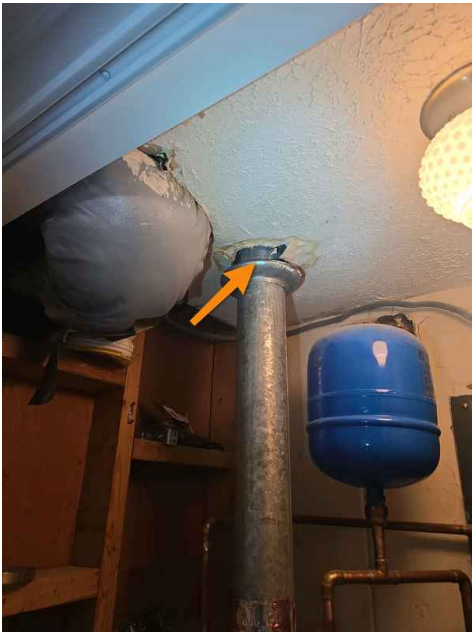
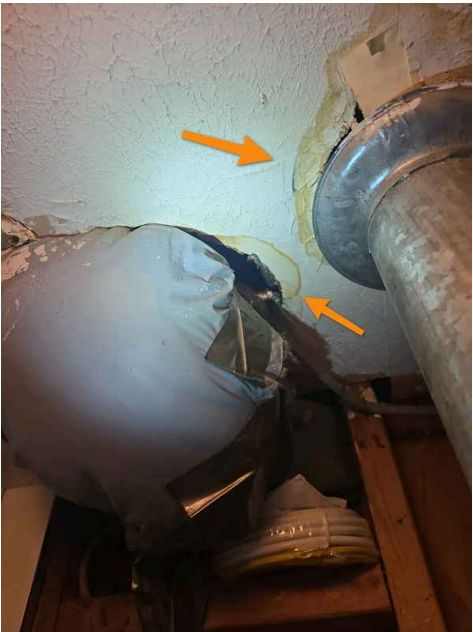
Hot water heater room

There is a stain on ceiling/wall that requires repair and paint.

Note: at the time of inspection the ceiling **was/wasn't** showing signs of moisture

Source of staining should be determined.

Recommend a qualified professional to advise

Contact a qualified professional.

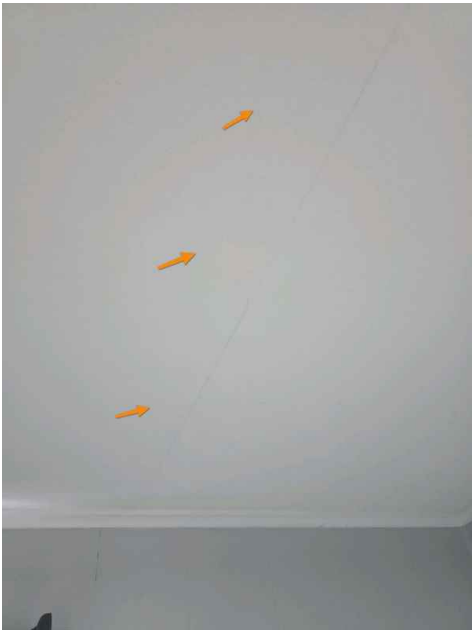
Observed minor cracks on the ceiling.
These may result in normal settling, or moisture issues.
Recommend painting and Monitoring and if cracks widen or multiply consult a licensed contractor.

Recommendation
Contact a qualified painting contractor.
