HOME EDGE INSPECTION

RESIDENTIAL REPORT

1234 Main Street
Bristol, VA 24202

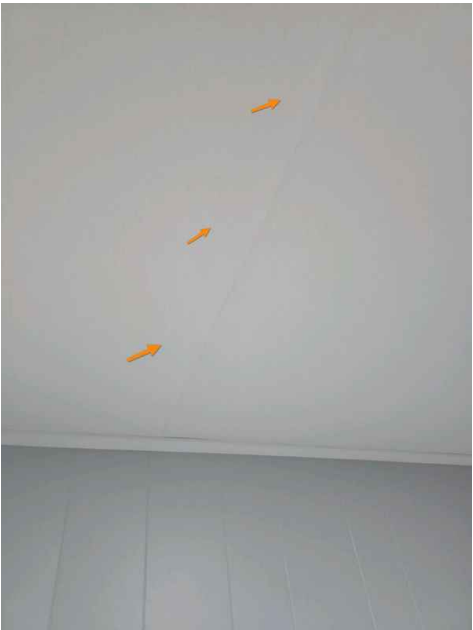
Front left room opposite side

CEILING CRACKS-MINOR

Observed minor cracks on the ceiling.
These may result in normal settling, or moisture issues.
Recommend painting and Monitoring and if cracks widen or multiply consult a licensed contractor.

Recommendation
Contact a qualified painting contractor.

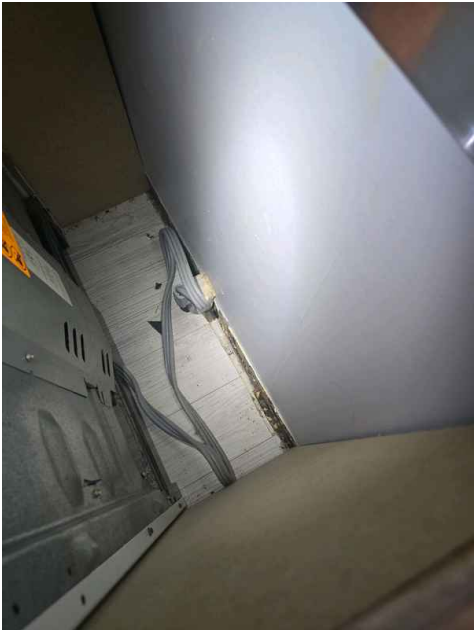
ANTI TIP BRACKET- MISSING

Missing Anti Tip Bracket.

These are a required safety feature for ranges. These prevent ranges from falling with excessive weight causing burns.

Recommend a qualified handyman to remedy.

Contact a qualified handyman.
