PSV RH0844691

PSV RH08444691 Inspection & Overview

Tag Number	No Tag (Rotable Valve)
Size	4x6 Ari Pressure Safety Valve
Model	Fig 901/902/911/912
Serial Number	RH08444691

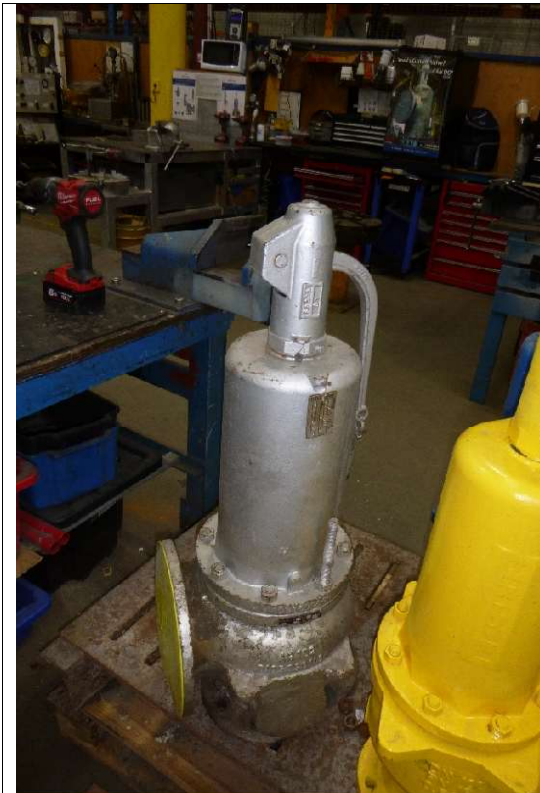
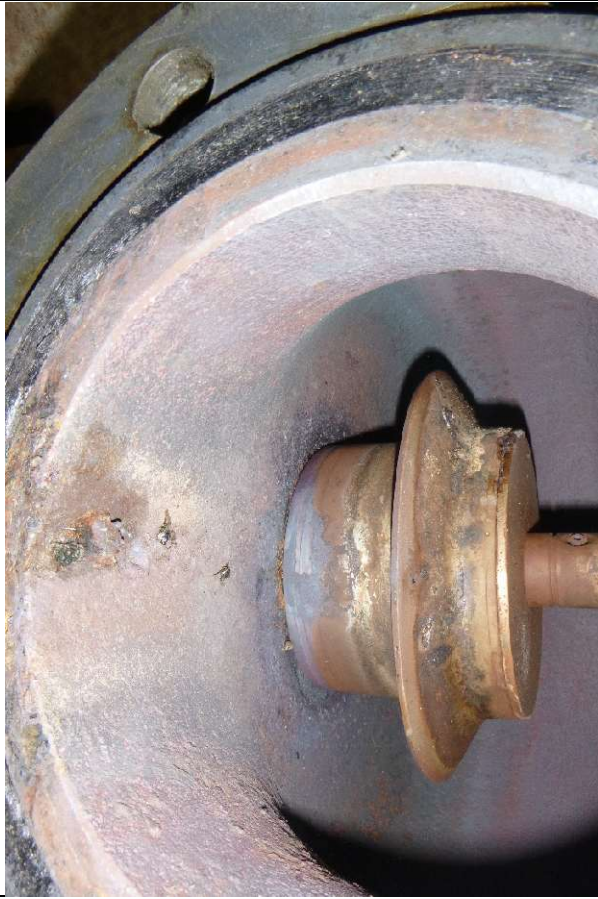
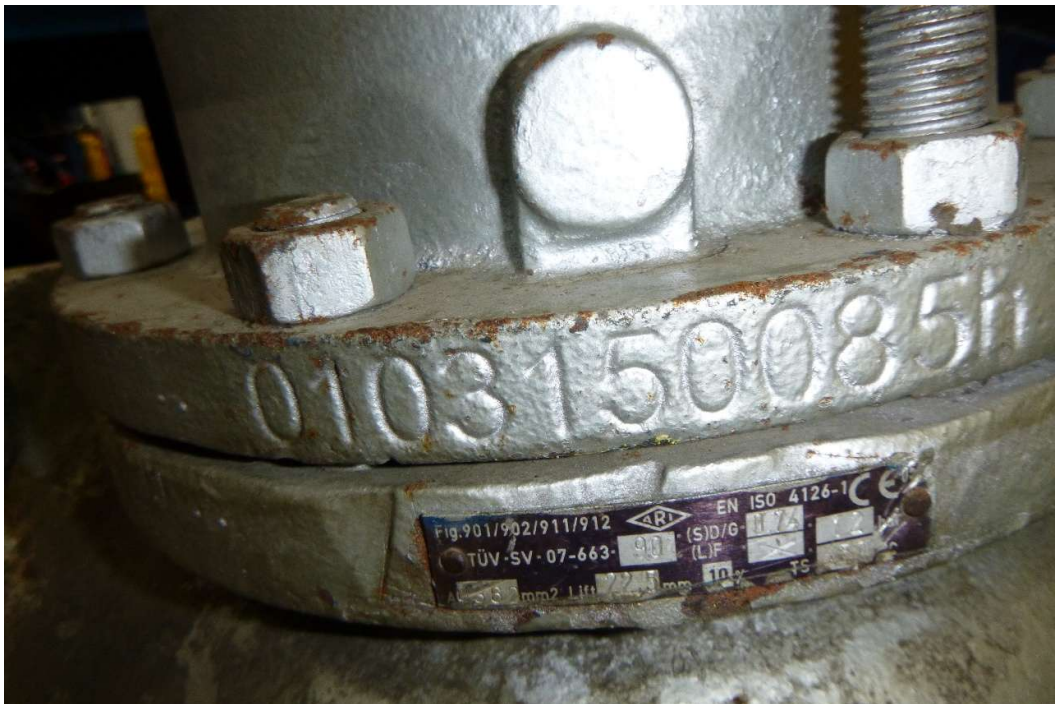
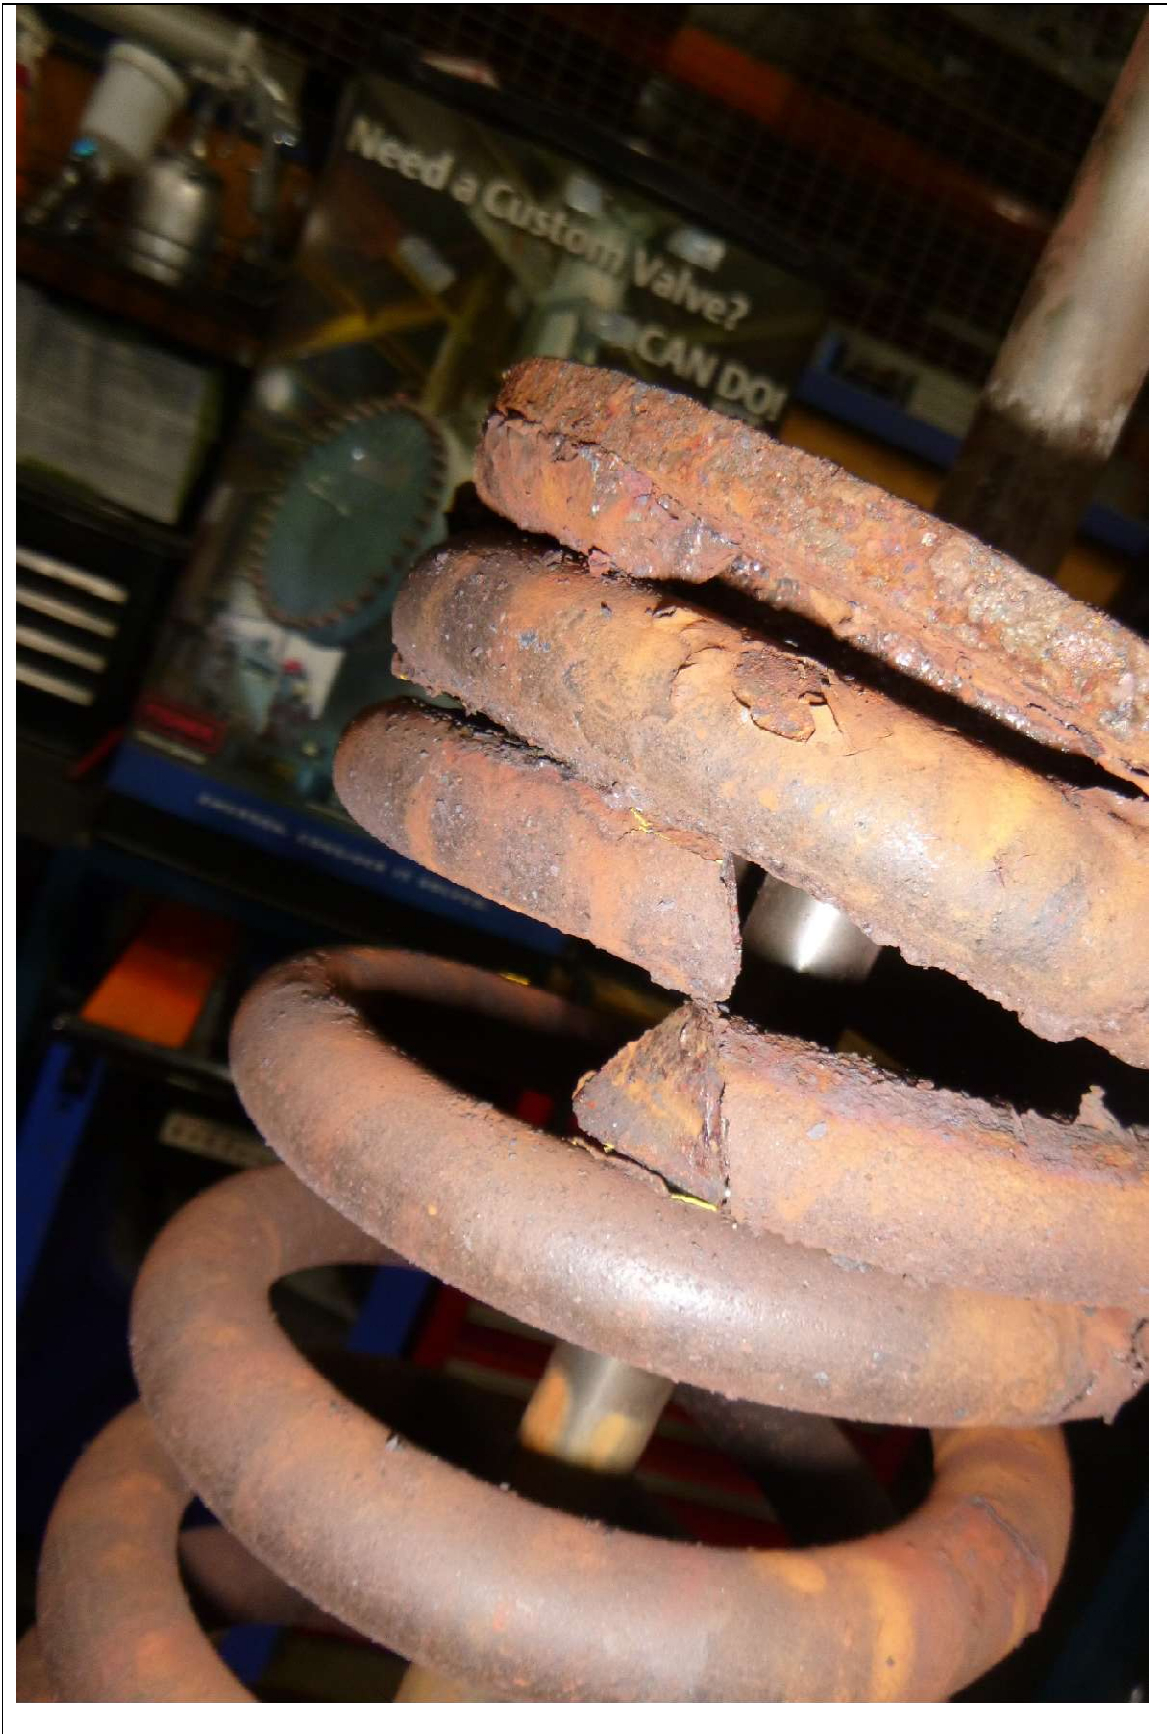
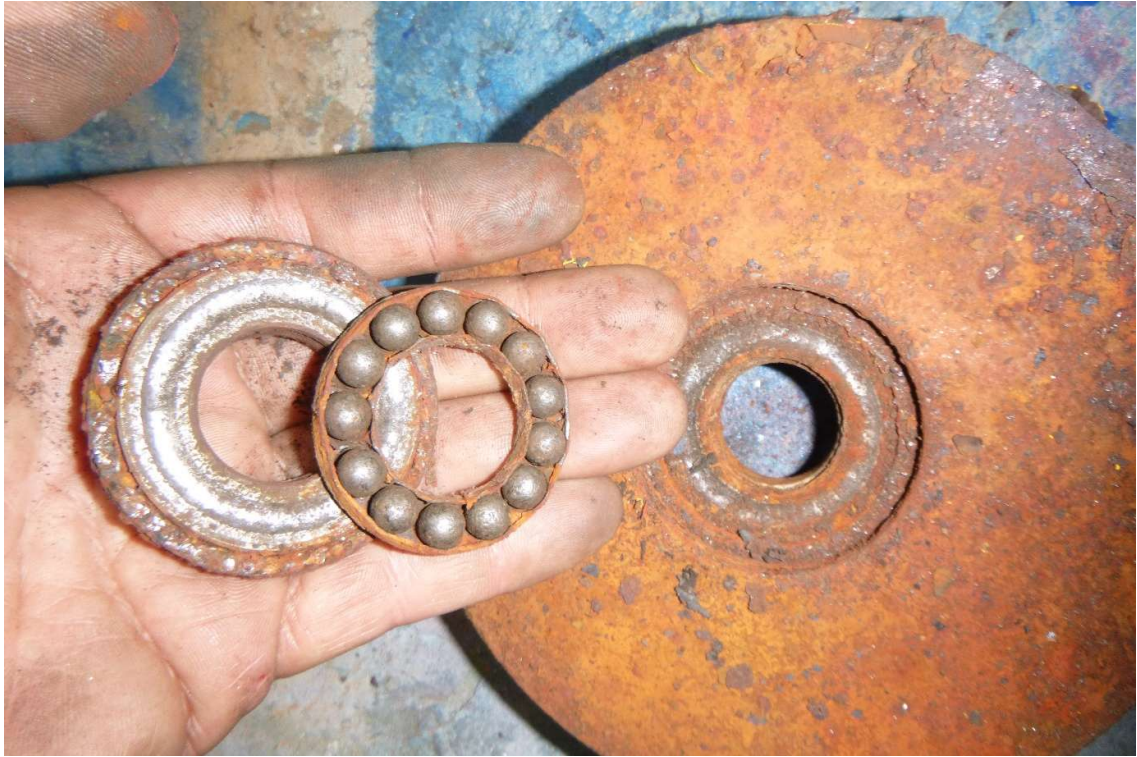
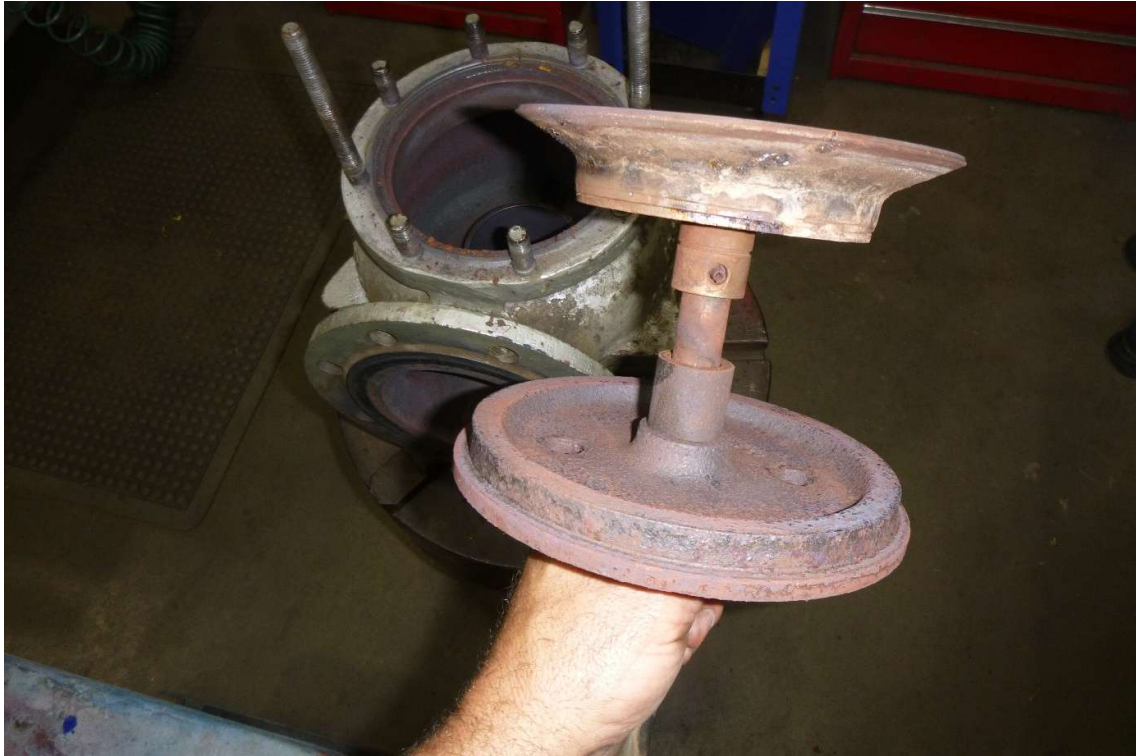
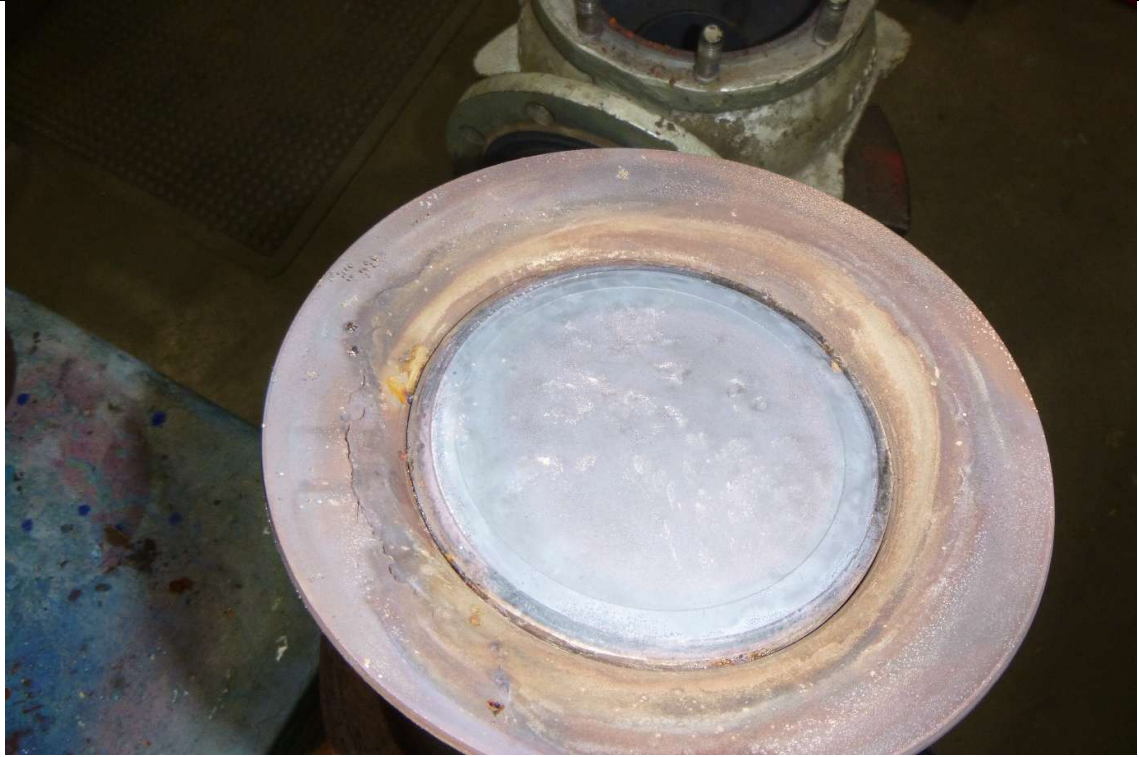
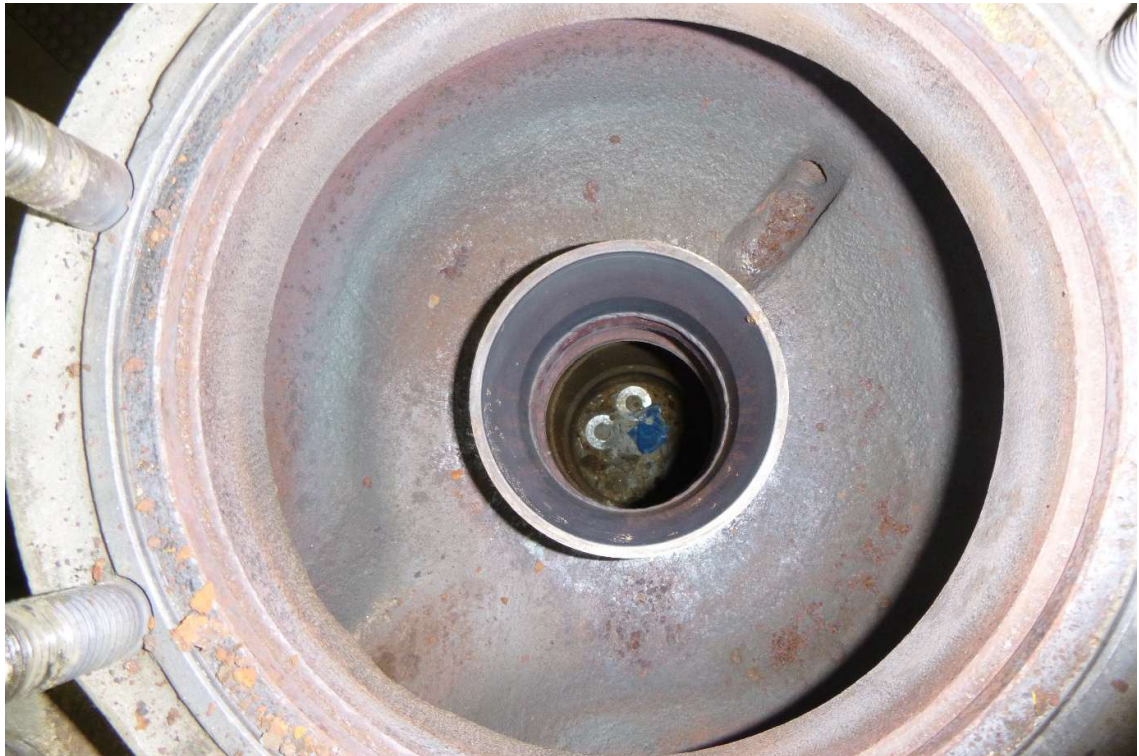
Finding	Notes
Internal Corrosion	Slight concern
Nozzle seized inside body	Severe failure due to age of valve
Set Spring Broken	Severe failure – valve not functional
Outlet body corrosion/erosion	Slight concern
Valve Failed initial pop test	Due to broken spring
Disc & Seat corrosion	Could be lapped out if nozzle can be removed attempting further removal tactics could damage components further

Internal components purchase will surpass the value of a new unit
Valve needs to be scrapped and replaced
