SUMMARY
2100 Whitehall Rd, Frederick, MD
21702
Michael Frustaci
September 29, 2022

Michael Frustaci
MD License # 10-34777
Checkpoint Home Inspections LLC
703-415-6127
inspector@checkpoint.homes

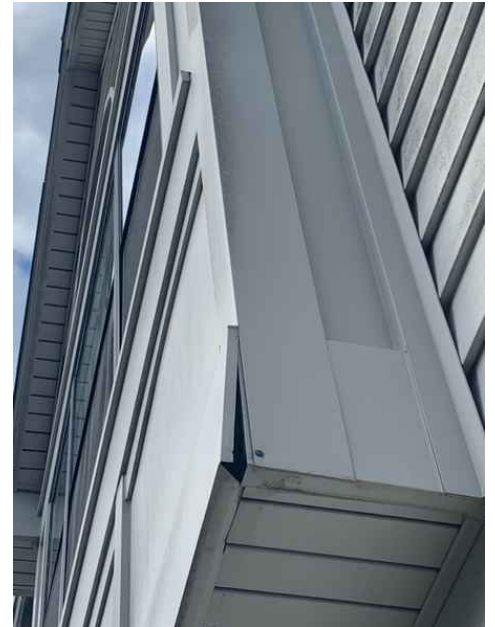
2.2.1 Siding, Flashing & Trim

LOOSE BOARDS

One or more siding/trim pieces were loose, which could result in moisture intrusion. Recommend a qualified siding contractor secure and fasten.

Recommendation
Contact a qualified siding specialist.

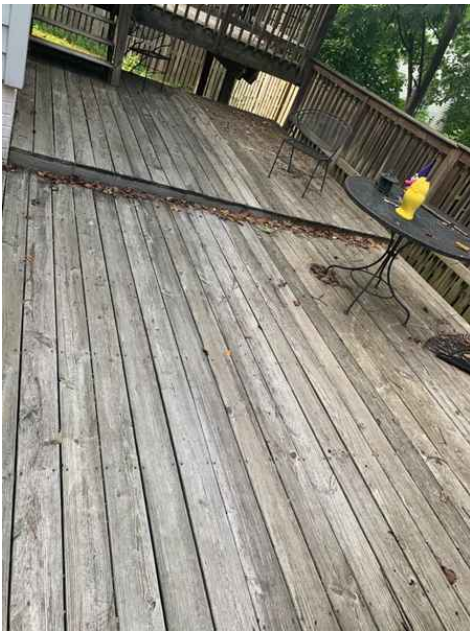
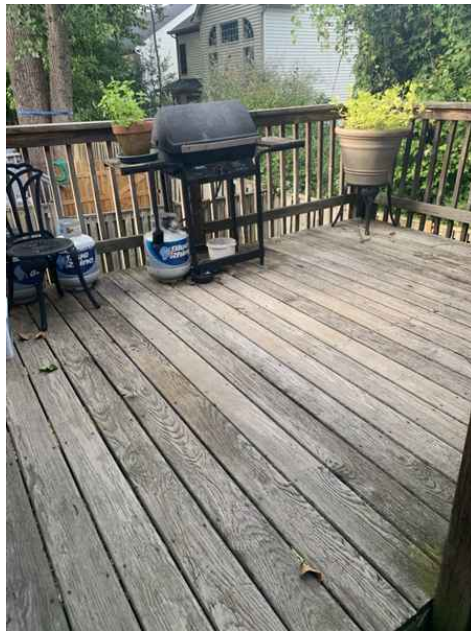
2.4.1 Decks, Balconies, Porches & Steps

DECK - WATER SEALANT REQUIRED

Deck is showing signs of weathering and/or water damage. Recommend power washing and water sealant/weatherproofing be applied.

Recommendation
Contact a qualified handyman.

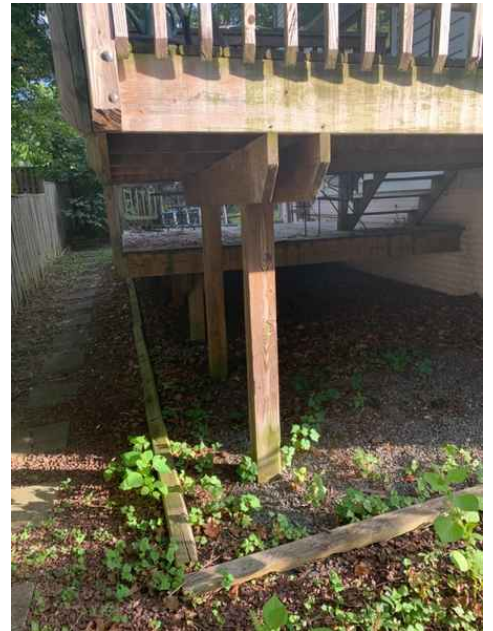
2.4.2 Decks, Balconies, Porches & Steps **IMPROPER DECK CONSTRUCTION PRACTICES**

Deck support beam is UNSAFE. Recommend immediate evaluation by a qualified carpenter/ deck contractor.

Recommendation
Contact a qualified deck contractor.

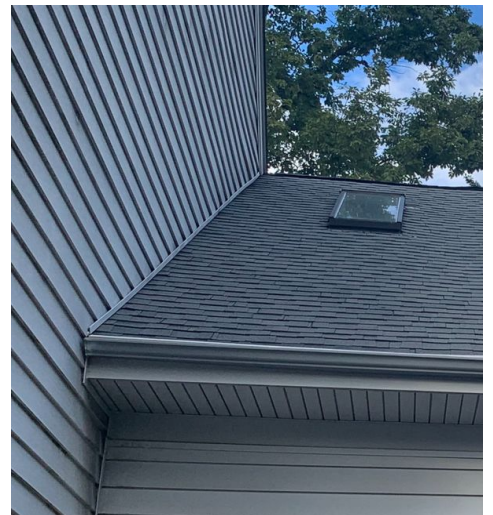
3.1.1 Coverings **KICK-OUT FLASHING**

Recommend installing kick-out flashing where the roof edge meets the side of the house.

Recommendation
Contact a qualified gutter contractor

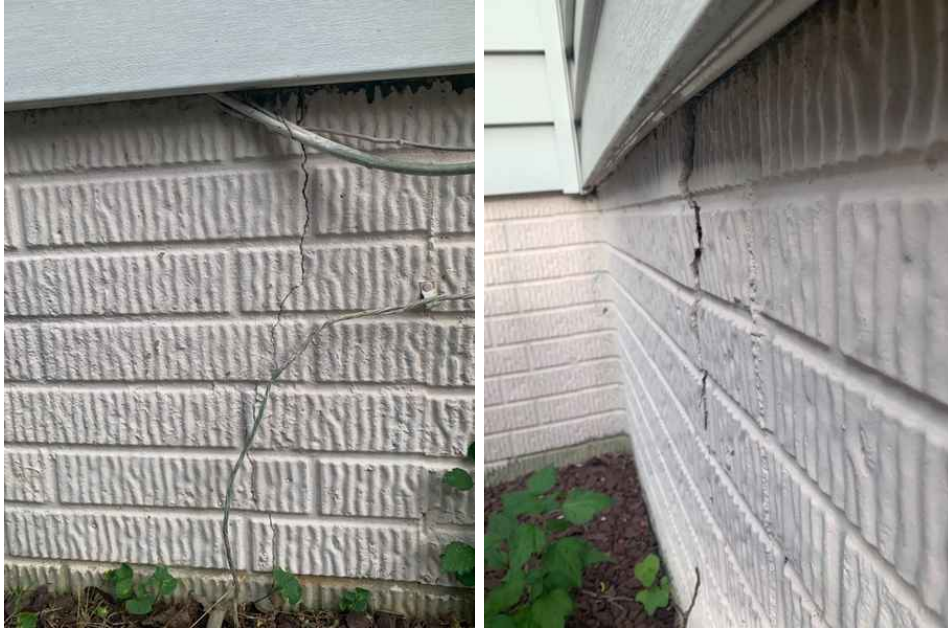
4.1.1 Foundation

FOUNDATION CRACKS - MINOR

Minor cracking was noted at the foundation. This is common as concrete ages and shrinkage surface cracks are normal. Recommend monitoring for more serious shifting/displacement.

Contact a qualified masonry professional.

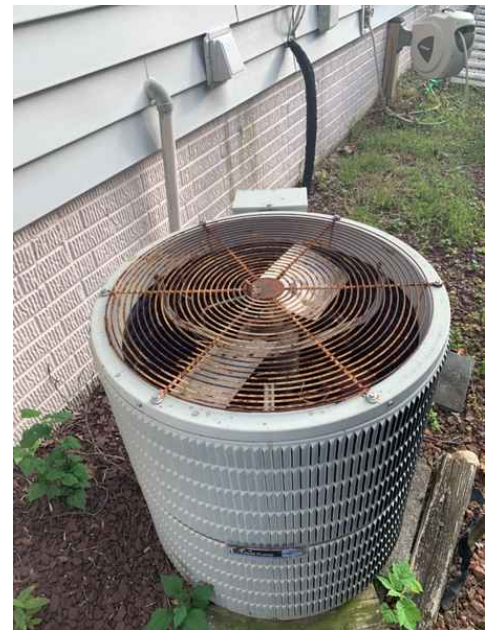
5.1.1 Equipment

CORROSION

Outdoor Compressor was corroded in one or more areas. This could be the result of improper venting, which the source would need to be identified. Recommend a HVAC contractor evaluate and repair.

Contact a qualified HVAC professional.

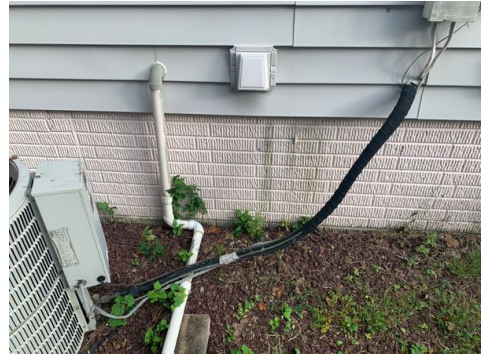
6.1.1 Cooling Equipment

INSULATION MISSING OR DAMAGED

Missing or damaged insulation on refrigerant line can cause energy loss and condensation.

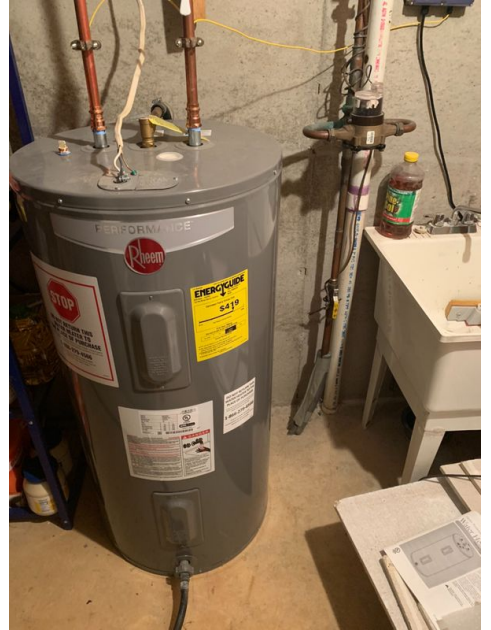
7.4.1 Hot Water Systems, Controls, Flues & Vents

NO DRIP PAN

No drip pan was present. Recommend installation by a qualified plumber.

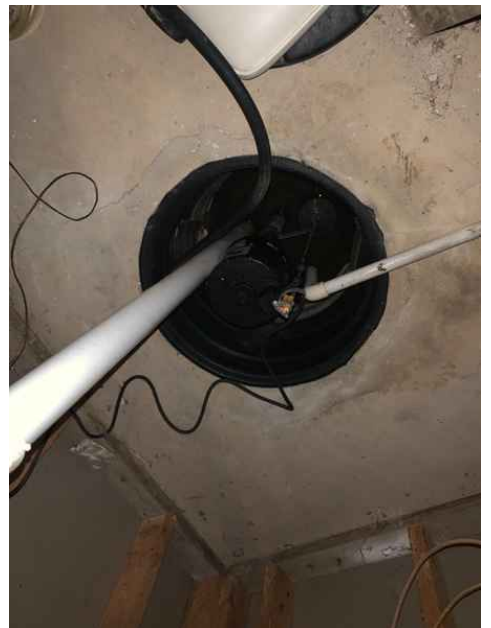
7.5.1 Sump Pump

IMPROPER INSTALLATION

Sump pump is missing the cover.

Recommendation
Contact a qualified handyman.

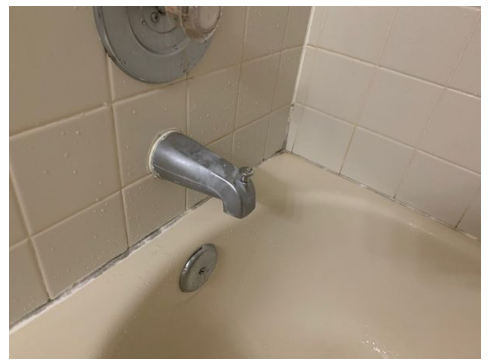
7.6.1 Bathroom

SHOWER CAULKING

Recommend replacement of shower caulking. Mold has entered behind the caulking. Recommend handyman to replace

Contact a qualified professional.

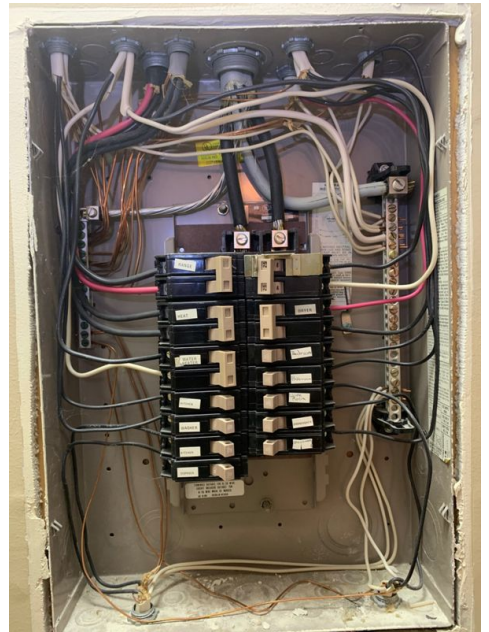
8.2.1 Main & Subpanels, Service & Grounding, Main Overcurrent Device

NEUTRAL WIRES SHARING LUGS

Neutral wires are sharing the same lugs in the main service panel. A loose connection could result in fire.

Contact a qualified electrical contractor.

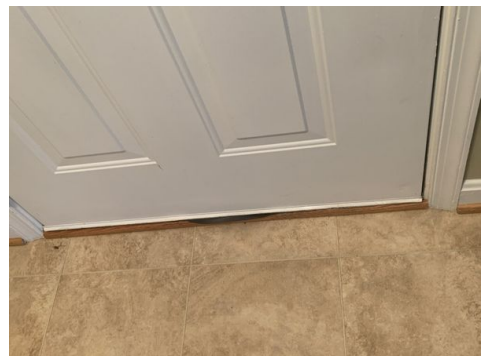
11.1.1 Doors

POOR WEATHER-STRIPPING

At the time of the inspection, weather-stripping at interior doors was generally damaged or deteriorated. The Inspector recommends replacement/installation of effective weather-stripping components as necessary by a qualified contractor.
