Property Inspection Report

**PROSPECTOR
HOME INSPECTIONS**

**123 Main St
Inspection Prepared For: Joe Smith
Agent:**

**Date of Inspection: 5/22/2023
Home Age: 16 yrs Size: 1937 Sq Ft**

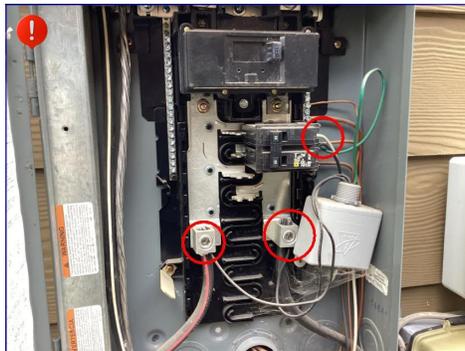
Electric - Main Panel		
Page 13	Main Panel General

There are lugs double tapped with the surge protector and feeder cables and the white wire coming from the 25 amp breaker is hot and needs to be labeled. I recommend a qualified electrician evaluate and repair.

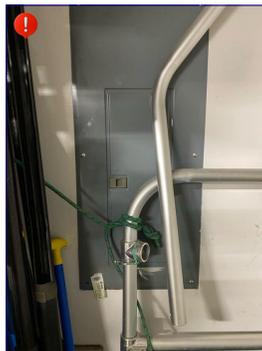
Electric - Sub Panel		
Page 14	Adequate Clearance To Panel	• The electric panel should have a minimum of 3 feet clearance in front of the panel and 2.5 feet on the sides.

The electric panel should be accessible.

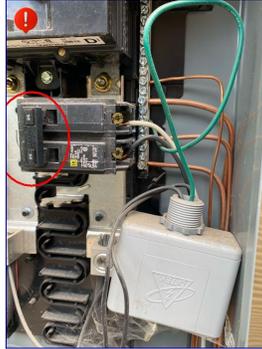
Exterior A/C - Heat Pump 1

The AC unit requires a minimum circuit amperage of 27.6. The breaker for the AC unit is rated at 25 amps. I recommend a qualified electrician evaluate and make repairs.

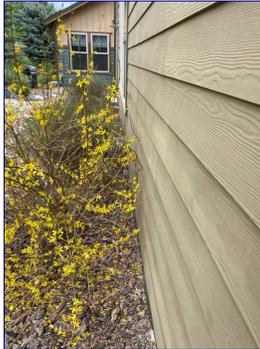
Landscape Affecting Foundation

There is vegetation in contact with the house. I recommend trimming trees and vegetation, so it doesn't come into contact with the home.

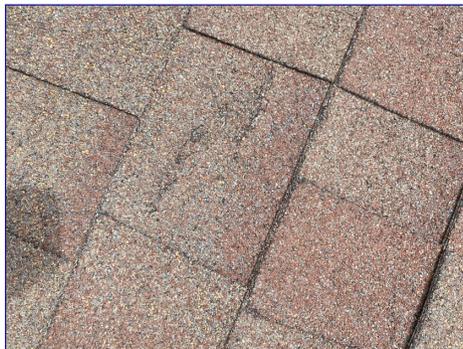
Condition of Roof Covering

Roof covering showed signs of curling, cracking, and aging. I recommend a qualified roofing contractor evaluate and repair.

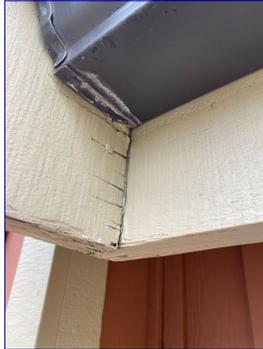
Gutters

There is evidence that the gutter is leaking at the seams. I recommend a professional contractor evaluate and repair as needed.

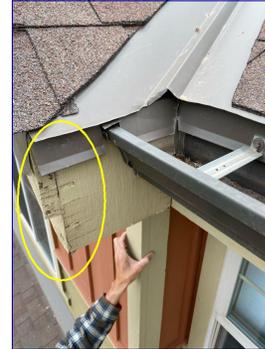
Gutter flashing was missing or insufficient. Adding gutter flashing will help direct the water into the gutter instead of allowing it onto the fascia. I recommend a professional roofer repair.

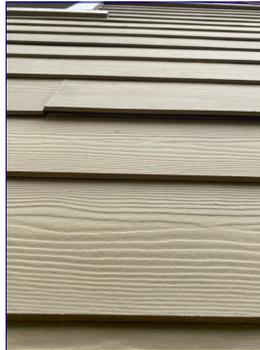
Siding

The exterior siding board is starting to curl. I recommend monitoring the siding and consulting a qualified contractor if the issue gets worse.

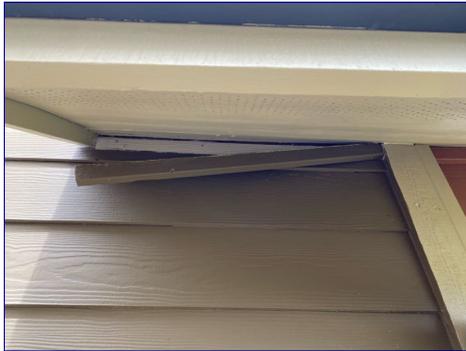
There is some loose exterior trim. I recommend repair. Consult a professional as needed.

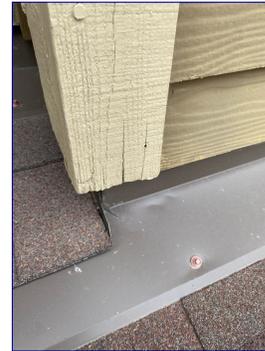
The exterior trim is in need of normal painting maintenance. There are a few places on the roof above the garage that will need attention in the near future.

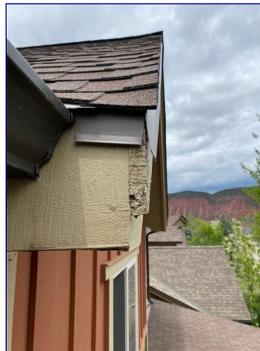
Fascia

Adding flashing would help protect the fascia from moisture damage. I recommend a qualified professional repair.

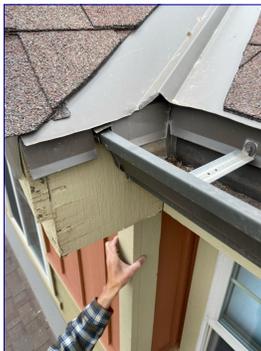
Flashing

There are a few places on the fascia above the garage that are seeing water damage. I recommend routine painting maintenance. I recommend consultation with a qualified roofing contractor to discuss flashing options to prevent the water damage.

- There are a few places on the upper roof above the garage that could use improvements in the flashing to prevent water damage occurring on the fascia. I recommend maintaining paint in good condition in these areas. I recommend addressing the issues with a qualified roofer.

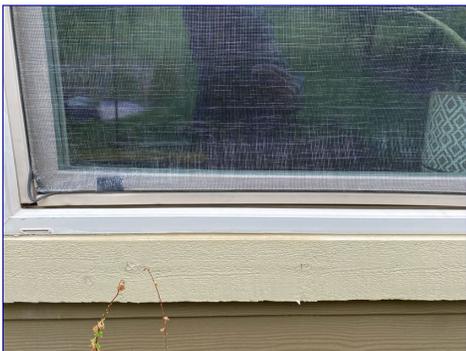
Windows/Screens

Some window screens are torn, damaged, or missing. Repair as needed.

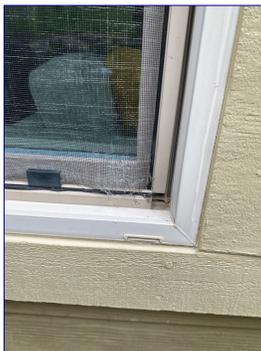
Some window screens are torn, damaged, or missing. Repair as needed.

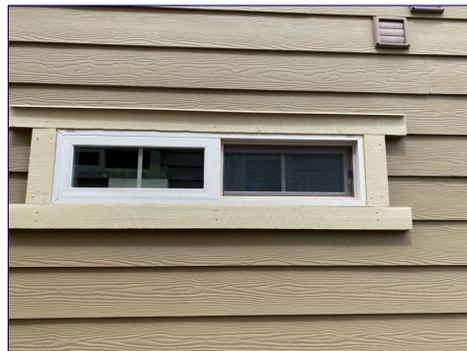
This window was installed upside down. The weep holes are at the top of the window frame in the photo. I recommend monitoring for water damage and repairing or replacing if needed.

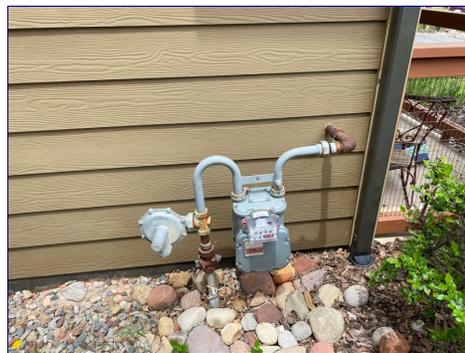
Gas Meter

Gas service pipes show corrosion. I recommend contacting the gas provider to service equipment.

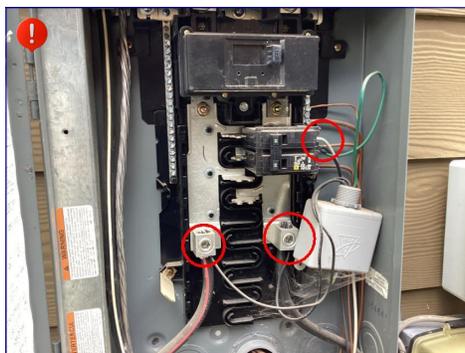
Main Panel General

There are lugs double tapped with the surge protector and feeder cables and the white wire coming from the 25 amp breaker is hot and needs to be labeled. I recommend a qualified electrician evaluate and repair.

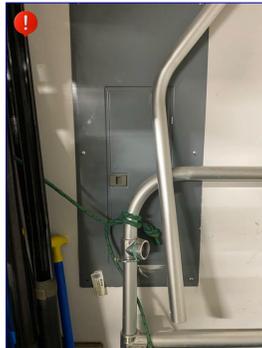
Adequate Clearance To Panel

- Adequate Clearance to Panel: No
- Observations:
- The sub panel was NOT inspected.
 - The electric panel should have a minimum of 3 feet clearance in front of the panel and 2.5 feet on the sides.

The electric panel should be accessible.

- The **GFCI** were NOT tested. I recommend making the sub panel accessible and testing GFCI.

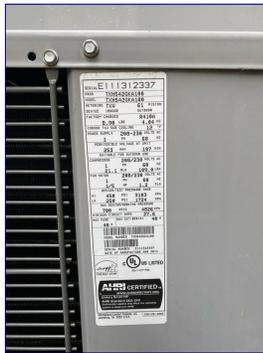
The AC unit requires a minimum circuit amperage of 27.6. The breaker for the AC unit is rated at 25 amps. I recommend a qualified electrician evaluate and make repairs.

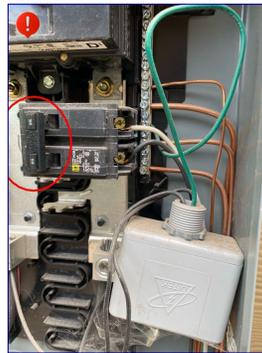
The AC unit requires a minimum circuit amperage of 27.6. The breaker for the AC unit is rated at 25 amps. I recommend a qualified electrician evaluate and make repairs.

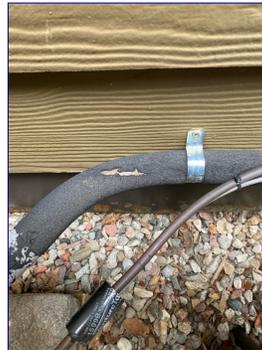
There is damaged and/or missing insulation on the air conditioner refrigerant line. I recommend replacing the insulation.
