N123AB

Premium Aircraft Acquisition Report

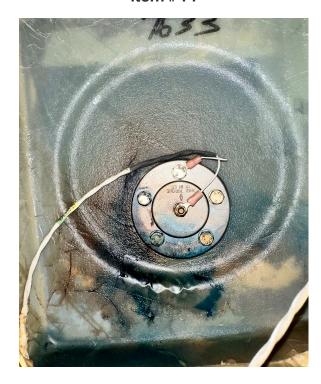
Item #11

Item	Description	Reference	Reccomendations	Estimated Correction Cost
11	LH wing, inboard fuel sending unit leaking at base gasket (AIRWORTHINESS ITEM)	SR22 MM	De-fuel tank. Remove and replace base gasket, complete a leak check	\$350
12	Popped rivet noted in RH wing, inboard TKS panel (AIRWORTHINESS ITEM)	SR22 MM	Install new rivet as required	\$100
13	Upper fueslage antenna seals dry and deteriorating		Reseal bases of antennas	\$350
14	Main cabin door foam seals deteriorating	SR22 MM	Remove and replace seals	\$350
15	Ignition switch loose in panel (AIRWORTHINESS ITEM)	SB2X-74- 02	Comply with Cirrus SB2X-74-02	\$150

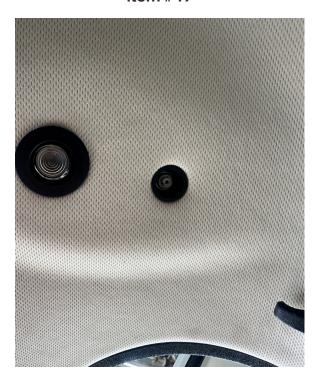
Item #17

Item	Description	Reference	Reccomendations	Estimated Correction Cost
16	Avionics had numerous faults during run-up (AIRWORTHINESS ITEM)	SR22 MM	Owner had swapped #2 430 with similar unit for repair. Configuration errors were found that need to be corrected	UNK
17	Aft RH overhead light missing switch cover	SR22 MM	Install switch cover as needed	UNK
18	Cirrus SB2X-95-27R Rocket Ignitor Replacement overdue (AIRWORTHINESS ITEM)	SB2X-95- 27R	Comply with mandatory SB by replacement of rocket ignitor assembly	UNK
19	Cirrus SB2X-95-31R1 due at next repack	SB2X-95- 31R1	Comply with SB at rocket/chute repack	UNK
20	Cirrus SB2X-25-30R1 Crew Seat Break-Over is due	SB2X-25- 30R1	Comply with SB by inspection seat break-over tension	\$250
