# Cleanup of the Closed Cooling Water System at AES Alamitos Units 5 and 6

Shawn S. Simmons

## ABSTRACT

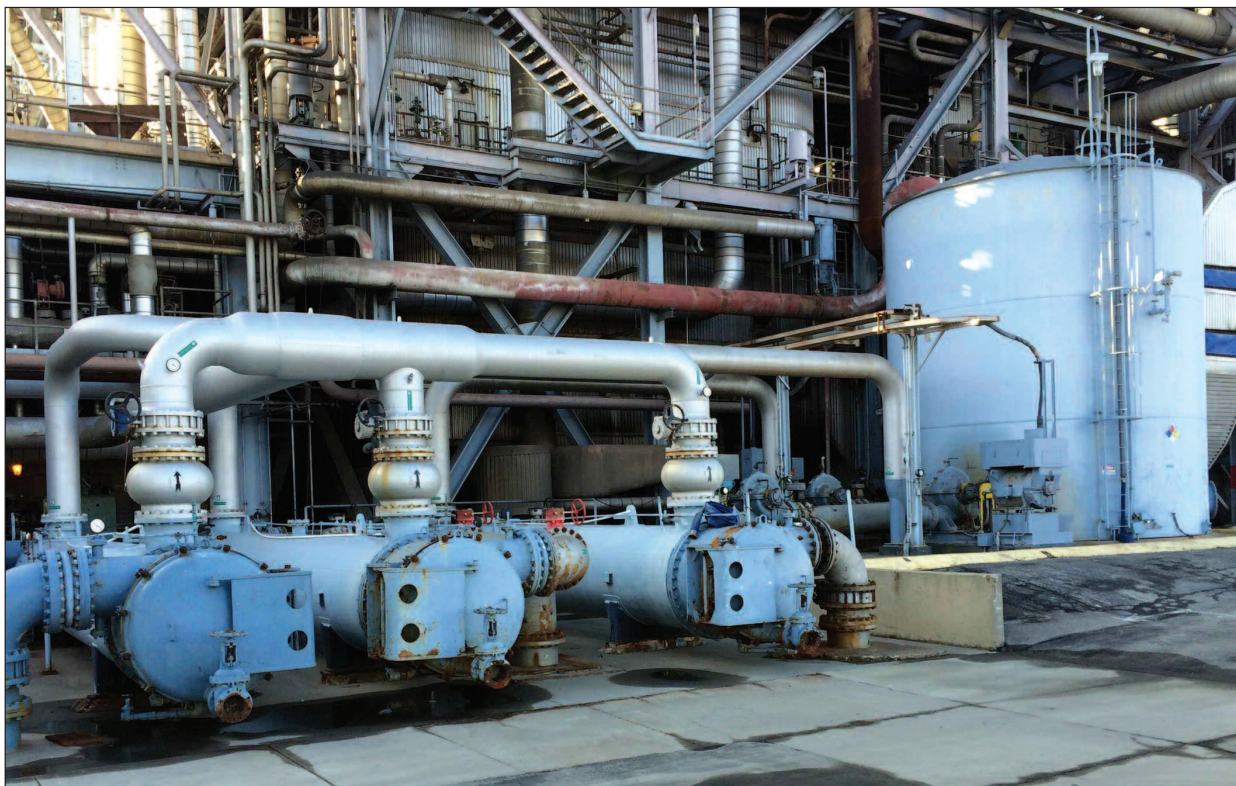
Figure 2:  
CCW heat exchangers and storage tank.

[Figure 2](#) is a picture that includes the CCW heat exchangers, pumps, and heat exchangers (from left to right). The tank's operating capacity is 210 000 L.

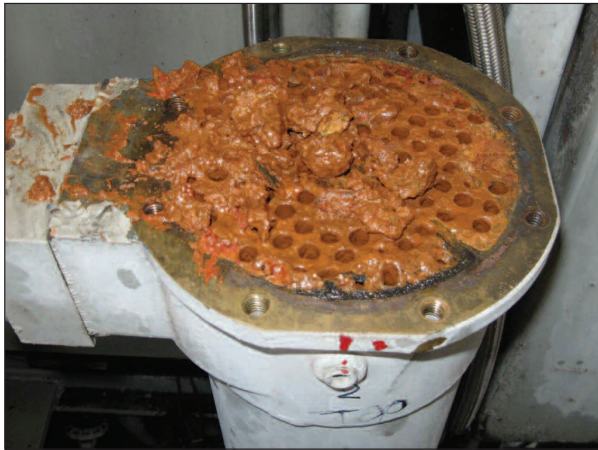
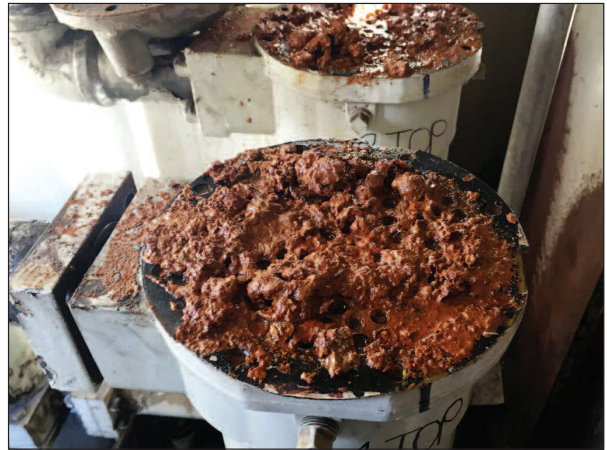
Figures 3 and 4 are pictures of the DEH oil coolers after their tops were removed. The tube sheets to the coolers were found largely occluded with foulant. The same issues were found in other coolers.

Figure 3:  
Unit 5 DEH cooler No. 2.

Figure 4:  
Unit 6 DEH coolers.

Cleanup of the closed cooling water system started on February 14, 2016 with the draining of the tank and the cleaning out of the DEH oil coolers. After the tank was cleaned by water blasting, it was refilled with deionized water (Figures 7 and 8).

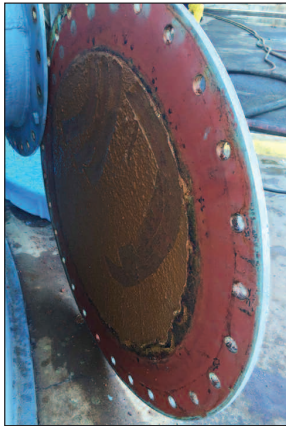
Figure 5:  
Inside of tank access cover.

The storage tank was then drained and opened for inspection. Up to the fill line, the tank walls were covered with a layer of foulant, averaging 1 cm thick (Figure 5). The foulant was a gelatinous mixture of bacteria slime and iron. The foulant likely contained iron-reducing as well as nitrite-reducing bacteria.

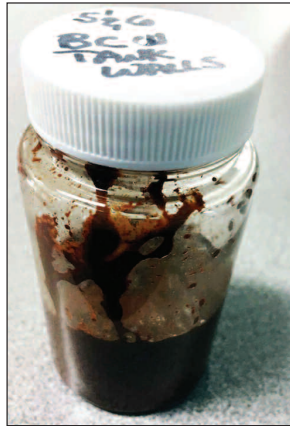
Figure 6:  
Tank wall sample.

When a tank wall sample collected by the station (shown in Figure 6) was inspected, the sample would jiggle (like a gelatin) when the container was gently shaken. This indicated it was gelatinous.

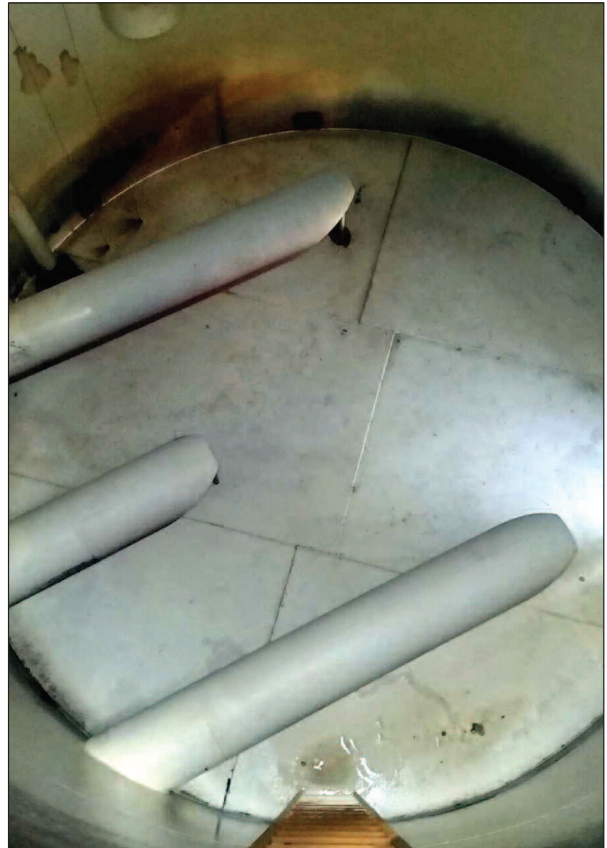
Figure 7:  
CCW tank floor before water blasting.

Figure 8:  
CCW tank floor after water blasting.

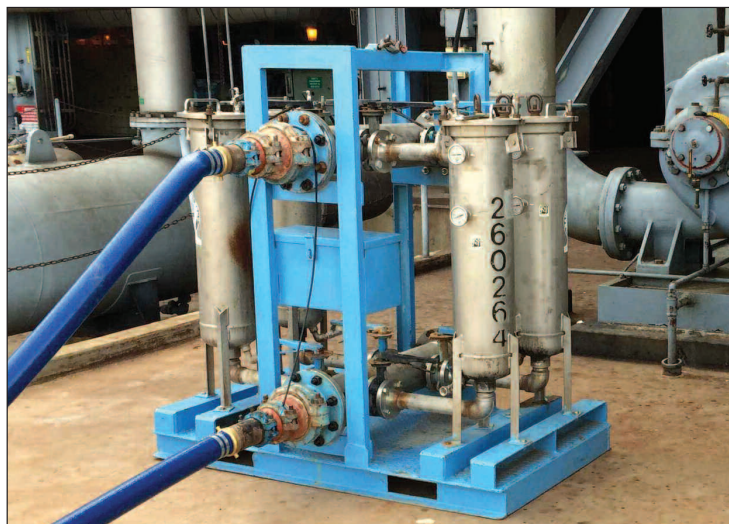
Figure 9:  
Skid used for side-stream filtration.

A side-stream filter was then set up for bio-solids removal, using a filter skid with four bag filters (Figure 9). Using hoses, the skid was configured to receive filter water from a point downstream and return filtered water to the storage tank (Figure 10). At the top of each filter housing there were inlet and outlet pressure gauges for monitoring differential pressure.

During the first week of filtering (starting on March 14, 2016), the station used "25-micron" bag filters; however, differential pressures indicated very little removal. On the fourth day, bio-detergent and biocide chemicals were added. The first chemical added was Nalsperse™ 72551, a soft foulant deposit cleaner. The second chemical was

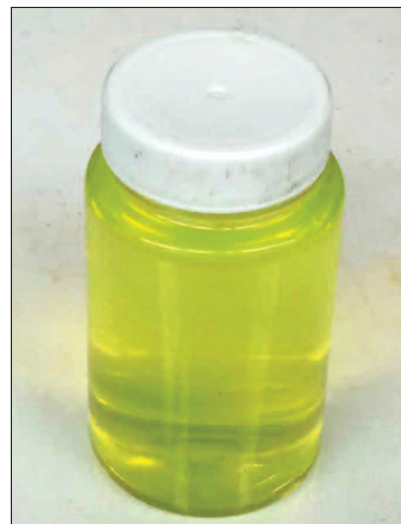
Figure 11:  
CCW sample containing uranine dye.

To begin the second week of filtering, the "25-micron" bags were replaced with "5-micron" bags and bio-detergent, defoamer, and isothiazolin chemicals were added a second time. The result for the heterotrophic plate count several days later was 44 CFU · mL<sup>-1</sup>. At the end of the second week, nitrite-based corrosion inhibitor and sodium fluorescein (uranine dye) were added. The uranine dye colors the water green (Figure 11), to serve as an indicator for leaks (because of Southern California's coastal climate, glycol antifreeze is not used).

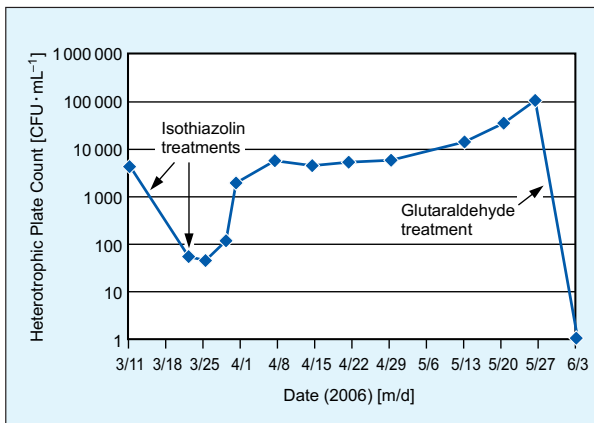
Figure 12:  
Heterotrophic plate count results.

Throughout the weeks of filtering, results for heterotrophic plate count steadily increased after the initial two treat-

ments with isothiazolin, as shown in Figure 12. In fact, the bacteria count reached  $101\,000\text{ CFU} \cdot \text{mL}^{-1}$  after ten weeks; however, even with this high bacteria population there was no nitrite loss from nitrite-reducing bacteria.

After eleven weeks of filtering, the side-stream filter was removed and  $125\text{ mg} \cdot \text{L}^{-1}$  of Nalco H-550 (50 % active, glutaraldehyde biocide) was added to the system. The glutaraldehyde treatment resulted in a bacteria count result of  $< 1\text{ CFU} \cdot \text{mL}^{-1}$ . In addition, the station identified leakage of cooling water at the main cooling water pump packings, and tightening them resulted in a tight system.
