## COMMERCIAL WINDSTORM MITIGATION REPORT (OIR-B1-1802)

Pelican Cove Condominium of Crystal River

10930-10936 W Cove Harbor Dr

As of 3/3/2021

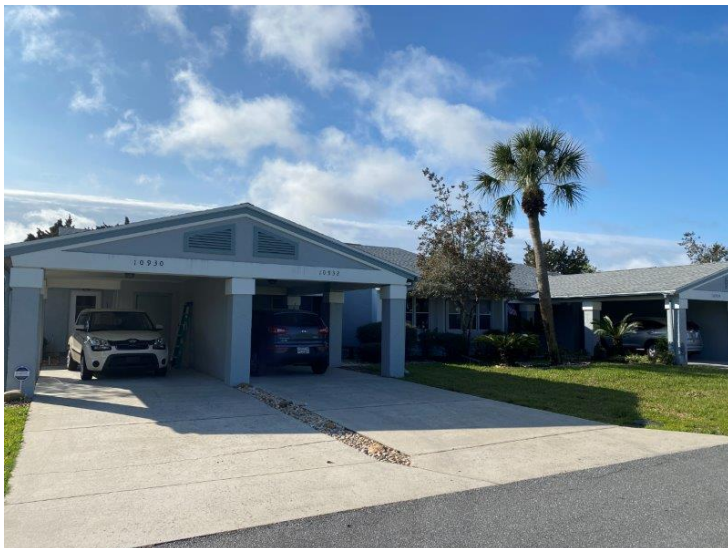
Exterior Elevation

| 5. <b><u>Roof Geometry:</u></b><br>Comments: | <b>Other Roof</b><br>Inspection verified a gable roof shape. |

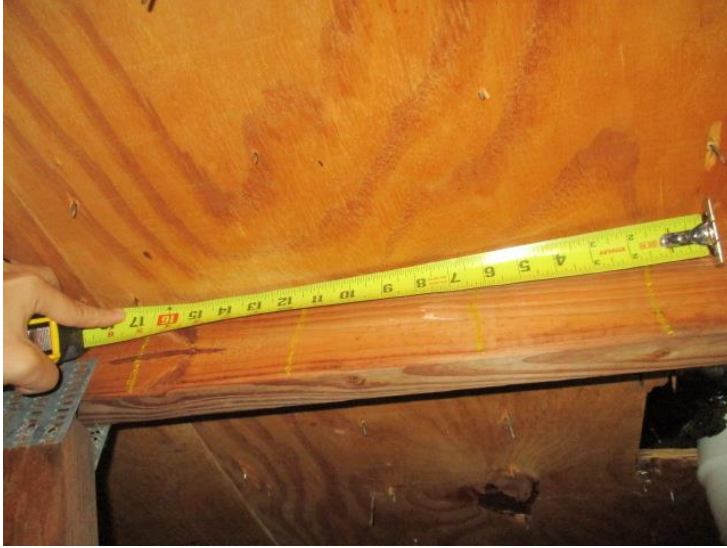
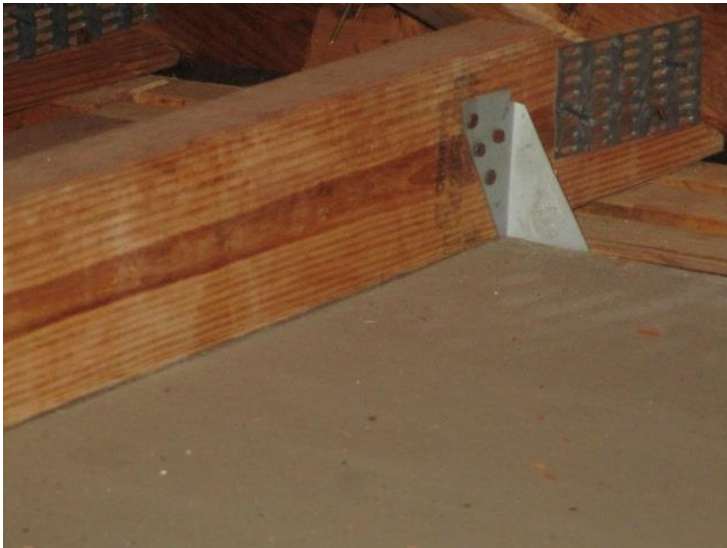
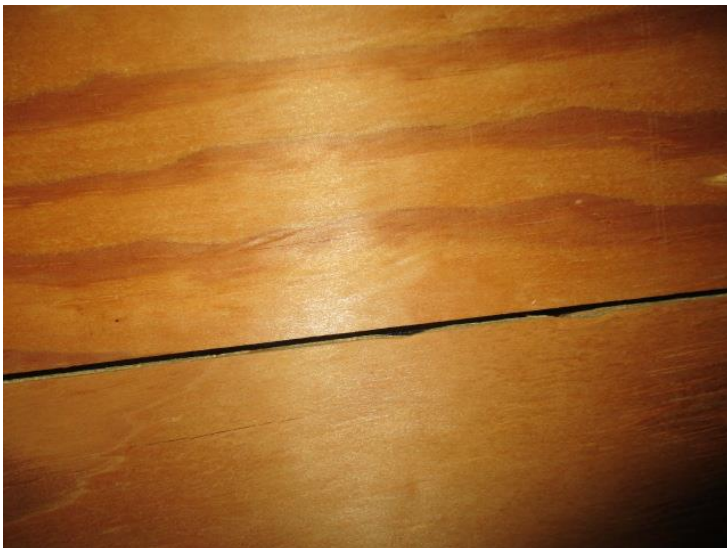
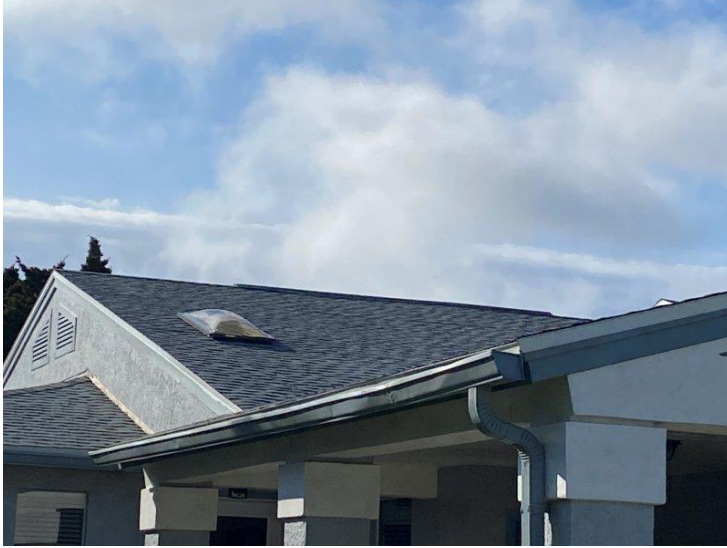
Roof Construction

| 3. <b><u>Roof Deck Attachment:</u></b><br>Comments: | <b>Level C</b><br>Inspection verified 1/2" plywood roof deck attached with 8d nails at a minimum 6" on the edge & 6" in the field. |
| 4. <b><u>Roof to Wall Attachment:</u></b><br>Comments: | <b>Clips</b><br>Inspection verified hurricane clips fastened with a minimum of three nails. |
| 6. <b><u>SWR:</u></b><br>Comments: | <b>Yes</b><br>SWR was verified at time of inspection. The Secondary Water Resistance verified is a self-adhering peel and stick. |
