August 2021

# Tamarack River, Horseshoe, Island and Minnewawa Lakes Nine Key Element Plan

Federal Clean Water Act Section 319 Small Watersheds Focus Grant Workplan

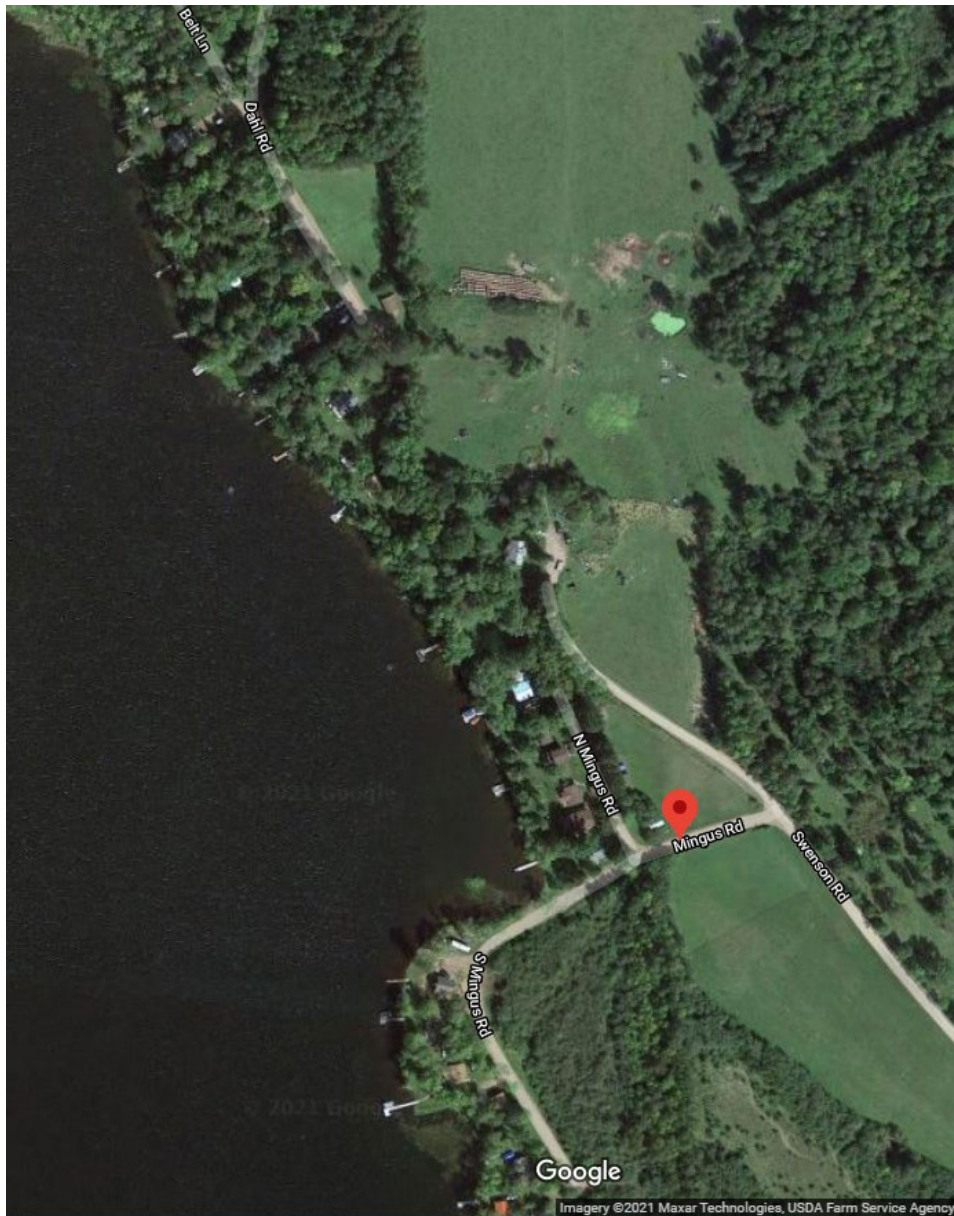
**Figure 10. Map of area Belt Lane and Mingus Road**

Concentrated, small lots on the east side of the lake along Belt Lane and Mingus Road (Figure 10) are highly impervious, densely developed with small lot sizes. This creates a high loading area due to density. Stormwater BMPs will be targeted to address these lots (Figure 5).
