Grant

March 2020

Skunk Creek Section 319 EPA Nine Element Plan

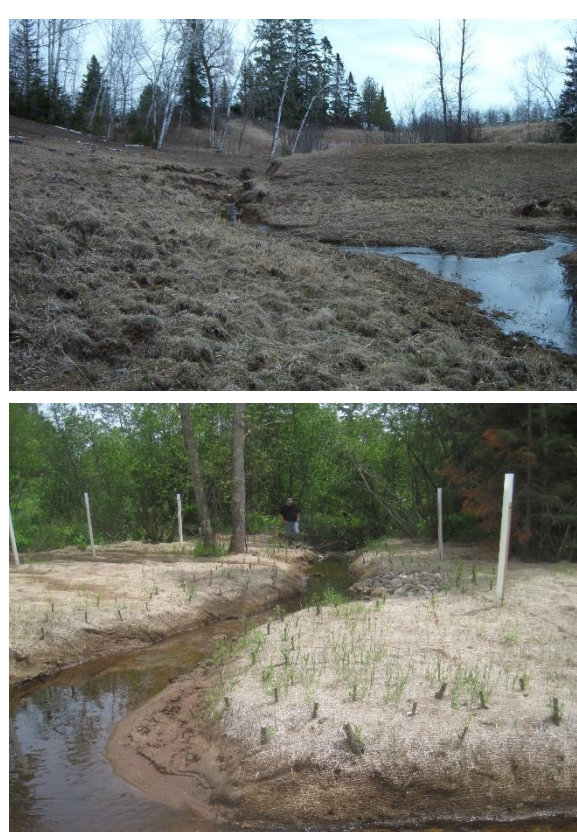
Figure 1. Example of Elim Creek restoration, Dam 3 before and after

In 2014, a Great Lakes Commission grant was secured by the Carlton SWCD to develop five erosion control design plans for the highest prioritized sites in Phase I. The project will utilize field surveying and GIS analysis to develop options for erosion control actions landowners may pursue with future funding. Each site features 30+ year old Red Clay Dams that have exceeded their life expectancy and are at varying stages of failure. The sediment retained by these structures over the last decade presents a massive sediment load into Lake Superior should the dams fail. The erosion control design plans will provide landowners options to either repair the erosion damage to the dams or restore the streams to natural channel design.

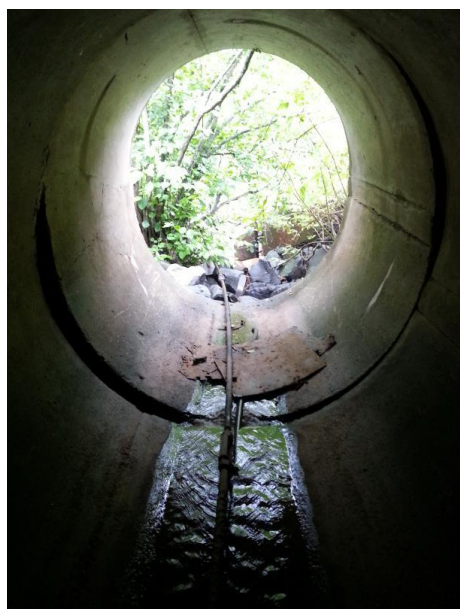
Figure 16. High-priority Soo Line Trail Crossing of Elim Creek

The culvert under the crossing of the Soo Line Trail at Elim Creek is pictured in Figure 16. The culvert is damaged and estimated to be perched 5 feet, inhibiting the fish passage.
