Inspection Report

Property Address:
123 Any Street
Scottsdale AZ 85255

Nau Inspections

Date: 5/15/2021	Time: 08:00:00 AM	Report ID: 051521BN9
Property: 123 Any Street Scottsdale AZ 85255	Customer: Linda Sample	Real Estate Professional:

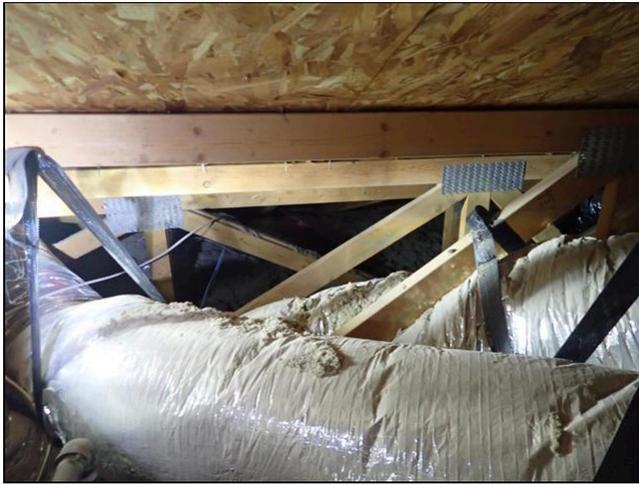
1.4 Item 1(Picture)

The visible portions of the roof and ceiling structure are in satisfactory condition.

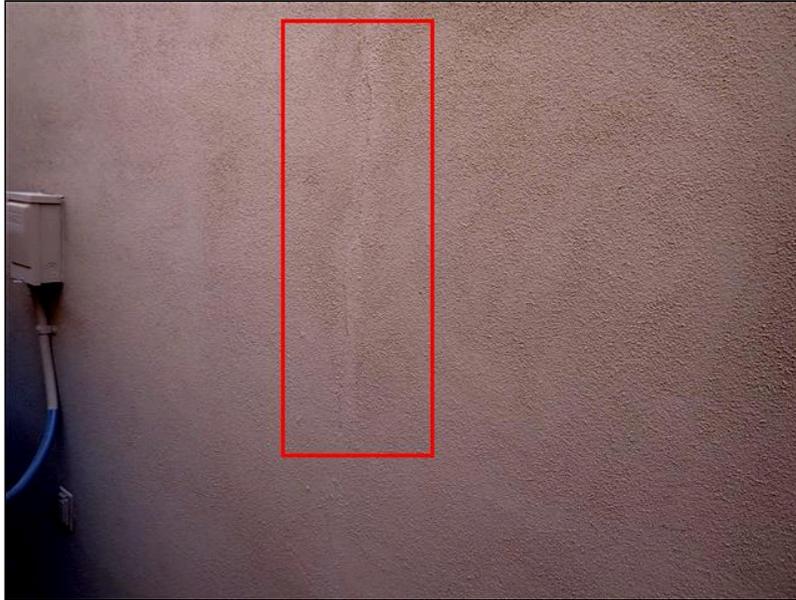
2.0 Item 1(Picture)

- (1) Overall, the visible portions of the exterior wall cladding is in satisfactory condition. Stucco has or will develop typical hairline cracks, seal all exterior penetrations as needed to prevent water intrusion.
- (2) Seal all exterior cracks and penetrations to prevent water and pest intrusion.

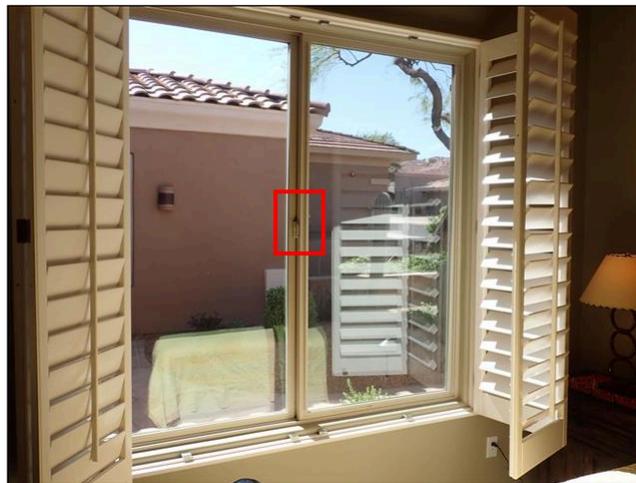
2.3 Item 1(Picture)

(2) The front courtyard left bedroom window does not lock. Repair as necessary.

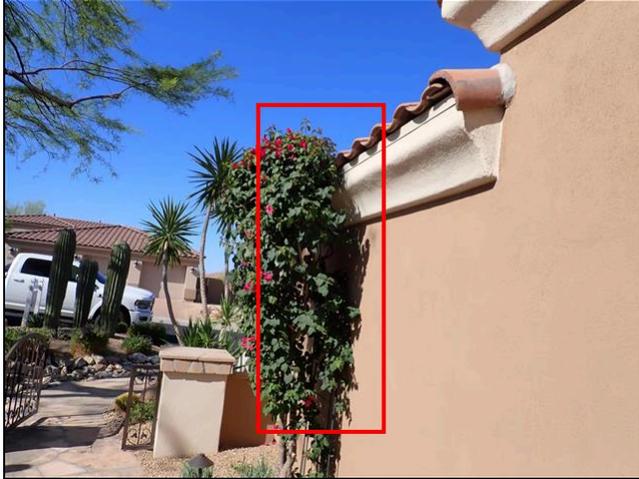
2.8 Item 1(Picture)

Tree limbs/vegetation in contact with the exterior and roof can cause damage and provide access for rodents. Trim as necessary to prevent damage.

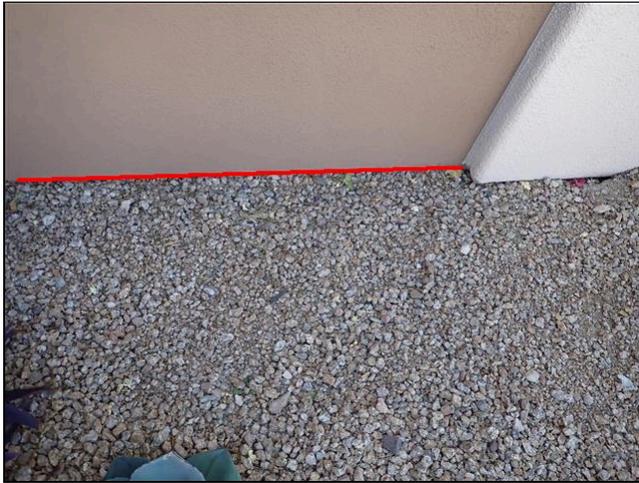
2.9 Item 1(Picture)

(2) The stucco runs to grade on the framed walls in several locations. This is conducive to water damage and termite activity. Keep the soil in the affected areas as dry as possible to prevent damage. Adjust the grade to direct surface water away from the walls.

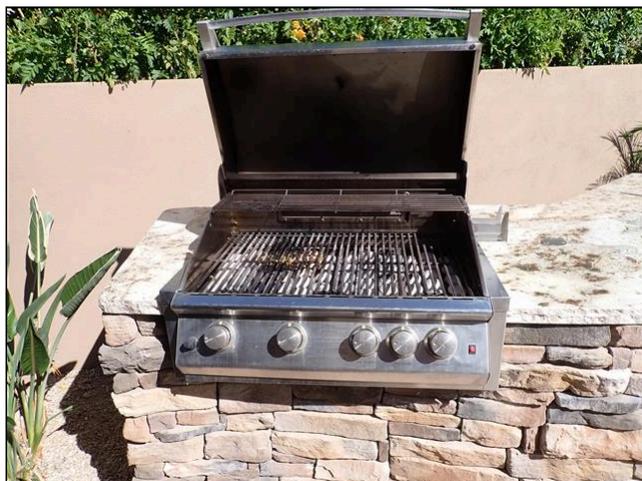
2.12 Item 1(Picture)

The exterior natural gas BBQ is operational and in satisfactory condition.

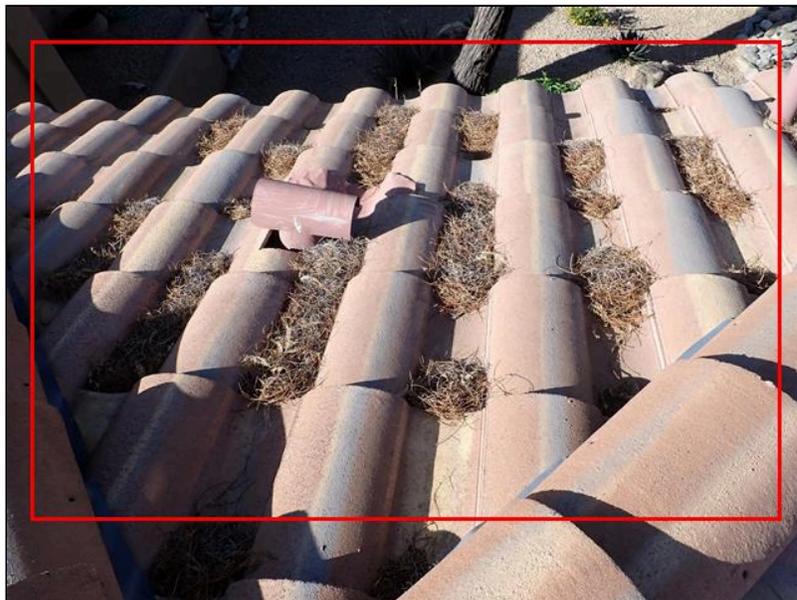
3.1 Item 1(Picture)

- (1) Overall, the roof drainage system is in satisfactory condition.
- (2) Remove the leaf litter to improve water flow off the roof.

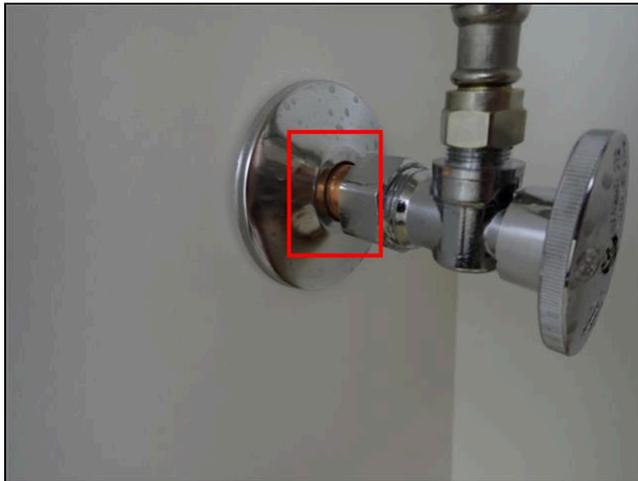
4.0 Item 1(Picture) Copper pipe

The visible portions of the interior supply and distribution system are in satisfactory condition.

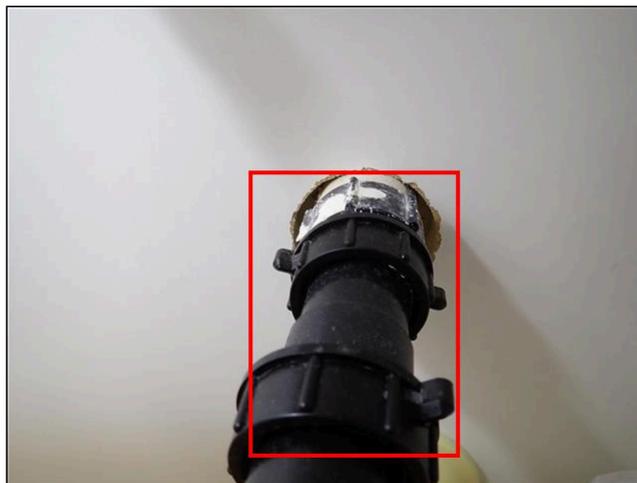
4.7 Item 1(Picture) ABS pipe

The visible portions of the waste and vent system are in satisfactory condition.

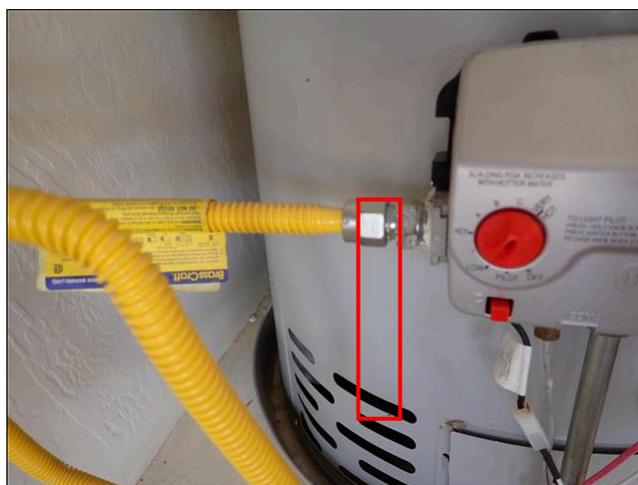
4.14 Item 1(Picture)

There is no sediment trap installed on the gas supply for the water heater. I recommend professional evaluation with repair as necessary to prevent hazard/damage.

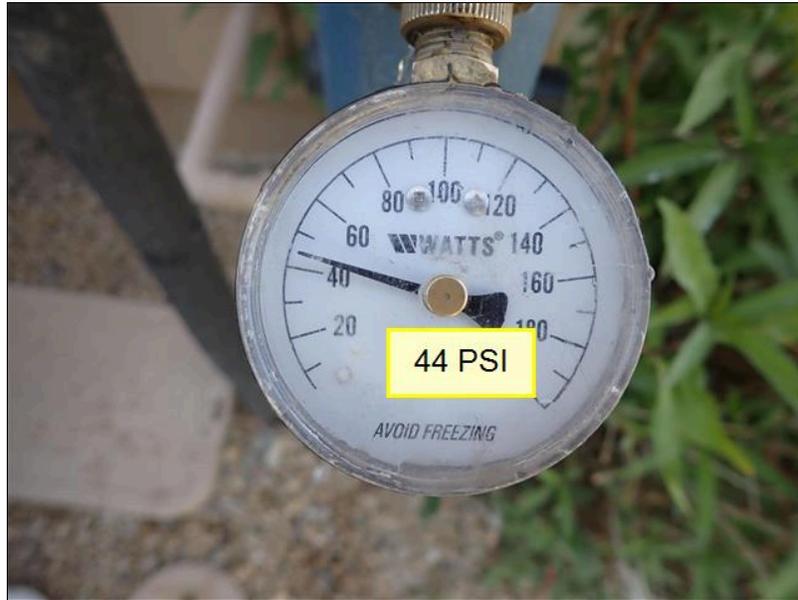
4.15 Item 1(Picture)

Water pressure is between 40-80psi.

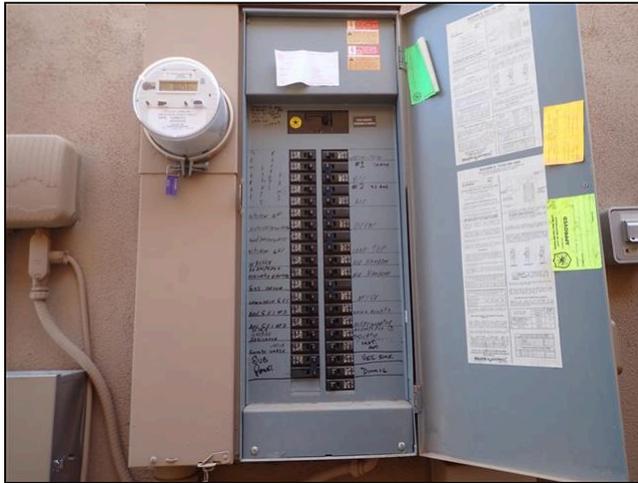
5.0 Item 1(Picture)

The main and distribution panels are in satisfactory condition.

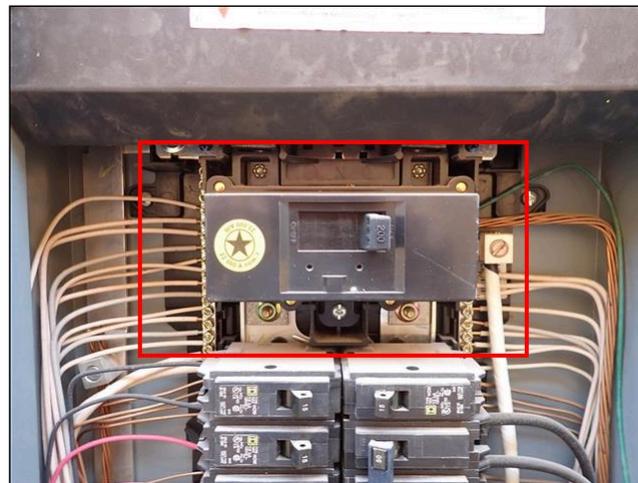
5.1 Item 1(Picture)

The visible portion of the electric service conductor and main overcurrent protection device are in satisfactory condition.

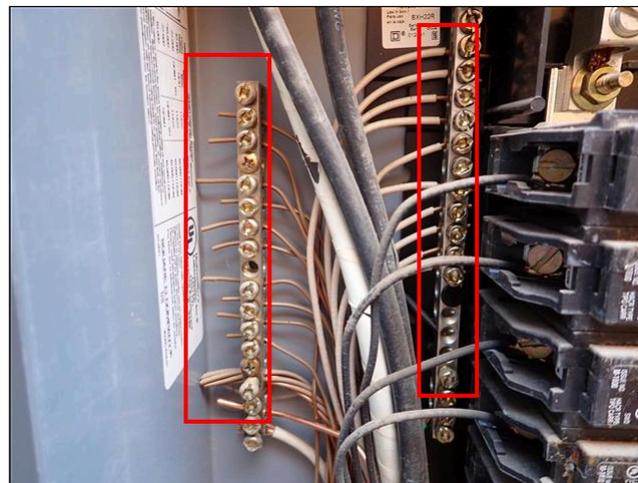
5.3 Item 3(Picture) Copper 15/20 amp branch circuits.

The visible portions of the over current protection devices (breakers/fuses) and branch circuit conductors (wires) are in satisfactory condition.

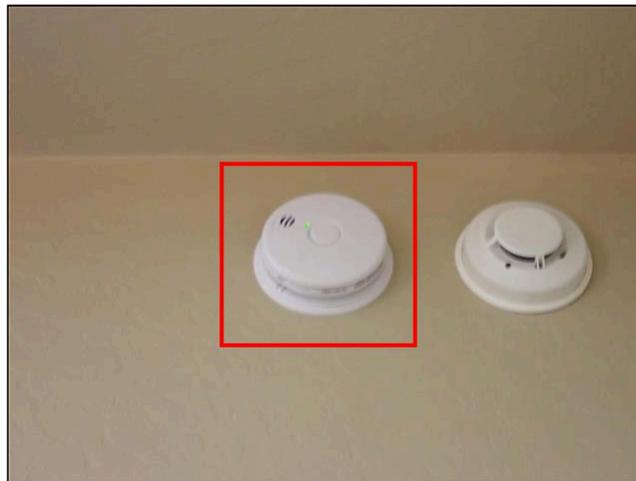
5.9 Item 1(Picture)

(2) Smoke detectors are present in the hallway but not in the bedrooms. I recommend the installation of new smoke detectors for each bedroom.

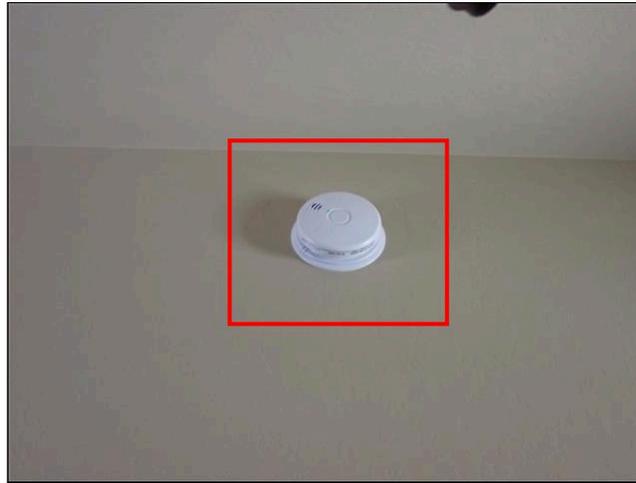
5.9 Item 2(Picture)

(3) There are carbon monoxide monitors present.

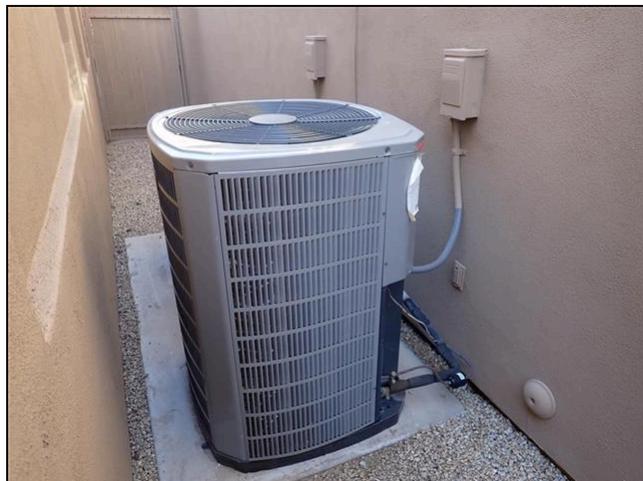
7.0 Item 1(Picture) 2018 Model 5 Ton

The visible portions of the cooling equipment are in satisfactory condition and operational.

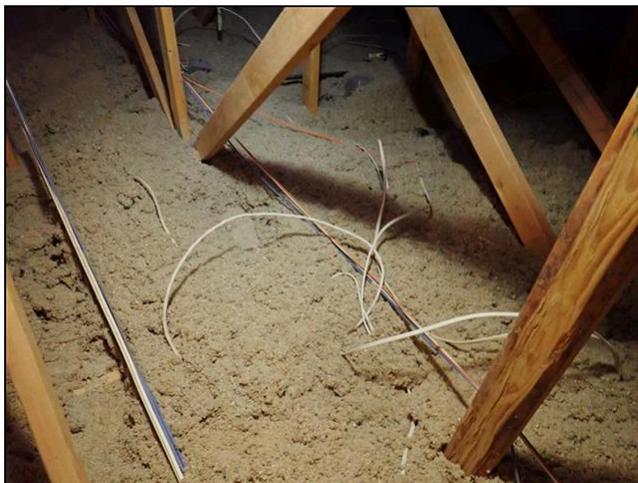
9.0 Item 1(Picture) Blown cellulose insulation.

The visible insulation is in satisfactory condition. Attic visibility is limited, portions of the attic are not visible from the attic access.

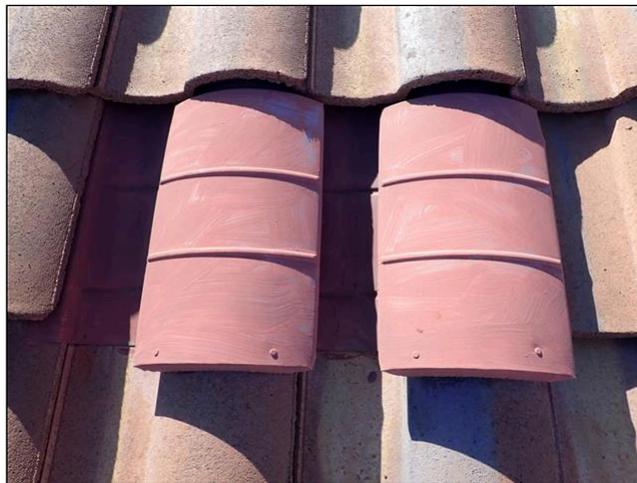
9.2 Item 1(Picture) Ohagen vents.

The visible portions of the attic ventilation are in satisfactory condition.

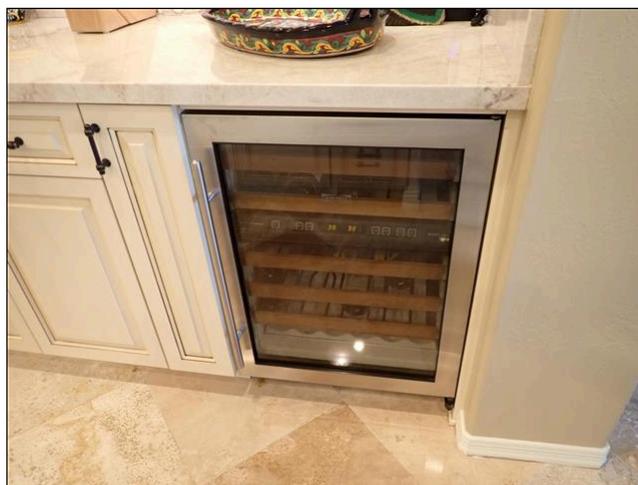
10.8 Item 1(Picture)

(1) The wine cooler is in satisfactory condition and operational.

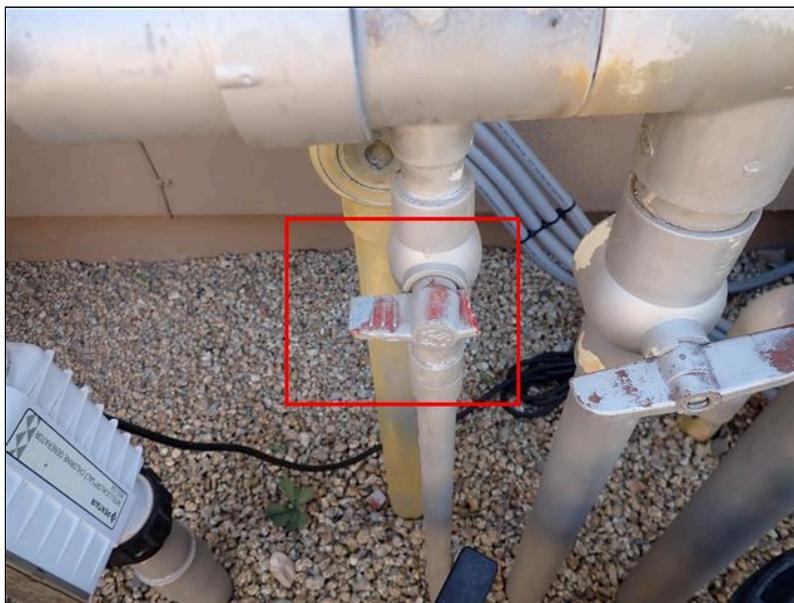
11.5 Item 2(Picture)

(2) The aerator valve handle is broken, I recommend replacement.

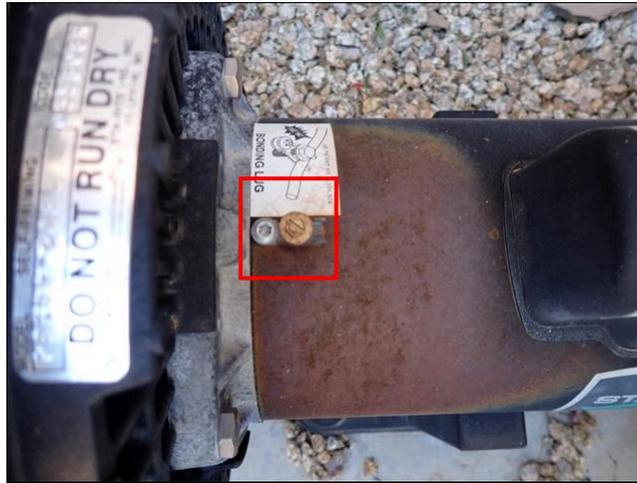
11.6 Item 7(Picture)

(2) The bonding conductor is not attached, secure the bonding conductor as needed to prevent electrical hazard.

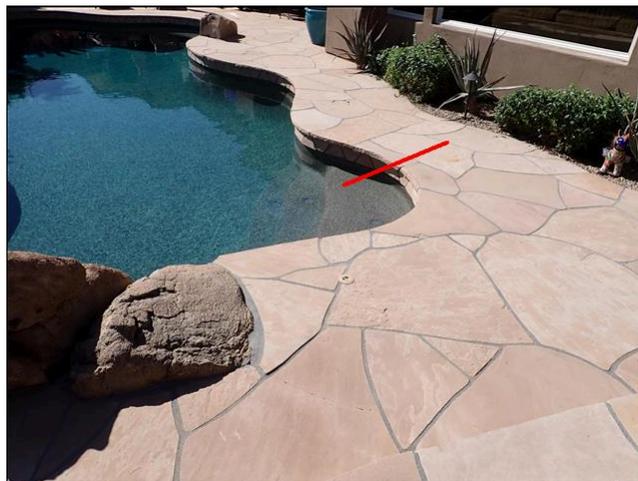
11.9 Item 1(Picture)

Consider the addition of hand rails for the stairs.

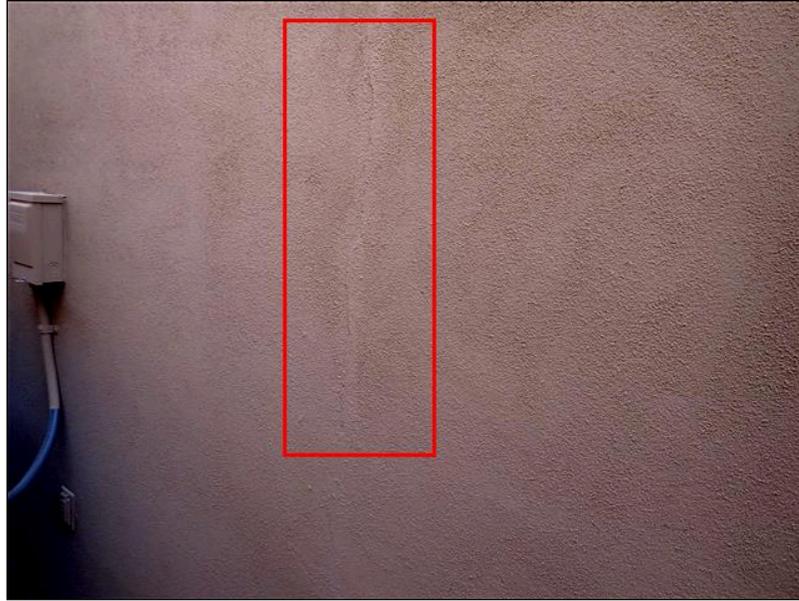
2.0 Item 1(Picture)

(2) Seal all exterior cracks and penetrations to prevent water and pest intrusion.

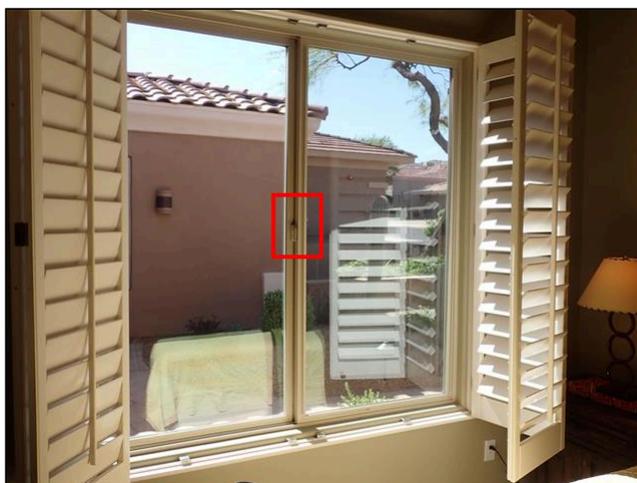
2.3 Item 1(Picture)

(2) The front courtyard left bedroom window does not lock. Repair as necessary.

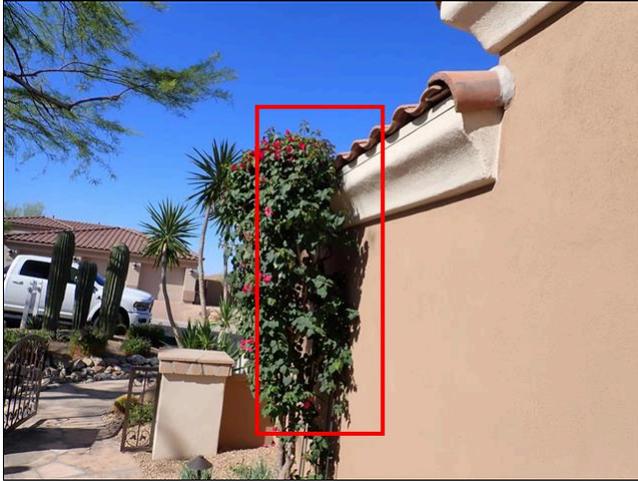
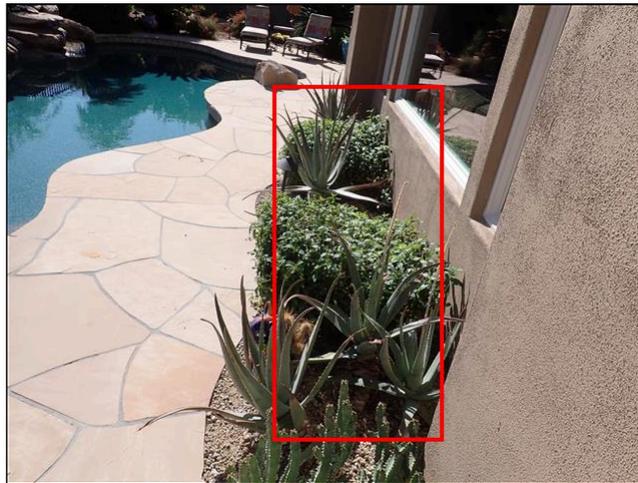
Tree limbs/vegetation in contact with the exterior and roof can cause damage and provide access for rodents. Trim as necessary to prevent damage.

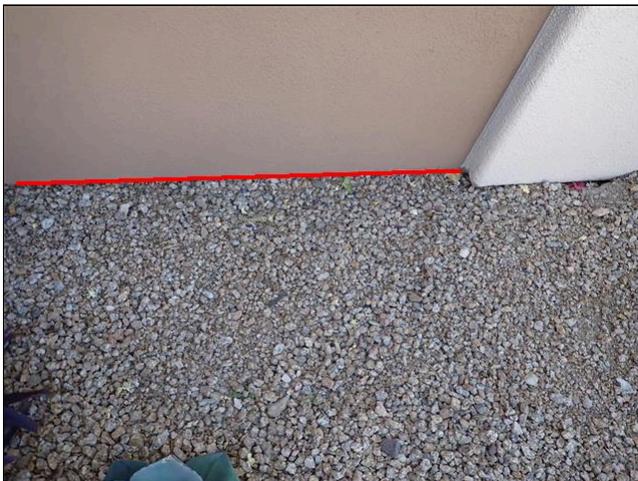
2.9 Item 1(Picture)

(2) The stucco runs to grade on the framed walls in several locations. This is conducive to water damage and termite activity. Keep the soil in the affected areas as dry as possible to prevent damage. Adjust the grade to direct surface water away from the walls.

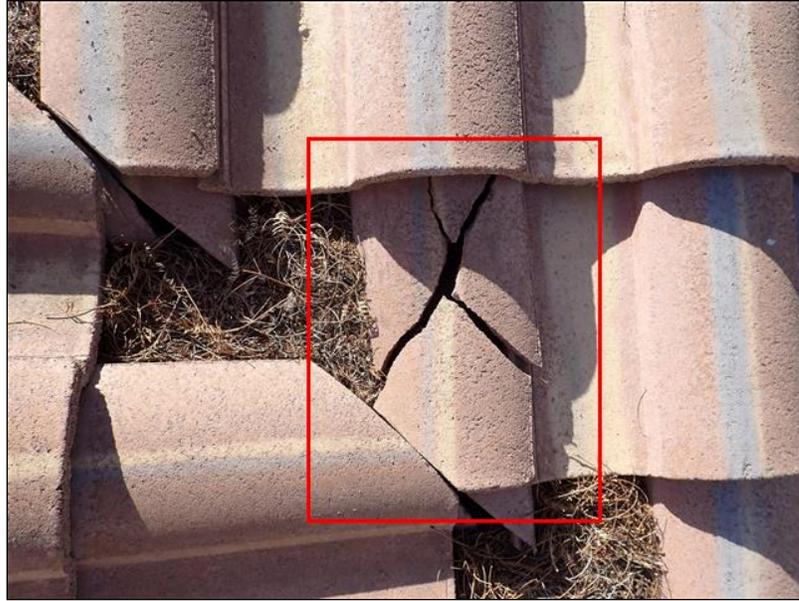
3.0 Item 37(Picture)

(3) Routine maintenance required to repair cracked tiles, secure slipped tiles and repair cracked mudballs. I recommend professional repair by a licensed roofer.

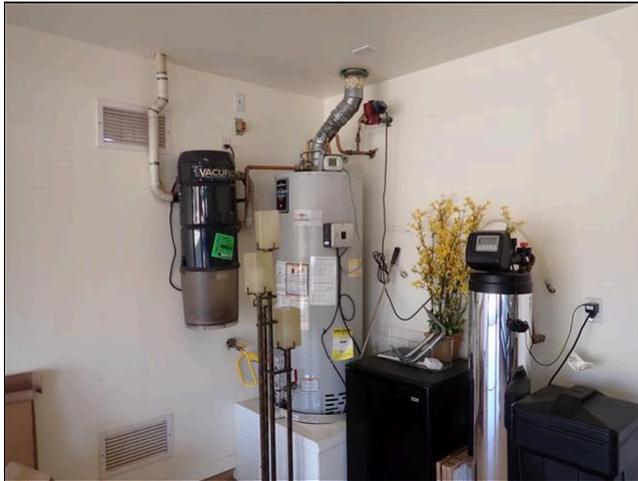
4.11 Item 1(Picture) 2013 Model 50 Gallon natural gas

Water heaters typically last 8-12 years in Arizona. This water heater is a 2013 model and near the end of its service life. Budget for replacement soon. I highly recommend the purchase of a home warranty to help defer owner expense in the event of water heater failure.

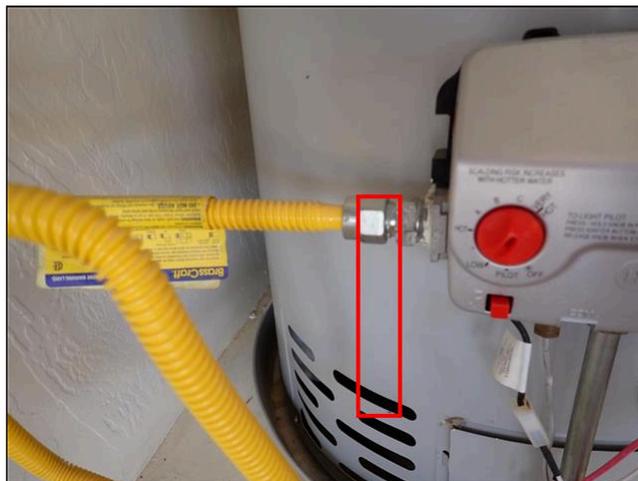
4.14 Item 1(Picture)

There is no sediment trap installed on the gas supply for the water heater. I recommend professional evaluation with repair as necessary to prevent hazard/damage.

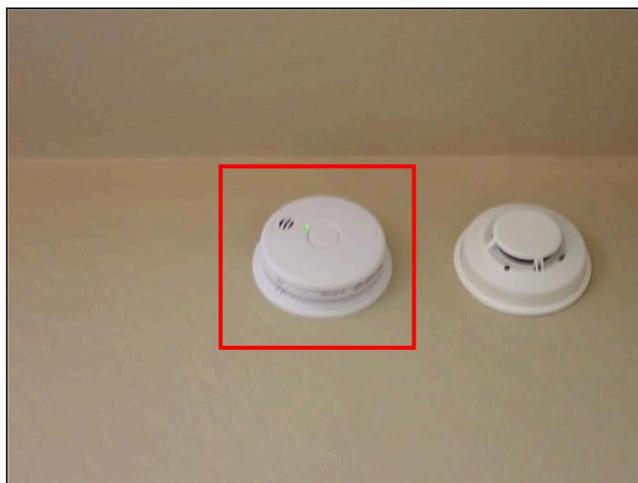
5.9 Item 1(Picture)

(2) Smoke detectors are present in the hallway but not in the bedrooms. I recommend the installation of new smoke detectors for each bedroom.

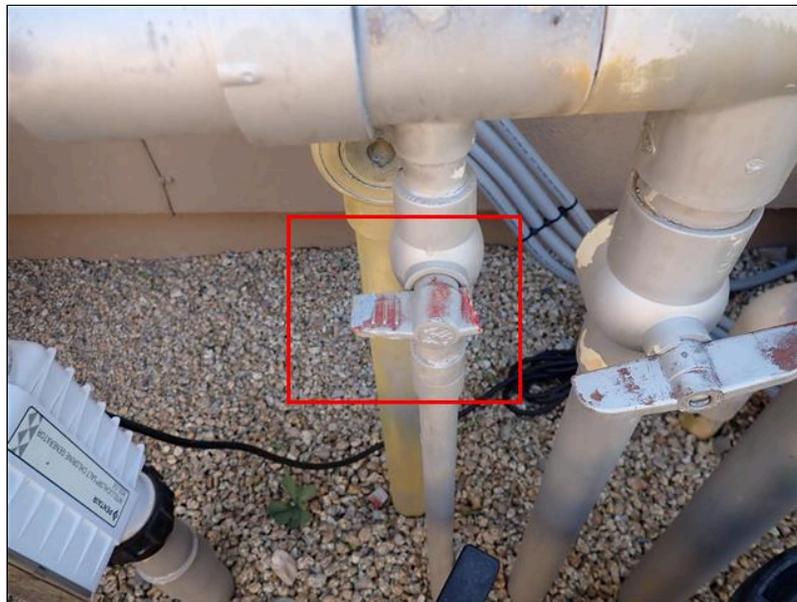
11.5 Item 2(Picture)

(2) The aerator valve handle is broken, I recommend replacement.

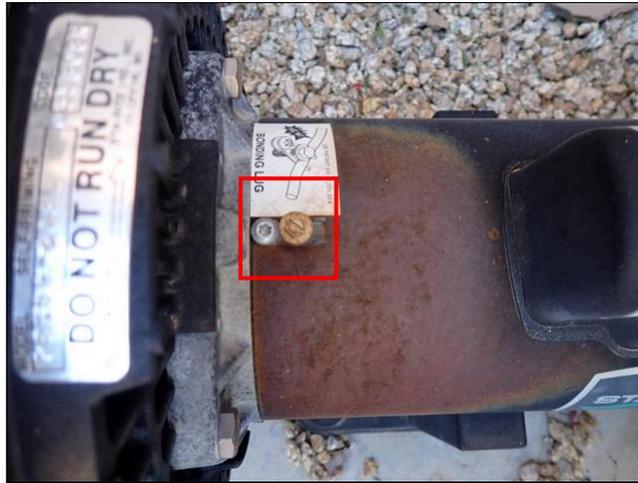
11.6 Item 7(Picture)

(2) The bonding conductor is not attached, secure the bonding conductor as needed to prevent electrical hazard.
