# Environmental Management Plan

## *North Windermere Island Boat Basin REV. 3*

Eleuthera, The Bahamas

DECEMBER 2021

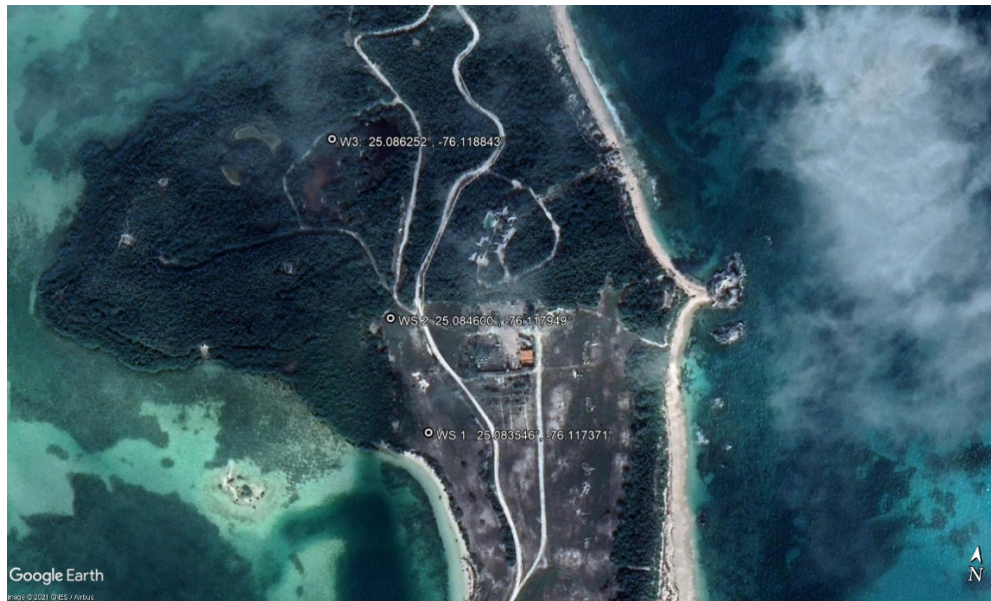
Figure 1:-Map showing location of excavated pits

The field survey area shown in Figure 1, is adjacent to the excavated basin on land reclaimed from the deposition of the spoil from the marina excavation pit into the seabed. Immediately offshore, the remnant of the spoil island was observed; red mangroves border the reclaimed land to the north and a seasonal pond is in the northern upper most area of the proposed marina site.

The Field Survey conducted on 28 August 2021 was preceded by the opening of three shallow pits using an excavator on the 26 August followed by the site visit on the 28 August. It was reported a significant rainfall event had occurred on the 27<sup>th</sup> August.

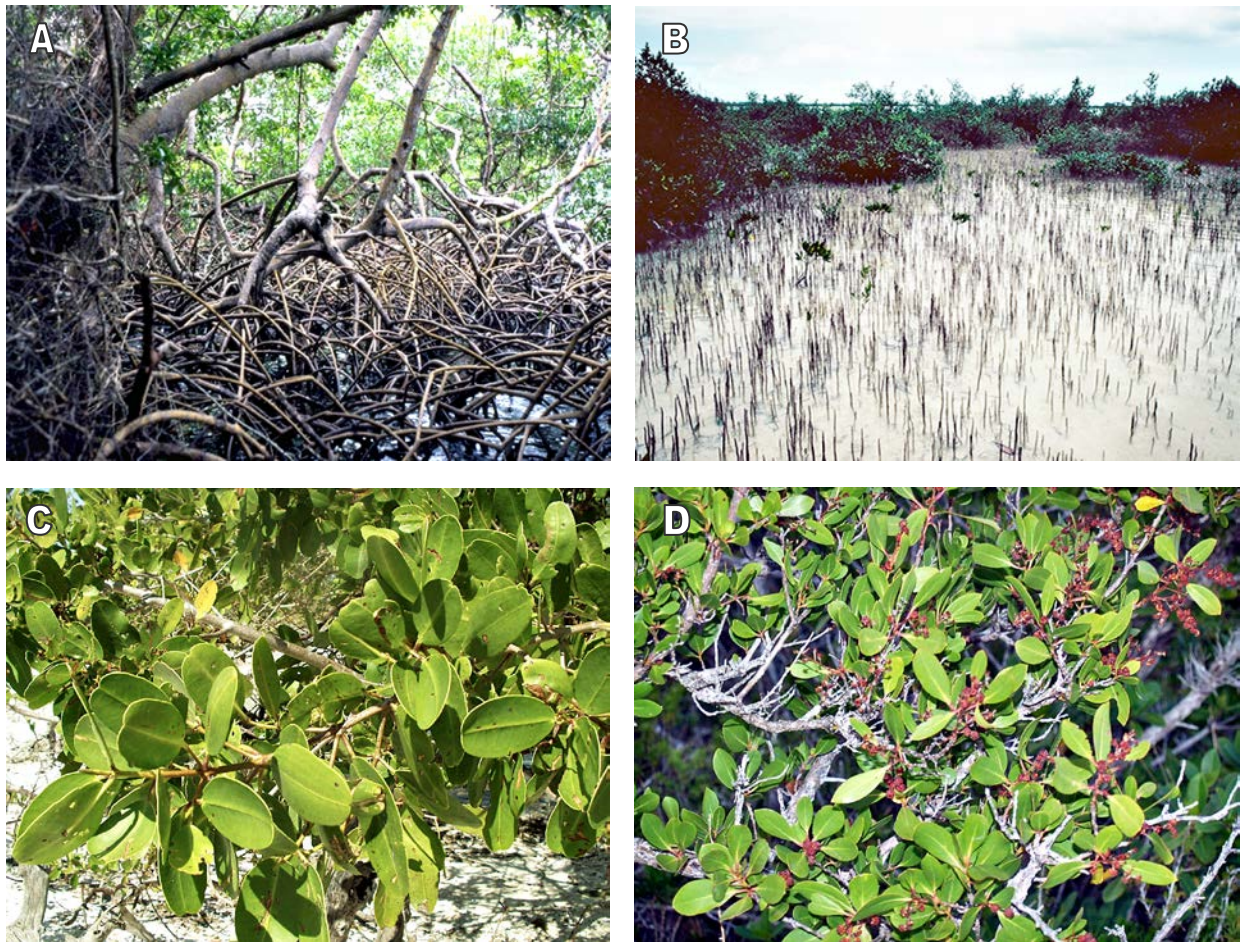
**Figure 1.3.** Mangroves that occur in the U.S. and Caribbean. A) *Rhizophora mangel* (red mangrove) showing the classical tangle of prop roots. B) *Avicennia marina* (black mangrove) showing the diagnostic presence of pneumatophores. C) *Laguncularia racemosa* (white mangrove). D) *Conocarpus erectus* (buttonwood mangrove (A, B = Research Planning, Inc. and C, D = Robin Lewis, Lewis Environmental Services, Inc.).

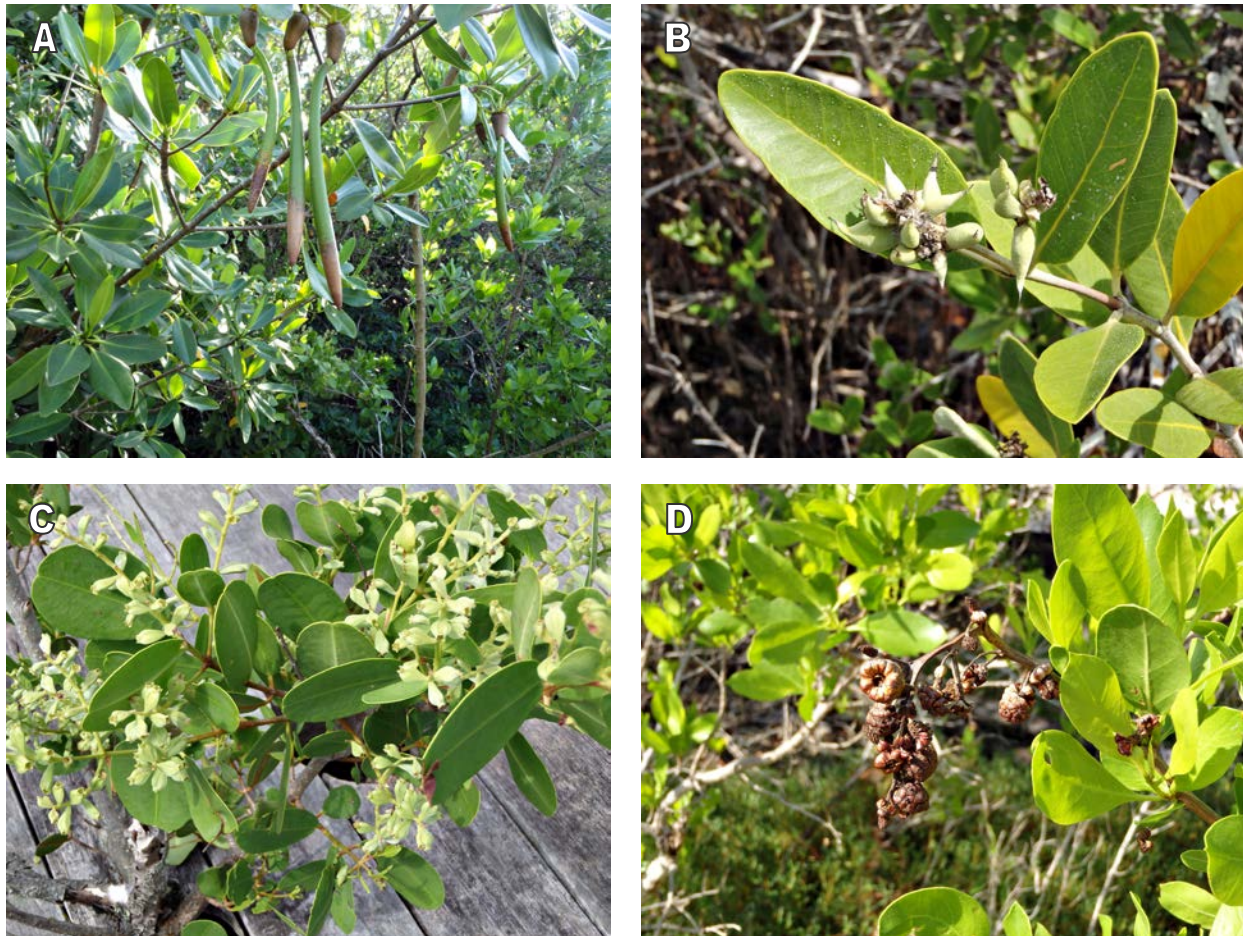
**Figure 1.5.** Examples of mangrove seedlings that occur in the U.S. and Caribbean. A) *Rhizophora mangle* (red mangrove). B) *Avicennia marina* (black mangrove). C) *Laguncularia racemosa* (white mangrove). D) *Conocarpus erectus* (buttonwood mangrove). (Robin Lewis, Lewis Environmental Services, Inc.).

Most mangroves are **hermaphroditic** (both sexes are present in an individual organism). Mangroves are pollinated almost exclusively by animals (bees, small insects, moths, bats, and birds), except for *Rhizophora*, which is primarily self-pollinated (Lowenfeld and Klekowski 1992). In most mangroves, germination takes place while the embryo is still attached to the parent tree (a condition called **vivipary**). The embryo has no dormant stage, but grows out of the seed coat and the fruit before detaching from the plant. Because of this, mangrove **propagules** are actually seedlings, not seeds (Figure 1.5).

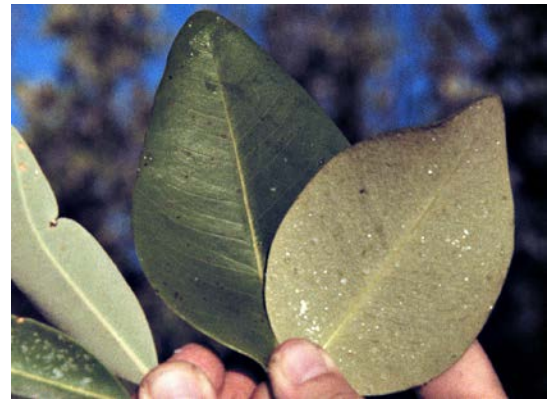
Figure 1.6. Close-up of mangrove leaf showing salt crystals (C.E. Proffitt; Gulf of Fonseca, Honduras).

Mangroves have evolved different mechanisms to tolerate high salinities: salt exclusion, salt secretion, and tolerance of high salt concentrations within plant tissues are the main strategies. Most mangroves have developed all three mechanisms, although to varying extents. *Rhizophora*, *Bruguiera*, and *Ceriops* have root ultra-filters that exclude salt while extracting water from soils (Rützler and Feller 1996). In salt secretion, special organs or glands remove salts from plant tissues. For example, *Avicennia* and *Laguncularia* have special, salt-secreting glands that cause salt crystals to form on the leaf surfaces (Figure 1.6). These crystals then can be blown away or easily washed away by the rain. Leaf fall is another mechanism for eliminating excess salt in mangroves (Kathiresan and Bingham 2001).

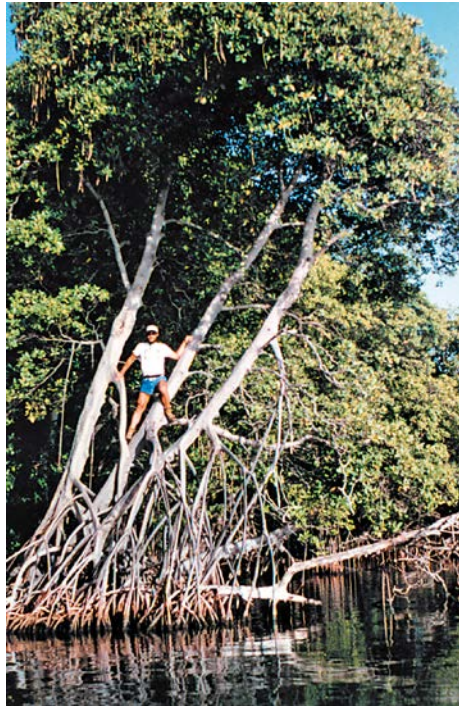
Figure 1.7. *Rhizophora* tree showing prop roots (C.E. Proffitt).

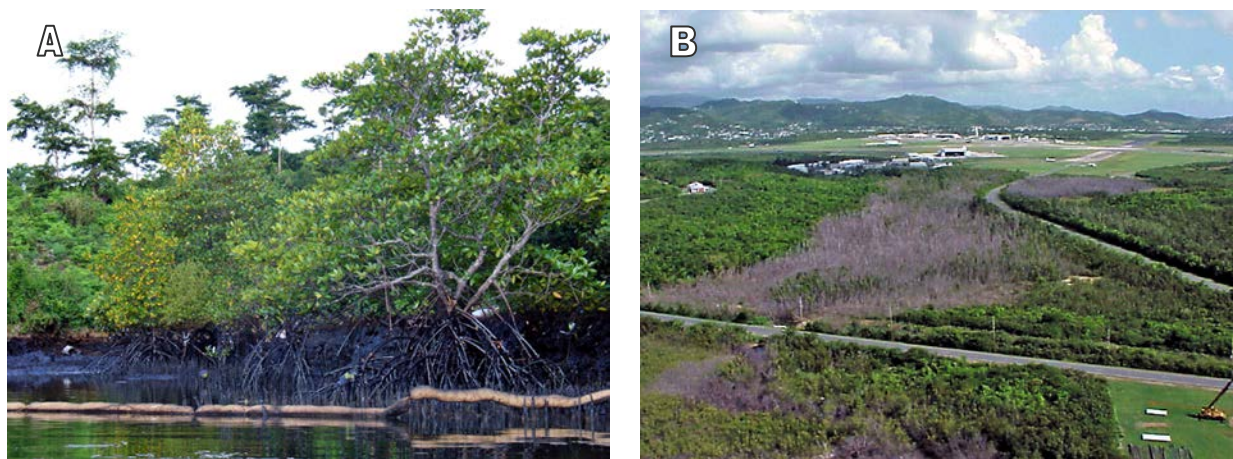
**Figure 2.1.** Acute oil toxicity effects. A) Chlorosis of red mangroves three weeks after a spill of an intermediate fuel oil spill from the M/T *Solar I* in the Philippines (Ruth Yender, NOAA). B) Aerial view of Roosevelt Roads, Puerto Rico jet fuel spill in 1999 showing dead mangroves (Dan L. Wilkinson, Geo-Marine, Inc).

The last observation is consistent with conditions observed at several oil spills in mangrove areas. In fact, obvious signs of mangrove stress often begin occurring within the first two weeks of a spill event, and these can range from chlorosis (Figure 2.1A) to defoliation to tree death. In the 1999 Roosevelt Roads Naval Air Station (Puerto Rico) spill of JP-5 jet fuel, an initial damage assessment survey conducted in the first month post-spill determined that 46% of mangrove trees, saplings, and seedlings along a transect in the most impacted basin area were stressed (defined as showing yellowed, or chlorotic, leaf color). This compared to 0% along the unoiled reference transect (Geo-Marine, Inc. 2000). Figure 2.2B shows the most heavily impacted area about nine months after the initial release with many of the initially stressed trees dead. Color **infrared**, aerial photography taken at regular intervals through 19 months post-spill confirmed the visual observations. Analysis of the infrared photographs of the affected mangrove area shown in Figure 2.2B indicated that two weeks after the release, 82% of the total mangrove area was classified as “impacted” relative to pre-spill conditions. Under more controlled conditions, studies using fresh crude oils have suggested that defoliation, when it occurs, should reach a maximum between 4-12 weeks post-spill.

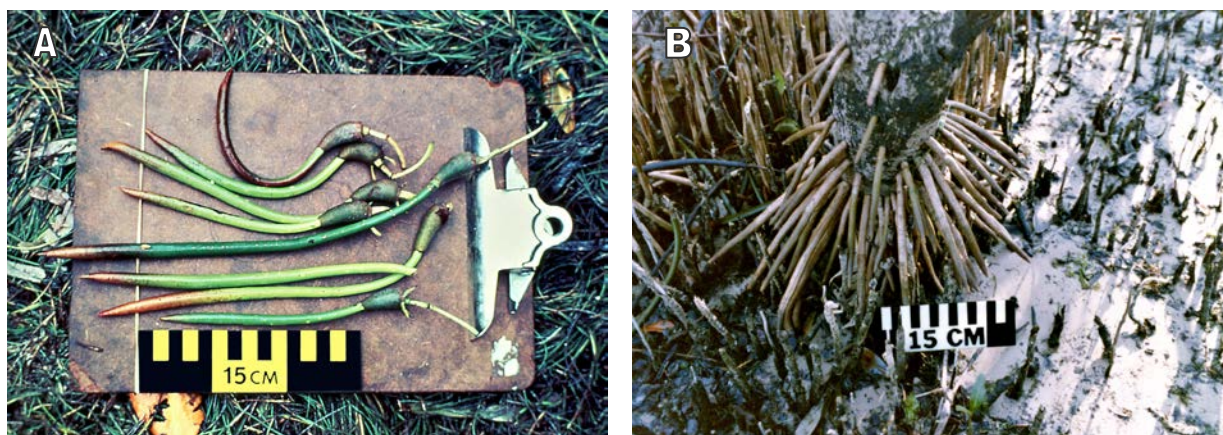
**Figure 2.2.** Propagule and root deformities observed in January 1980 as response to the chronic effects of oil exposure after the 1978 *Howard Star* oil spill in Tampa Bay, Florida. A) Deformed red mangrove propagules collected from oil sediments (upper) contrasted with normally developed propagules from adjacent unoled sediments (lower). B) Abnormal adventitious roots at the base of a black mangrove tree (Research Planning, Inc.).

Root abnormalities have been reported as a response to chronic oil exposures. Adventitious roots and deformed red mangrove propagules were observed on *Avicennia* trees after the 1978 *Howard Star* spill in Tampa Bay (Figure 2.2) and at many spills since then. *Avicennia* mangroves oiled during the 1991 Gulf War spill had surviving pneumatophores that tended to develop branched secondary pneumatophores. These were observed two years after the spill in areas that were known to have been oiled, and were interpreted to be a response to impairment of normal respiration (Böer 1993).

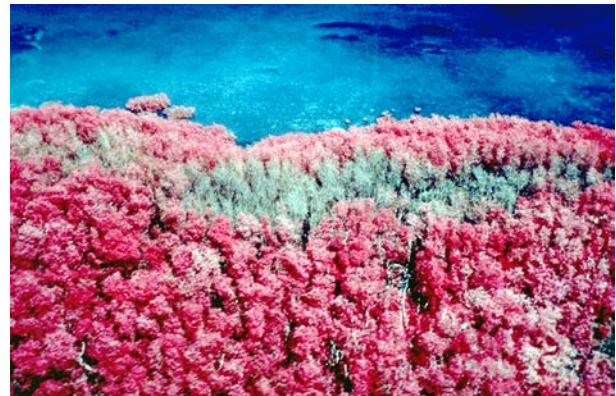
Figure 3.2. Infrared aerial photograph of a band of dead mangroves where oiling was heaviest on the prop roots and penetrated into the soils. Note the lighter color of the outer fringe mangroves indicating stress. This is a classic example of inner fringe impact (Research Planning, Inc.).

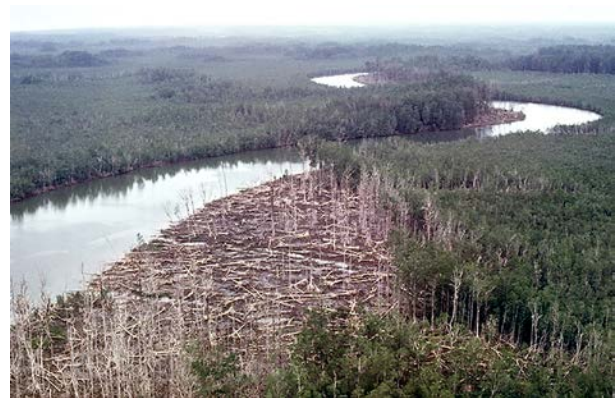
Figure 3.3. Extensive riverine impacts to mangroves three years after the Funiwa 5 spill of 400,000 barrels of crude oil in Nigeria in 1980 (Research Planning, Inc.).

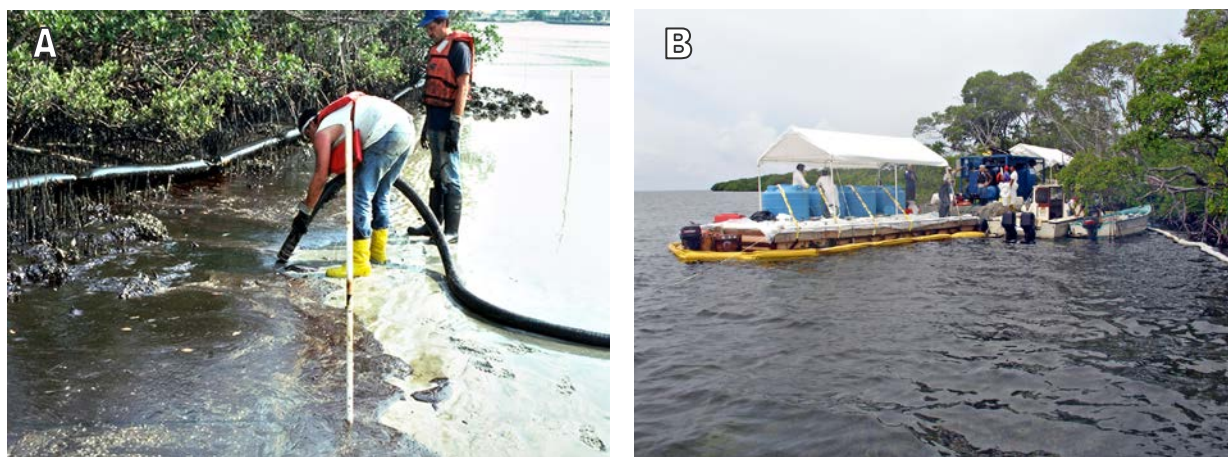
**Figure 3.4.** Vacuuming techniques in mangroves. A) Successful removal of thick oil from mangroves working on a firm sand flat during the 1993 Tampa Bay, Florida spill (Jacqueline Michel, Research Planning, Inc.) B) Unsuccessful attempt to remove floating oil trapped in the mangrove fringe during the 2007 Guánica, Puerto Rico spill of heavy fuel oil. Note the multiple tanks to separate the large volume of water recovered (Brad Benggio, NOAA).

Vacuuming free-floating oil on the water surface is much more difficult. Vacuuming of a heavy fuel oil floating in the mangroves on the south coast of Puerto Rico generated mostly water, requiring extensive oil:water separation systems (Figure 3.4B). Overall, it was not very effective.

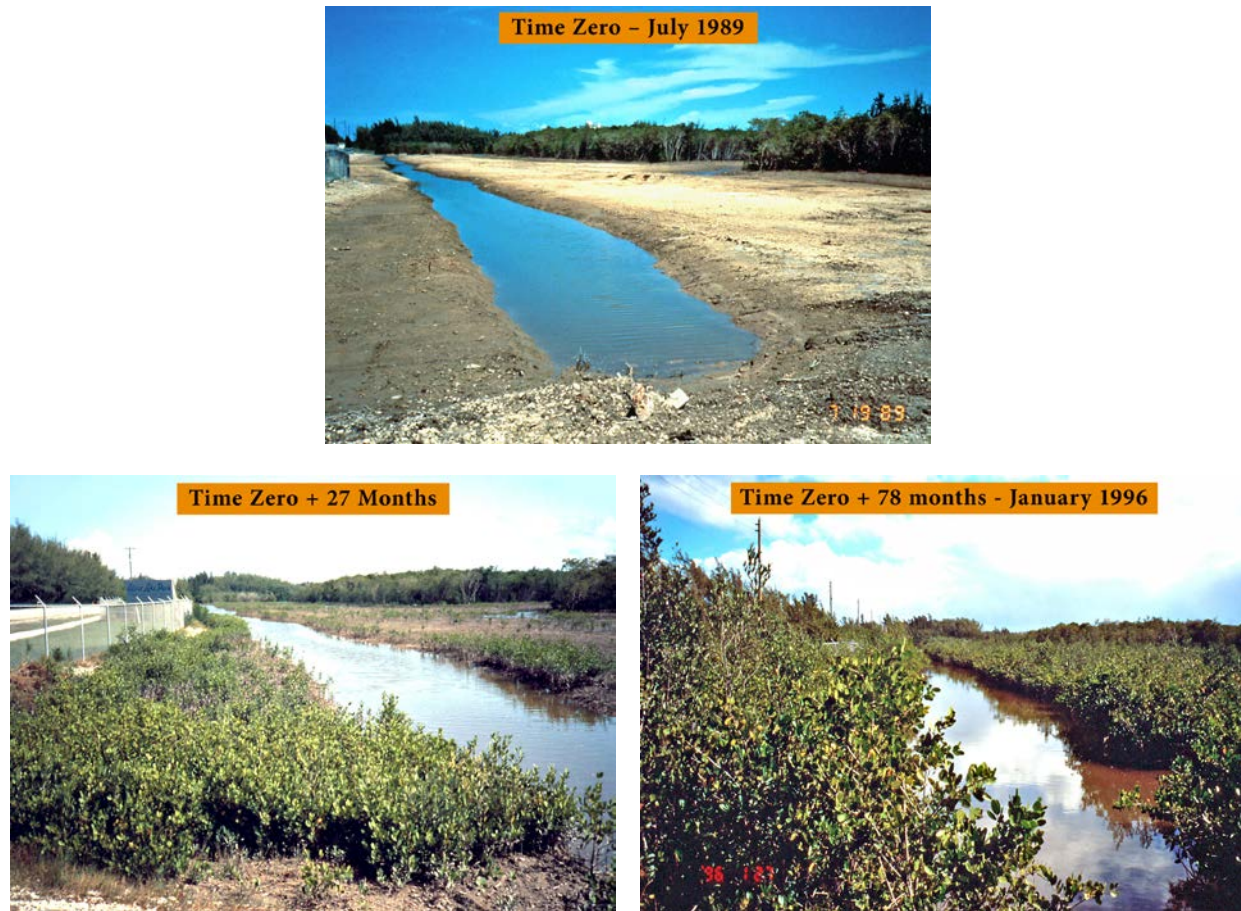
**Figure 4.1.** Mangrove restoration project at West Lake Park, Ft. Lauderdale, Florida. Dredged materials were excavated to the appropriate tidal elevation. No planting was conducted, mangroves re-established solely by natural recruitment once hydrology was restored (Robin Lewis, Lewis Environmental Services, Inc.).

Adequate hydrology has been identified as the most important parameter for mangrove recruitment (Lewis and Streever 2000). When tidal connections have been cut off or altered, as is common along developed coasts, re-establishing these connections can promote natural recruitment and improve the overall health and functioning of the mangrove ecosystem. Roosevelt Roads NAS is an example where impounded mangroves were impacted by a jet fuel spill in 1999. These mangroves suffered both from toxic fuel impacts and from extended submersion of roots when tidal conduits were closed to contain the spill during response. Facilitating or increasing tidal exchange to these impounded mangrove forests could be a promising restoration activity. A component of in-kind restoration conducted after the Tampa Bay spill involved restoring tidal circulation at a previous dredge disposal site where mangroves had been impounded by dikes. Figure 4.1 shows an example of a restoration project where dredged materials were excavated to the appropriate elevations and natural recruitment was very successful.

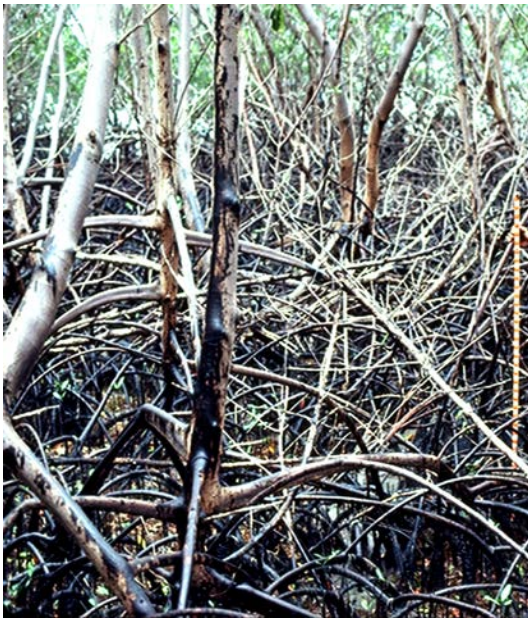
Figure 5.1. Heavy oiling of red mangrove prop roots from the *Peck Slip* spill in Puerto Rico in 1978. Note that the oil has spread 2 m above high tide by climbing crabs. The rod to the right is 1.5 m high (Research Planning, Inc.).

Within two to three months the heavily oiled inner fringing and basin mangroves at the Punta Medio Mundo forest were defoliated. Prop-root oiling had widened to a band of over 2 m high, possibly from climbing crabs that were oiled (Figure 5.1). Later site visits confirmed that mangroves with the most heavily oiled prop roots remained defoliated 10 and 18 months later (Getter et al. 1981). This was one of five sites studied by Getter et al. (1981). From these studies the authors urged that inner fringing and inner basin mangroves receive highest priority for protection from oil spills.

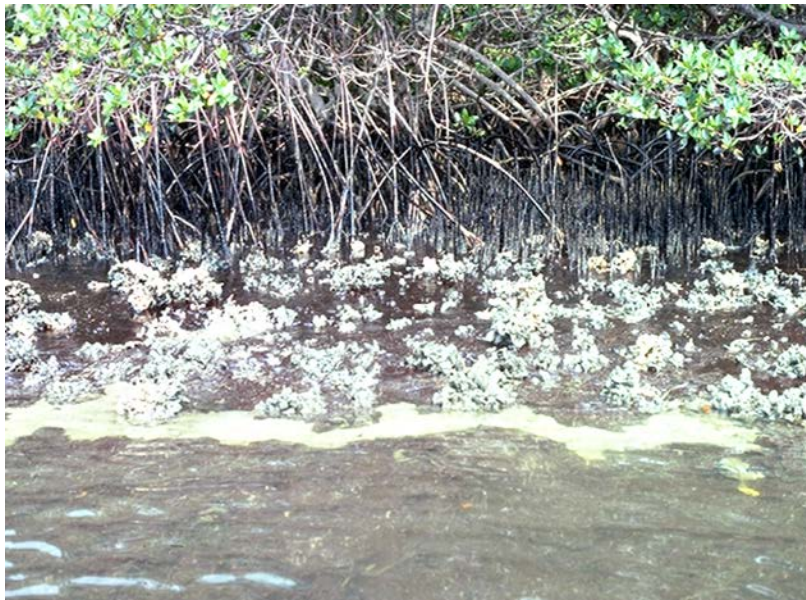
**Figure 5.2.** Heavy oil stranding on the mangrove substrate and coating of the prop roots and pneumatophores (Research Planning, Inc.).

By August 16 very little floating oil was seen offshore. In the shallow, low-energy areas along the mangrove islands inside Johns Pass and at a few locations in the surf zone, oil had mixed with beach sand and shallow sediments to form underwater tarmats, some of which came ashore on the mangrove keys (Figure 5.2)

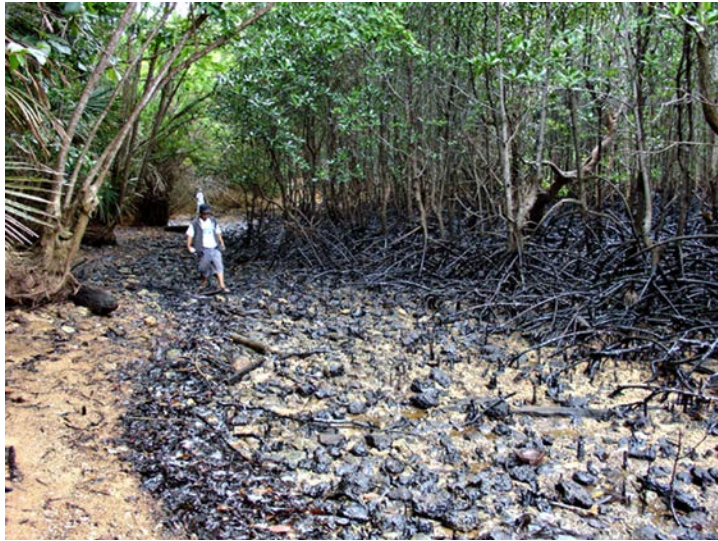
**Figure 5.3.** Heavy fuel oil from the M/T *Solar I* that penetrated completely through the mangrove forest to the landward zone, coating the prop roots and trunks of the trees (Ruth Yender, NOAA).
