Enviro Septic 271 E Morris Blvd Morristown, TN 37813 423-473-7842 https://www.enviroseptictn.com

Inspected Tuesday, February 9, 2021

Inspection Summary

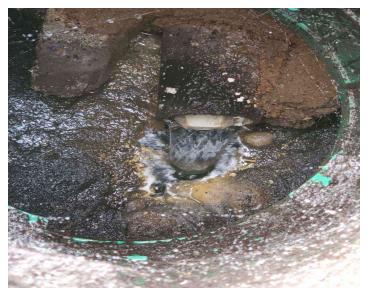
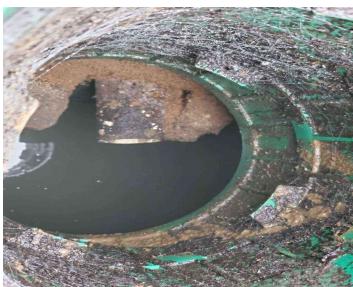
1: Condition of Inlet Baffle?

Inlet baffle has been removed. The purpose of the inlet baffle is twofold to direct the flow from the house sewer downward into the tank to create a longer detention time for the sewage to allow settling of solids and to keep the floating scum layer from backflowing into and plugging the inlet pipe from the house. Pipe appears to have slight back pitch angle towards the house.

At some point the inlet baffle was removed and a pvc pipe used as a by pass

Condition of Inlet Baffle? - Intact, Other, Severely Damaged

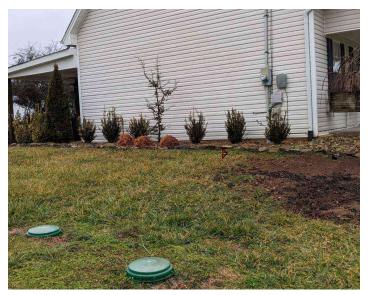
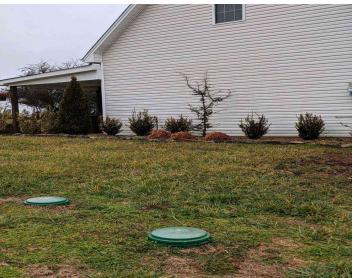
3: Condition of Top and Lids?

Riser covers in good condition.

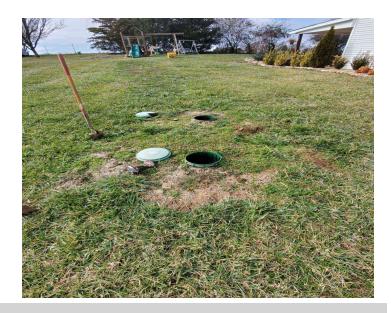
4: Condition of Inspection Port?

Inspection port is in good condition.

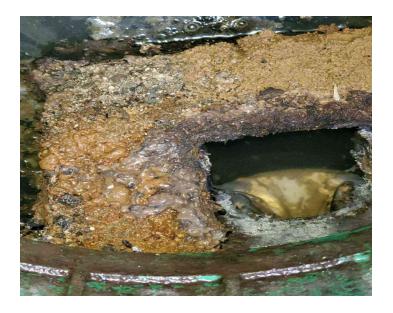
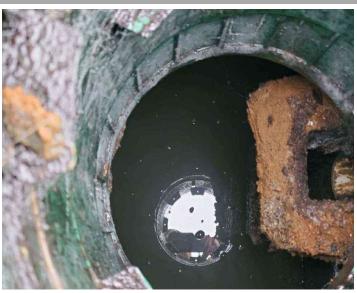
5: Condition of Outlet Baffle?

The outlet baffle was viewed from the interior of the tank and is in satisfactory condition.

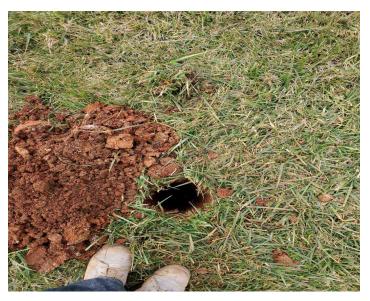
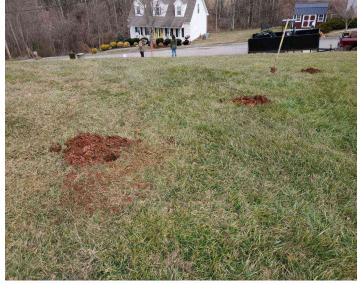
6: How much aggregate in absorption system?

The field was probed in six locations and found no signs of seepage or other signs of system failure.

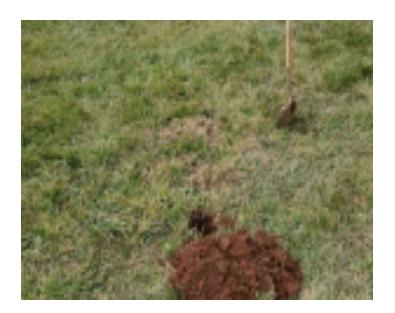
7: Is effluent evenly distributed in absorption area?

Ground cover shows even growth reflecting satisfactory absorption.
