## RESIDENTIAL INSPECTION

1234 Main St. Newnan Georgia 30263

04/21/2021 9:00AM

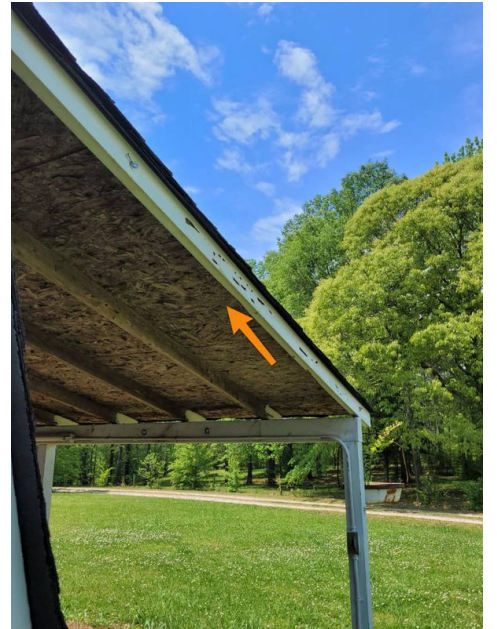
We observed evidence that the home appears to be infested with insects, birds and/or rodents. We recommend having the home treated for insects and/or rodents prior to occupation.

Carpenter bees. Detached building

Contact a qualified professional.

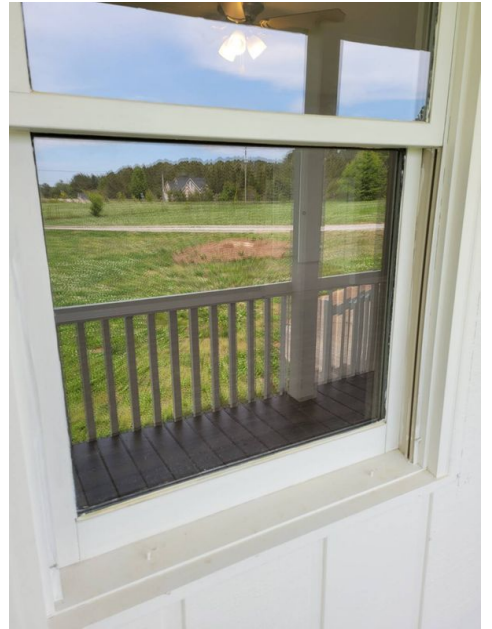
**SCREENS - DAMAGED AND/OR MISSING.**

One or more screens were damaged and/or missing at the time of the inspection.

No screens present

Contact a qualified window repair/installation contractor.

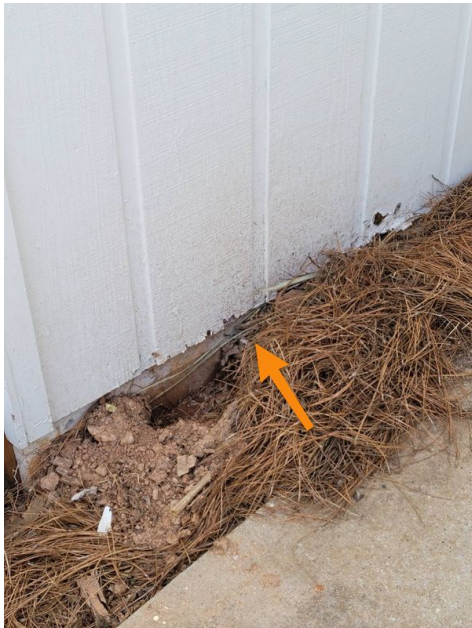
Right front

**WOOD ROT**

There is wood rot that should be repaired to prevent further damage and deterioration.

Contact a qualified siding specialist.

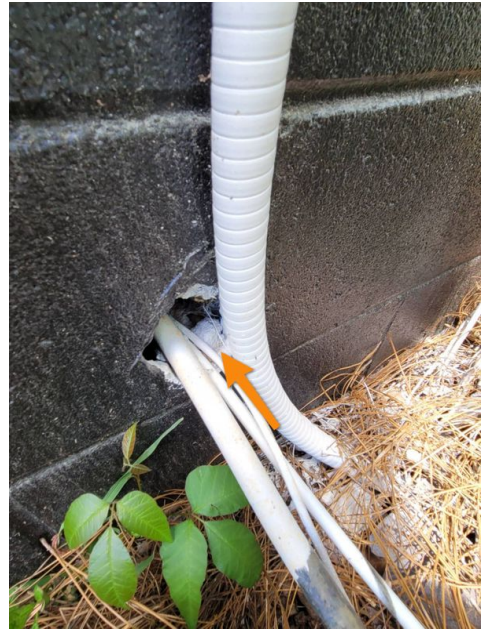
All penetrations

**GAP NEEDS FILLED**

Recommend sealing or filling gaps to prevent moisture, rodent, or insect damage.

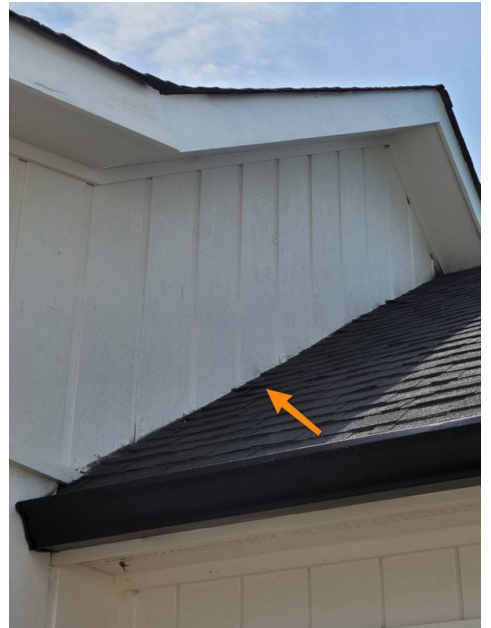
Right front and back

Siding on the home did not have the recommended clearance of 1.5" to the roof. Running siding close to asphalt shingles results in moisture damage and premature failure. Recommend trimming or replacing the siding for proper clearance.

Contact a qualified professional.

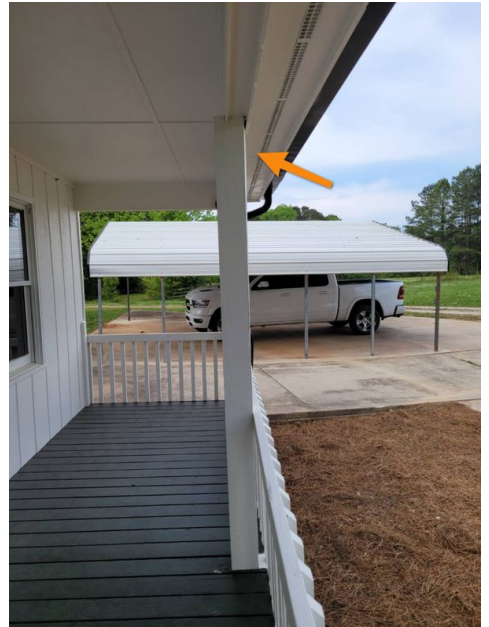
**DECK/BALCONY UNSTABLE SUPPORT**

One of more areas of the deck or balcony support appears unstable. This could cause a safety hazard and further deterioration of the deck or balcony

Warped post

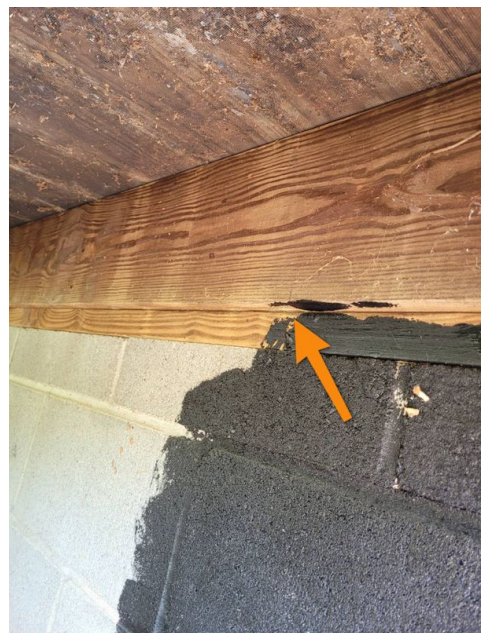
Rear deck

**LEDGER BOARD IMPROPERLY INSTALLED**

The ledger board is not properly attached to the building. This can cause the deck to pull away from the building and possibly collapse.

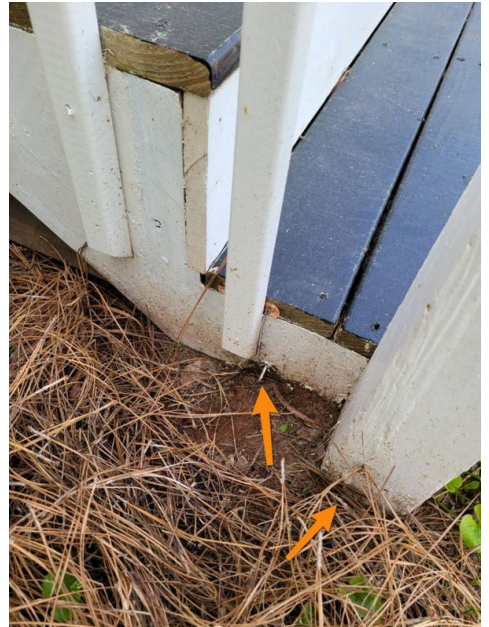
Front & Rear Porches

One or more parts of the structure were in direct contact with the ground. This can cause premature deterioration and should be fixed to prevent further damage.

Contact a qualified professional.

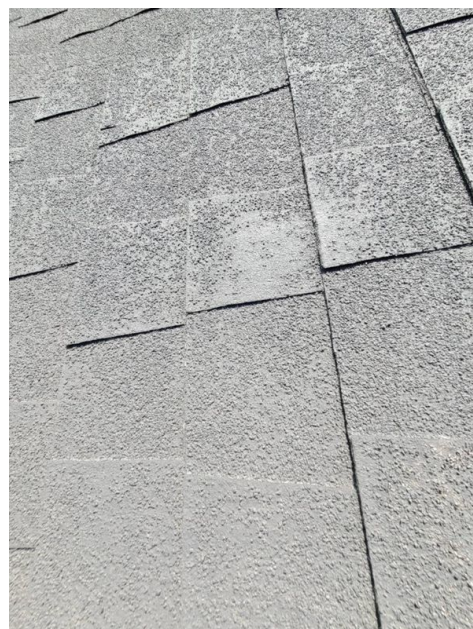
The roof appeared to be modified, installed, and/or added on to in a manner that is inconsistent with modern building practices. The roof covering may have been installed incorrectly which could lead to moisture intrusion or structural issues. Further evaluation by a licensed roofing contractor is recommended.

Roof appears to have been painted

Contact a qualified professional.

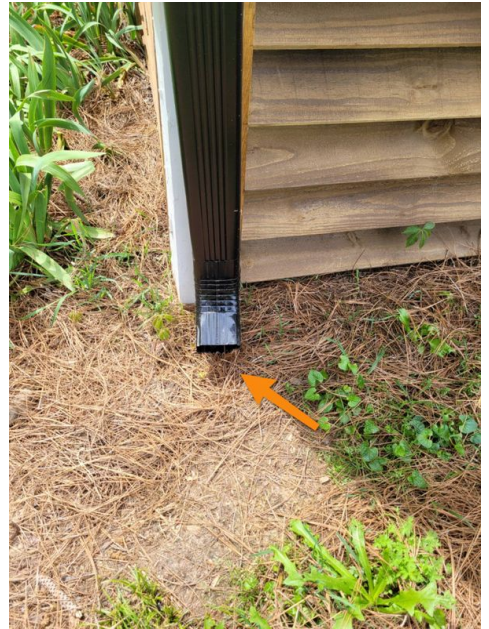
Multiple locations

One or more downspouts drain too close to the home's foundation. [Adjust downspout extensions to drain at least 4-6 feet from the foundation.](#)

Contact a qualified gutter contractor

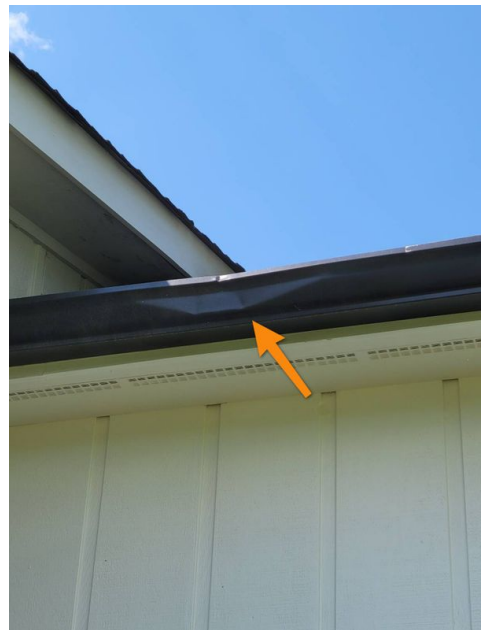
Left rear

**GUTTER DAMAGED**

Gutters were damaged. This can result in excessive moisture in the soil at the foundation, which can lead to foundation/structural movement.

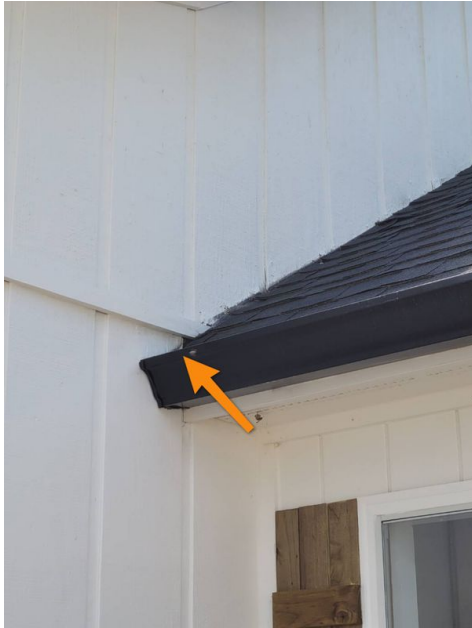
Right front and back

**MISSING KICKOUT FLASHING**

Kick-out flashing was missing where walls extended past roof edges.

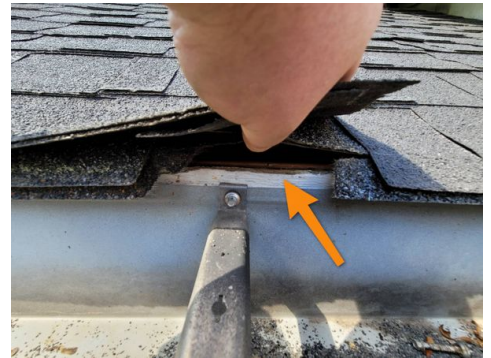
**ROOF EDGE FLASHING MISSING**

Areas of the roof were missing roof edge flashing. Lack of roof edge flashing leaves the edges of roof sheathing and underlayment exposed to potential moisture damage from wood decay and/or delamination. The inspector recommends replacement of roof edge flashing in areas where it is missing. All work should be performed by a qualified contractor.

Contact a qualified roofing professional.

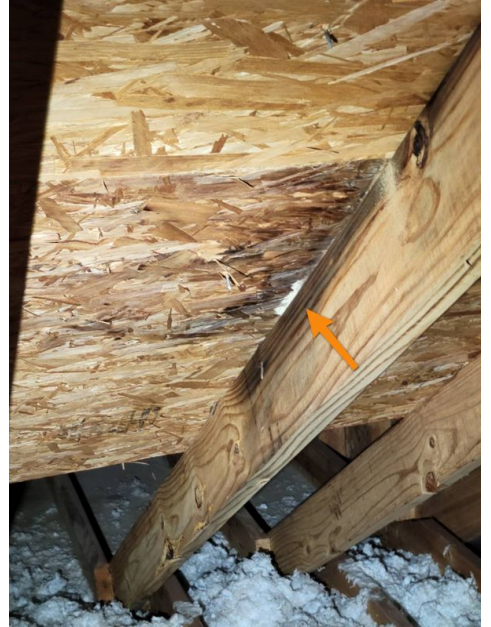
Multiple locations

A possible source of moisture is the bathroom exhaust venting into the attic.

Contact a qualified professional.

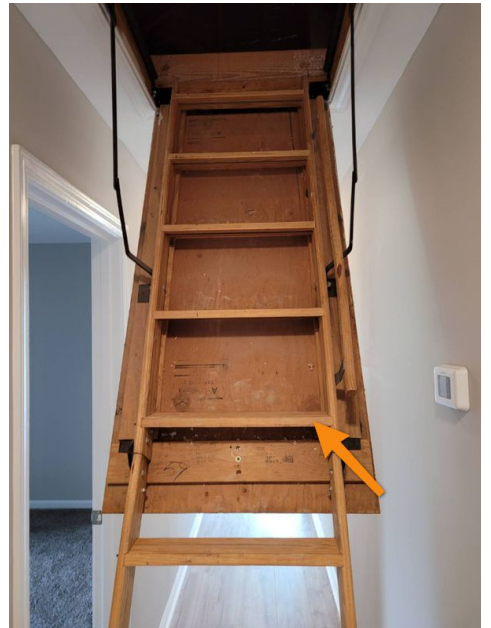
**ATTIC DOOR NOT INSULATED**

Contact a qualified professional.

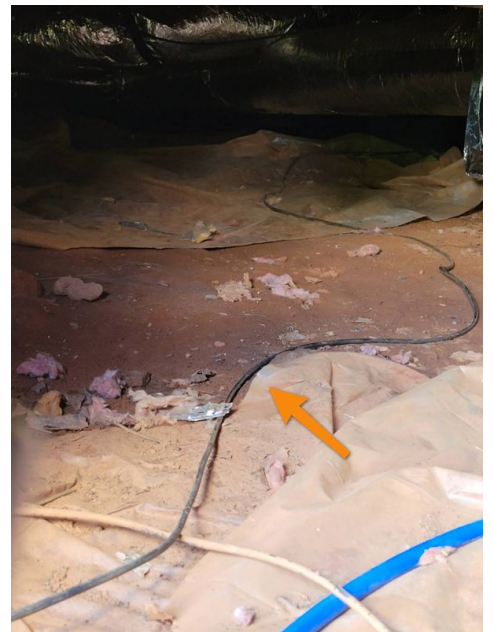
Multiple locations

**IMPROPER INSTALLATION**

Vapor barrier is improperly installed. This can result in unwanted moisture. The inspector recommends having a qualified insulation contractor evaluate and repair.

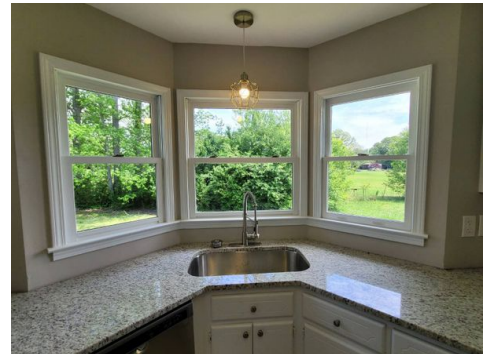
Multiple locations

One or more windows throughout the home were difficult to operate. Adjust/repair as needed.

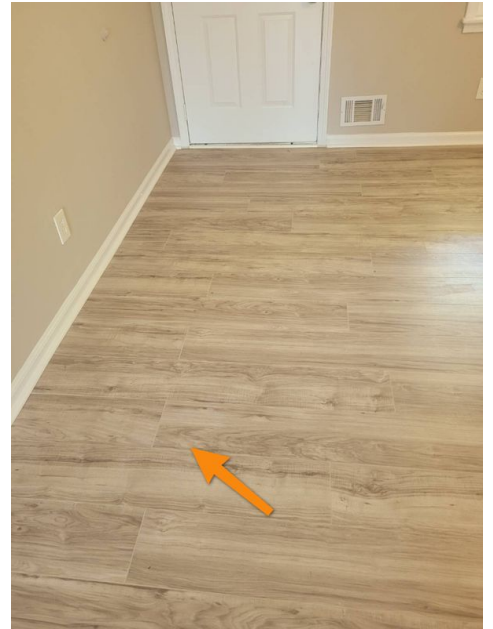
Flooring was soft and/or moved excessively when pressure was applied. This could be the result of deteriorated floor sheathing/structure, fastener failure, or foundation degradation.

Lifted flooring

Contact a qualified professional.

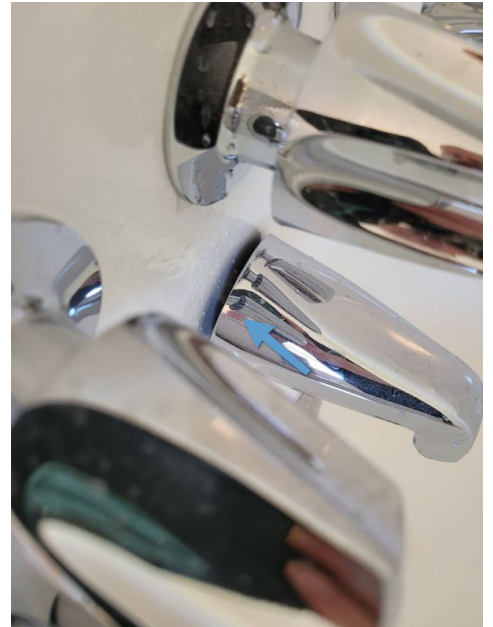
Multiple locations

Sealant maintenance is recommended around tubs, showers and sinks to prevent moisture intrusion.

Recommended DIY Project

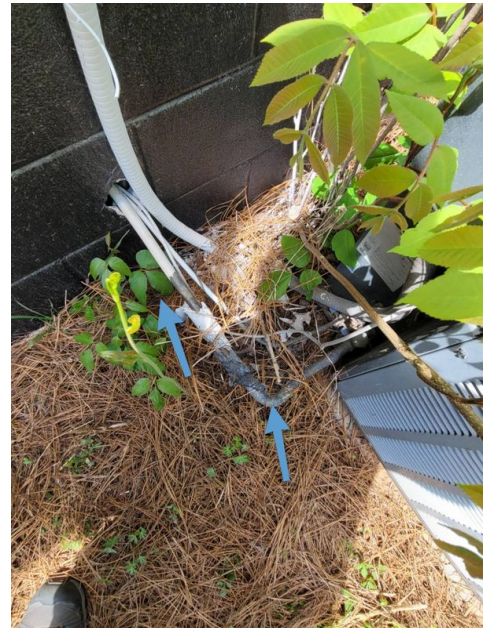
#### **INSULATION MISSING OR DAMAGED**

Refrigerant line insulation is missing and/or damaged. Missing or damaged insulation on refrigerant lines can cause energy loss and condensation buildup - leading to moisture intrusion. Recommend repair area of concern by owner or hvac contractor.

Contact a qualified HVAC professional.

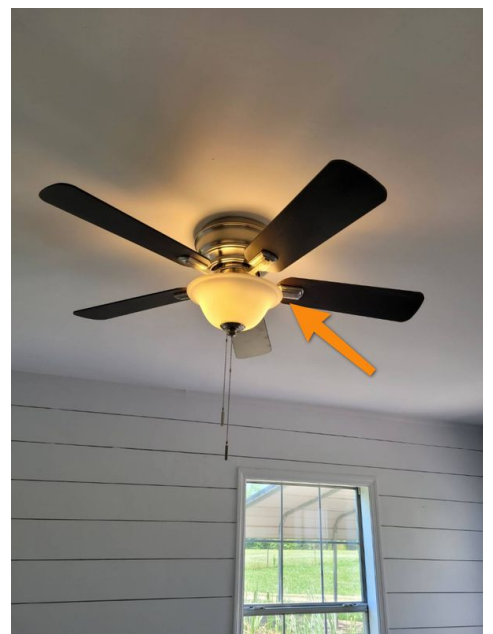
Master

The ceiling fan was inoperable at the time of the inspection. It might be operated by a remote control which was not found during the inspection.

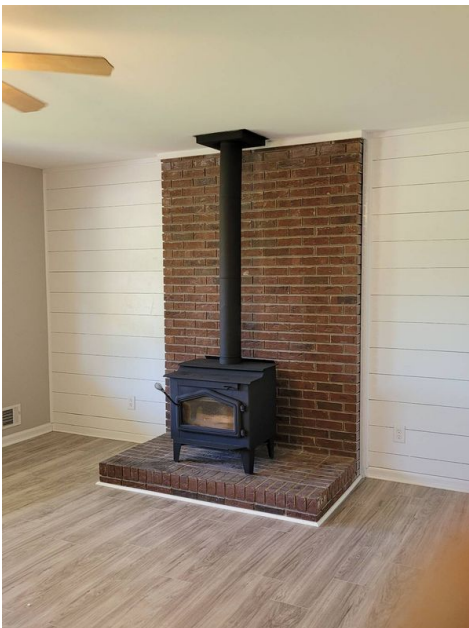
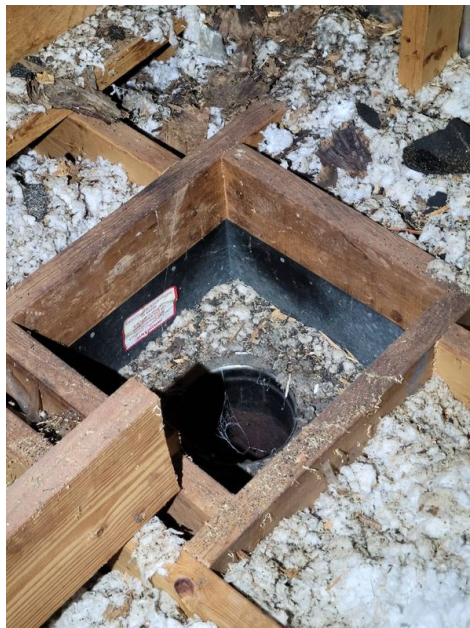
The wood burning stove was vented directly into the attic. This is a fire hazard and should be remedied immediately.

Contact a qualified professional.

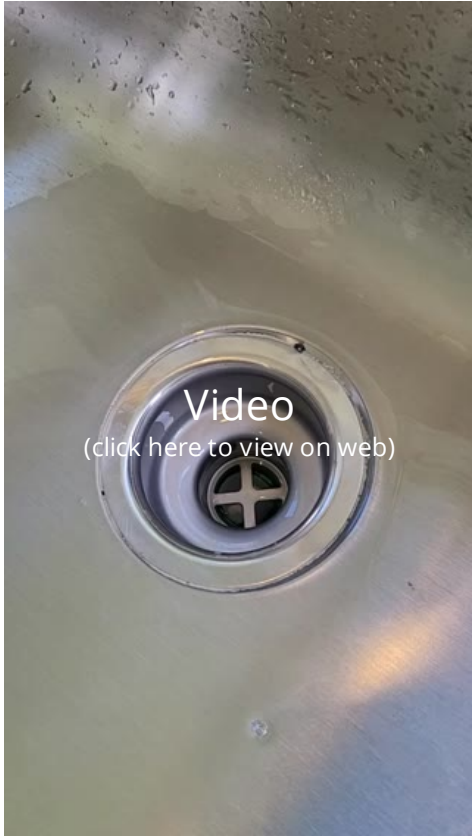
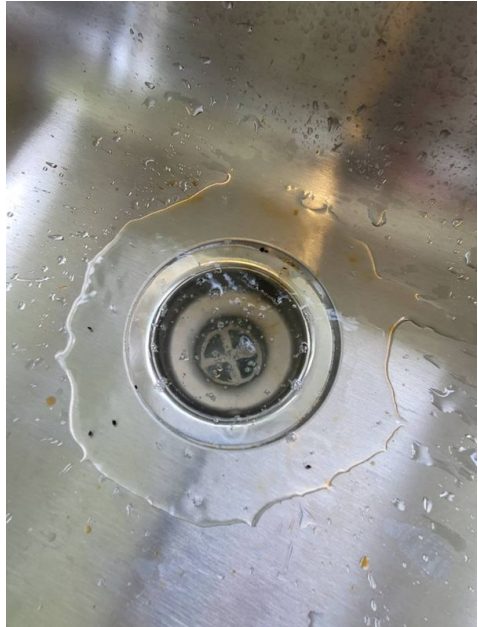
As dishwasher drains

One or more drain lines were clogged at the the time of inspection. Recommend a licensed plumber for further evaluation.

Contact a qualified plumbing contractor.

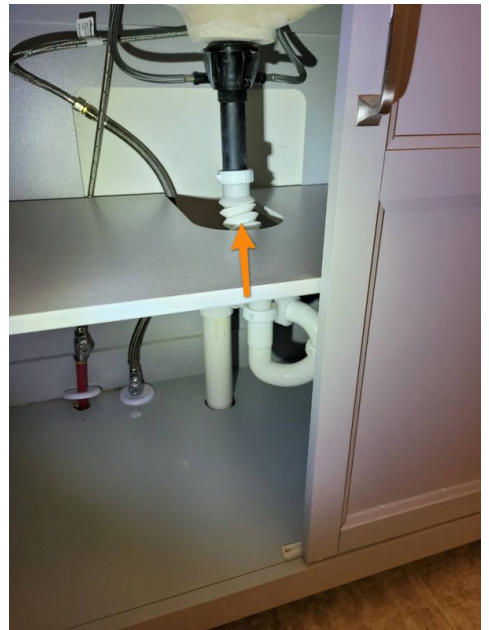
Multiple locations throughout

Ribbed, flexible drain pipe was used at one or more locations of the drain system. This type of drain pipe accumulates debris more easily than smooth wall pipe and is likely to clog. Recommend that a qualified plumber replace flexible piping with standard plumbing components (smooth wall pipe) to prevent clogged drains.

Contact a qualified plumbing contractor.

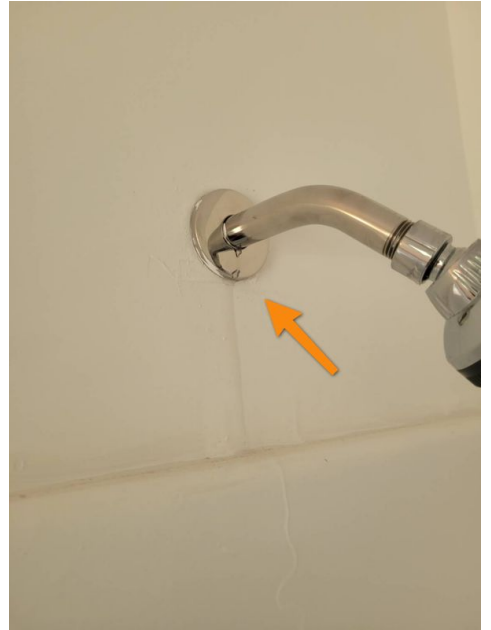
Front center bedroom attached bathroom

Moderate Item**DISTRIBUTION PIPE LEAKING**

Contact a qualified plumbing contractor.

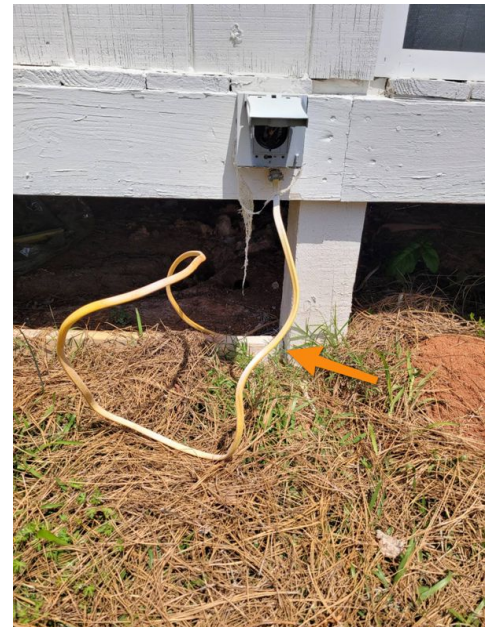
Back porch. Hot!

Contact a qualified electrical contractor.

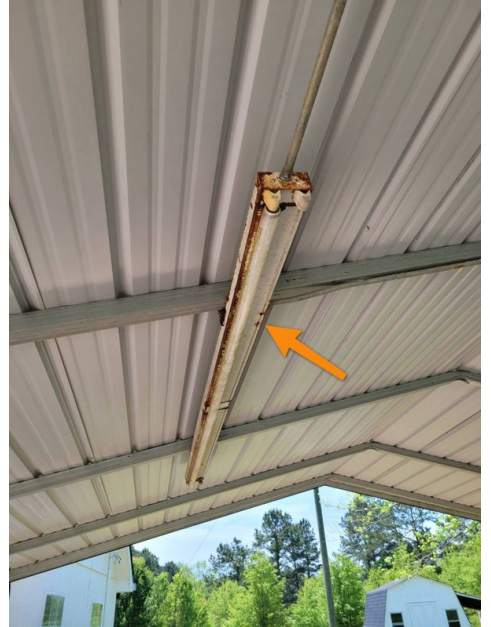
**LIGHT INOPERABLE**

Light fixture did not respond to the switch. The bulb may need to be replaced or there may be a problem with the switch, wiring or light fixture.

Both carport lights

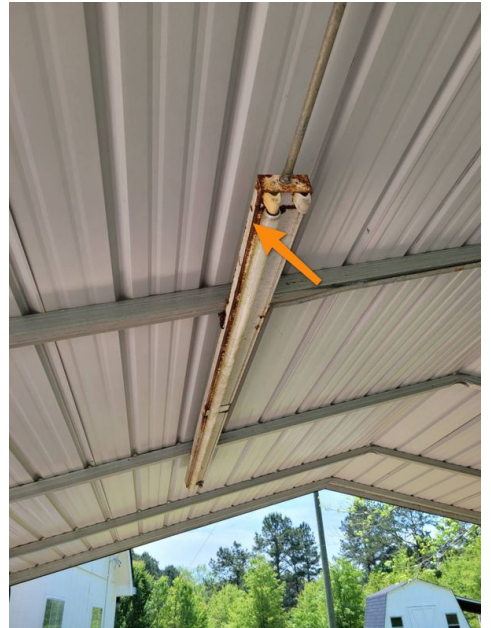
**DAMAGED/LOOSE LIGHT FIXTURE**

A light fixture showed visible damage or was not secure at time of inspection.

Rust on carport fixtures

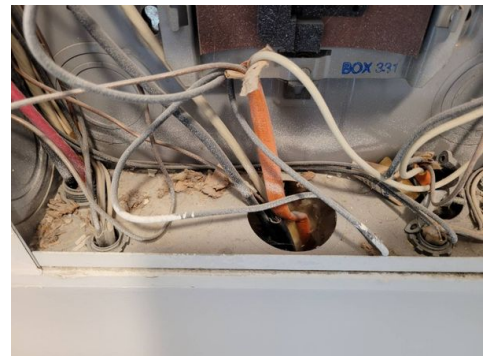
Multiple locations

### MISSING BUSHING

Missing bushings should be repaired by a licensed electrician.

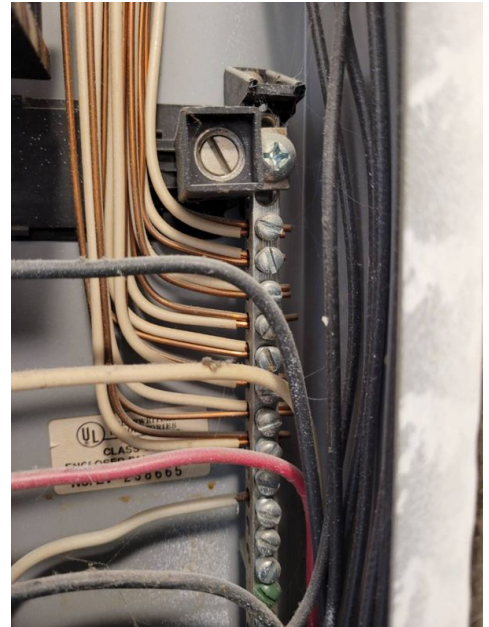
Multiple locations. Neutrals with ground under same lug

Contact a qualified electrical contractor.

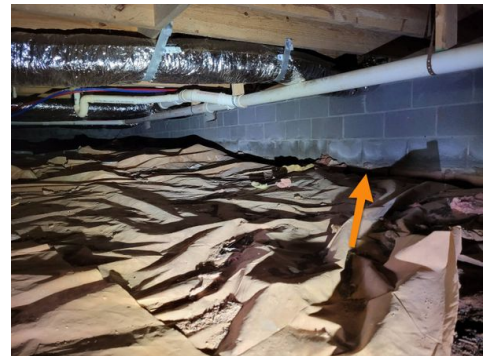
Multiple locations

Water intrusion was evident on the surface of the floor slab or in the basement/crawlspace. This can compromise the soil's ability to stabilize the structure and could cause damage.

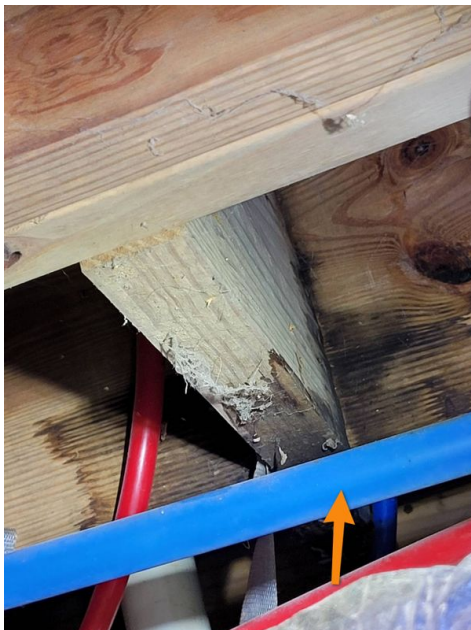
There were signs of water intrusion in the underlying floor structure.

Multiple locations. Previous water damage

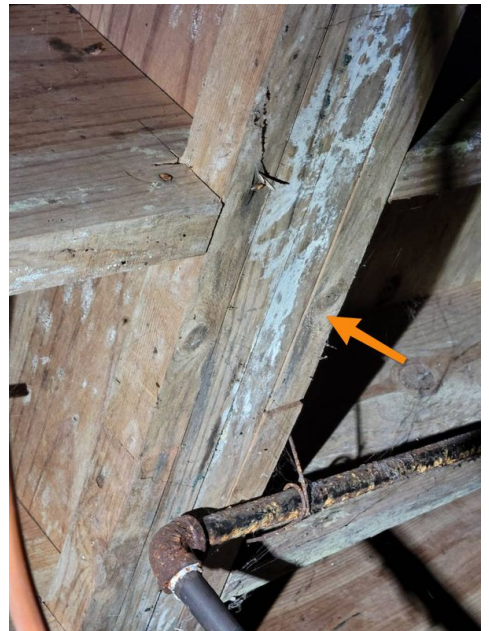
Multiple locations

Observed signs of mold or mildew in one or more areas of the structure.

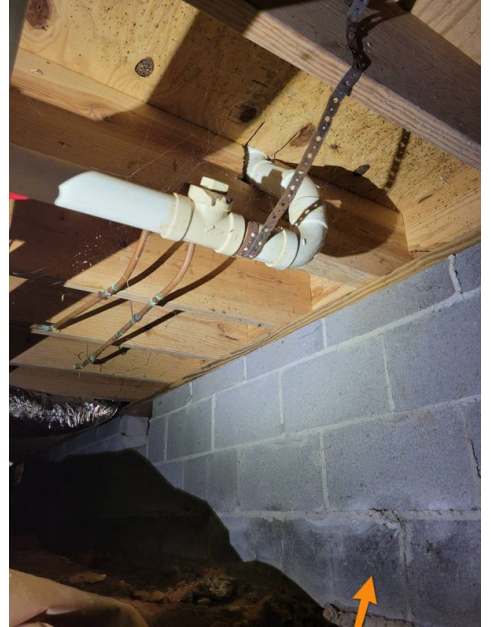
Multiple locations

Efflorescence noted on the basement or crawl space surfaces.
