# COOK'S HOME INSPECTIONS

## HOME INSPECTION REPORT

1234 Main Street  
Jonesboro, AR 72404

10/12/2025 9:00AM

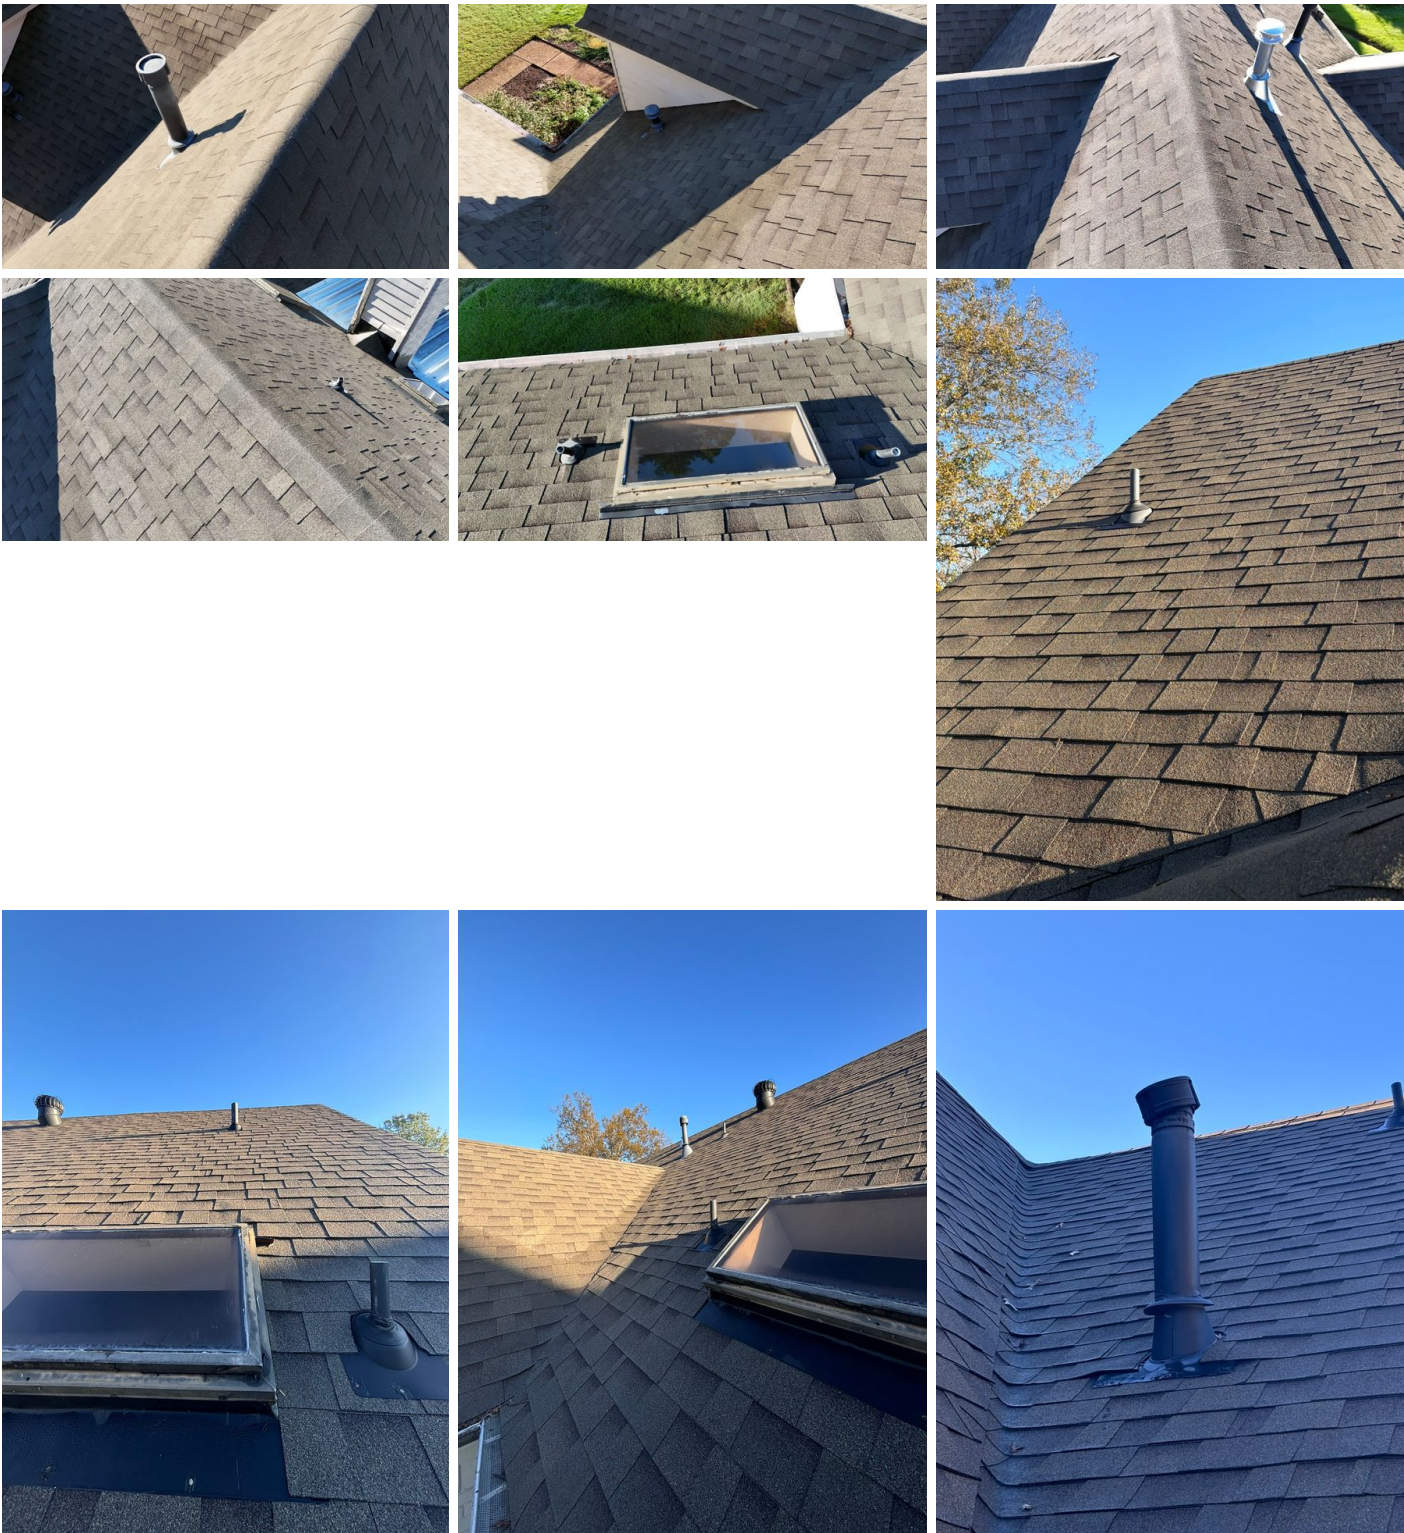
Skylight: Sealant Degraded - Minor

Ceiling around skylight was noted a slightly degraded. No leaking was noted inside the home. Recommend monitoring and repairing as needed.

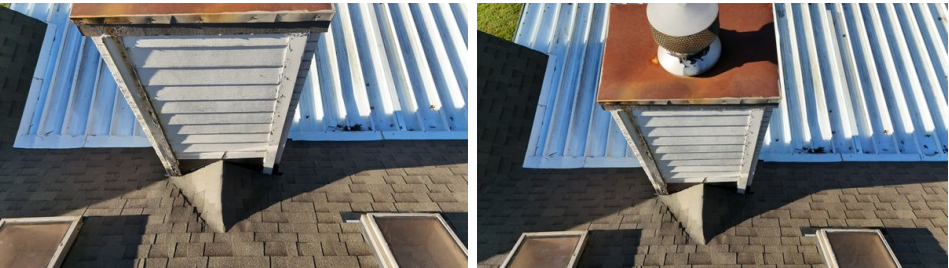
One or more areas of the siding on the chimney was noted as degraded which can allow water intrusion. Recommend repair or replace siding.

Recommendation  
Contact a qualified siding specialist.

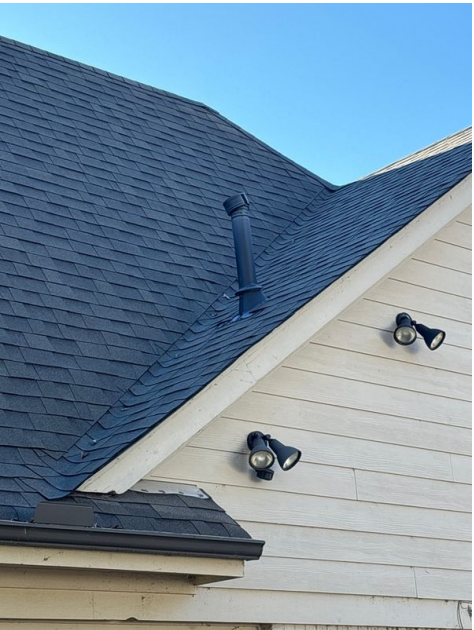
The gas flue pipe for the hot water heater had a damaged cap.

Recommendation  
Contact a qualified professional.

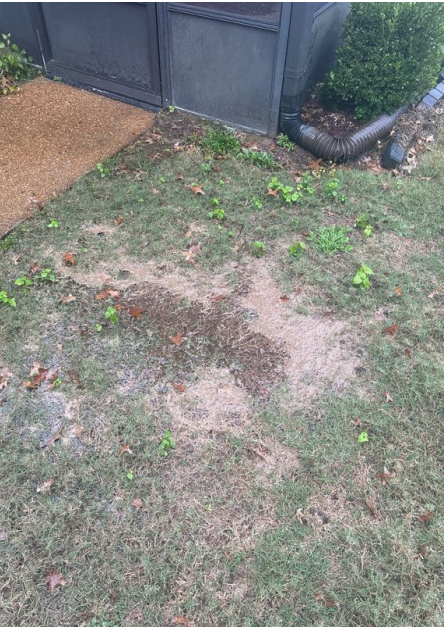
**Vegetation, Grading, Drainage & Retaining Walls (With respect to their effect on the condition of the building): Drainage Towards Home**

Drainage was noted towards home. Negative draining could cause moisture buildup in crawlspace/basement. Recommend monitoring for problems.

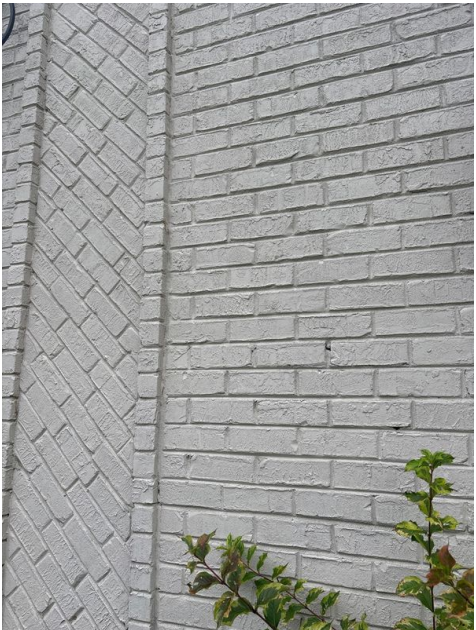
Siding, Flashing & Trim

**PAINTED BRICK**

Because the brick is painted, it makes it hard to see deficiencies in the mortar and the brick.

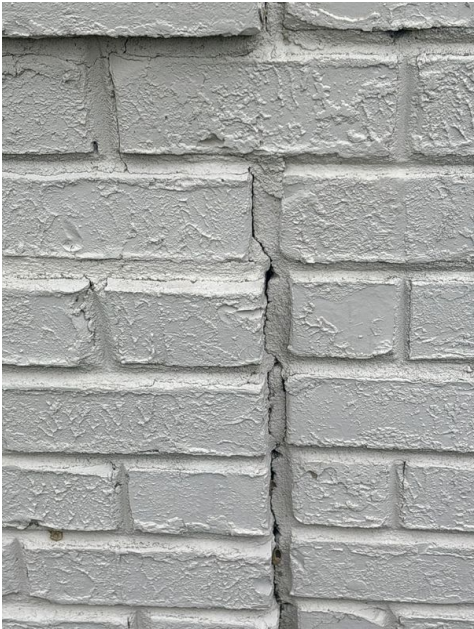
3.1.1 Siding, Flashing & Trim

**MORTAR DEGRADED**

Mortar degradation noted in brick veneer siding which could allow for moisture intrusion. Recommend correction by repair/fill failing mortar.

Contact a qualified masonry professional.

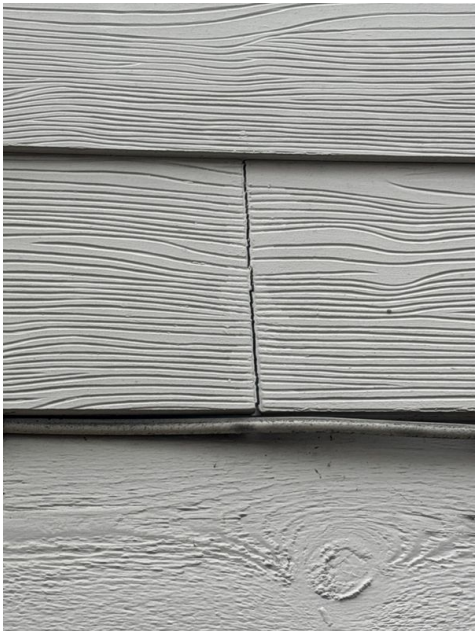
3.1.5 Siding, Flashing & Trim

**SIDING DAMAGED**

There was moisture damage around the dormer windows where the siding meets the roofline.

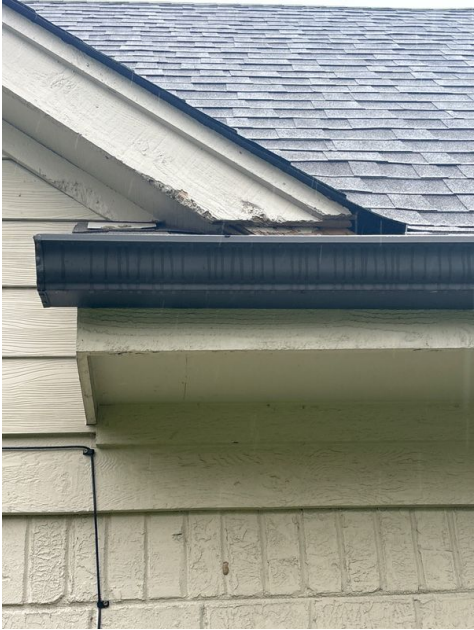
It appears that something has been chewing on the side of the fascia on the house. Recommend painting and mitigating the pest intrusion

Recommendation  
Contact a qualified professional.

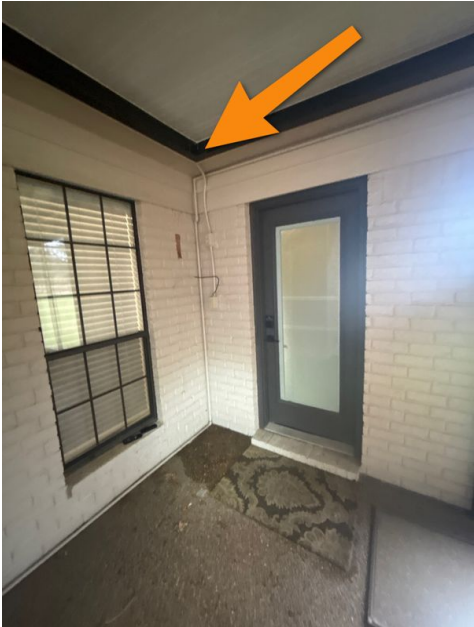
3.5.1 Decks, Balconies, Porches & Steps

**LEAK IN THE COVERED PORCH**

A leak in the covered porch was identified right next to the exterior door. This could lead to moisture damage between the covered porch and house fascia.

Recommendation  
Contact a qualified professional.

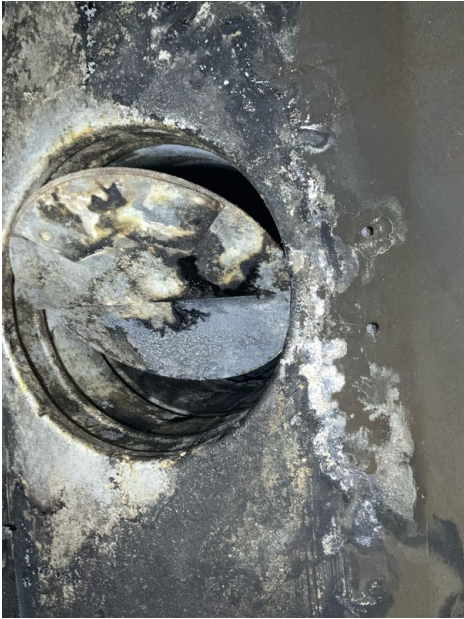
**Fire place: Photos**

Fire place: Gas fireplace place

House contained a wood-burning fireplace that had been converted to gas. Recommend having fireplace inspected and cleaned a chimney sweep prior to use.

It is recommended that the fireplace be cleaned and serviced by a licensed chimney sweep.

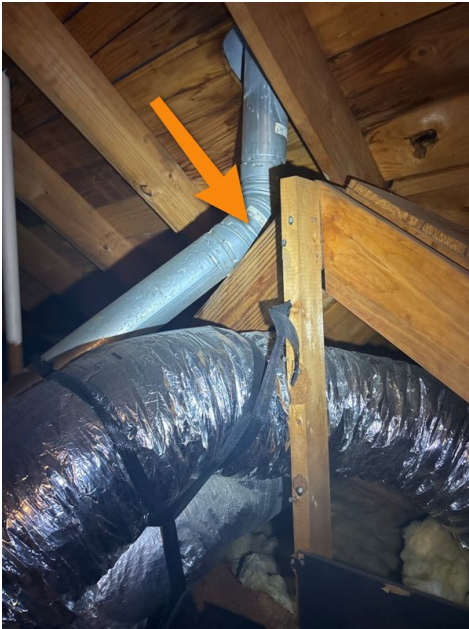
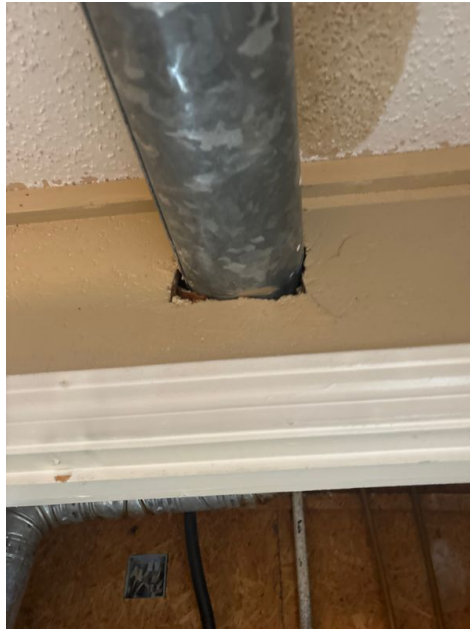
5.1.1 Exhaust Systems

Dryer exhaust was noted as clogged in noted area which can cause lint and humidity buildup in dryer and home. Recommend cleaning and monitor for proper function.

Contact a qualified professional.

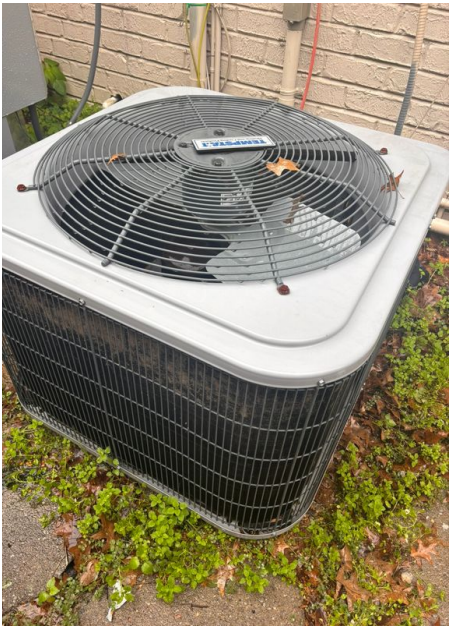
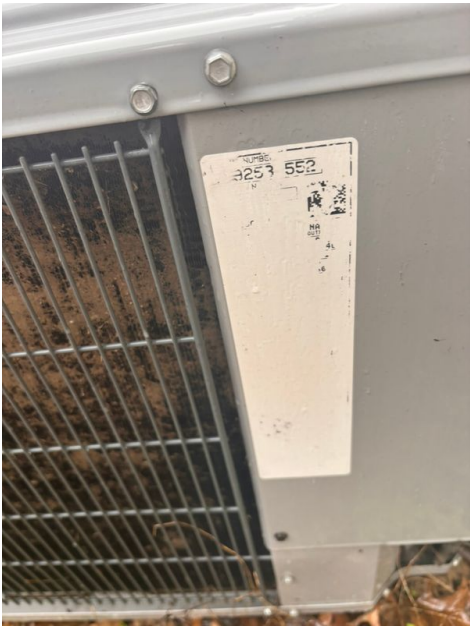
HVAC Heat Pump Equipment: Estimated Condenser Age 1  
0 years

Unknown age of condenser unit as the data plate had deteriorated.

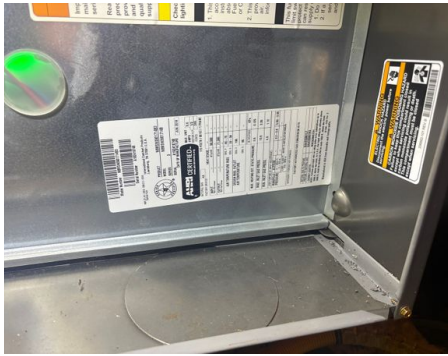
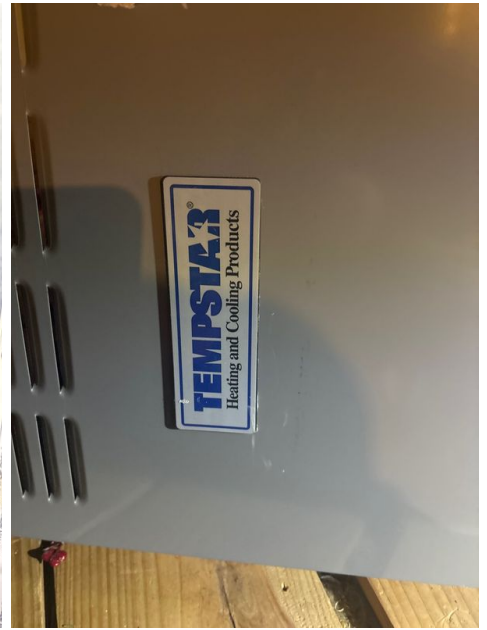
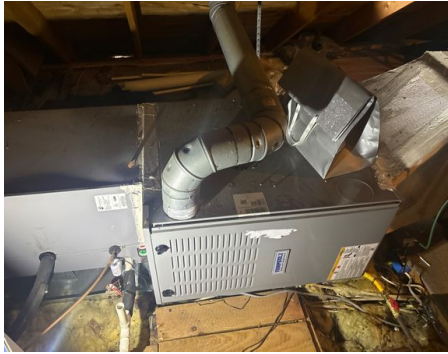
**HVAC Heat Pump Equipment: Estimated Air Handler / Evaporator Age 1**

5 years

Standard industry recognized 12-15 years lifespan.

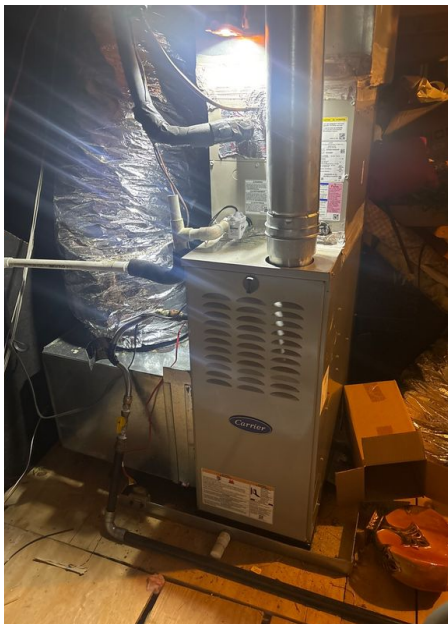
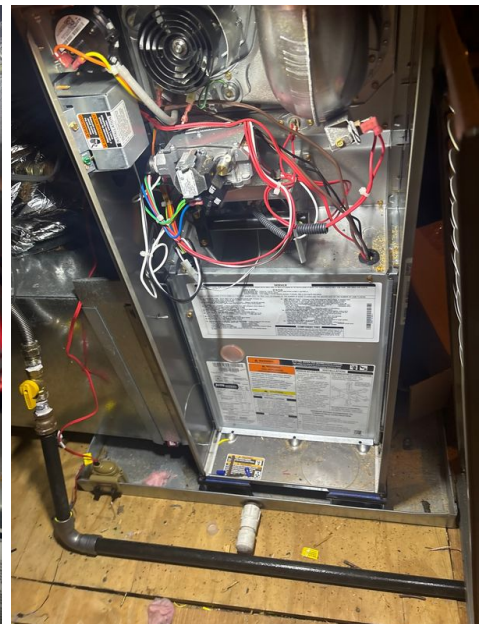
**HVAC Heat Pump Equipment: Estimated Air Handler / Evaporator Age 2**

2 years

Standard industry recognized 12-15 years lifespan.

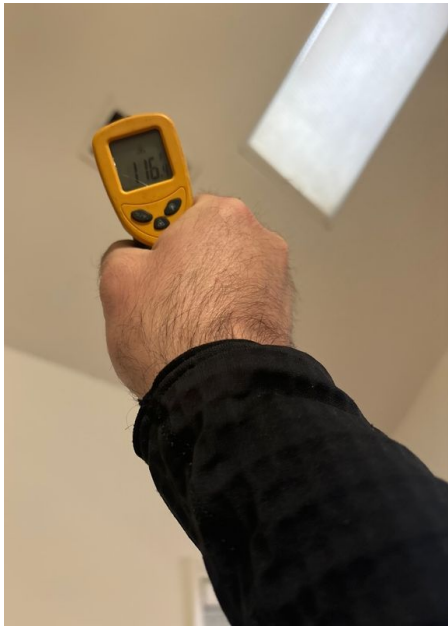
### Normal Operating Controls: Heating Temperature (Furnace) - Satisfactory

Temperature was taken from noted source using an IR thermometer; both source and ambient temps are measured. Temps are within norms. Temps from register should be within at least 20 degrees or higher from ambient room temps.

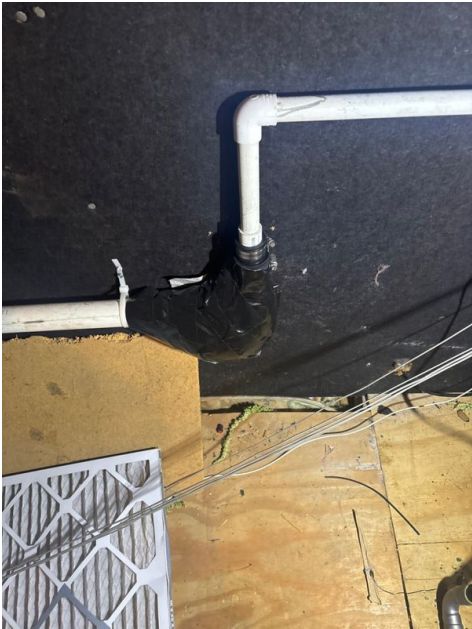
### CONDENSATE LINE DAMAGED

Condensate line was damaged in noted areas, which can discharge moisture inside home or crawlspace. Recommend correction by repairing or installation of a new line to properly discharge water outside.

Contact a qualified handyman.

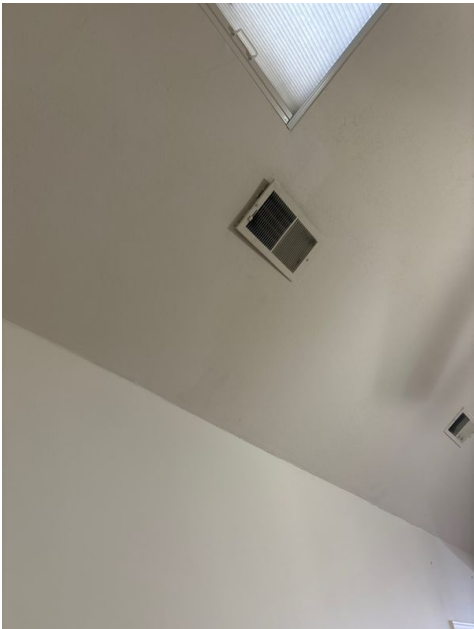
6.5.1 Heating & Cooling Source

**REGISTER LOOSE**

Register was noted as loose. Recommend correction by properly installing register.

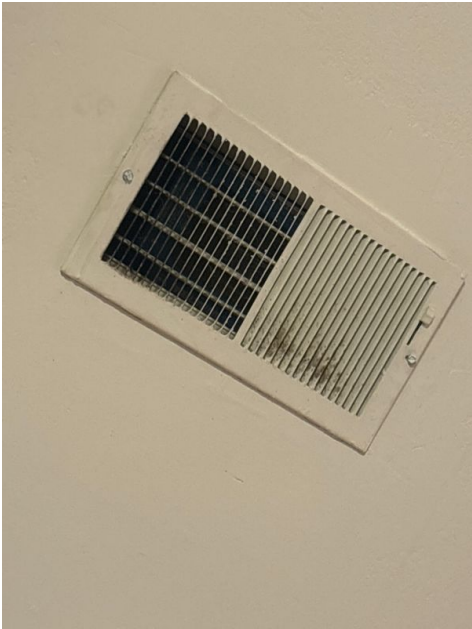
6.5.2 Heating & Cooling Source

The AC and heating registers show signs of dirt recommend cleaning the ductwork.

Contact a qualified professional.

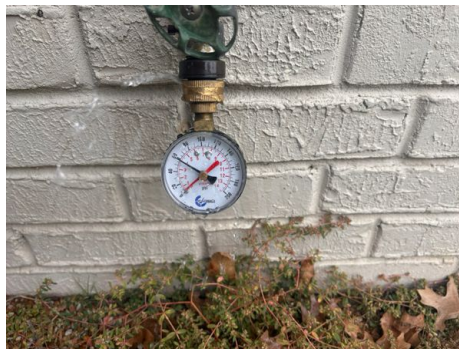
#### Water Supply, Distribution Systems: Water Pressure

@ exterior valve, 60 psi.

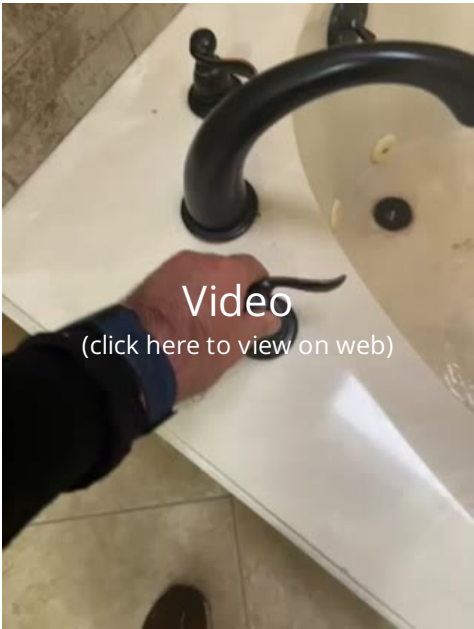
7.4.1 Shower, Tubs & Sinks

HARDWARE DEGRADED

Hardware was noted degraded at time of inspection. Shower nozzle is not secured and is pulled out from liner upon use. Recommend further evaluation and repair or replace.

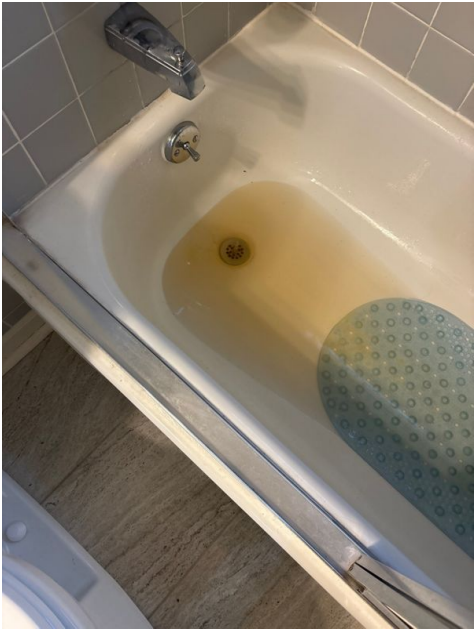
7.4.4 Shower, Tubs & Sinks

**FIXTURE LEAKS**

Shower knob leaks

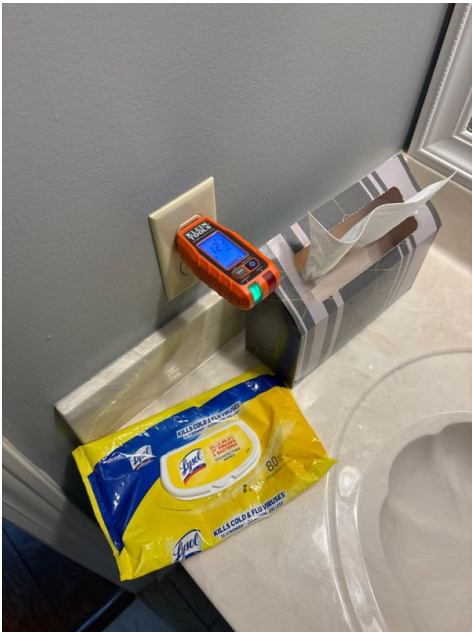
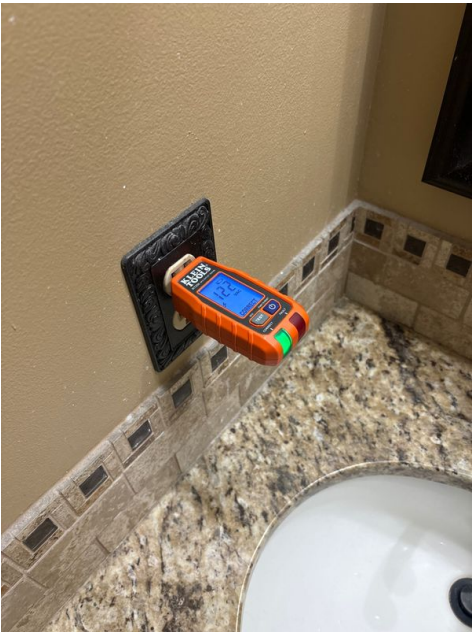
8.5.4 Receptacles (All Accessible)

**NO GFCIS IN BATHROOM AND KITCHEN**

One or more of the interior receptacles was not GFCI protected in the bathrooms and kitchen. Recommend installation in noted areas and can be achieved by any one of the methods below:  
1. Replacing an individual standard receptacle with a GFCI receptacle. 2. Replacing the electrical circuit receptacle located closest to the overcurrent protection device (usually a breaker) with a GFCI receptacle. 3. Replacing the breaker currently protecting the electrical circuit that contains the receptacles of concern with a GFCI breaker.  
Here is a link to read about how GFCI receptacles keep you safe.  
Recommendation  
Contact a qualified professional.

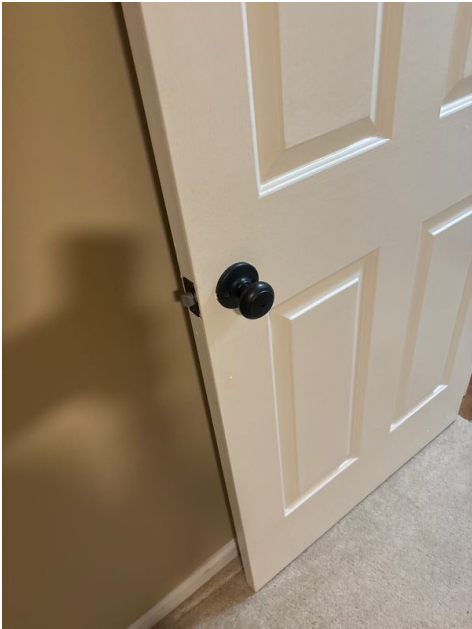
9.3.1 Doors

DOOR DOES NOT LOCK

Contact a qualified professional.

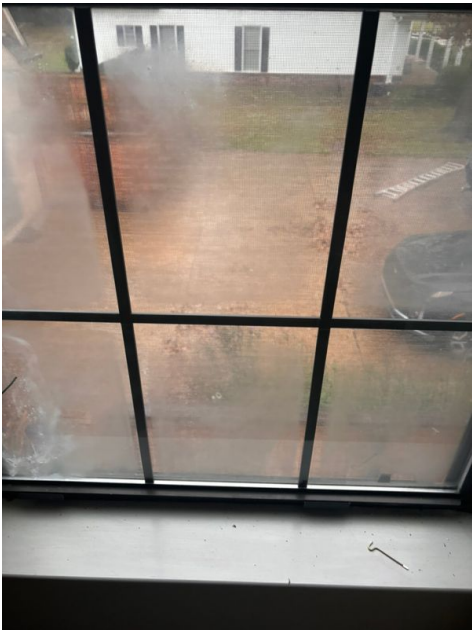
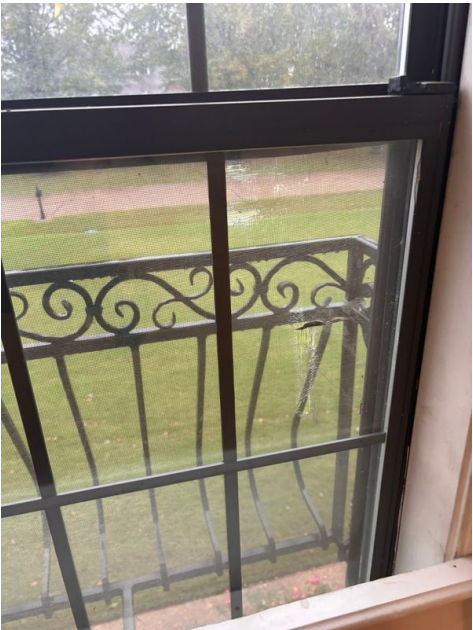
9.4.1 Windows

**AGING WINDOWS**

Contact a qualified window repair/installation contractor.

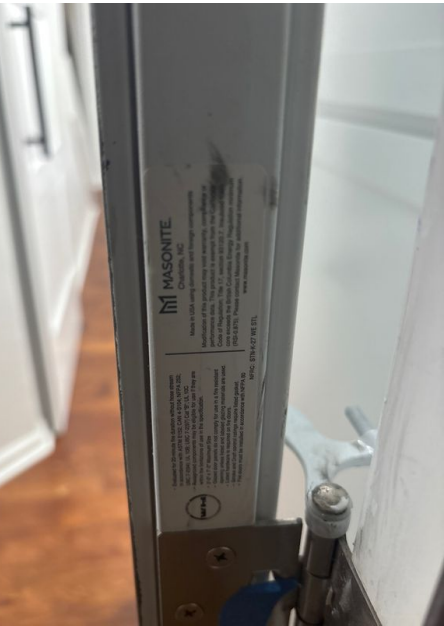
**Occupant Door (From garage to inside of home): Door - Satisfactory**

Door was a proper solid door and has seals on bottom which delays spread of fire and limits CO to interior of home.
