# Million\$ to be Saved Through Insulation Optimization

# Corrosion Under Insulation (CUI)

# Thick Film Insulation Coating

# Thin Film Insulation Coating

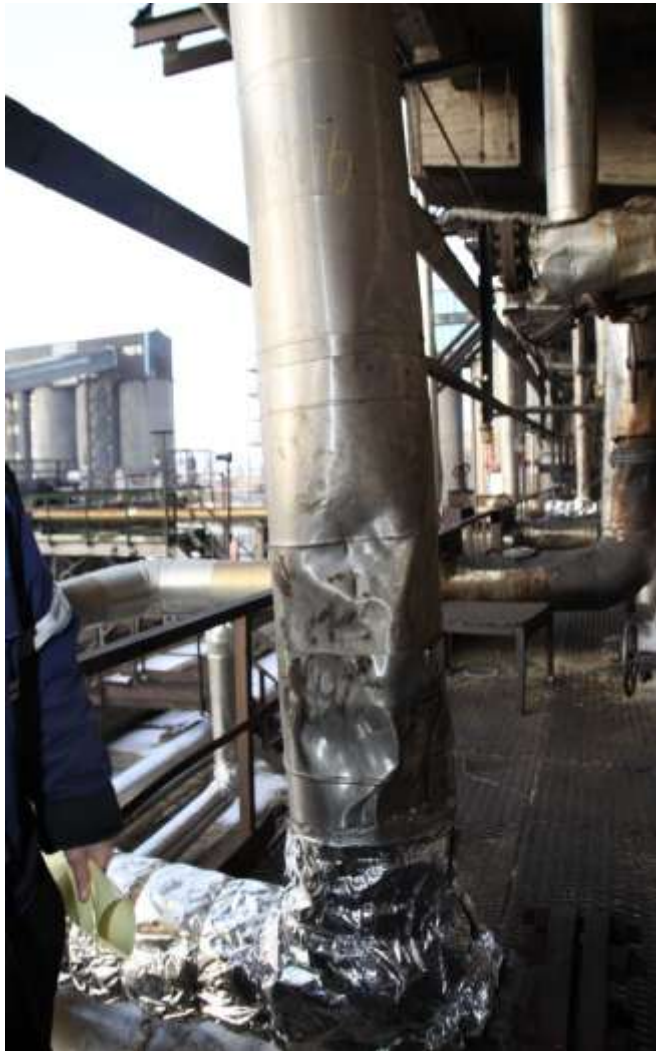
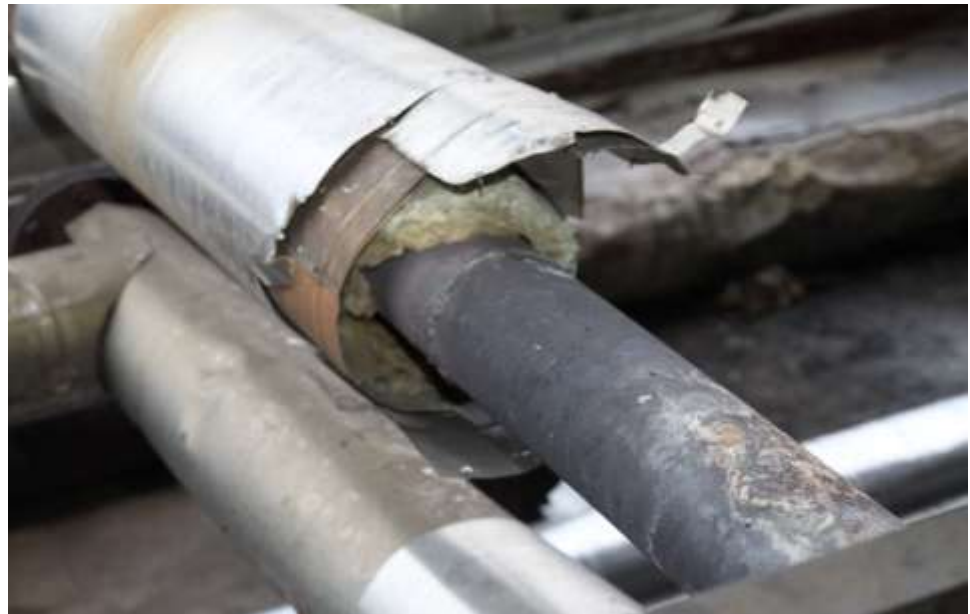
# Conventional Pipe Insulation

How it works:

- Uses small pockets of air that only slow conductive heat transfer.
- Heat will be absorbed and transferred to the cooler side, at an accelerated rate.

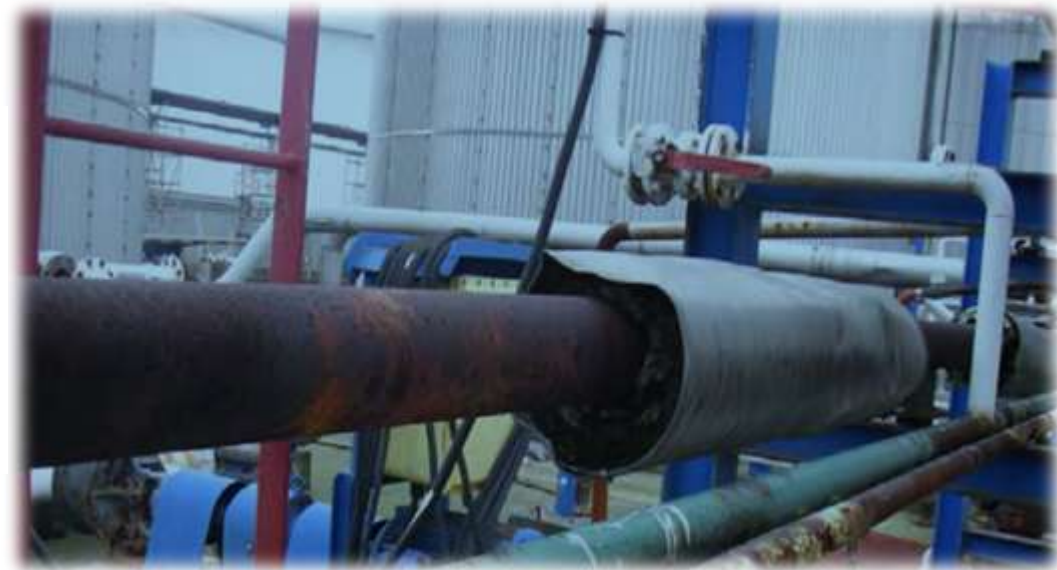
Rockwool, fiberglass, or other traditional types of insulation promote corrosion, and also act as a carrier and spread the corrosion to other areas of the pipeline

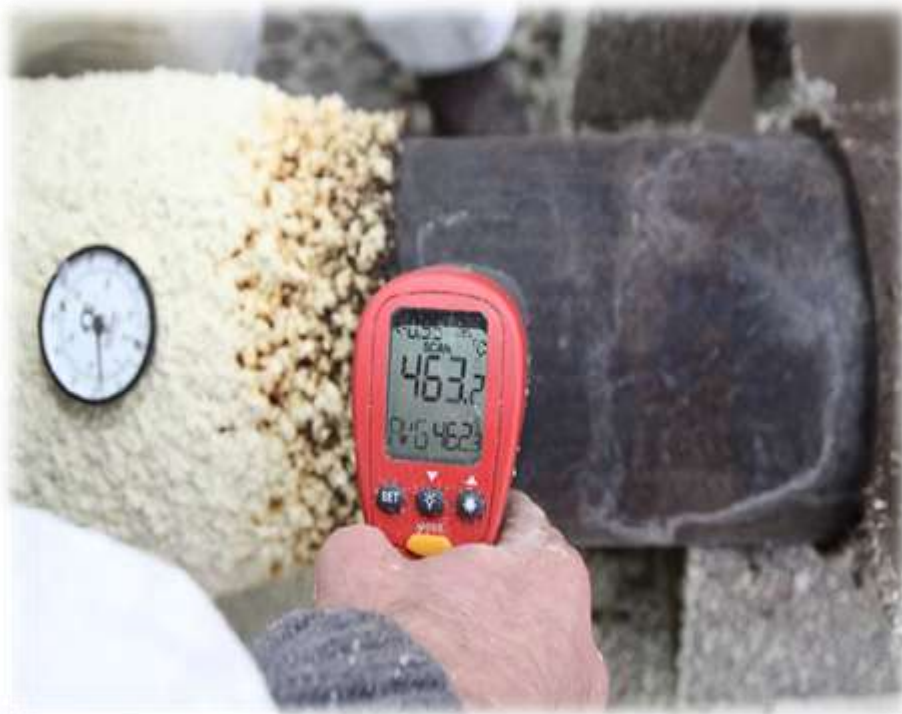
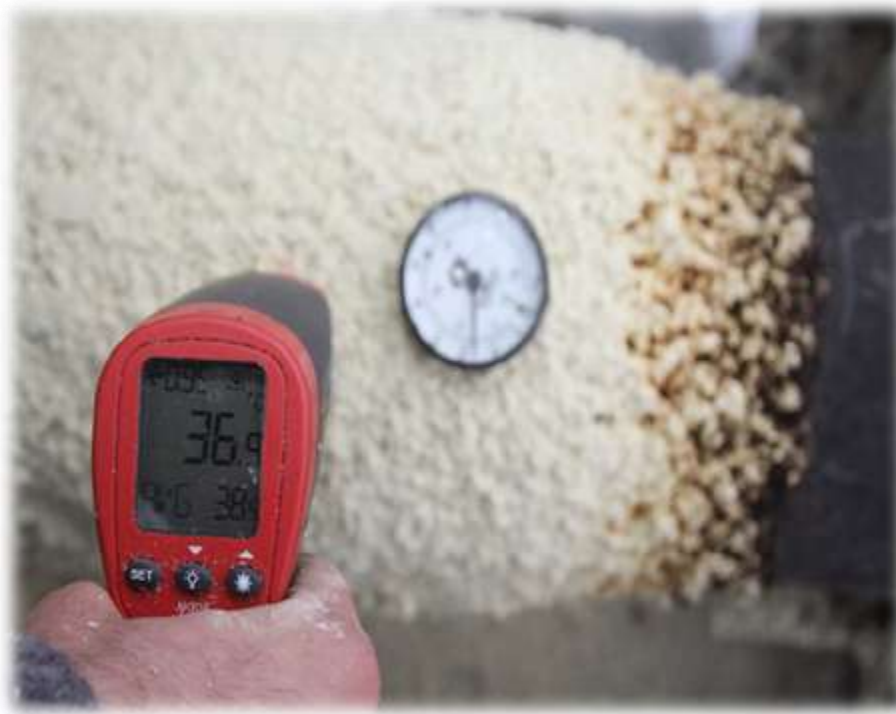
# Before & After

BEFORE => AFTER

463C Bare Pipe Temp. => 36C Skin Temp  
Applied at 30mm – No Shutdown

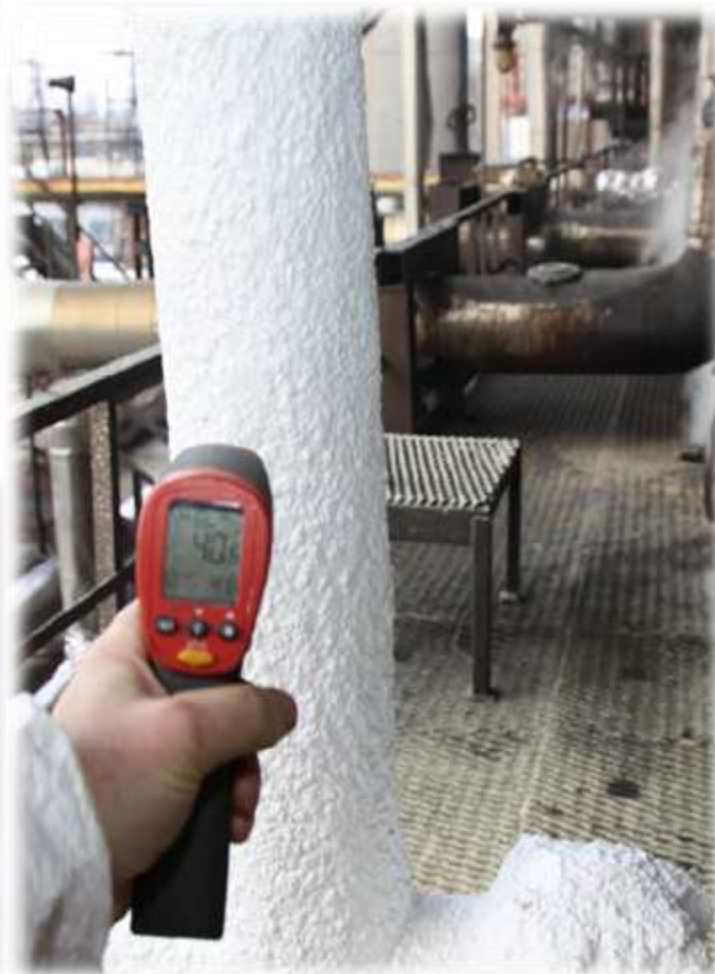
30MM Thickness

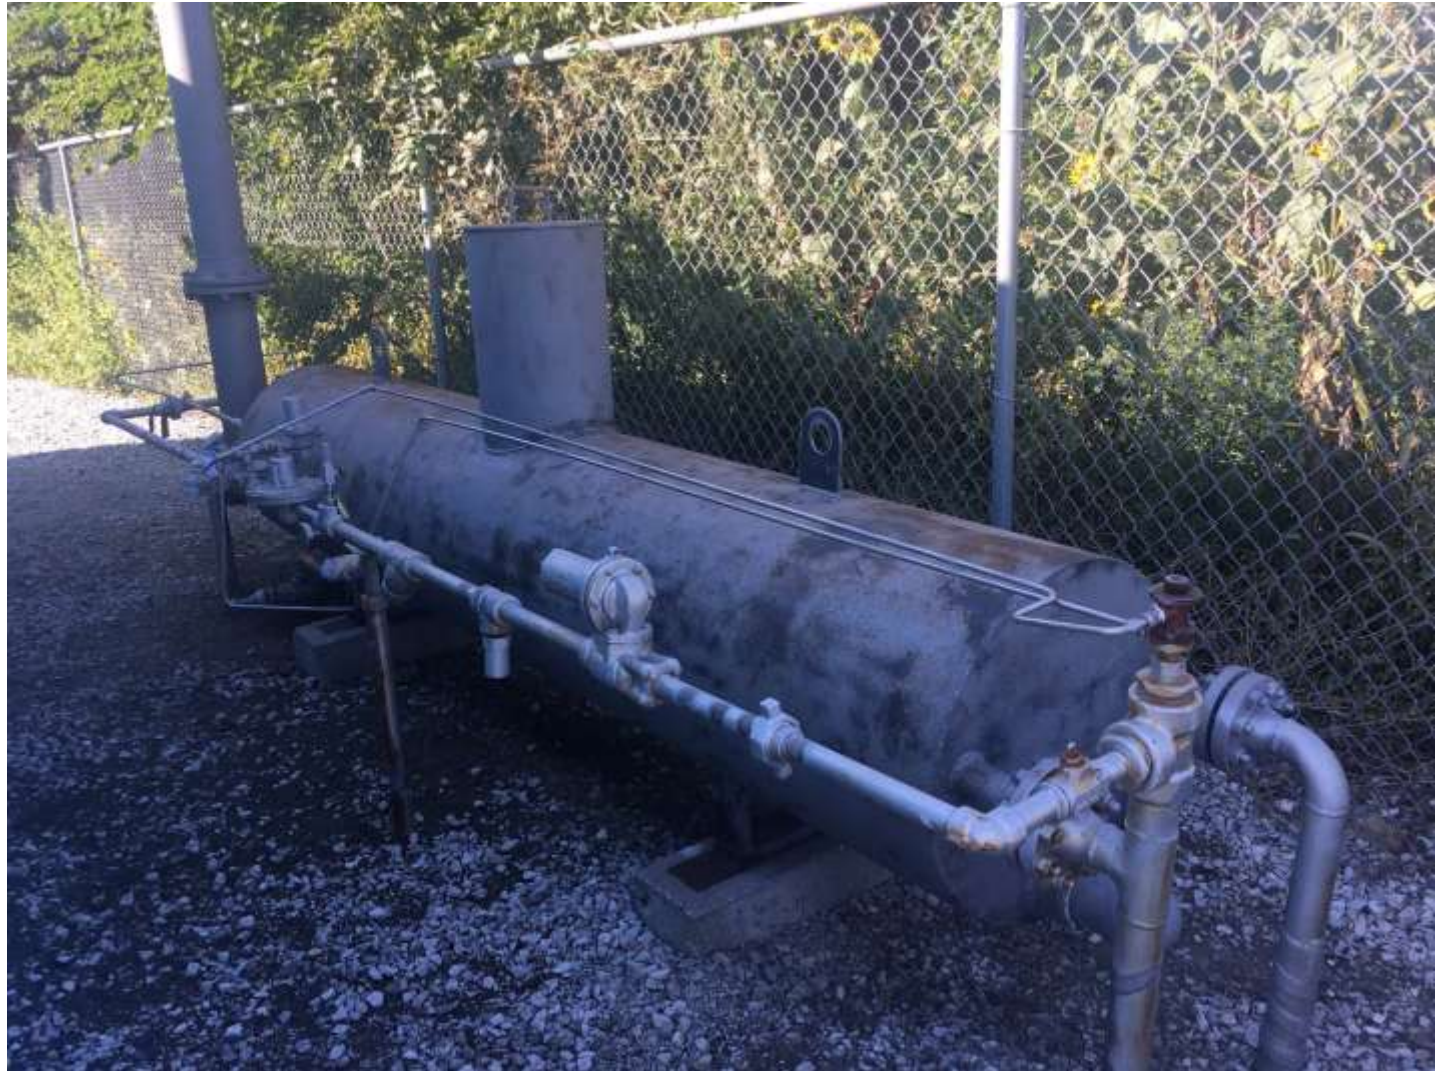
Coating  
application:

Picture  
taken after  
NACE 4  
surface  
preparation.

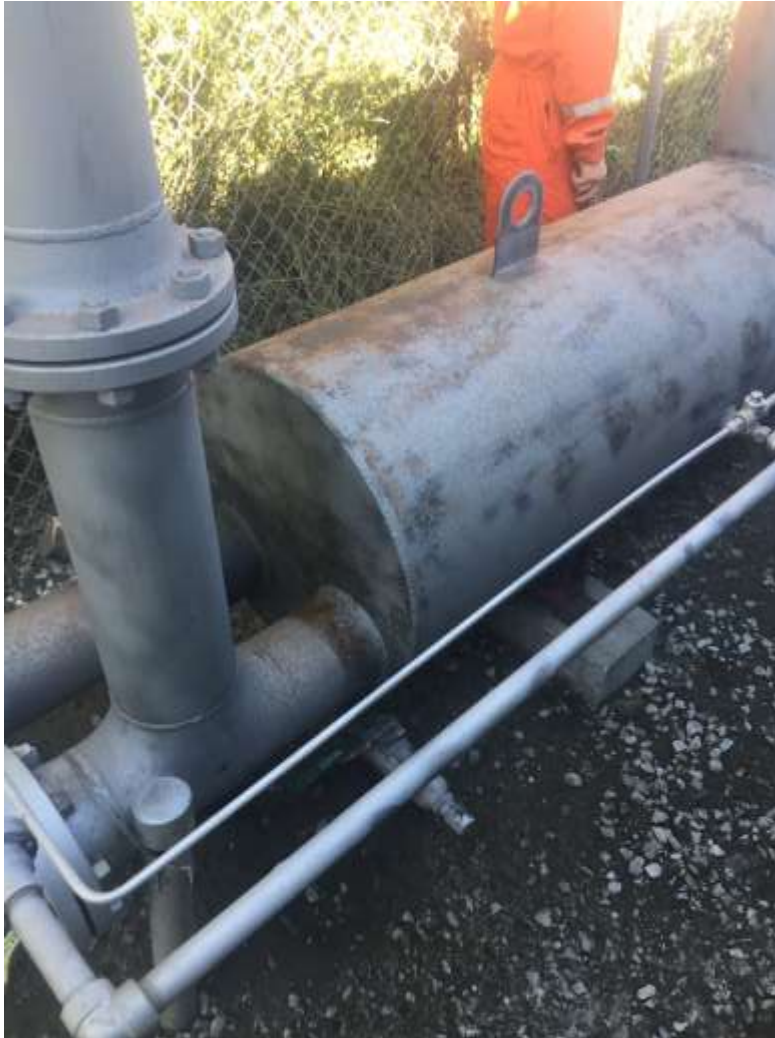
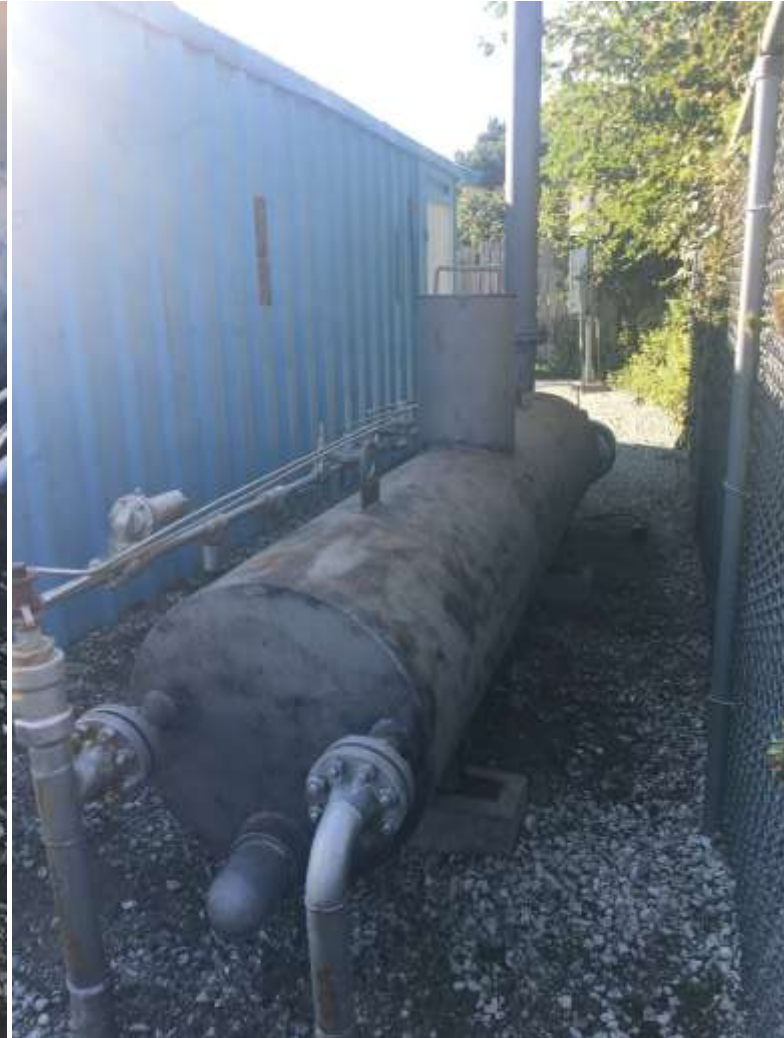
Coating  
application:

Picture  
taken after  
NACE 4  
surface  
preparation.

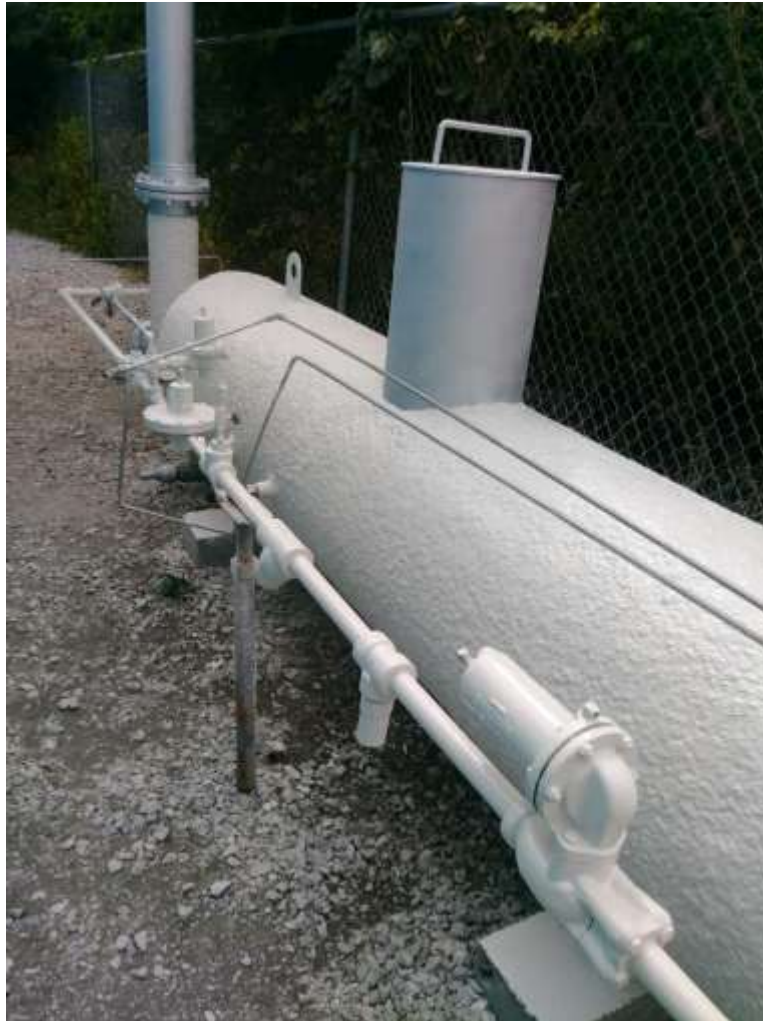
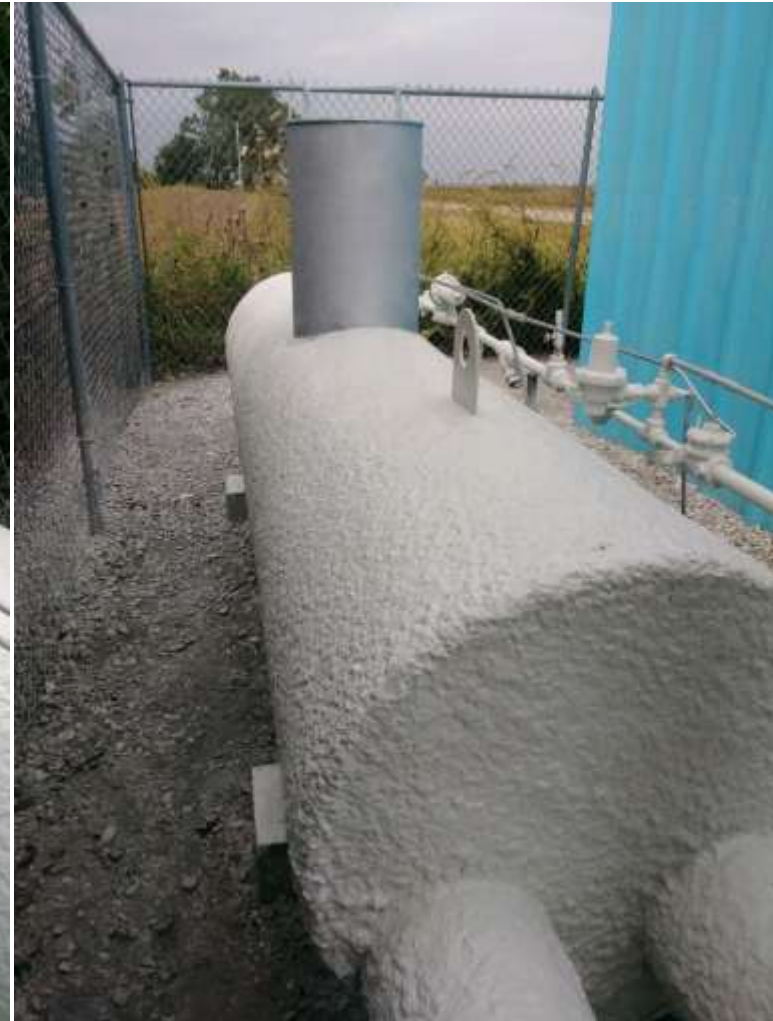
AFTER:

Insulation  
coating  
application

Polyurethane  
top coat

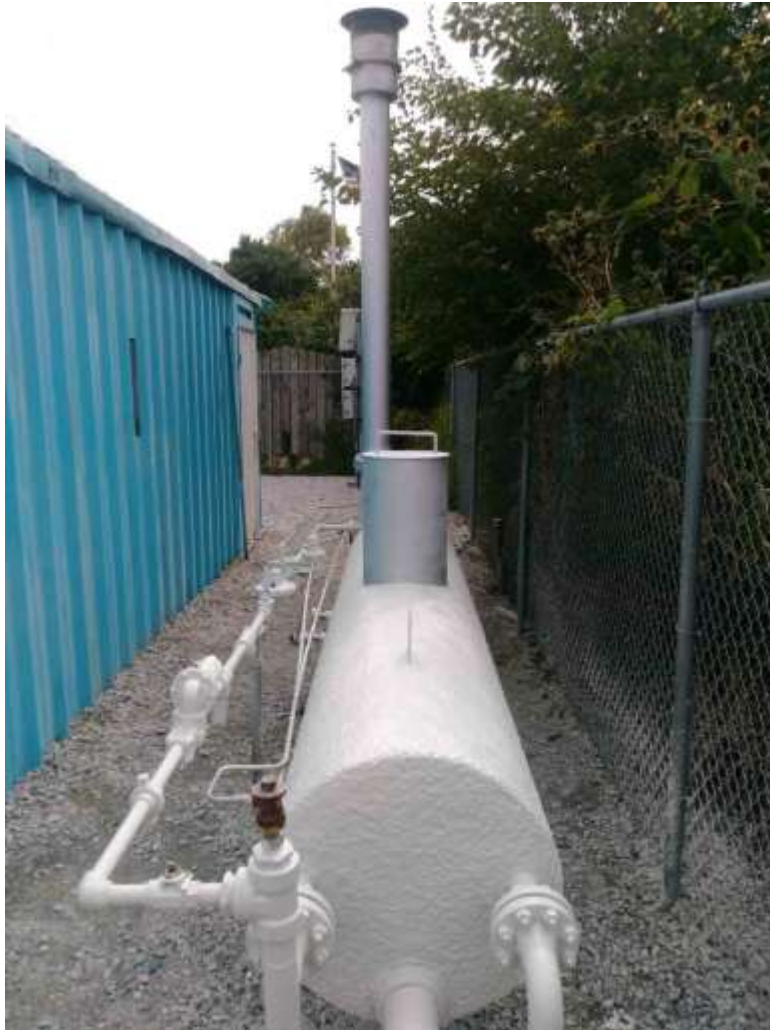
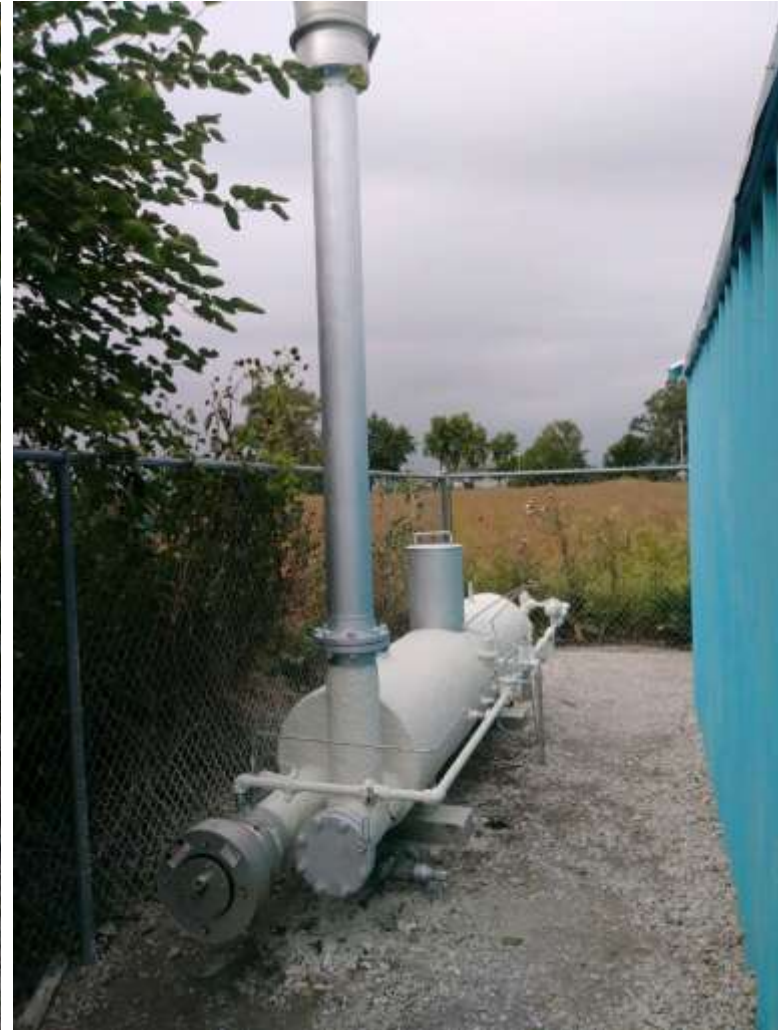
AFTER:

Insulation  
coating  
application

Polyurethane  
top coat

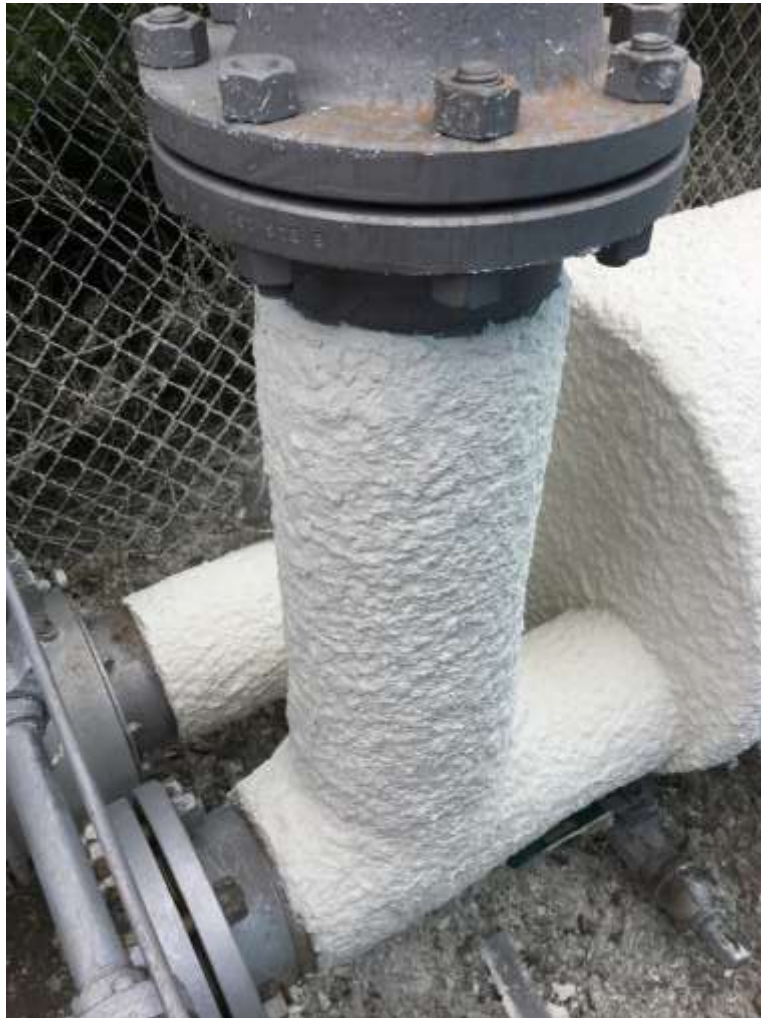
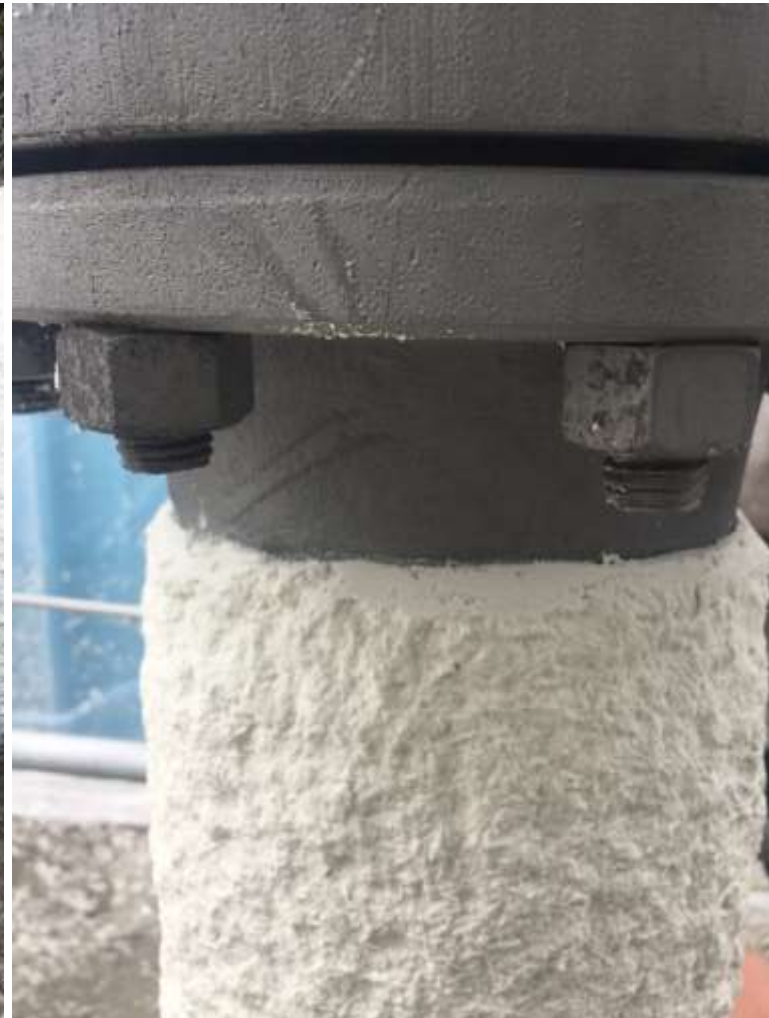
Angled profiles  
using handheld  
razor to  
discourage  
ponding water

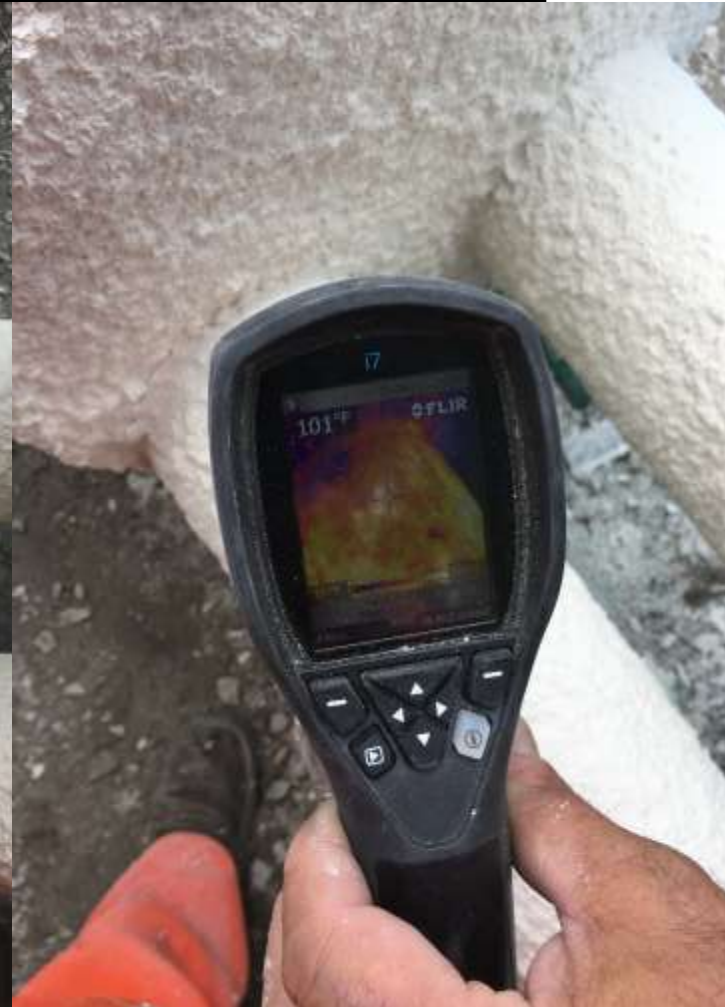
Before: 174 F

After: 204 F

Skin Temperature: 101 F

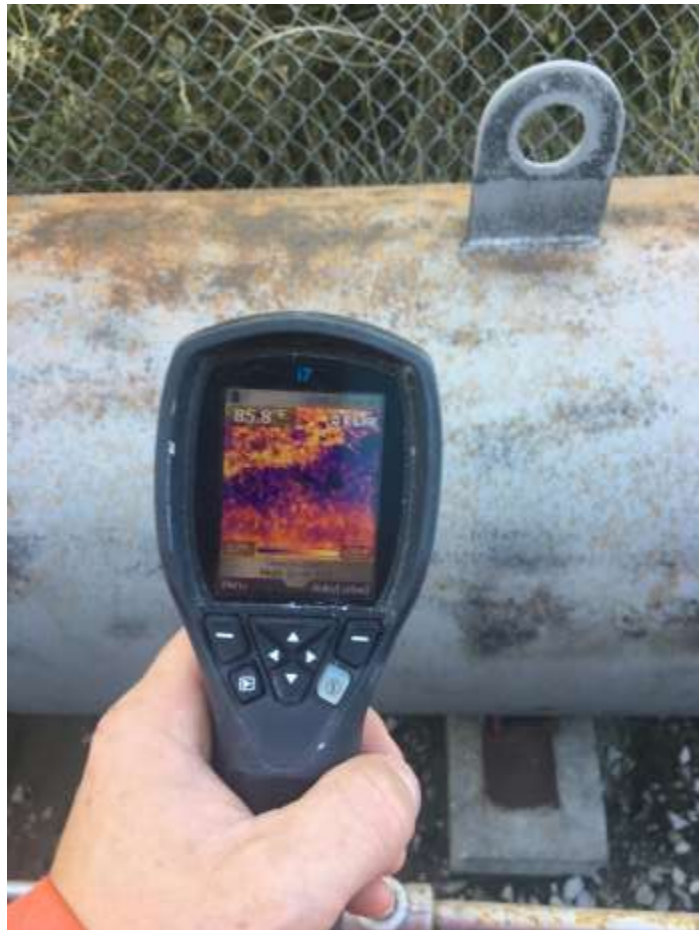
Before: 85F

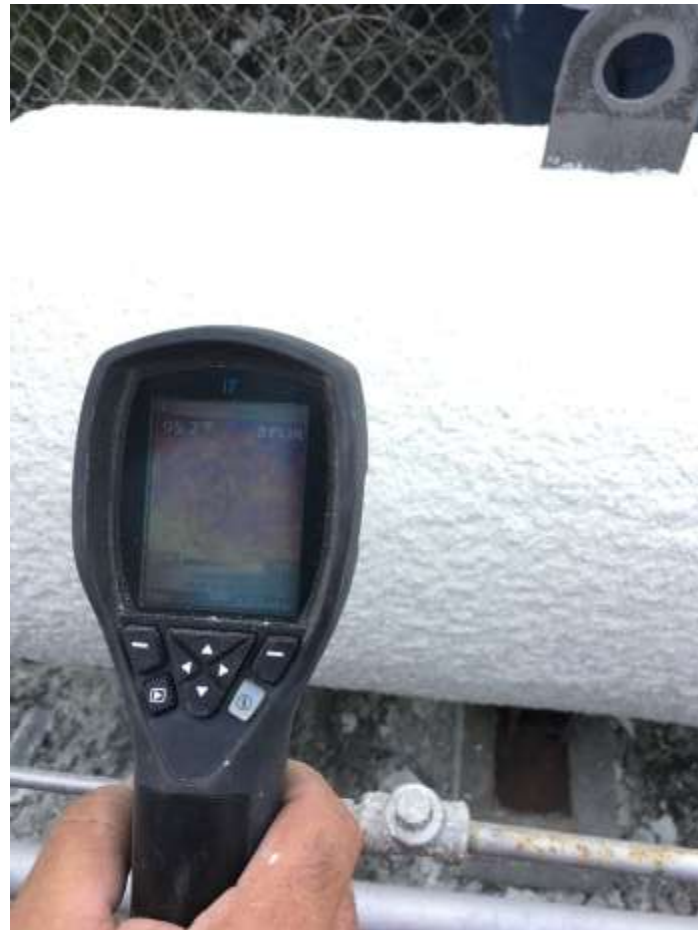
After: 95F

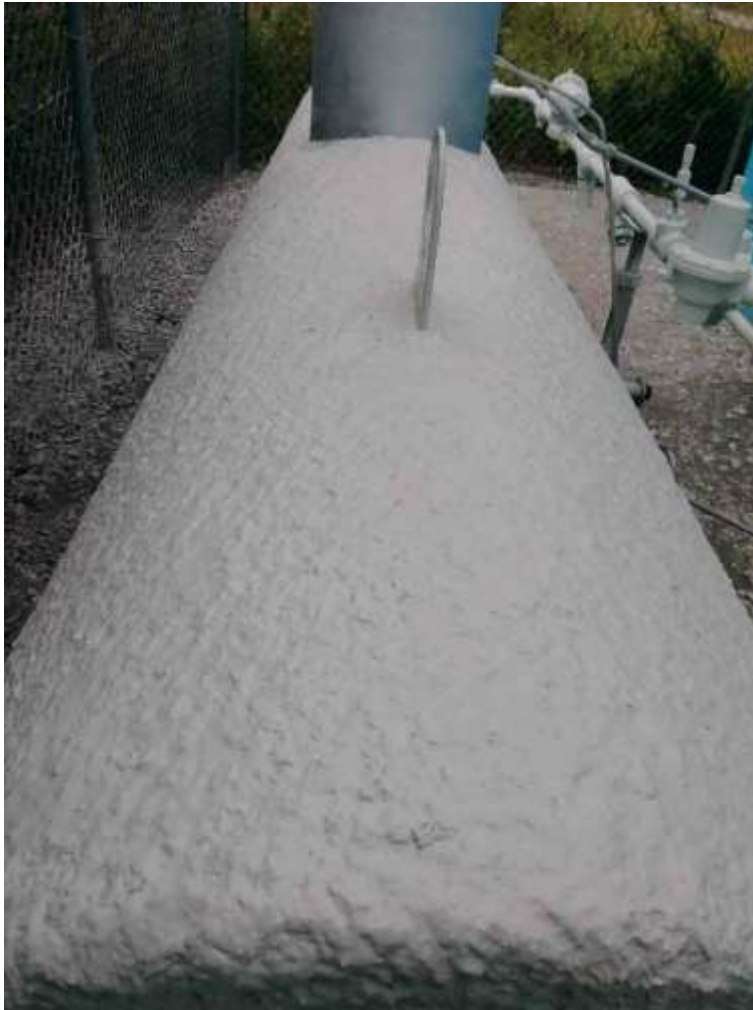
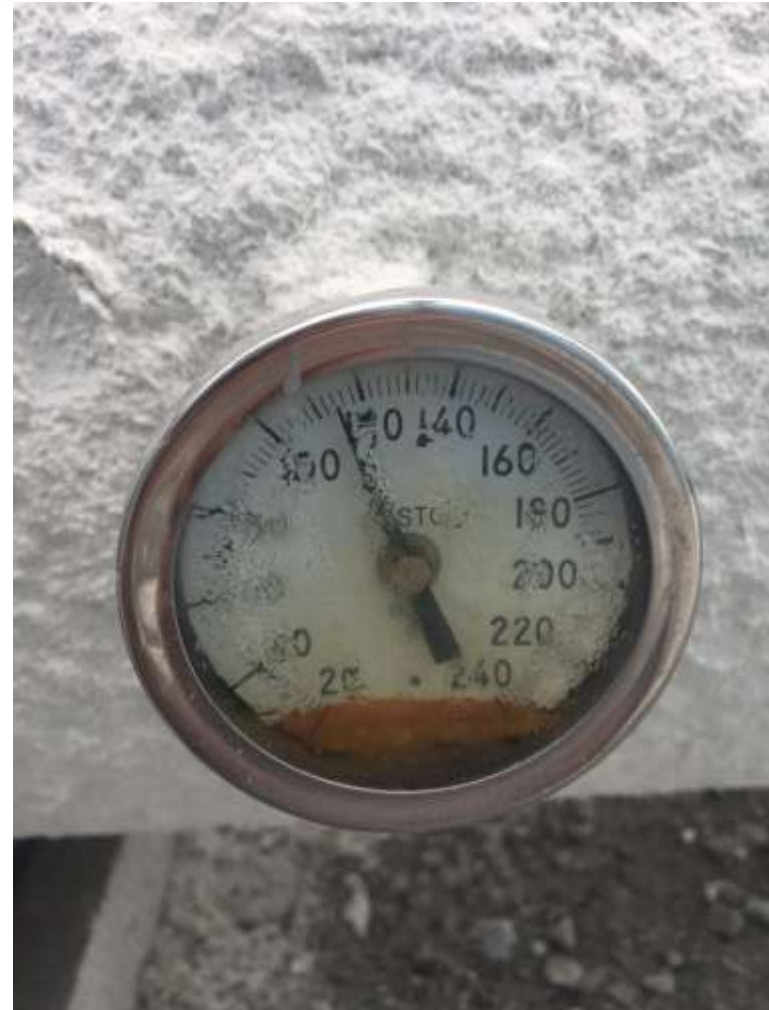
Water Temp:

Before

Below 99 F

After

Above 118 F

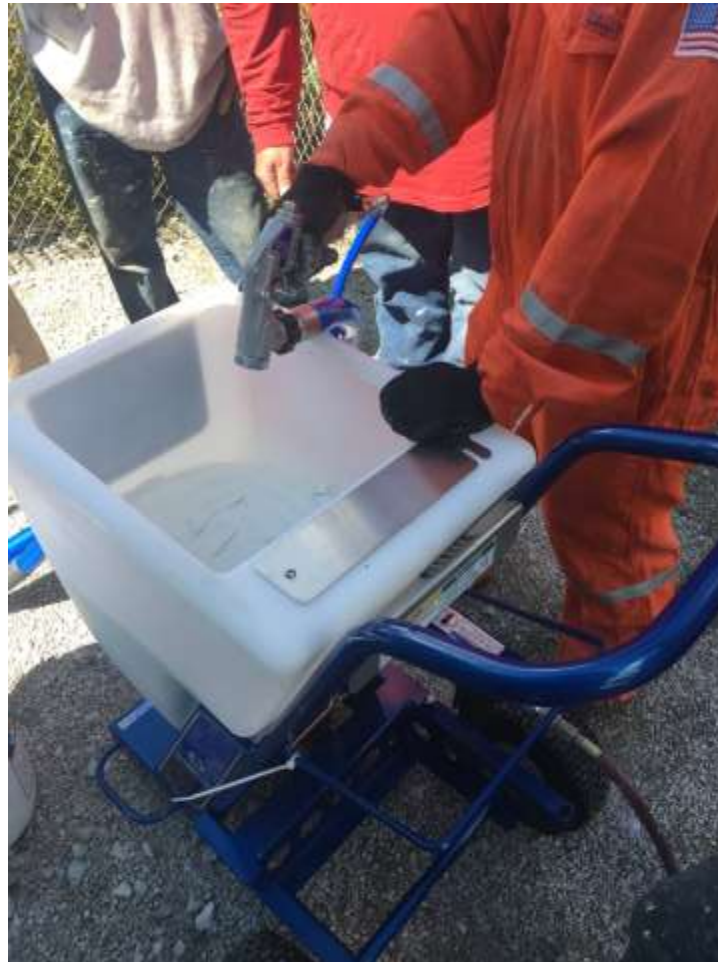
Equipment: Graco GTX EX 2000

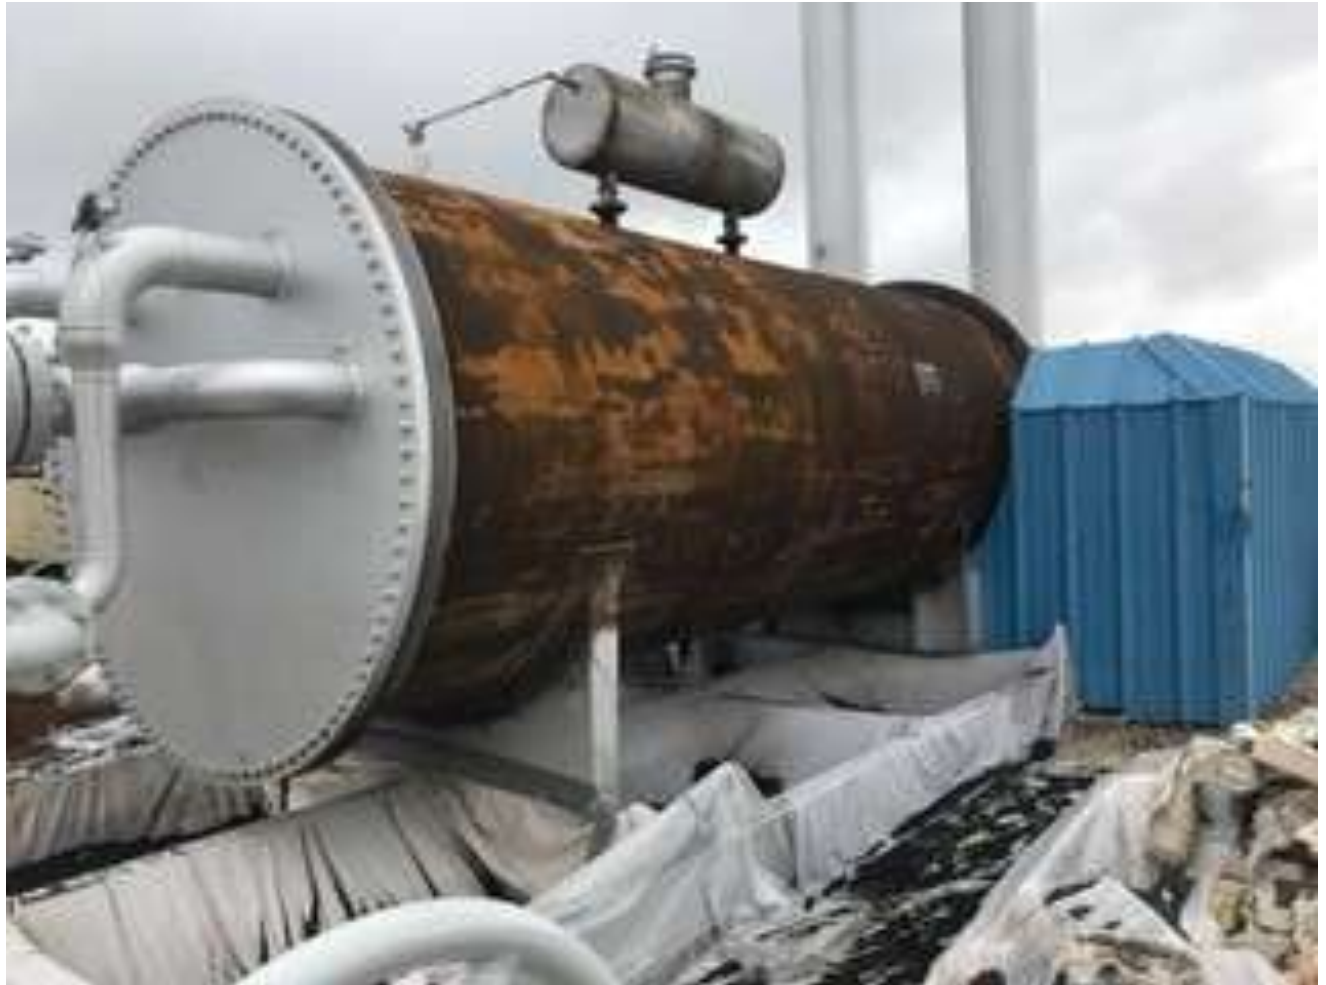
Picture taken  
after NACE 4  
surface preparation.

Operating surface  
temperature is  
120F max without  
insulation.

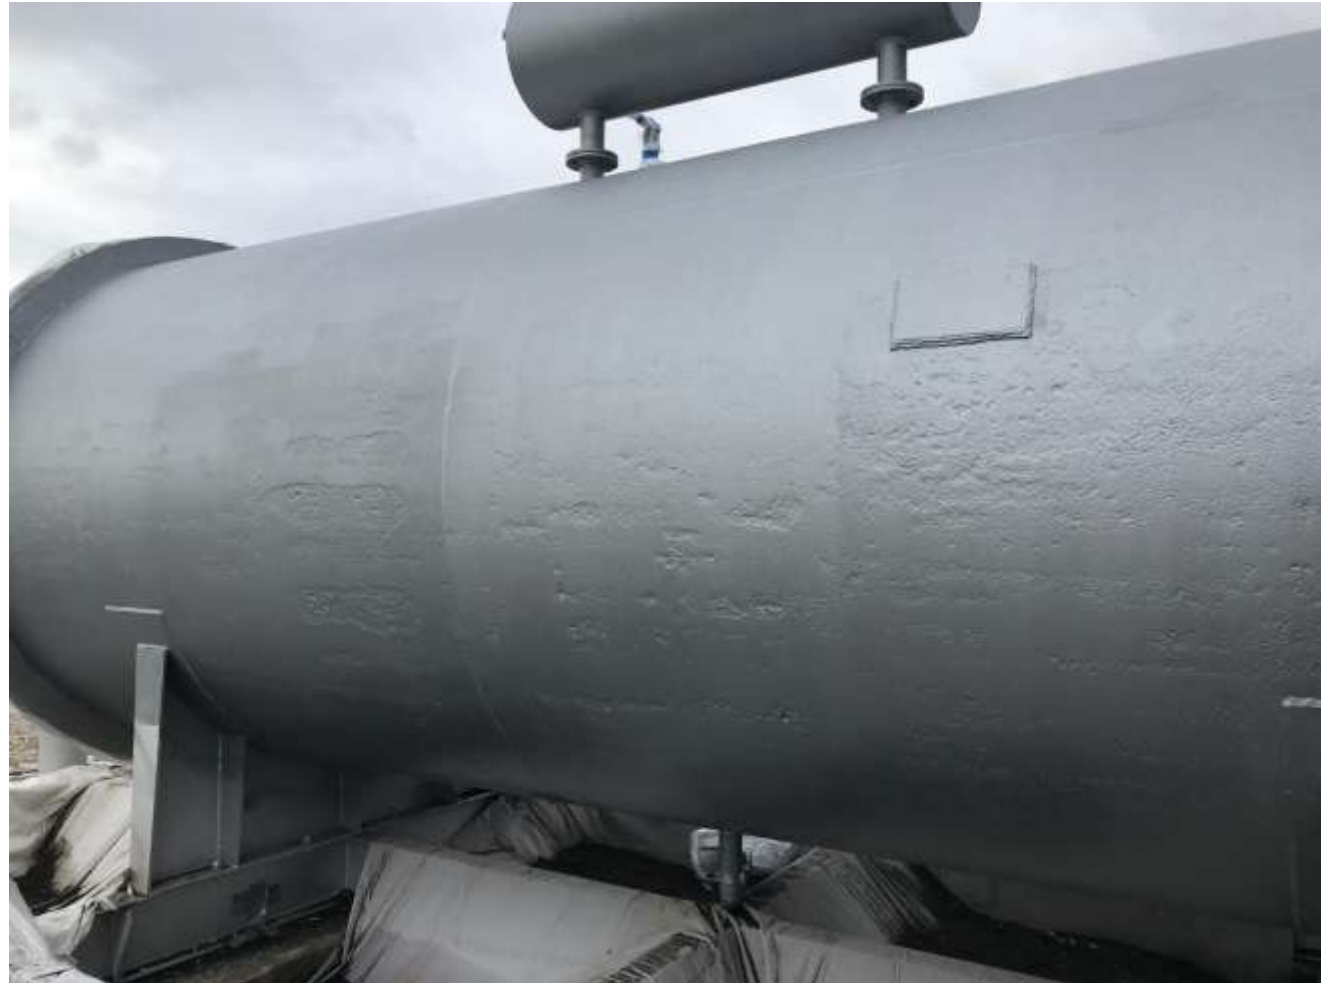
Primer:

Applied to body only,  
not ends.

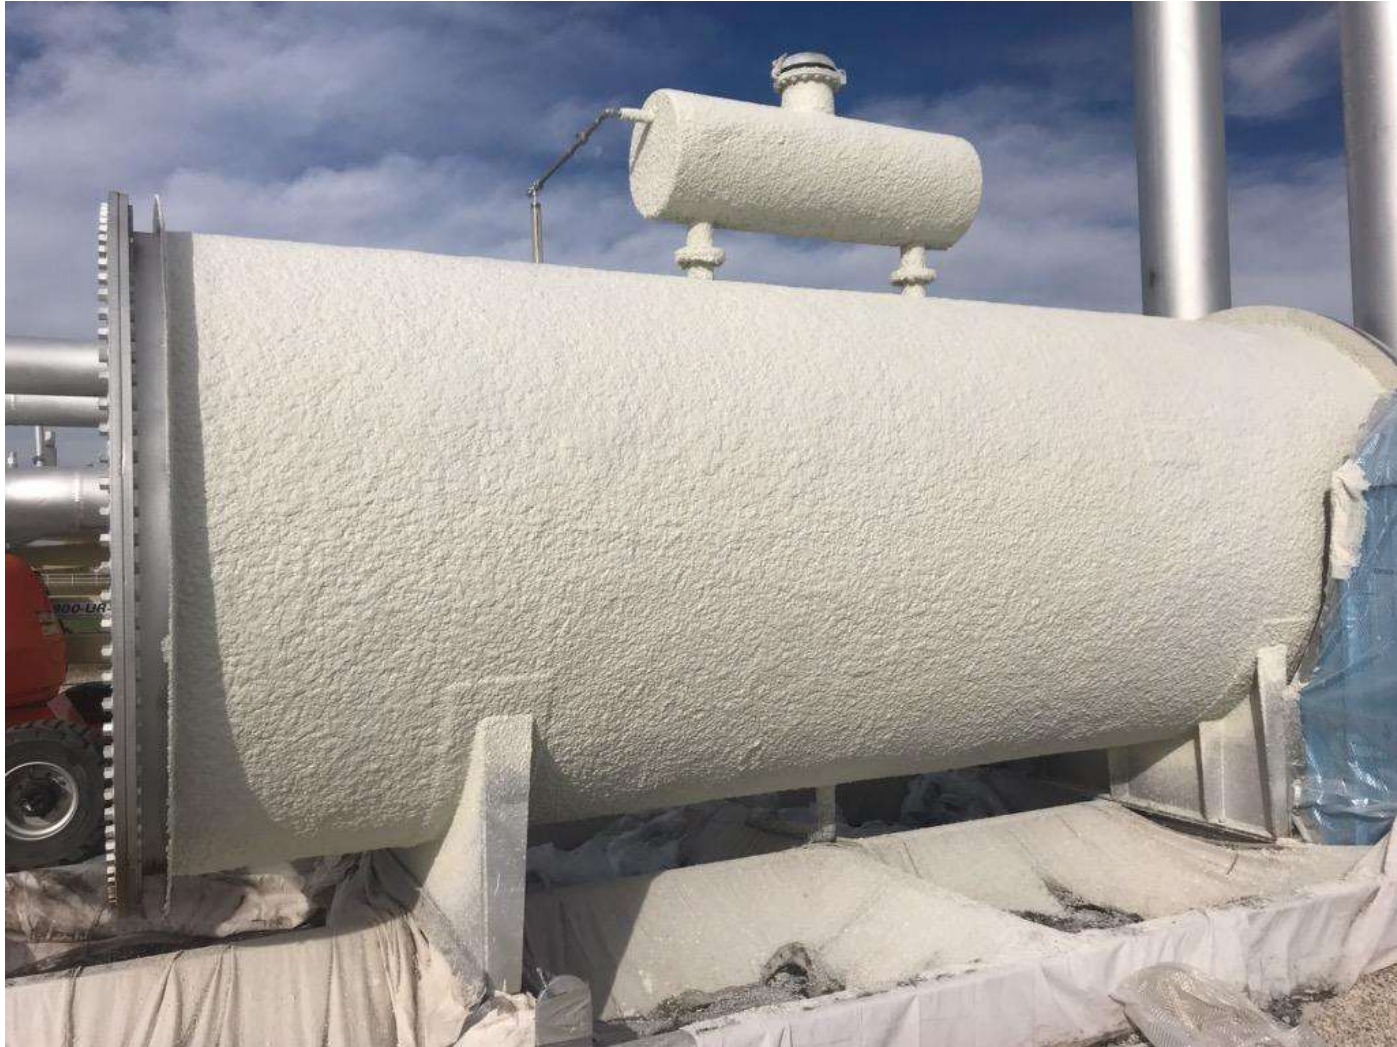
AFTER:

Insulative  
coating  
application:

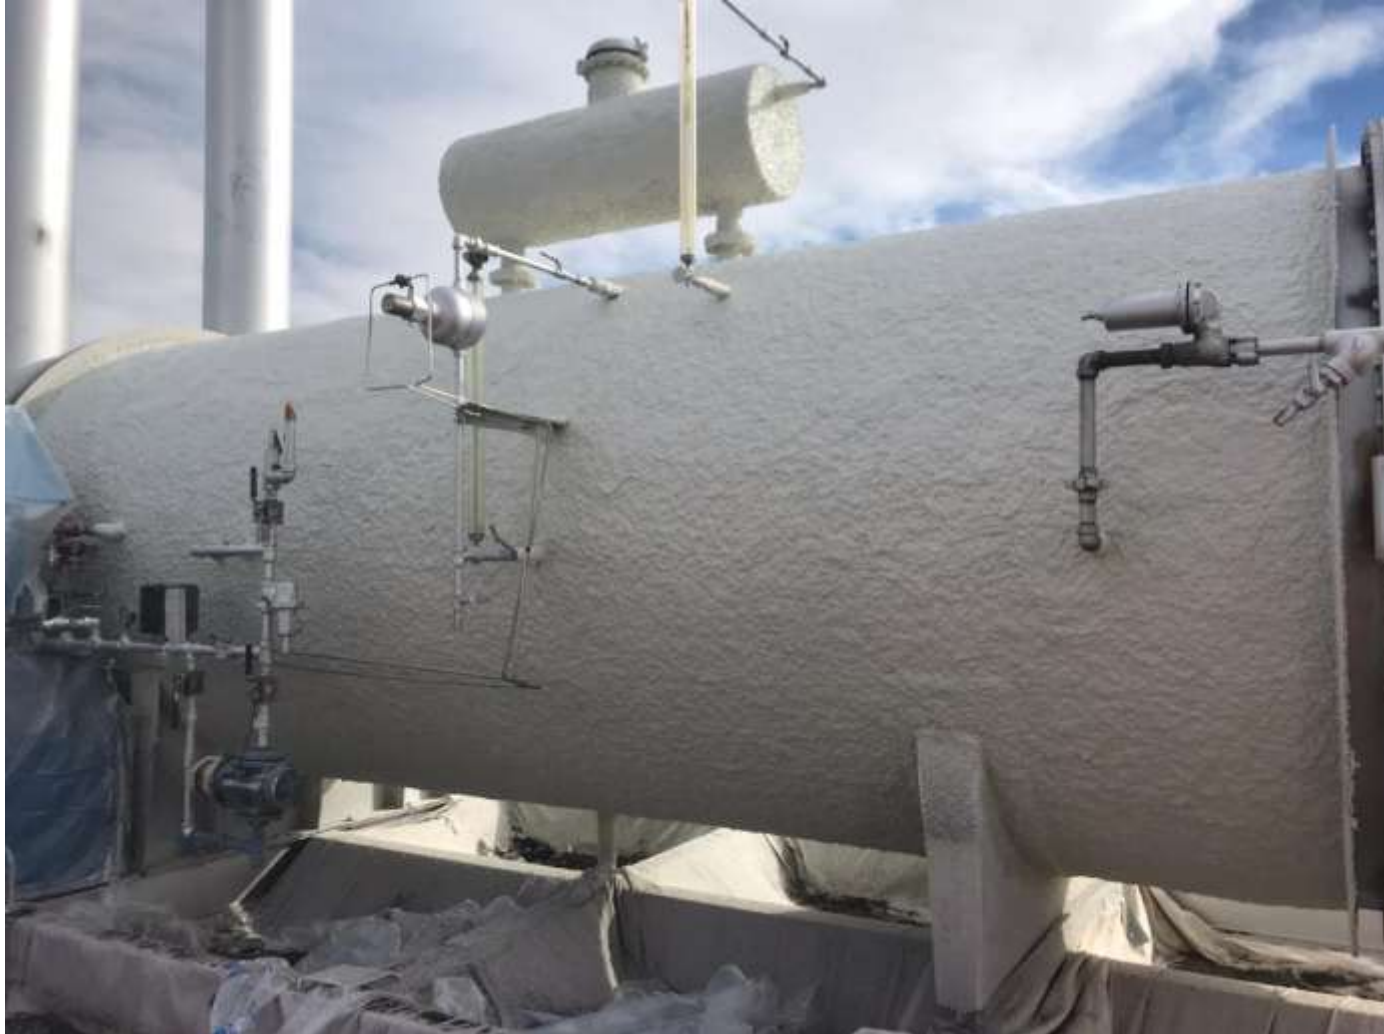
## TOP COAT:

Polyurethane  
to waterproof

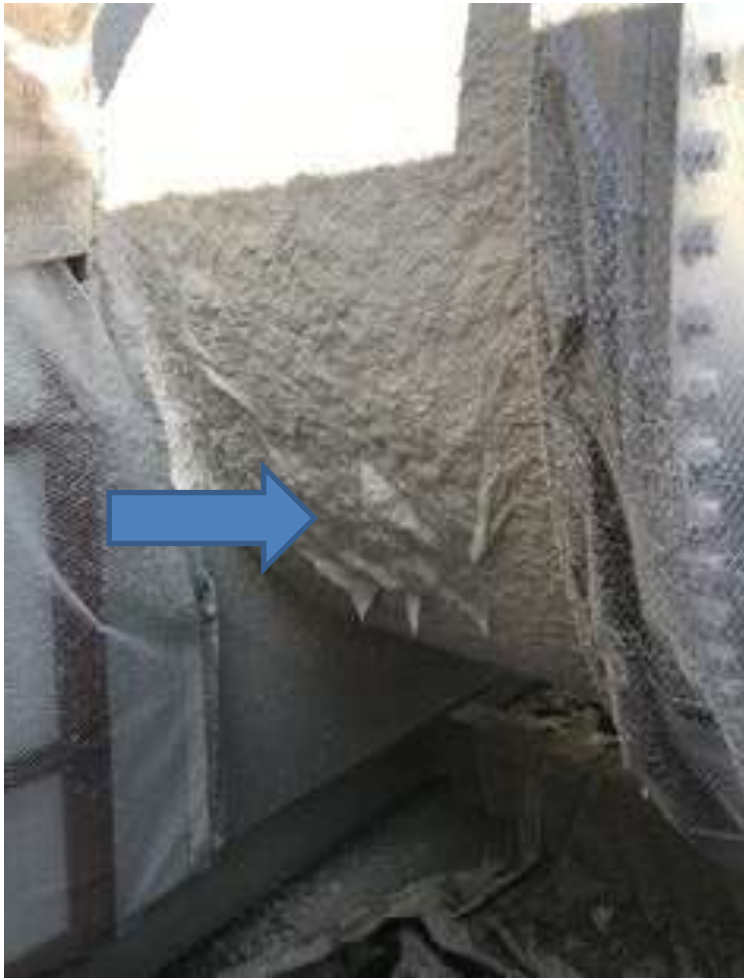
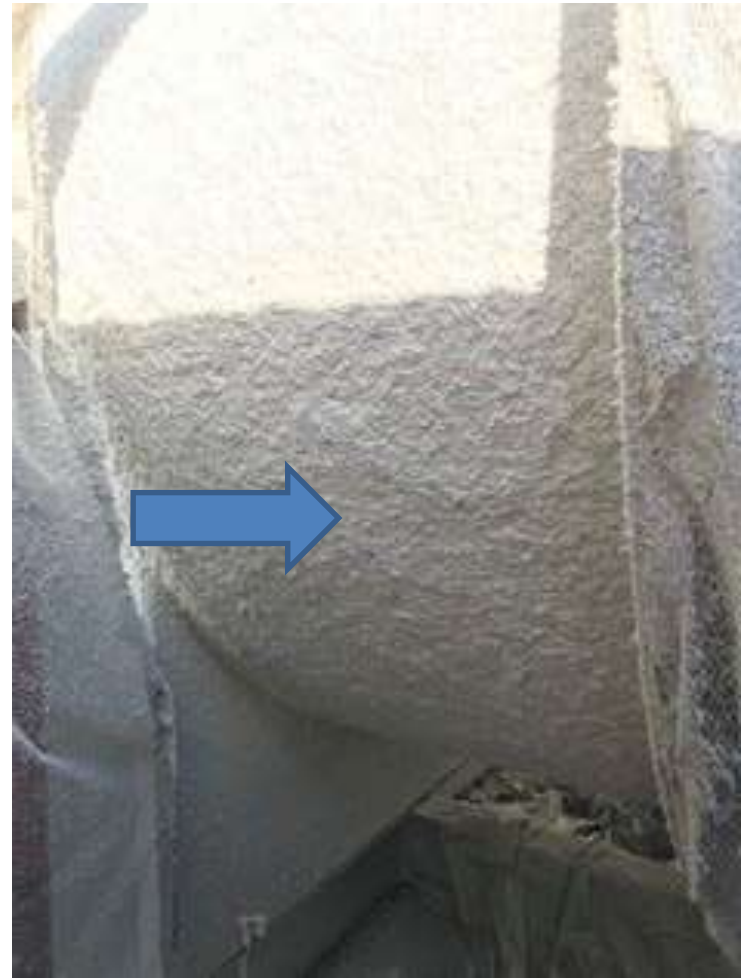
OVER SPRAY REPAIR: Immediate Hand Trowel, no material lost.
