# Million\$ to be Saved Through Insulation Optimization

# Corrosion Under Insulation (CUI)

# Thick Film Insulation Coating

# Thin Film Insulation Coating

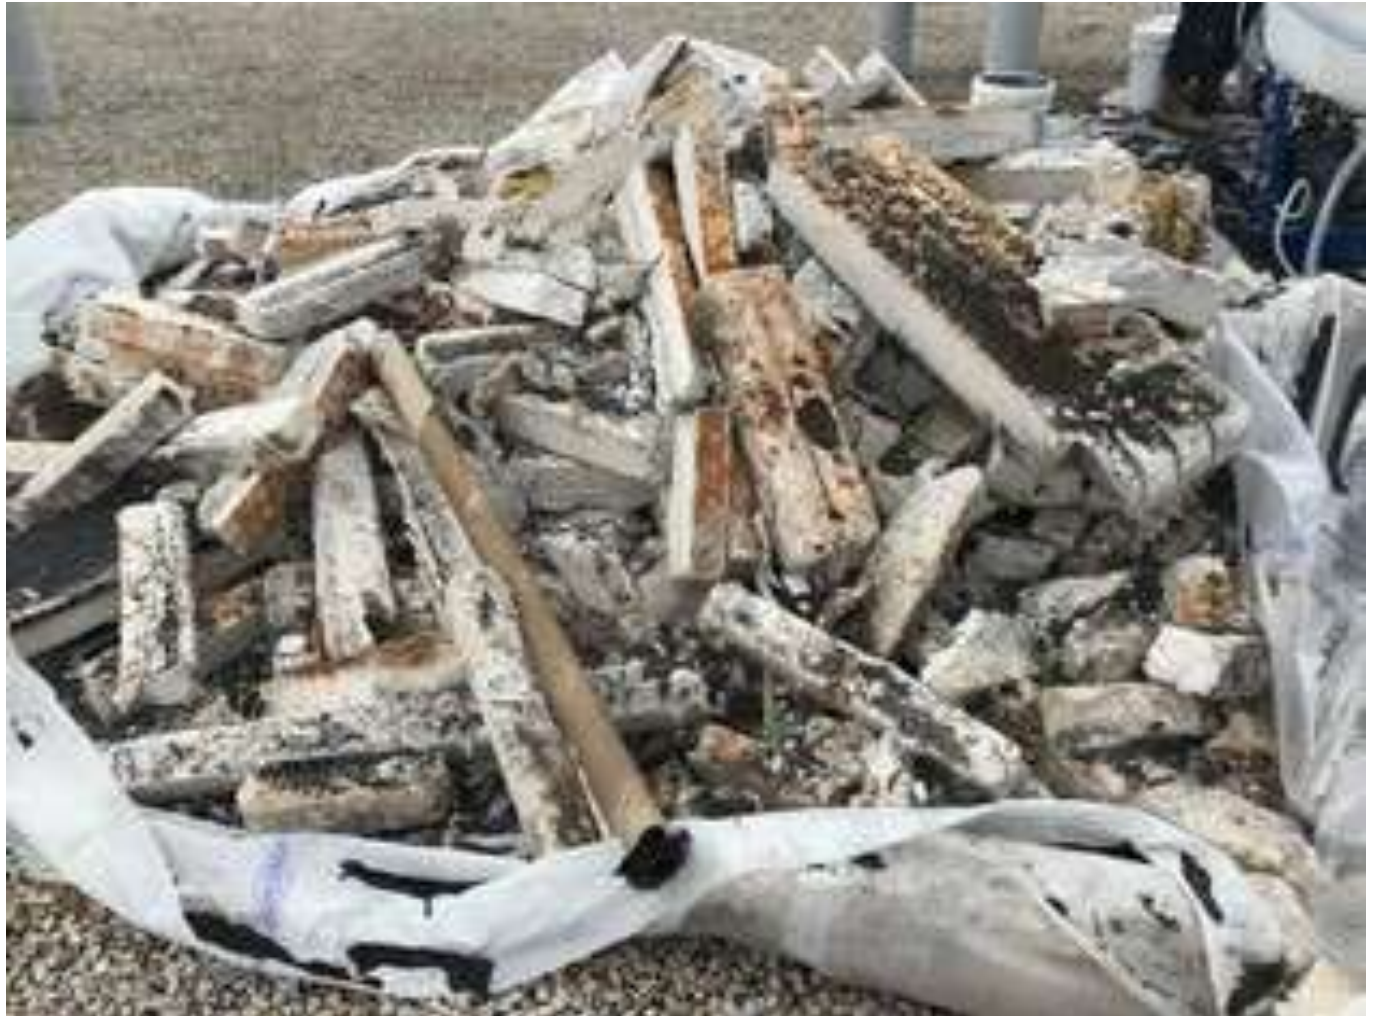
Conventional  
Jacket Insulation

Visible Corrosion

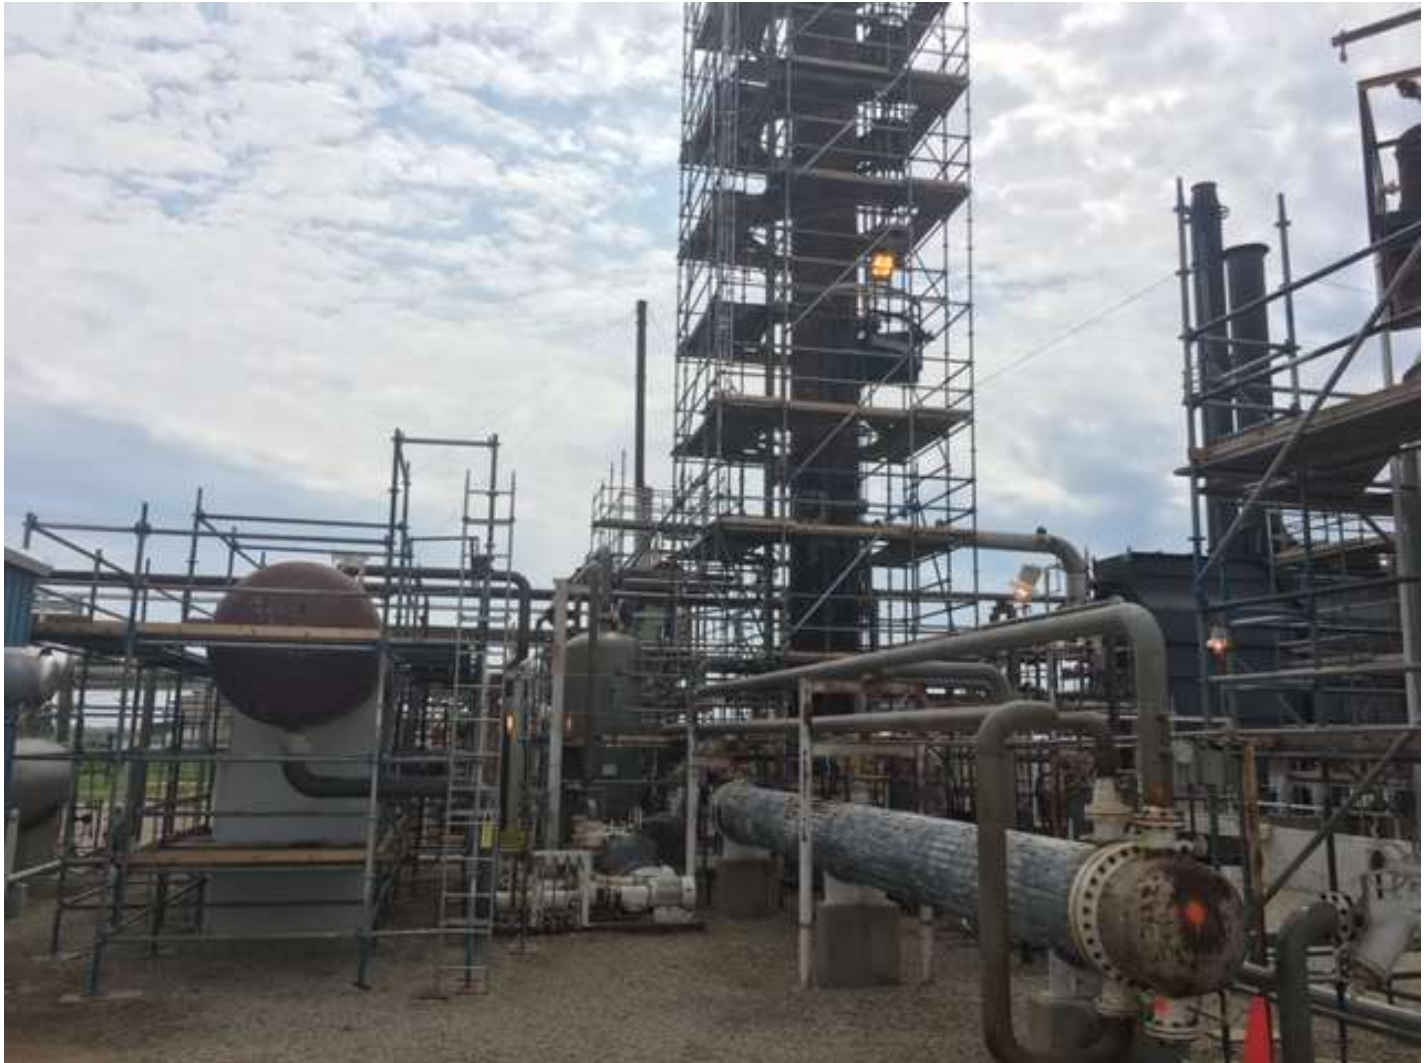
Only surface  
preparation  
3,000 psi  
power wash,

No abrasive  
blasting

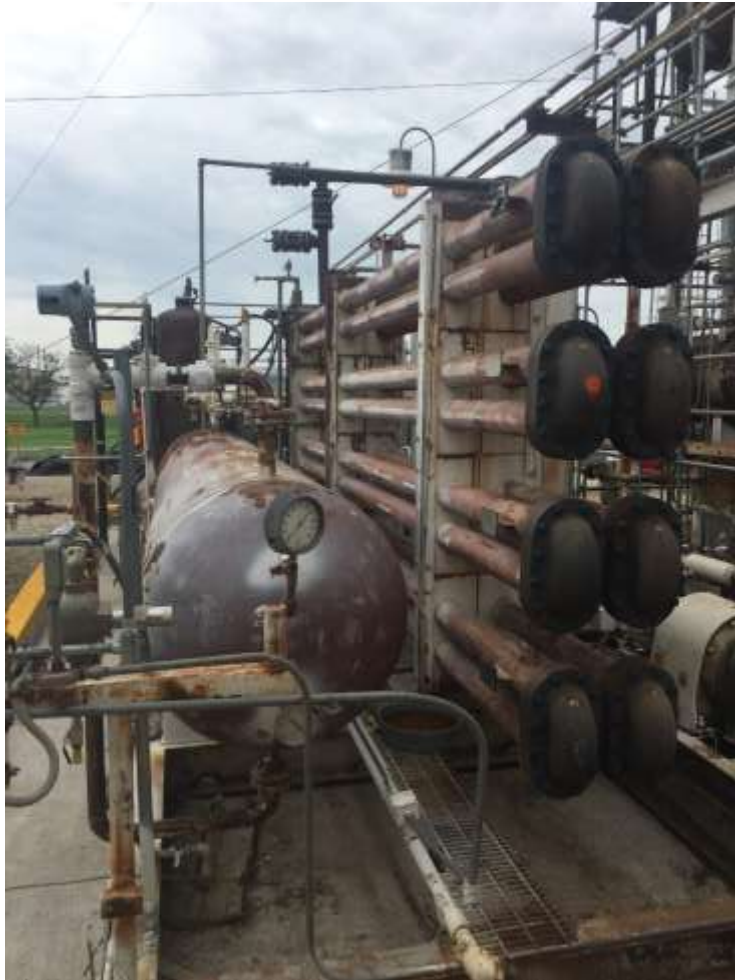
BEFORE: Bare Pipe

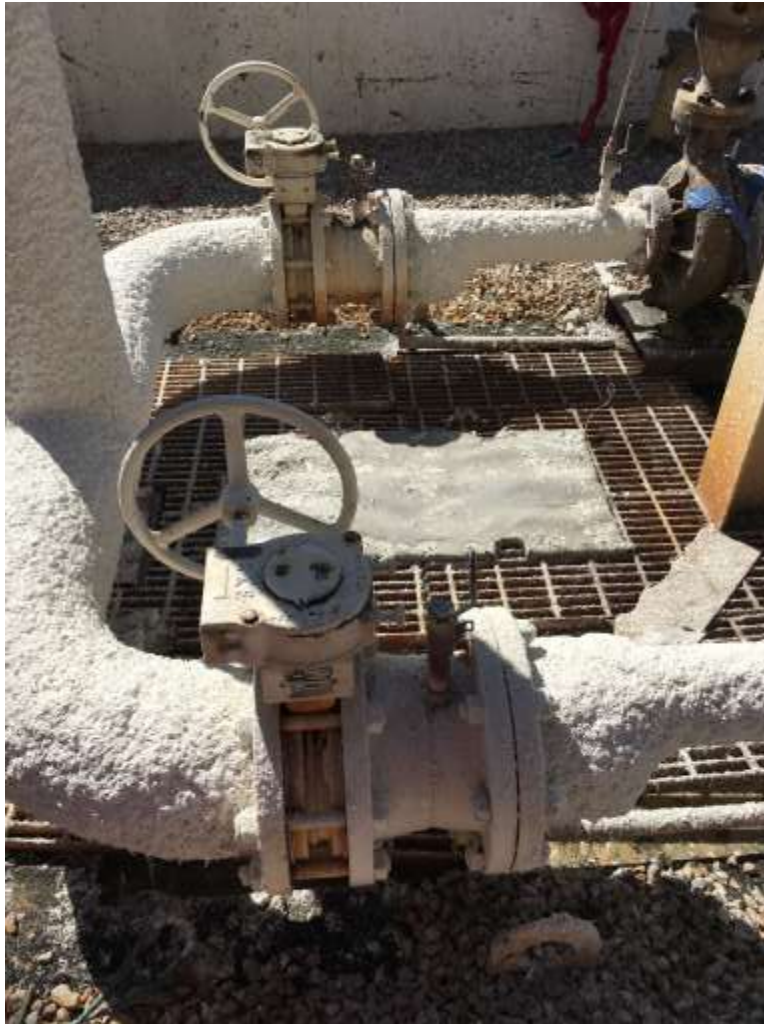
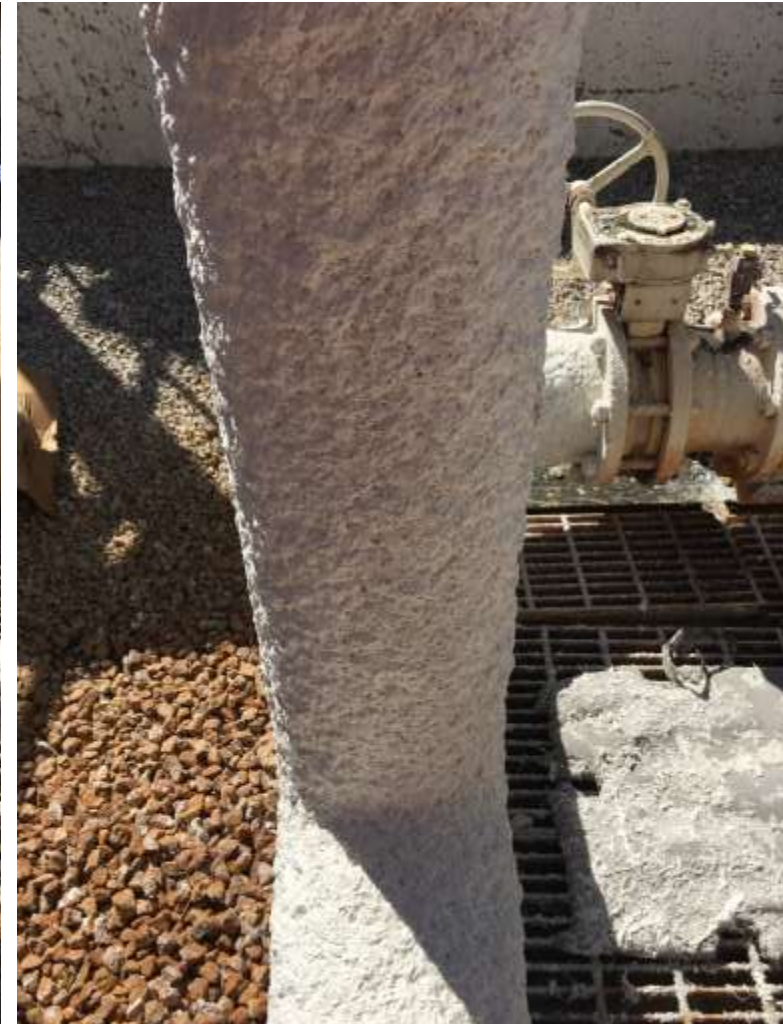
Insulative  
coating  
application.

Prior to  
top coat

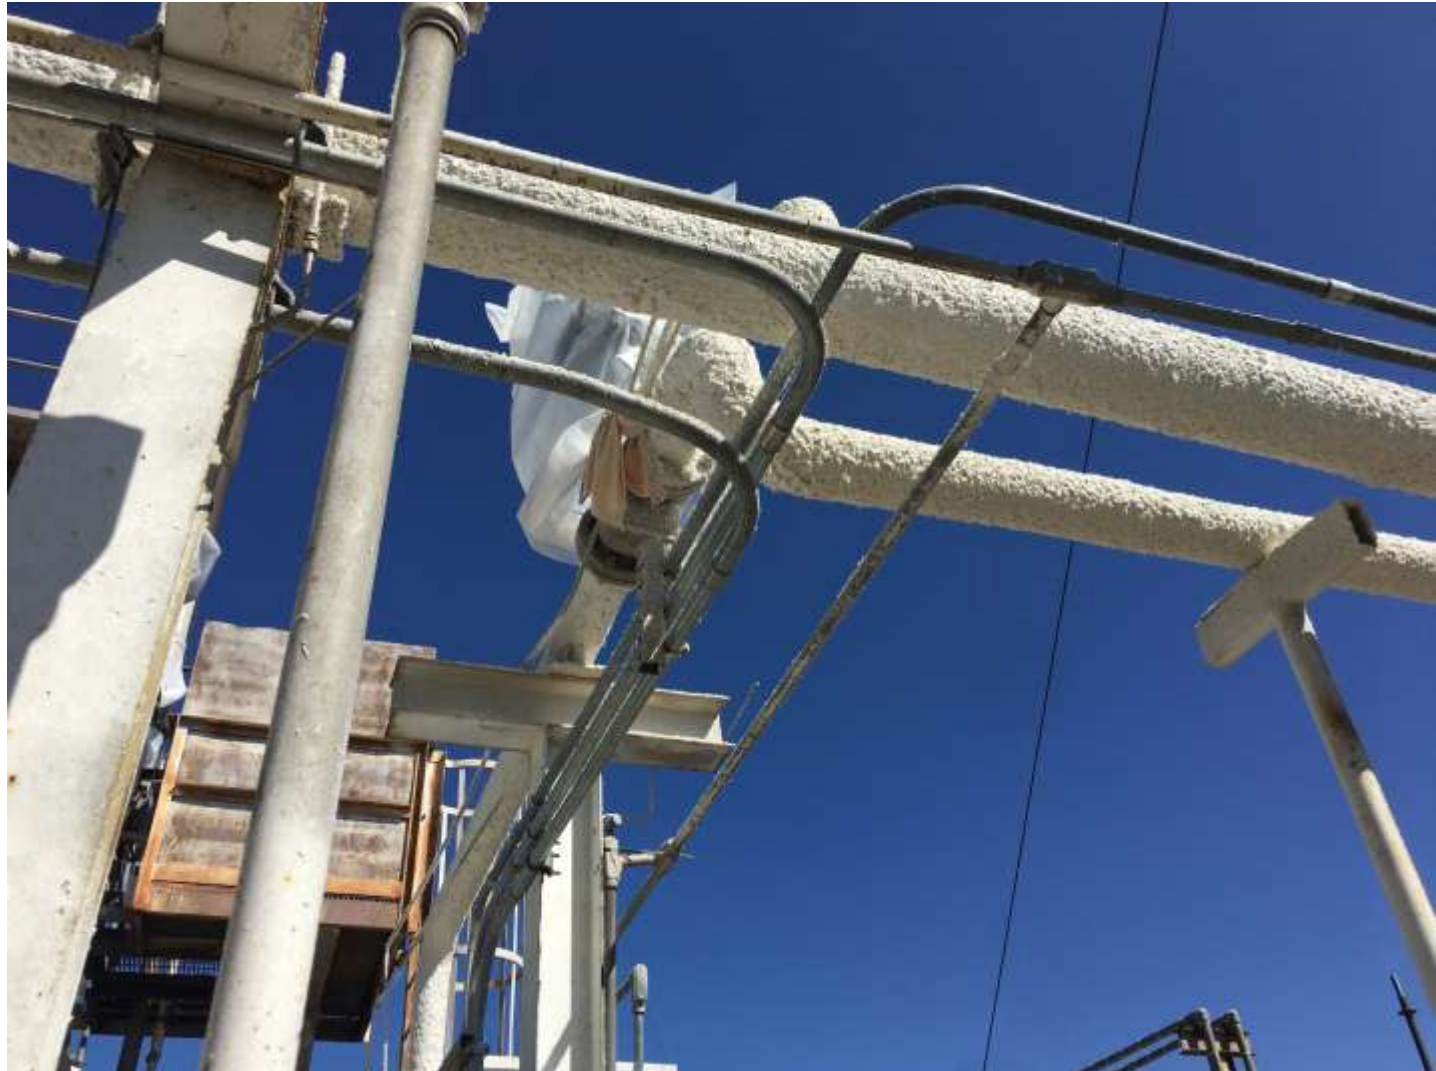
Overhead piping  
required less  
thickness

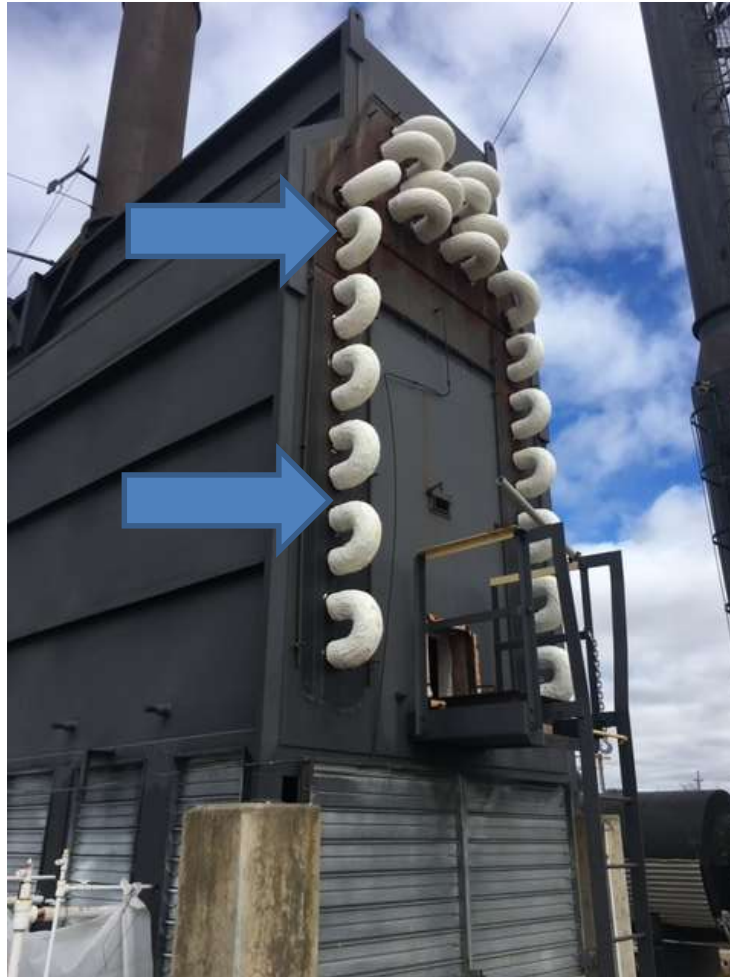
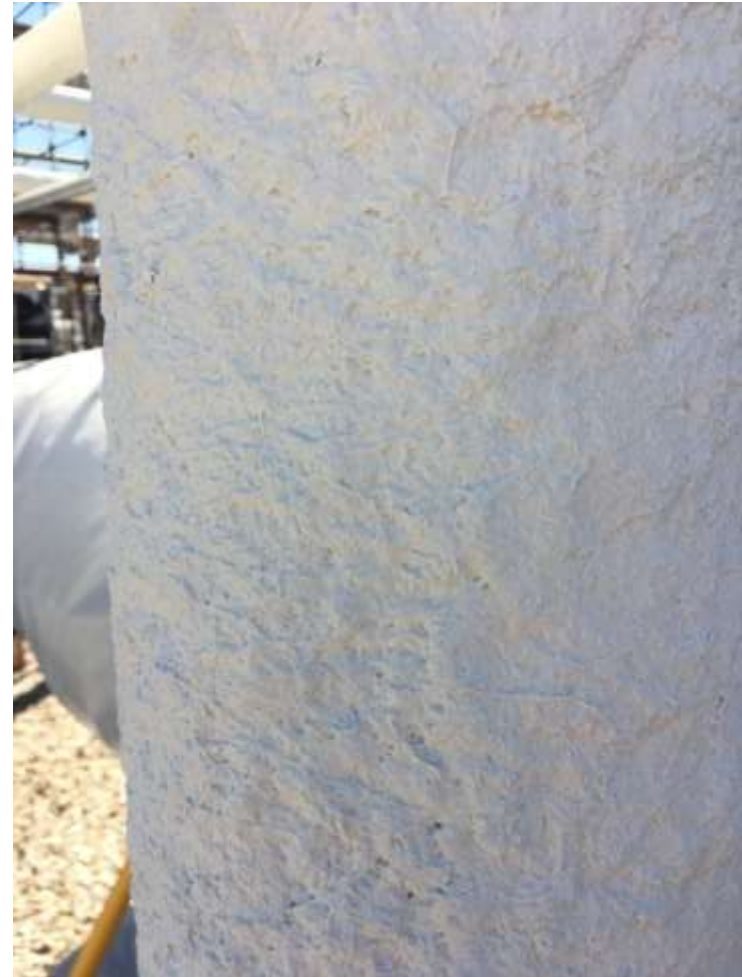
Previously  
not possible  
to insulate  
effectively using  
conventional  
jacket insulation

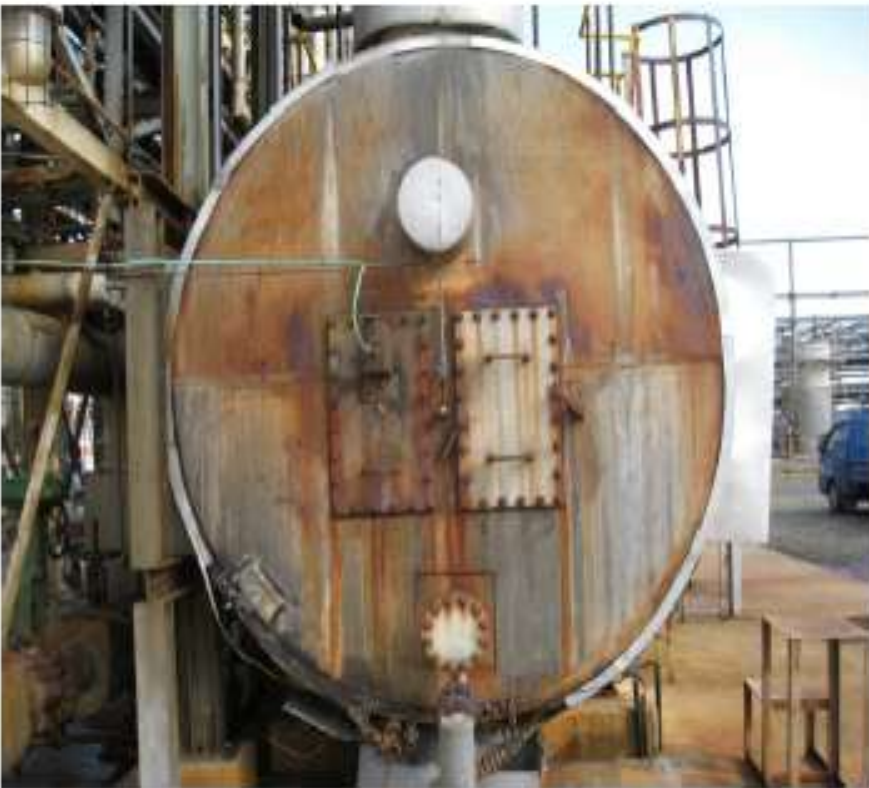
Incinerator Before: 180°C

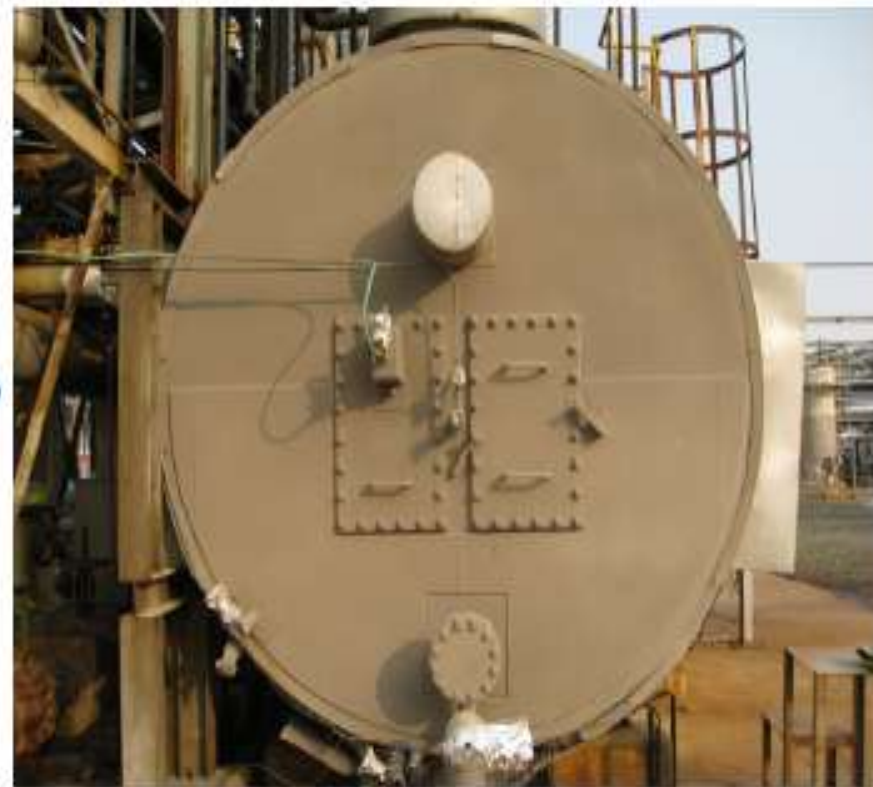
Incinerator After: 50°C

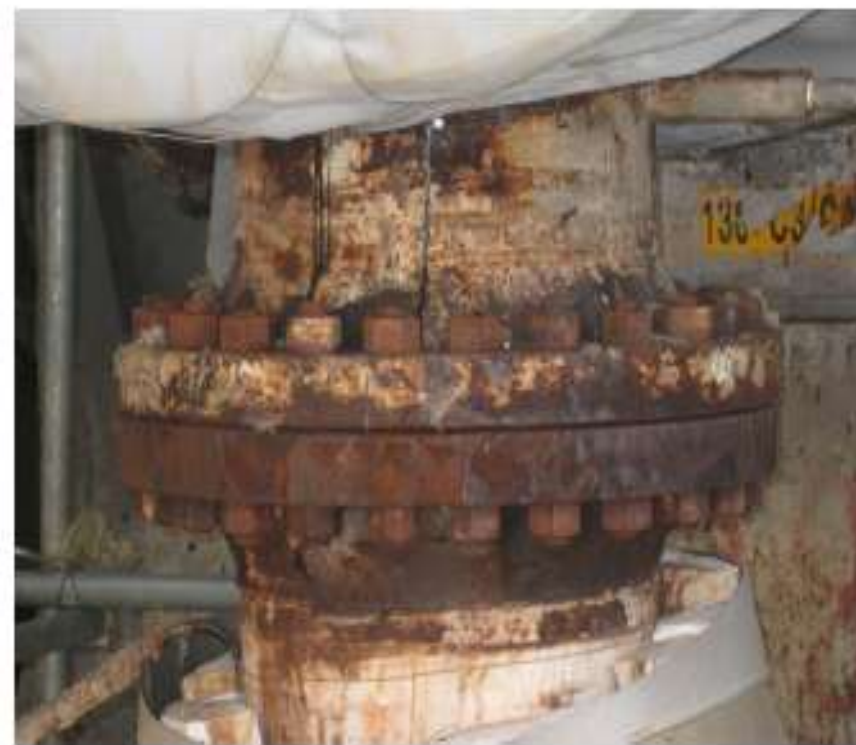
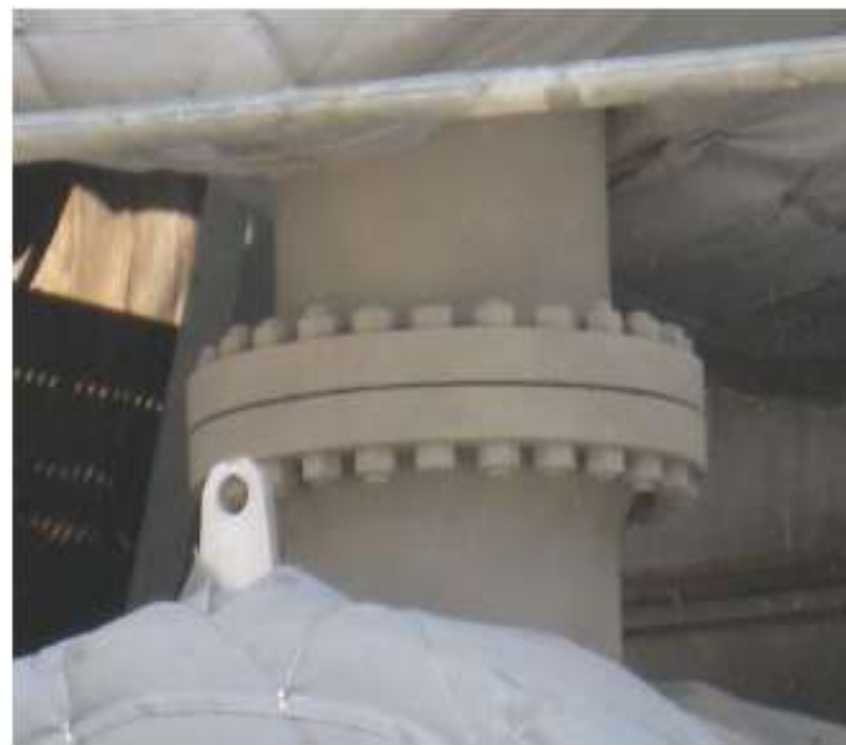
# Flange, Korea

Flange Before coating: 185°C

Flange After coating: 55°C

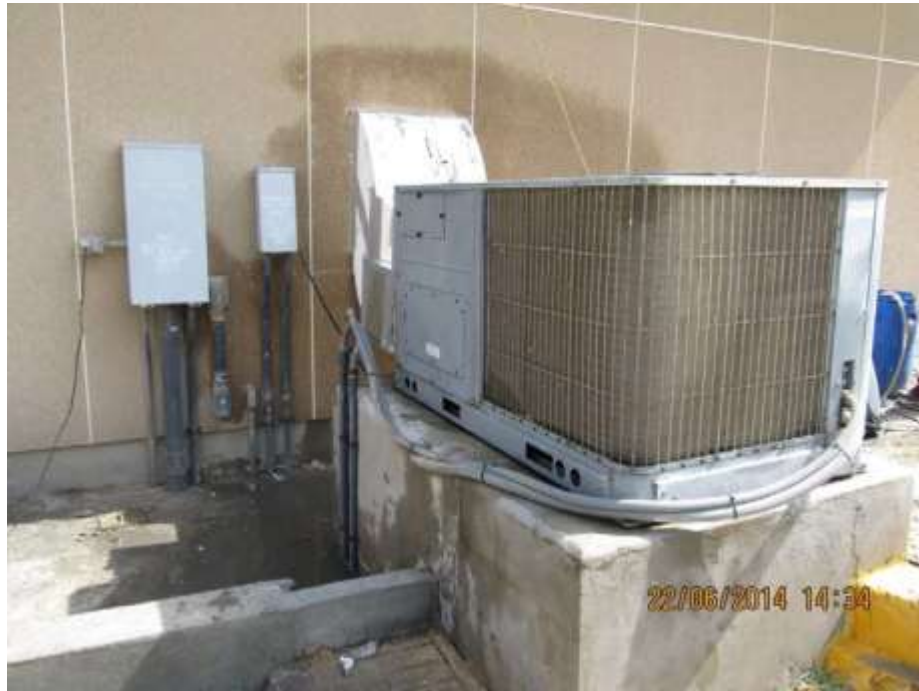
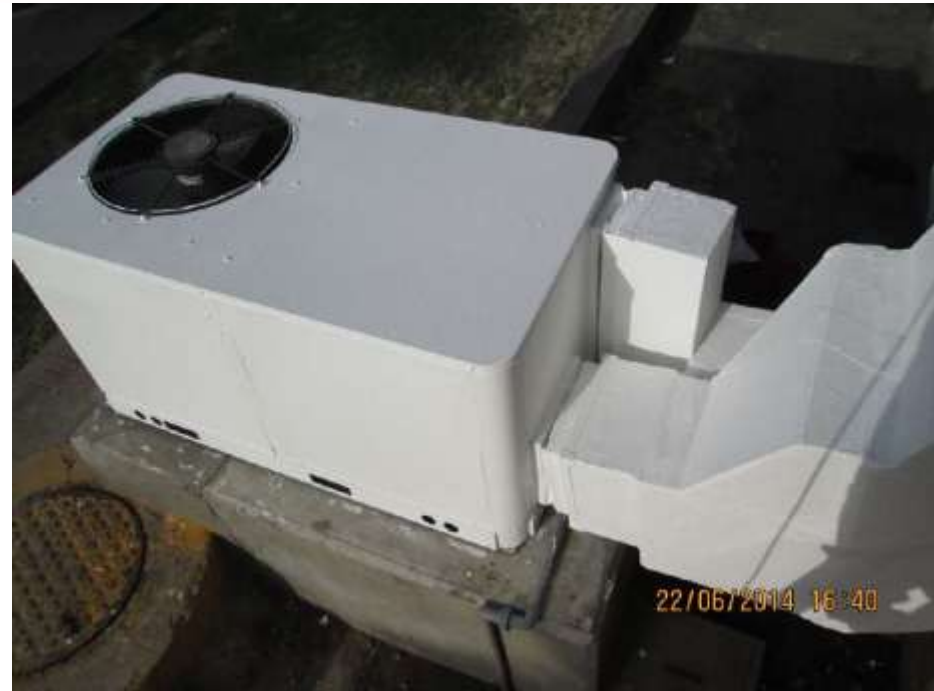
# Air Conditioning Units

**10% BTU Energy Savings – Just from painting AC unit shell**

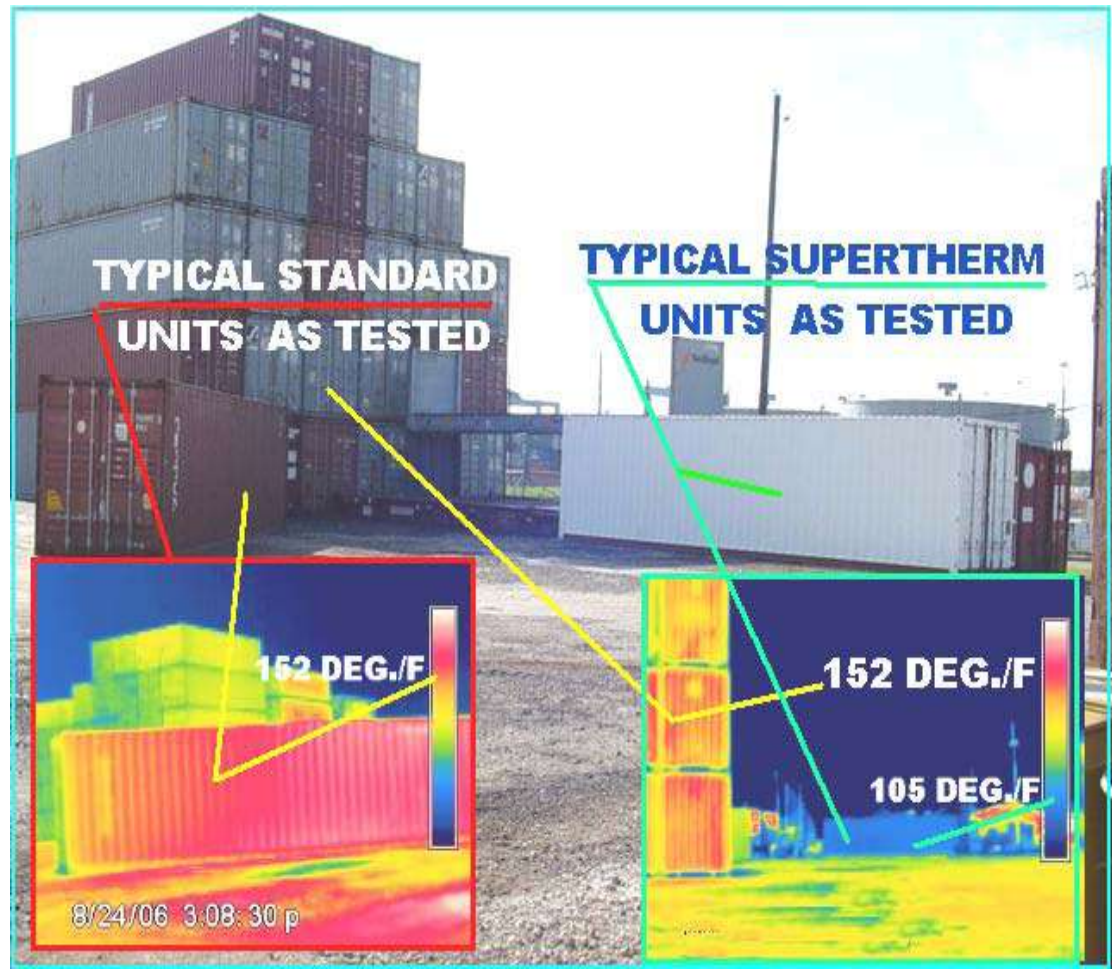
- Surface conduction related energy loads were reduced approximately 46 to 52%
- Inside ambient temperature 22F degrees cooler
- External Surface temp 47F degrees cooler
- Internal moisture level 28.5% dryer

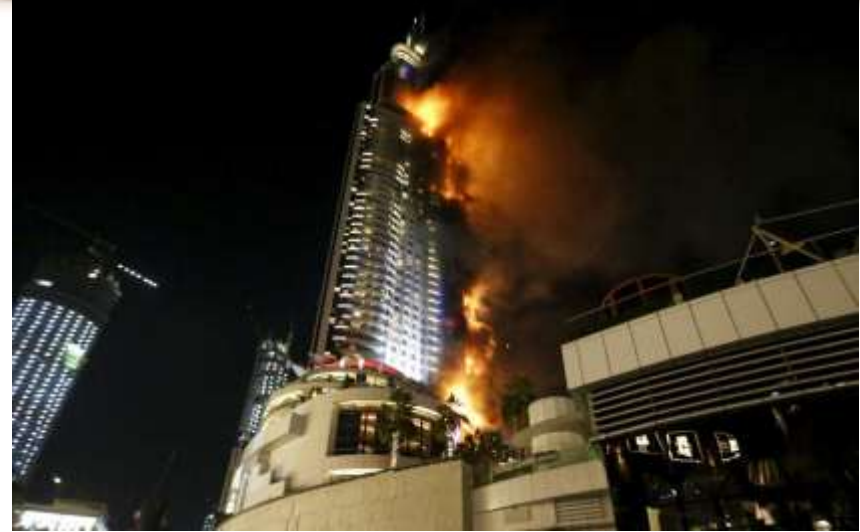
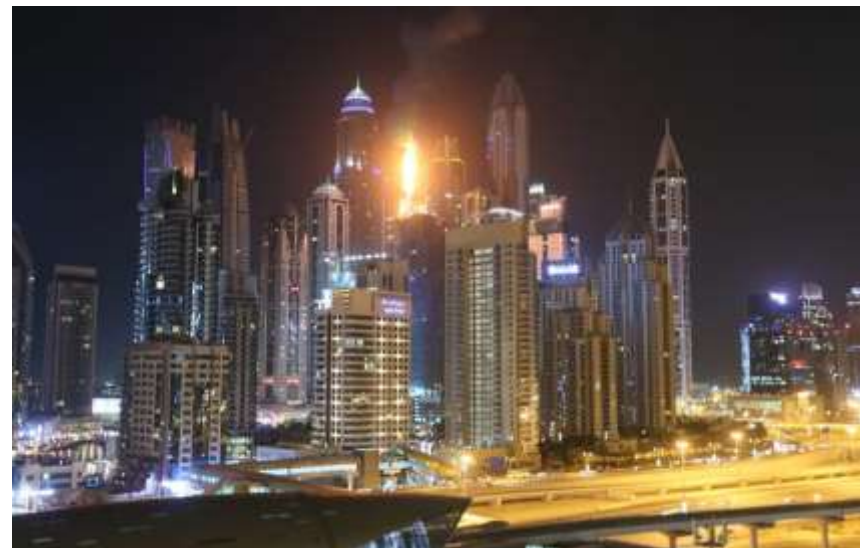
ASTM E84 Flame Spread Testing

Conventional Insulation is High Flammable

Insulative Coatings are Fire Resistant

Does Not Contribute to Flame Spread.
