# Viscous Elastic Coating for Protecting Bell & Spigot Water Lines from Crude Oil Exposure

# Improving Safety of Crude Oil and Regional Water System Pipeline Crossings

*EVALUATION OF VISCOTAQ<sup>®</sup> PIPELINE WRAP PERFORMANCE RELATED TO CRUDE OIL EXPOSURE*

Final Report

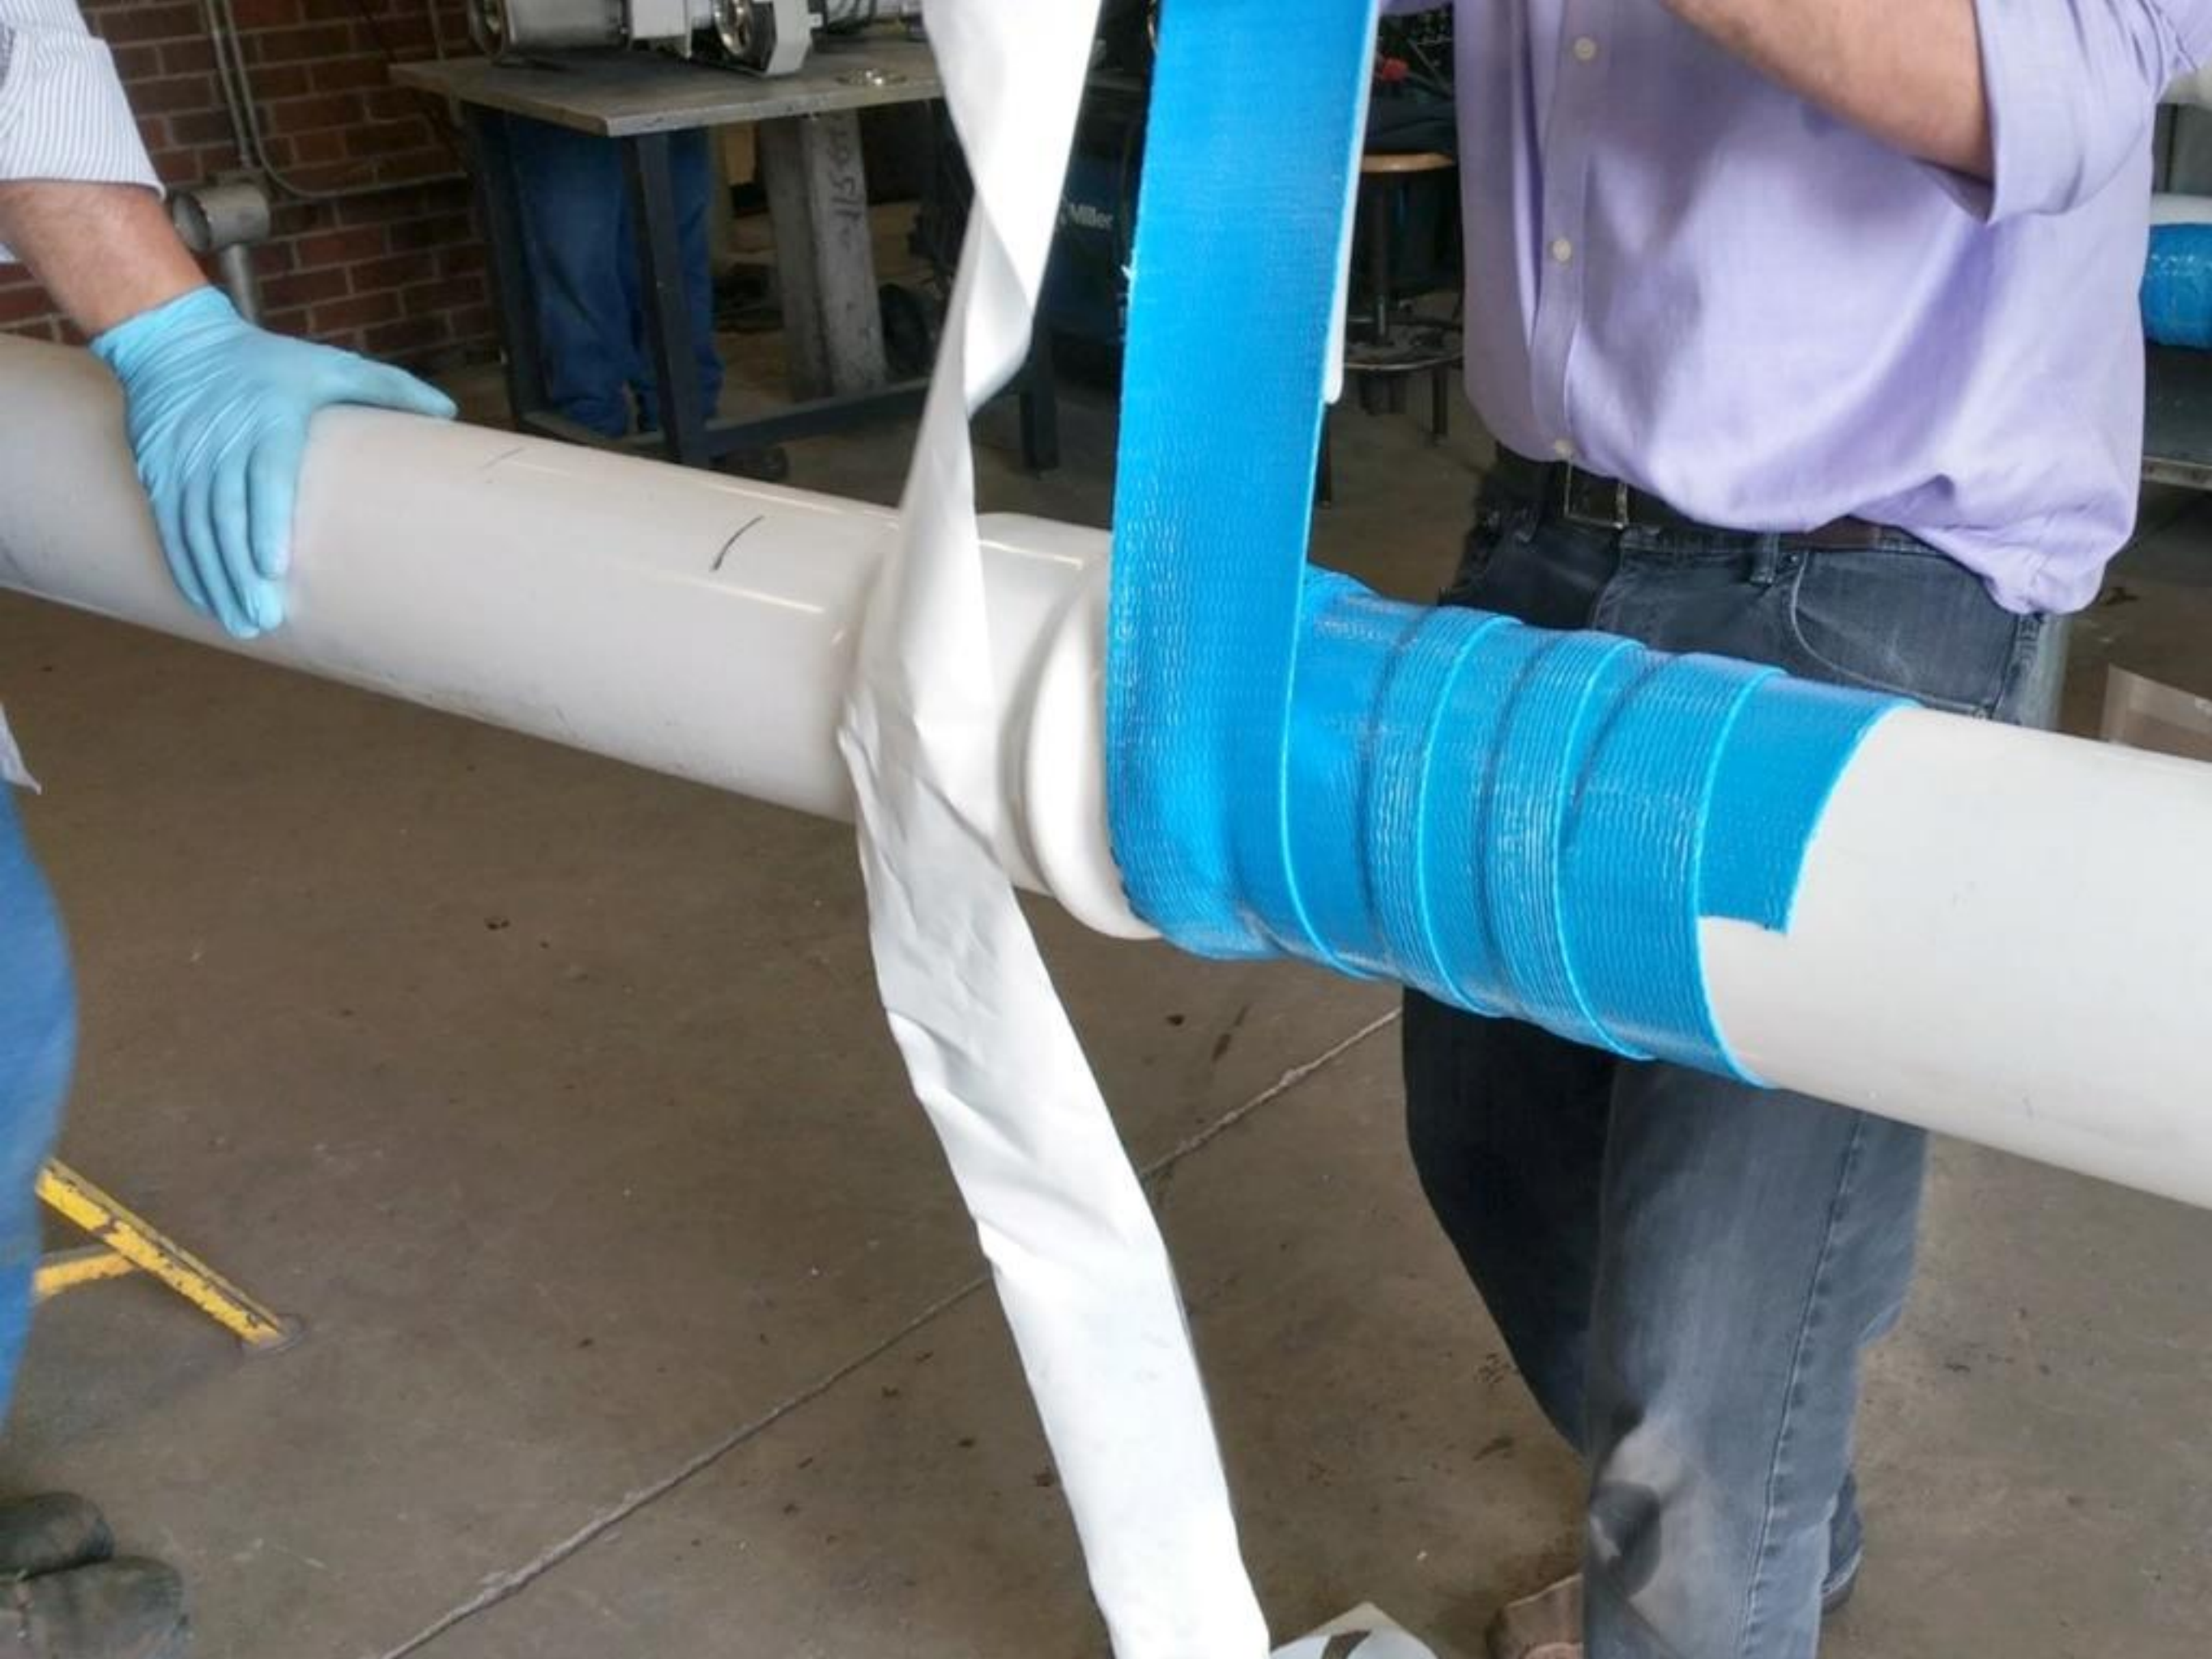
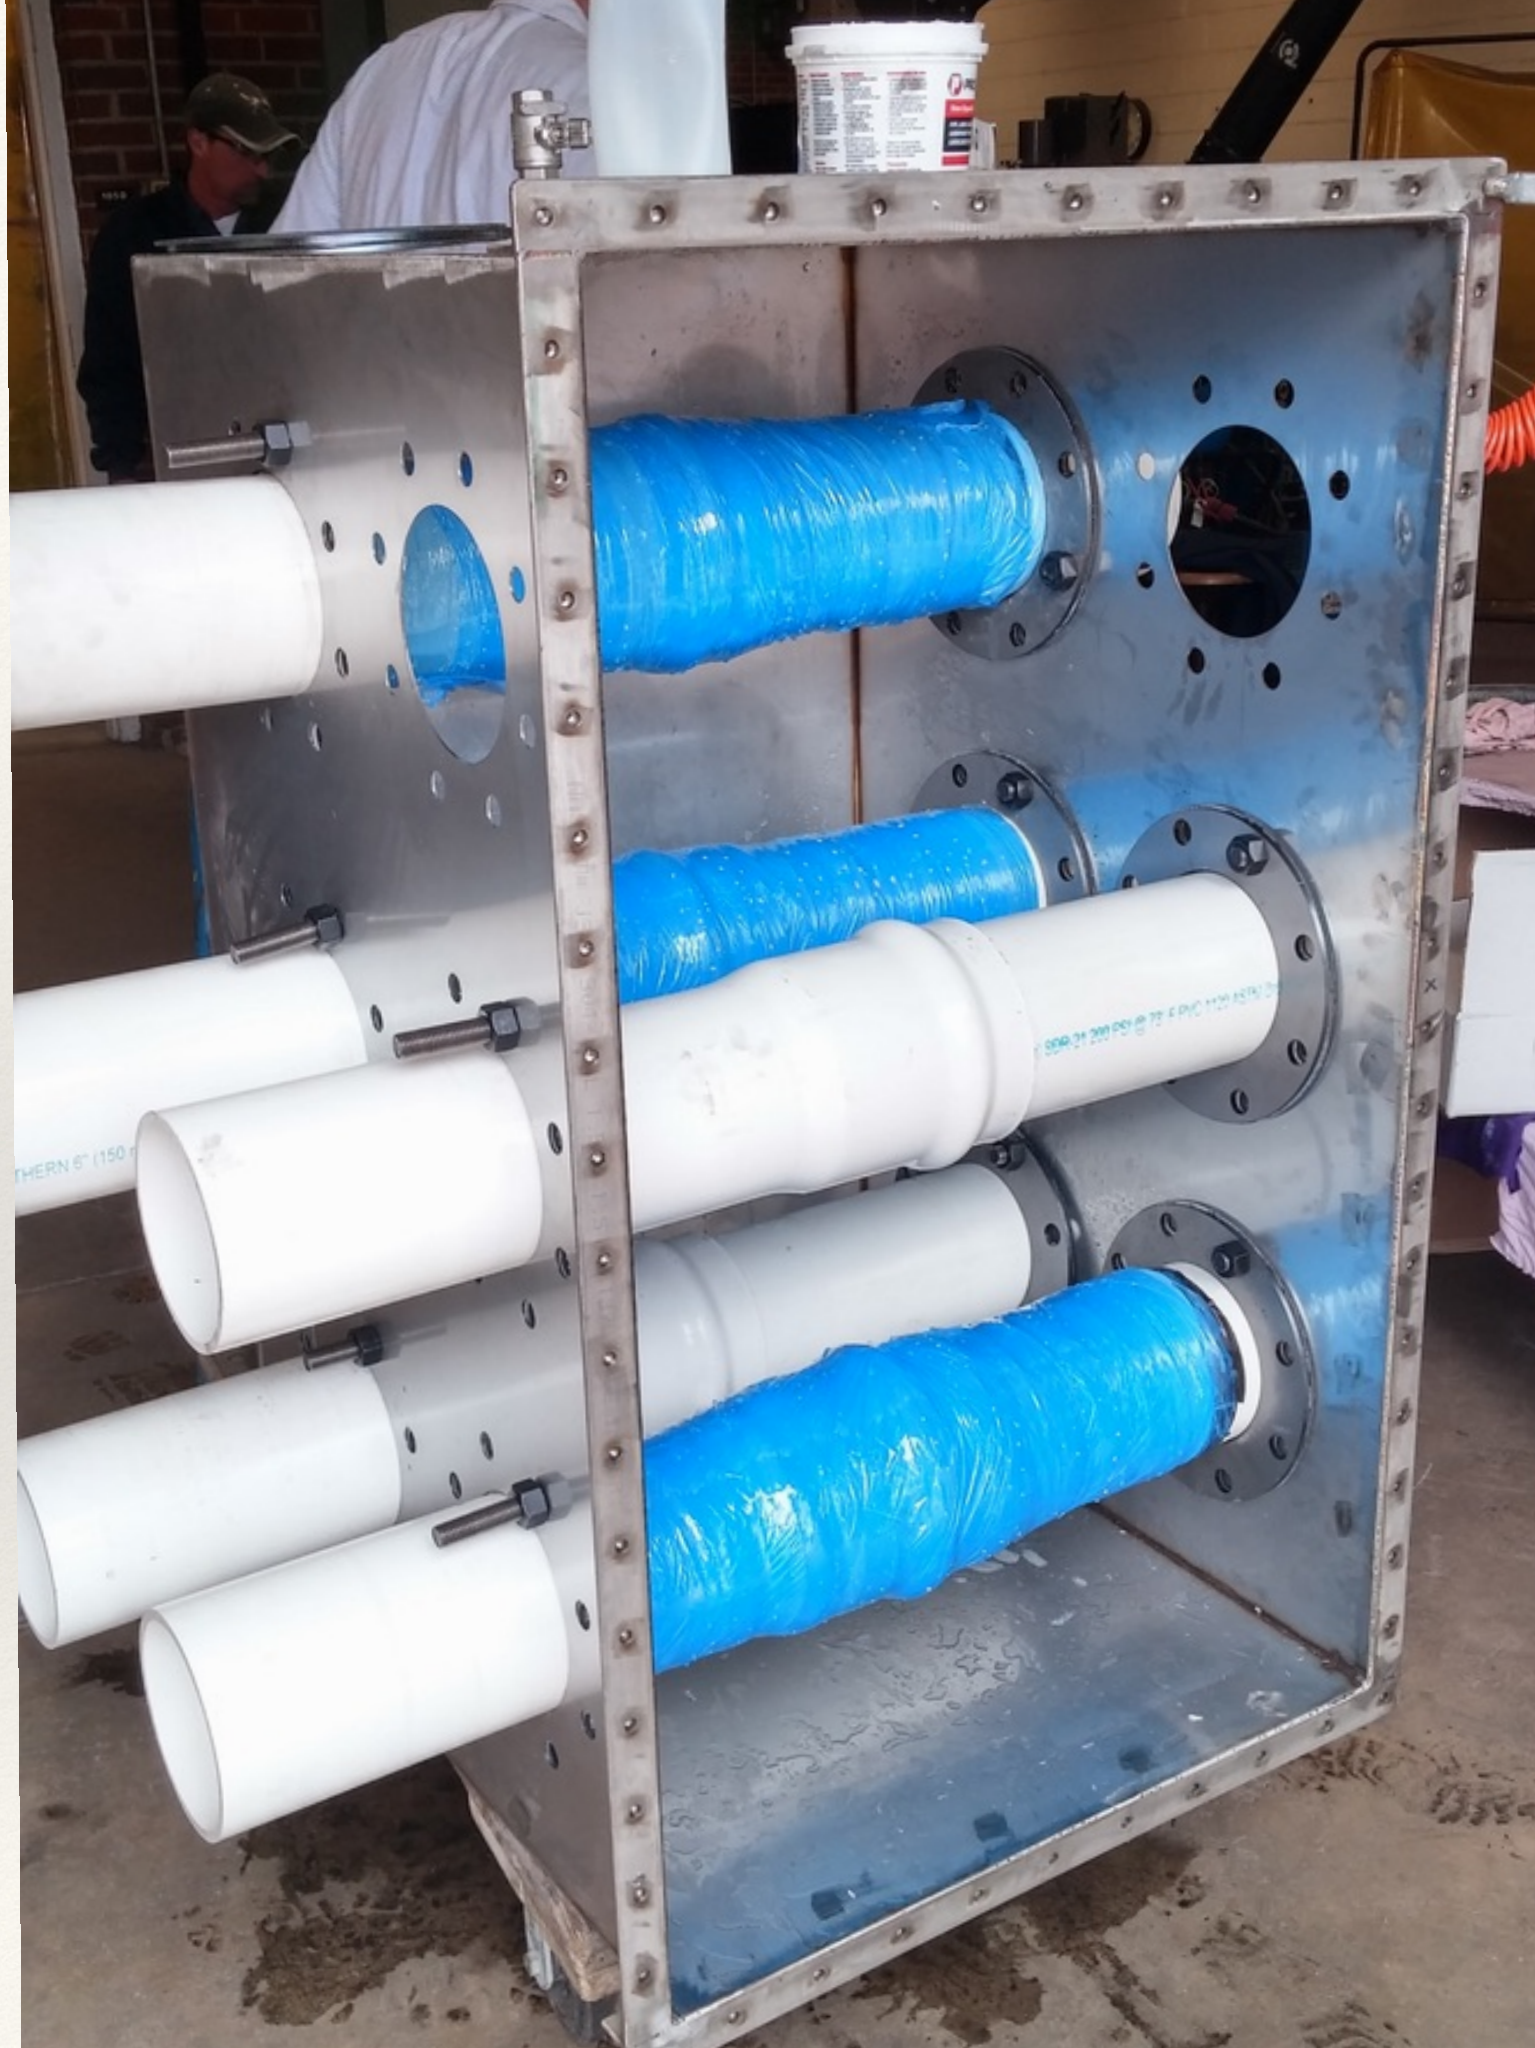
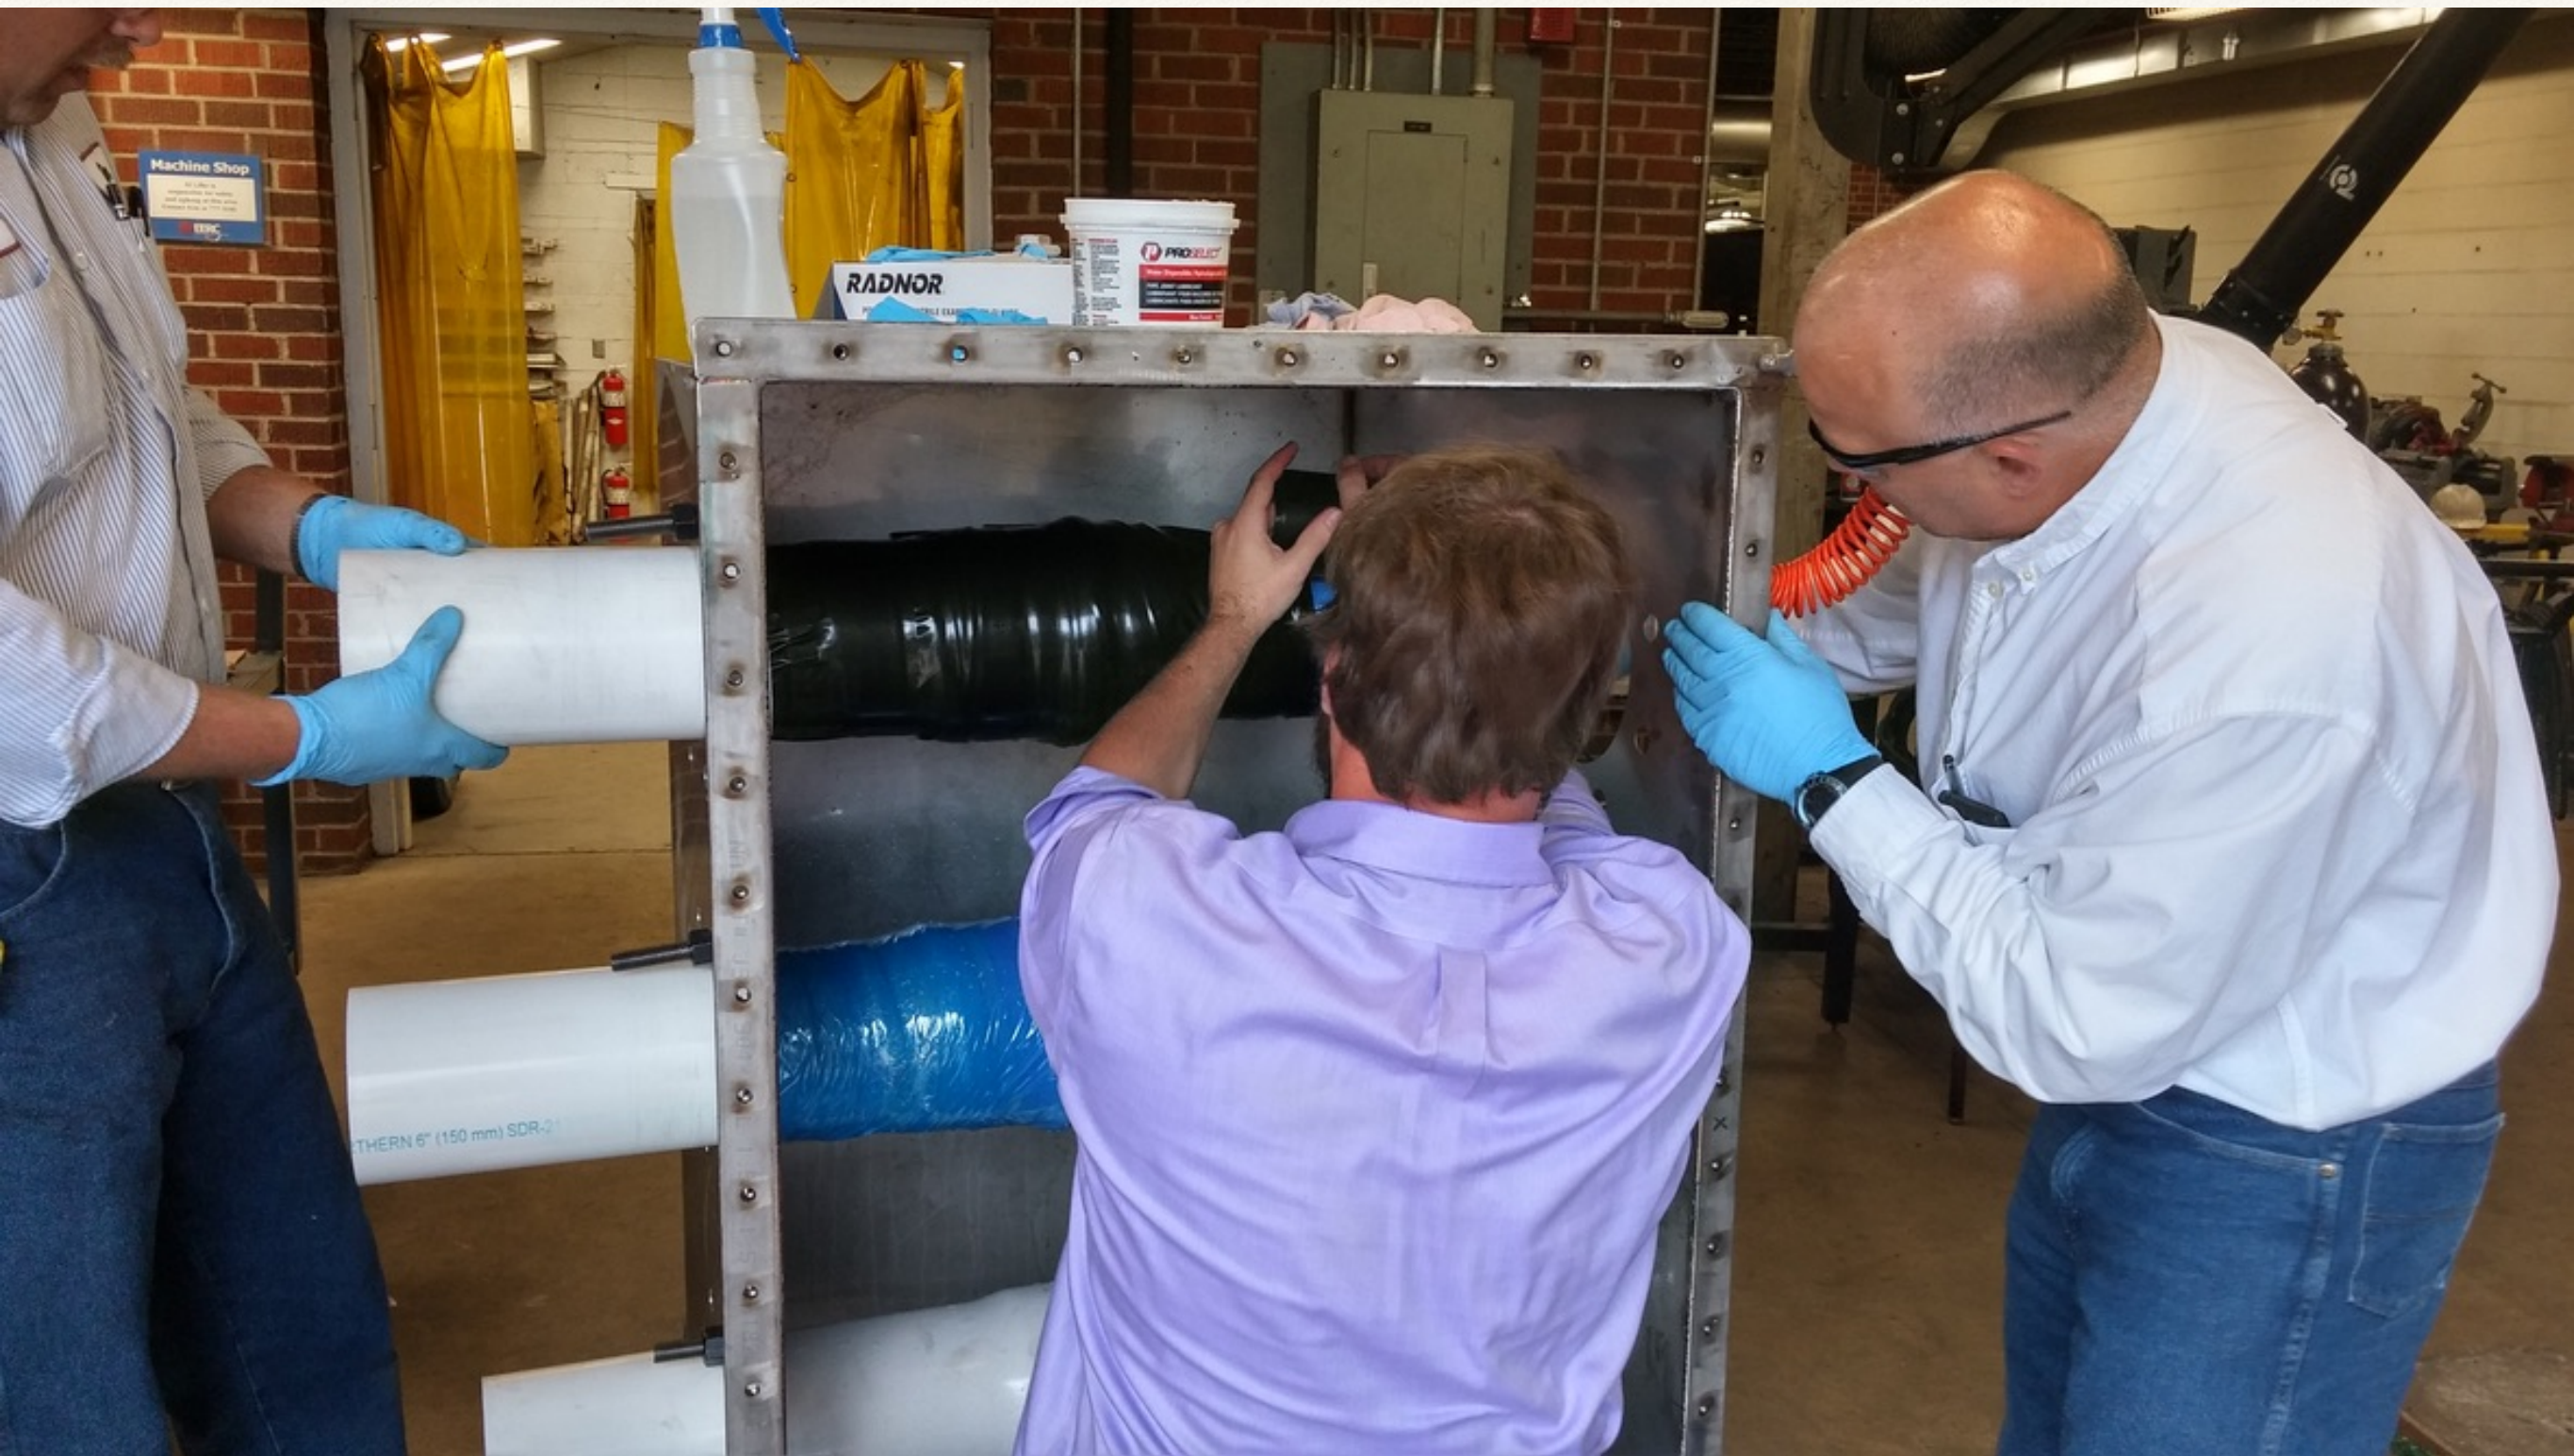
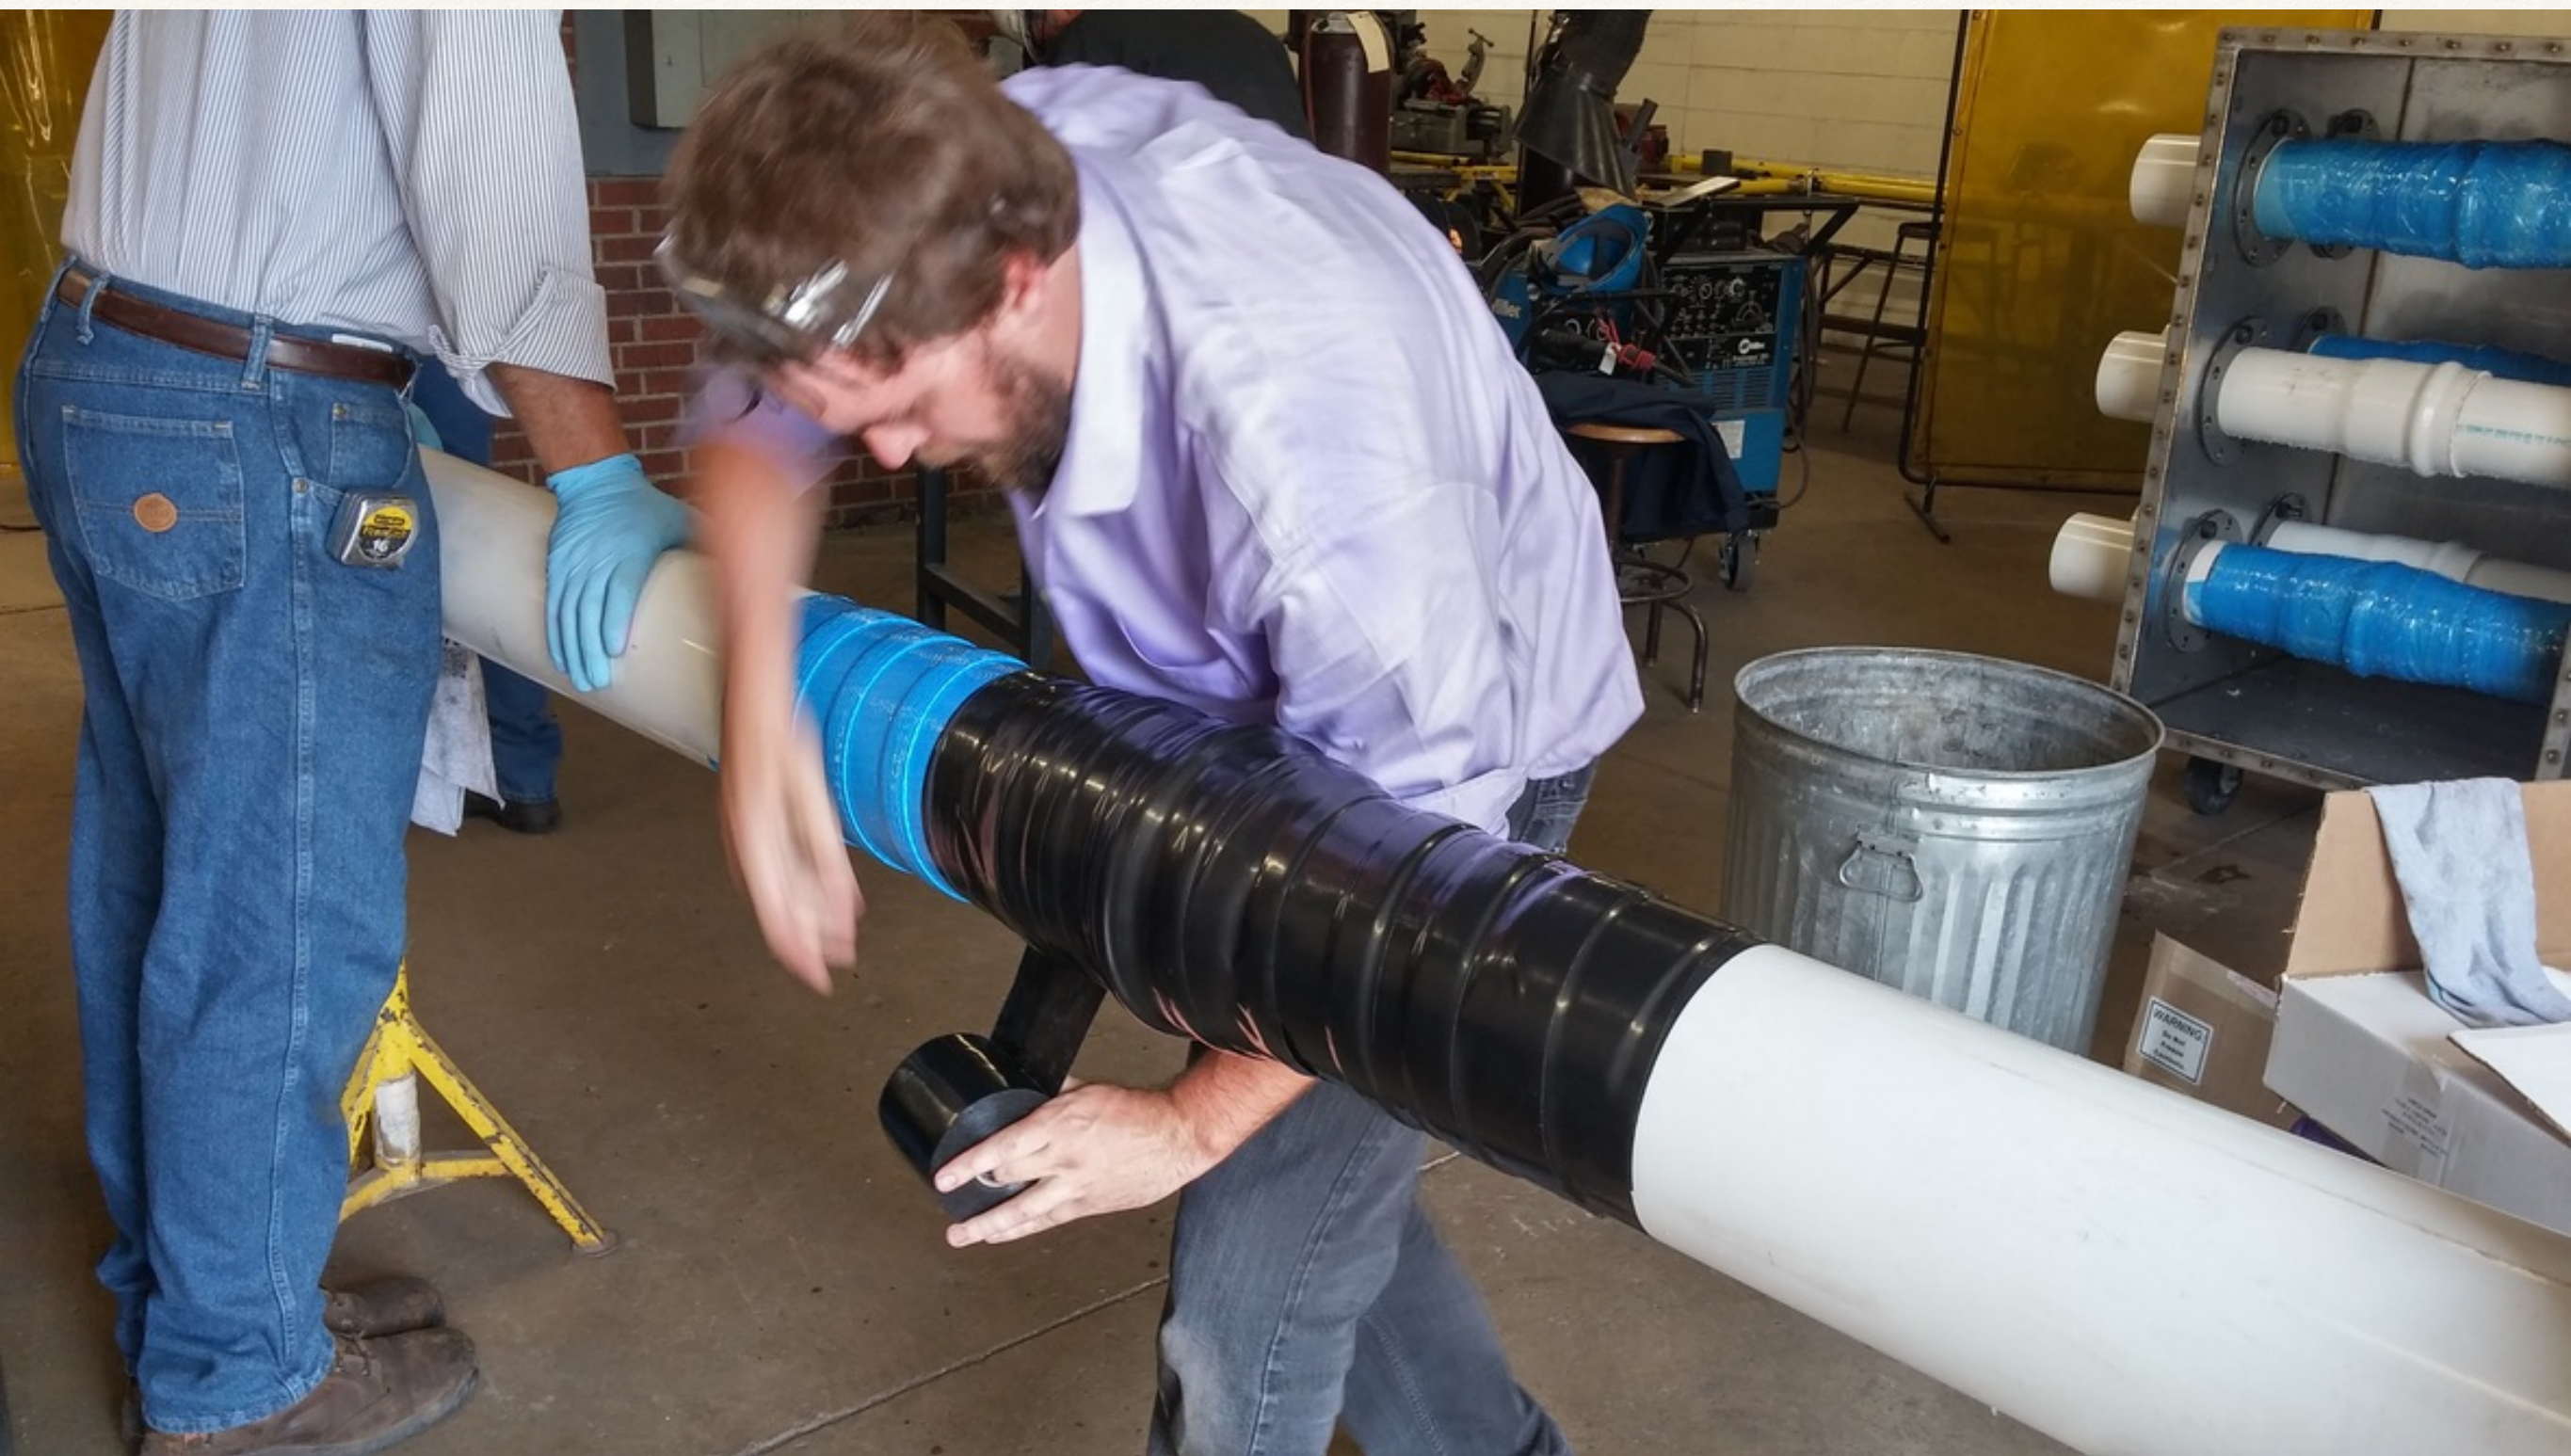
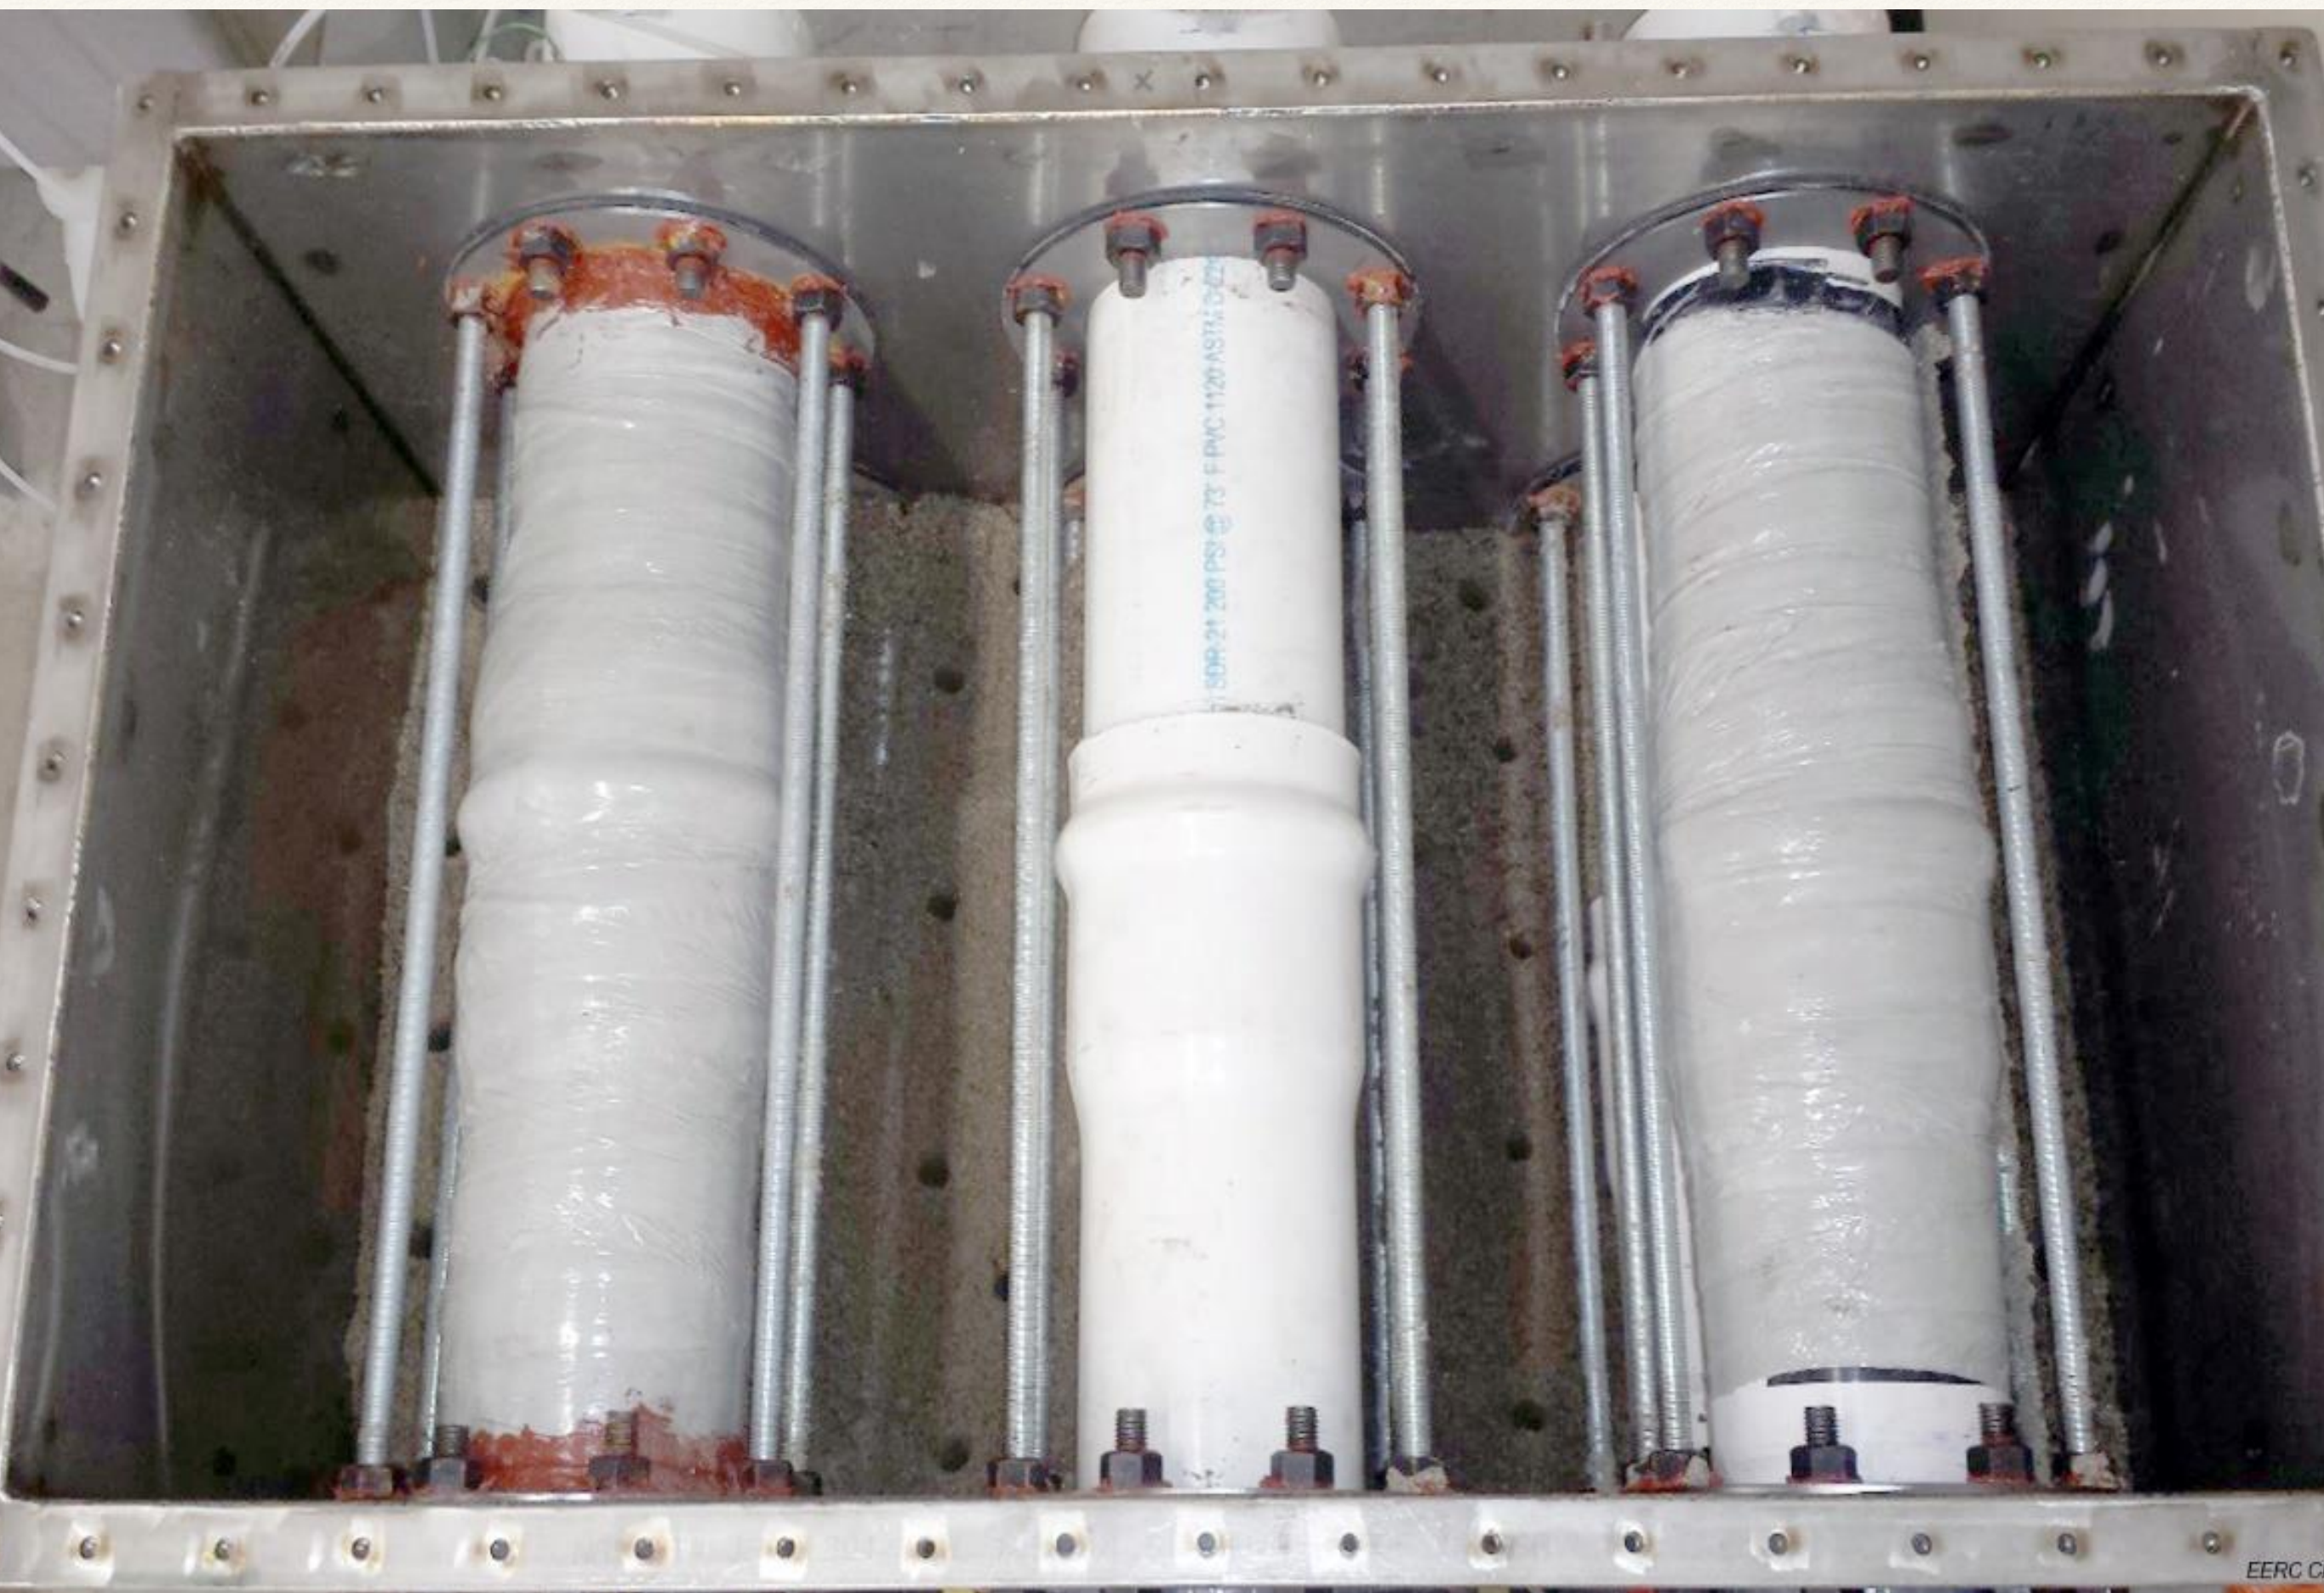
**Pipe 1:** Single wrap extending to the flanges on the internal walls of the box and sealed with silicone. Internal water pressure of 45 to 47 psi.

**Pipe 2:** No wrap. Internal water pressure of 45 to 47 psi.

**Pipe 3:** Single wrap with no silicone sealant. No internal water pressure.

**Pipe 4:** Double wrap with no silicone sealant. Internal water pressure of 45 to 47 psi.

**Pipe 5:** Single wrap with no silicone sealant. Internal water pressure of 45 to 47 psi.

**Pipe 6:** No wrap. No internal water pressure.
