# Viscous Elastic Coating for Protecting Bell & Spigot Water Lines from Crude Oil Exposure

# Improving Safety of Crude Oil and Regional Water System Pipeline Crossings

*EVALUATION OF VISCOTAQ<sup>®</sup> PIPELINE WRAP PERFORMANCE RELATED TO CRUDE OIL EXPOSURE*

Final Report

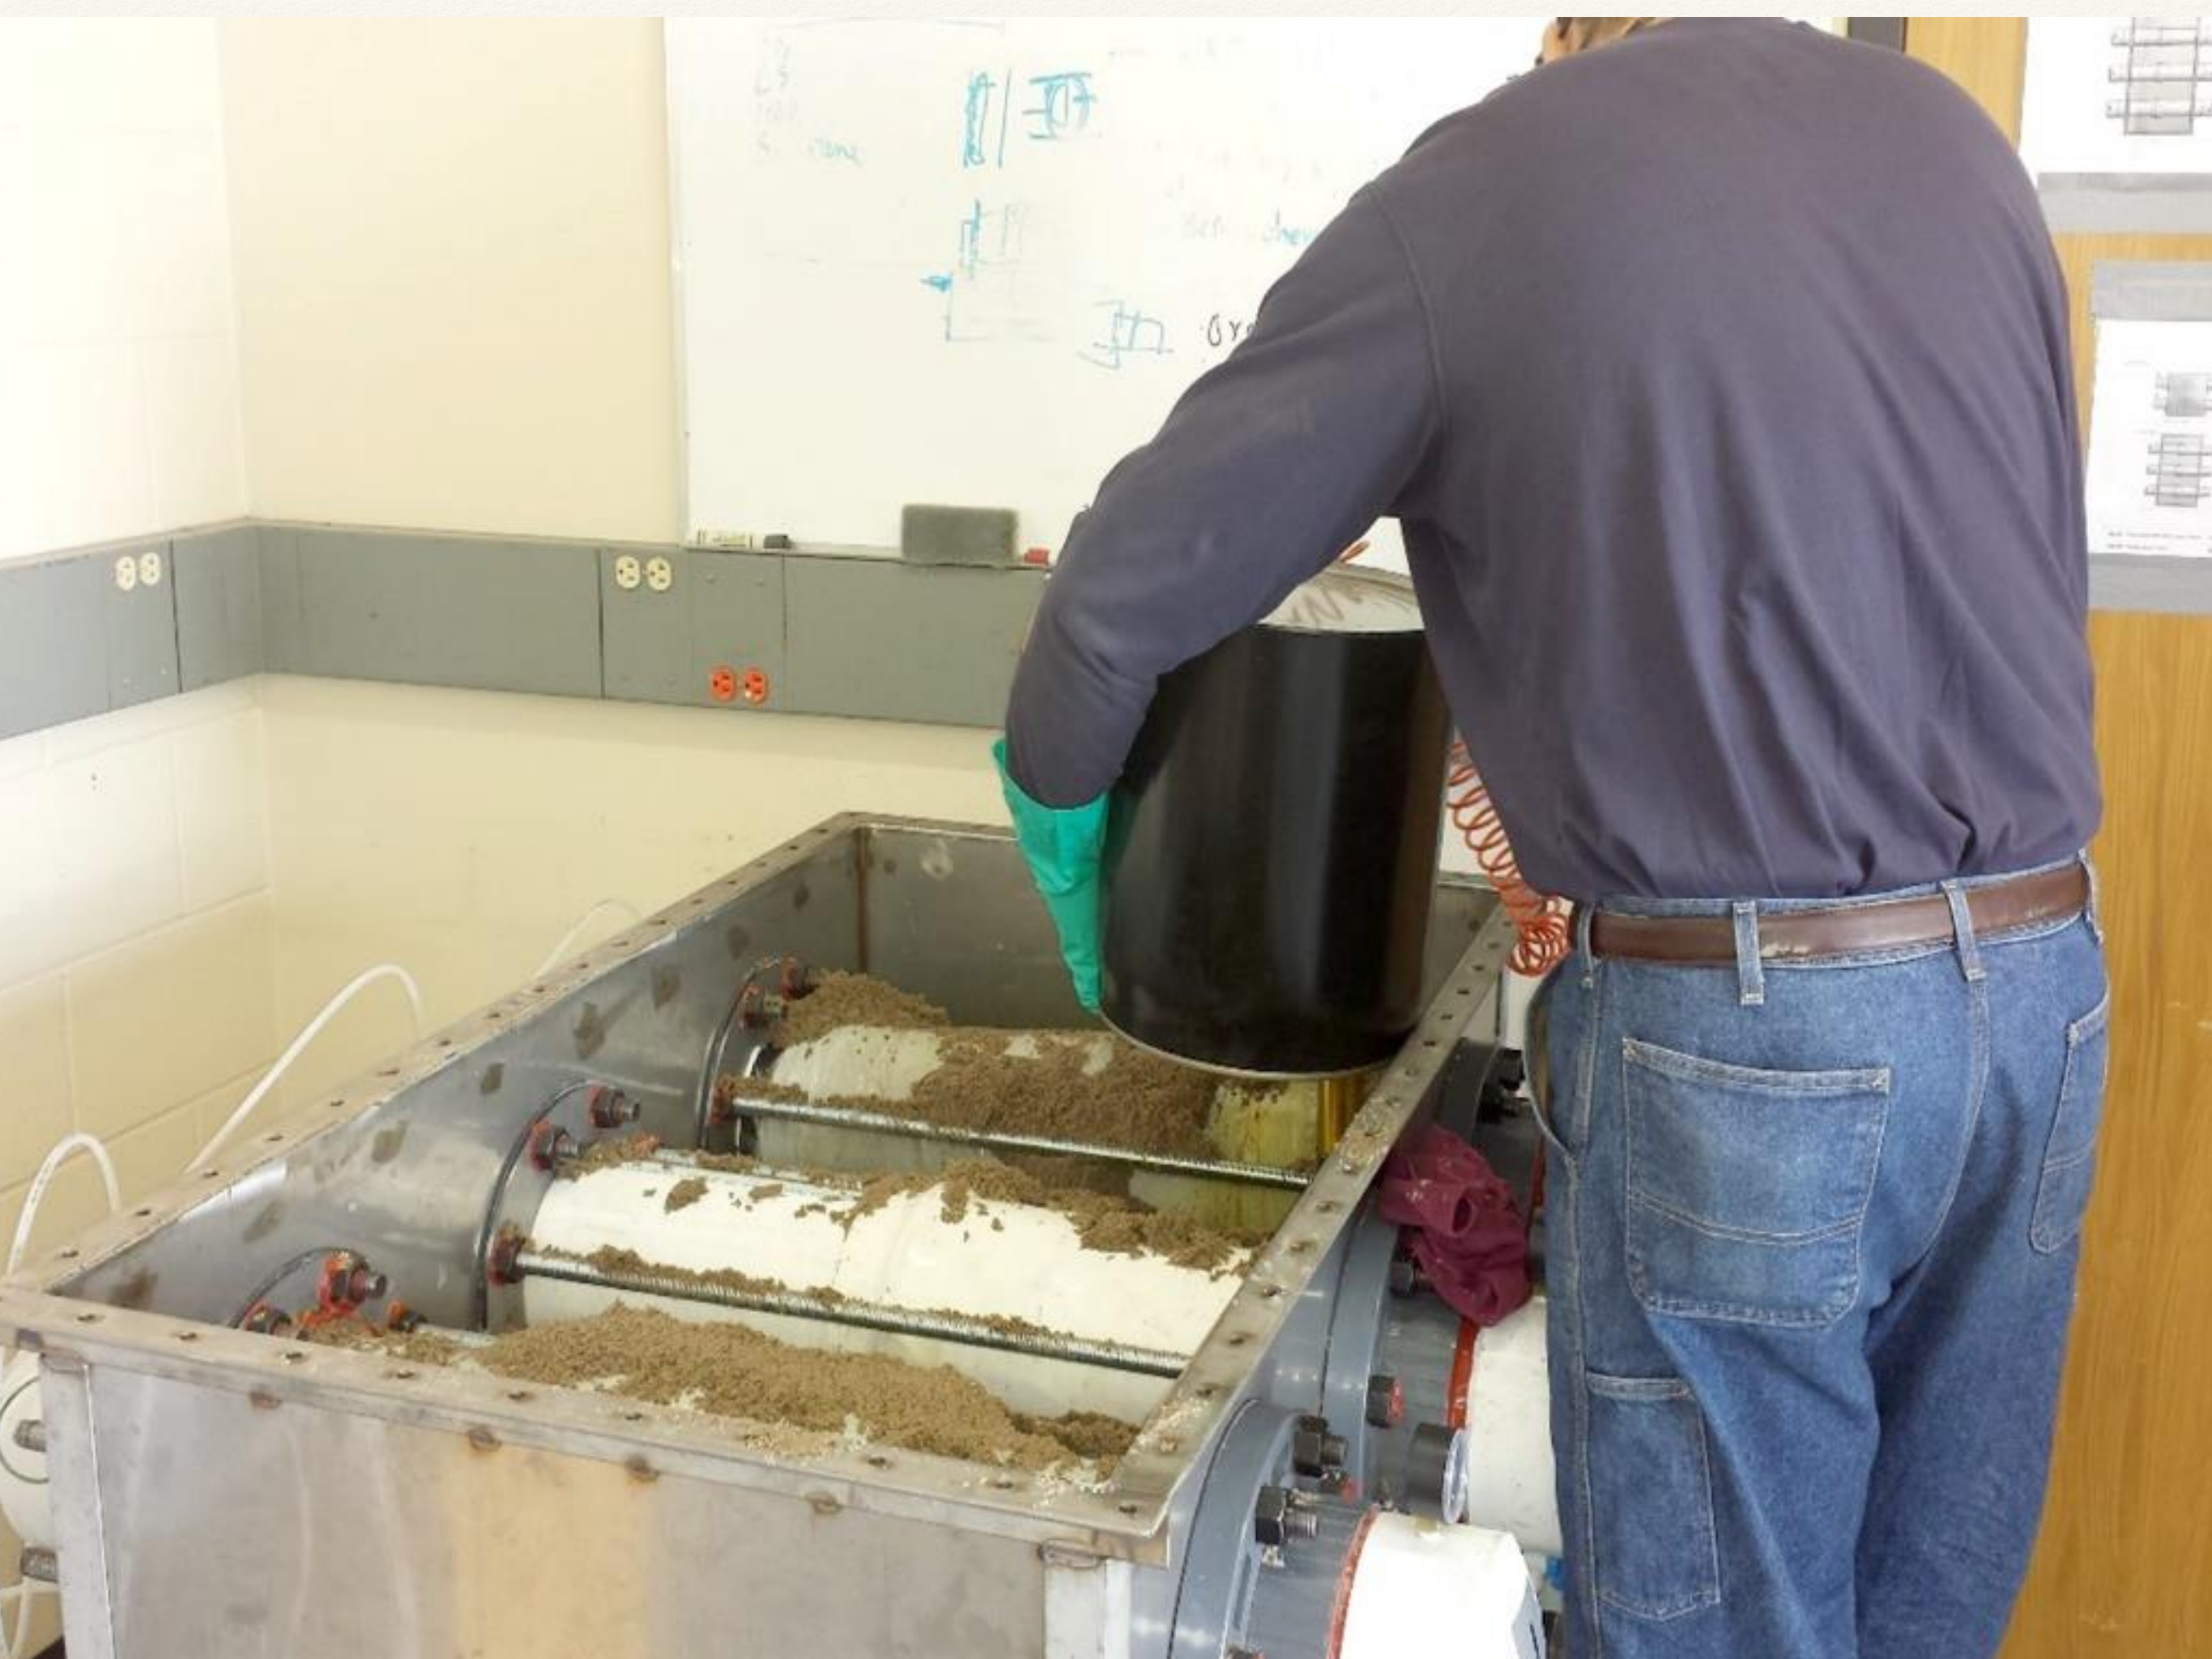
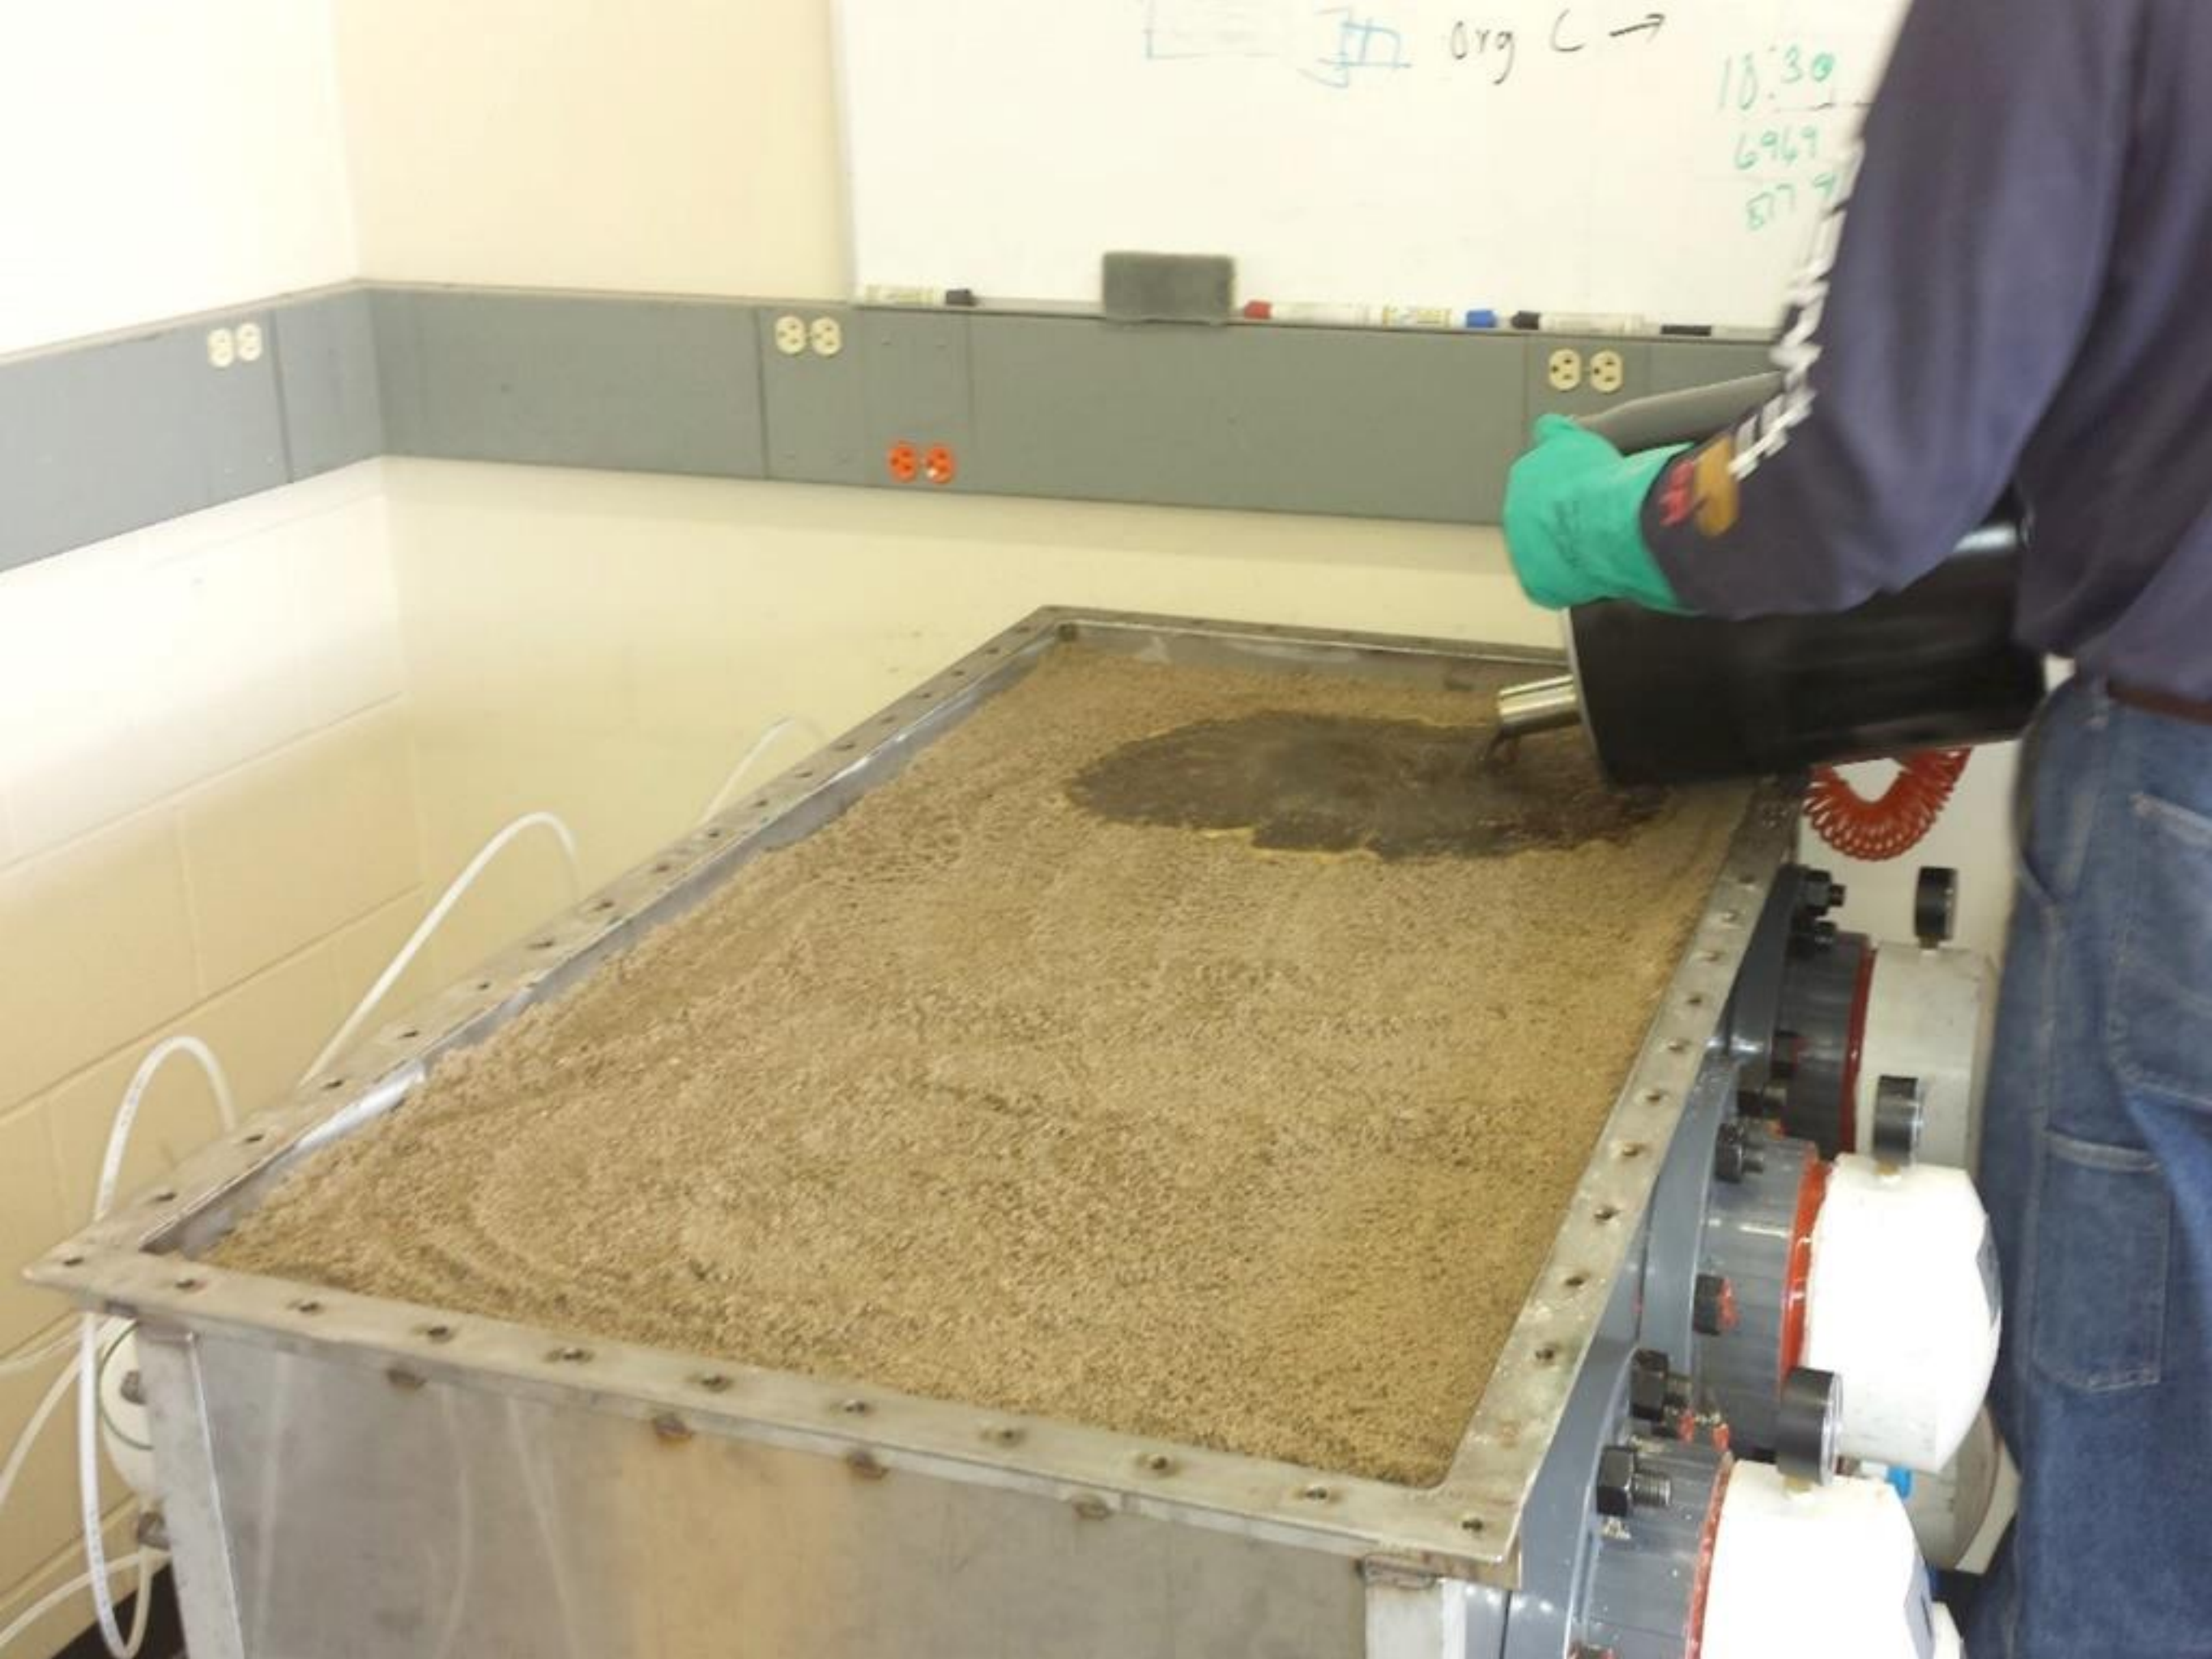
On June 11, 2015, the box was filled with a mixture of damp sand and Bakken crude oil.

- ❖ The sand and oil were added in layers by filling the box approximately one-third full with sand and then pouring 20 gallons (four 5-gallon pails) of crude slowly over the sand, and repeating. Total of 55 gallons of crude oil were used.
- ❖ The test box was covered with a stainless steel plate lined with a Viton® gasket and bolted along the edges. A pressure release valve was installed in the center of the top cover, with a pipe vent to an exhaust fan.

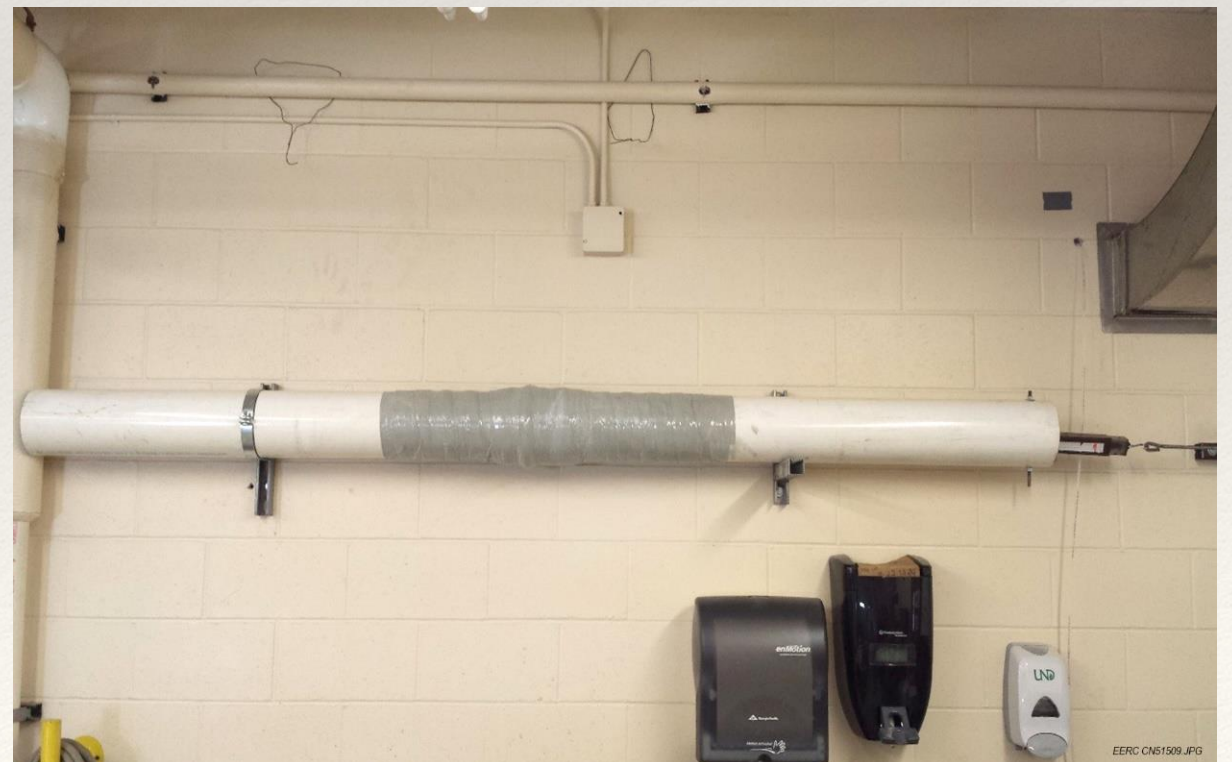
- ❖ An additional tension test was established to test and evaluate the cohesiveness of the VEC sealing system when subject to expansive and compressive stress conditions as a result of seasonal temperature fluctuations in the subsurface.

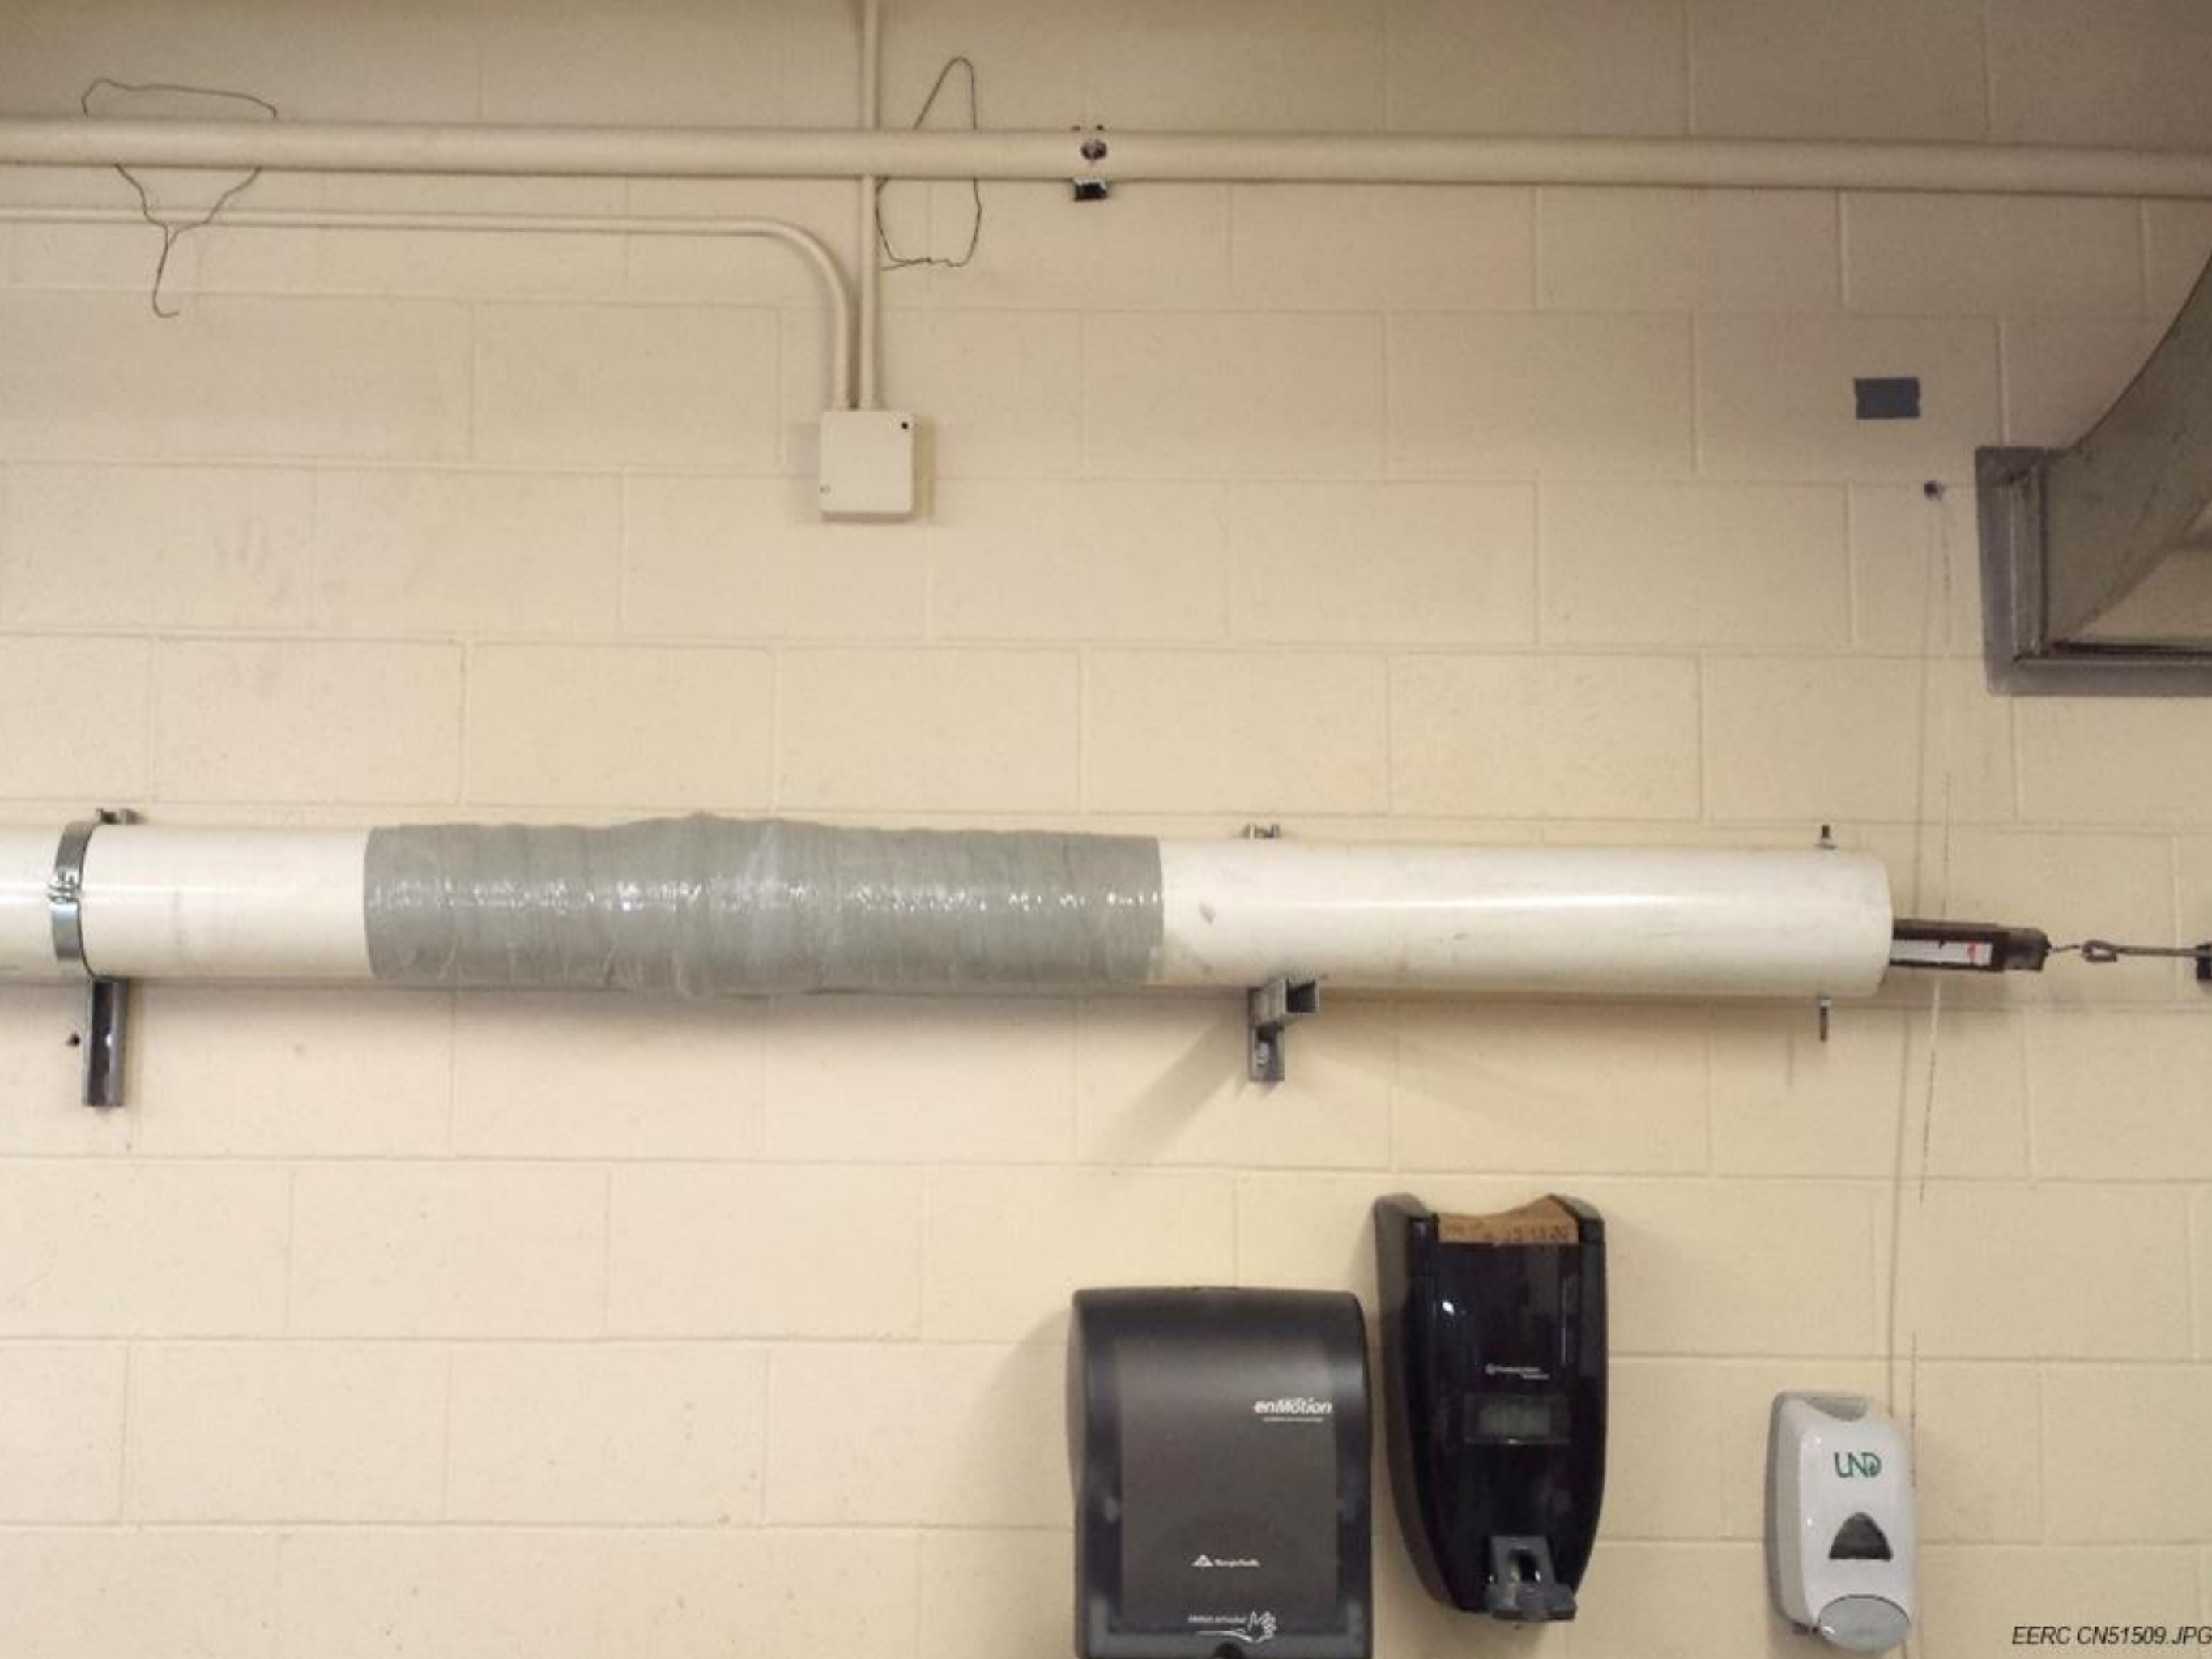
- ❖ 30 psi was applied to one end of the pipe
- ❖ One end was fixed to a stable bracket.
- ❖ Spring gauge was used to monitor the tension on the pipe
- ❖ Gauge was checked regularly for the duration of the project.
- ❖ The tension remained at 30 psi
- ❖ Conclusion: no visible changes to the pipe or the VEC pipe wrap were detected.
