MILK RIVER RIDGE RESERVOIR

Data Report 09-16-2020 for the County of Warner

Beryl Zaitlin (Zaitlin Geoconsulting Ltd.) and Leah Zaitlin (volunteer)

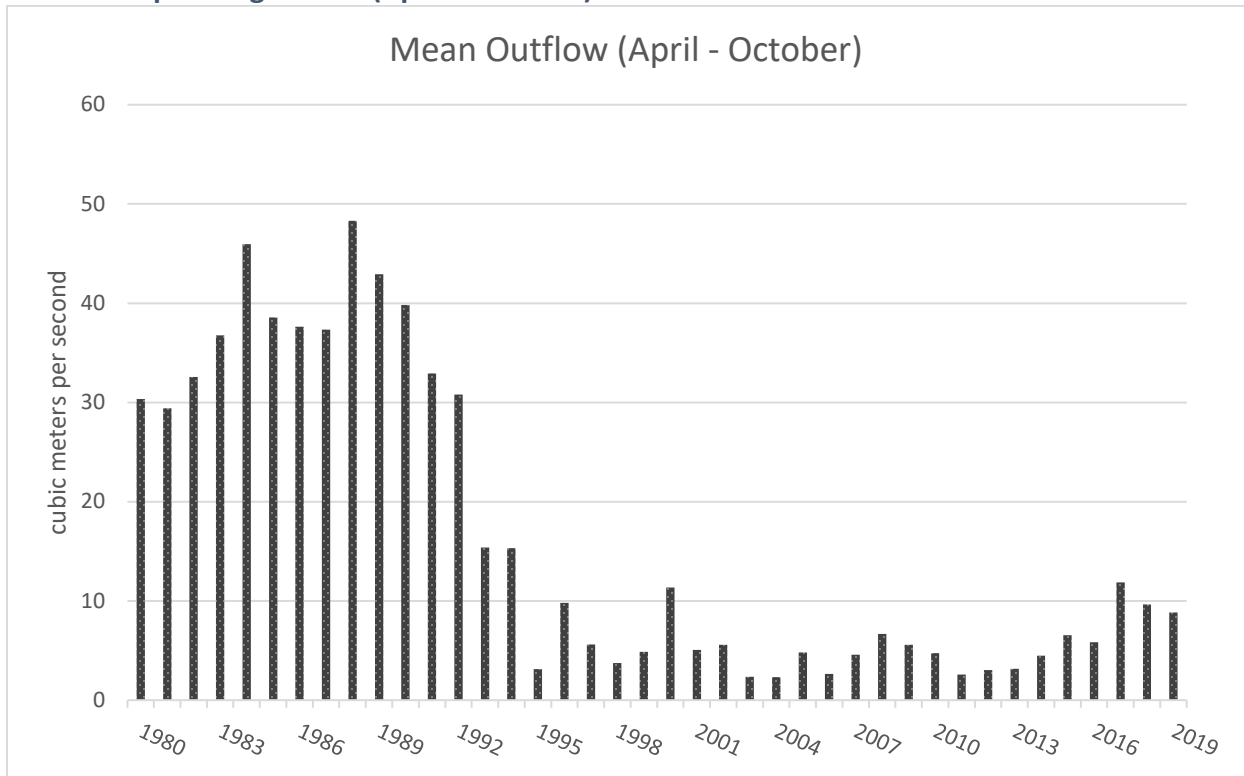
Figure 3. Mean outflow from the Milk River Ridge Reservoir through the North Outlet during the canal operating season (April – October) from 1980 to 2019

Water from the St. Mary – Milk River Ridge Headworks Canal was diverted in 1995 to provide generating power for the Raymond Reservoir Generating Station. Water from the Headworks Canal was sent through a generator and then the water was released directly to the Raymond Reservoir. Prior to the generating station being built, an average of approximately 34 m³ per second of water had to be released from the MRRR via the North Outlet during the canal operating season to maintain the reservoir at an approximately constant volume of 95,000 cubic decameters (dam³). After the diversion, an average of approximately 5.5 m³ per second of water had to be released through the North Outlet to maintain the storage volume in the reservoir during the canal operating season (Figure 3) (M. Sabur, AEP, pers. comm.).
